# MONTANA DEPARTMENT OF TRANSPORTATION STREAM MITIGATION MONITORING REPORT

*North Fork Bear Creek  
Ravalli County, Montana*

*Year Project Completed: 2011  
Monitoring Report #5: Submitted December, 2017*

MDT Project Number: NH-7-1(114)56  
Control Number: 2015 003

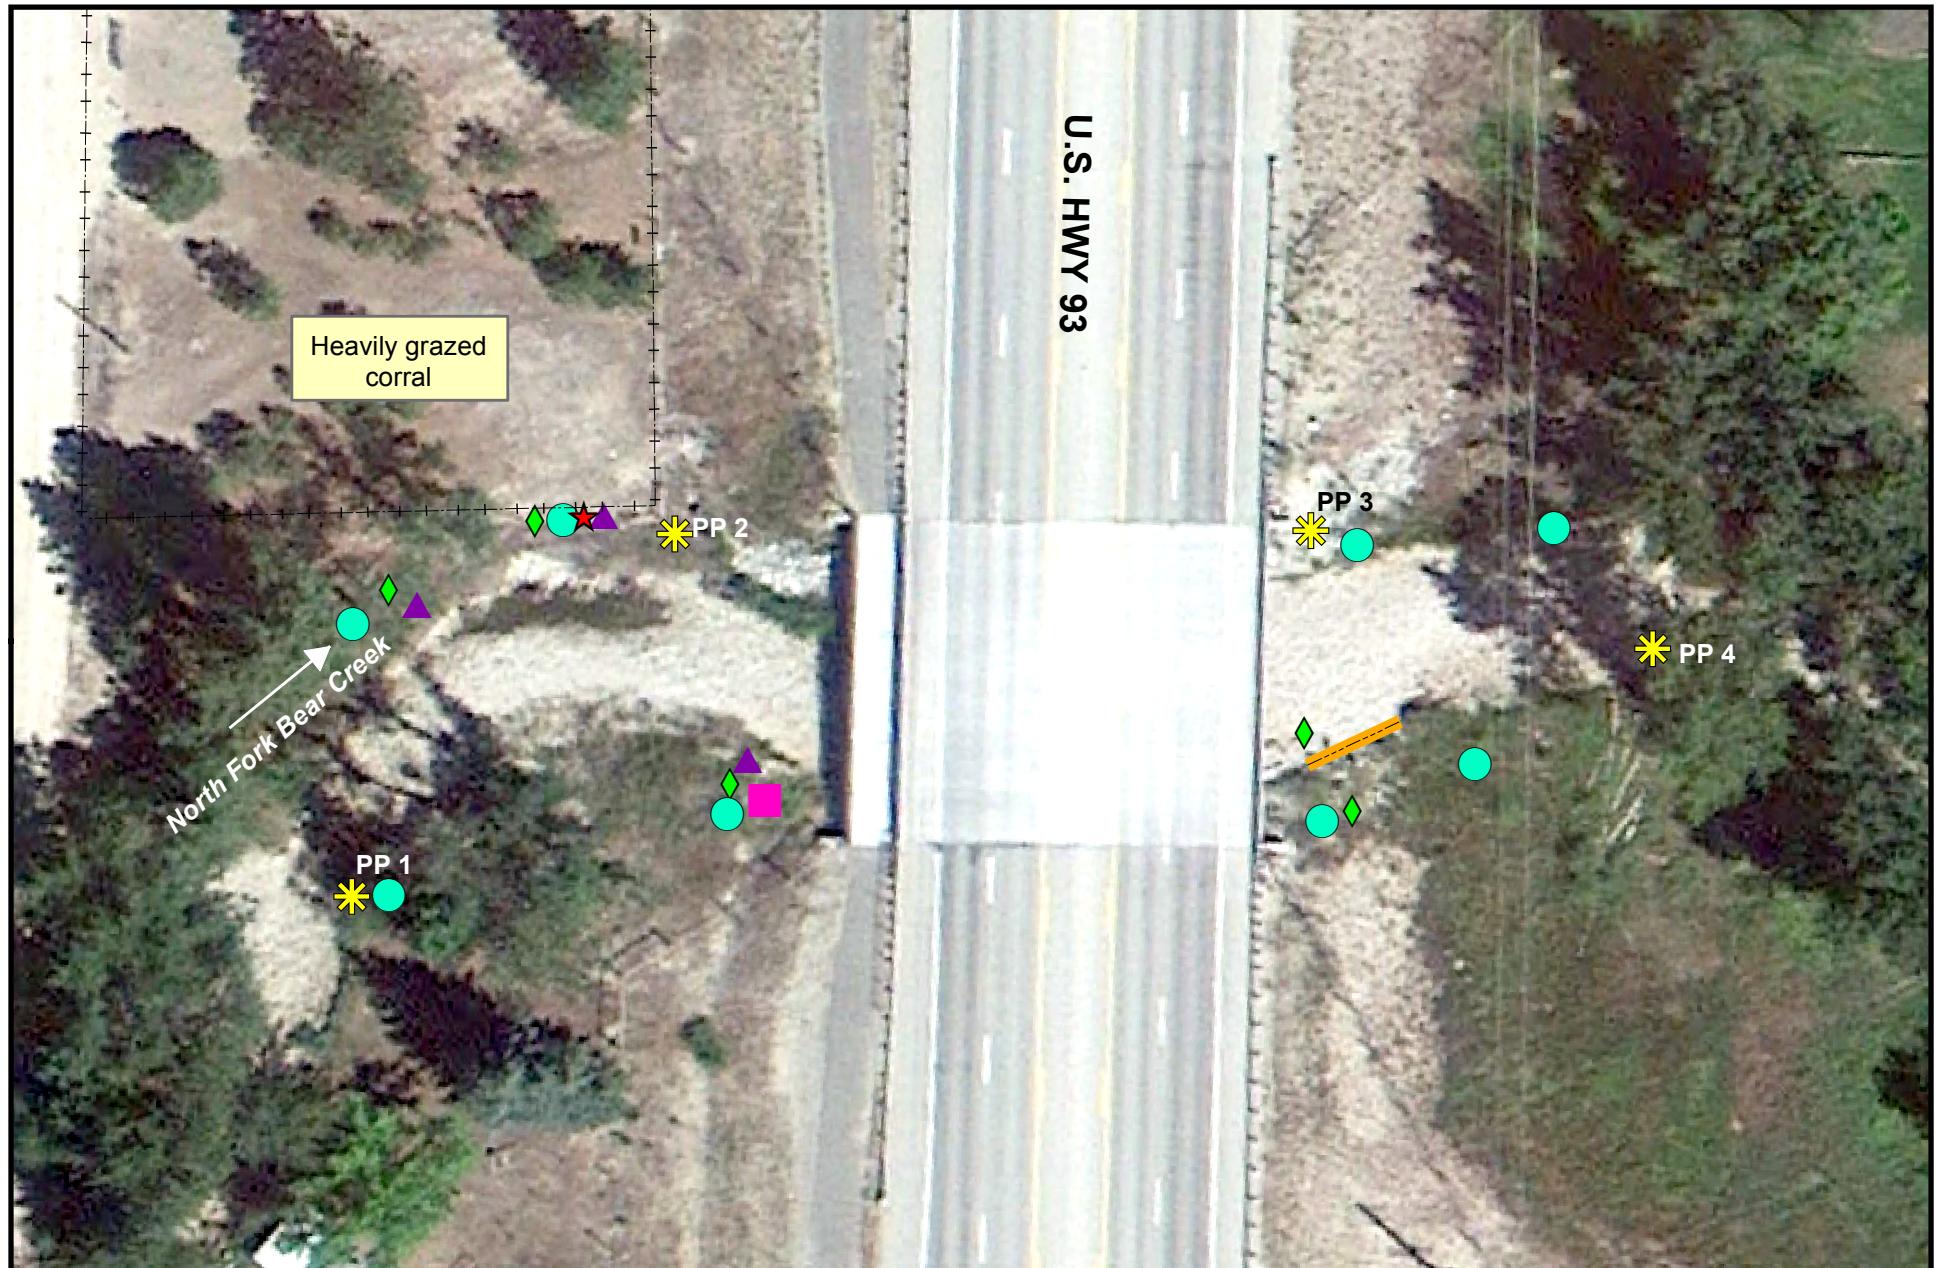
Figure 2

Field examination of the North Fork Bear Creek project site documented one actively eroding stream bank within the project area. This newly eroding bank segment occurs immediately downstream of the Highway 93 Bridge on the right (south) bank. Erosion was noted along approximately 22' of the bank, which exhibits signs of undercutting and bank sloughing. The bank consists of cobble and gravel material and is vegetated with a mixture of herbaceous and woody species including common yarrow (*Achillea millefolium*), narrow-leaf cottonwood (*Populus angustifolia*), woods rose (*Rosa woodsii*), and spotted knapweed (*Centaurea stoebe*). Based on photo documentation, it appears the bank has retreated by approximately 1-2 feet in the past year (see photo points 3.2 and 3.3 in Appendix B). The relatively short extent of erosion and lack of infrastructure in jeopardy of being damaged by continued erosion here makes stabilization or correction efforts unwarranted at this time. No other erosion was noted along the project reach and all root wads installed appear to be intact and preventing lateral channel movement.

One relatively short bank segment appears to have retreated by approximately two feet in the past year. The eroding bank segment is 22 feet long and represents 5% of the overall bank length (not including banks beneath the highway bridge). This erosion is relatively short and does not currently jeopardize any infrastructure; as such, its repair is unwarranted at this time.

Many infestations of noxious weeds were observed along both banks of the project reach. Although each individual weed infestation is relatively small in extent, the area of all infestations combined warrants concern and must be addressed to achieve the success criterion for riparian cover. Future weed management efforts should take into account the presence of wildlife friendly fencing along the riparian corridor upstream and downstream of the U.S. 93 Bridge over the North Fork of Bear Creek.

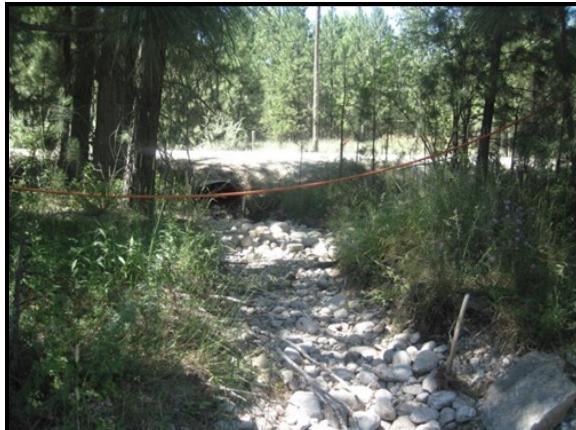
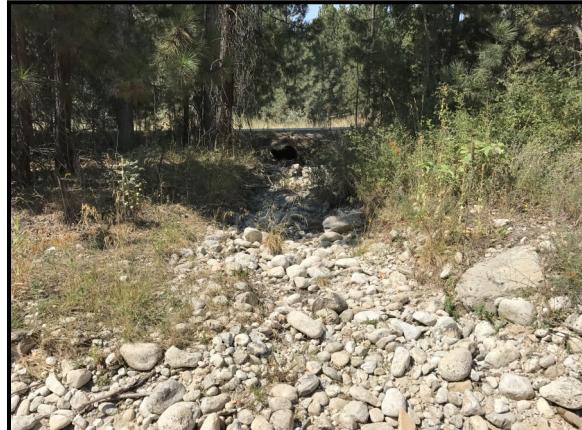
**Photo Point 1.1:** View of tributary/culvert entering from west. **Compass:** 270 (West)

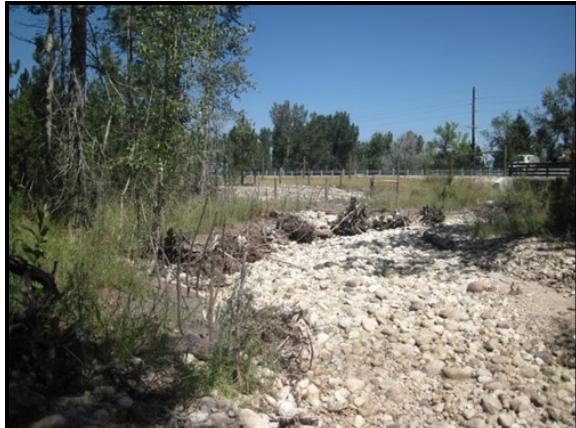
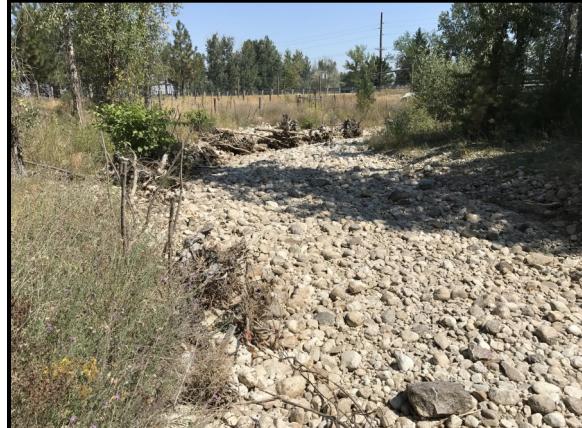
**Photo Point 1.2:** View of north streambank looking downstream. **Compass:** 45 (Northeast)

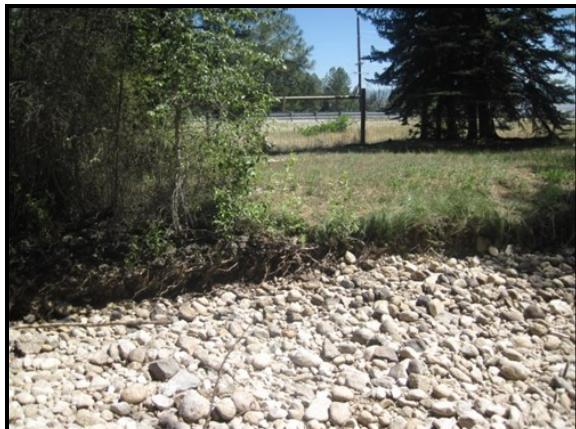
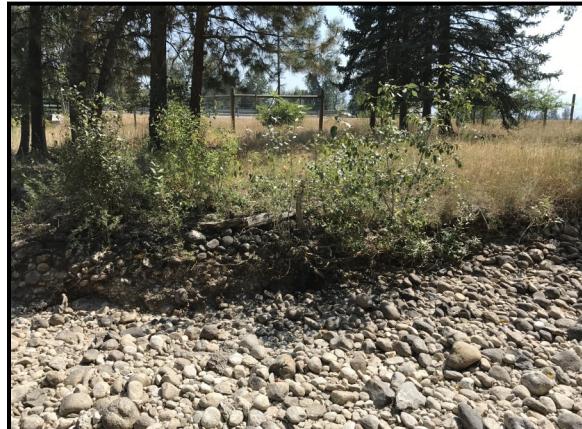
**Photo Point 1.3:** View of north streambank. **Compass:** 90 (East)

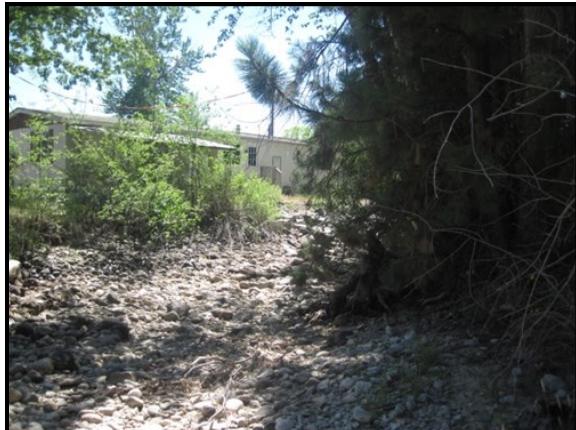
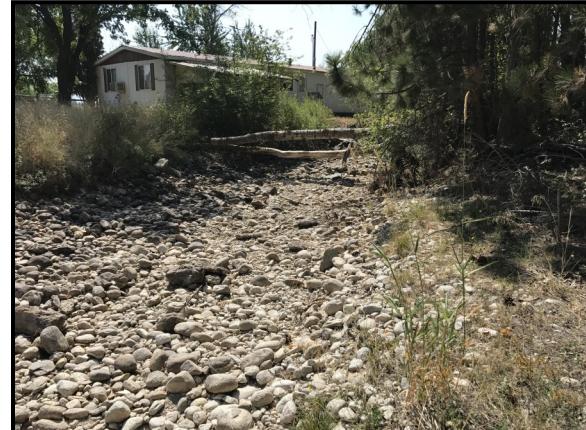
**Photo Point 1.4:** View of dry channel looking upstream. **Compass:** 230 (Southwest)

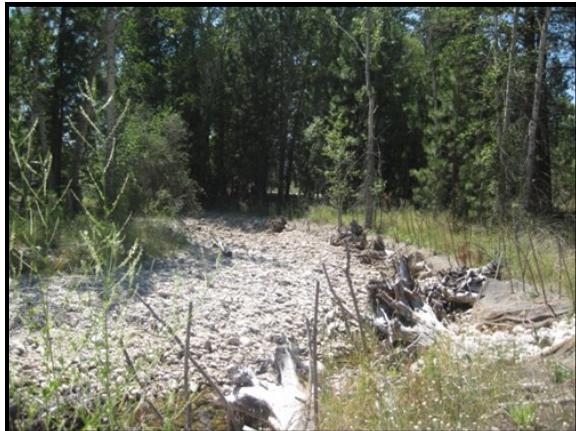
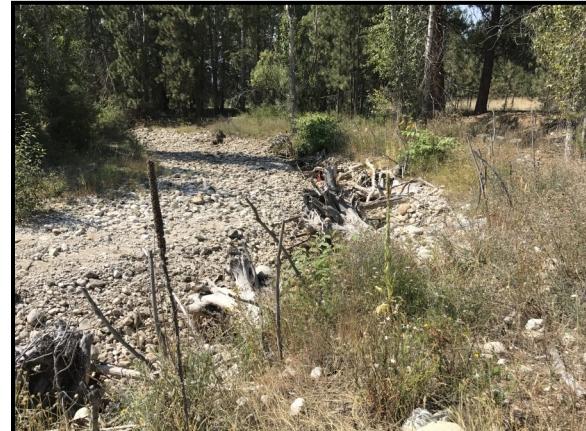
Root wads placed along the north bank both upstream and downstream of the bridge appear stable. Cobble placed atop one of the rootwads upstream of the bridge appeared to have partially washed out during 2014; however no additional bank erosion has been noted in this area during the past three years. Given the integrity of the channel, no measures are currently warranted to improve bank stability within the project reach, and the project site is currently meeting success criteria for bank stability.

**Photo Point 2.1:** View of root wads on north bank. **Compass:** 225 (Southwest)

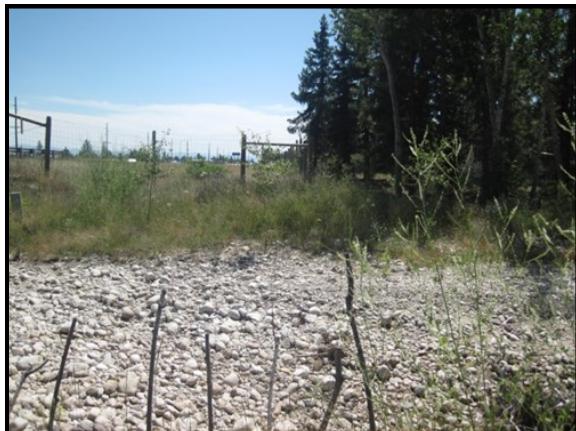
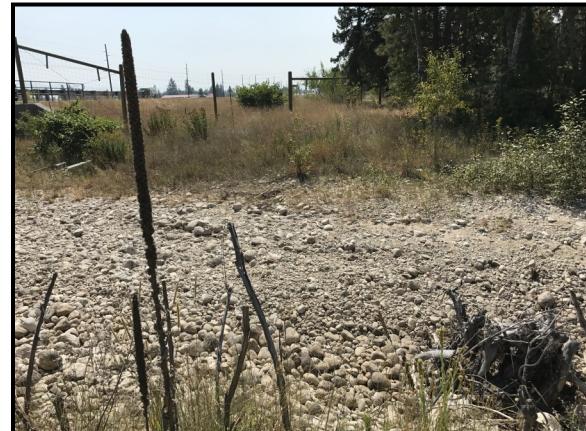
**Photo Point 2.2:** View across channel of south streambank. **Compass:** 180 (South)

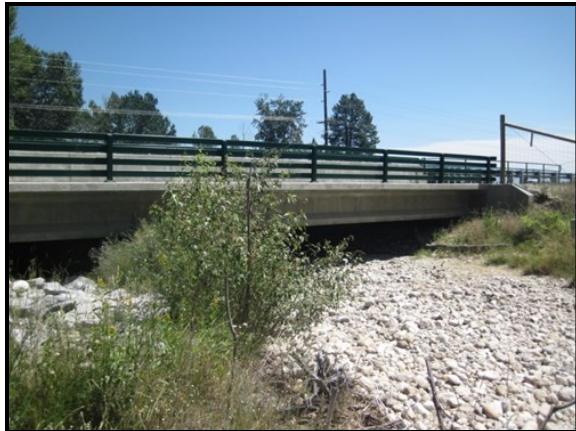
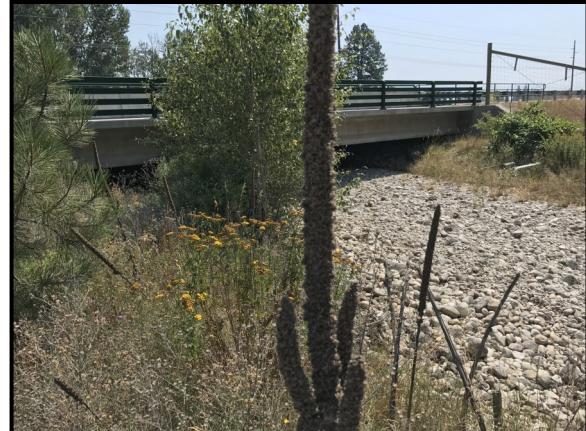
**Photo Point 2.3:** View from north bank looking across channel. **Compass:** 135 (Southeast)

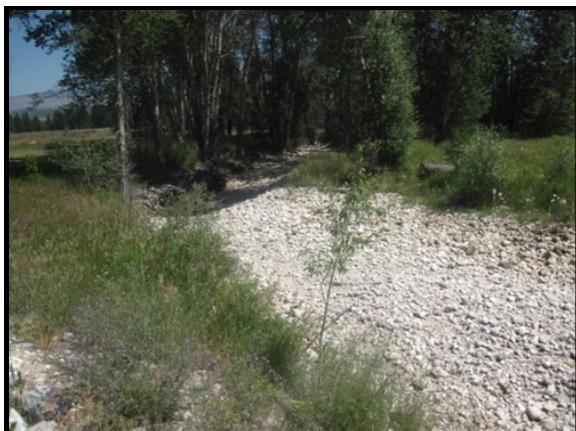
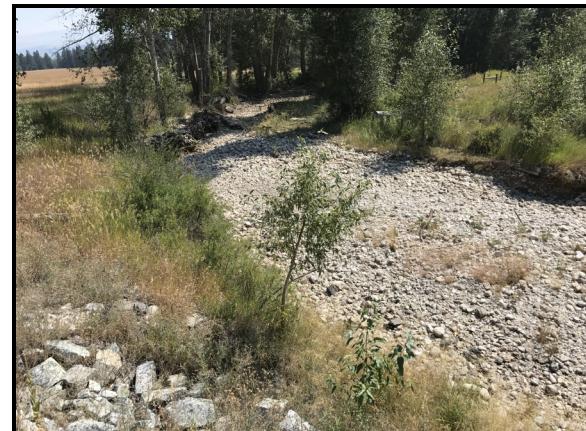
**Photo Point 3.1:** View downstream from north bridge abutment. **Compass:** 90 (East)

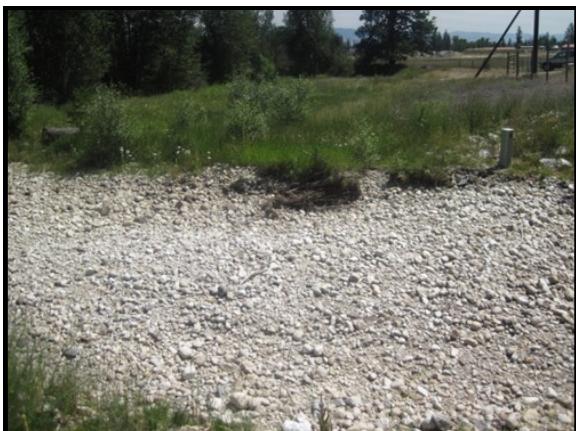
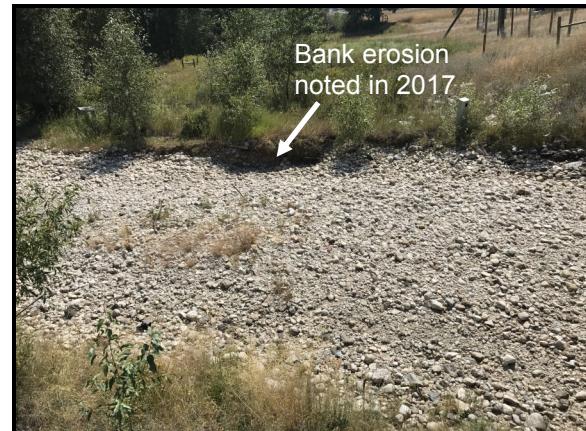
**Photo Point 3.2:** View of south streambank from left abutment. **Compass:** 135 (Southeast)

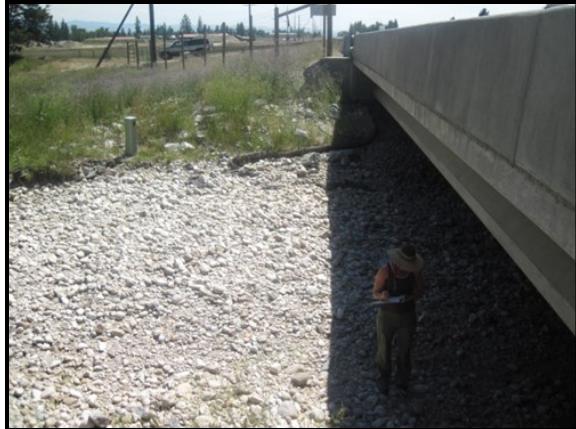
**2013**  
**Photo Point 3.3:** View across channel of south bank from north bridge abutment. **Compass:** 180 (South)

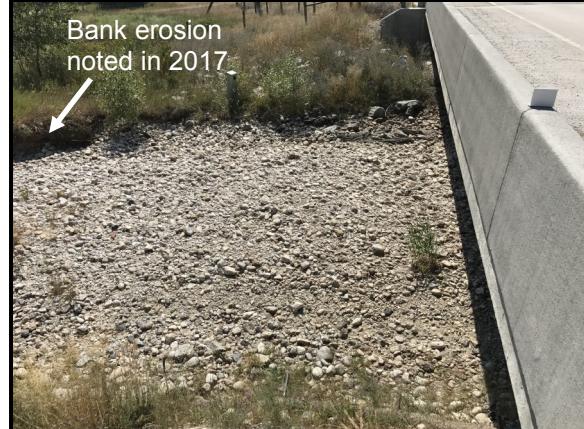
**2017**  
**Photo Point 3.3:** View across channel of south bank from north bridge abutment. **Compass:** 180 (South)

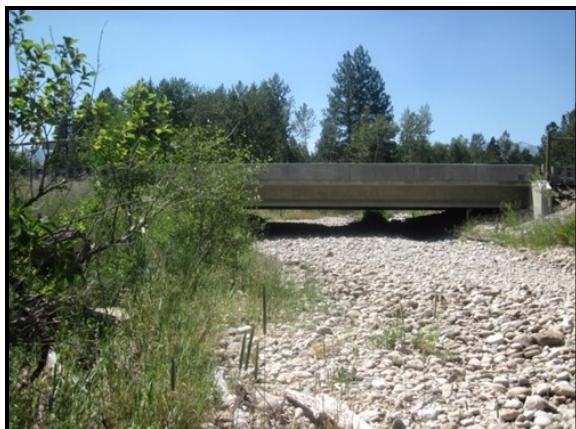
**2013**  
**Photo Point 4.1:** View from south bank looking upstream from downstream extent. **Compass:** 270 (West)

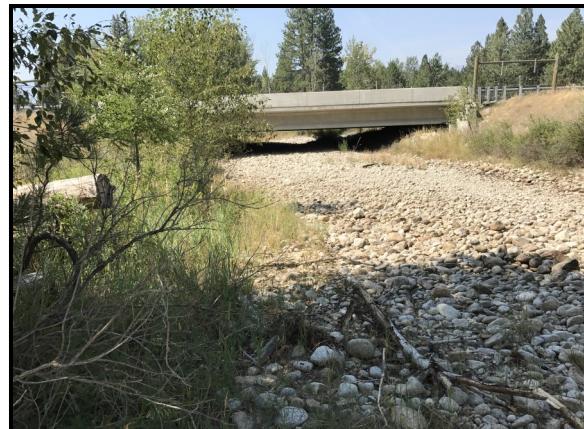
**2017**  
**Photo Point 4.1:** View from south bank looking upstream from downstream extent. **Compass:** 270 (West)

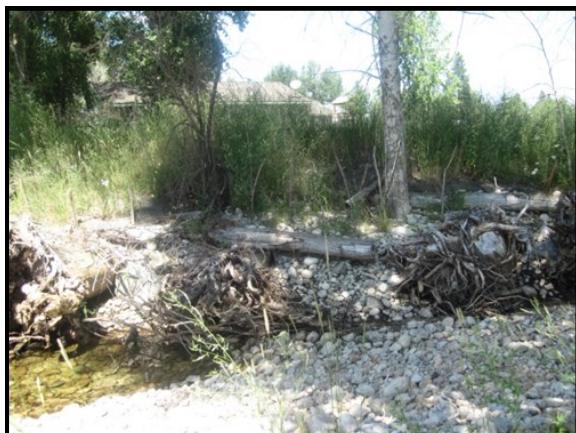
**2013**  
**Photo Point 4.2:** View of root wads on north bank downstream of bridge. **Compass:** 0 (North)

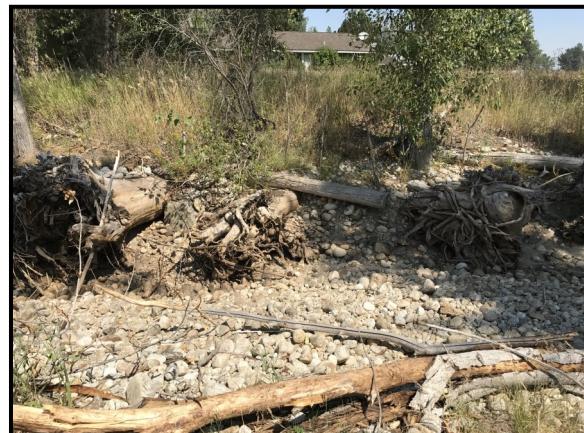
**2017**  
**Photo Point 4.2:** View of root wads on north bank downstream of bridge. **Compass:** 0 (North)

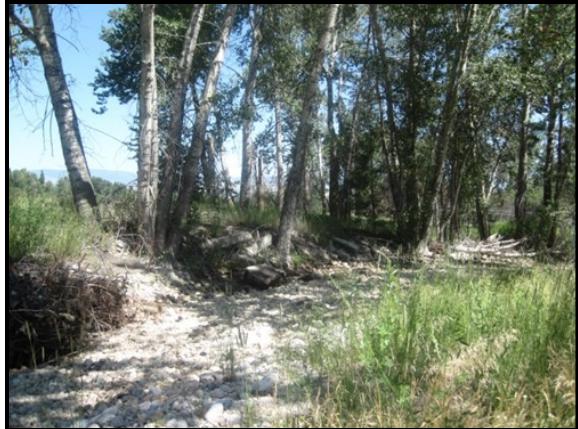
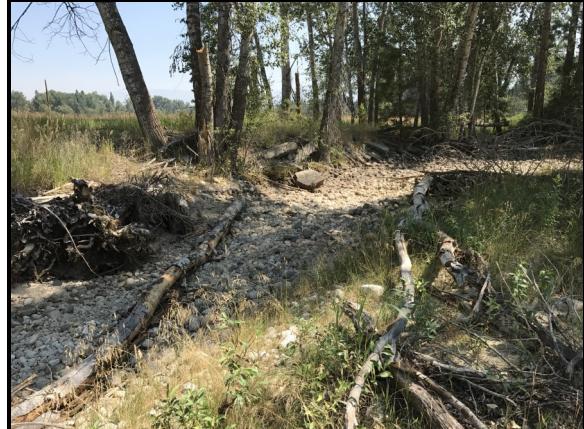
**Photo Point 4.3:** View of north bank from downstream extent of project site. **Compass:** 68 (East-Northeast)
