MONTANA DEPARTMENT OF TRANSPORTATION STREAM MITIGATION MONITORING REPORT

*Ashley Creek
Flathead County, Montana*

*Project Completed: 2010
Monitoring Report #4: December, 2018*

MDT Project Number: NH-MT 5-3(59) FST
Control Number: 2038

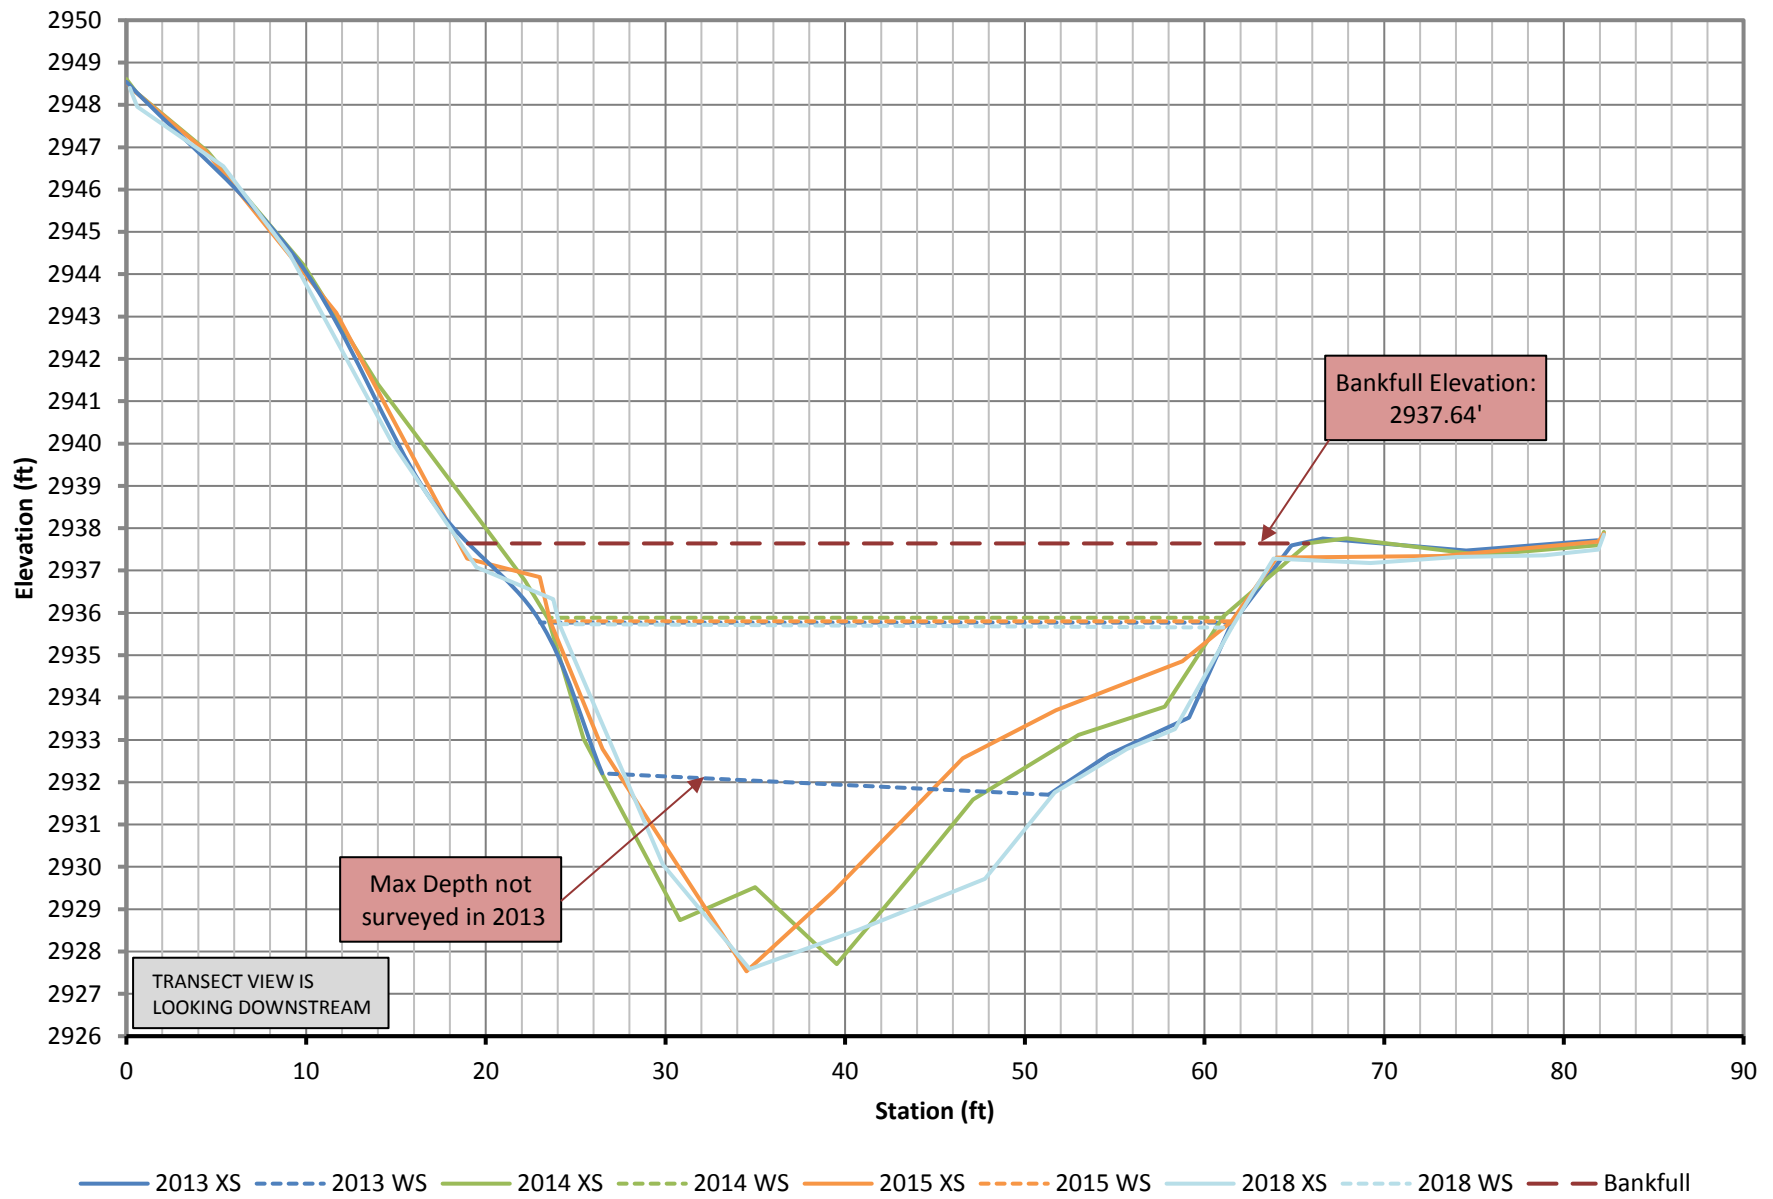
Ashley Creek Transect #1 - Pool

The longitudinal profile indicates three distinct pools occur within the reach, and have maintained their depths throughout the monitoring period. A deep pool exists at the upstream end of the project reach, where the newly aligned segment of Ashley Creek turns east. Transect #1 runs through this pool, which is formed by a tight meander bend in the channel generating scour against the riprapped north bank. This pool exhibits a bankfull width of 45.5 feet, maximum depth of 10.1 feet, with a well-developed floodplain bench on the south side of the channel. Surveys indicate the point bar along the right (south) bank initially extended northward, but has since retreated. It should be noted the left (north) bank of this transect has been riprapped. Surveying through riprap can often lead to varying results based on the exact location of surveyed points; therefore elevation changes along the left bank are not attributed to bank retreat or erosion.

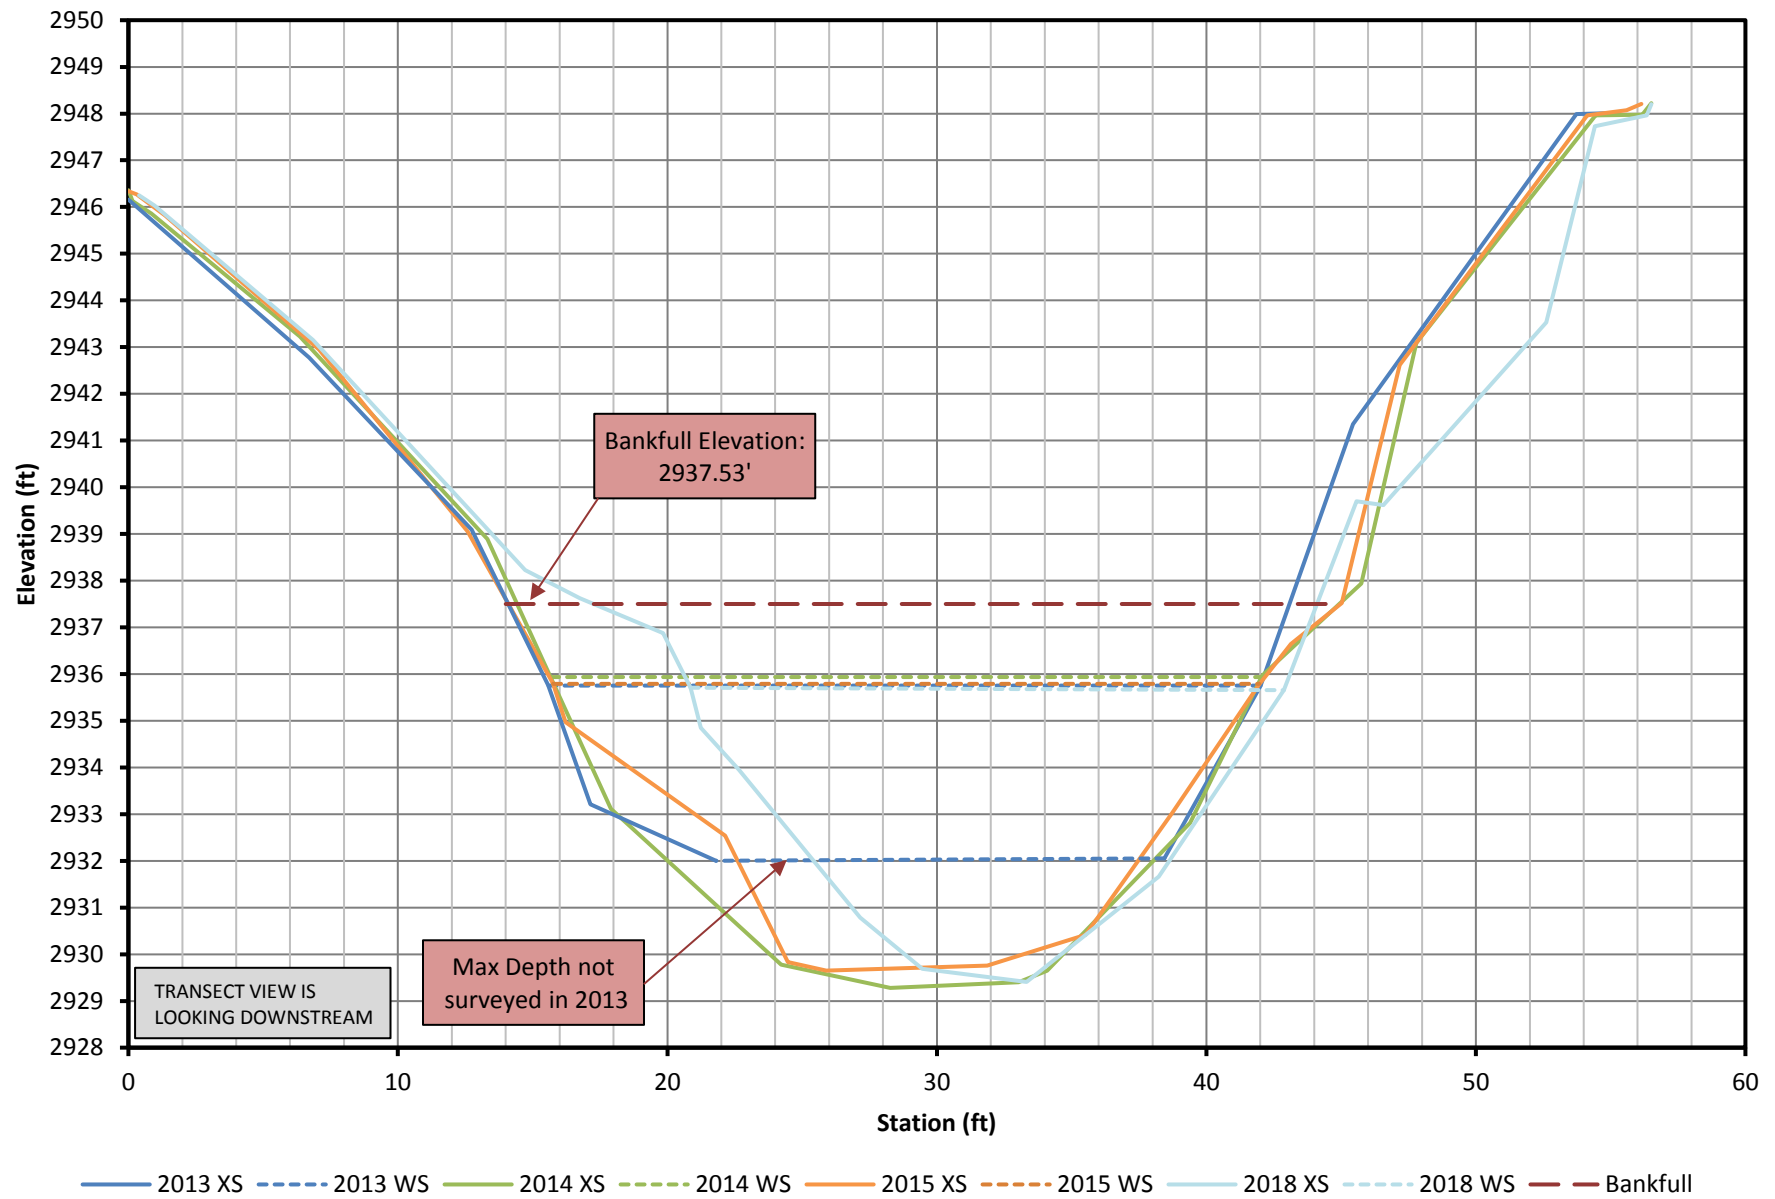
Ashley Creek Transect #2 - Pool

Transect #2 runs through a second pool which has formed along a straight channel segment between Station 1+40 and 2+30. The bankfull width of the channel at Transect #2 has reduced from 31 to 26.5 feet due to a bar developing on the left (north) side of the channel. The developing bar is immediately downstream of a culvert outlet that was repaired in 2015 by placing additional rock along the toe of the bank. This rock may be contributing to the bar development, which is likely to direct water toward the south bank. This bank (EBR1-2) shows continued signs of instability and bank sloughing; however the clay lens at the bank toe has protected it from more severe lateral migration.

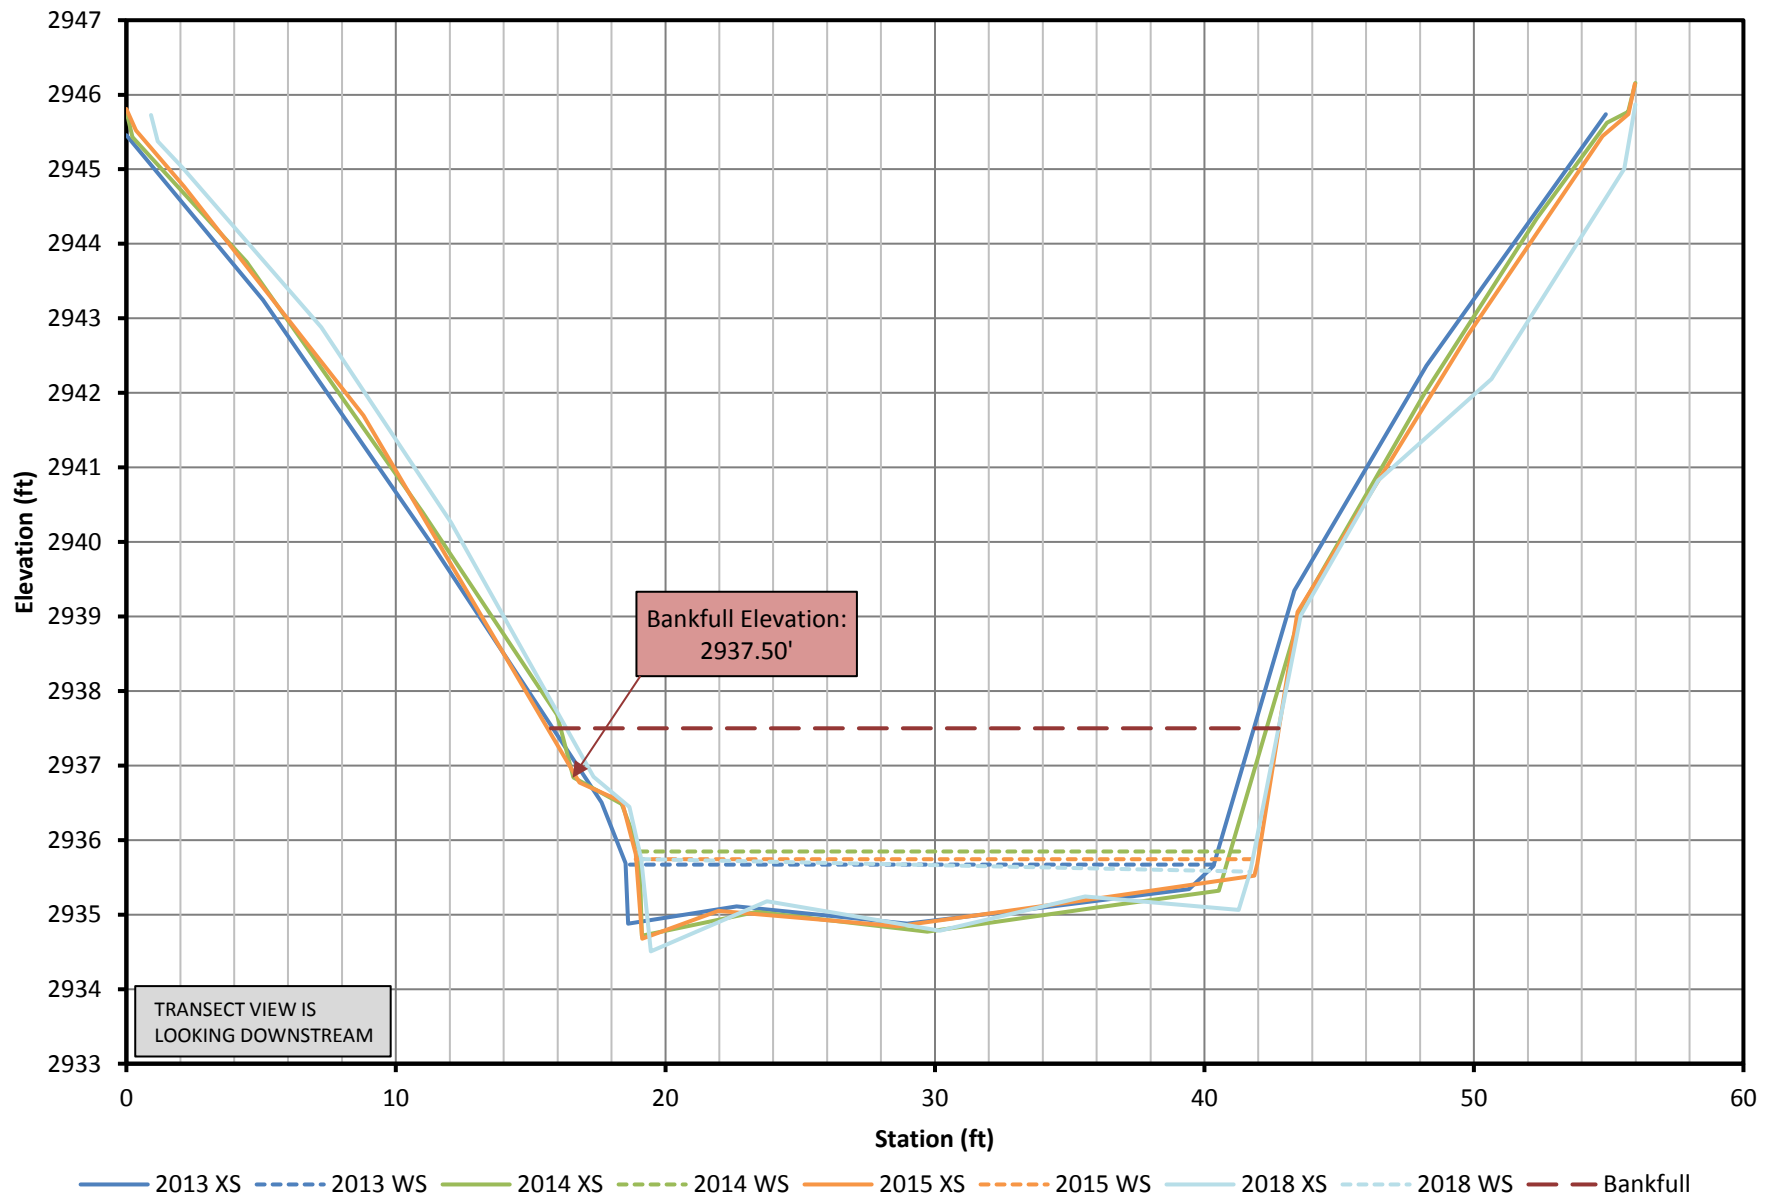
Ashley Creek Transect #3 - Riffle

Transect #3 runs through a 50-foot riffle that extends from Station 2+30 to 2+80. Bank erosion has been relatively limited here, also due to the clay lens evident at the bank toe. The bankfull width and depth at Transect #3 have remained relatively consistent over the monitoring period, and are 26.3 and 2.7 feet respectively.

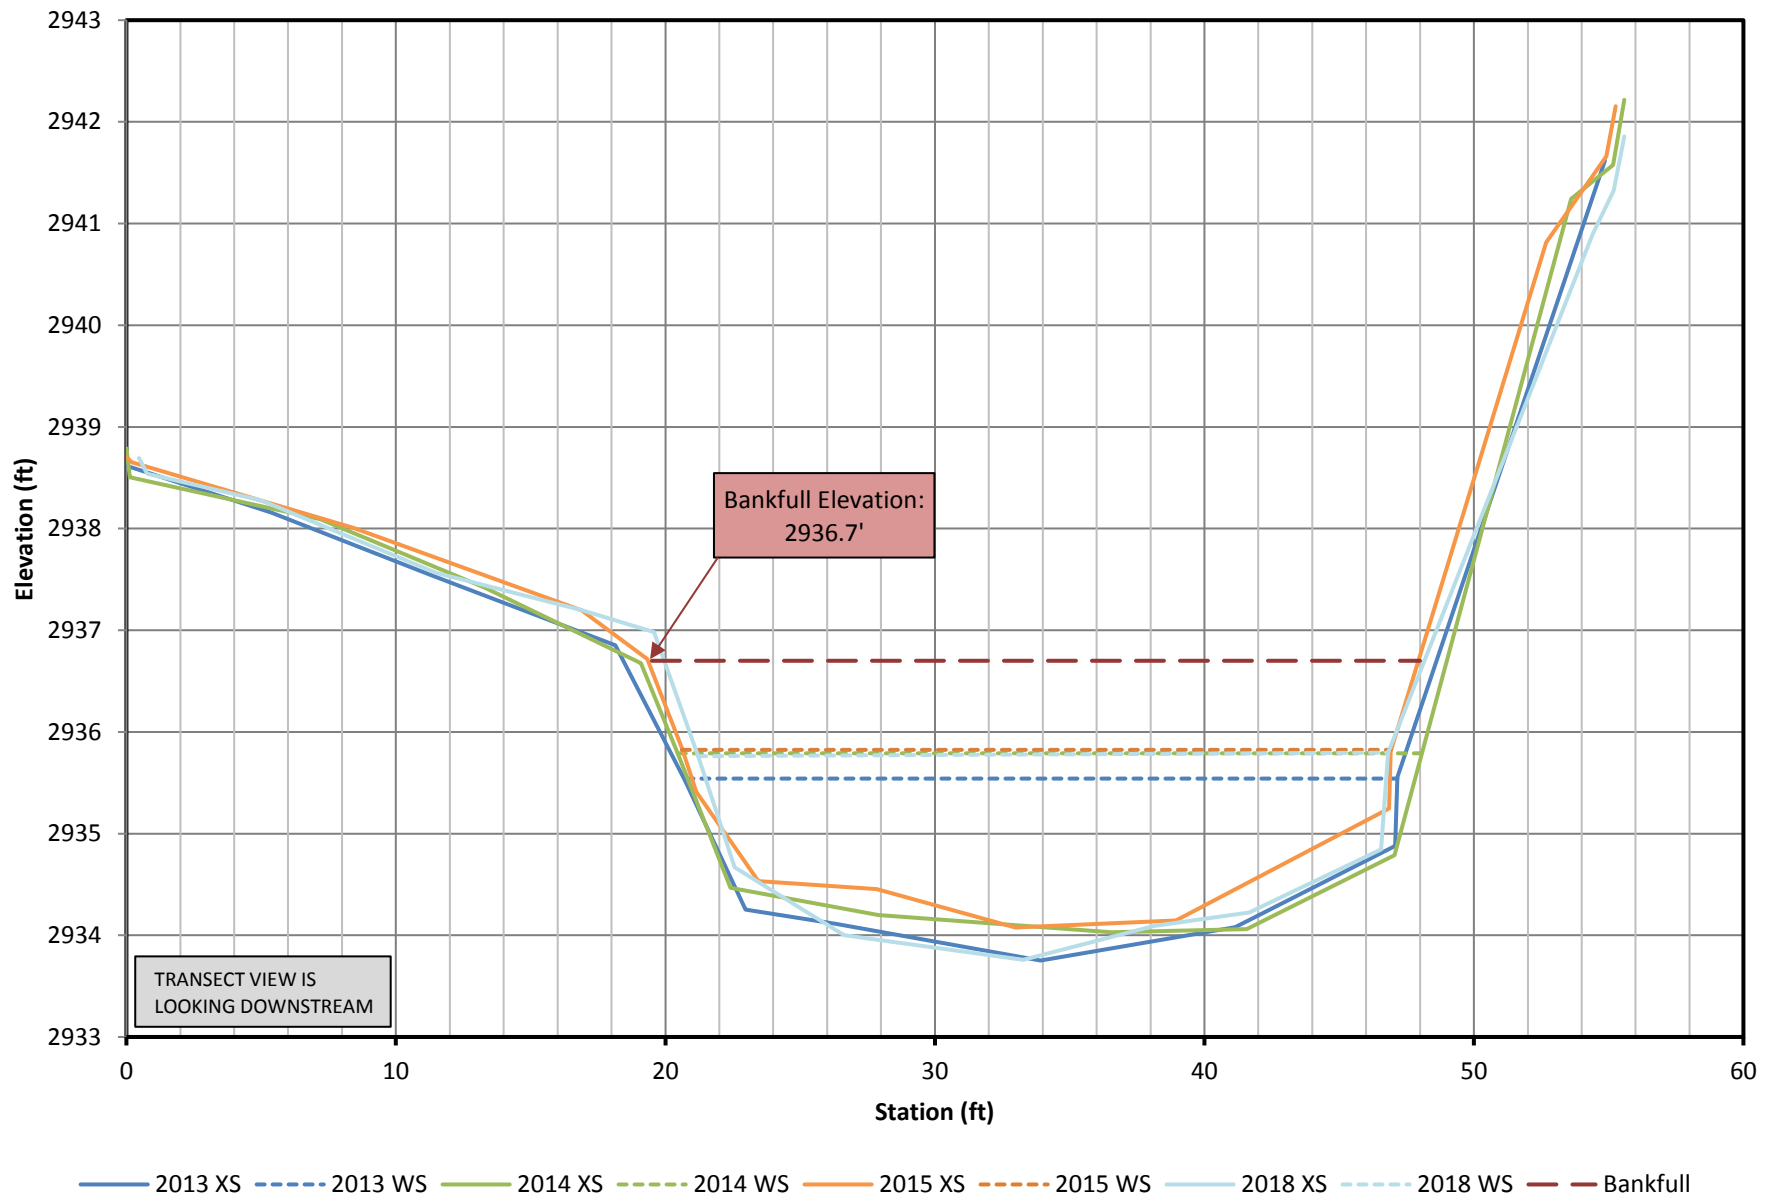
Ashley Creek Transect #4 - Riffle

Transect #4 is located just upstream of the confluence with Spring Creek. As shown in the longitudinal profile, its location lies at the tail end of the third pool, and is approximately 20 feet upstream of the next riffle crest. The channel has exhibited minor changes since 2013, and has a bankfull width of 28 feet and maximum depth of 2.8 feet.

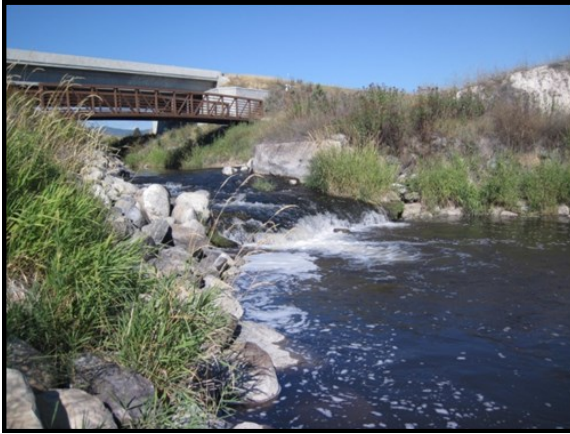
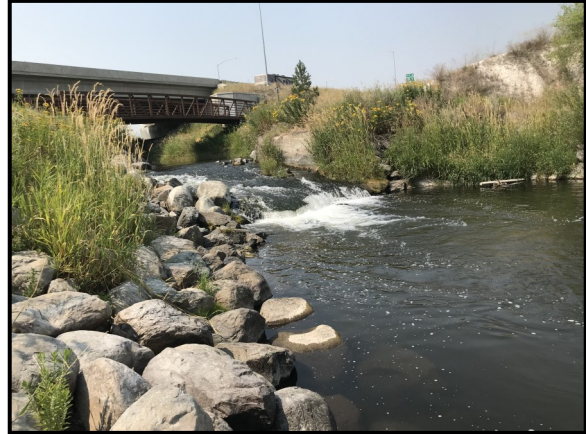
Photo Point 1: View of grade control structure downstream of project area. **Compass:** 315 (Northwest)

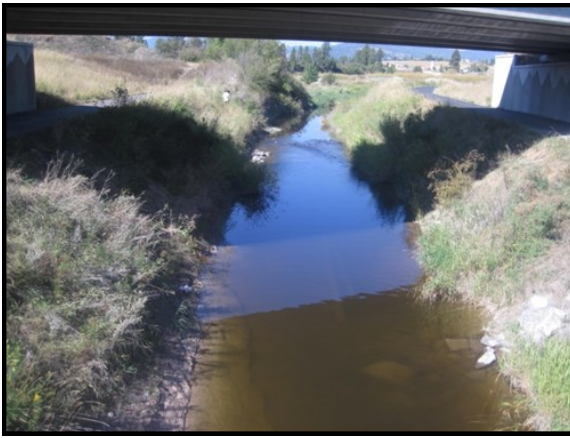
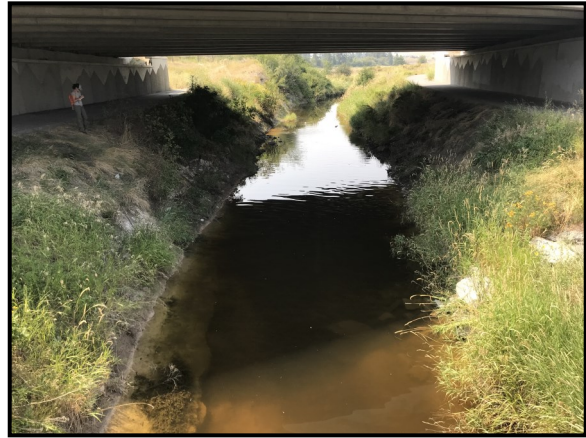
Photo Point 2: View looking upstream from pedestrian bridge. **Compass:** 315 (Northwest)

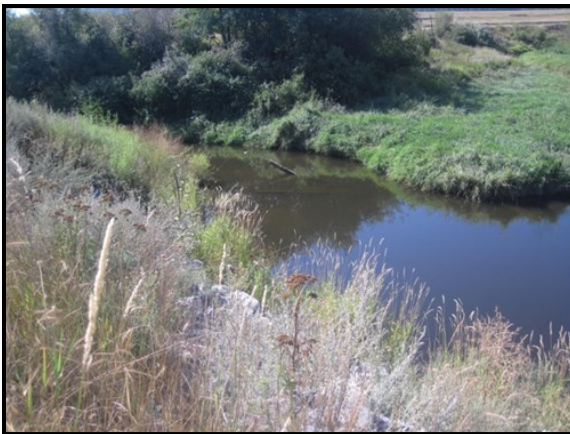
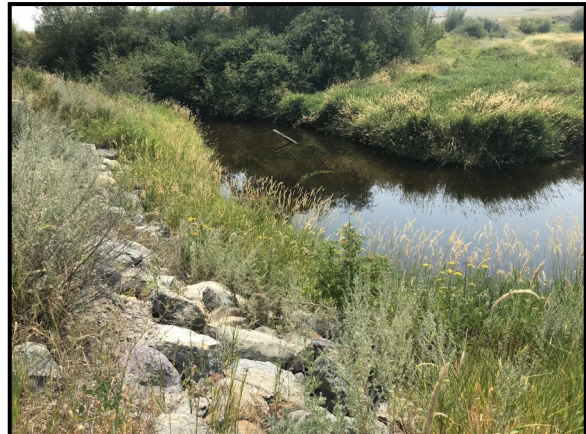
Photo 3.1: View looking south at upstream end of project site. **Compass:** 180 (South)

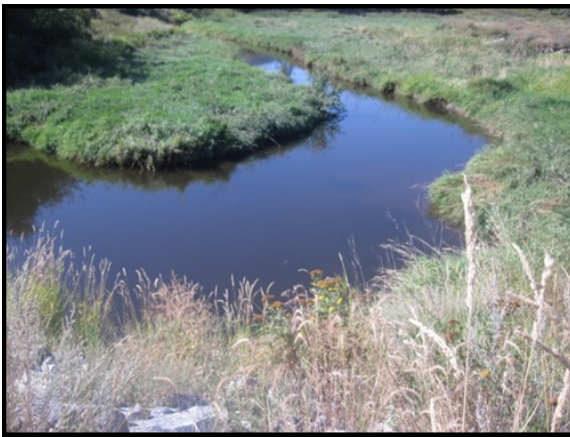
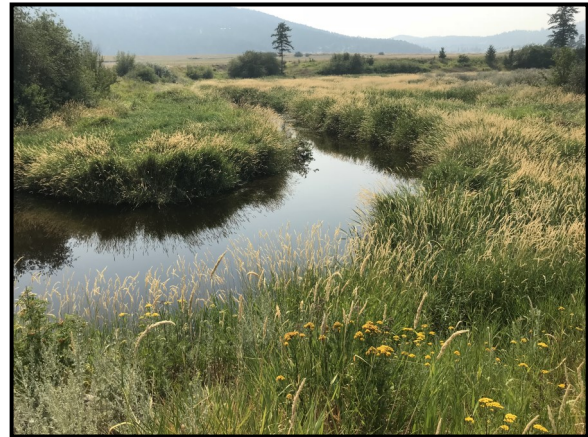
Photo 3.2: View looking at upstream end of project site. **Compass:** 225 (Southwest)

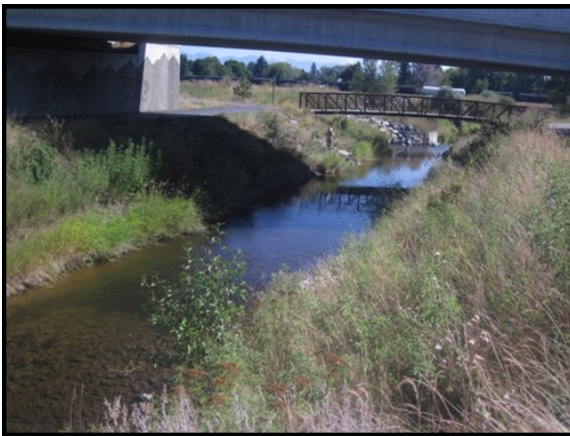
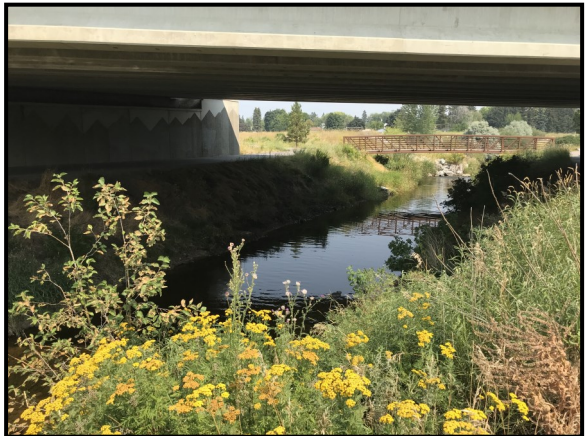
Photo 4.1: View looking downstream from south bank. **Compass** 90 (East)

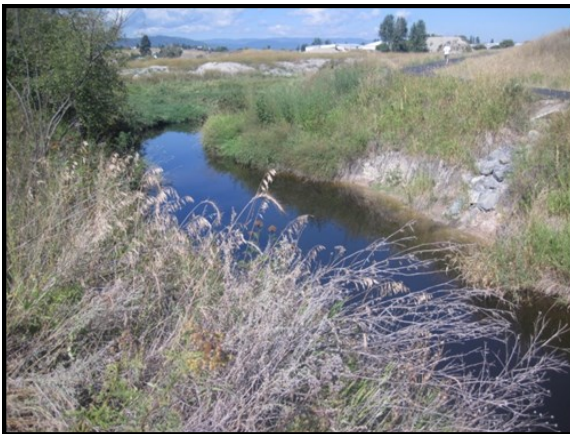
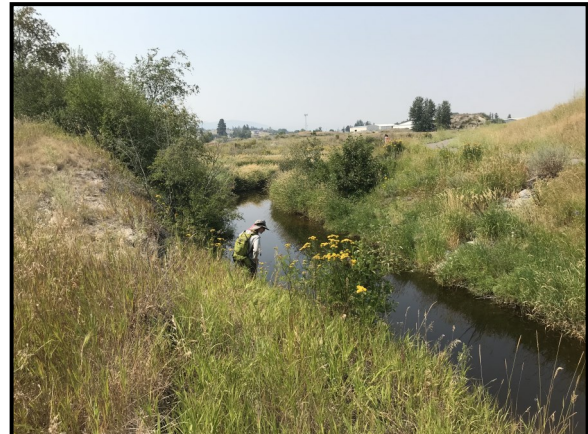
Photo 4.2: View of channel looking upstream from south bank. **Compass** 315 (Northwest)

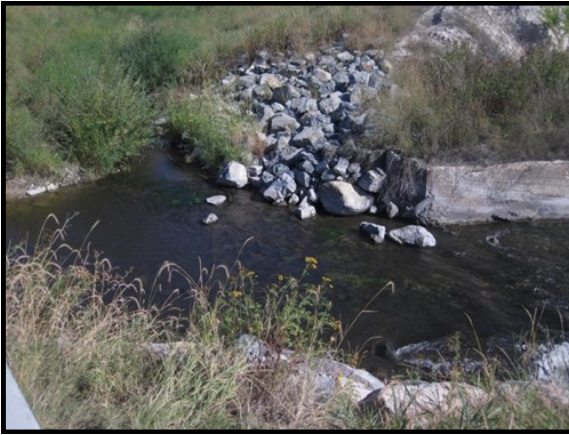
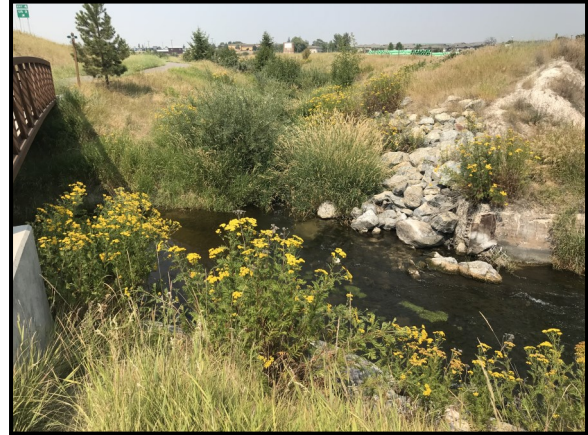
Additional Photo 1: View of Ashley/Spring Creek confluence.

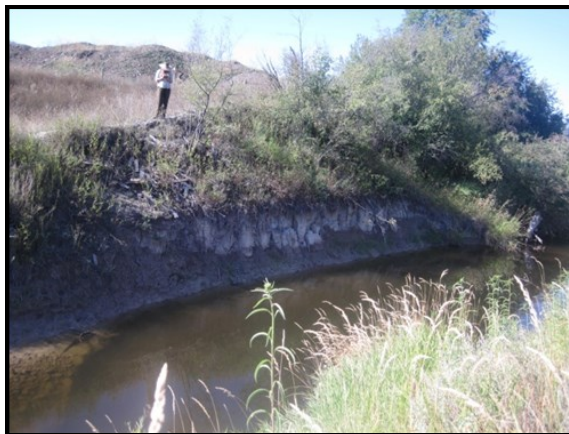
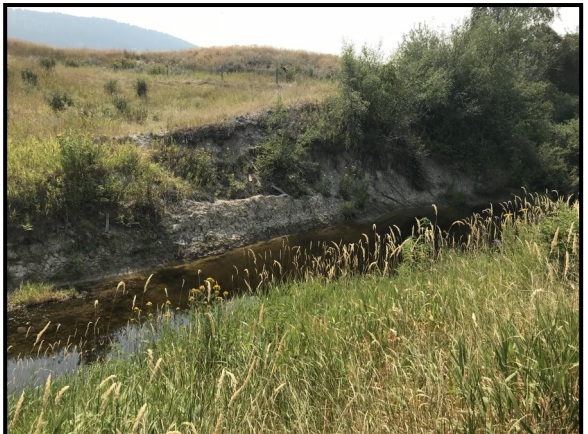
Eroding banks EBR1 and EBR2 occur along the south side of the channel. Inspection of the site in 2018 revealed erosion is now occurring along the previously stable segment of bank between EBR1 and EBR2. As a result, this bank erosion segment will be referred to as EBR1-2.

Erosion along bank EBR1-2 begins along a high terrace that was not disturbed during construction of the project, extends along the straight segment of the channel, and terminates at the pedestrian bridge over Ashley Creek. The eroding bank length increased from 53 feet to 97 feet in 2015, and has now lengthened to 205 feet. Of the 205 feet of erosion along this bank, 110 feet occurs beneath the bridge deck (Additional Photos 3 and 4 in Appendix C). Erosion along this bank appears to stem from saturation of fine-grained bank materials during high flows followed by sloughing of the lower bank. Vegetation along these banks does not appear capable of withstanding erosion and sloughing following high flows. This action has resulted in the exposure of bare ground along a steep lower bank angle. A clay lens exists along the toe of the bank which protects it from more rapidly eroding; however it does not protect the bank from sloughing. The upper bank along EBR1-2 also shows signs of instability, with several cracks and sloughs evident. Erosion of the upper bank may be due to a combination of lower bank failure and increased surface runoff from the adjacent bike/foot path. Erosion severity along this bank is considered high due to the lack of vegetation capable of stabilizing the bank, the relatively steep bank angle, fine grained bank materials, and lack of functional floodplain along this segment of the channel. Due to these factors, erosion is likely to continue along this bank, albeit at a slow pace due to the presence of the clay lens.

Additional Photo 2: Upper end of Eroding Bank EBR1 –2

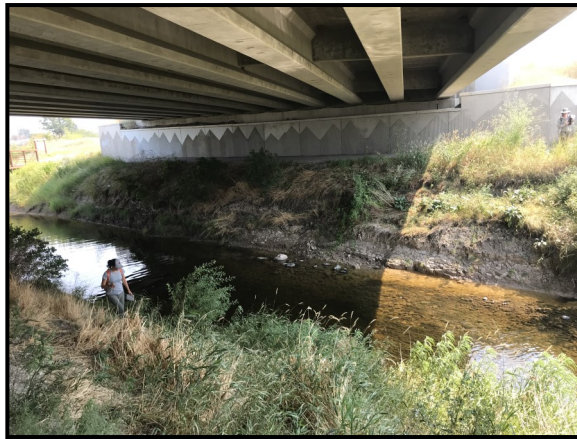
Additional Photo 4: Middle of Eroding Bank EBR1-2.

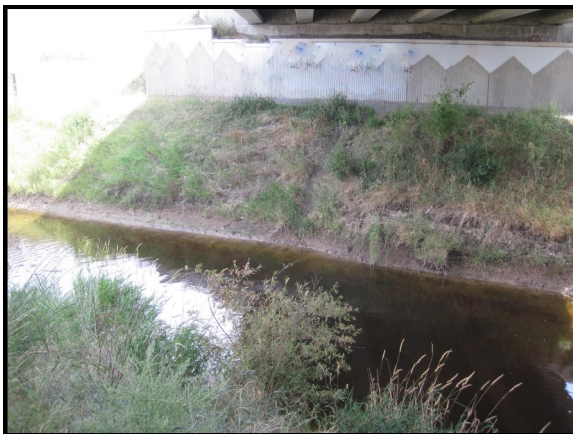
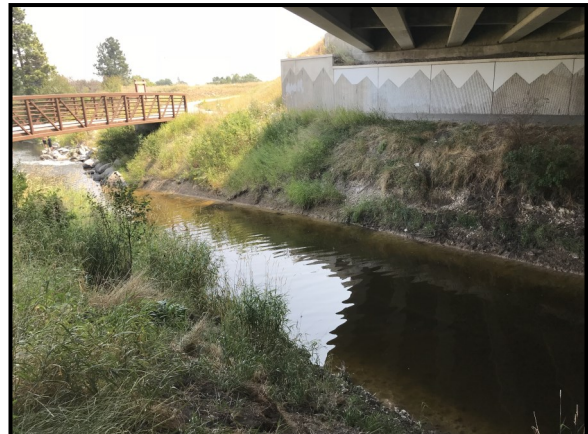
Additional Photo 5: Downstream end of eroding Bank EBR 1-2.

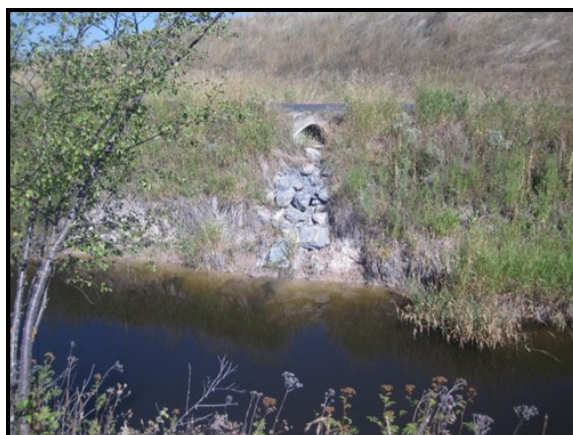
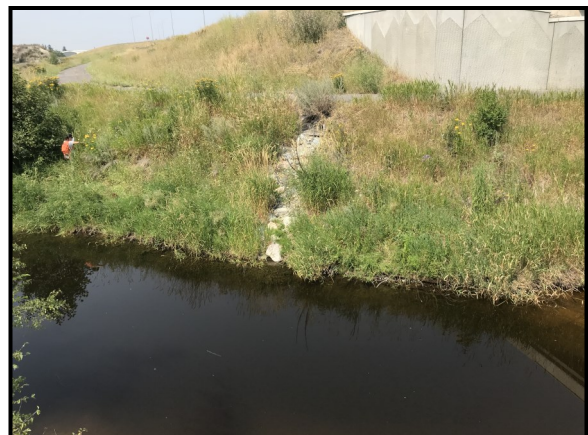
Eroding bank EBL1 was originally documented in 2013 along the outlet of a storm water culvert discharging into Ashley Creek upstream of the highway bridge. During the first construction phase of the project, riprap was improperly placed below the culvert outlet to protect the bank from erosion, causing it to slough into the creek. During the most recent construction phase of the project, additional riprap was placed and keyed into the stream bed. As a result, this bank has stabilized and is no longer classified as eroding.

Additional Photo 6: Stabilized culvert outlet.

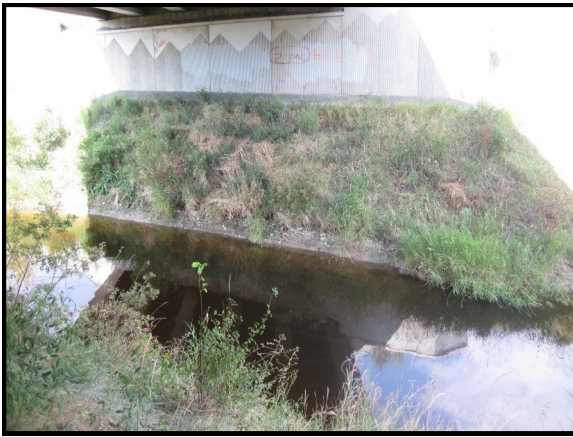
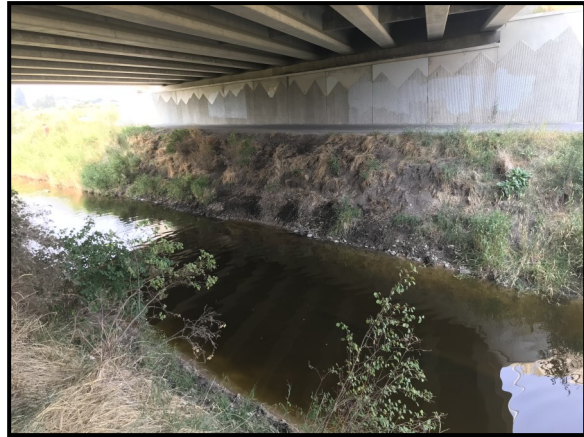
Dominant species recorded along the riparian transects were combined with visual observations in other areas to develop a vegetation community map (Figure 3, Appendix A). Four community types were observed in 2018, which included community Types 1 – *Phalaris arundinacea*, 3 – *Phalaris arundinacea/Elymus* spp., 4 – Bare Ground/*Elymus* spp., and 5 – *Cornus alba/Alnus incana*. Side slopes along the straight channel alignment are dominated by bare ground, wild rye (*Elymus* spp.), and reed canary grass (*Phalaris arundinacea*). As the planted shrubs mature and become larger over time, the corridor is expected to become more dominated by woody species. The right bank along the upstream extent of the project reach, which was not disturbed during construction, is dominated by reed canary grass. Community Type 3 on both the left and right stream banks has shifted since the 2015 monitoring event, to include community Types 4 and 5, due to the increase observed in 2018 in bare ground, red osier dogwood (*Cornus alba*), and speckled alder (*Alnus incana*). The majority of the bare ground observed within the riparian corridor was concentrated under the bridge overpass in an area that is permanently shaded. This lack of direct sunlight and precipitation beneath the overpass is contributing to the lack of vegetative cover and increase in bare ground (see additional photos 7, 8, and 9 on pages C-4 and C-5).

Eroding bank EBL2 also occurs along the straight channel segment of Ashley Creek opposite EBR1-2. This bank was documented as eroding during the 2014 monitoring event, and appears to be relatively stable with the exception of upper bank sloughing. The eroding bank length at EBL2 remains at 40 feet as documented in 2014. Bank

conditions and causes of erosion are identical to EBR1-2, with fine grained soils, relatively steep bank slopes, and lack of functional floodplain adjacent to the channel. A clay lens also protects the left bank from more accelerated erosion.

Additional Photo 7: Eroding Bank EBL2

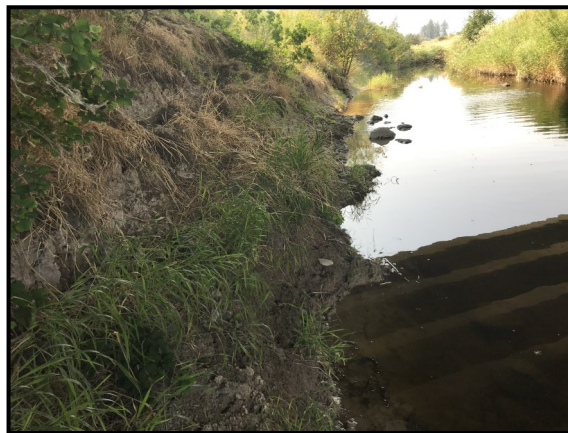
Additional Photo 8: Toe of eroding bank EBR1-2 showing bank sloughing.

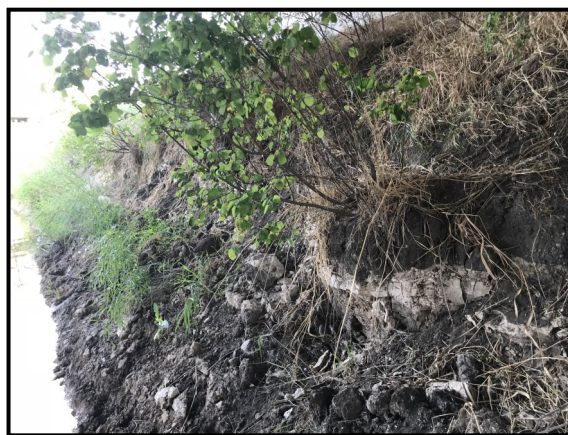
Additional Photo 9: Toe of eroding bank EBR1-2 showing potential loss of woody vegetation.
