## MONTANA DEPARTMENT OF TRANSPORTATION STREAM MITIGATION MONITORING REPORT

*Ashley Creek  
Flathead County, Montana*

*Project Completed: 2010  
Monitoring Report #5: December, 2019*

MDT Project Number: NH-MT 5-3(59) FST  
Control Number: 2038

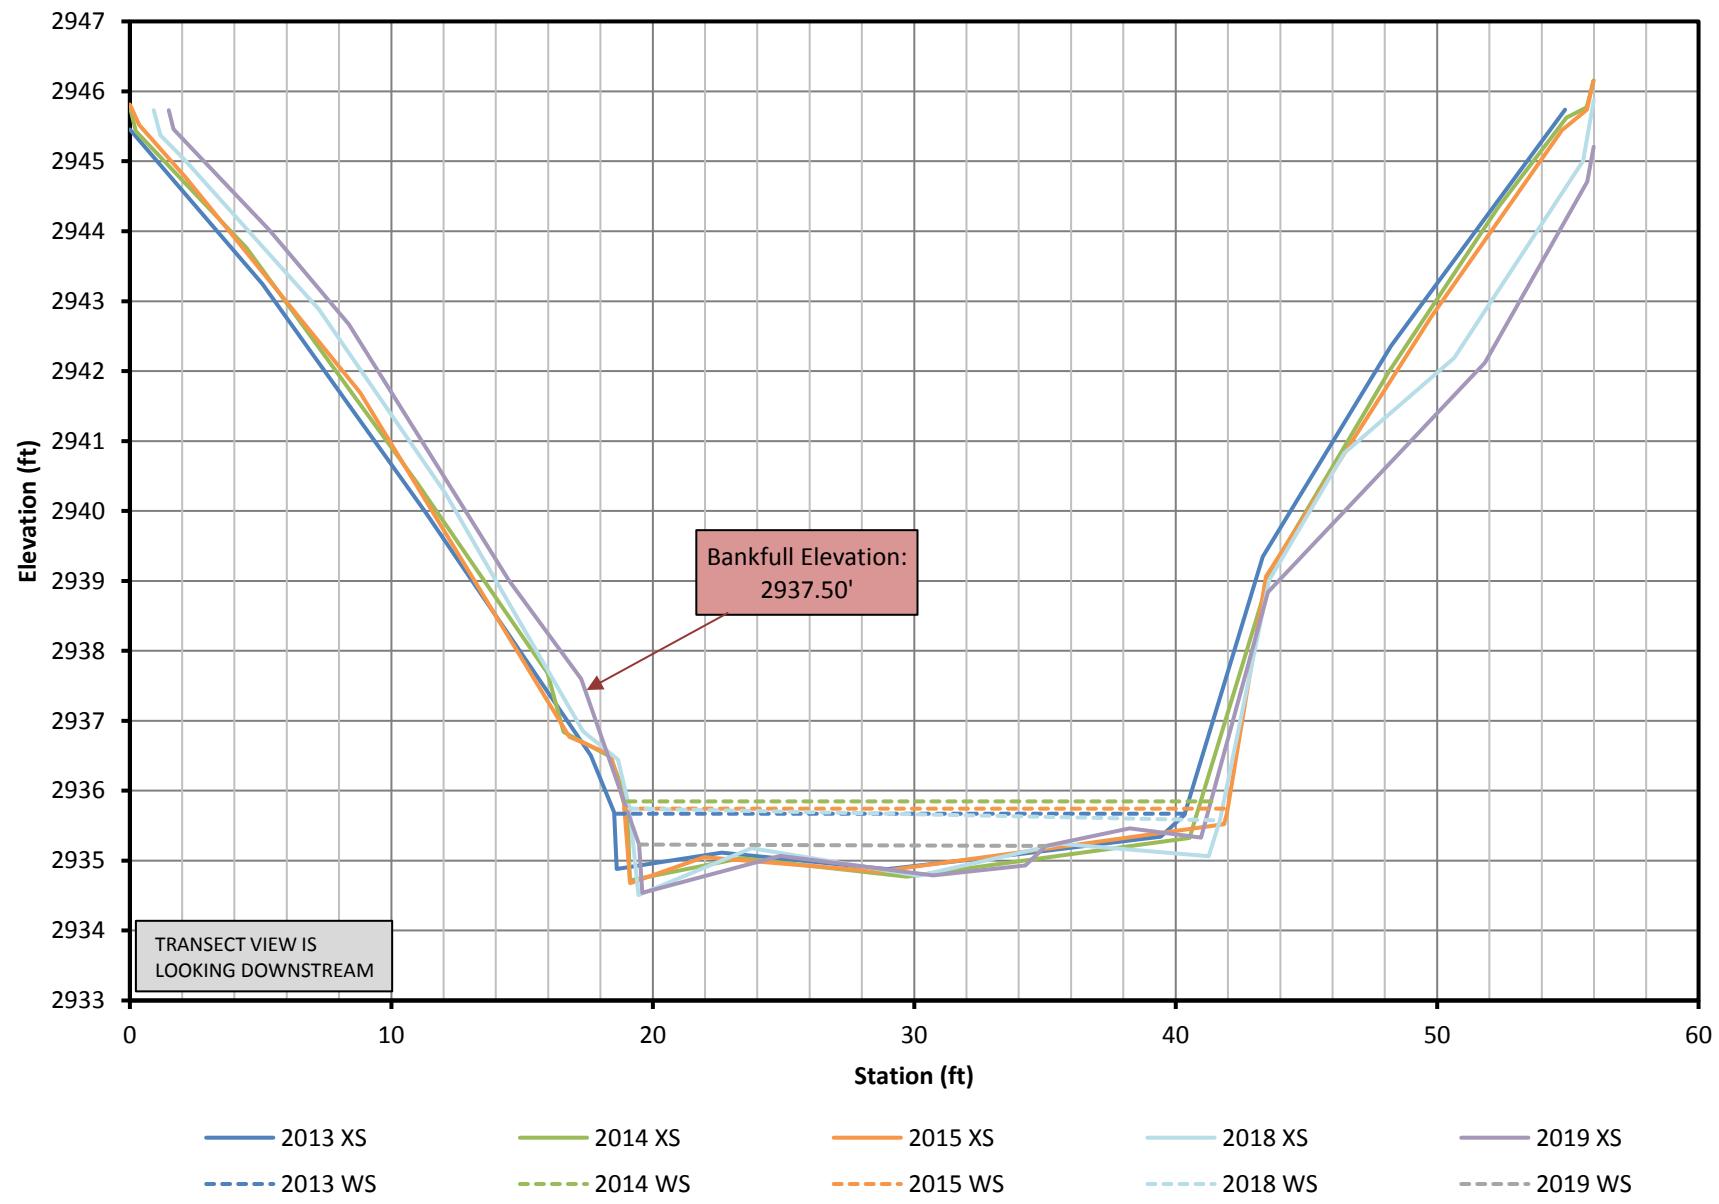
## Ashley Creek Transect #3 - Riffle

Transect #3 runs through a 50-foot riffle that extends from Station 2+30 to 2+80. Bank erosion along the toe of the channel (EBR1-2) has been relatively limited at the transect location, also due to the clay lens that acts to protect the channel from more severe erosion. Inspection of the cross section (page B-3) indicates the upper bank along the right (south) side of the channel has retreated by as much as four feet over the past six years. In addition, a thalweg has begun to develop along the left side of the channel.

The bankfull width and depth at Transect #3 is have remained relatively consistent over the monitoring period, and are 25.3 and 3.0 feet respectively.

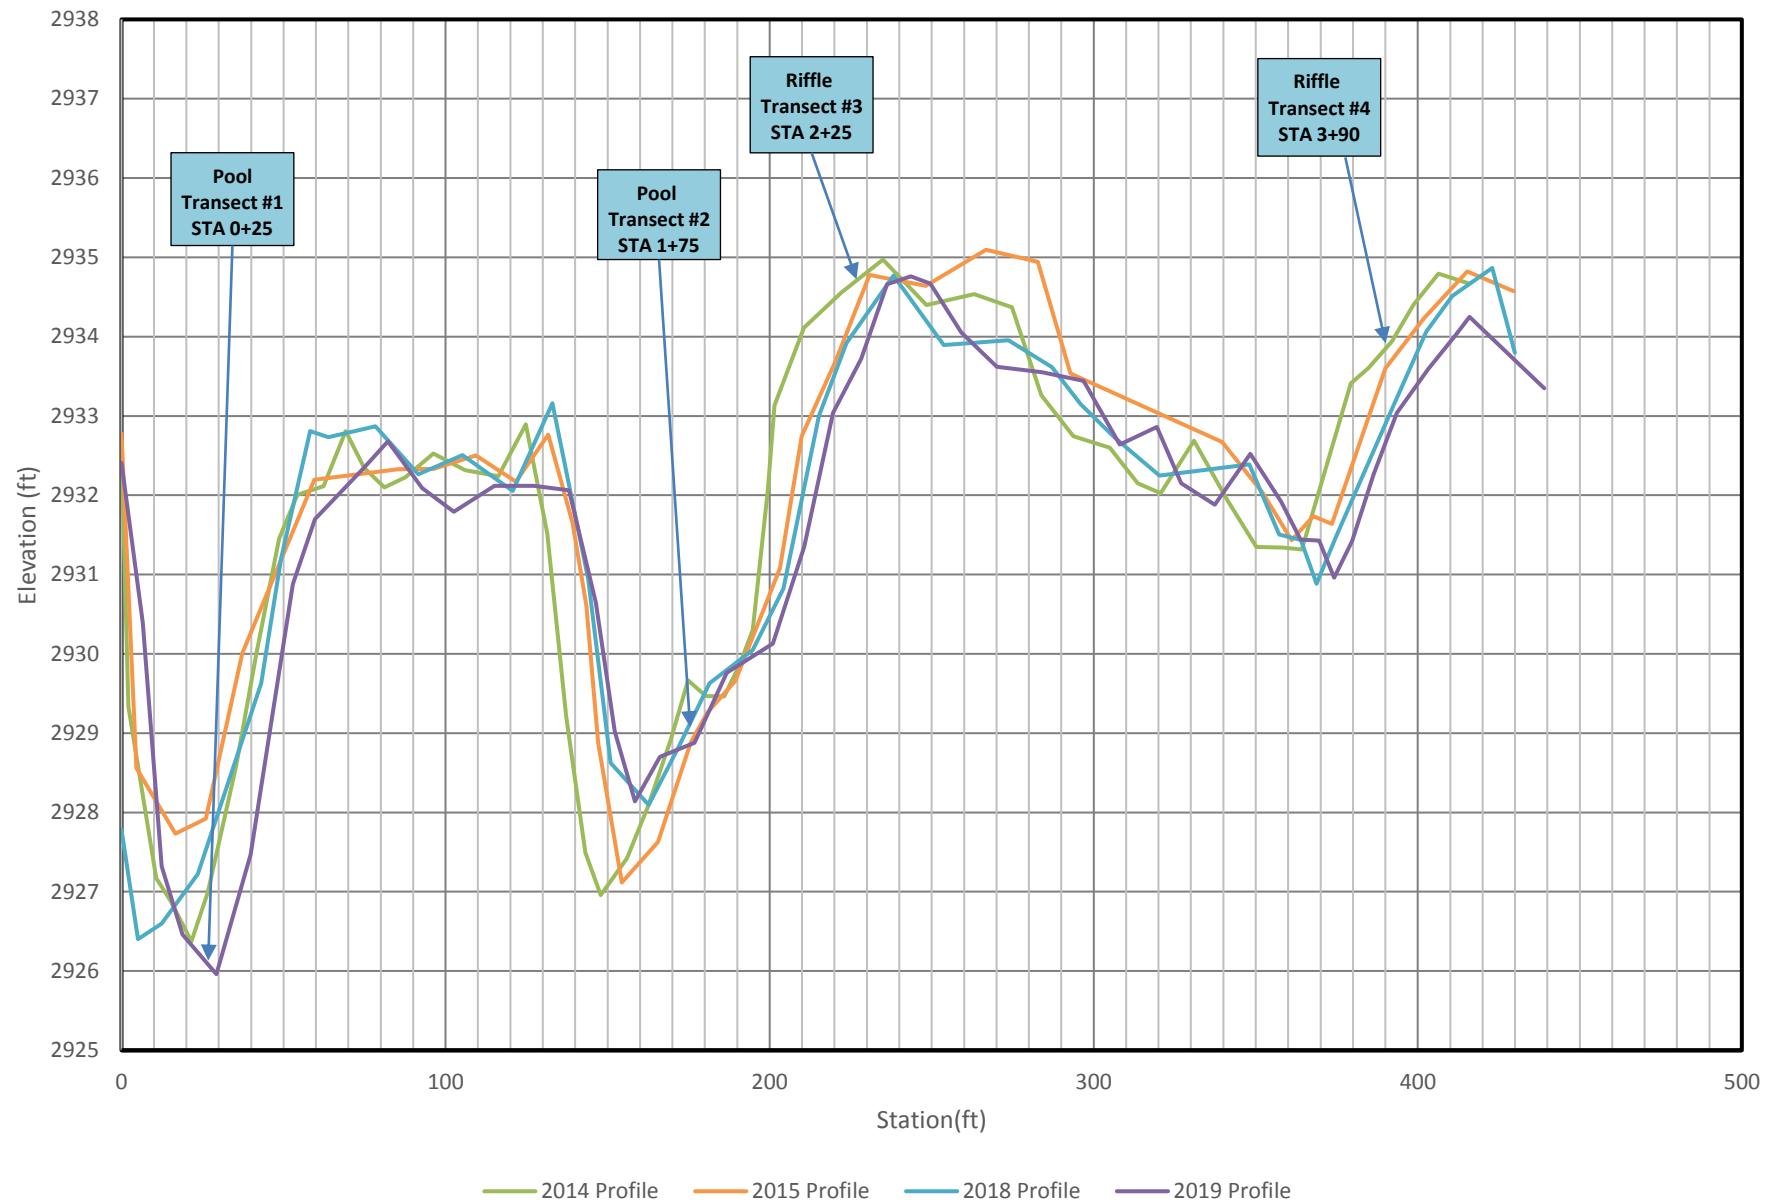
## Ashley Creek Longitudinal Profiles

The longitudinal profile indicates the three distinct pools originally surveyed within the reach have maintained their depth over the past six years (see profile page B-5). A deep pool exists at the upstream end of the project reach, where the newly aligned segment of Ashley Creek turns east. Transect #1 runs through this pool, which is formed by a tight meander bend in the channel generating scour against the riprapped north bank. This pool exhibits a bankfull width of 44.9 feet, maximum depth of 9.7 feet, and a well-developed floodplain bench on the south side of the channel. Surveys indicate the point bar along the right (south) bank initially extended northward, but has since retreated. It should be noted the left (north) bank of this transect has been riprapped. Surveying through riprap can often lead to varying results based on the exact location of surveyed points; therefore elevation changes along the left bank are not attributed to bank retreat or erosion.

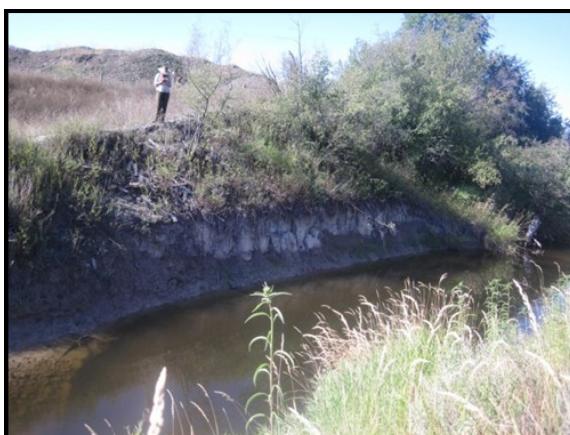
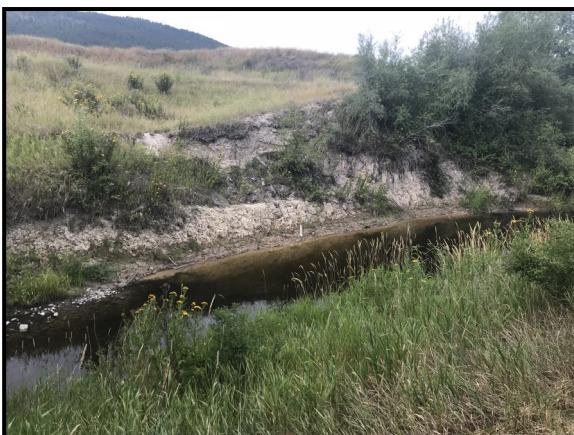
Eroding banks EBR1 and EBR2 were originally mapped as separate eroding bank segments; however, in 2018, erosion noted between these two segments resulted in their being combined in the inventory as a single eroding bank which is referred to as EBR1-2. Erosion along bank EBR1-2 begins along a high terrace that was not disturbed during construction of the project, extends along the straight segment of the channel, and terminates at the pedestrian bridge over Ashley Creek. The eroding bank length increased from 53 feet to 97 feet in 2015, and has now lengthened to 228 feet. Sloughing of the upper bank is getting close to undermining the bike path on the south side of the channel.

Additional Photo 2: Upper end of Eroding Bank EBR1-2

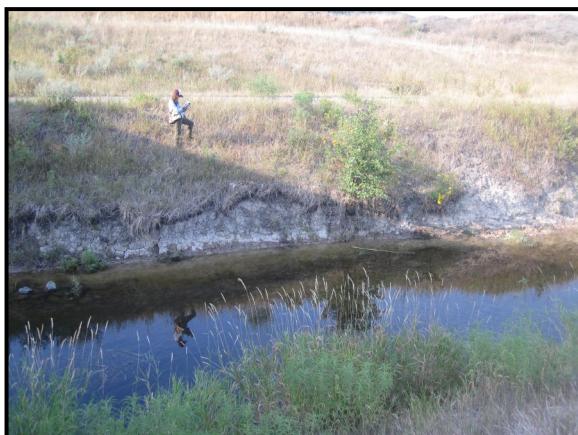
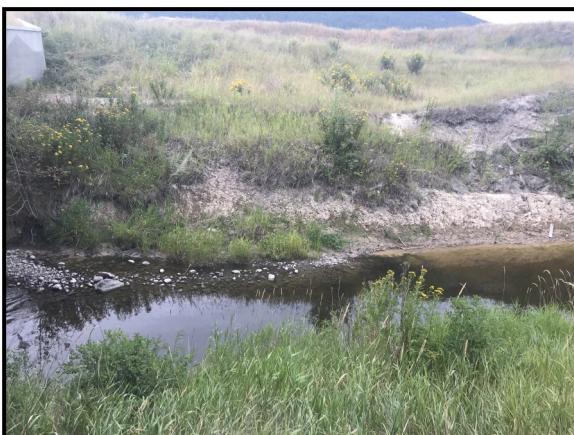
Of the total eroding bank length along EBR1-2, 110 feet occurs beneath the bridge decks (Additional Photos 3 and 4 in Appendix C). Erosion along this bank appears to stem from saturation of fine-grained bank materials during high flows followed by sloughing of the lower bank. Vegetation vigor along EBR1-2 has continued to decline due to the bridge widening project in 2016, and does not appear capable of withstanding erosion and sloughing following high flows and has resulted in the exposure of bare ground along a steep lower bank angle. A clay lens exists along the toe of the bank which protects it from more rapidly eroding; however it does not protect the upper bank from sloughing. The upper bank has retreated by as much as four feet since 2013 (see bank transect #2, page B-2), and many cracks were observed along

the entire bank. Erosion of the upper bank may be due to a combination of lower bank failure, increased surface runoff from the adjacent bike/foot path, and disturbance during construction of the expanded bridge. Erosion severity along this bank is considered high due to the lack of vegetation capable of stabilizing the bank, the relatively steep bank angle, fine grained bank materials, and lack of functional floodplain along this segment of the channel. Due to these factors, erosion is likely to continue along this bank, albeit at a slow pace due to the presence of the clay lens.

Additional Photo 3: Middle of Eroding Bank EBR1-2.

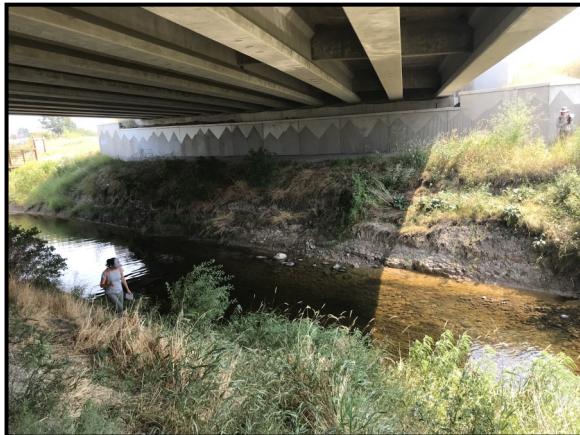
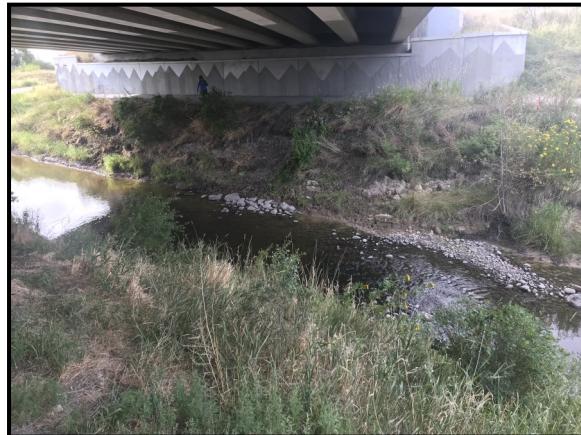
Additional Photo 4: Middle of Eroding Bank EBR1-2.

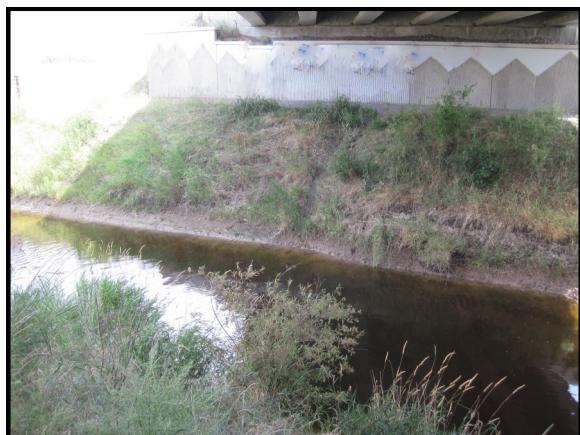
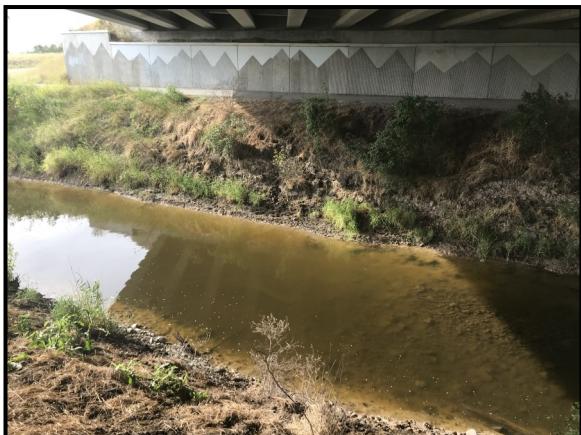
Additional Photo 5: Downstream end of eroding Bank EBR 1-2.

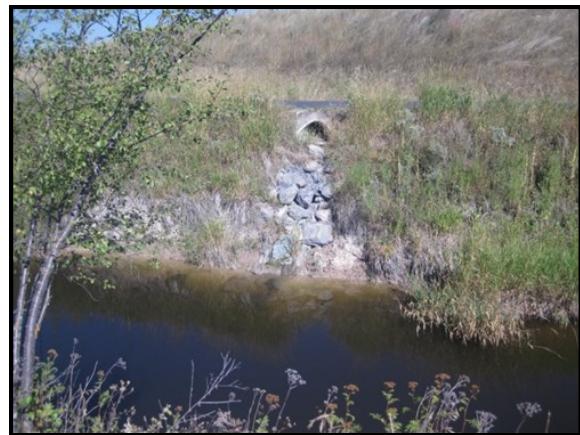
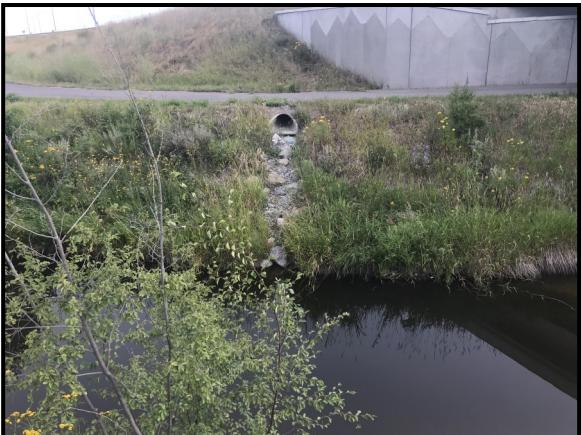
Eroding bank EBL1 was originally documented in 2013 along the outlet of a storm water culvert discharging into Ashley Creek upstream of the highway bridge. During the first construction phase of the project, riprap was improperly placed below the culvert outlet to protect the bank from erosion, causing it to slough into the creek. During the most recent construction phase of the project, additional riprap was placed and keyed into the stream bed. As a result, this bank has stabilized and is no longer classified as eroding.

Additional Photo 6: Stabilized culvert outlet.

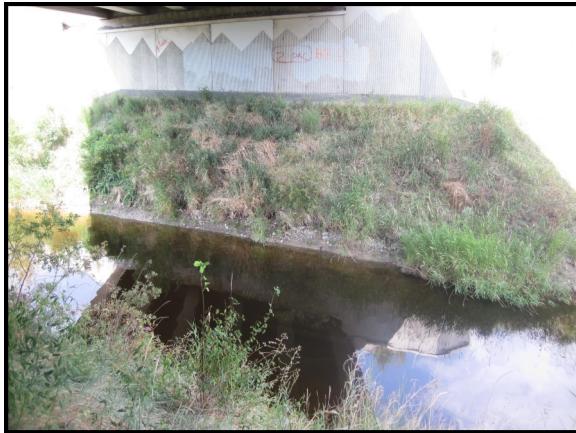
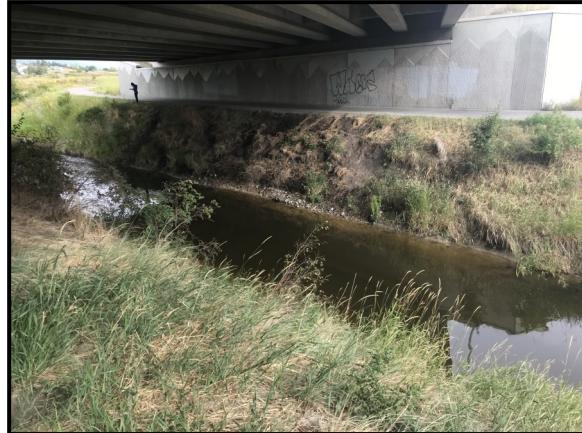
species, and an increase in bare ground (see additional photos 7, 8, and 9 on page C-5). In 2019, there was a notable increase in bare ground observed along the left bank, particularly in areas that had been previously sprayed with herbicide and areas adjacent to dead and dying shrubs. In general, total vegetation cover beneath the bridge overpass, from both woody and herbaceous species, is expected to decrease over time due to the lack of sunlight and precipitation available to vegetation establishing beneath the bridge. A reduction in vegetation is likely to contribute to increased erosion and bank instability.

Eroding bank EBL2 occurs along the straight channel segment of Ashley Creek beneath the bridge. This bank segment exhibits little in terms of lateral migration; however, bare soil and upper bank sloughing provide signs of bank instability. The presence of bare soil, reduced vegetation coverage, and sloughing stems from a lack of direct sunlight and precipitation beneath the bridge, which is causing the vegetation to become sparser each year. The sloughing bank length at EBL2 has more than doubled from the originally mapped length of 40 feet in 2014 to 84 feet in 2019. This closely corresponds to an original 2-lane bridge width of 50 feet, which expanded to a width of 100 feet following completion of the second 2-lane bridge deck over Ashley Creek. Bank conditions and causes of erosion are due to fine grained soils, relatively steep bank slopes, lack of a functional floodplain adjacent to the channel to dissipate energy, and lack of woody shrubs. A clay lens is protecting the left bank from more accelerated erosion.

**Additional Photo 7:** Eroding Bank EBL2

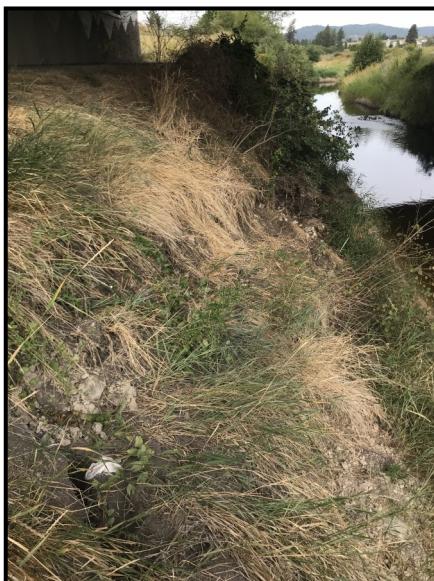
**Additional Photo 8:** Toe of eroding bank EBR1-2 showing bank sloughing.

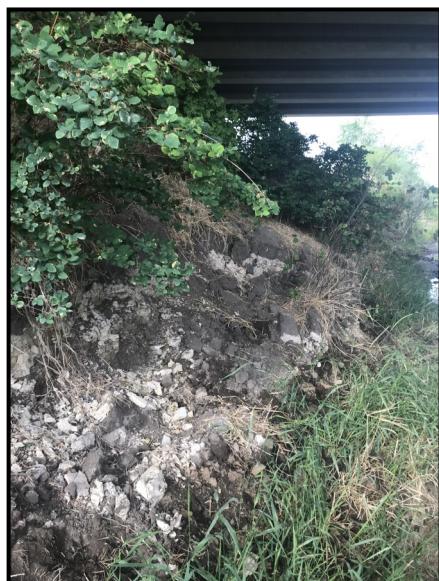
**Additional Photo 9:** Toe of eroding bank EBR1-2 showing loss of woody vegetation.
