MONTANA DEPARTMENT OF TRANSPORTATION STREAM MITIGATION MONITORING REPORT

*Bowser Creek
Flathead County, Montana*

*Project Completed: 2010
Monitoring Report #7: December, 2019*

MDT Project Number: NH 15(93)
Control Number: 2038-011

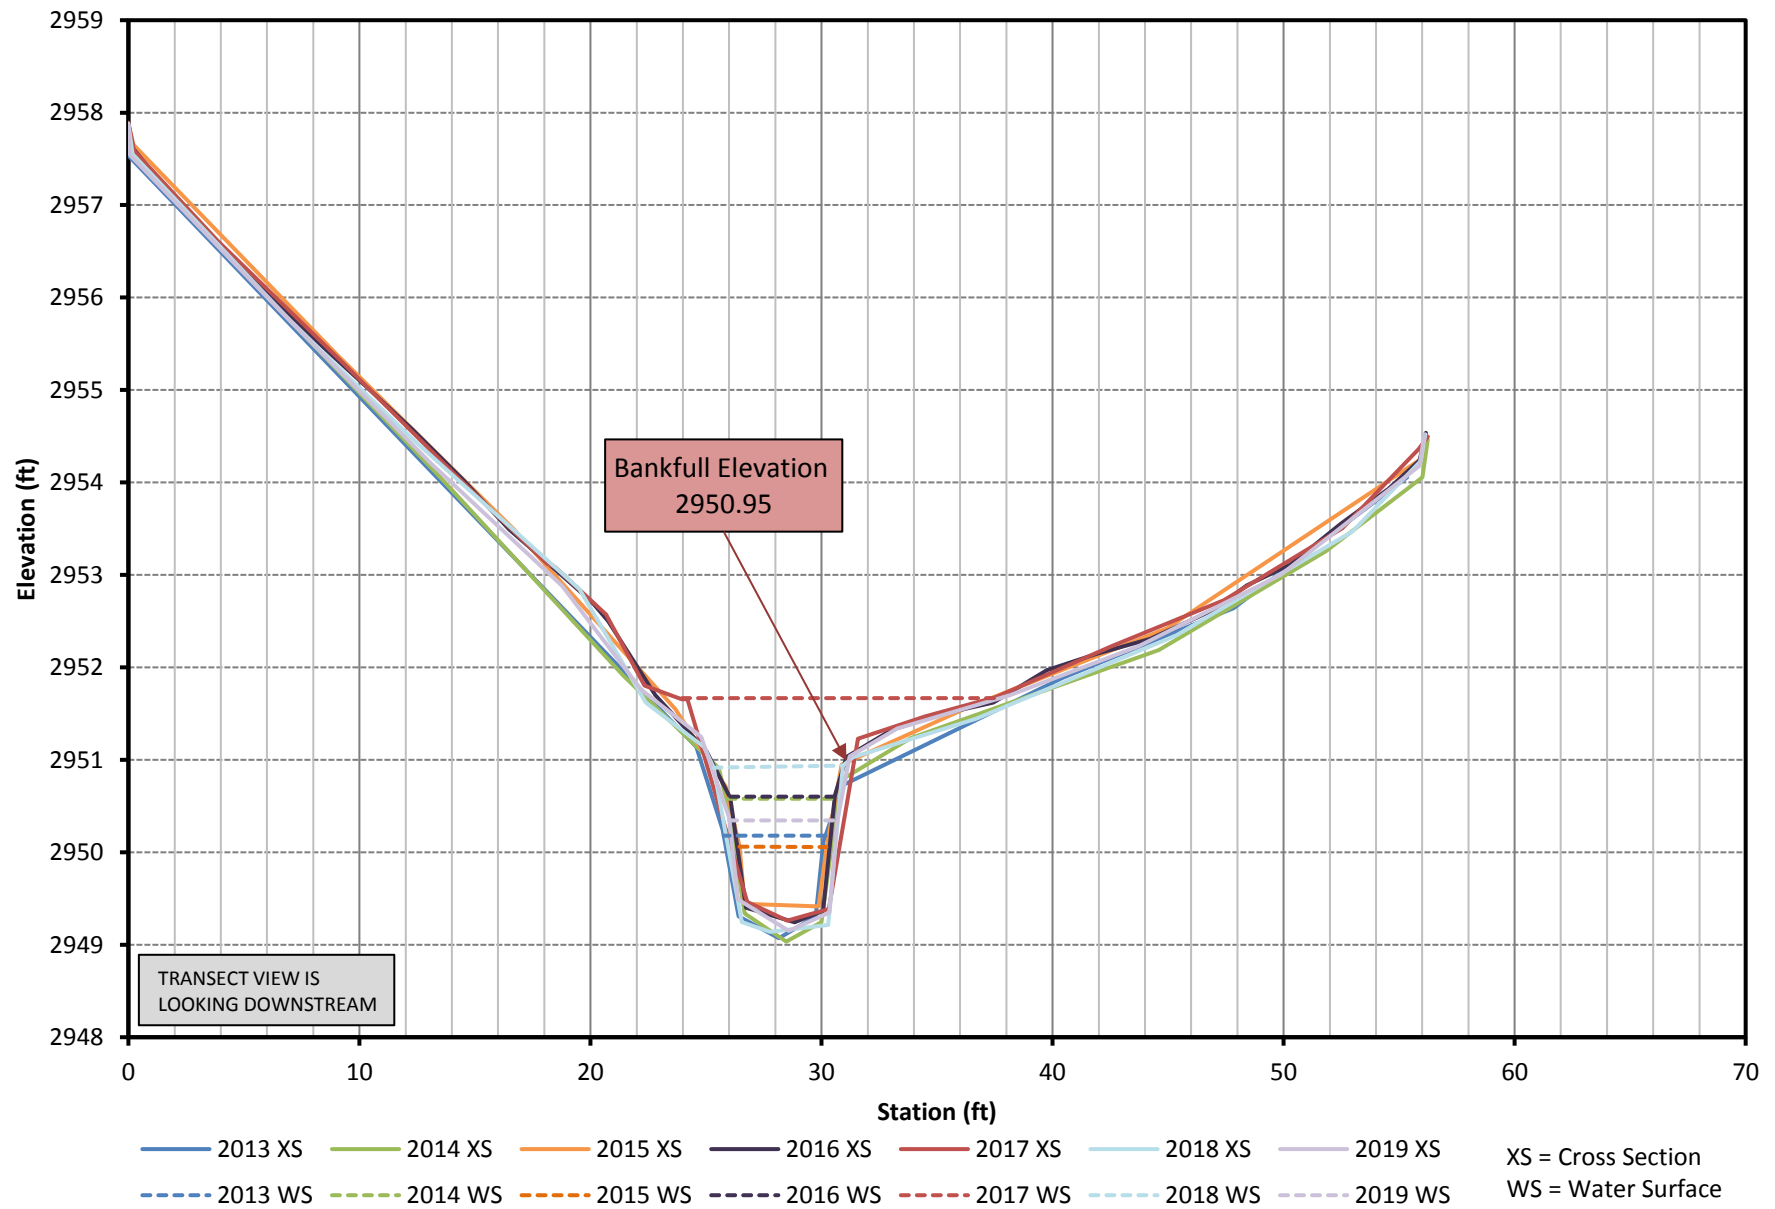
Bowser Transect #1 - Pool

Two perpendicular cross section transects were surveyed at pools and two at riffles, with maximum depth and bankfull width for each indicated in Table 5 (plots for each transect included in Appendix B). In 2019, maximum bankfull depths ranged from 1.8 to 3.3 feet and bankfull widths ranged from 5.9 to 13.6 feet. Over the past seven years, the average maximum depth surveyed has varied by less than a half foot, while the average bankfull width has varied by less than one foot. These data, when combined with the bank erosion inventory, indicate the channel has only slightly adjusted since 2013, and the channel appears to have reached an equilibrium with regard to its dimensions.

Two segments of the channel are wider than originally constructed due to a combination of the natural degradation of coir logs placed during construction and bank slumping where seeps enter the channel from the north. These channel segments are unlikely to recover back to the design dimension due to the unnatural hydrology and continuous saturation caused by seepage from the adjacent retention pond; however they provide a diversity in channel form and are not continuing to degrade or erode. Based on the vast majority of the reconstructed channel performing as intended, attempts to narrow the channel through these relatively short, over-wide segments remains unwarranted.

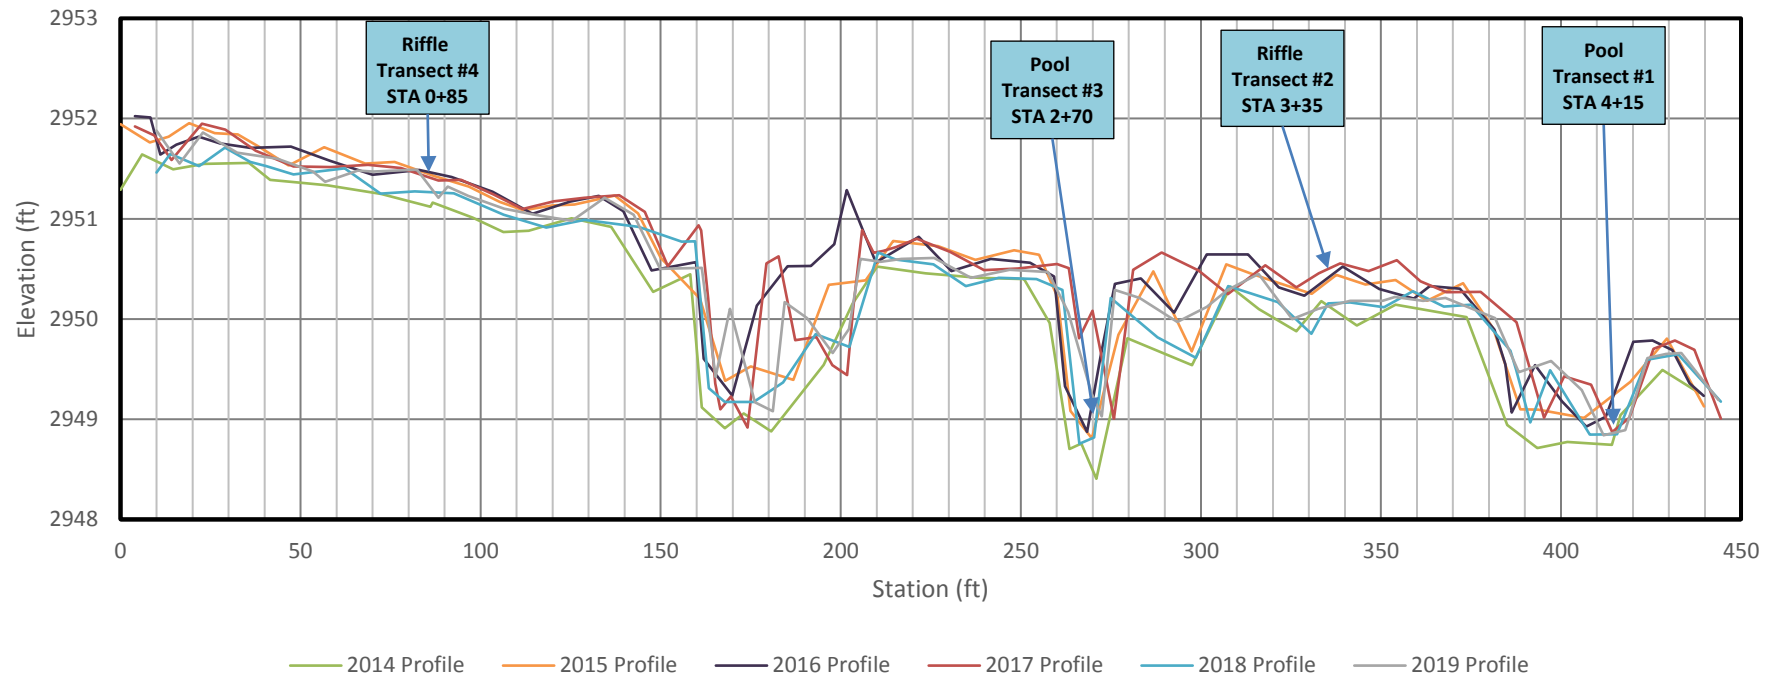
Bowser Creek Longitudinal Profiles: 2014 - 2019

A longitudinal profile through the Bowser Creek project area has been surveyed annually since 2014, with results provided on pages B-5 and B-6. The profile on page B-5 provides the results of each year's profile, indicating the channel has generally maintained a variety of habitat features including pools and riffles over the past six years. Three distinct pools exist along the reconstructed channel alignment, which are approximately one foot deeper than riffle features. A plot of the thalweg profile for 2014 and 2019 only is provided on page B-6, which indicates the pools may be filling with small gravel and fine materials. Pool length has become shorter and pool depths have become slightly shallower since 2014 based on this profile.

Fine sediment deposits have been commonly observed in the channel, and may be due to a combination of factors, including 1) increased roughness of the channel bed and

water column caused by proliferation of watercress during the growing season, 2) the reduced ability of the channel to transport fine sediments through the short reaches that have widened, 3) upstream development along Bowser Creek that may be contributing fine sediment, and 4) the inability of the channel to scour pool features due to the relatively straight channel alignment. Although reference reach data was not collected as part of this monitoring effort, Bowser Creek may also have a naturally high sediment load.

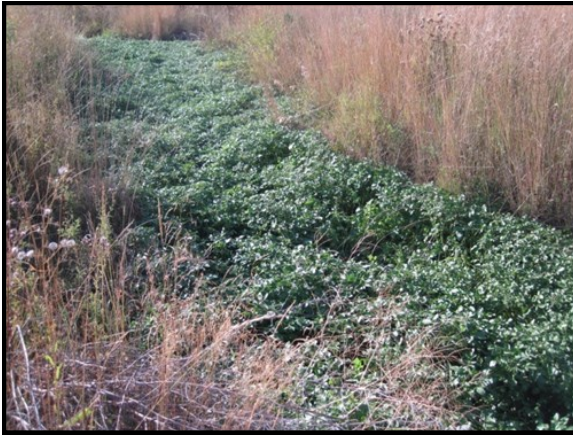
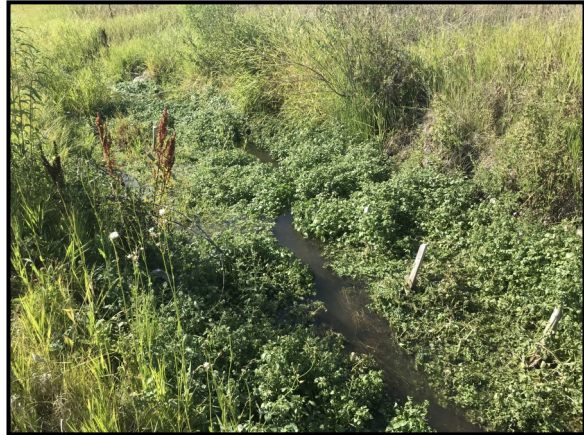
Additional Photo 1: Prolific watercress growth shown in 2013 was less prevalent in 2018.

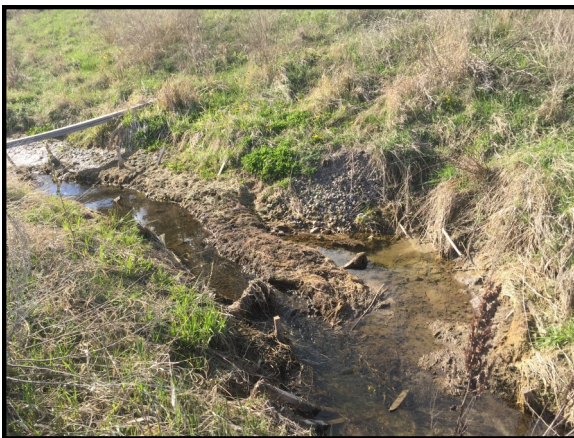
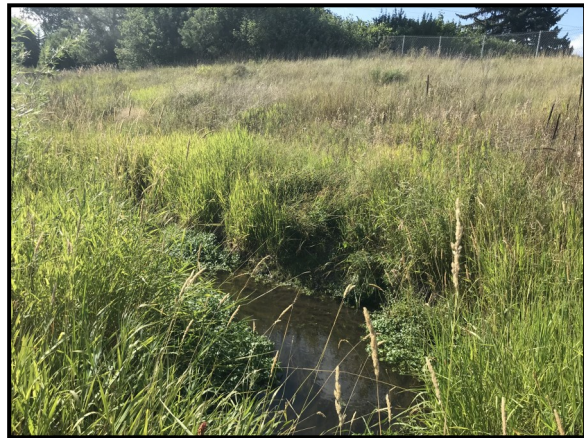
The eroding bank inventory is challenging to perform in late summer due to the density of watercress within the channel and groundcover along both banks. As such, eroding banks are best observed outside of the growing season when vegetation is dormant and the stream banks can be easily observed. A bank erosion inventory was conducted during a site visit in April, 2019, during which one eroding bank was observed. This eroding bank (EBL3 on Figure 2 in Appendix A) is due to an incoming seep which saturates a 15-foot segment of the left (north) bank. This seep has been observed for three consecutive years, and is resulting in minor bank sloughing. The bank has colonized with wetland vegetation and is unlikely to continue eroding or need corrective action. This bank length represents less than 2% of the overall reconstructed bank length of 880 feet. Photos of this eroding bank during both the April and August site visits can be found in Appendix C.

construction; however, the channel has not continued to widen in these areas. Erosion observed within the project reach in 2019 is due to the seeps entering the channel from the north side of the channel rather than scour during high flows.

Additional Photo 2: Eroding bank EBL3.

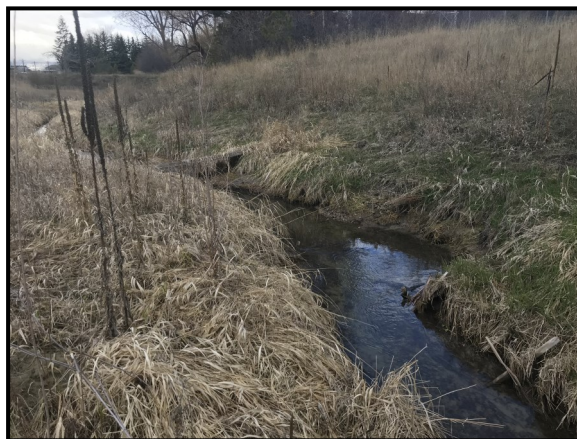
Additional Photo 2: Eroding bank EBL3 (taken in April 2019)
