Montana Department of Transportation Stream Mitigation Monitoring Report
ASHLEY CREEK MITIGATION SITE

Monitoring Year: 2020

Corps Permit Number: NWO-2009-01808-MTM

Monitoring Conducted By: Confluence Consulting Inc.

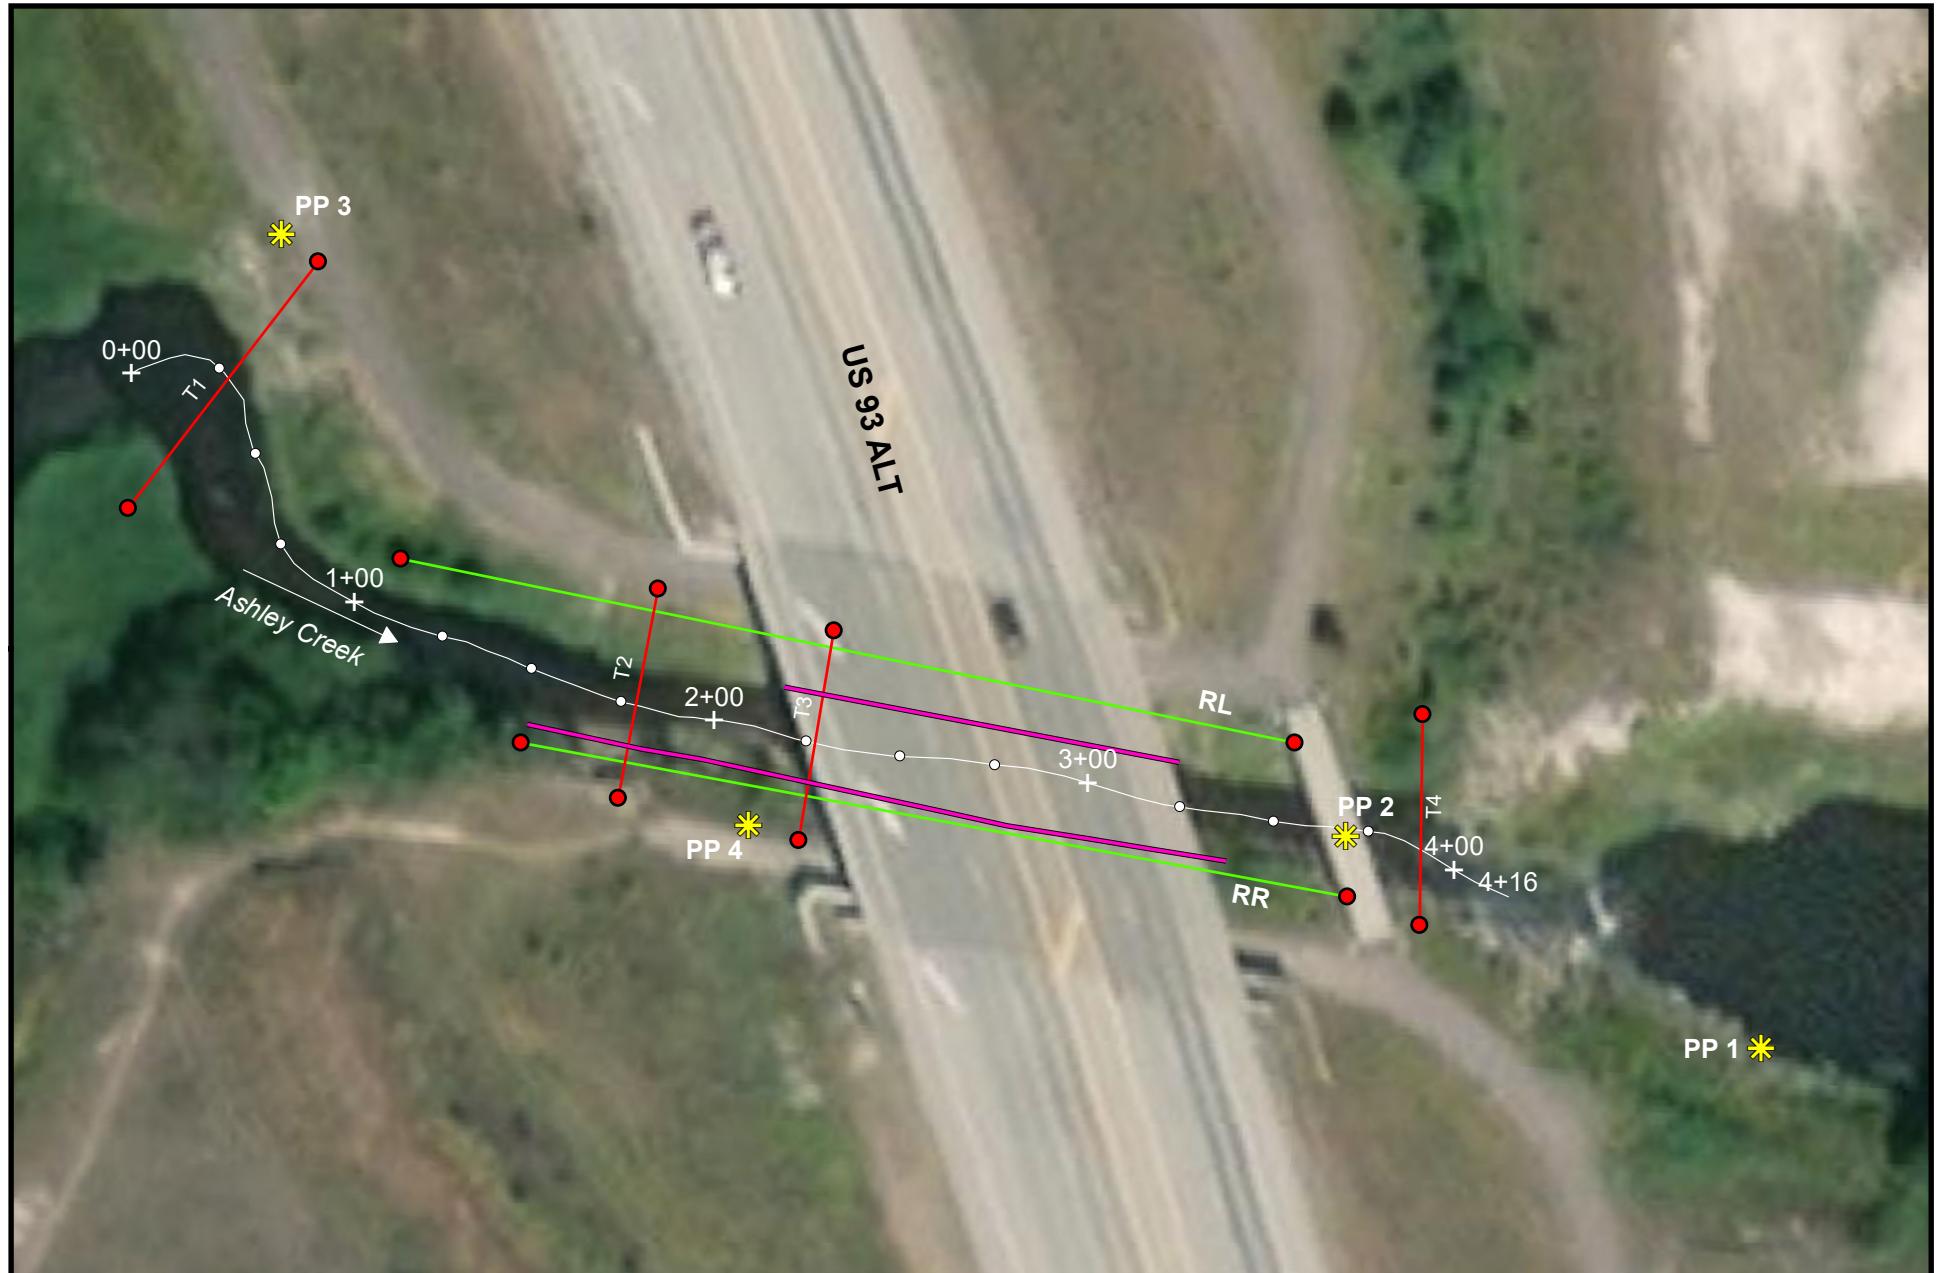
Previous monitoring reports documented bank erosion beneath the Highway 93 Bridge. For the purposes of this report an "eroding bank" is defined as any bank greater than two feet in length that is more than 50% bare mineral soil and has no roots, surface vegetation, or other stabilizing structure (e.g. rock, woody debris) to inhibit erosion. The following section provides an updated bank erosion inventory where new erosion is occurring and where previous erosion has been addressed. Photos of each eroding bank are included in Appendix B of this report, while Figure 2 in Appendix A provides the locations of each eroding bank.

Total eroding bank length within the Ashley Creek mitigation project area decreased from 312 feet in 2019 to 292 feet in 2020. The length of erosion on the right bank (EBR 1-2) is 187 feet, which decreased by 41 feet since 2019, as the downstream end of this bank has been stabilized by woody vegetation, including chokecherry and snowberry, perennial grasses, and a patch of common tansy (*Tanacetum vulgare*) along this bank. Left bank erosion increased by 21 feet in 2020, and now is 105 feet long, owing to reduced vegetative cover on the upstream end of this bank segment. All stream banks under the footprint of the Highway 93 Bridge are now considered eroding. The only length of eroding bank that is not under the bridge is the upstream end of EBL 1-2, which is 75 feet long. This bank segment is a steep cut-bank that will not support vegetative growth or otherwise become stabilized in its current configuration.

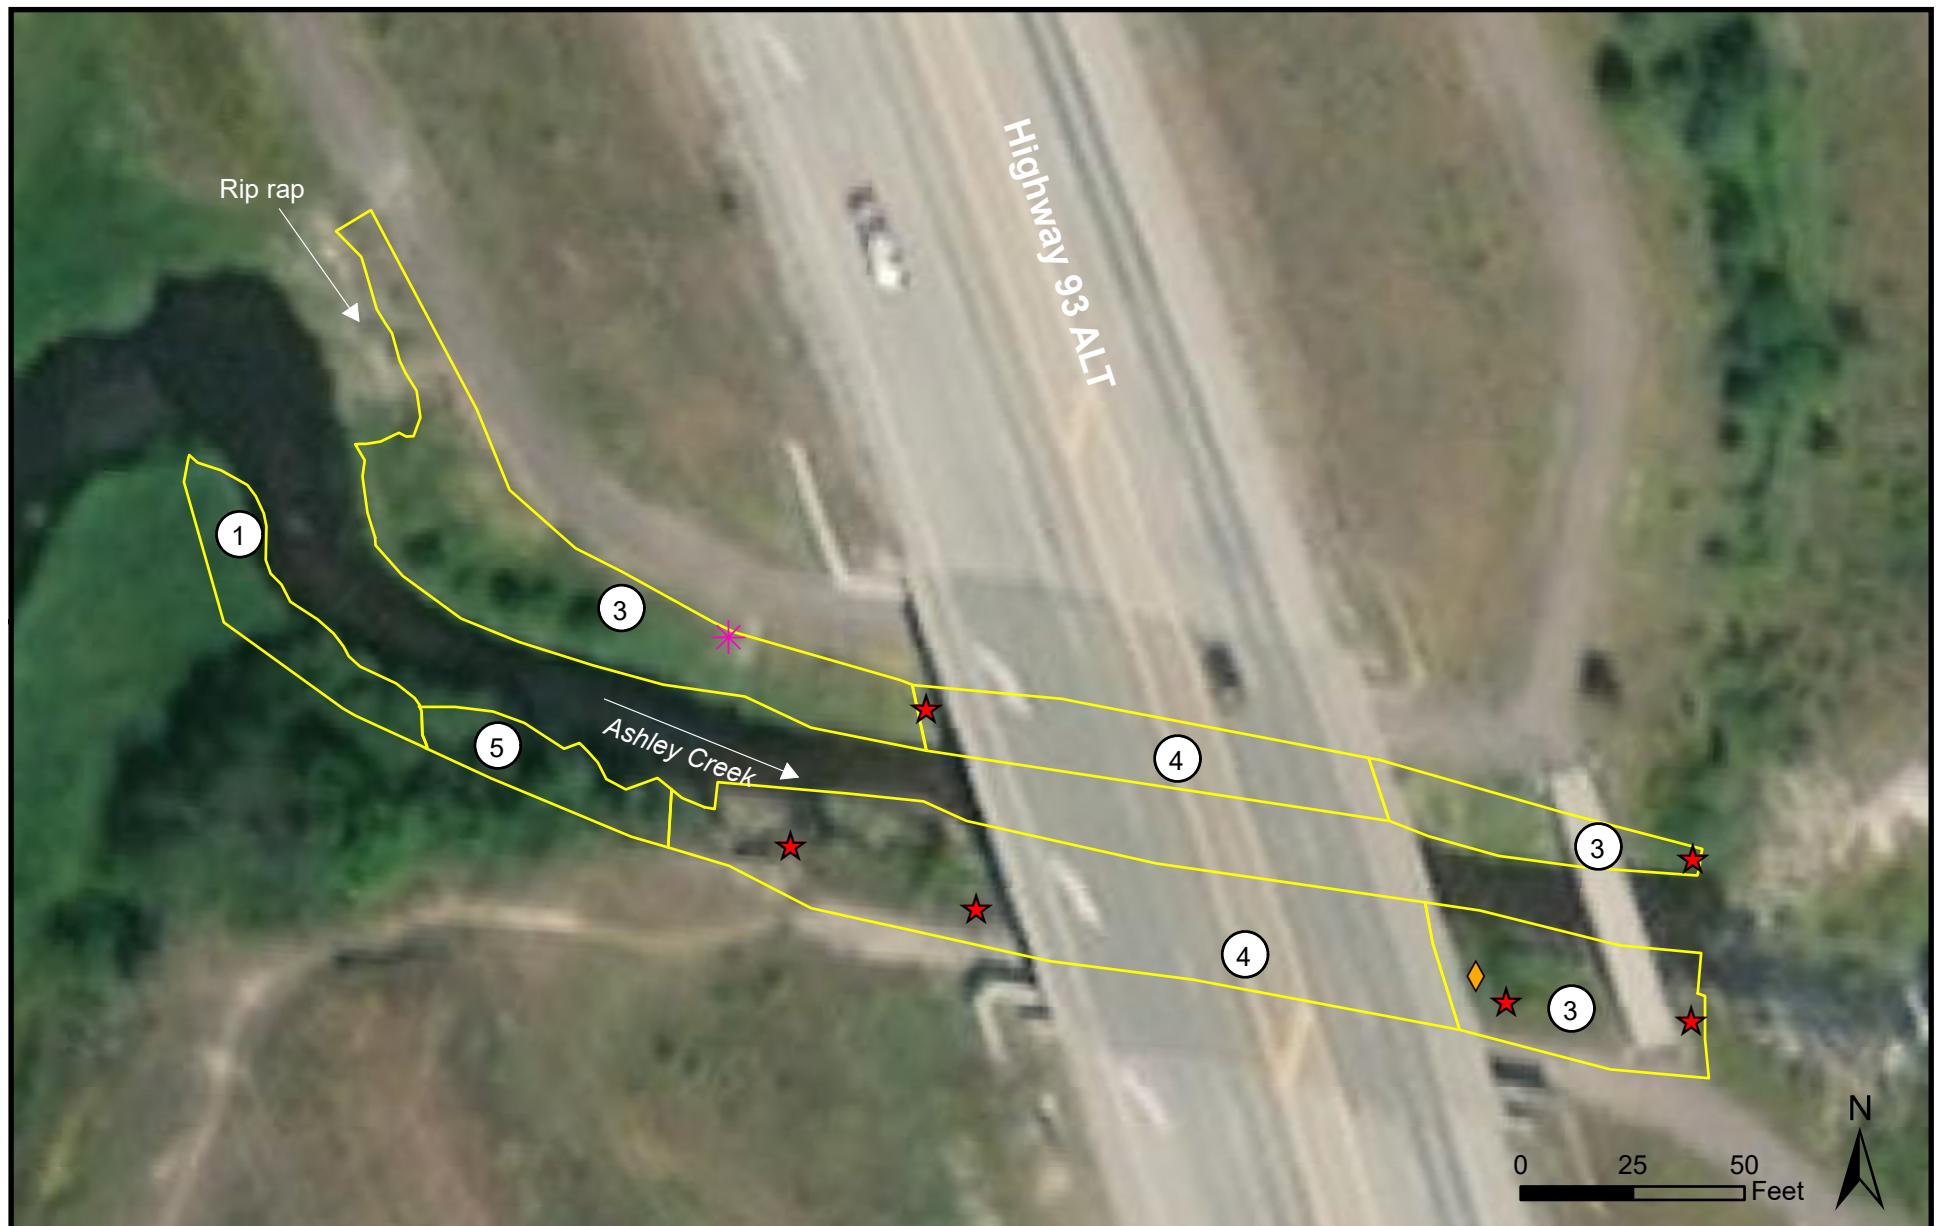
Dominant species recorded along the riparian transects were combined with visual observations in other areas to develop a vegetation community map (Figure 3, Appendix A). The same four community types documented in 2019 were observed during the 2020 monitoring event. These include community Type 1 – *Phalaris arundinacea*, 3 – *Phalaris arundinacea/Elymus* spp., 4 – Bare Ground/*Elymus* spp., and 5 – *Cornus alba/Alnus incana*. Side slopes along the straight channel alignment are dominated by bare ground, wild rye (*Elymus* spp.), and reed canary grass (*Phalaris arundinacea*). The right bank along the upstream extent of the project reach, which was not disturbed during construction, is dominated by reed canary grass. Community Type 3 on both the left and right stream banks has shifted since the 2015 monitoring event, to include community Types 4 and 5, due to increases in bare ground, red osier dogwood (*Cornus alba*), and speckled alder (*Alnus incana*).

Eight infestations of three Montana Listed Priority 2B noxious weeds were mapped within the riparian corridor at the Ashley Creek stream mitigation site and included Canadian thistle (*Cirsium arvense*), field bindweed (*Convolvulus arvensis*), and common tansy (*Tanacetum vulgare*) (MDA 2019). Noxious weed occurrences are displayed on Figure 3 in Appendix A with the exception of those observed in trace amounts, which were not mapped. Spotted knapweed (*Centaurea stoebe*) and houndstongue (*Cynoglossum officinale*) were observed in isolated trace amounts but were not mapped. A low cover class (1 to 5 percent) was identified for all mapped weed occurrences within the project area. An estimated 3% of the project area has been colonized by noxious weeds, with common tansy (*Tanacetum vulgare*) identified as the most prevalent. Based on these results, the riparian buffer meets the noxious weed success criterion which requires less than 10% noxious weed cover in the riparian buffer.

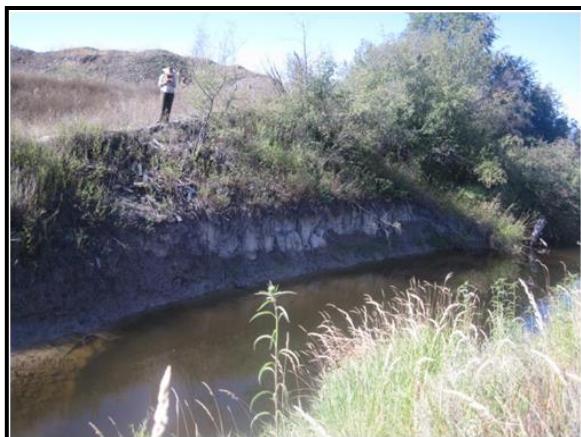
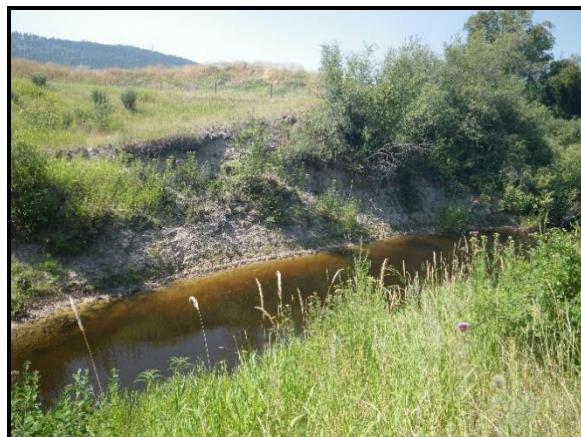
Although the total eroding bank length has decreased since 2019, the severity of erosion has increased on the stream banks under the bridge. Vegetative cover along EBR 1-2 and EBL 2 has decreased every year since monitoring began. This trend has continued over the last year and there are now large sections of both banks that are completely bare. Sloughing was observed on both banks and new slump blocks were observed along EBR 1-2. Erosion of these banks is also being accelerated by anthropogenic use (i.e. foot traffic) on both EBR 1-2 and EBL 2. Reduced vegetative cover and increased bare soil stem from a lack of direct sunlight and precipitation beneath the bridge, which are required elements for plant growth.

Additional Photo 2: Upper end of Eroding Bank EBR1 –2.

Adaptive Management actions are being evaluated by MDT to address streambank erosion and subsequent changes to the channel form under the US Highway 93 - Kalispell Bypass bridge over Ashley Creek. MDT is in the process of developing construction plans with a stream restoration firm to address the eroding banks along Ashley Creek within this mitigation area in coordination with the US Army Corps of Engineers for permits and stream crediting.

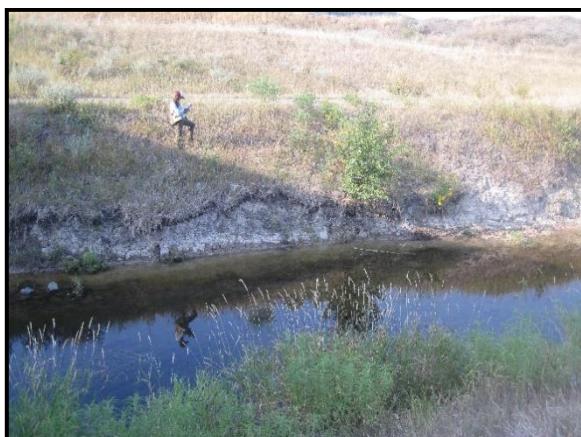
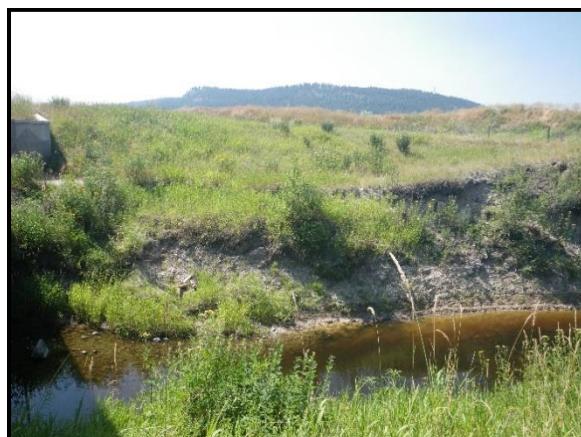
Additional Photo 3: Middle of Eroding Bank EBR1-2.

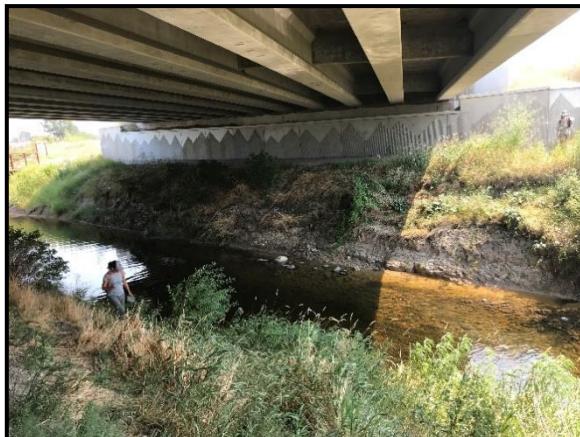
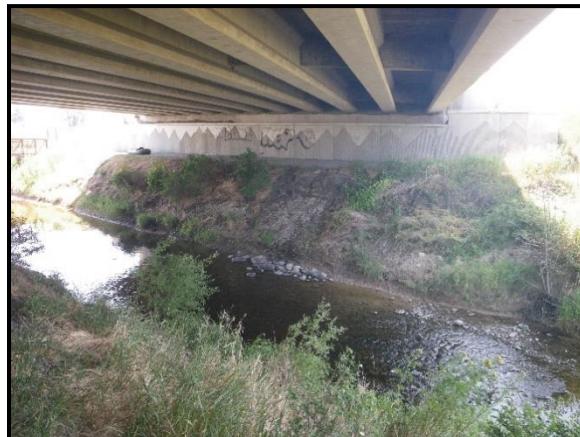
Additional Photo 4: Middle of Eroding Bank EBR1-2.

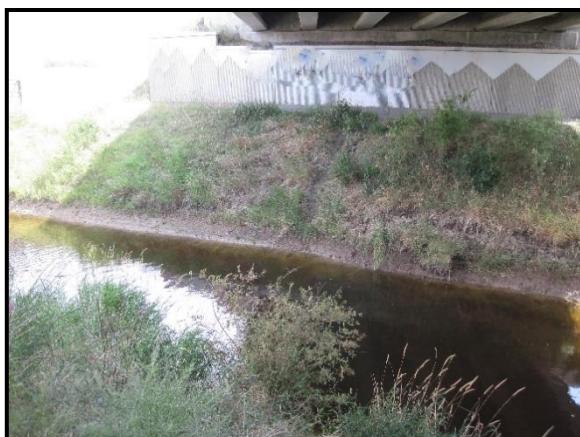
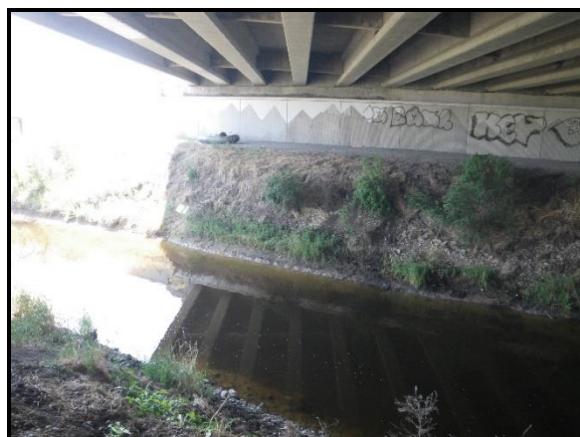
Additional Photo 5: Downstream end of eroding Bank EBR 1-2.

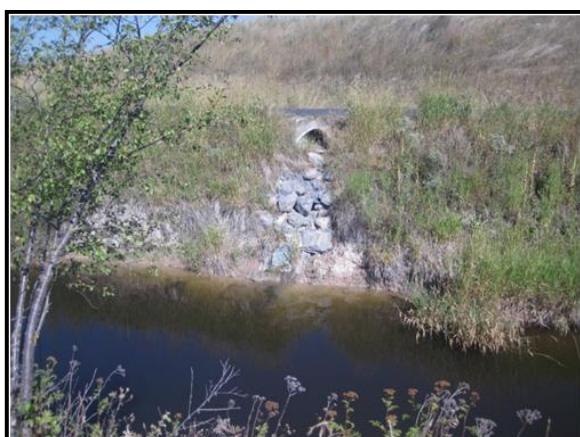
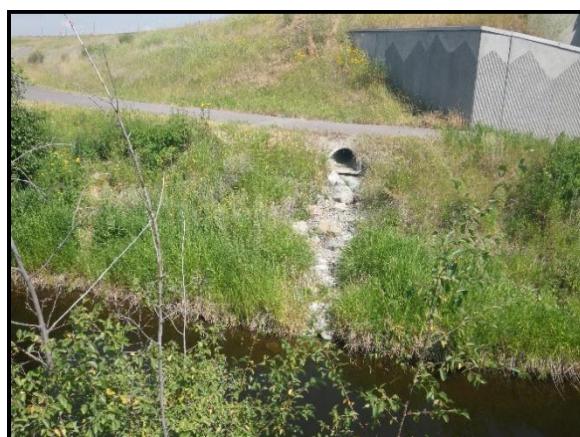
Two eroding banks were previously identified downgradient of storm water culvert outlets which drain into the channel. One of these culvert outlets is located the left bank on the upstream end of the project reach, and the other is on the right bank on the downstream end of the reach. Both outfall areas have been repaired and armored, and are no longer actively eroding (see photos in Appendix B).

Additional Photo 6: Stabilized culvert outlet.

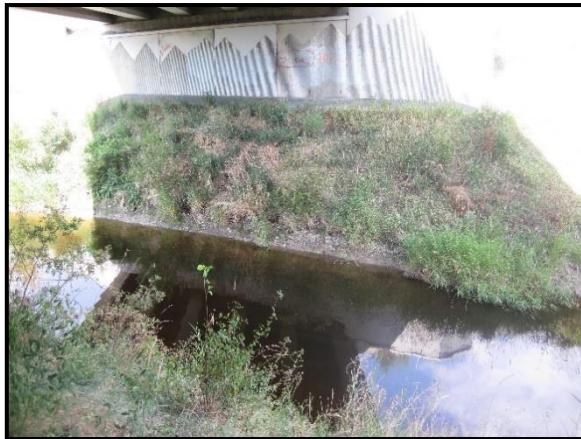
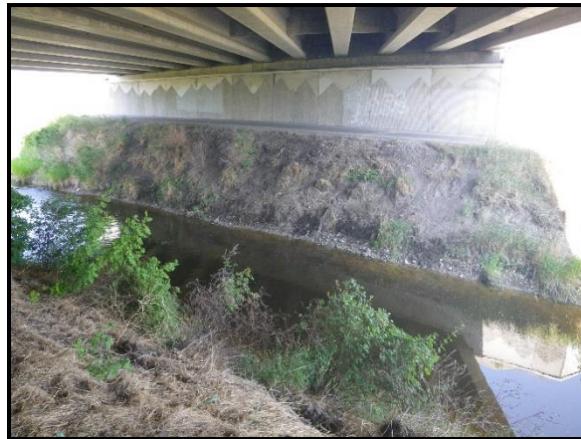
Additional Photo 7: Eroding Bank EBL2

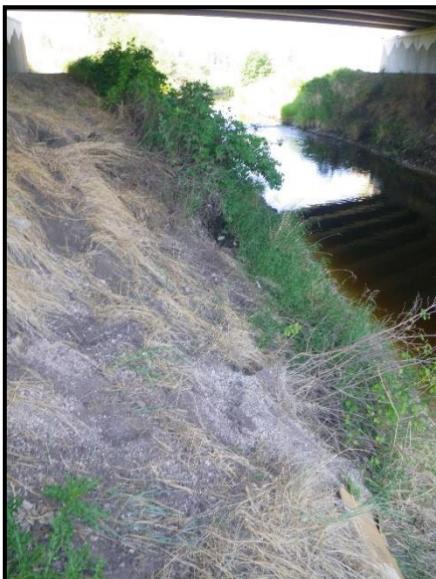
due to a lack of direct sunlight and precipitation beneath the bridge and the use of herbicides. The poor vigor of shrubs planted along the lower banks (particularly along the south bank) is also influenced by bank sloughing. Additionally, over the past few years, it has been challenging to locate shrubs that may have died several years ago, which can skew the results toward a higher survival rate if the number of live shrubs is compared to the number of dead shrubs observed.

Despite continued erosion on the upper banks, the Ashley Creek channel does not exhibit signs of lateral migration. A clay lens, located at toe of the streambank, protects the banks from eroding laterally; however, this feature does not protect the upper portions of the streambanks. This conclusion is supported by annual cross-sectional transect surveys (Appendix E) which show little lateral movement at the edge of the bankfull channel and slumping on the upper bank at Transects 2-4. The upper banks have retreated by as much as four feet since 2013 (Appendix E), due to loss of vegetation and subsequent bank erosion. Erosion severity along the upper banks is considered high due to the relatively steep bank angle, the bank material being fine grained, and the lack of vegetation. Without corrective action, erosion is likely to continue along both banks under the Highway 93 Bridge.

Additional Photo 8: Toe of eroding bank EBR1-2 showing bank sloughing and loss of woody vegetation.

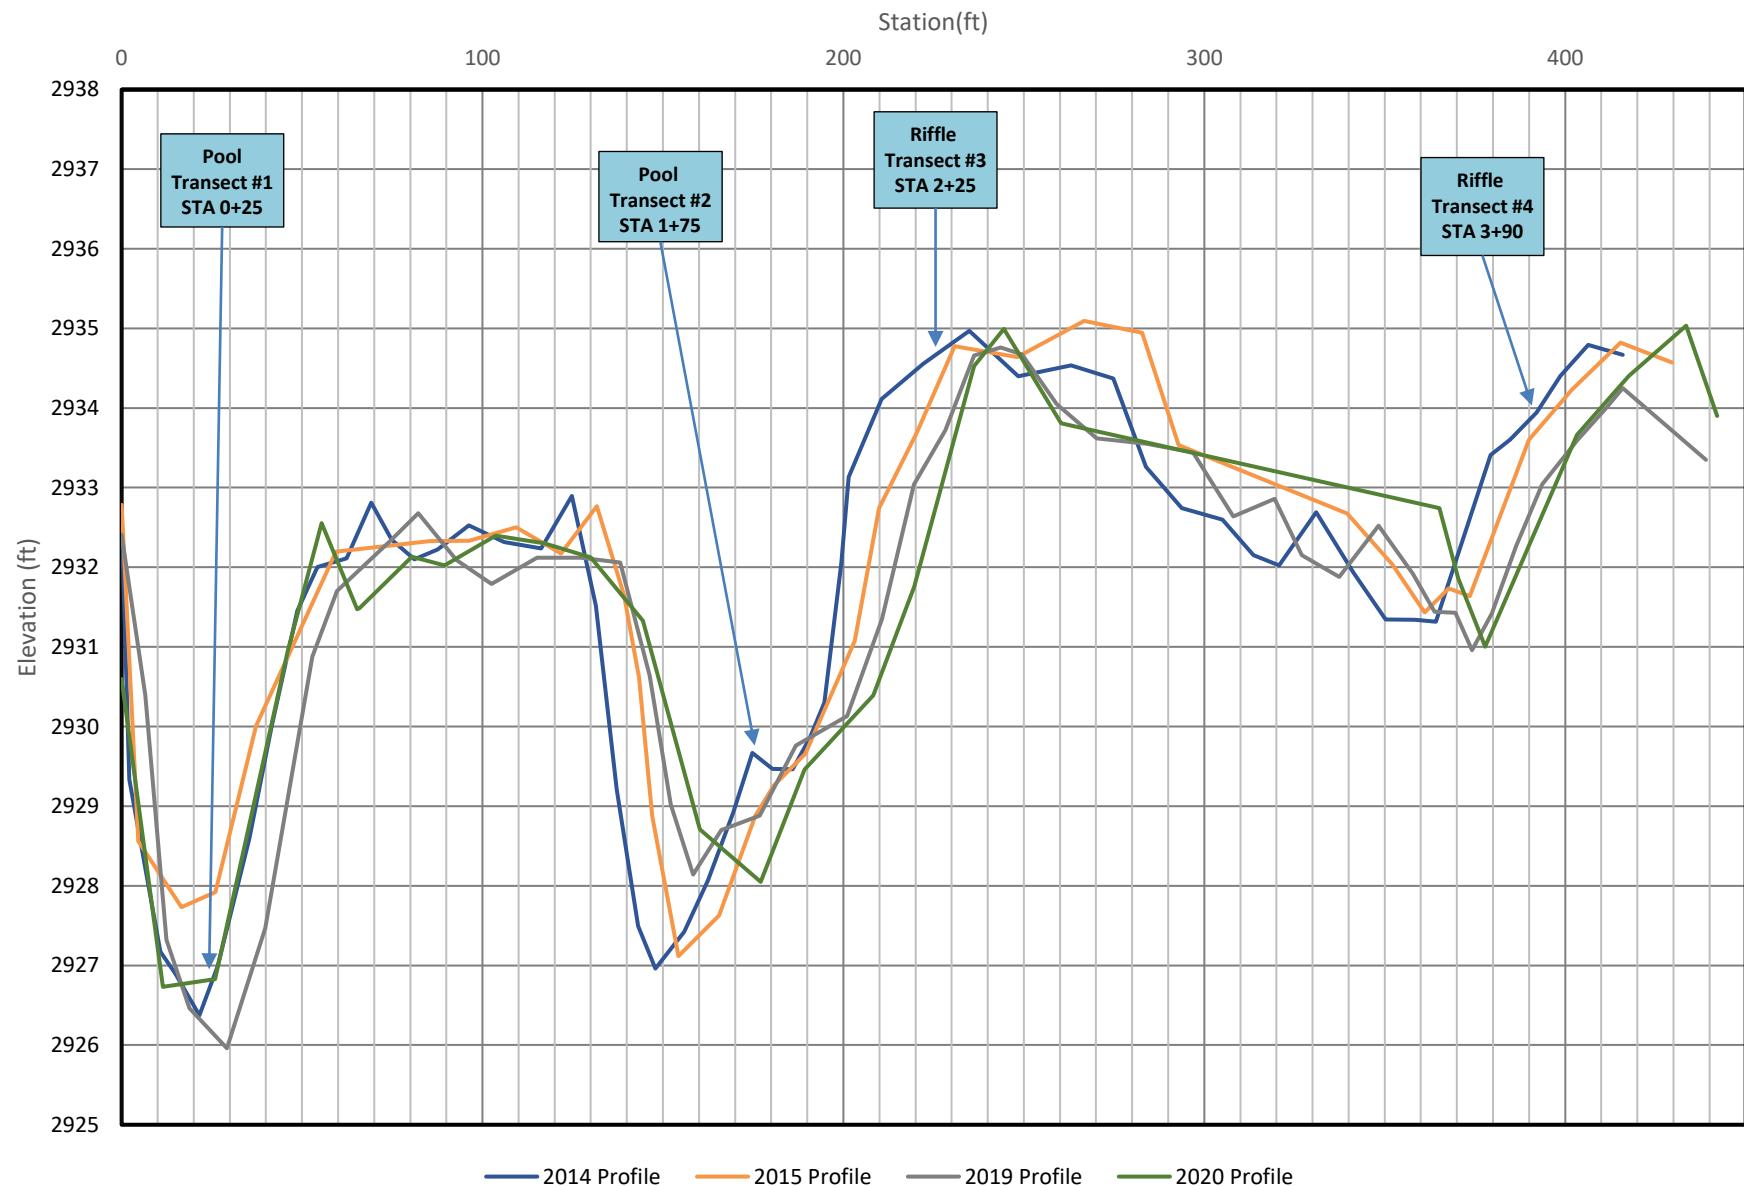
Ashley Creek Longitudinal Profiles

Annual surveys of the Ashley Creek longitudinal profile indicate that the channel form is stable and that pool and riffle features are being maintained over time (Appendix E). The mitigation reach supports three pools, each of which are separated by a distinct riffle. Pool features occur along a sharp meander bend at the upstream extent of the project and within the straight segment of the channel. In combination, these pool-riffle sequences provide adequate slow water habitat for fish and faster-moving shallow water habitat for insect production.
