Montana Department of Transportation Stream Mitigation Monitoring Report

FOY'S BEND FISHERIES CONSERVATION AREA

Monitoring Year: 2020

Monitoring Conducted By: Confluence Consulting Inc.

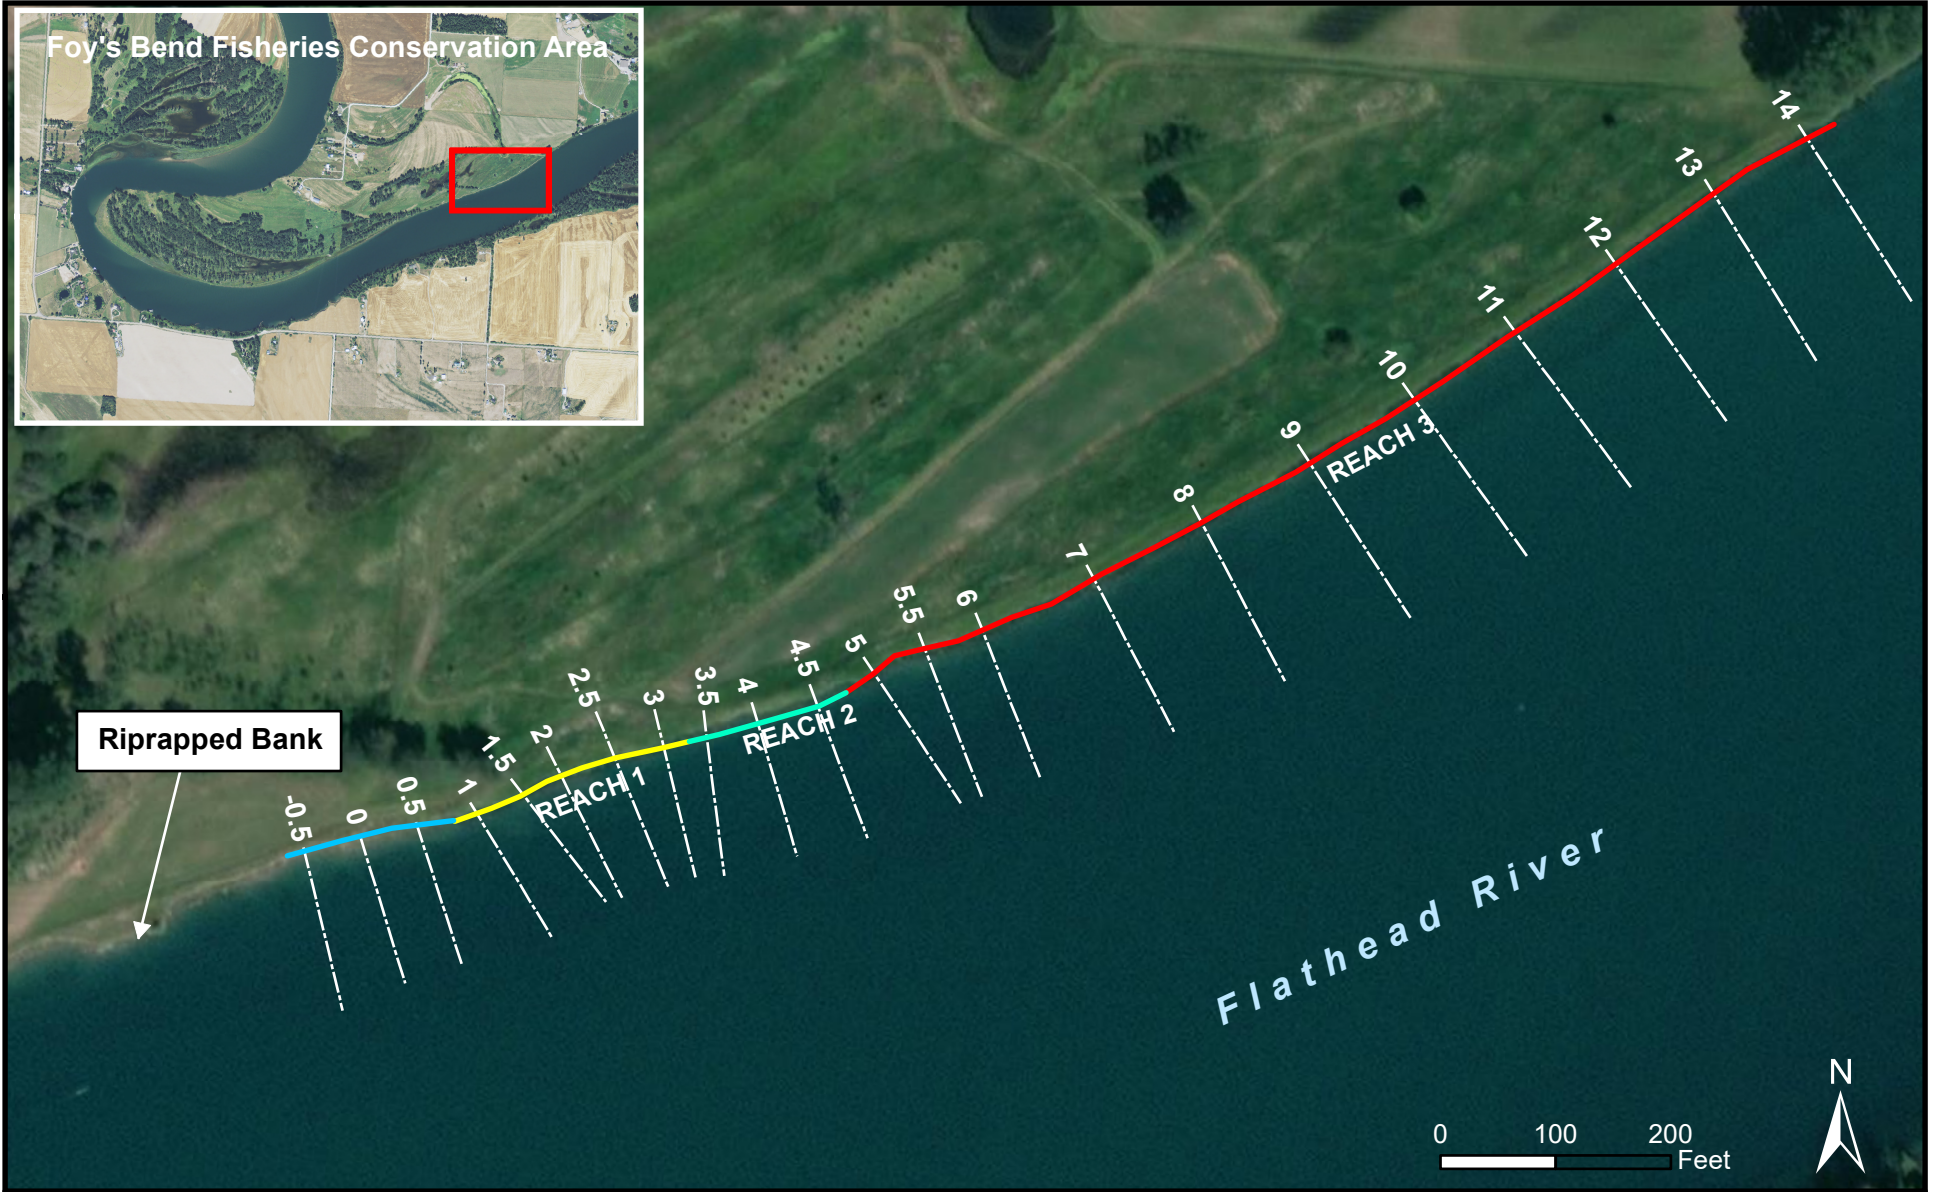
Figure 2

Erosion Upstream of Reconstructed Bank – Erosion has been monitored at three transects (-0.5, 0, 0.5) upstream of the treated bank since 2016, where approximately 775 feet of bank is actively eroding (Figures 2 and 5, Appendix G). This bank segment has often exhibited higher erosion rates as compared to transects downstream (Table 7). The majority of erosion observed in this reach is in the uppermost portion of the bank and extends downstream far enough to intercept the reconstructed bank where it has begun to influence the stability of Reach 1, and has captured a portion of the protective fencing installed around a revegetated area (see photo point 5.1 and survey photos 14 & 15, Appendix B). Over the survey timeframe, Transect -0.5 has exhibited the highest bank retreat rate when compared to all other transects surveyed. Between 2016 and 2020, Transect -0.5 retreated by 12.2 feet (3.1 feet/year). The bank is also retreating at Transects 0.0 and 0.5, although at a slower pace; 1.5-2 feet per year. The trend of rapid bank retreat the upstream reach continued in 2020, when the bank retreated 1-2 feet between April and July (Table 7). Since this reach is not treated or reconstructed portion of the mitigation project, it is not compared against the success criteria.

Reach 1 – Reach 1 spans the upstream 235 feet of reconstructed bank and contains five transects (Transects 1-3; Figure 2). Annual surveys of these transects indicate that upper portions of the reconstructed bank that were re-sloped and revegetated remain stable but that the lower portions of the bank have retreated by an average of 4.6 feet since 2013 (Table 7). The average annual retreat rate of lower bank is approximately 0.6 feet/year which is considered “functional” in the performance standards (less than 1 foot annually). However, the average retreat rate across the Reach 1 transects was 2.2 feet per year since 2019, which would be considered “Functional at Risk” in the performance criteria. Additionally, the area beneath the bank treatments has become vertical and is susceptible to undercutting and bank failure (Appendix G). Bank failures were observed at Transects 2.5 and 3, where the bank slumped and retreated by approximately three feet between April and July 2020 (Table 7; Appendix G). The bank has now retreated past the edge of the coir mat at these transects and remains quite steep between the low and high-water elevations. The increased bank retreat observed over the 2020 summer is primarily attributed to undercutting beneath the reconstructed portion of the bank, which has caused the fascines and coir soil lift to slump down in elevation by an average of 0.8 feet over the last year. Erosion is expected to continue along these transects at a relatively rapid pace now that the bank is no longer protected by the bank treatments.

Reach 2 – Reach 2 is 135 feet long and is represented by Transects 3.5 through 4.5 (Figure 2). Although the re-sloped and revegetated upper portions of the reconstructed bank remain stable, severe bank erosion beneath the woody fascines was observed in Reach 2 between 2013 and 2017, and the fascines became detached from the bank. Due to the loss of bank protection from the fascines, the bank has eroded more rapidly over the past three years. The leading edge of the bank has retreated 1-2 feet over the past year, and between 9 and 11 feet since monitoring began in 2013 (Appendix G). The average retreat rate for Reach 2 is 1.2 feet/year over the monitoring period, which is considered “functional at risk” in the performance standards. Bank retreat is expected to continue in Reach 2 given the lack of bank protection beneath the treated area.

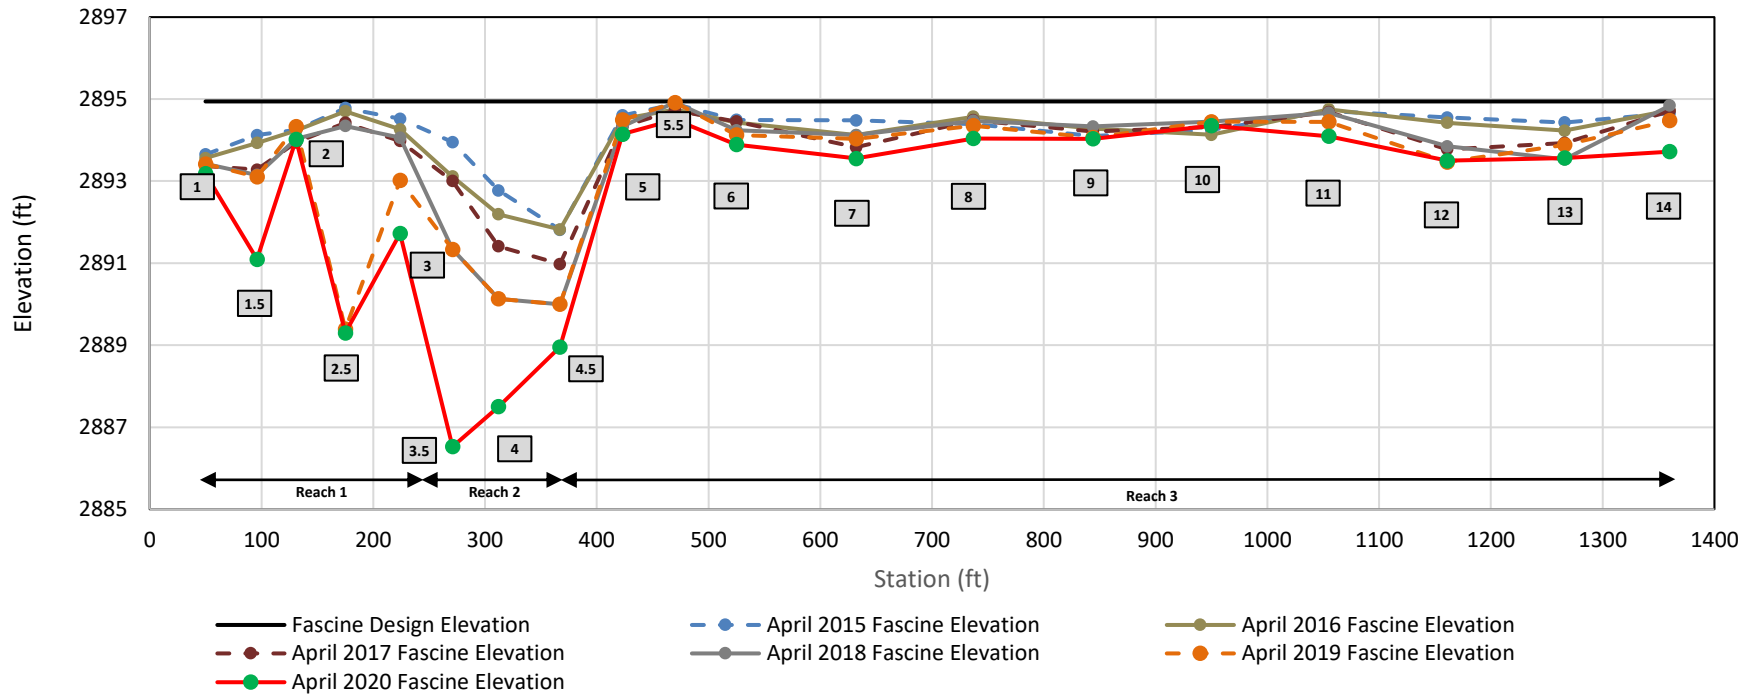
Foy's Bend Fascine Profile

The elevation of the woody fascine in Reach 2 continued to drop over the past year and is now between 6.0 and 8.4 feet below the design elevation (Table 7). The woody fascine has continued to slump due to undercutting and soil loss beneath the bank treatment. Extended transect surveys indicate that the

submerged toe of the bank has moved northward 5-7 feet between 2016 and 2020 and is therefore likely contributing to the soil loss beneath the bank treatment in Reach 2.

Reach 3 – Reach 3 contains 1,000 feet of the reconstructed bank and is represented by transects 5-14. The upper, re-sloped portion of the reconstructed bank above the soil lift in Reach 3 has maintained a stable configuration with no documentation of lateral erosion. The lower portion of the bank has eroded some, but at much lower erosion rates than in all the other reaches. The average lateral erosion rate since 2013 was 2.4 feet, which equates to 0.3 feet per year for Reach 3. This erosion rate is considered “functional” in the performance standards. Individual transects have eroded laterally between 1.0 and 3.8 feet during the monitoring period, with the highest amounts of erosion having been observed at transects 6-8 and transect 14 (Table 7). However, increased erosion of up to 1.3 feet was observed at individual transects between the April and July 2020 monitoring events, indicating that the lower banks in this reach may be trending toward becoming less stable. On average, the elevation of the woody fascine in Reach 3 has only dropped slightly since 2019 and has only dropped about 1 foot since 2013 (Table 7).

The original design for the fascines and reconstructed banks specified that these features be installed over a wide range of elevations to account for fluctuating water levels in Flathead Lake, but various permitting agencies limited the design elevations to the mean summer water level. Since 2015, the elevation of the woody fascine below the soil lift has consistently dropped to between one and three feet below the design elevation (i.e. the assumed constructed elevation). Fascine elevation drops have been more drastic in Reaches 1 and 2, where the fascine elevations are now an average of 3.5 and 7.8 feet below the design elevation, respectively (Table 7, Appendix G). The lowering of the fascine is primarily the result of slope failure beneath the fascine causing the leading edge of the reconstructed

bank to slump into the river, although settling of the soils beneath the fascines and of the woody fascines themselves may also have contributed. The slope has failed because it is completely unprotected and drops steeply into the Flathead River. Any material that sloughs off of the bank and deposits at the toe, is washed away by swift river currents when the lake levels are low. This cycle prevents the formation of a supportive sub-surface bank, and therefore the bank continues to undercut. Without solid bank material to hold the soil lift and fascine in place, the fascine will continue to fall further into the water.
