Montana Department of Transportation Stream Mitigation Monitoring Report  
**ASHLEY CREEK MITIGATION SITE**

**Project Overview**

**MDT Project Number: NH-MT 5-3(59) FST / UPN # 2038010**

**Monitoring Year:** 2021

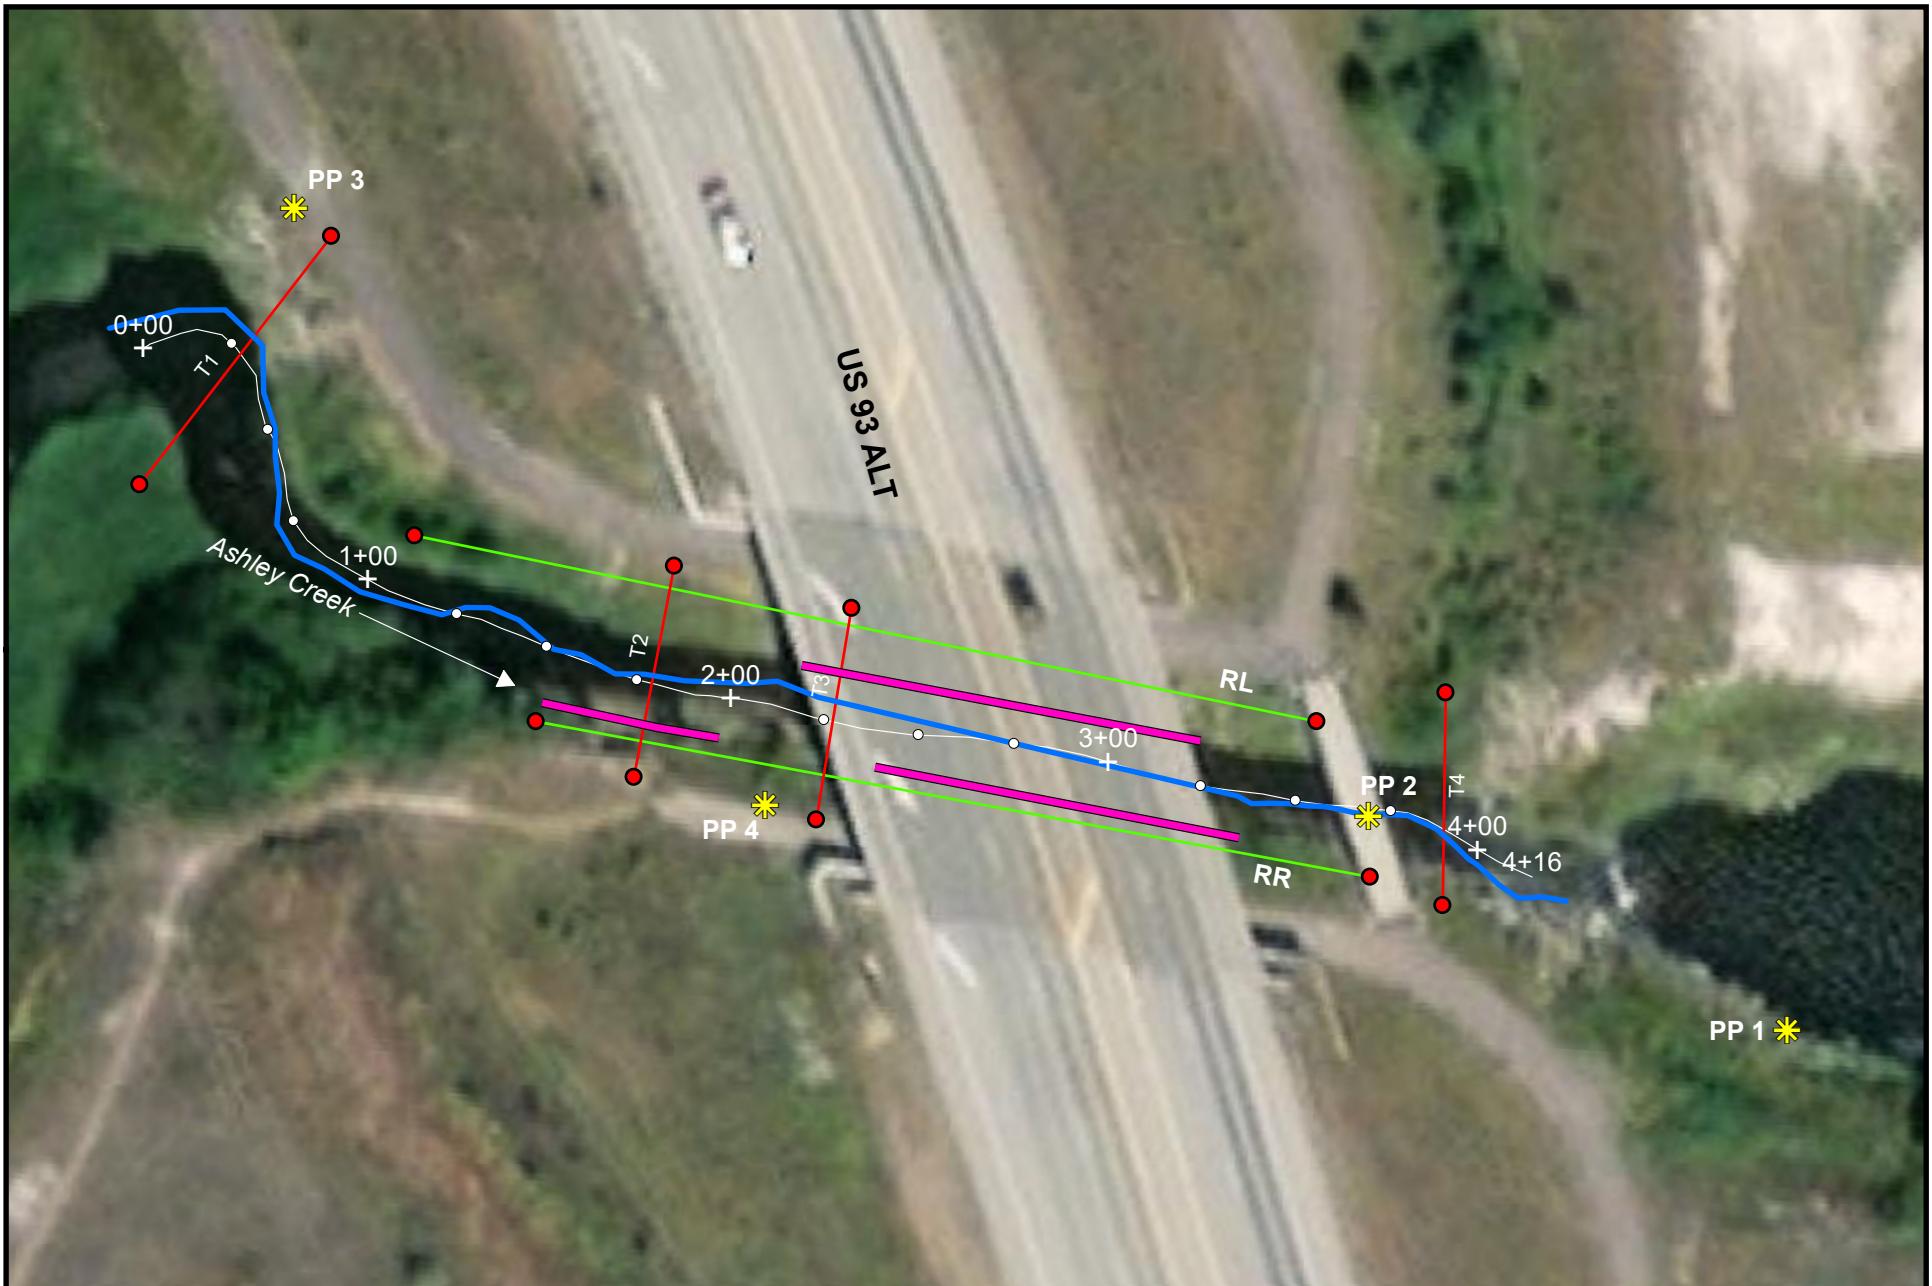
Figure 2

Total eroding bank length within the Ashley Creek mitigation project area decreased from 292 feet in 2020 to 266 feet in 2021. This decrease is due to improved vegetative cover on the right bank immediately upstream of the bridge. The length of erosion on the right bank is now 161 feet and occurs in two separate sections EBR1 (65 feet) and EBR2 (96 feet). The 26-foot section of bank between EBR1 and EBR2 has begun to stabilize in the last year, with increased perennial grass cover on the lower portion of the bank and woody species growth on the upper bank (Additional Photo 3, Appendix B). Slump blocks previously observed on the lower portion of the bank have begun to heal and the bank is now more than 50% vegetated. The length of erosion along the left bank (EBL 2) remained at 105 feet, which was consistent with observations in 2020. All stream banks under the footprint of the Highway 93 Bridge are considered eroding. The only eroding bank that is not under the bridge is EBR 1, which is located on a steep cut-bank that will not support extensive plant growth in its current configuration.

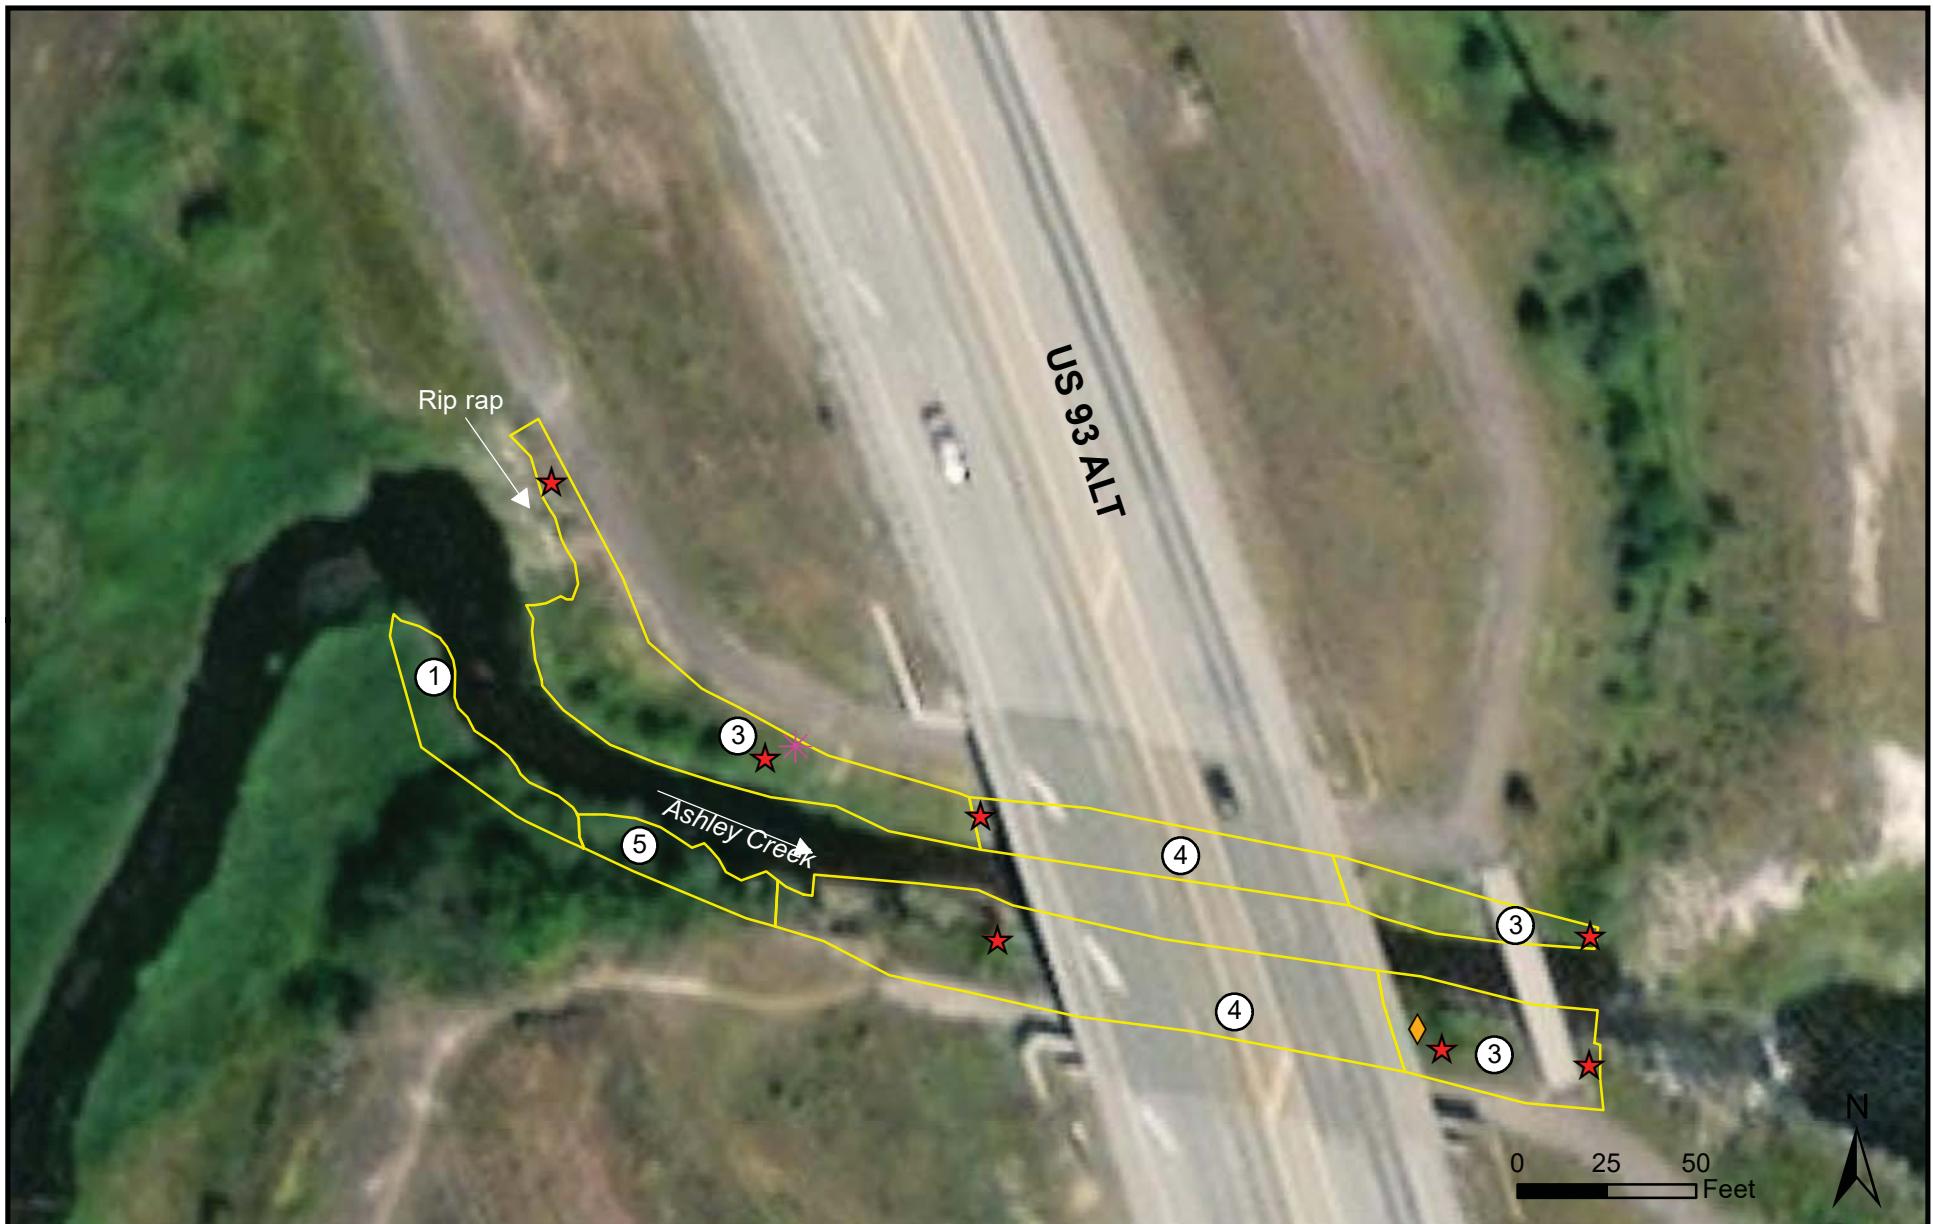
Dominant species recorded along the riparian transects were combined with visual observations of vegetation in other areas to develop a vegetation community map (Figure 3, Appendix A). The same four community types documented in 2018 through 2020 were observed during the 2021 monitoring event. These include community Type 1 – *Phalaris arundinacea*, 3 – *Phalaris arundinacea/Elymus* spp., 4 – Bare Ground/*Elymus* spp., and 5 – *Cornus alba/Alnus incana*. Side slopes along the straight channel alignment are dominated by bare ground, wild rye (*Elymus* spp.), and reed canary grass (*Phalaris arundinacea*).

(*Convolvulus arvensis*), and common tansy (*Tanacetum vulgare*) (MDA 2019). A low cover class (1 to 5 percent) was assigned to for all mapped weed infestations within the project area. An estimated 3% of the project area has been colonized by noxious weeds, with common tansy (*Tanacetum vulgare*) as the most prevalent. Noxious weed occurrences are displayed on Figure 3 in Appendix A with the exception of spotted knapweed (*Centaurea stoebe*) and houndstongue (*Cynoglossum officinale*) which were observed in trace amounts (<1%), and not mapped on Figure 3.

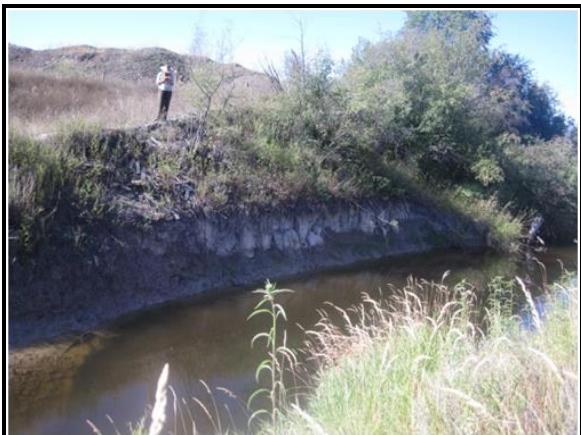
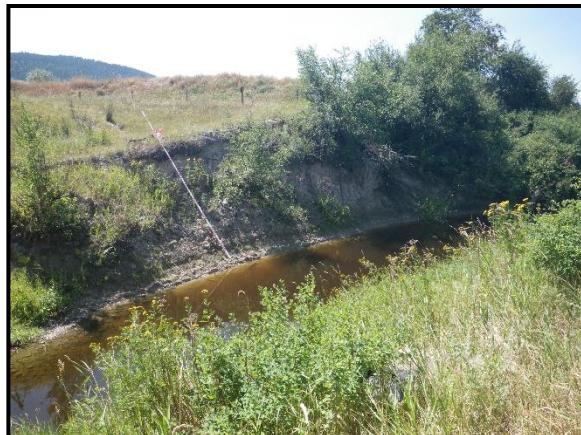
**Additional Photo 2:** Eroding Bank EBR1.

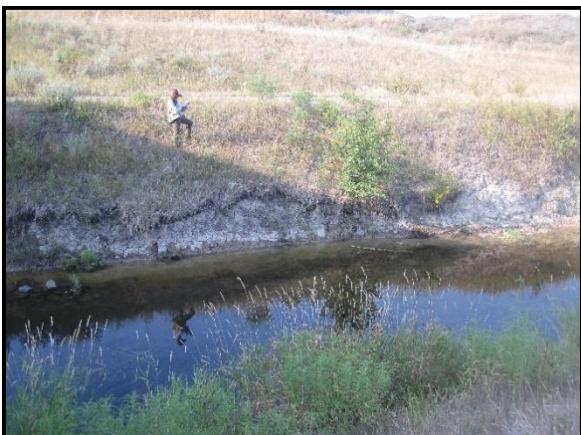
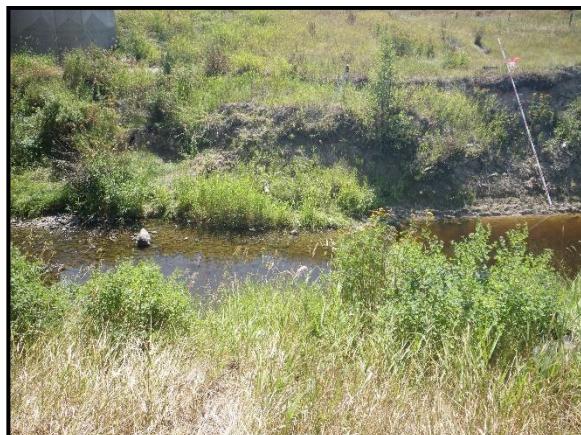
**Additional Photo 3:** Section of stabilized bank (previously considered eroding) between EBL 1 and EBL 2.

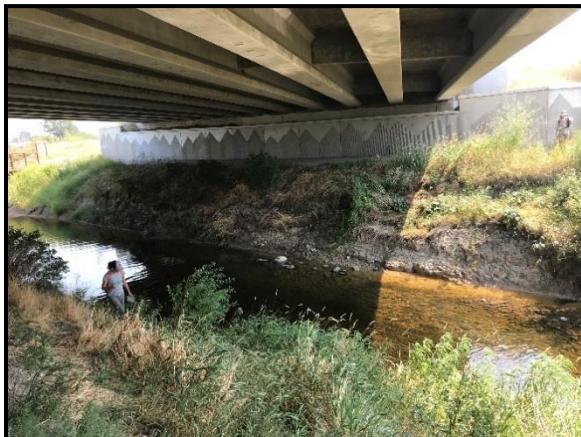
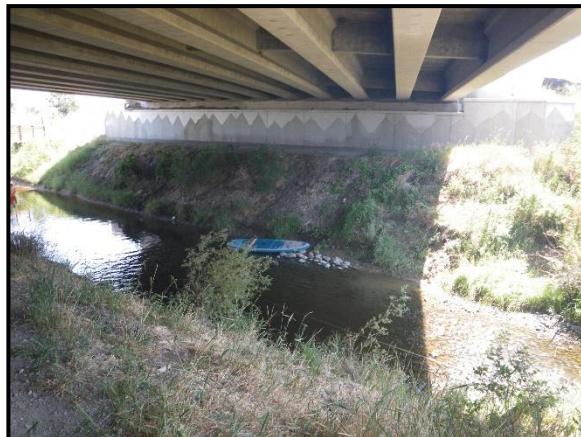
Although the total eroding bank length has decreased since 2019, the severity of erosion has increased on the stream banks under the bridge. Vegetative cover along EBR 2 and EBL 2 has decreased every year since monitoring began, and large sections of both banks are now completely bare. Sloughing was observed on both banks and new slump blocks were observed along EBR 2. Erosion of these banks has been accelerated by anthropogenic use (i.e. foot traffic) on both EBR 2 and EBL 2.

**Additional Photo 4:** Eroding Bank EBR 2.

Adaptive Management actions have been evaluated by MDT to address streambank erosion under the US Highway 93 - Kalispell Bypass bridge over Ashley Creek. MDT is in the process of developing plans to address the eroding banks for submission to the US Army Corps of Engineers for permits and approval.

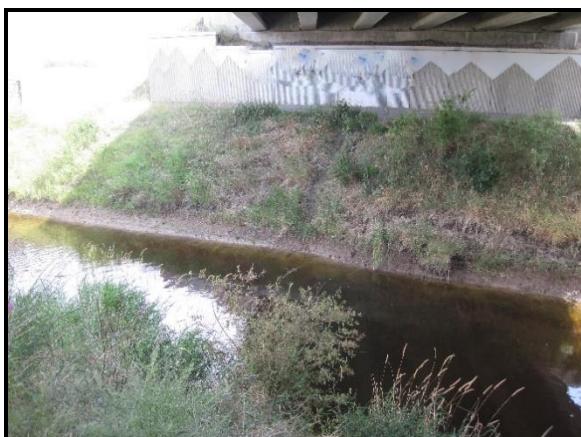
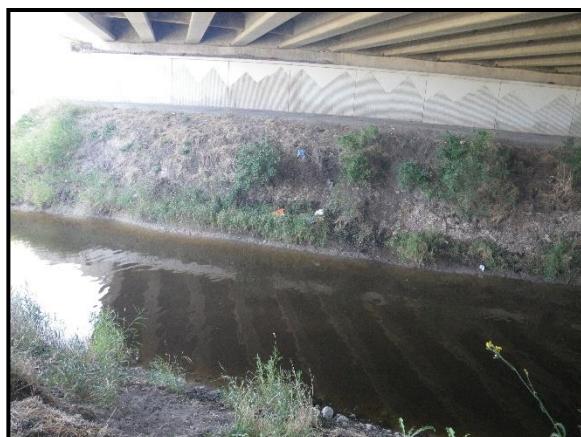
**Additional Photo 5:** Downstream end of eroding Bank EBR 2.

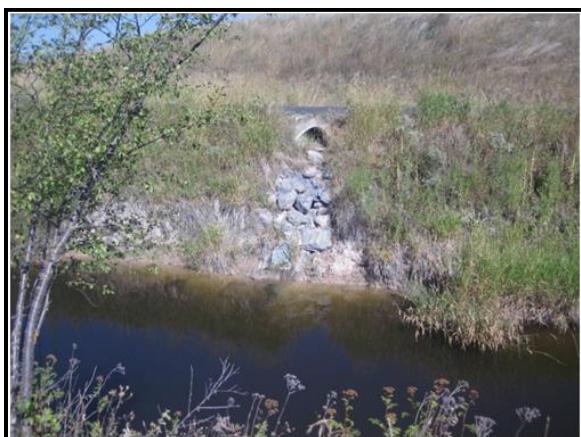
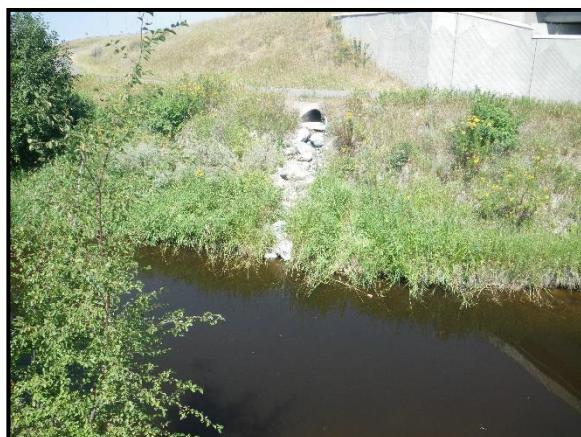
Two eroding banks were previously identified downgradient of storm water culvert outlets which drain into the channel. One of these culvert outlets is located on the north bank at the upstream end of the project reach, and the other is on the south bank at the downstream end of the reach. Both outfall areas have been repaired and armored, and are no longer actively eroding.

**Additional Photo 6:** Stabilized culvert outlet on the upstream end of the project area.

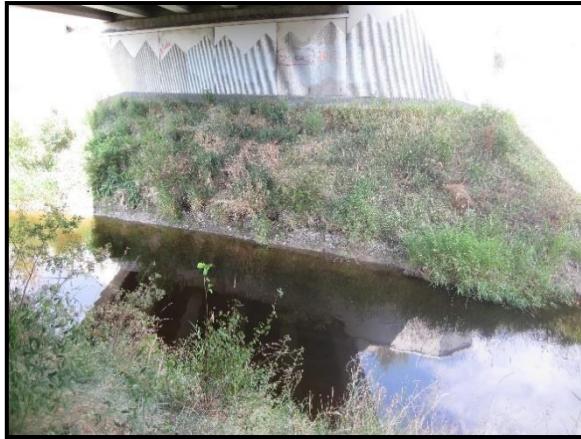
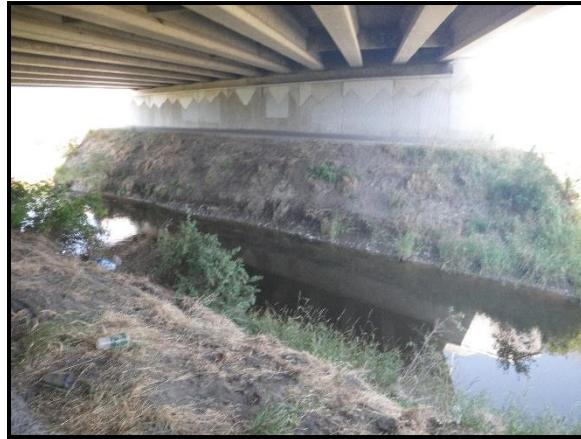
**Additional Photo 7:** Eroding Bank EBL2

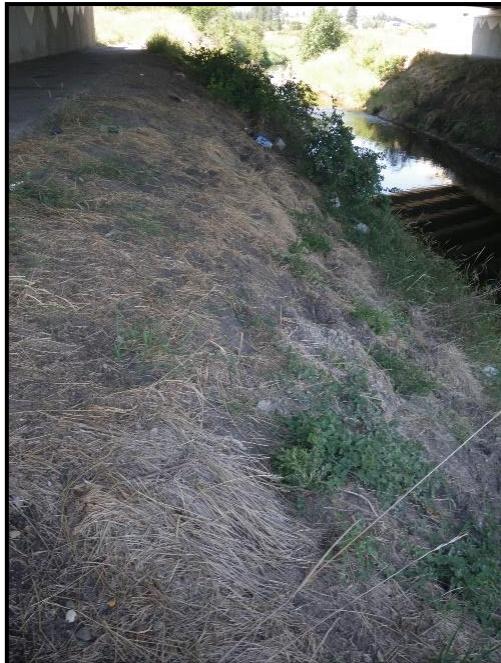
**Additional Photo 8:** Looking upstream at eroding bank EBR 2 showing bank sloughing and loss of woody vegetation.

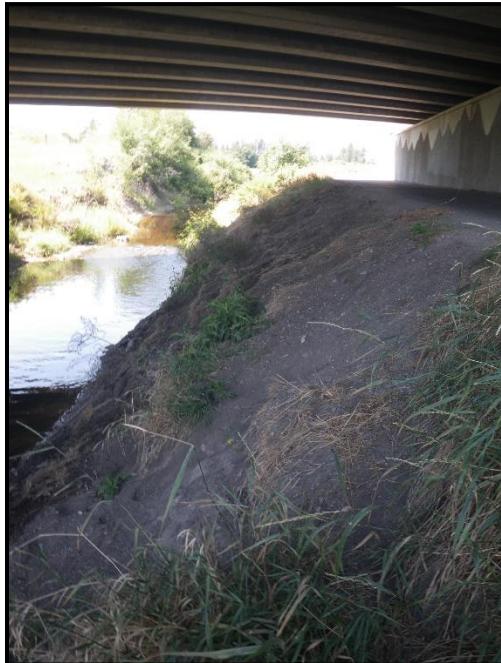
**Additional Photo 9:** Looking upstream at eroding bank EBL 2 showing bank sloughing and loss of vegetation.

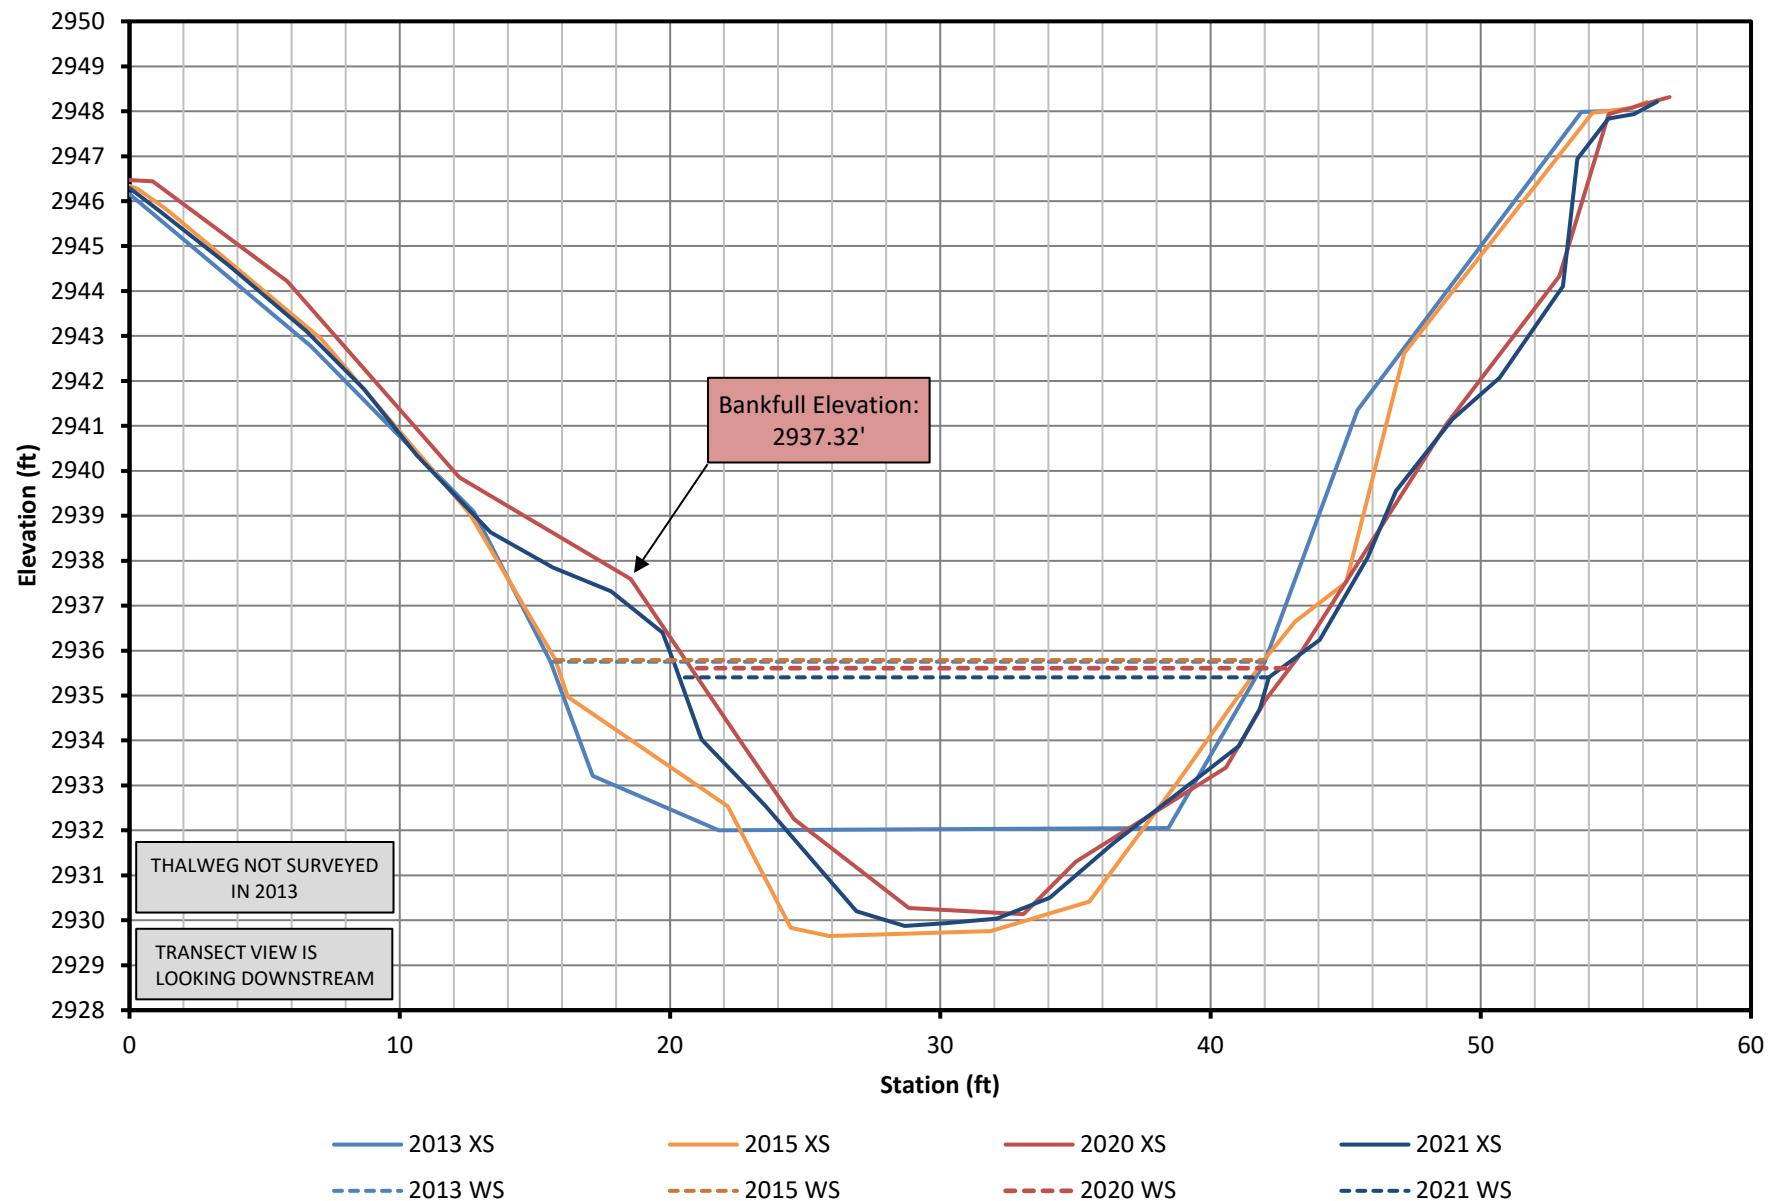
## Ashley Creek Transect #2 - Pool

Survey data collected at the four cross-section transects, indicate that the bankfull channel dimensions have been maintained over time at Transects 1 and 3. However, Transects 2 and 4 show evidence of channel narrowing, which is probably the result of upper bank sloughing. The average bankfull pool depth was 8.2 feet and average bankfull riffle depth was 2.8 feet. The average bankfull width was 24.7 feet at riffle transects and 35.3 feet at pool transects. These dimensions have remained relatively static since monitoring began in 2013 although Transects 3 and 4 have shown signs of channel narrowing in the last two years as a result of upper bank sloughing (Table 4).

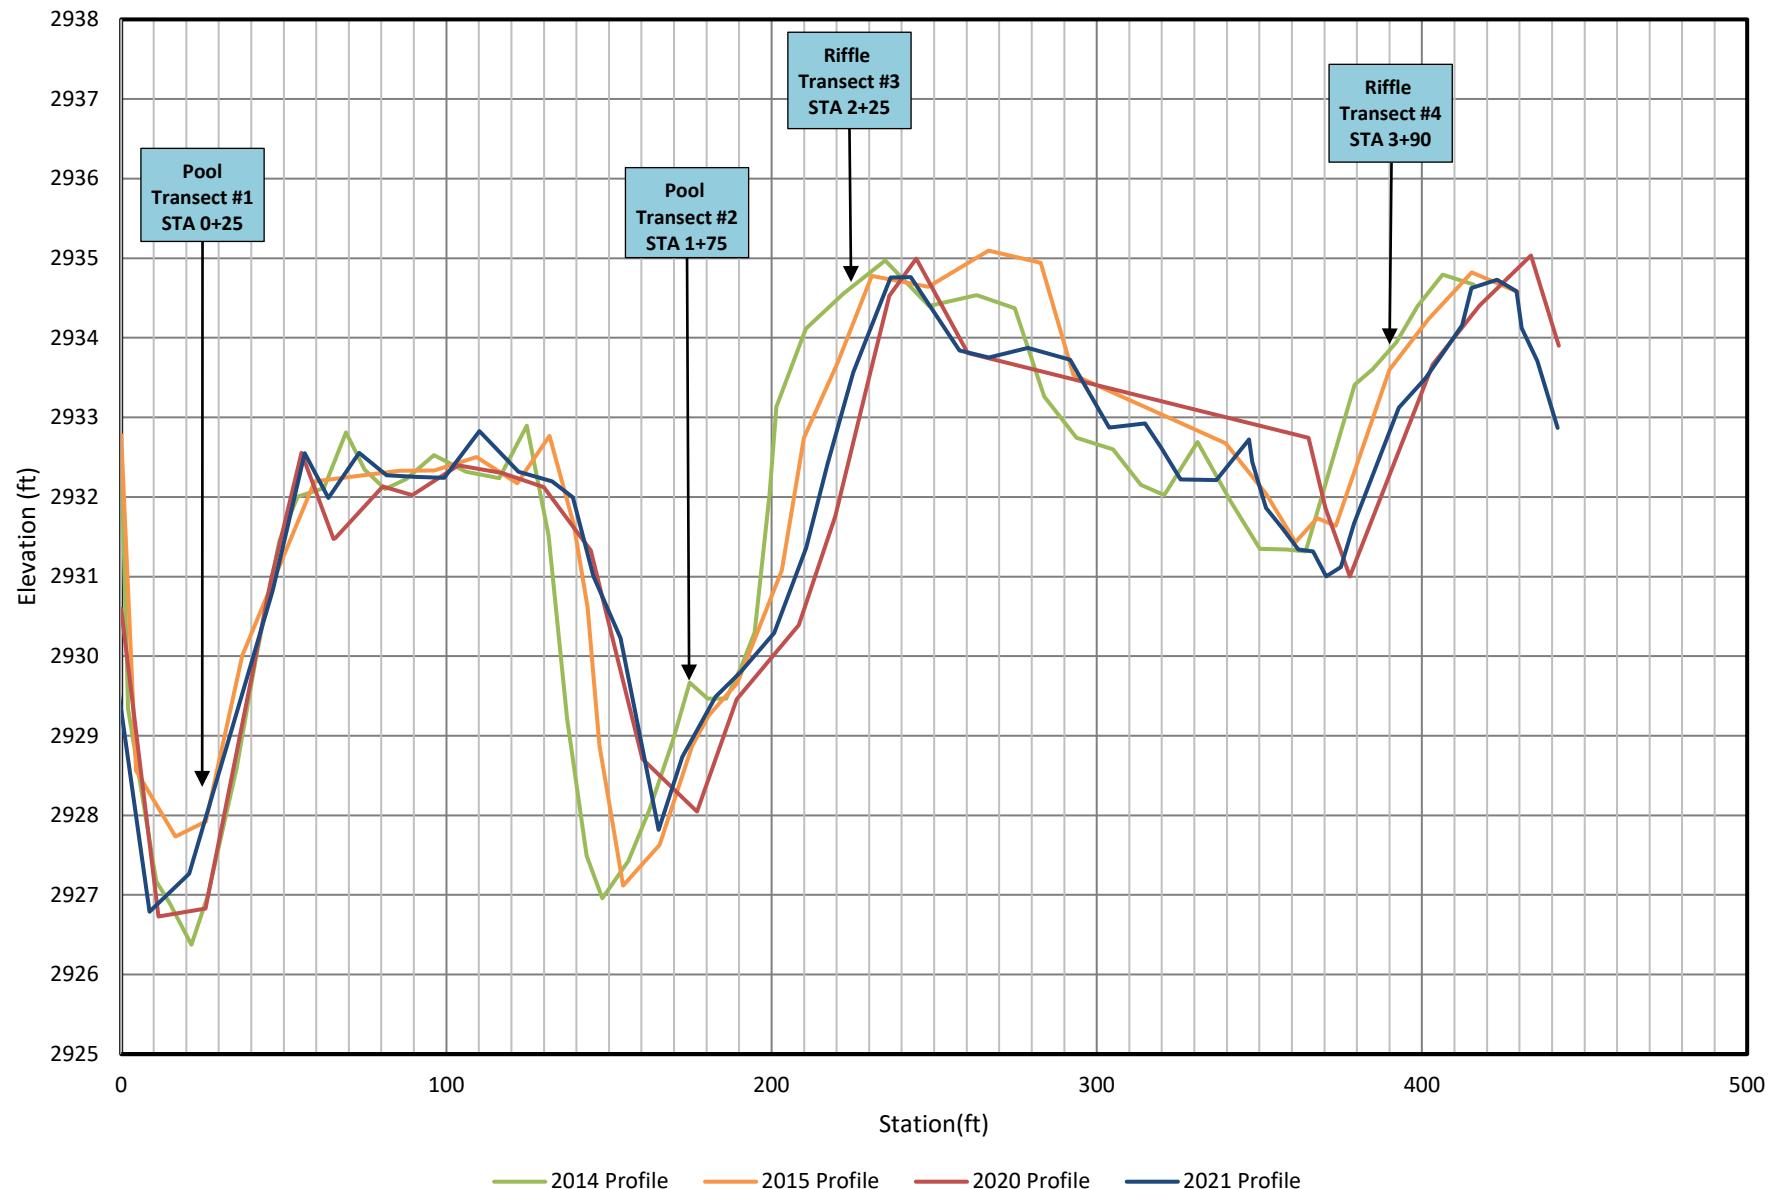
## Ashley Creek Longitudinal Profiles

Annual surveys of the Ashley Creek longitudinal profile indicate that the channel form is stable and that pool and riffle features are being maintained over time (Appendix E). The mitigation reach supports three pools, each of which are separated by a distinct riffle. Pool features occur along a sharp meander bend at the upstream extent of the project and within the straight segment of the channel. In combination, these pool-riffle sequences provide adequate slow water habitat for fish and faster-moving shallow water habitat for insect production.
