Montana Department of Transportation Stream Mitigation Monitoring Report
BOWSER CREEK MITIGATION SITE

MDT Project Number: NH-MT5-3(50)109F UPN #: 2038013

Monitoring Year: 2021

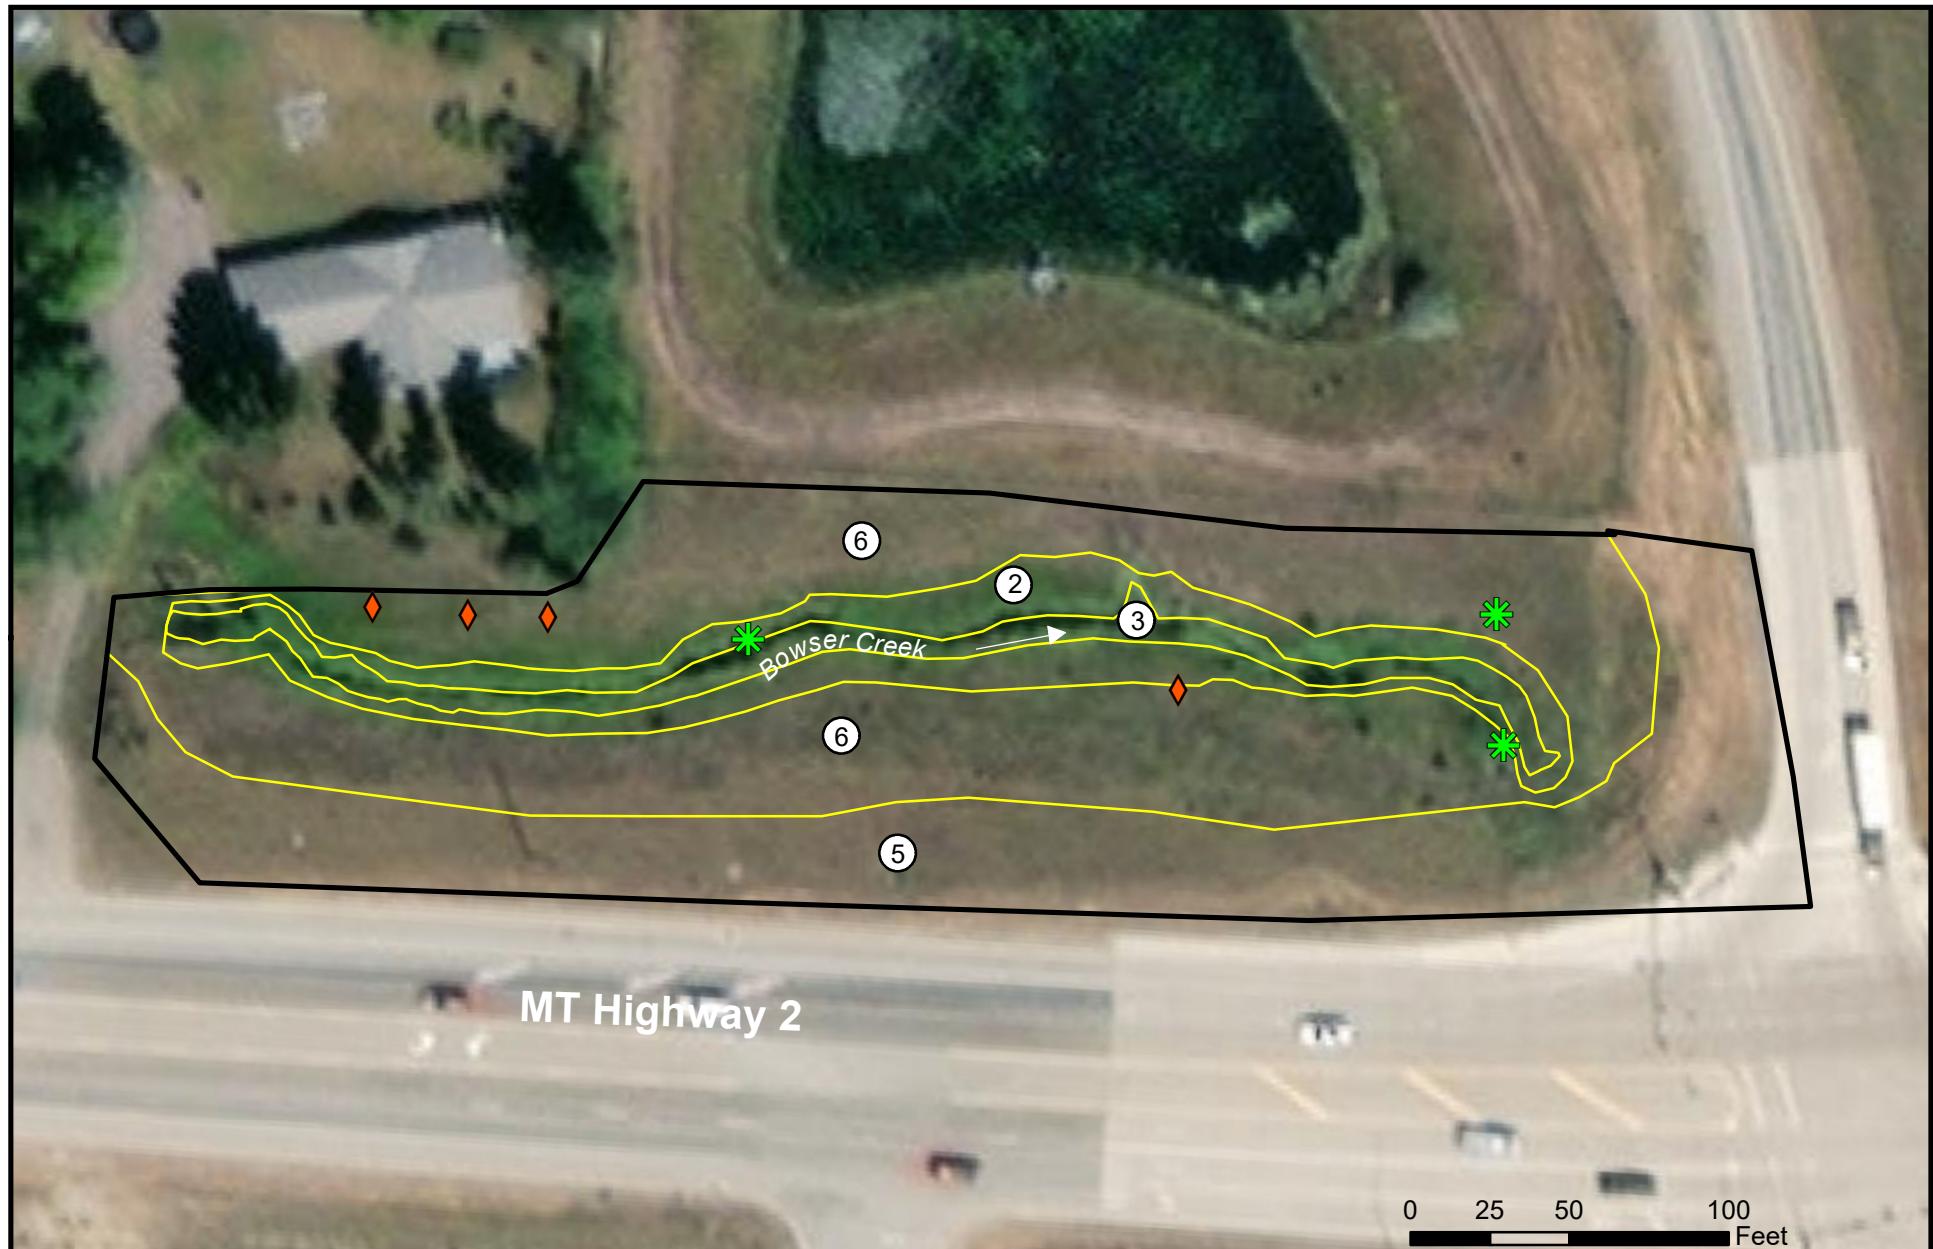
Figure 2

A total of seven Priority 2B noxious weeds were identified within the Bowser Creek stream mitigation site and included spotted knapweed (*Centaurea stoebe*), Canada thistle (*Cirsium arvense*), houndstongue (*Cynoglossum officinale*), St. Johnswort (*Hypericum perforatum*), oxeye daisy (*Leucanthemum vulgare*), yellow toadflax (*Linaria vulgaris*), and common tansy (*Tanacetum vulgare*) (MT Department of Agriculture, 2019). Locations of noxious weed infestations are provided on Figure 3 in Appendix A, with the exception of those observed as

isolated occurrences and those in trace amounts, which include spotted knapweed, St. Johnswort, common tansy, houndstongue, and oxeye daisy. A low cover class (1 to 5 percent) was assigned to all mapped weed occurrences within the project area. In 2021, a visual estimate of 3% of the project area was colonized by noxious weeds, representing an increase of 1% since the 2020 monitoring event. Infestations of Canada thistle, the most prevalent noxious weed, were located throughout the project area, although in far lesser amounts than observed in previous monitoring inspections.

**Bowser Creek - 2021
Noxious Weeds and
Vegetation Community**
Figure 3
Date: 2/14/2022
Bowser_monitor2021.mxd

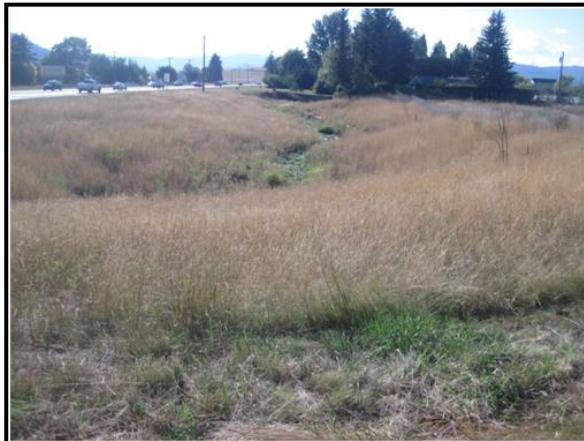
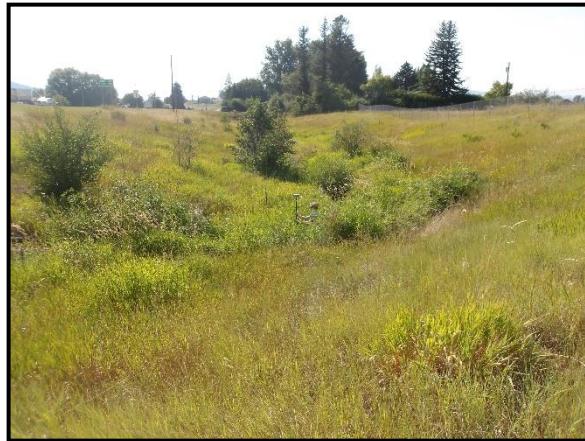
Photo 1: View looking west (upstream) of Bowser Creek.

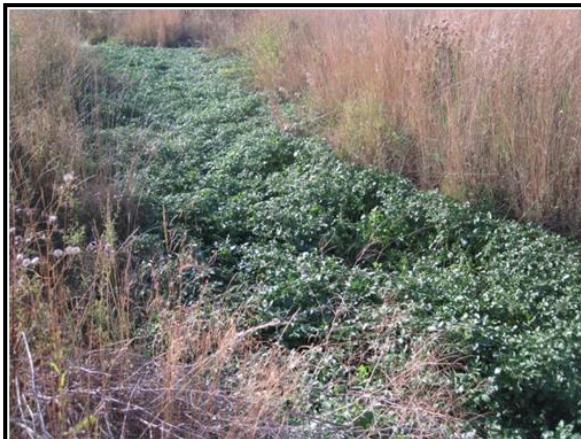
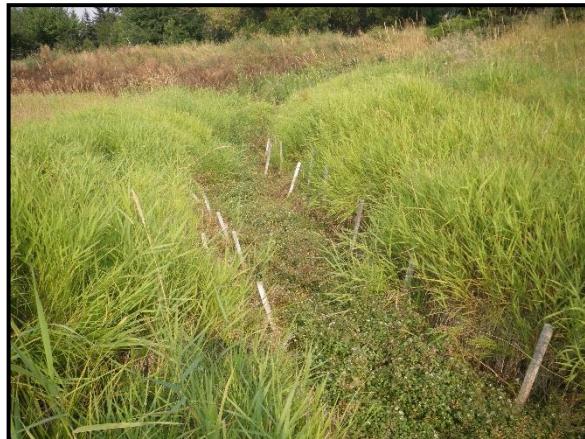
Vegetation community Type 3 – *Nasturtium officinale* was observed within the channel. Watercress dominated this community type with more than 50% cover growing in the channel bed and 6 to 10% cover along both stream banks. This community has been consistently observed in dense stands along the stream bed and edges of stream banks during the growing season since the 2015 monitoring event.

Additional Photo 1: Prolific watercress growth shown in 2013 was less prevalent in 2021.

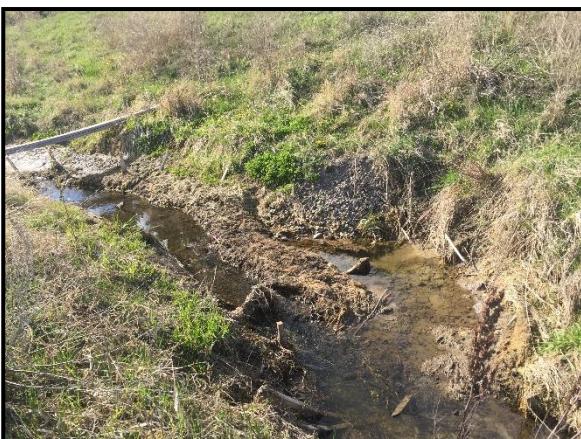
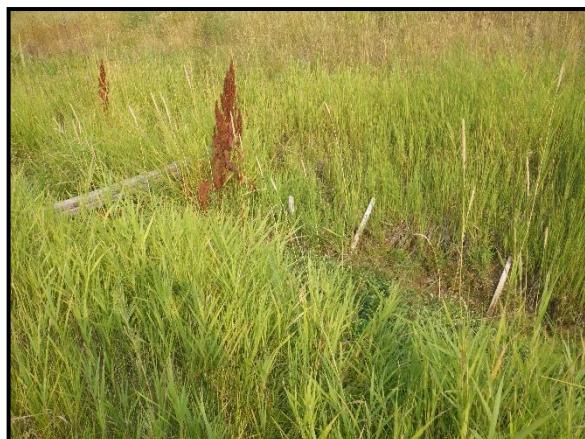
One 22' long eroding bank was observed at Bowser Creek in 2021. This eroding bank is just downstream of the confluence of the outflow from a stormwater detention pond which is upgradient of the creek. Increased scour just below the outlet culvert indicates that discharges from this outlet may have been higher or more frequent in the last year, which could have exerted additional erosive forces on the bank below the confluence with Bowser Creek (Additional Photo 4, Appendix B). The severity of this erosion is low as it consists of minor sloughing and is not threatening the overall stability of the site or any infrastructure.

Additional Photo 2: Eroding bank EBL3.

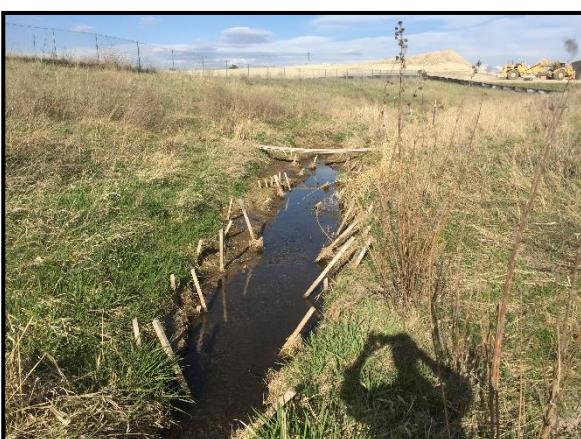
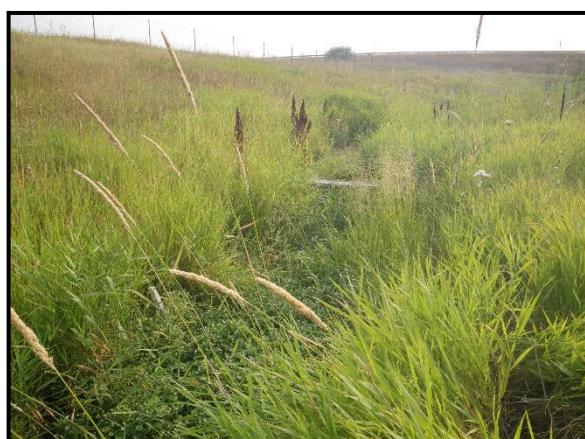
The longitudinal profile indicates that three pool and riffle sequences have been maintained since 2014 (Appendix E). Pool width and depth has not been maintained in all cases and riffle elevations have adjusted up and down over the years. The pools located at Transect #1 and between stations 1+52 and 2+10 have partially filled, and the pool located at Transect #3 has filled in by approximately one foot (Table 5 & 6). The change in pool dimensions observed within the project reach are the result of sediment inputs either from upstream sources or as a result of channel widening, though cross-sectional data do not indicate that the latter is occurring.

Additional Photo 3: Widened channel segment.

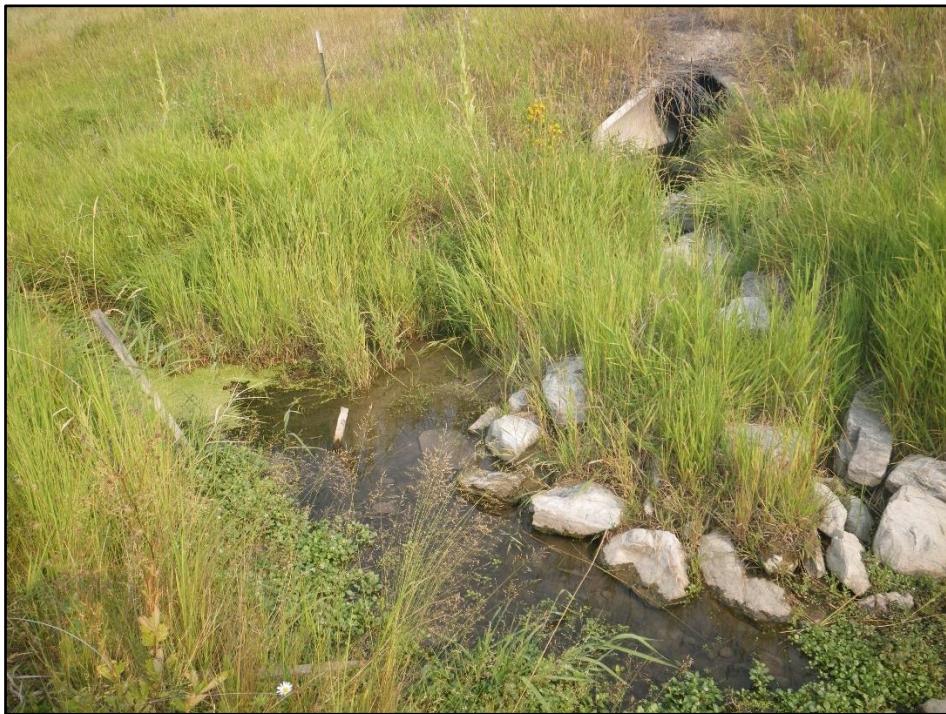
Additional Photo 4: Stormwater pond culvert and outflow confluence with Bowser Creek in August 2021.

site. Inspections of the stormwater outflow may be warranted to ensure that this feature does not become problematic for the outlet or impoundment structure.

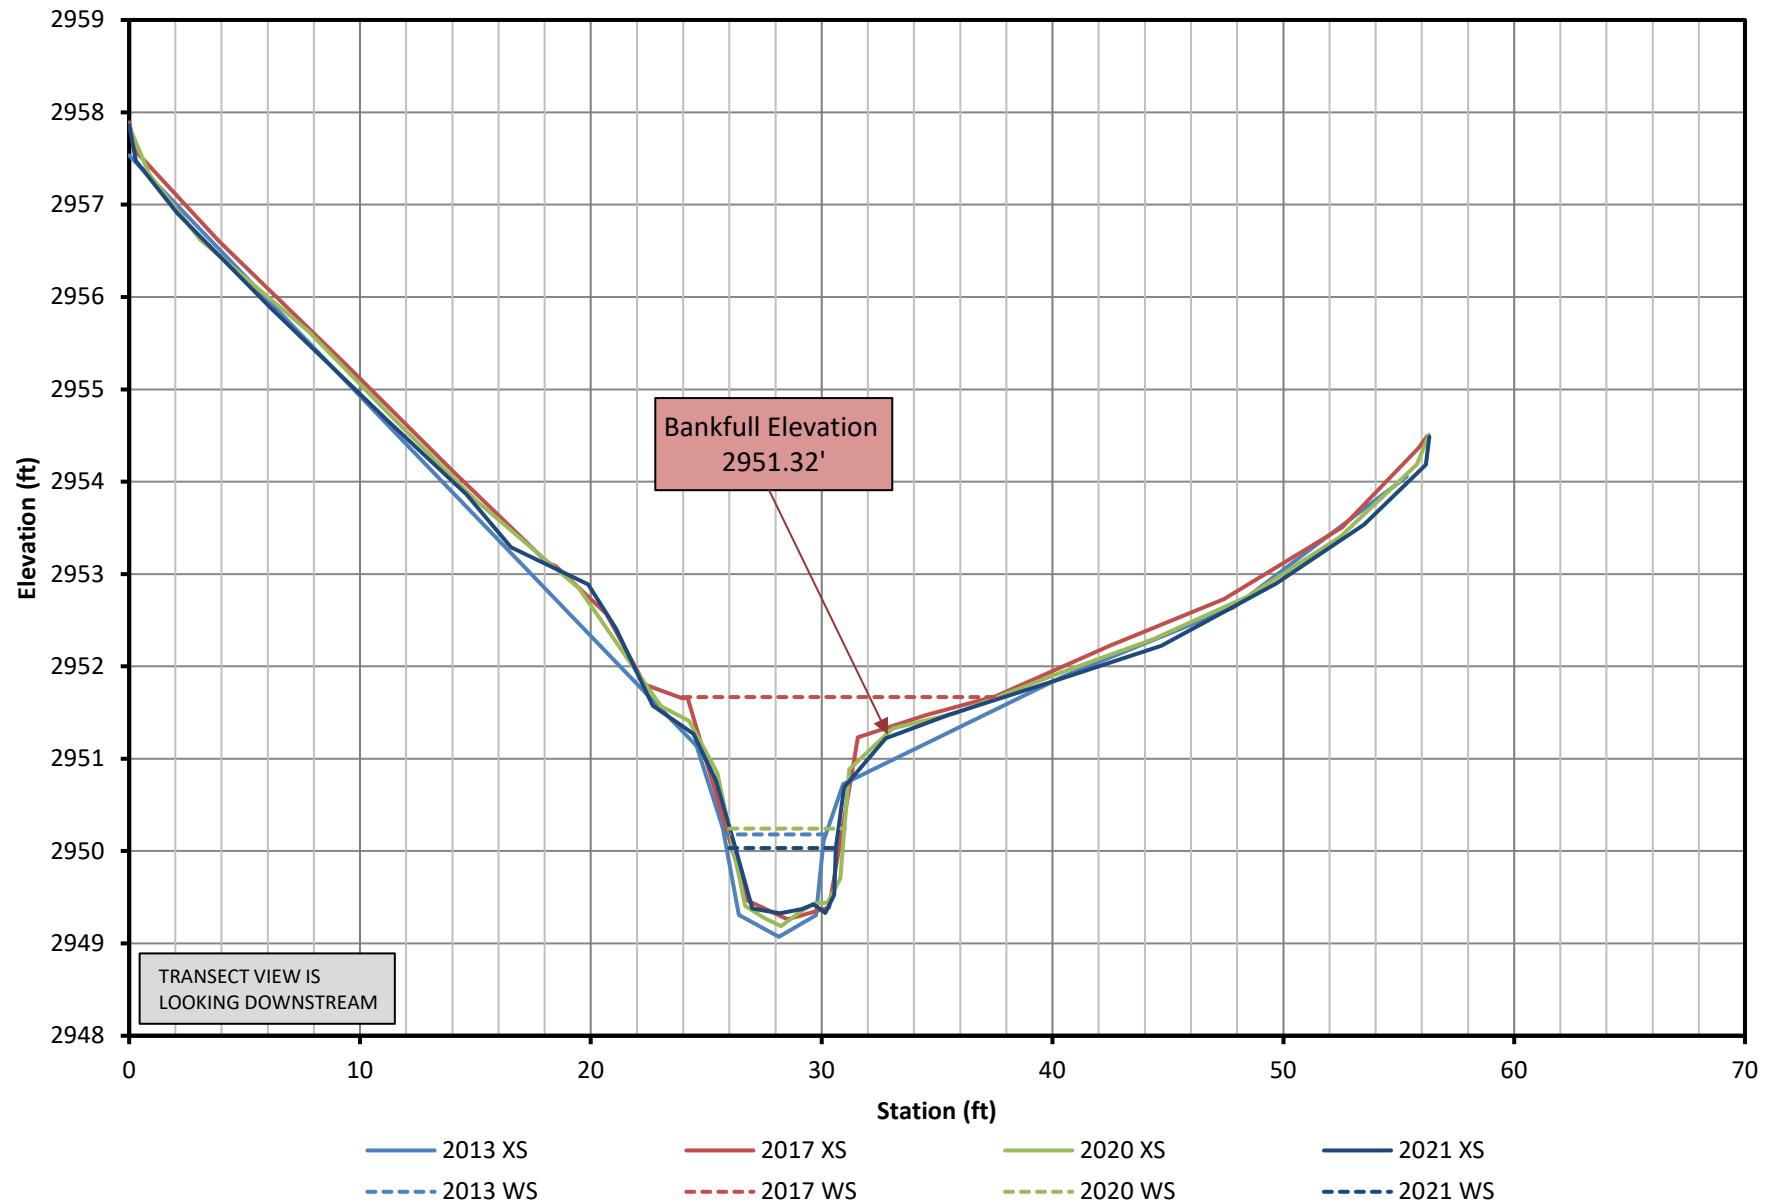
Bowser Transect #1 - Pool

The cross-sections (i.e. transects) of Bowser Creek surveyed 2021 indicate that channel dimensions have remained relatively stable throughout the monitoring period (Appendix E). The bankfull channel width has remained quite consistent through the monitoring period, with the exception of Transect #3, where the channel has become wider and shallower by almost one foot since 2019 (Table 6). As no bank erosion was observed at this location, the observed channel widening is not considered to be problematic and may be due to survey discrepancies or natural channel adjustments.
