Montana Department of Transportation Stream Mitigation Monitoring Report
ASHLEY CREEK MITIGATION SITE

MDT Project Number: NH-MT 5-3(59) FST / UPN # 2038010

Monitoring Year: 2023

Monitoring Conducted By: Confluence Consulting Inc.

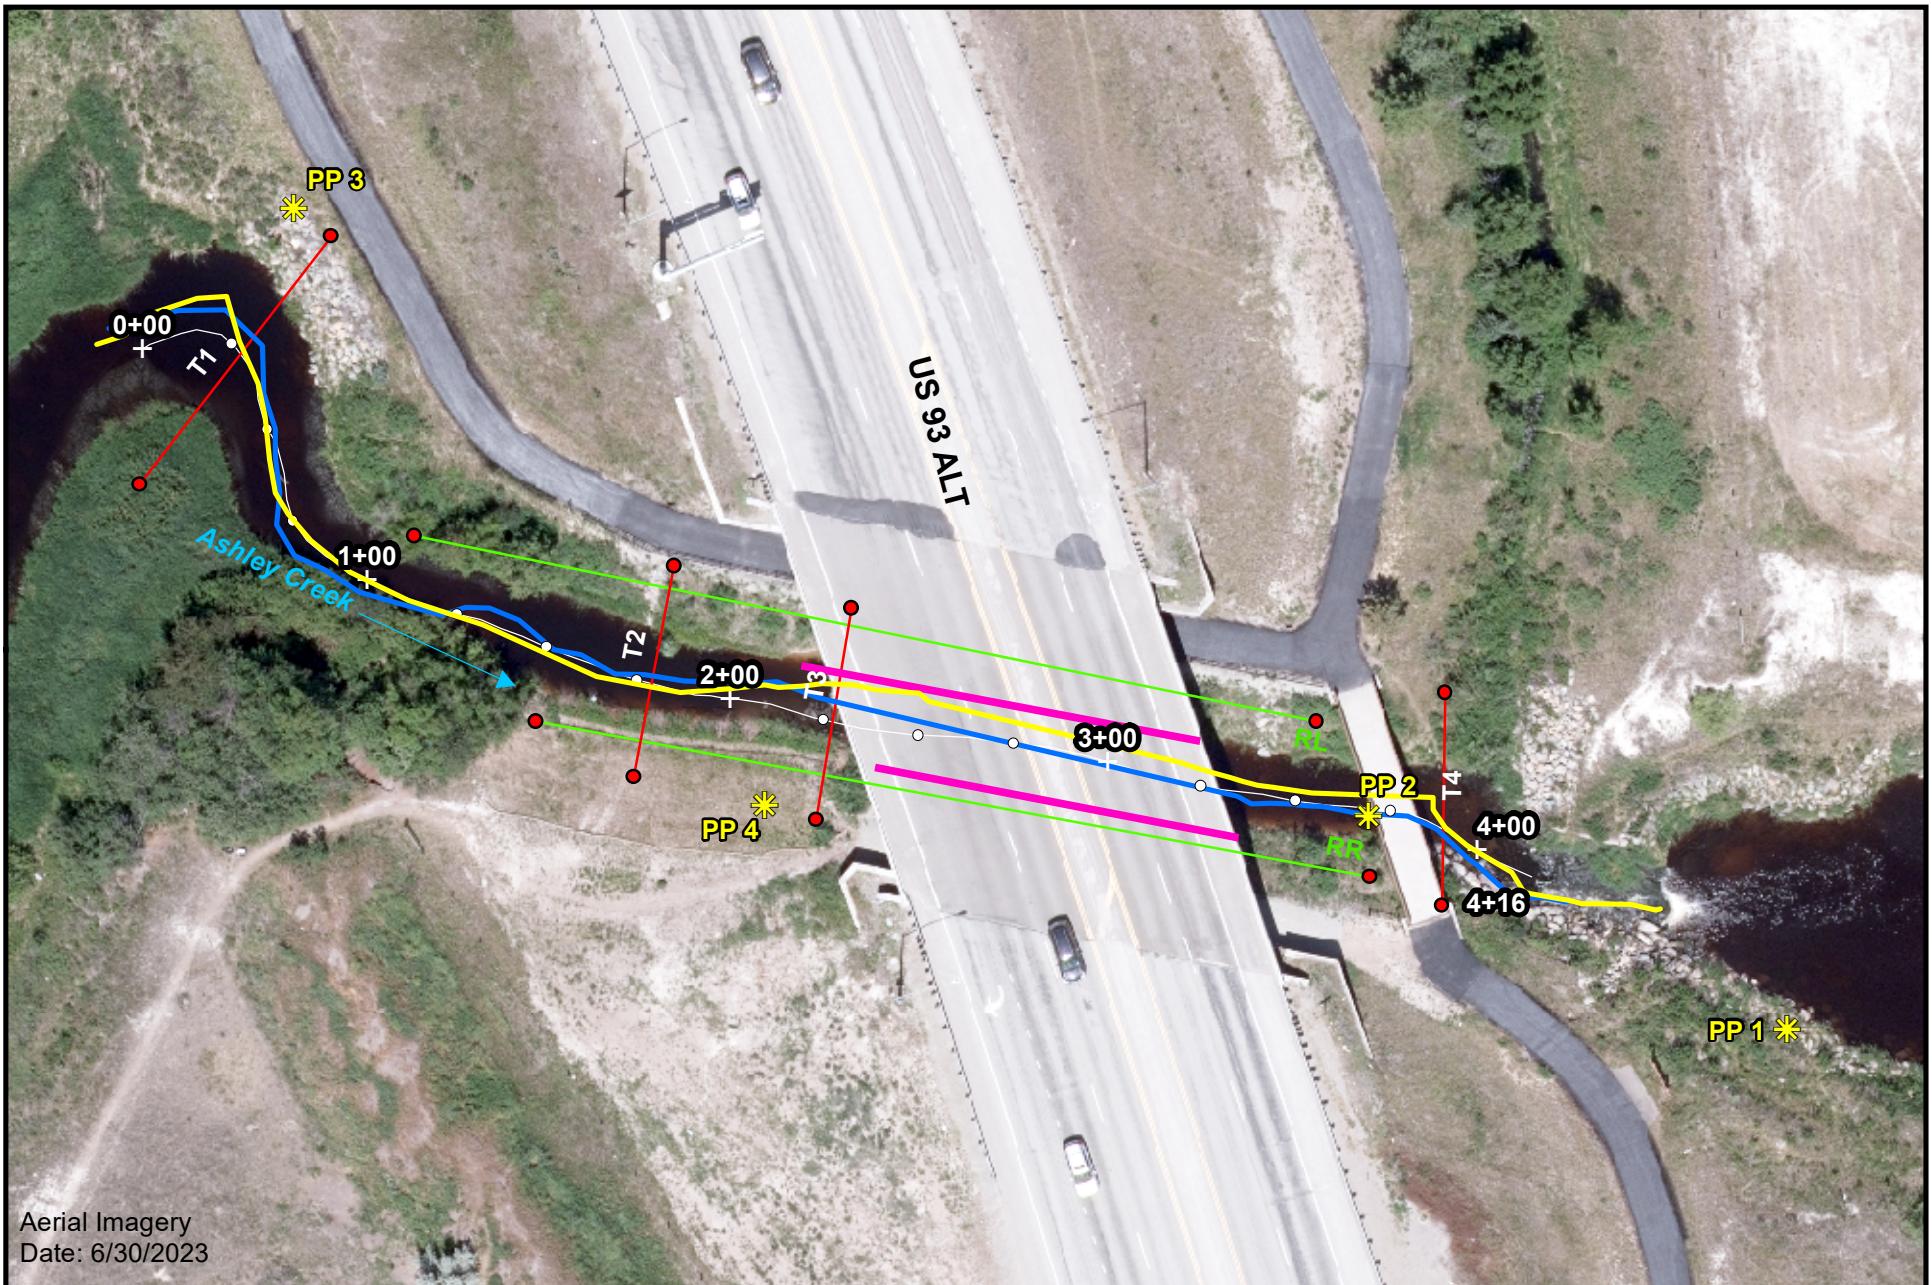
Ashley Creek - 2023 Monitoring Features
Figure 2
Date: 12/07/2023
Ashley_features2023.mxd

Total eroding bank length within the Ashley Creek stream mitigation project area decreased from 266 feet in 2021 to 201 feet in 2023. This decrease is due to corrective actions that were taken in 2022 to stabilize eroding banks. The length of erosion on the south bank is now 96 feet and was only documented underneath the US 93 – Kalispell Bypass bridge in 2023, where in previous years bank erosion had also been noted on the south bank above the bridge. The eroding south bank that was previously documented upstream of the bridge (EBR1) was stabilized in 2022 by reducing the slope angle, and installing erosion control fabric, soil lifts, and willow cuttings. All of these corrective actions had effectively stabilized this bank segment in 2023. Approximately 105 feet of the north bank were eroding during the 2023 monitoring event, which is consistent with 2020 and 2021. Despite the efforts made to repair the eroding banks under the bridge in 2022, both the north and south banks are sparsely vegetated and have large sections that are slumping (Additional photos 3-6 and 8-10, Appendix B).

One factor potentially contributing to the upper north bank erosion could be that the thalweg appears to have shifted toward the north bank since the 2021 monitoring event (Figure 2, Appendix A). This shift has not caused erosion along the toe of the north bank to date. The clay lens at toe of both streambanks, noted in previous monitoring reports, is still present and likely still protecting the lower portions of the stream banks from lateral erosion.

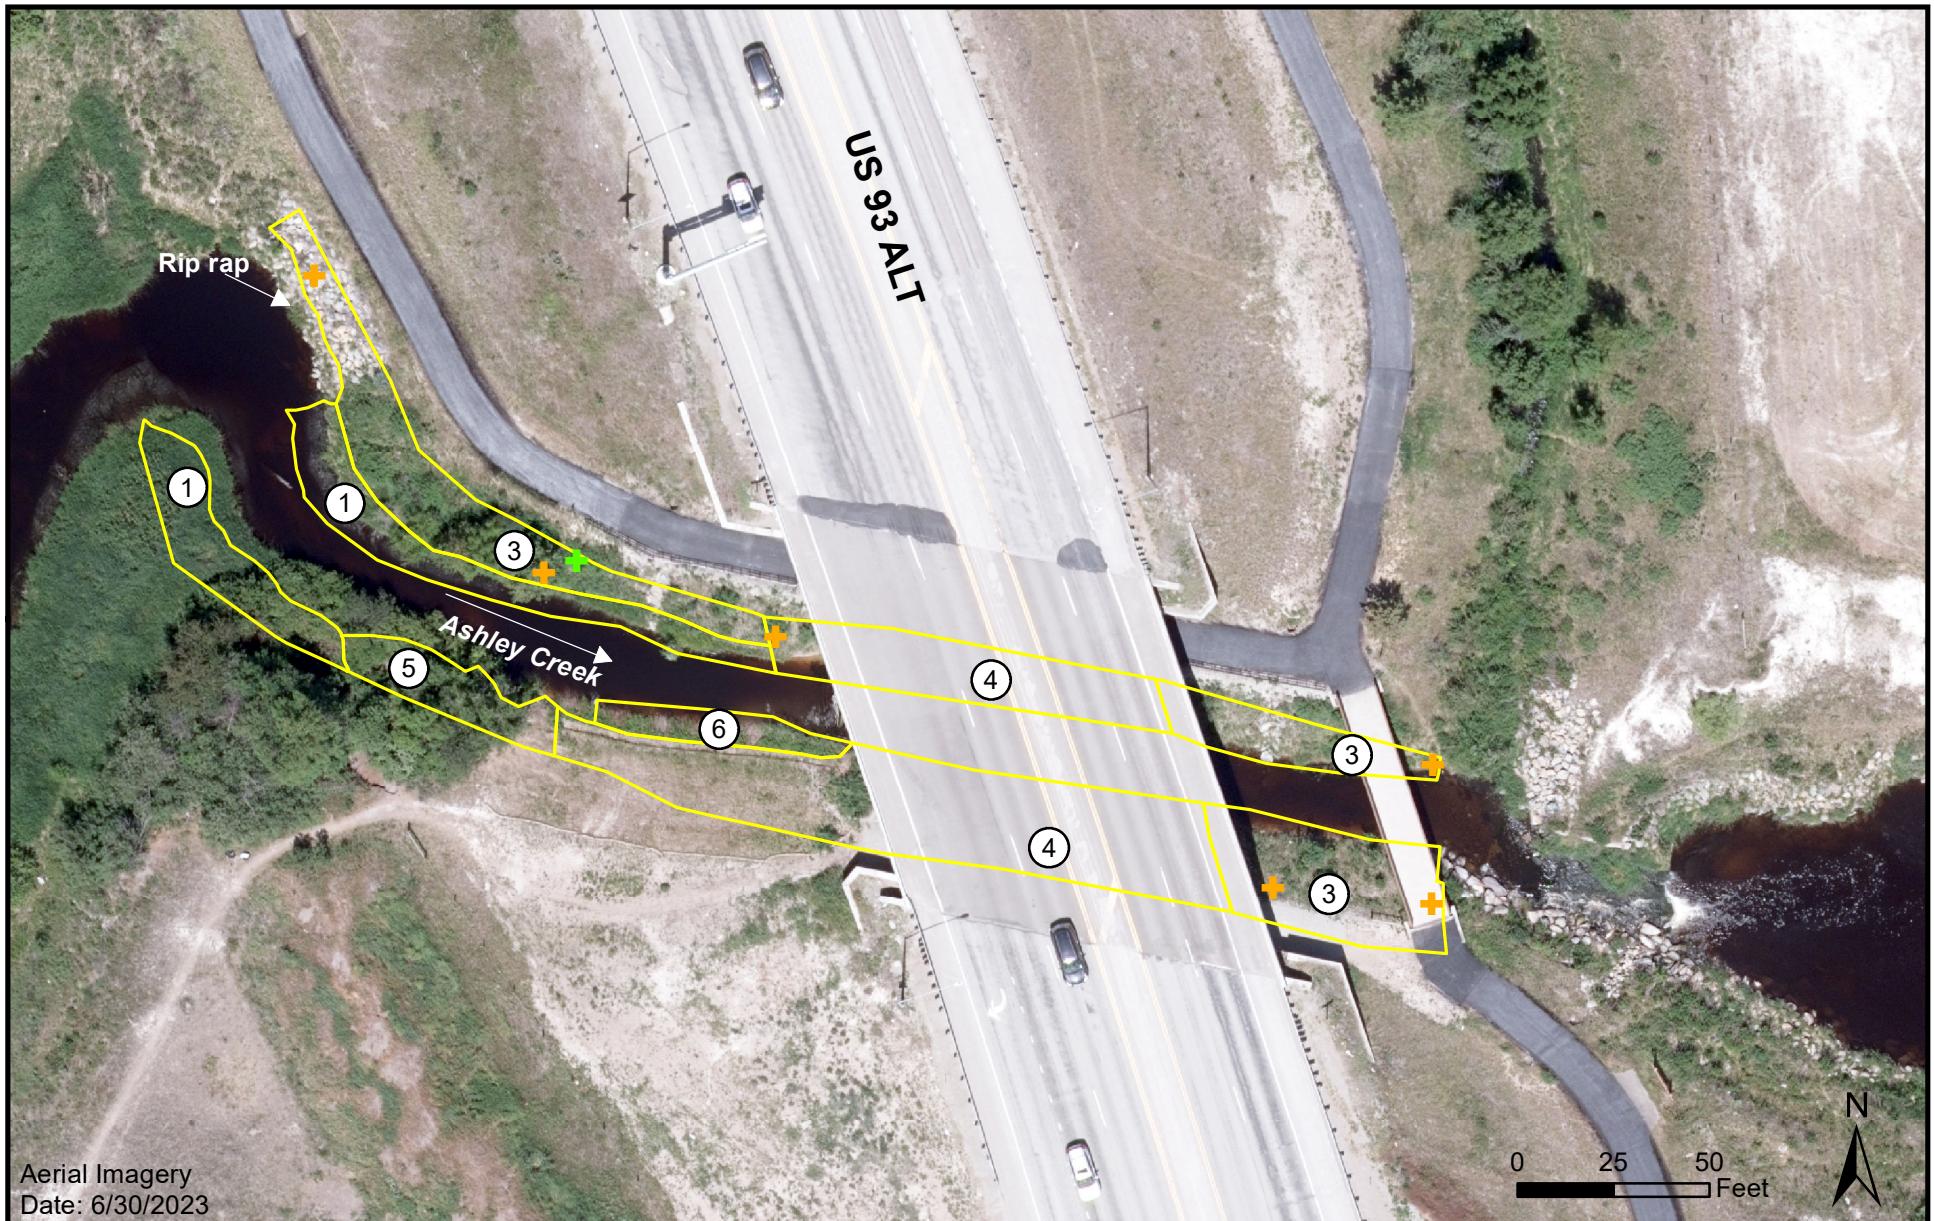
**Ashley Creek - 2023
Noxious Weeds and
Vegetation Communities**

Dominant species recorded along the riparian transects were combined with visual observations of vegetation in the surrounding area to develop a vegetation community map (Figure 3, Appendix A). The four community types documented since 2018 were again observed during the 2023 monitoring event, with the addition of a community Type 6. Vegetation communities at the site include: Type 1 (*Phalaris arundinacea*), Type 3 (*Phalaris arundinacea/Elymus* spp.), Type 4 (Bare Ground/*Elymus* spp.), Type 5 (*Cornus alba/Alnus incana*), and Type 6 (*Salix* spp.). The streambanks below the bridge are dominated by bare ground and are highly disturbed, and area dominated by early successional species including lamb's quarters (*Chenopodium album*), tall hedge-mustard (*Sisymbrium altissimum*), prickly Russian thistle (*Salsola tragus*), and wild rye (*Elymus* spp.).

Four Montana-Listed noxious weed species were identified during the 2023 monitoring event. Noxious weed infestations of a low cover class (1 to 5 percent) or higher were mapped and are displayed on Figure 3 (Appendix A). Noxious weed infestations identified in isolated and trace amounts (<1%) were noted but not mapped. Seven infestations of two Priority 2B noxious weeds were mapped within the riparian corridor at the Ashley Creek site (MDA 2019). These infestations included six occurrences of common tansy (*Tanacetum vulgare*) and one occurrence of field bindweed (*Convolvulus arvensis*). A low cover class was assigned to each mapped weed infestation within the project area. An estimated 3% of the project area has been colonized by noxious weeds, with common tansy as the most prevalent. In 2023, this includes Canada thistle (*Cirsium arvense*), and spotted knapweed (*Centaurea stoebe*).

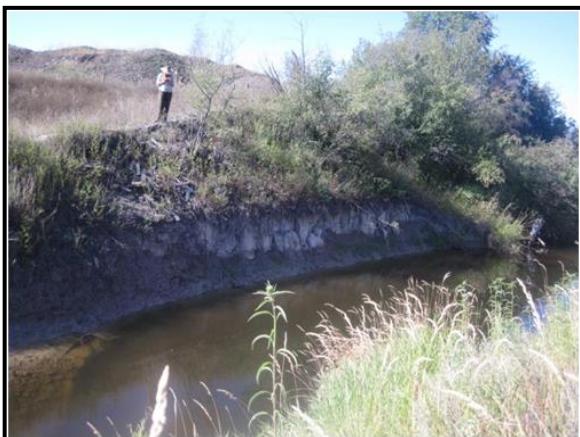
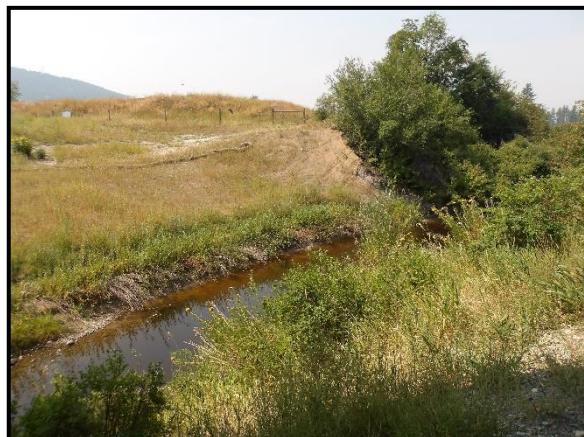
Additional Photo 2: South bank upstream of the US 93-Kalispell Bypass Bridge before and after the 2022 bank repair.

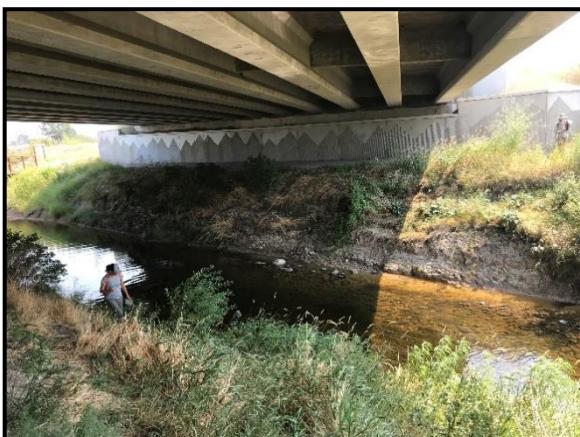
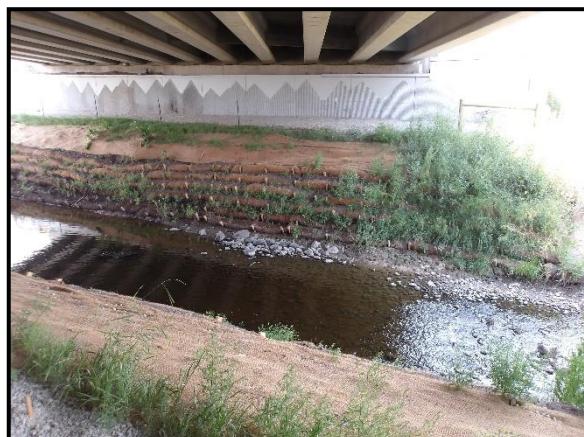
Additional Photo 3: Upstream end of eroding south bank under the US 93-Kalispell Bypass bridge.

Specific recommendations for additional corrective actions: While adaptive management was implemented in 2022 to address bank erosion, the streambanks under the US Highway 93 - Kalispell Bypass bridge are still eroding. The bank reconstruction work completed in the winter of 2022 is beginning to deteriorate due to design/construction issues and public usage of the site for access to Ashley Creek. MDT is aware of the issues and is working with the contractor and designers to address the situation.

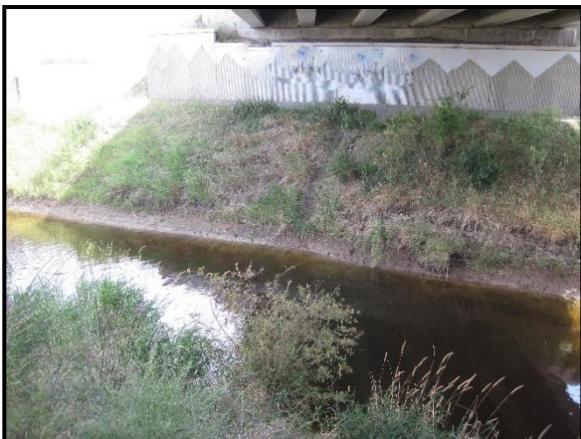
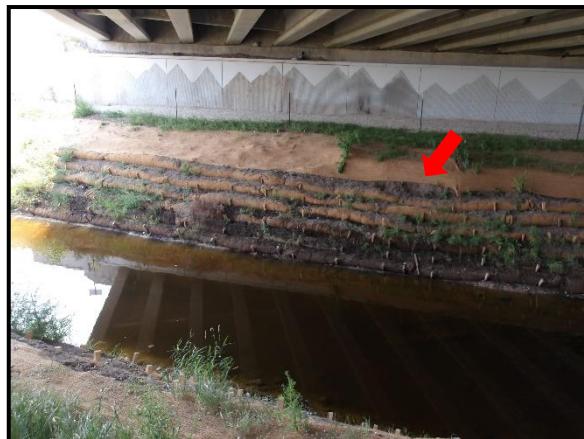
Additional Photo 4: Downstream end of the eroding south bank under the US 93-Kalispell Bypass Bridge. The area denoted with the arrow is slumping and the soil lifts are pulling away from the bank.

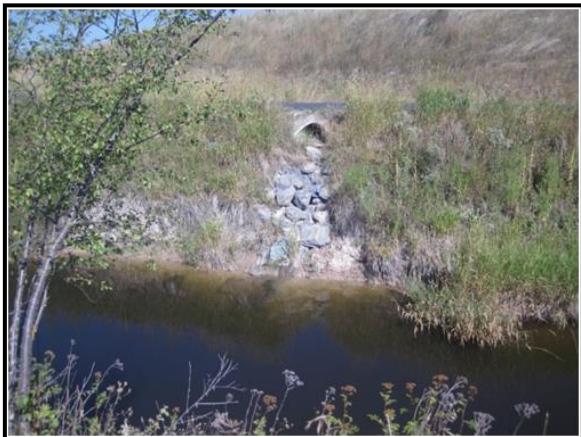
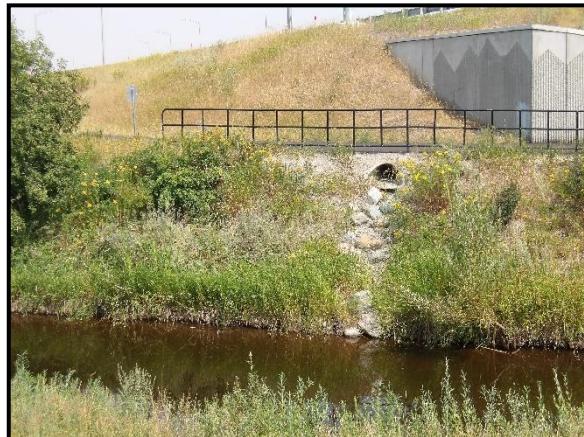
Additional Photo 5: Stabilized culvert outlet on the upstream end of the project area. This culvert may have been jeopardized by fence post placement, which appears to be washing out. See additional Photo 7.

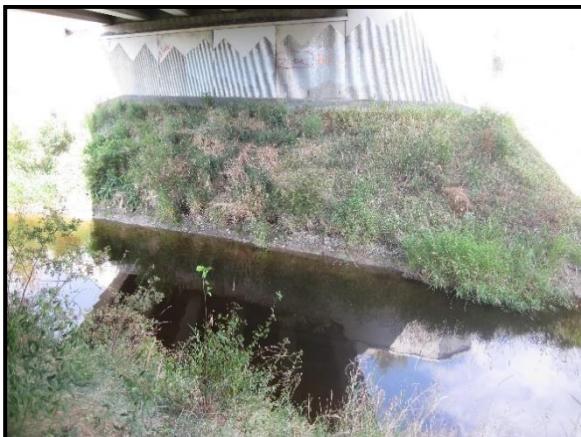
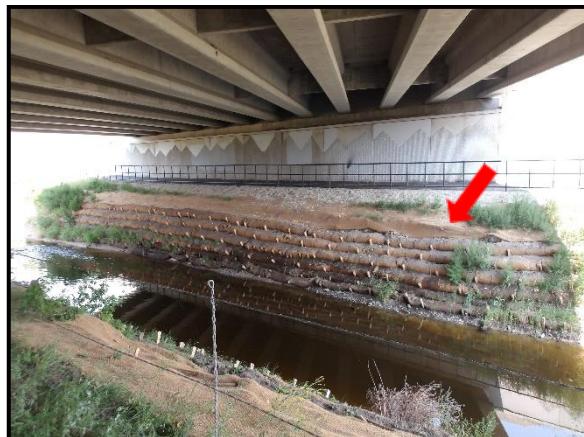
Additional Photo 6: Eroding left bank under the US 93 – Kalispell Bypass bridge. The area denoted with the arrow is slumping and the soil lifts are pulling away from the bank.

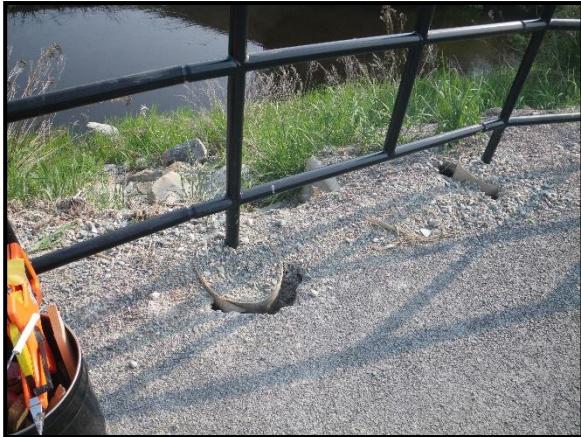
Additional Photo 7: Looking at the culvert shown in additional photo 5 from above. The area around the fence post footers is eroding.

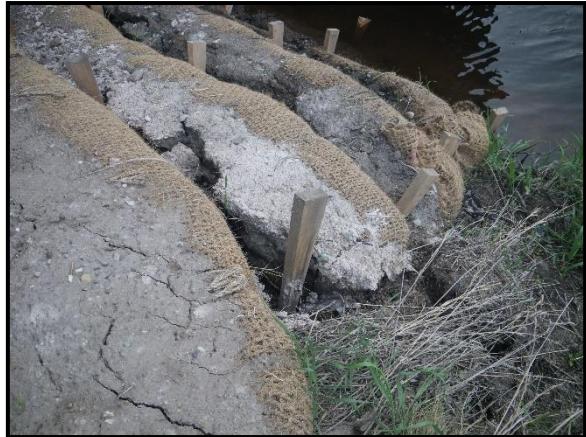
Additional Photo 8. Close-up of the downstream end of the south bank repair showing cracks and slumping.

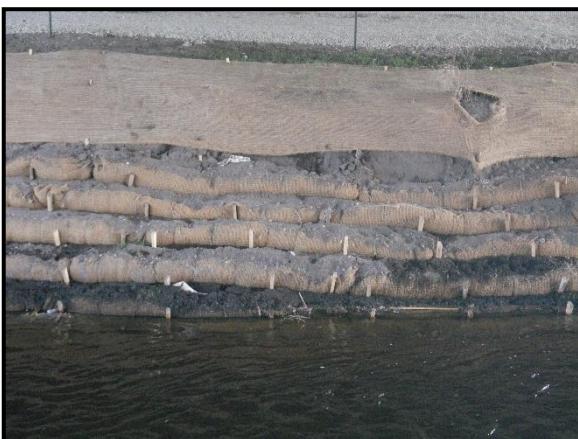
Additional Photo 9. Close-up of the middle of the south bank repair showing cracks and soil lift slumping.

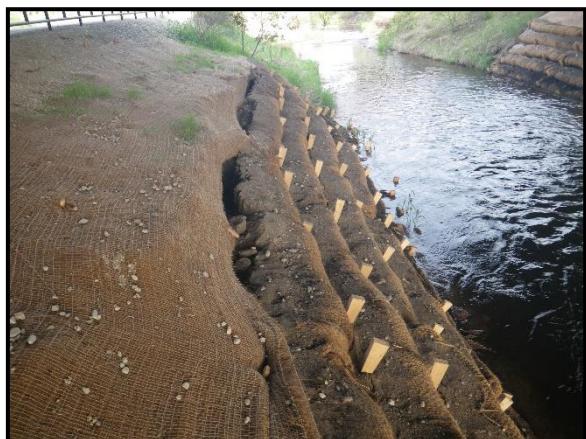
Additional Photo 10. Close-up of the middle of the north bank repair showing cracks and soil lift slumping.

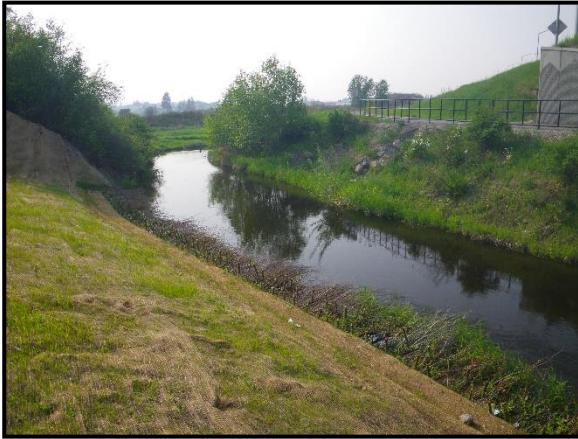
Additional Photo 11. Repaired south bank upstream of the bridge.

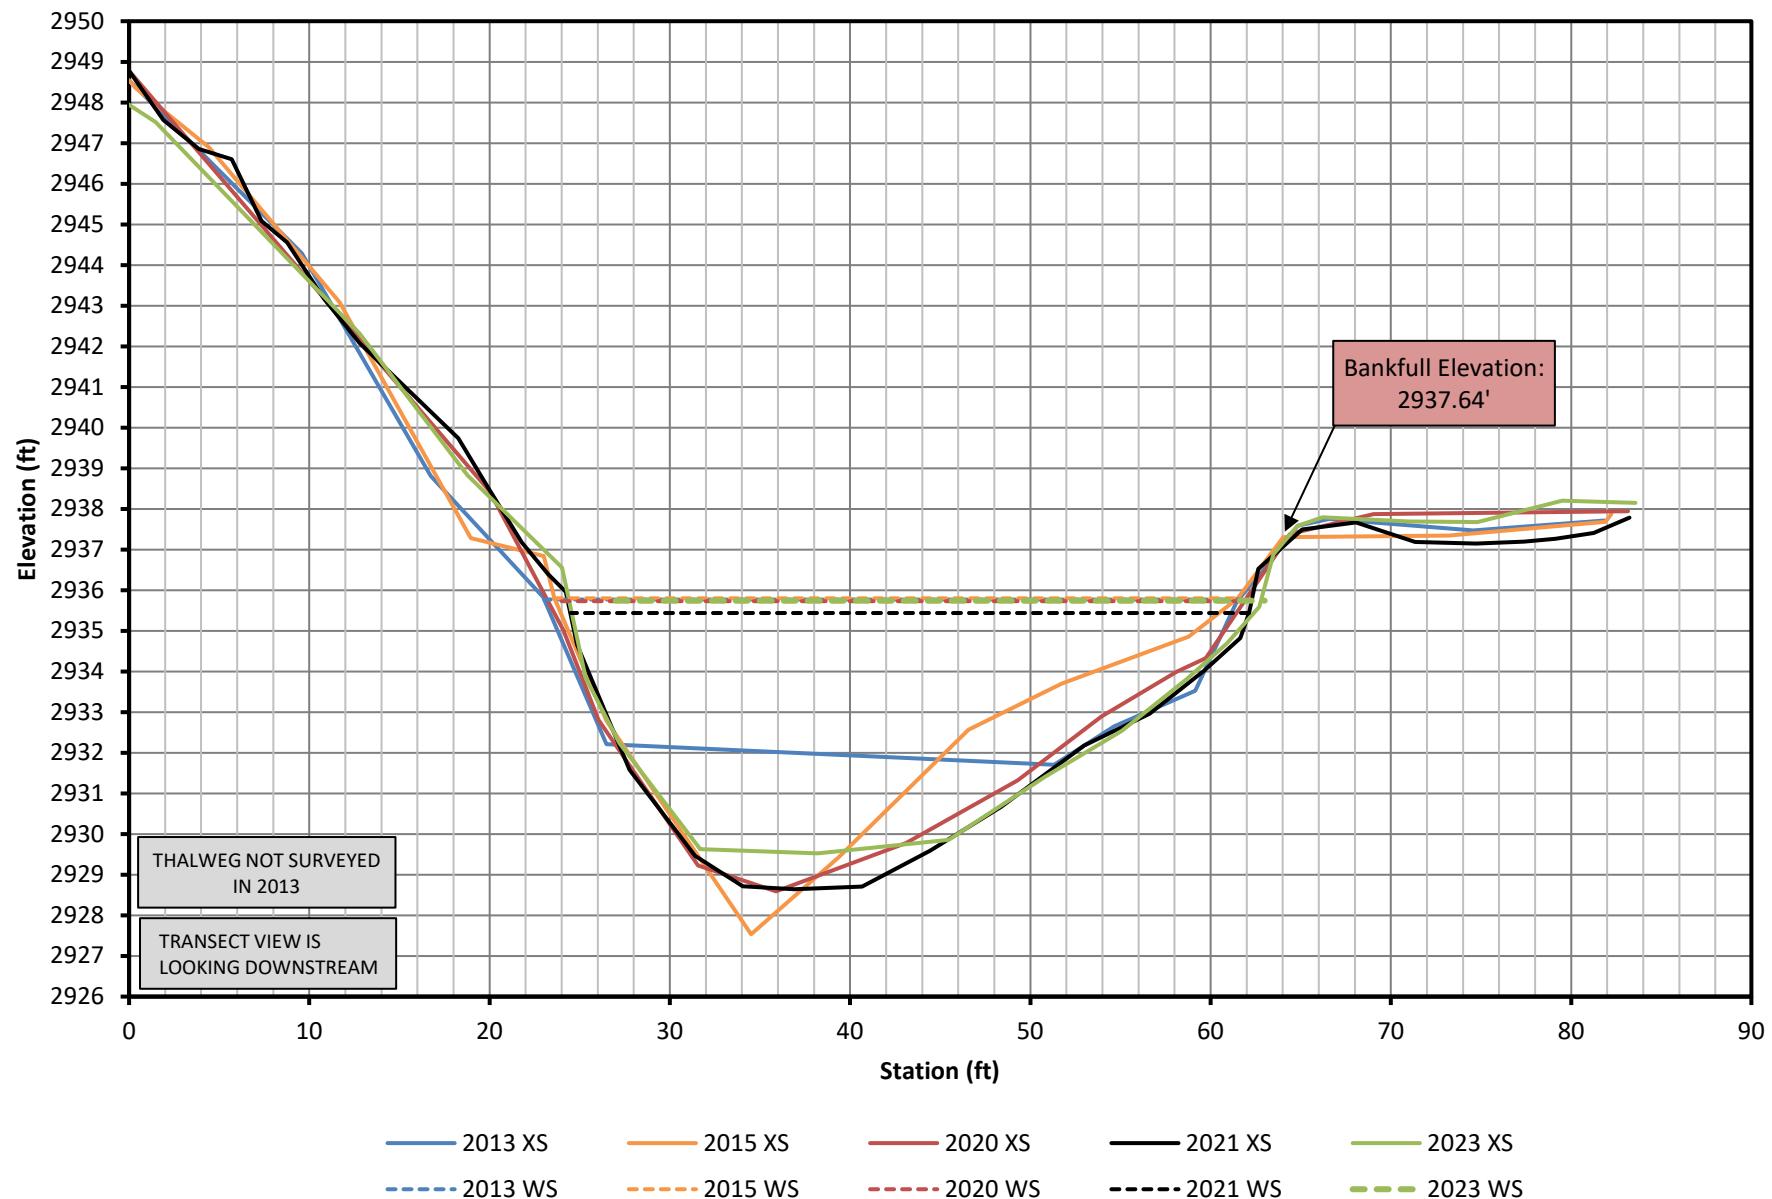
Ashley Creek Transect #1 - Pool

The four cross-sectional transects monitored annually reflect some of the changes that occurred within the project reach since the 2022 streambank reconstruction. The Transect 1 cross-section, which is located above the area impacted by the 2022 bank reconstruction activities, indicates that the bankfull channel dimensions have been maintained over time. The bank profiles at Transects 2 and 3 were modified during the 2022 bank repair, and the cross-sectional profiles show how the south bank were re-sloped. Both banks at Transect 2 were reconstructed to a reduced slope, as was the south bank at Transect 3. The north bank at Transect 3 was built to a steeper slope than it was prior to reconstruction. As mentioned in the bank erosion section, the south bank of Transect 4 also appears to have slumped since the 2021 monitoring event.

While the channel geometry below the bankfull elevation remained similar to the pre-construction geometry at all four monitoring transects, the channel has become approximately one foot shallower at Transects 1 and 2 (pool transects) since 2021. The average bankfull depth in riffles was 2.8 feet, as it has been in years past. The average bankfull pool depth was 7.3 feet, approximately one foot shallower than in 2021. The average bankfull width was 26.1 feet at riffle transects (T3 & T4), which is approximately 1.5 feet wider than in 2021. The increase in average bankfull width at riffle transects is entirely due to the expansion of the bankfull channel on the south bank at T2. The average bankfull width at pools was 34.8 feet which is similar to that of previous years (Table 3).

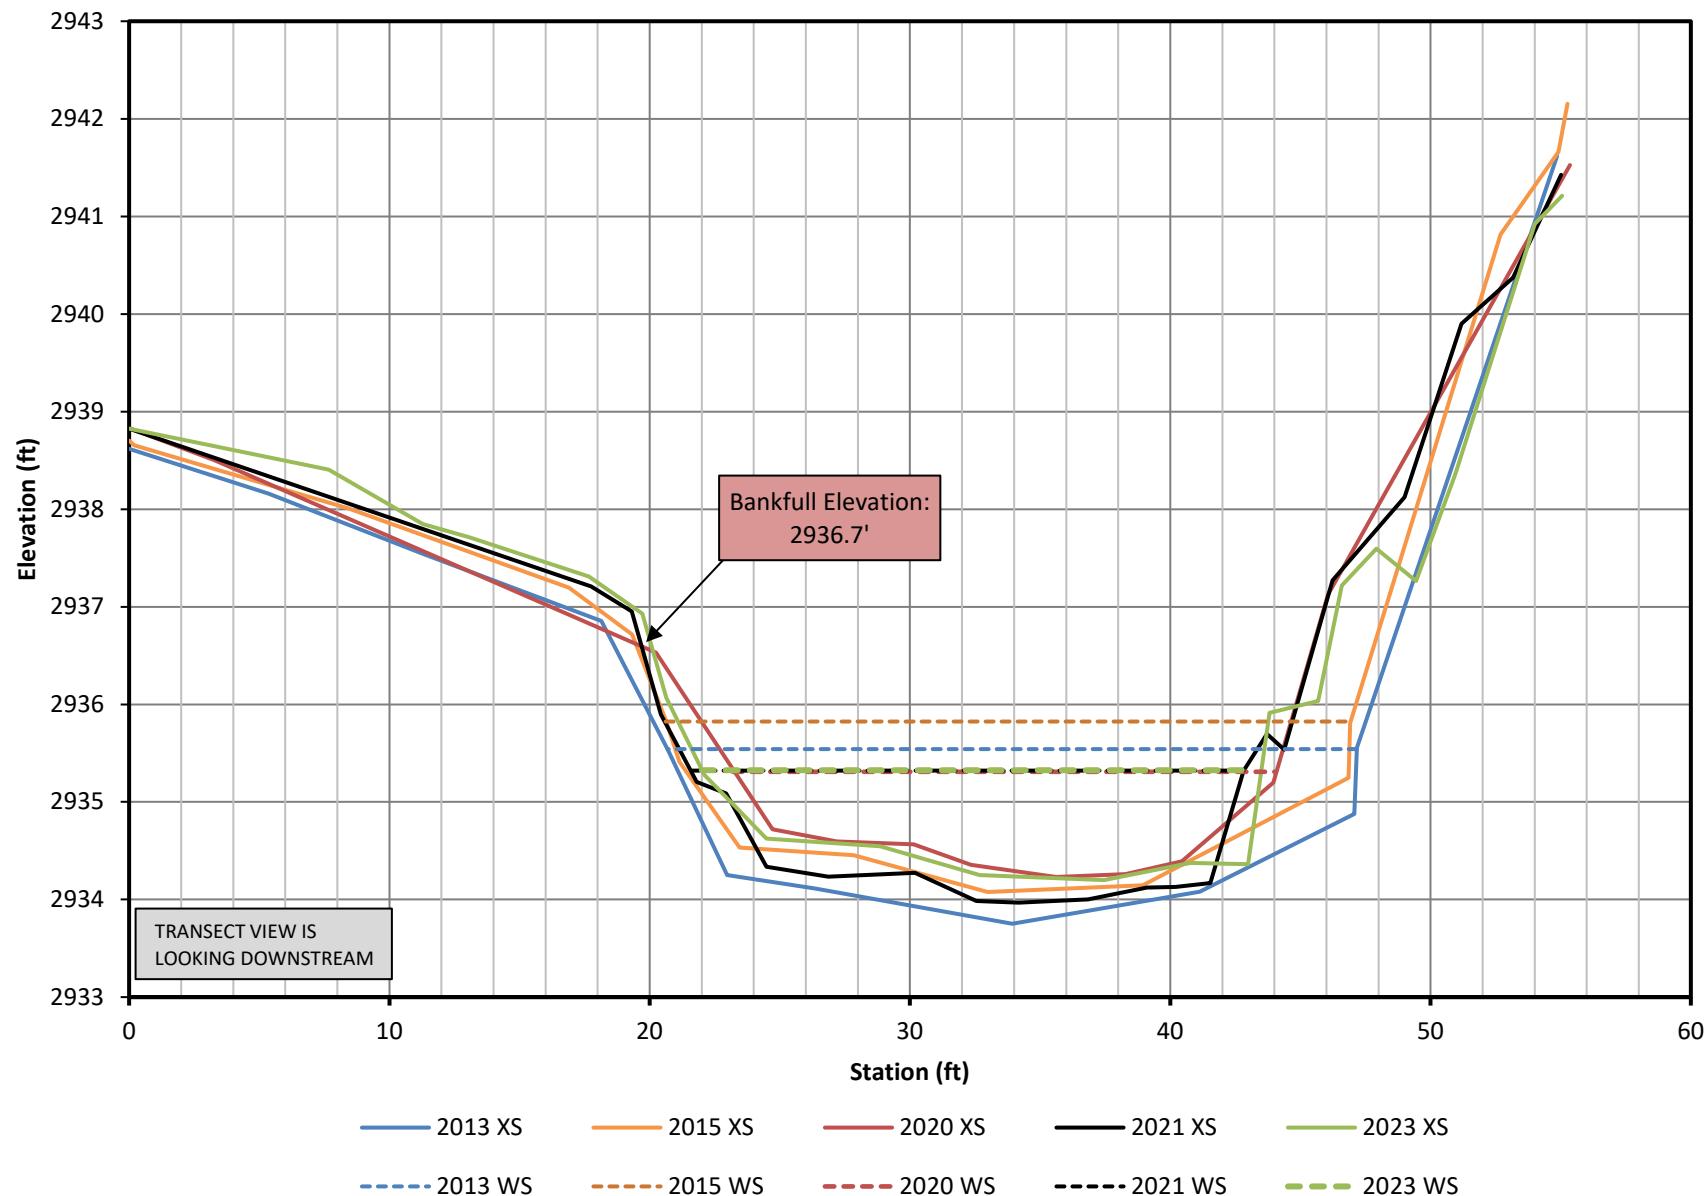
Ashley Creek Transect #4 - Riffle

Annual cross-section surveys show slumping on the upper north bank at Transect 4. While this bank still has enough plant cover to prevent excessive erosion, it should be monitored in future years to ensure this remains true. Since much of the stream has been fenced off, it appears that people are now accessing the creek in locations that are not fenced, such as in the vicinity of Transect 4 along the south bank, thus causing impacts to the streambanks in locations not observed before.

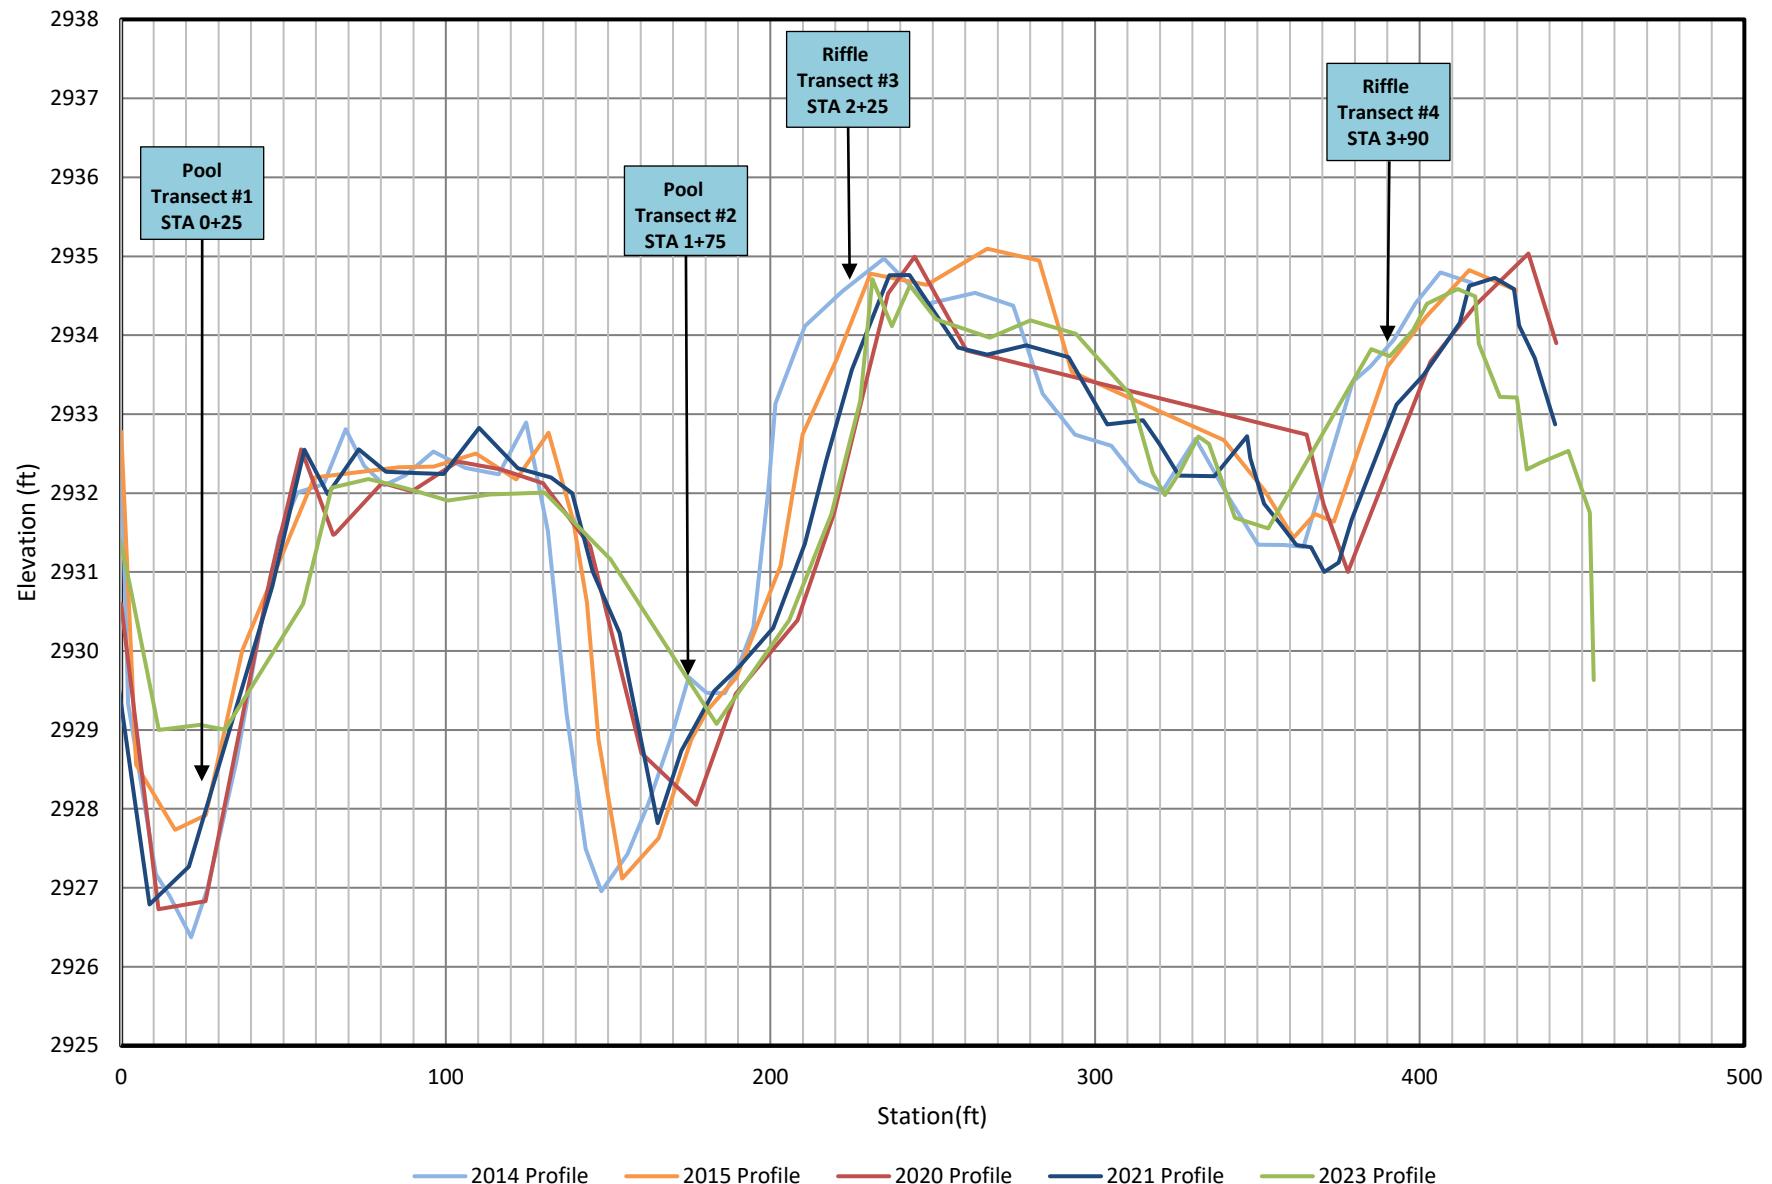
Ashley Creek Longitudinal Profiles

Annual surveys of the Ashley Creek longitudinal profile indicate the channel form is generally stable and that pool and riffle features are being maintained over time (Appendix E). The mitigation reach supports three pools, each of which are separated by a distinct riffle. These pool-riffle sequences provide adequate slow water habitat for fish and faster-moving shallow water habitat for insect production. However, in 2023, all three of the pools were 1-2 feet shallower than in 2021 or 2020. Continued monitoring will determine if the current pool depth is maintained or if pool depths increase again in the future.
