Montana Department of Transportation Stream Mitigation Monitoring Report
BOWSER CREEK MITIGATION SITE

MDT Project Number: NH-MT5-3(50)109F UPN #: 2038013

Monitoring Year: 2023

Monitoring Conducted By: Confluence Consulting Inc.

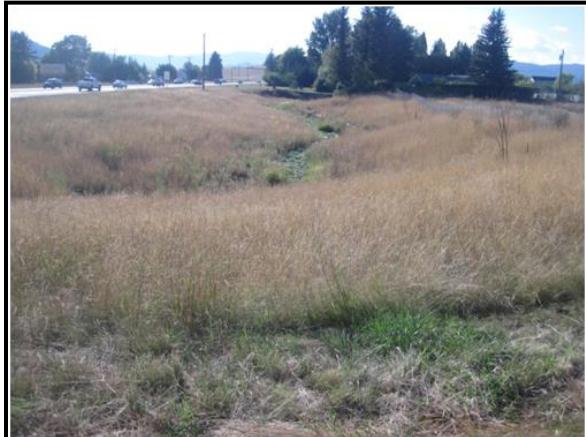
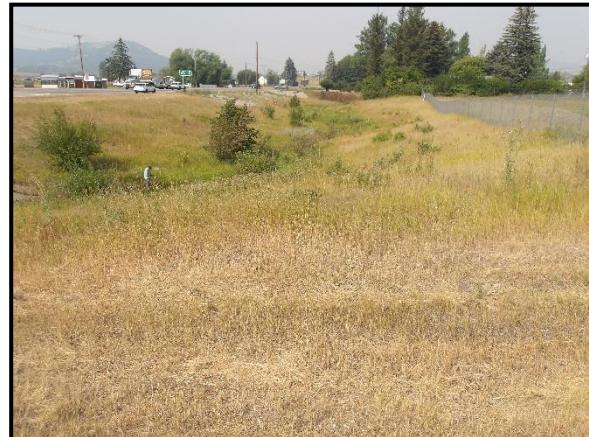
Photo 1: View looking west (upstream) of Bowser Creek.

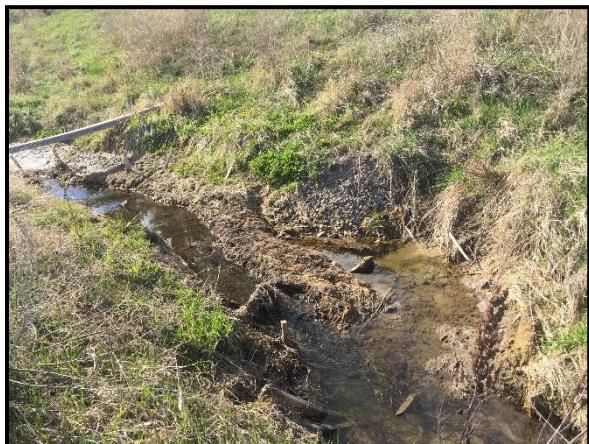
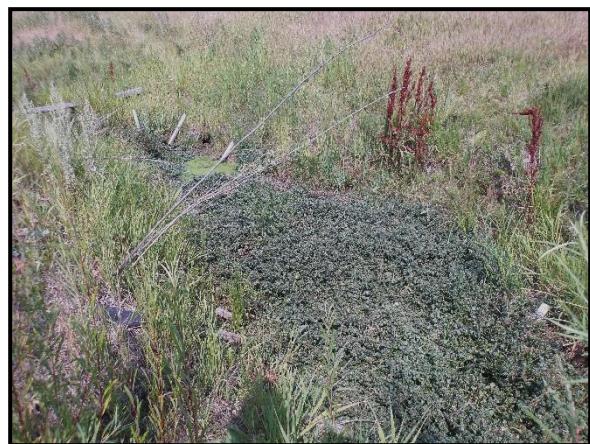
No eroding banks were observed within the Bowser Creek site in 2023. All previously noted bank erosion has healed.

Additional Photo 1: Eroding bank observed in 2013 which has healed.

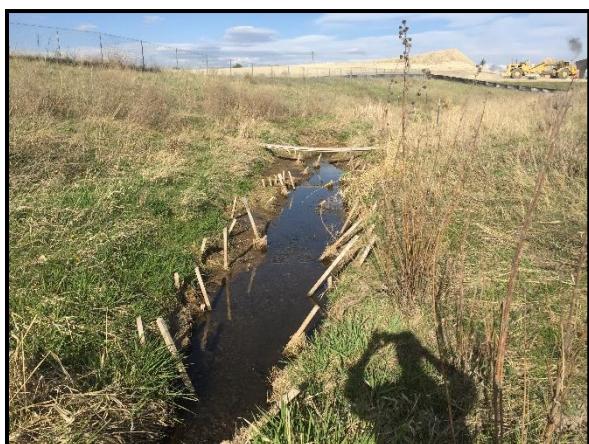
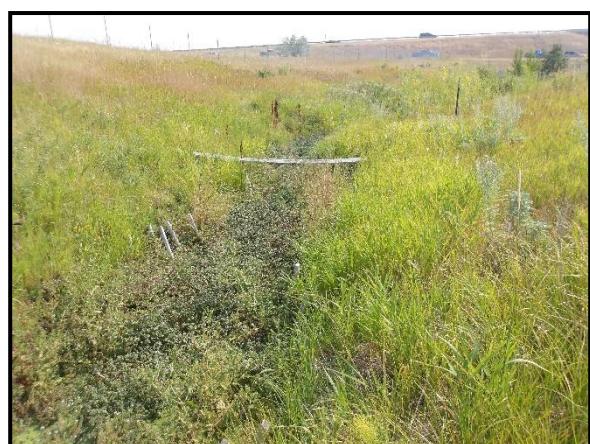
Additional Photo 2: Middle of Bowser Creek looking downstream.

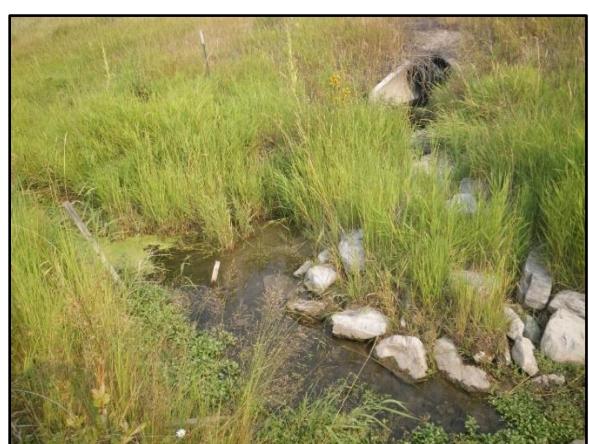
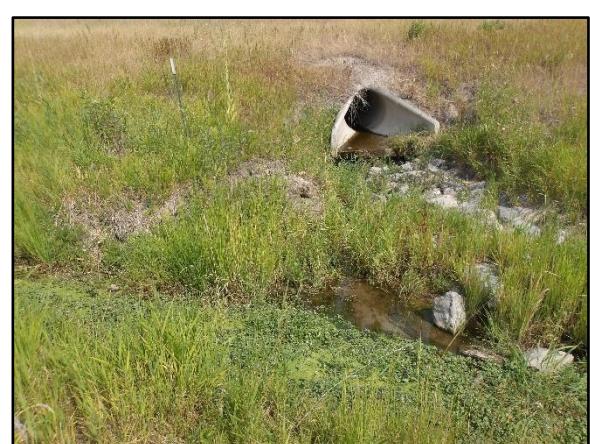
Additional Photo 3: Stormwater pond culvert and outflow confluence with Bowser Creek.

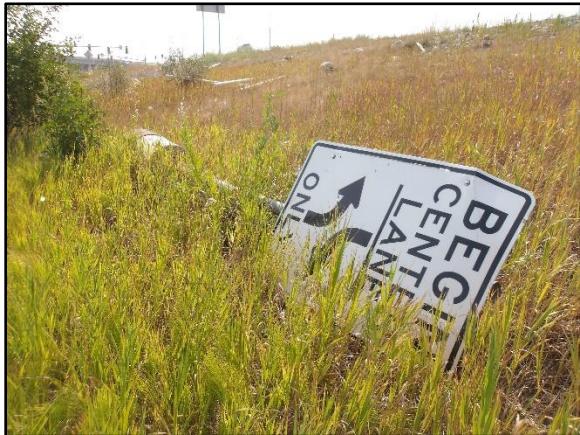
Additional Photo 5: Debris observed in the uplands in the southwest corner of the mitigation site.

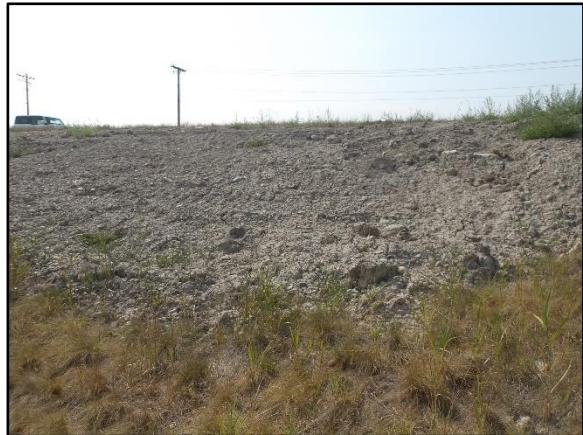
Additional Photo 6: Debris observed in the uplands in the southwest corner of the mitigation site.

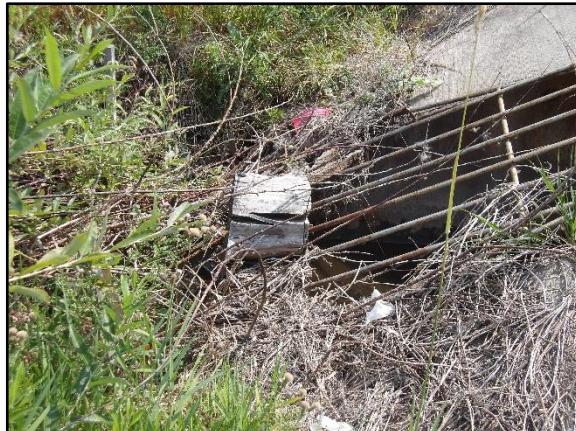
Additional Photo 7: Debris accumulation at the mouth of Bowser Creek. Downstream/east end of the mitigation site.

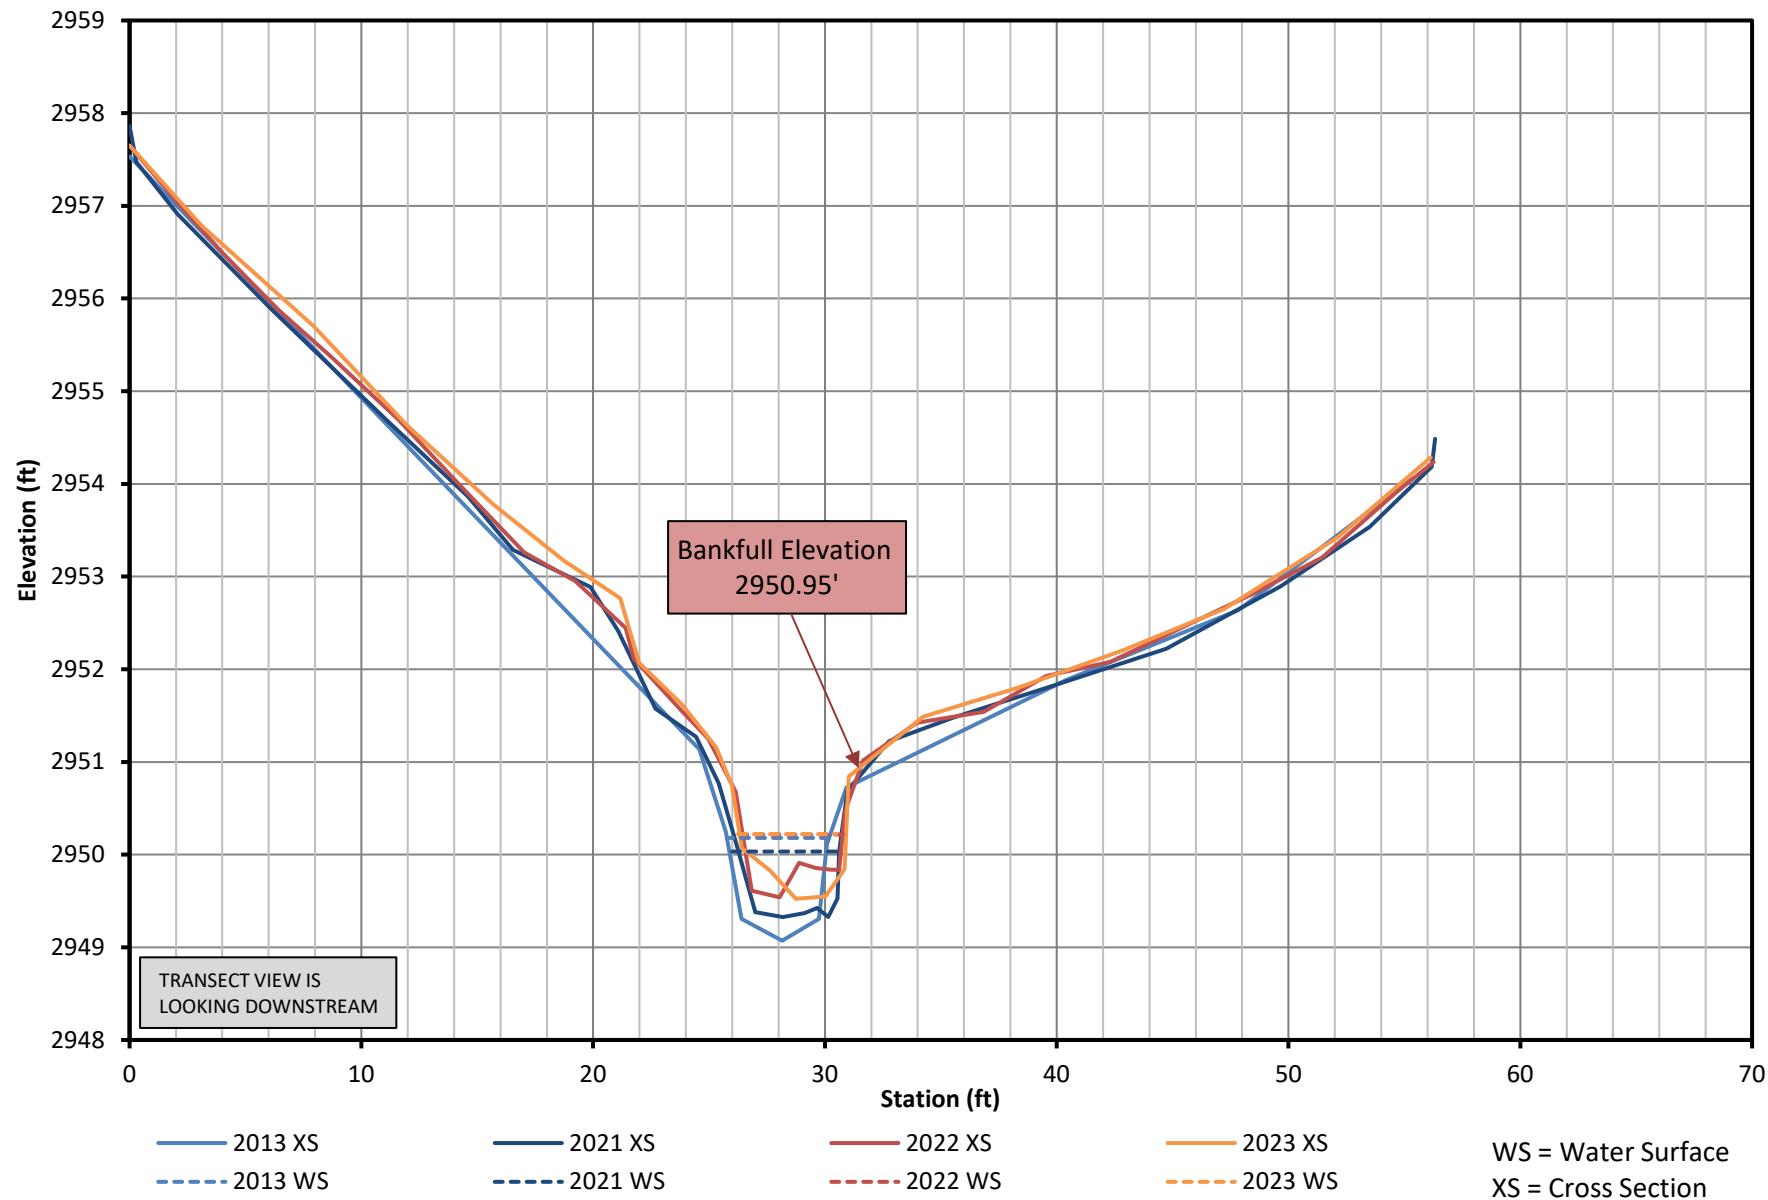
Bowser Transect #1 - Pool

The cross-sections (i.e. transects) of Bowser Creek surveyed in 2023 indicate channel widths have remained stable since 2013 and no signs of lateral migration were observed (Table 6). Cross section data indicates that channel depths decreased slightly since 2022 at two of the four transects. Additionally, the 2023 longitudinal profile indicates all three pools have completely filled-in since the initial monitoring event in 2013. The decreased channel depths observed at pools within the project reach are likely the result of upstream sediment inputs as no sediment sources are evident within the project reach. The reach is relatively straight, and lacks scour-inducing features that help to maintain deeper pool habitat. However, the longitudinal profile also indicates that bed elevations are being maintained at riffles, signifying that the whole reach is not aggrading (Table 5; Appendix E).

Transect	Type	Max Depth (ft)				
		2013	2020	2021	2022	2023
1	Pool	1.9	1.8	1.6	1.4	1.3
2	Riffle	2.2	2.0	2.0	2.1	2.1
3	Pool	3.6	2.5	2.5	2.1	1.9
4	Riffle	1.9	1.8	2.1	1.9	1.9
Average Riffles		2.1	1.9	2.1	2.0	2.0
Average Pools		2.8	2.3	2.2	1.8	1.6
Average All		2.4	2.1	2.1	1.9	1.8
