Montana Department of Transportation Stream Mitigation Monitoring Report
ASHLEY CREEK MITIGATION SITE

MDT Project Number: NH-MT 5-3(59) FST / UPN # 2038010

Monitoring Year: 2024

Monitoring Conducted By: Confluence Consulting Inc.

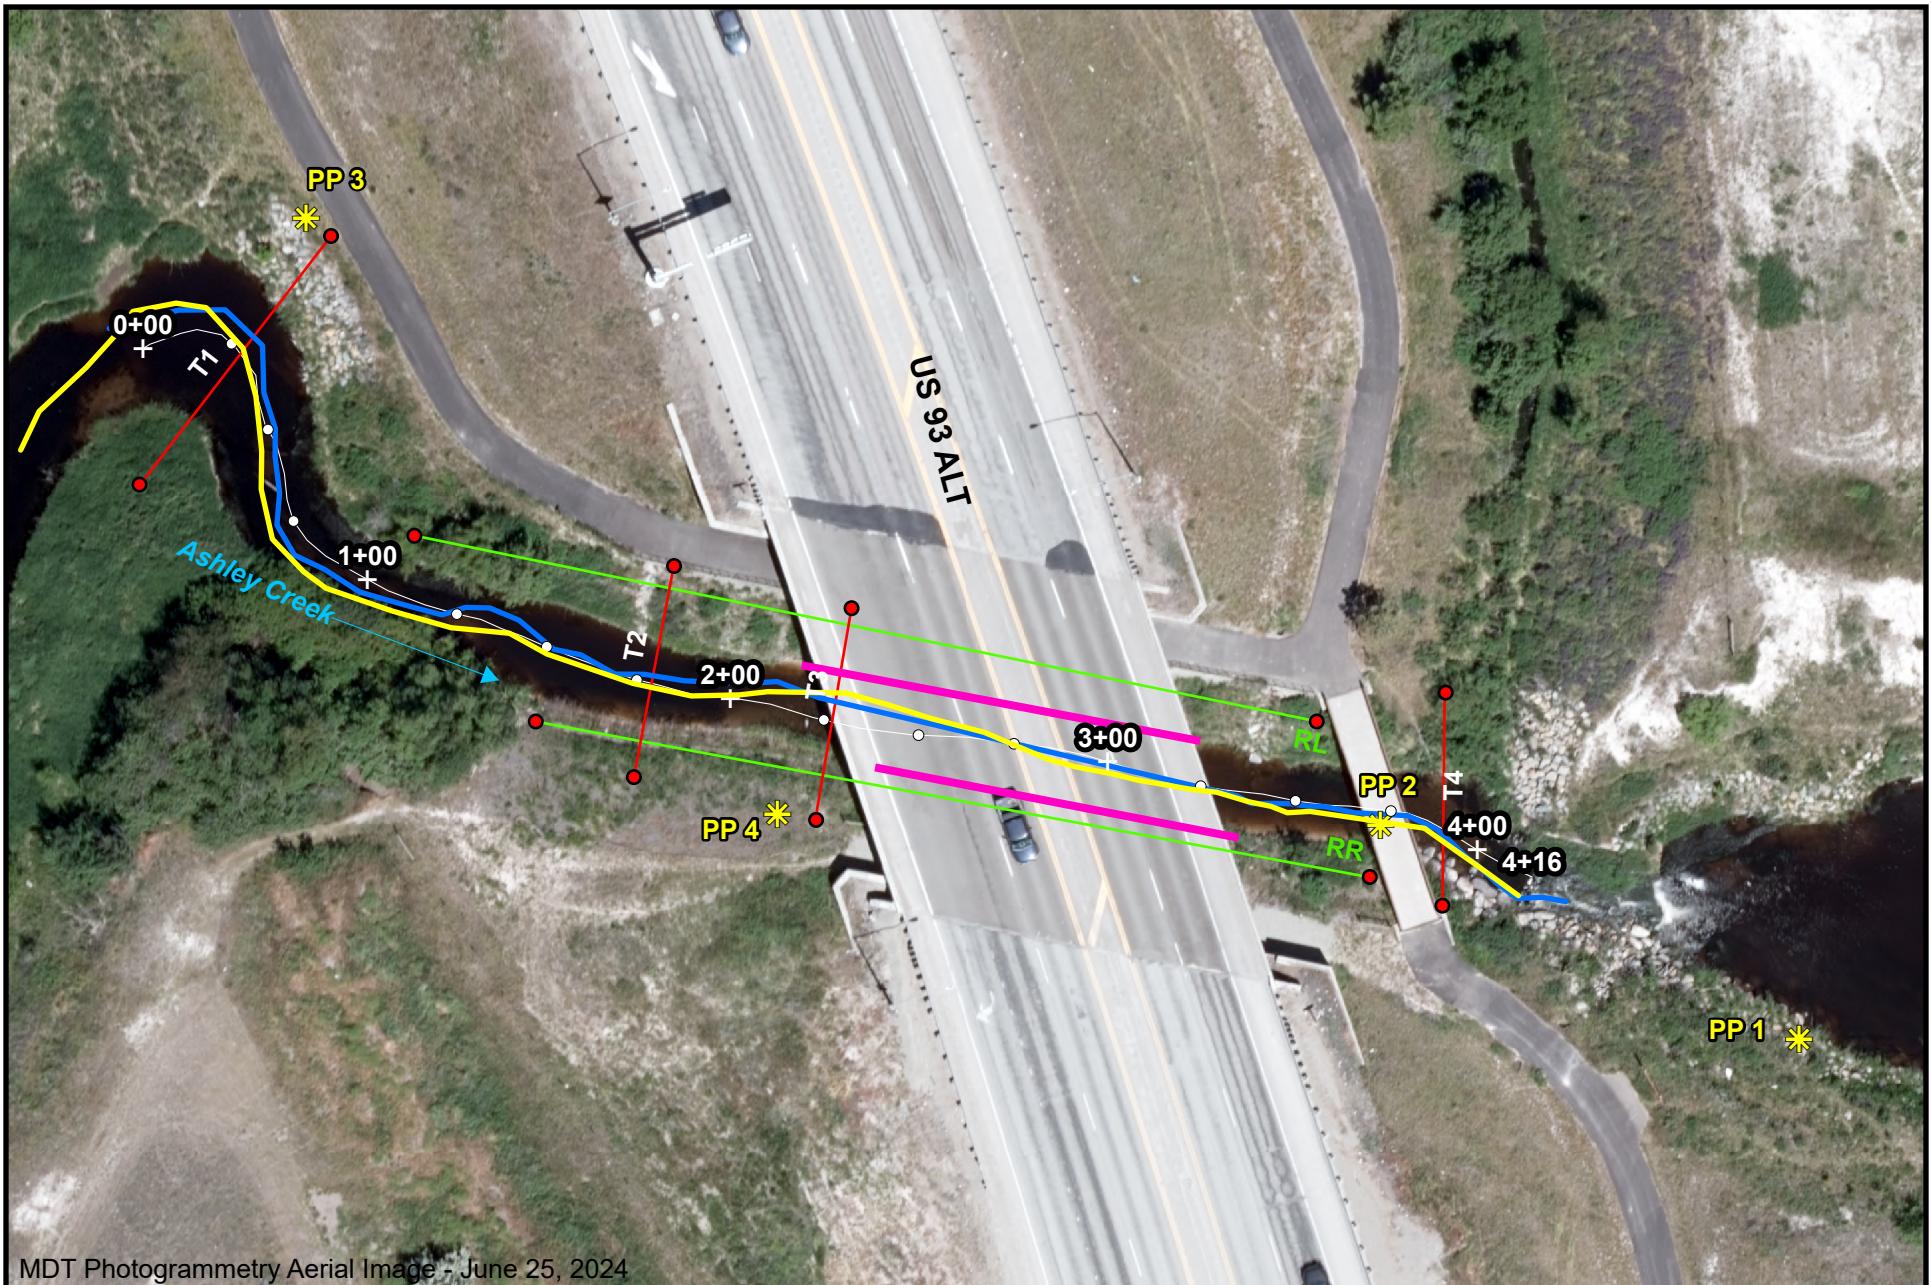
Figure 2

Bare ground accounted for greater than 50% cover along the stream-bank vegetation transects, which extend both upstream and downstream of the overpass (Figure 2, Appendix A). Reed canary grass comprised between 21% and 50% cover along the north bank and between 11 and 20% along the south bank (Table D-1, Appendix D). The low vegetation cover is partially due to active bank erosion and limited sunlight beneath the bridge overpass. As most of the stream banks were bare, the dominant stream bank community type was considered “barren”, and the site was assigned a corresponding root stability index value of 1 (Winward 2000).

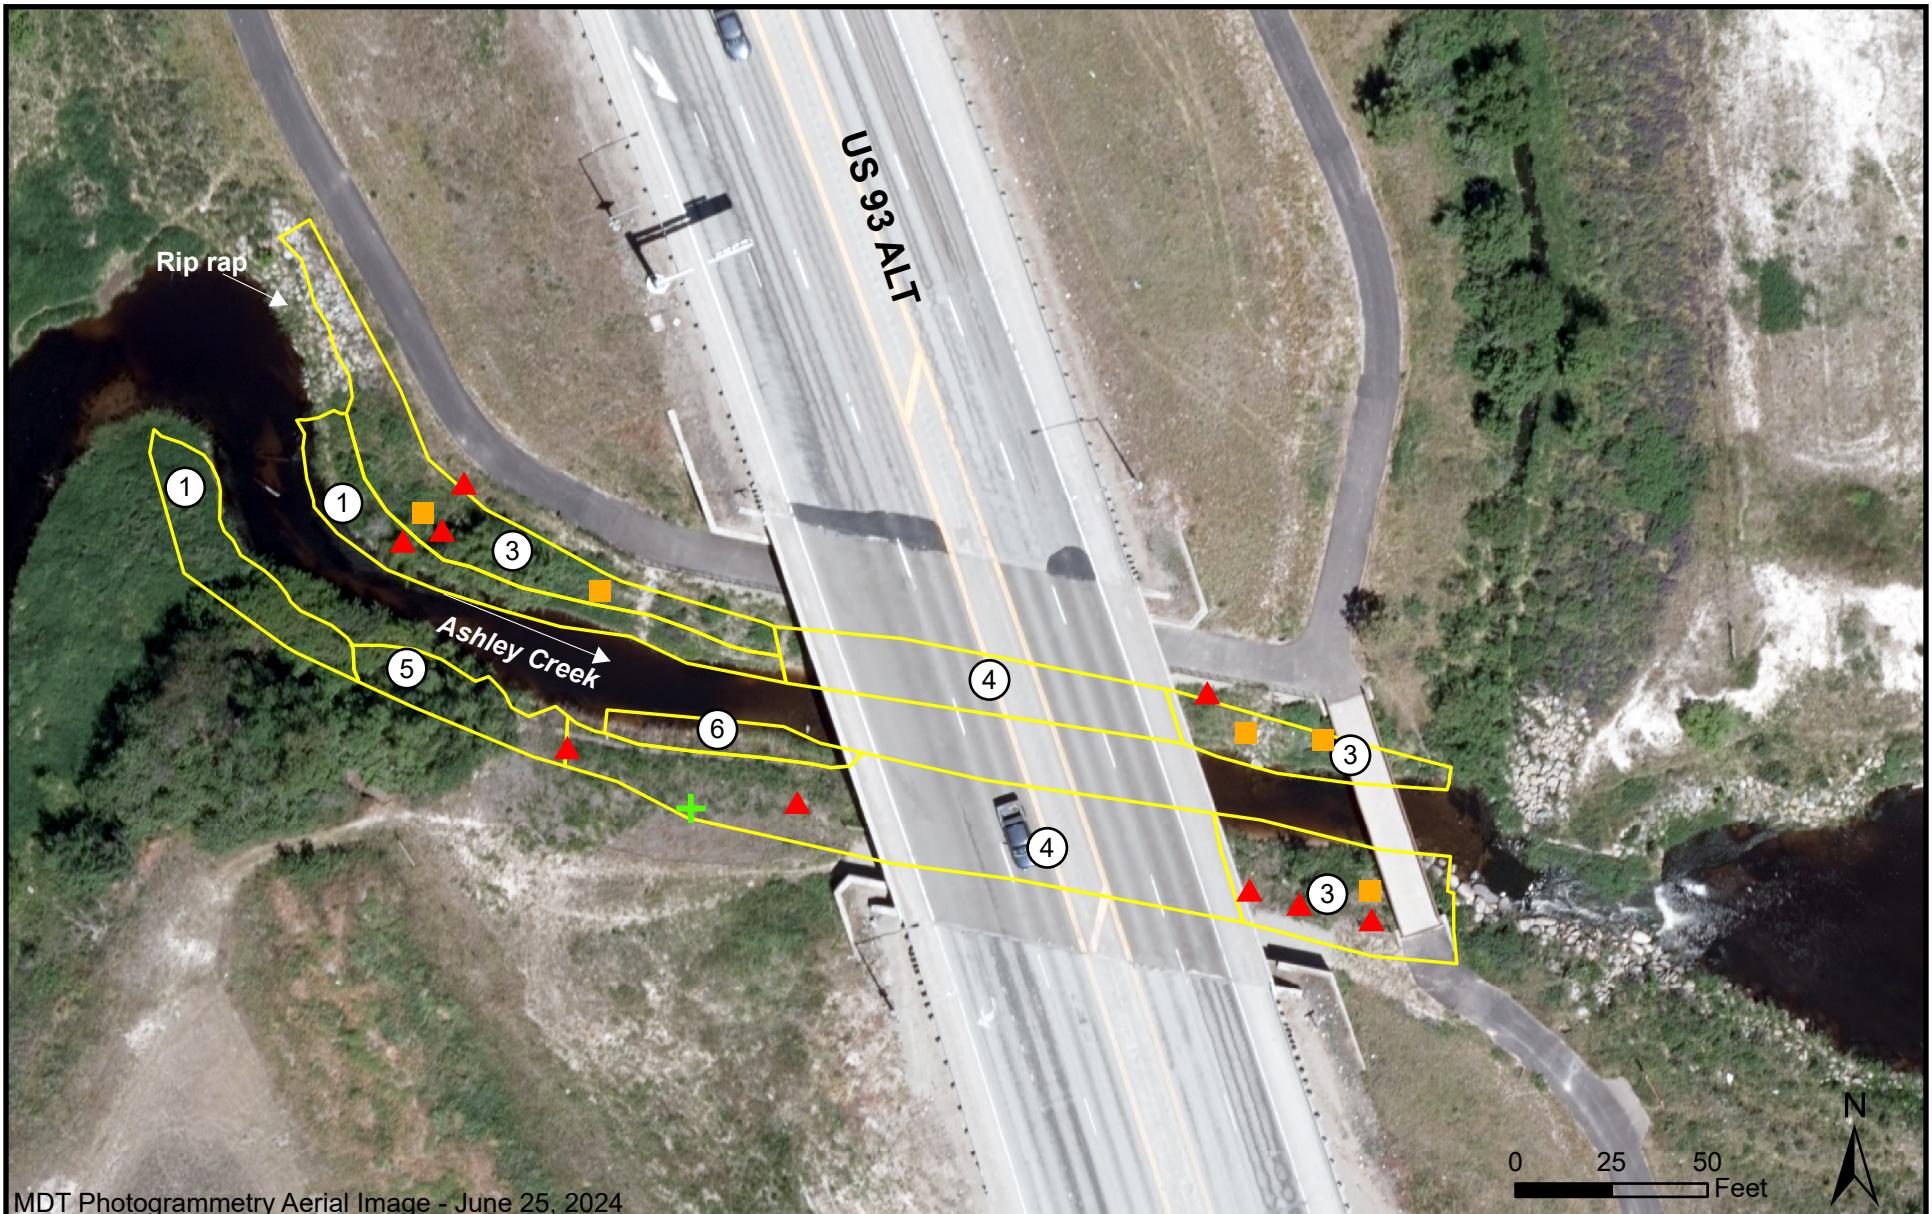
Four Montana-Listed noxious weed species were identified during the 2024 monitoring event. Noxious weed infestations of a low cover class (1 to 5 percent) or higher were mapped and are displayed on Figure 3 (Appendix A). Noxious weed infestations identified in isolated and trace amounts (<1%) were noted but not mapped. In total, 15 infestations of two Priority 2B noxious

weeds were mapped within the riparian corridor (MDA 2019). These infestations included nine occurrences of Canada thistle (*Cirsium arvense*), five occurrences of common tansy (*Tanacetum vulgare*) and one occurrence of field bindweed (*Convolvulus arvensis*). A low cover class was assigned to each mapped weed infestation within the project area. An estimated 5% of the project area has been colonized by noxious weeds, with Canada thistle as the most prevalent in 2024. Weed treatments will continue in 2025 between MDT contractors and the City of Kalispell.

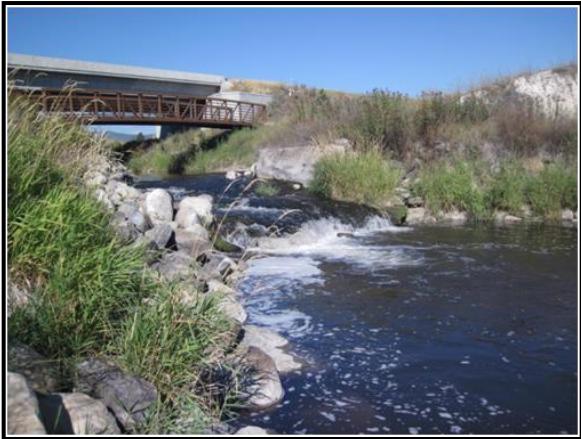
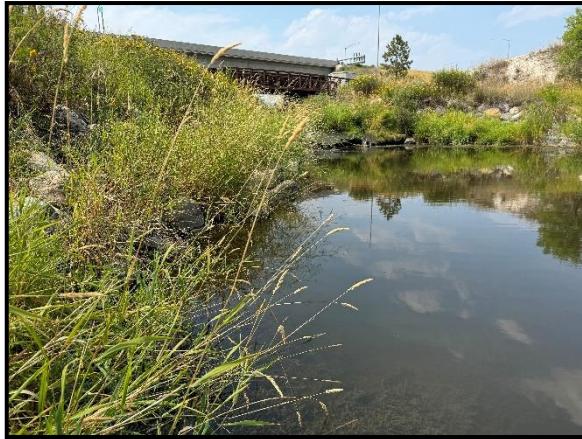
Photo Point 1: View of grade control structure downstream of project area. **Compass:** 315° (Northwest)

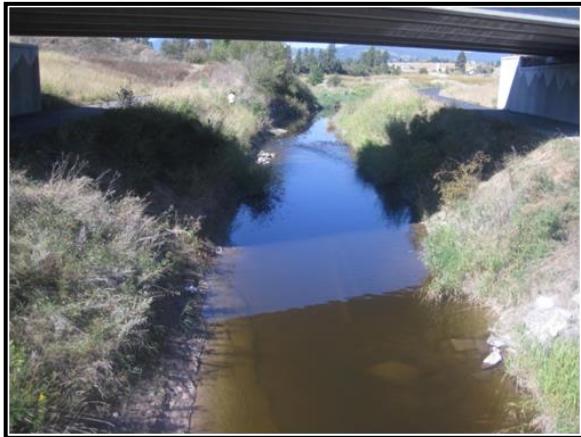
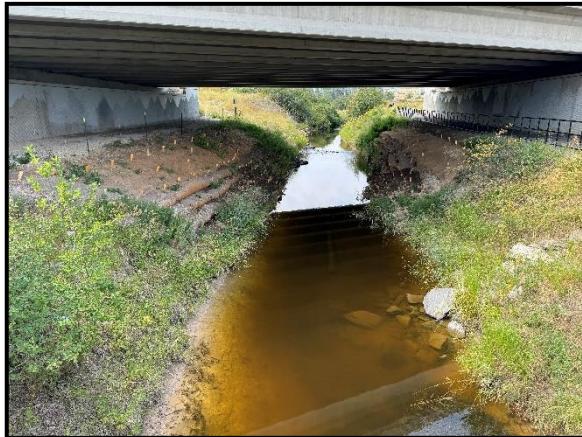
Photo Point 2: View looking upstream from pedestrian bridge. **Compass:** 315° (Northwest)

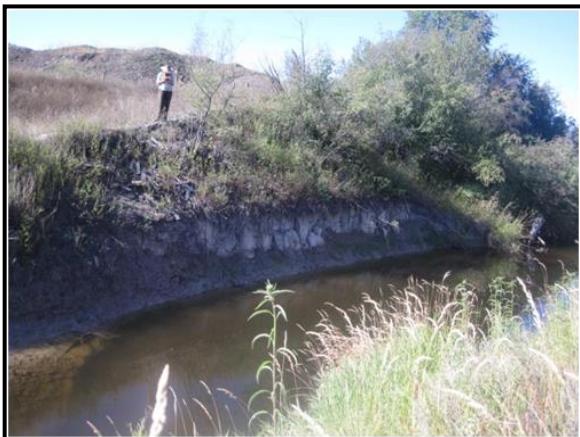
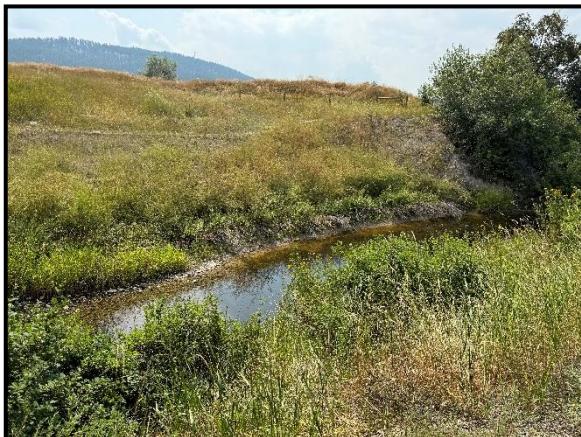
Additional Photo 2: South bank upstream of the US 93-Kalispell Bypass Bridge before and after the 2022 repair.

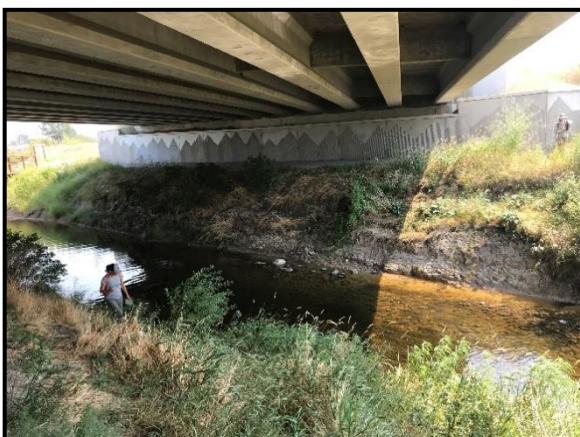
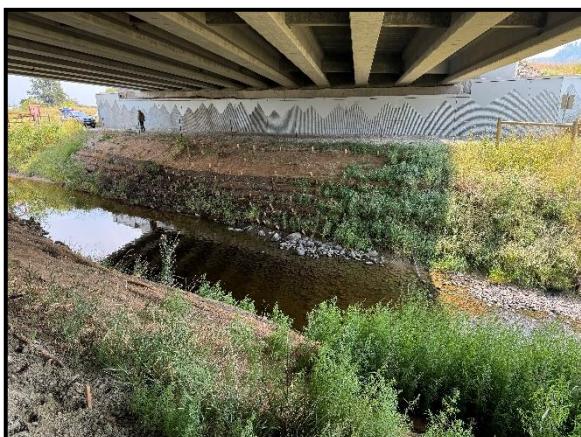
The total eroding bank length within project reach did not change between 2023 and 2024 and remains at 24% of the total bank length. While the success criteria for bank erosion (<25%) was again met, erosion beneath the bridge has worsened with 36' of the north bank collapsing as a result of failing coir-wrapped soil lifts and a lack of vegetative establishment to stabilize those soils. Environmental constraints stemming from the bridge including permanent shading and cover from precipitation are preventing successful vegetative establishment and contributing to the bank erosion occurring beneath it.

Additional Photo 3: Upstream end of eroding south bank under the US 93-Kalispell Bypass bridge.

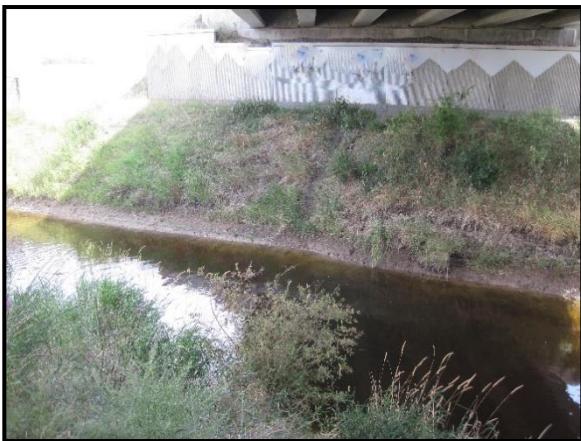
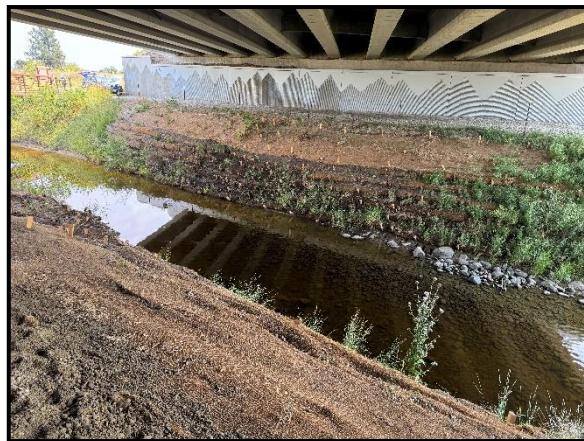
Additional Photo 4: Downstream end of the eroding south bank under the US 93-Kalispell Bypass Bridge.

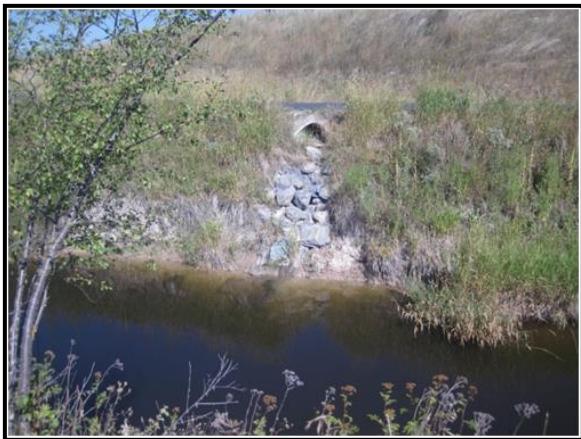
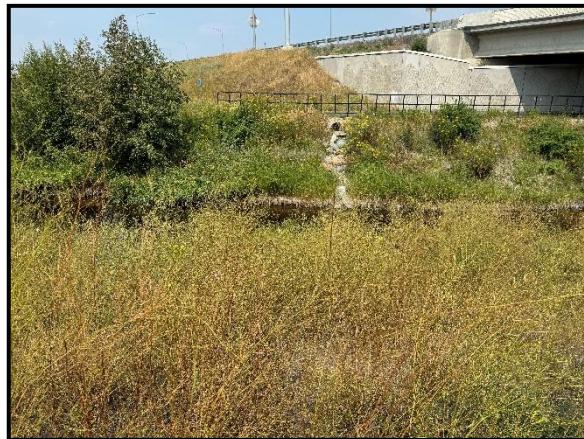
Additional Photo 5: Stabilized culvert outlet on the upstream end of the project area. This culvert may have been jeopardized by fence post placement, which appears to be washing out. See additional Photo 7.

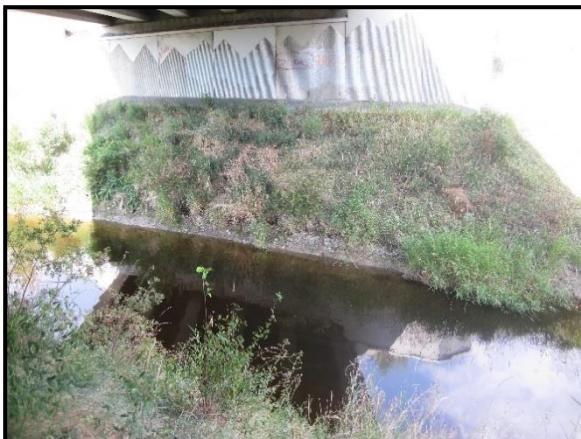
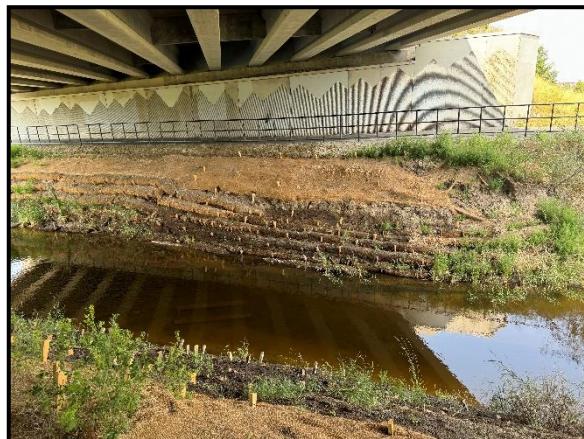
Additional Photo 6: Eroding north bank under the US 93 – Kalispell Bypass bridge.

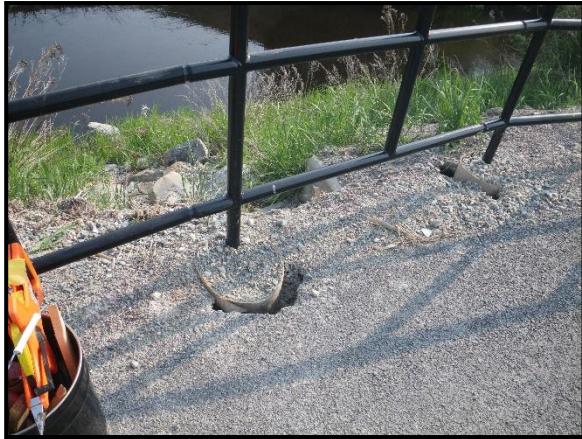
Additional Photo 7: Looking at the culvert shown in additional photo 5 from above. The area around the fence post footers is eroding.

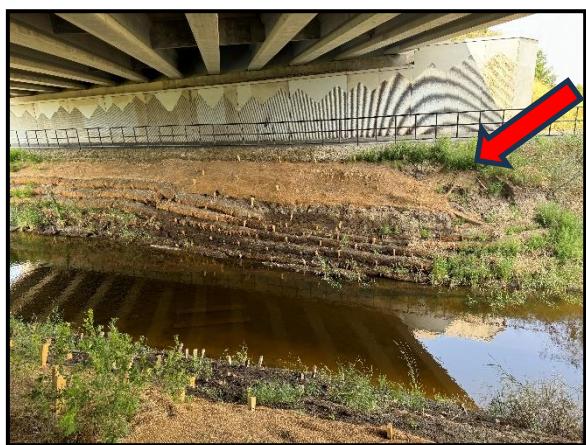
Additional Photo 10. Photo of the north bank during the 2024 monitoring event. The downstream extent has collapsed and is failing.

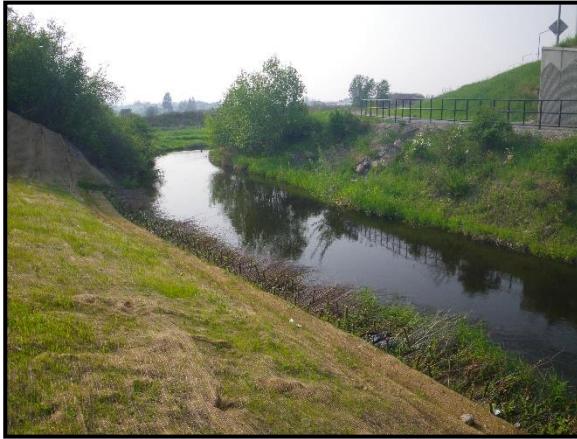
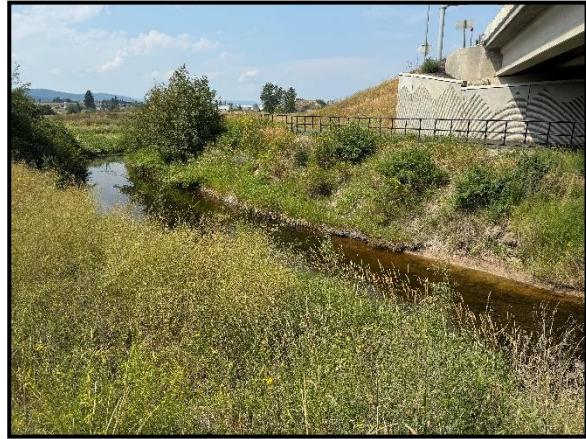
In contrast to the eroding banks beneath the bridge, the south bank that was stabilized in 2022 (ERB1) has continued to vegetate and exhibited increased stability in 2024. While pedestrian access to Ashley Creek within the US-93 Bridge area is still prevalent, the exclusionary fencing appears to be discouraging foot traffic and is contributes to the vegetative establishment.

Additional Photo 11. Repaired south bank upstream of the bridge.
