Montana Department of Transportation Stream Mitigation Monitoring Report  
**BOWSER CREEK MITIGATION SITE**

**MDT Project Number:** NH-MT5-3(50)109F UPN #: 2038013

**Monitoring Year:** 2024

**Monitoring Conducted By:** Confluence Consulting Inc.

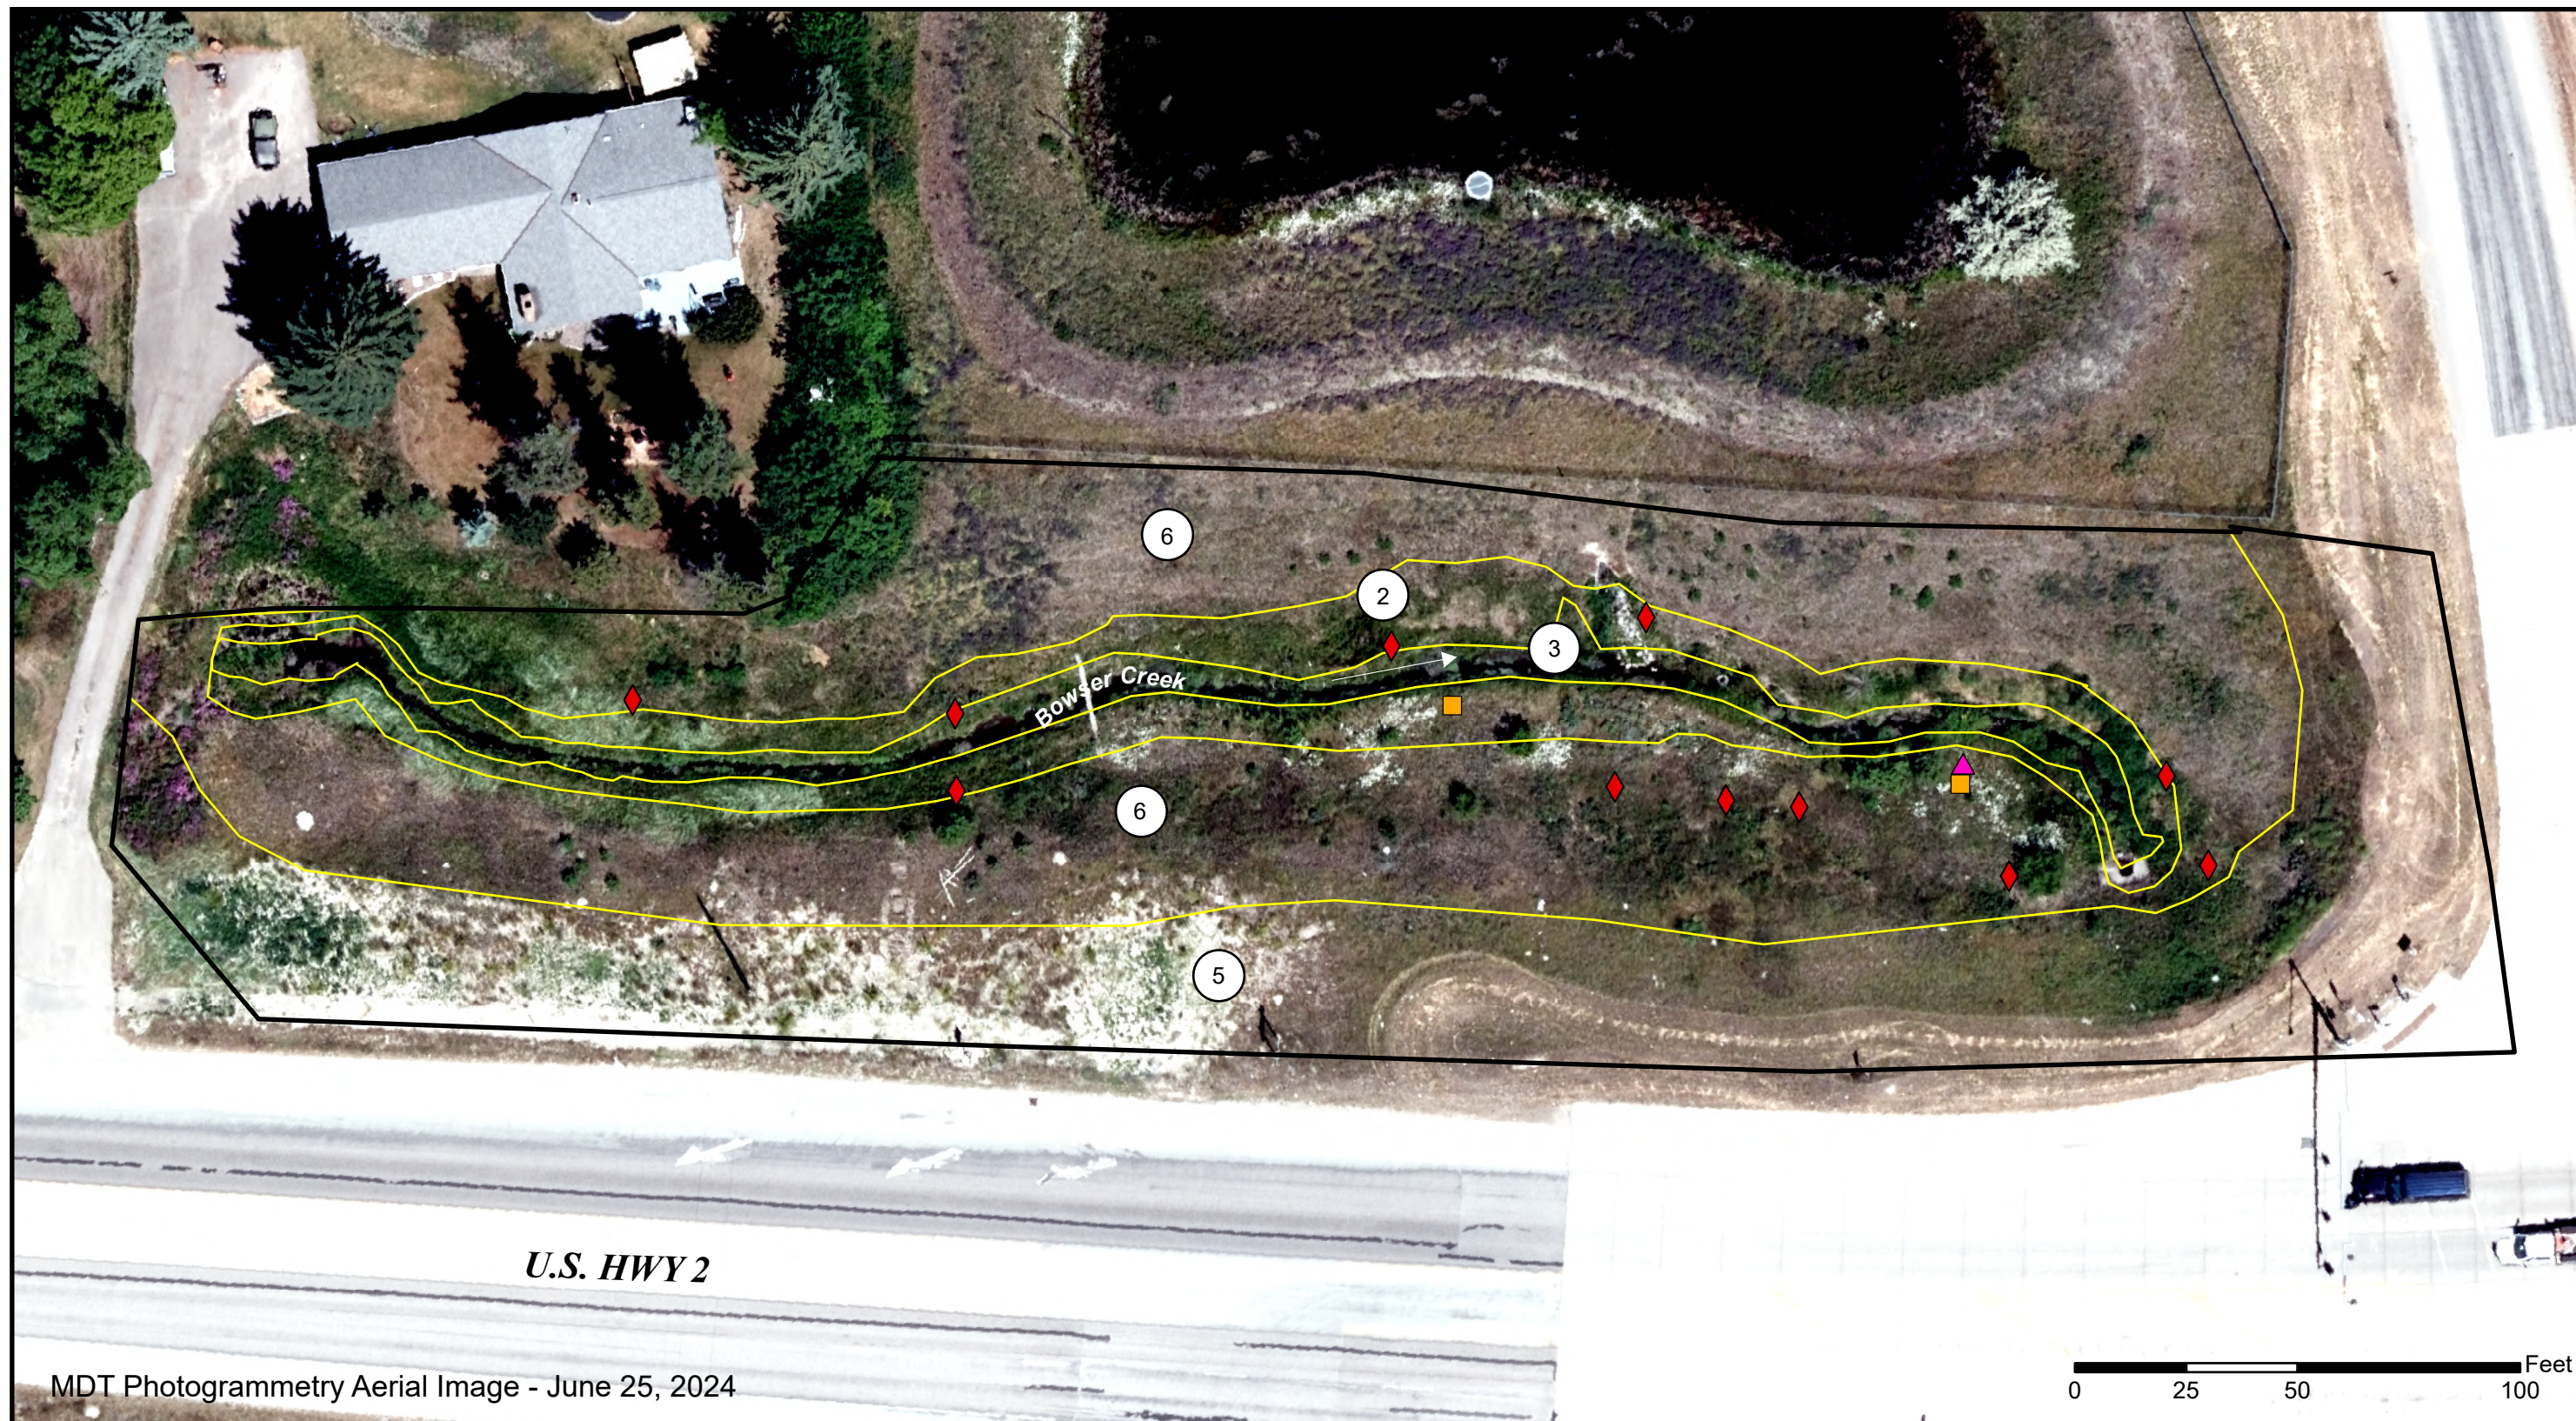
weed coverage is estimated at 5% . A low cover class (1 to 5 percent) was assigned to all mapped weed occurrences within the project area in 2024. Canada thistle was the most prevalent noxious weed with many infestations located on the eastern half of the project area. Locations of noxious weed infestations are provided on Figure 3 in Appendix A, except for gypsy flower and butter-and-eggs, which were observed as isolated occurrences in trace amounts.

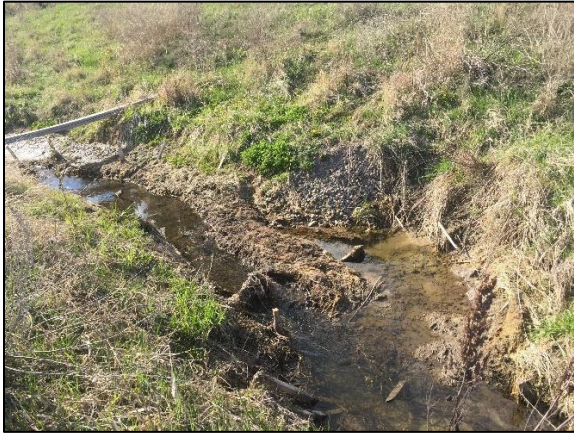
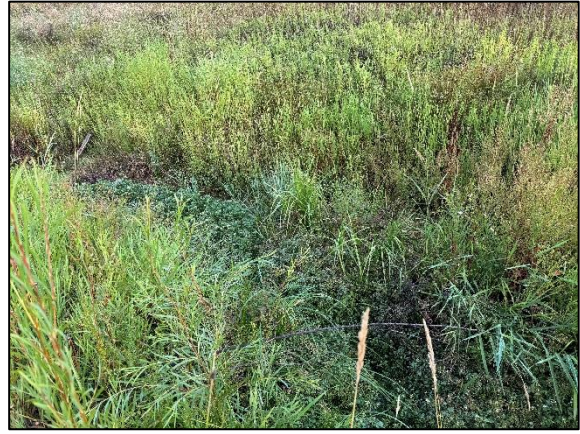
A single eroding bank was observed immediately downstream of the stormwater detention pond outlet at STA 3+25 on the north bank. The eroding bank less than 7' in length and does not appear to be problematic. All previously noted bank erosion has healed.

**Additional Photo 1:** Eroding bank observed in 2013 which has healed.

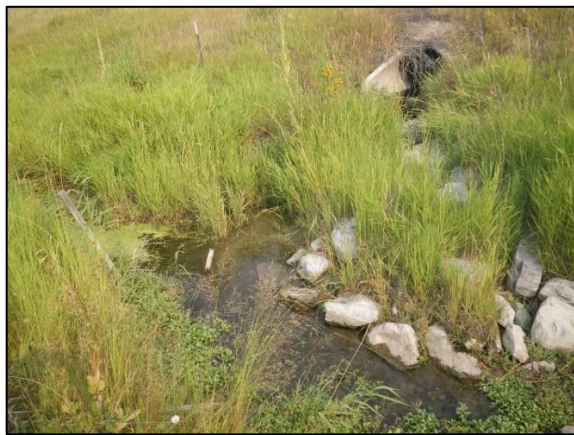
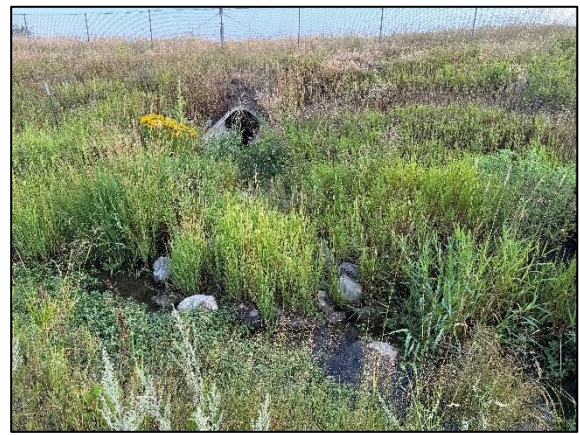
**Additional Photo 3:** Stormwater pond culvert and outflow confluence with Bowser Creek.

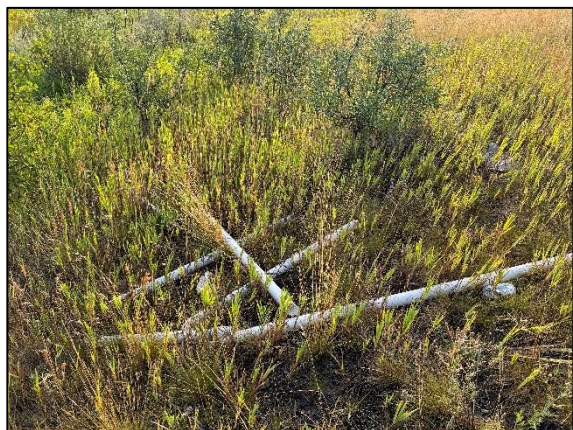
**Additional Photo 5:** Debris on the southern bank of the mitigation site.

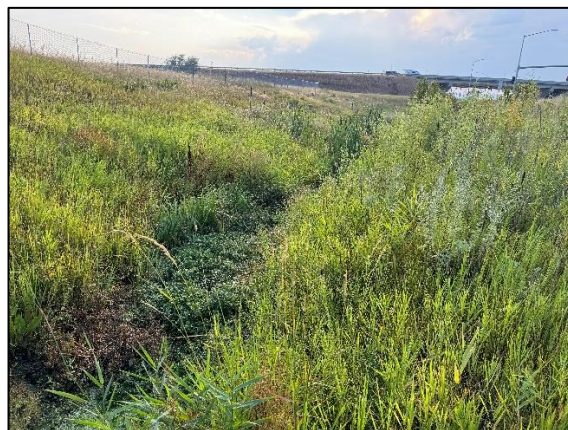
Vegetation community Type 3 – *Nasturtium officinale* (watercress) was observed within the stream channel. Watercress dominated this community type with more than 50% cover growing in the channel bed and 6 to 10% cover along both stream banks. This community has been consistently observed in dense stands along the stream bed and edges of stream banks since the 2015 monitoring event. This community also includes common duckweed (*Lemna minor*), climbing nightshade (*Solanum dulcamara*), and true forget-me-not (*Myosotis scorpioides*), although in much lesser amounts than watercress.

**Additional Photo 6:** Upper reach of Bowser Creek is largely grown in with watercress (*Nasturtium officinale*).

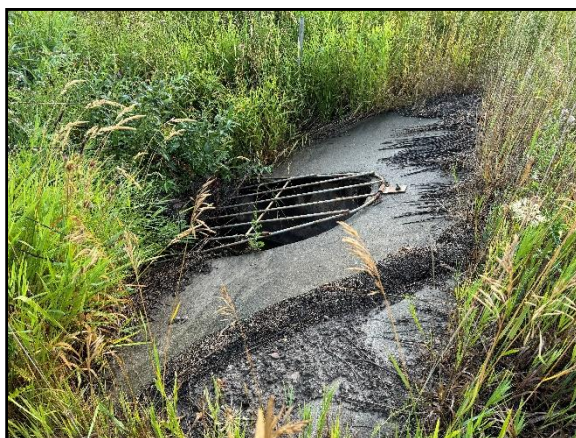
**Additional Photo 7:** The downstream trash rack is clear of debris, however, is well vegetated at the invert of the culvert.

**Specific recommendations for additional corrective actions:** One recommendation is for MDT Maintenance to clean the trash rack at the culvert under US 2 periodically of debris to allow the movement of sediments within the restored Bowser Creek channel upstream of that location. Discuss with the US Army Corps of Engineers and staff botanists on whether planting additional woody vegetation along the stream banks is beneficial, or should we allow the volunteer woody vegetation community to expand as is occurring to meet this vegetative establishment goal.

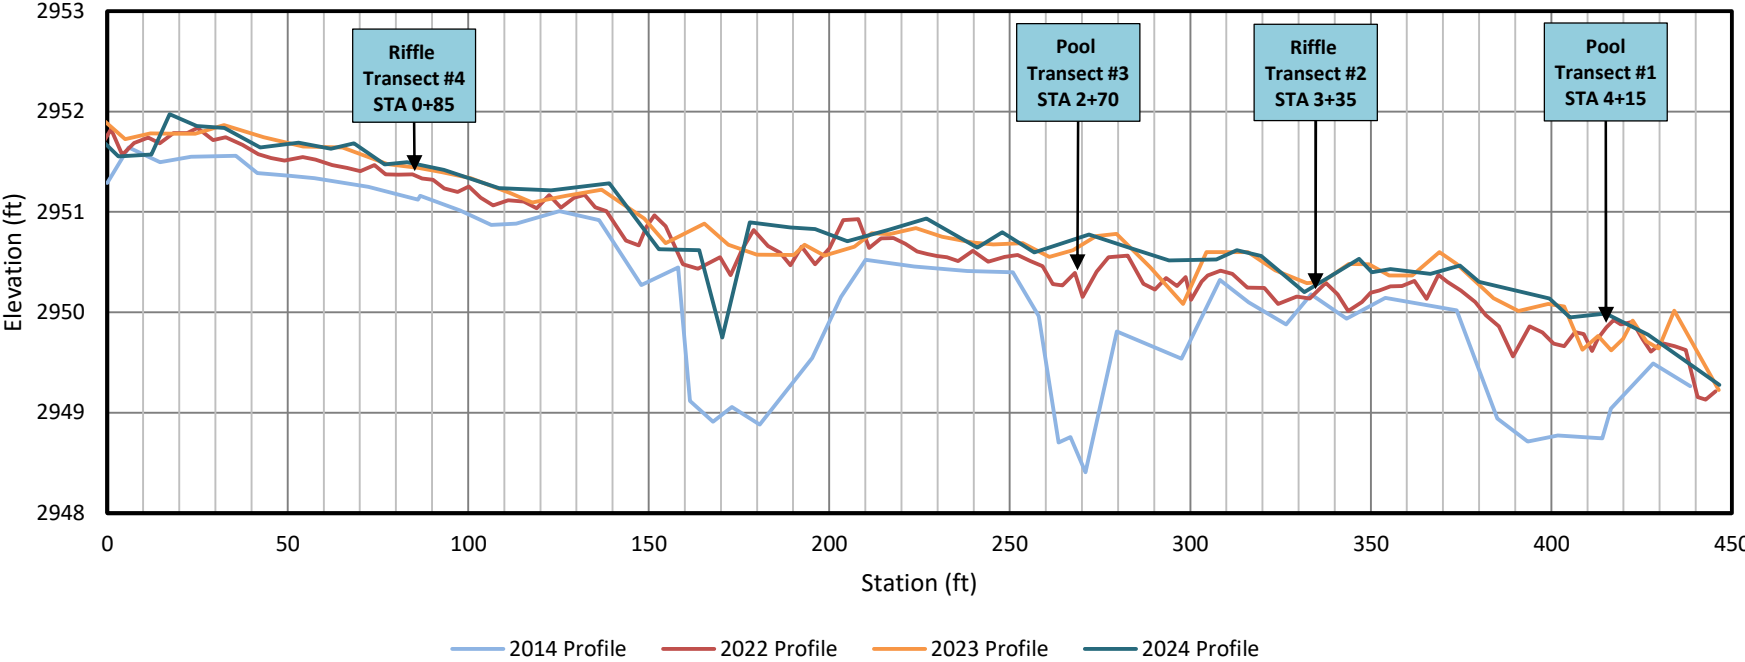
# Bowser Creek Longitudinal Profiles

The cross-sections (i.e. transects) of Bowser Creek surveyed in 2024 indicate minimal lateral channel migration since 2013 and no significant signs of lateral migration were observed during the 2024 monitoring event (Table 5). Riffle transect #4 was the only location to show any lateral movement with the channel expanding 2' to the north bank. Cross section data indicates channel depths overall have decreased slightly since 2023. Additionally, the 2024 longitudinal profile indicates all three pools have filled in since the initial monitoring event in 2013. The decreased pool depths are likely the result of a relatively low gradient, straight channel alignment that lacks scour-inducing features capable of maintaining deeper pool habitat. No sediment sources are evident within the project reach; therefore, sediment supply is originating from upstream inputs. The longitudinal profile does indicate bed elevations are being maintained at riffles, signifying the whole reach is not aggrading (Table 5; Appendix E).

The Bowser Creek stream mitigation site is meeting all performance standards except for the percent survival of planted trees and shrubs, and the qualitative channel form stability criteria. Besides less-than-desirable cover from woody vegetation, the site is well vegetated and has limited noxious weed cover. Gradual loss of pool habitat limits the ability of the creek to provide habitat complexity; however, riffle elevations are being maintained, signifying the reach as a whole is not aggrading.
