EXPERIMENTAL PROJECTS CONSTRUCTION REPORT AND EVALUATION

Barrier Reflector Durability Study

Location: Cascade County/Great Falls District: I-15 Deck Structures
Emerson and Sun River

Experimental Project: MT-19-06

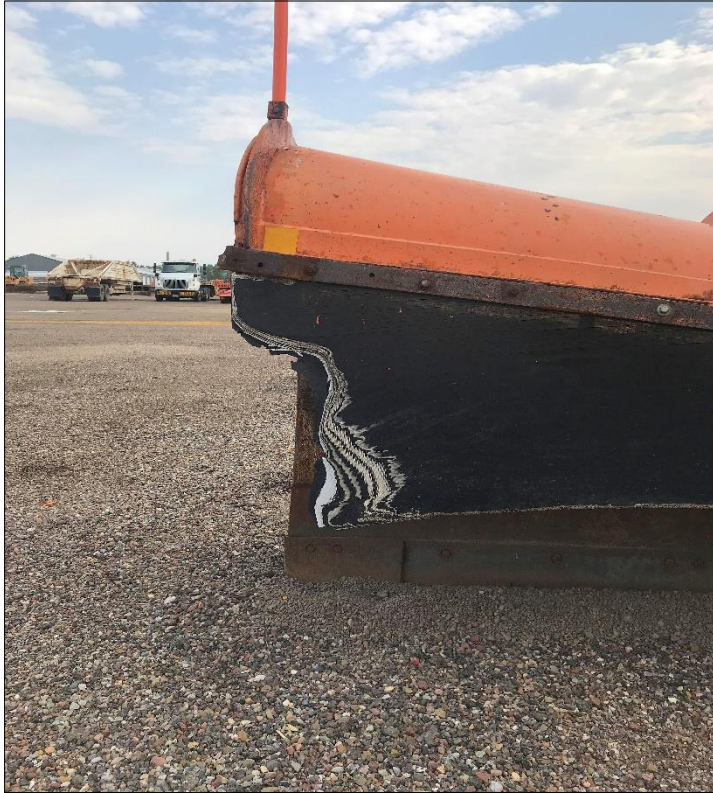
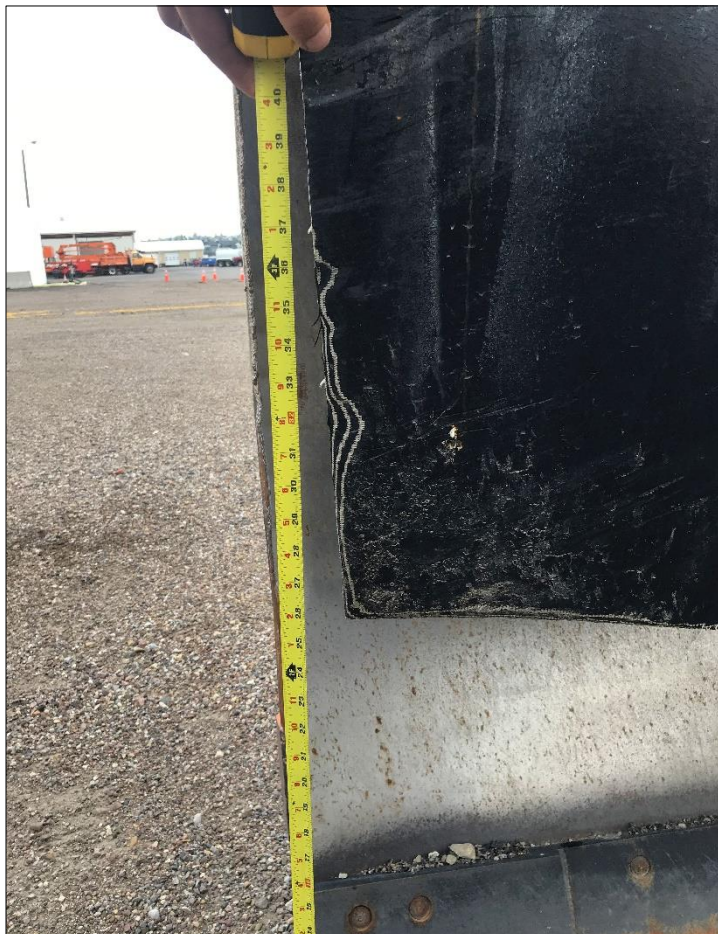
Blade Snow Deflectors

↩ ↓ Typically made of a reinforced rubber material or poly. Installed on the top edge of the plow and is used to increase user's visibility while plowing by minimizing the snow that flies up over the top of the plow and onto the windshield, a needed safety measure for effective plowing.

The examples shown represent those styles of deflectors which obviously strike parts of the bridge barrier resulting in damage to the reflectors.

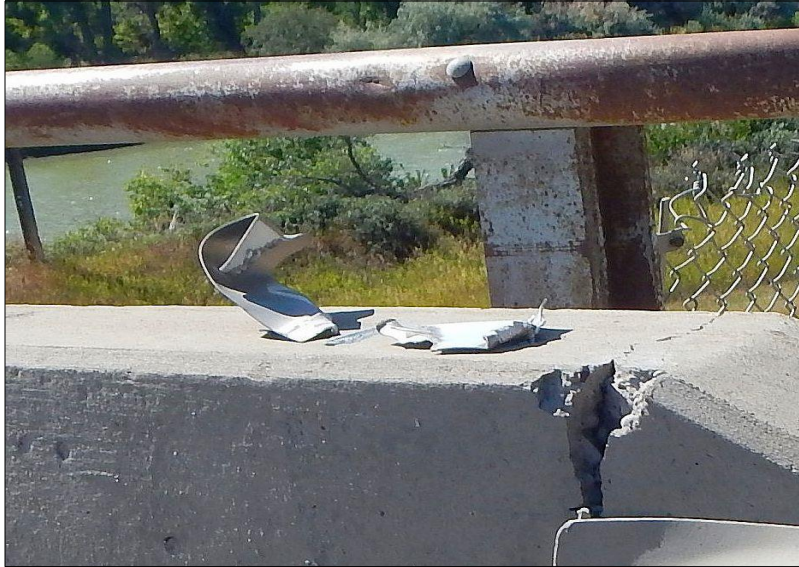
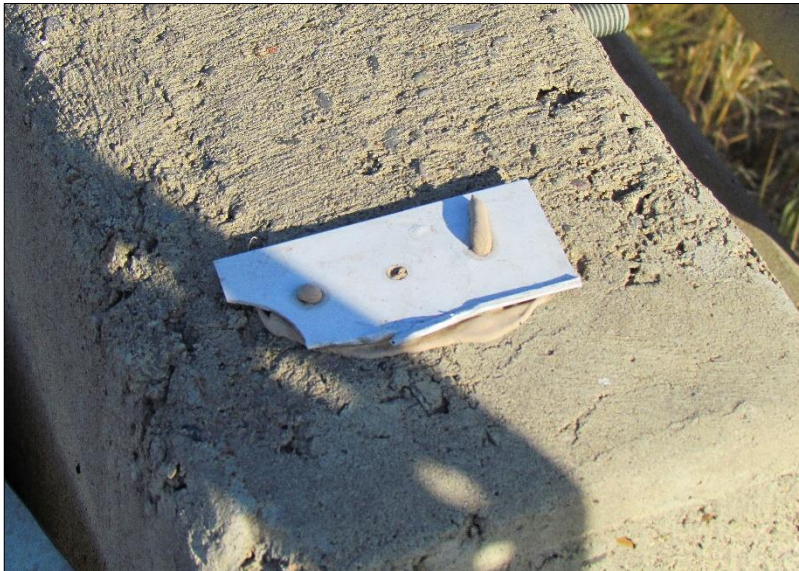
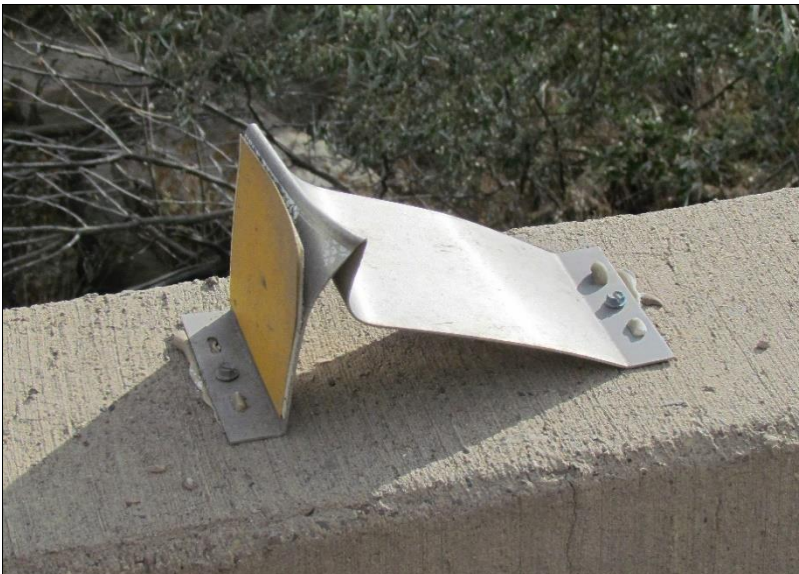
← ↓ Several examples of damaged or missing reflectors on the Emerson and Sun River structures

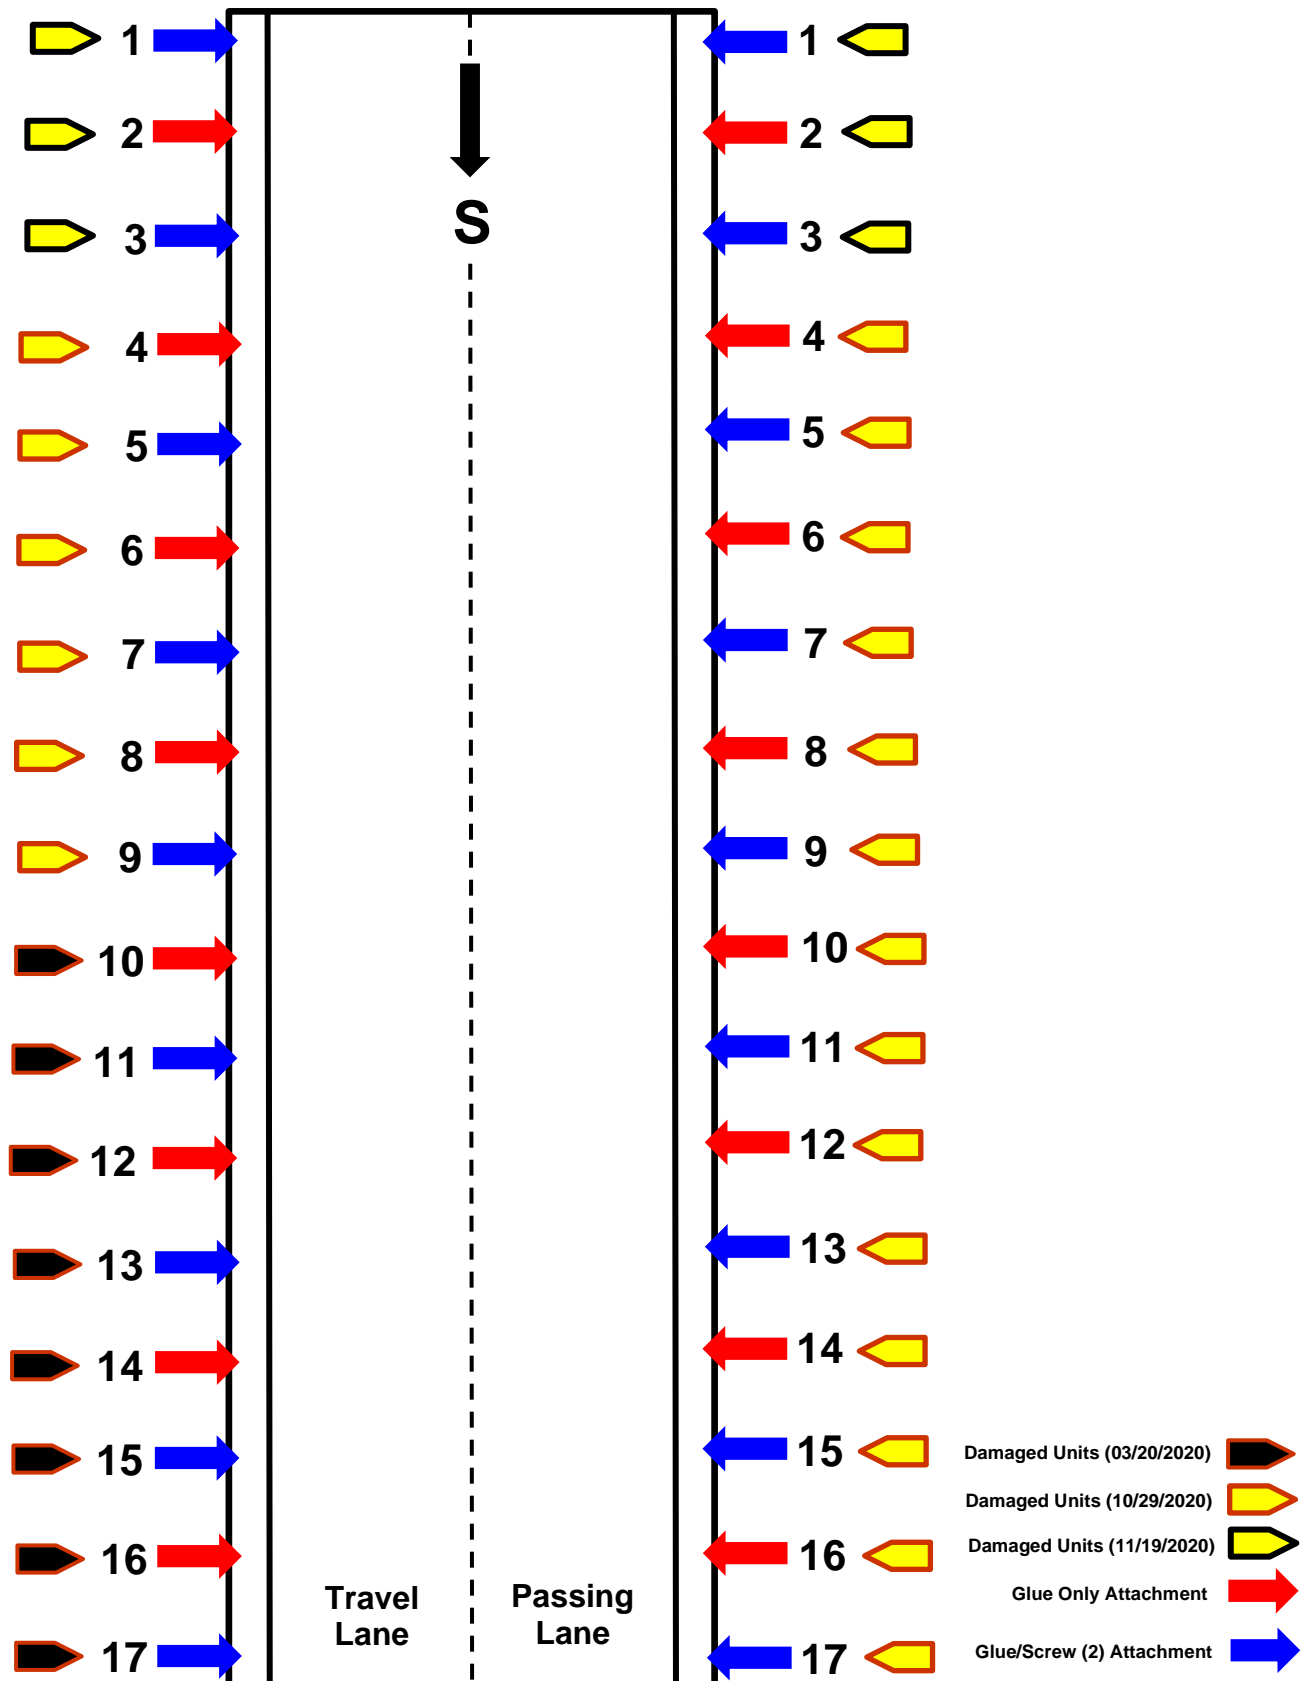
*Test Section Delineator Design T4: Sun River Bridge – South Bound

However, District staff reported on **March 20** on the Sun River southbound structure (T4) that damaged units were observed in the travel lane. Research visited the site on March 23 and found eight units damaged (units 10-17), see page 18 for more detailed description.

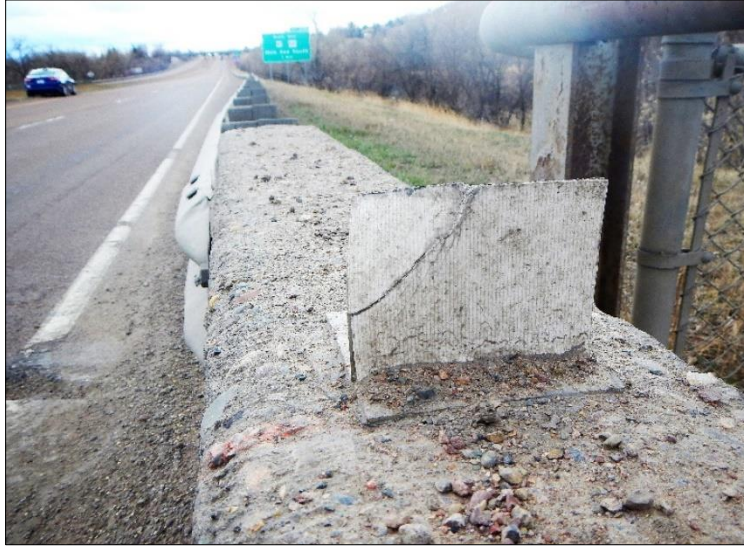
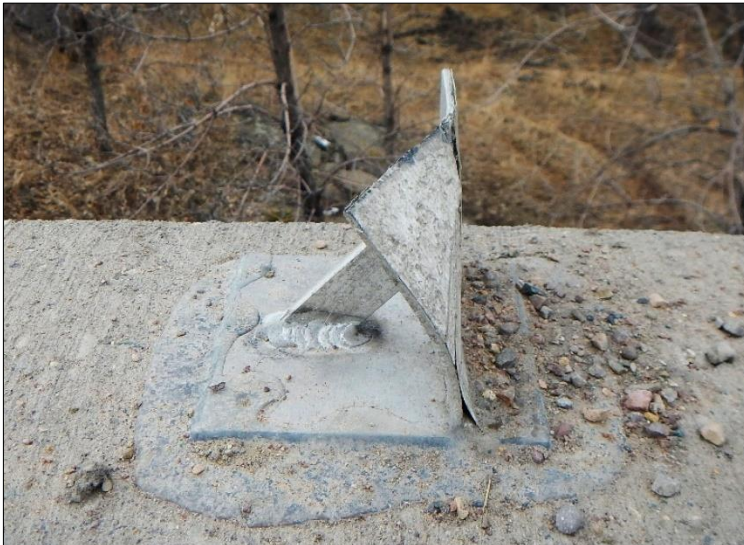
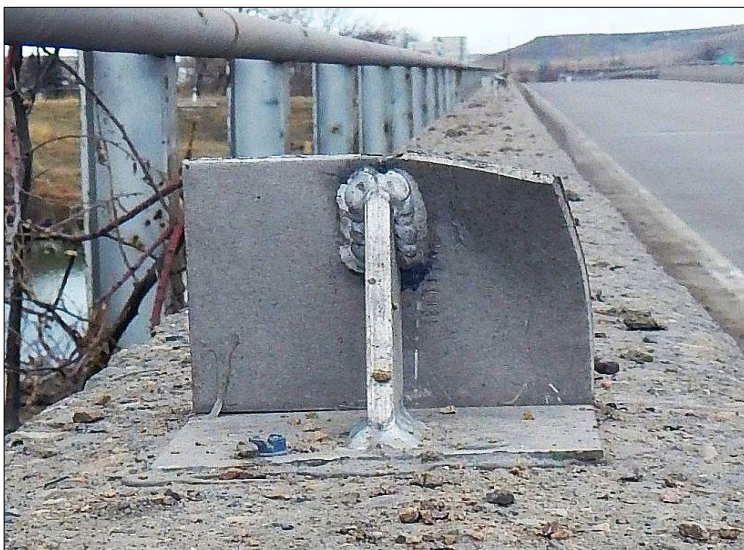
Damage Description and Timeline: March 20, 2020

↩ ↓ As previously stated on page 3, and as denoted on page 17; District staff reported **T4** damaged reflector units on the south end of Southbound Sun River bridge on March 20.

The units affected were **T4** 10 through 17; 4 glue-only units and 4 glue and screw units.

All documented units had consistently the same type of damage as seen in these images; a dog-eared bend in the upper-left top portion of the reflector.

District Maintenance staff has reported that no plowing activity occurred during the week of March 16, currently it is the consensus that this damage may have been caused by a wide load clipping the units.

Upon inspection, visually; the reflector base either glue-only or glue and mechanical attachment held tight after impact.

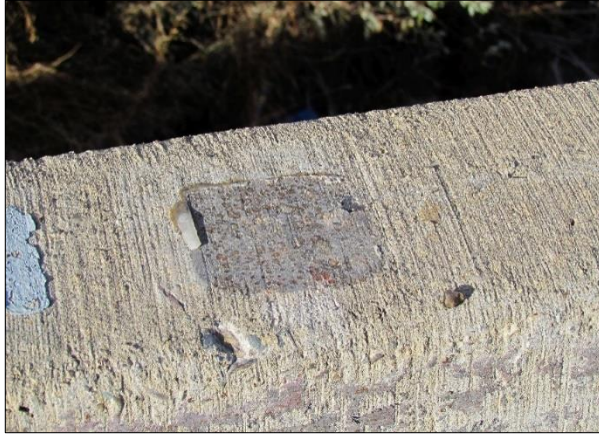
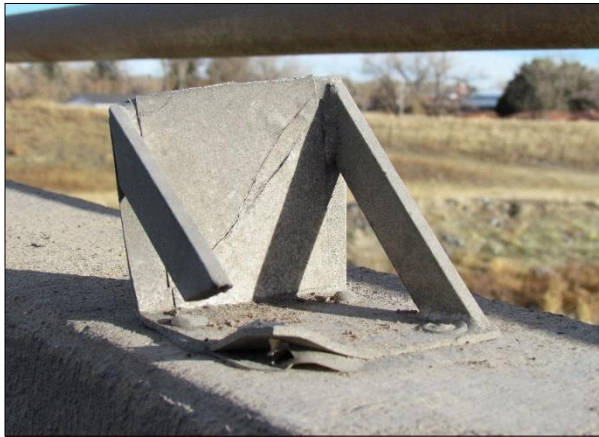
Damage Description and Timeline: November 19, 2020: Sun River Bridge NB

↩↓ Representative images of some of the damaged or missing **T3 units** on the NB Sun River Bridge.

The top image is a glue-only reflector (left passing lane) that was completely removed by impact.

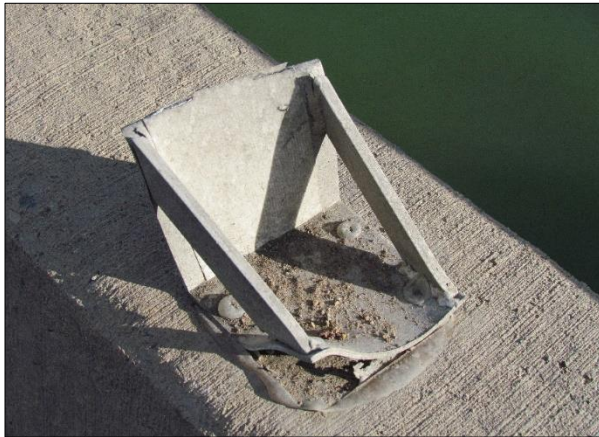
↩ Here is an impact (glue only attachment) that has broken the welded bracket.

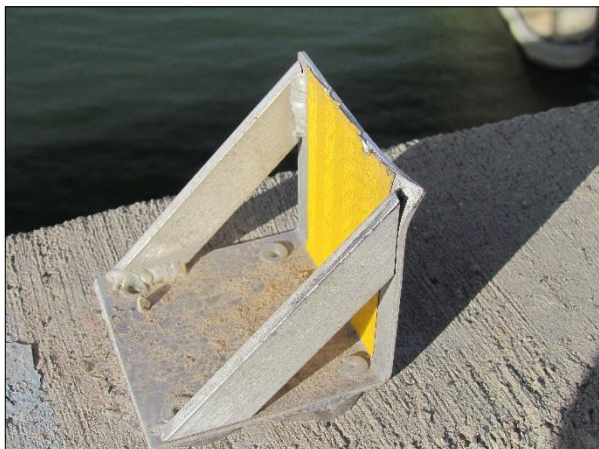
↩↓ These two units show minor impact which has either clipped the top of the reflector or pulled up at the base.

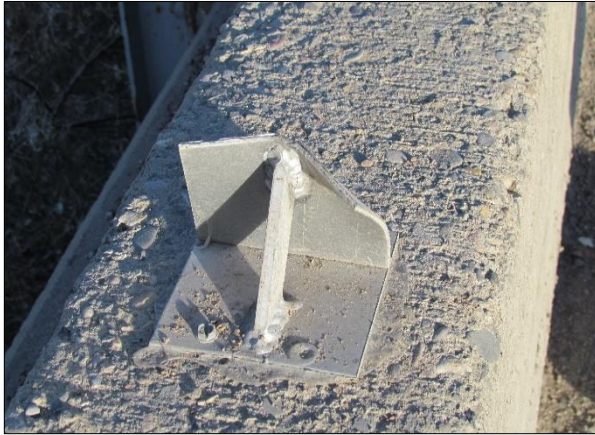
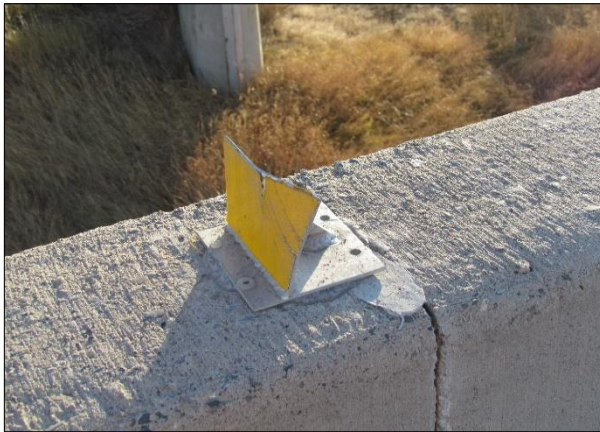
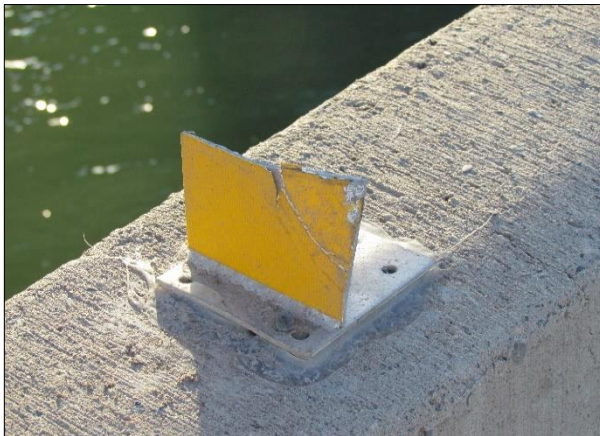
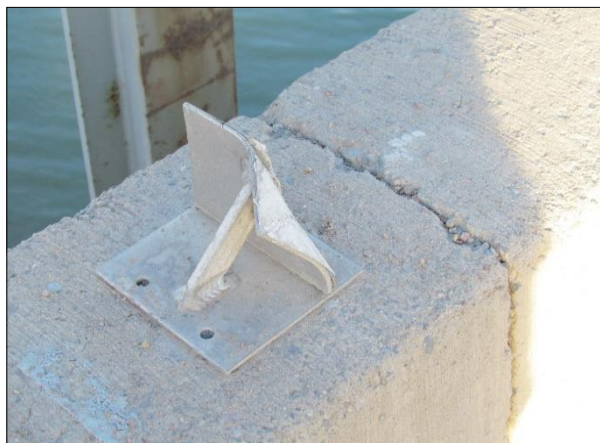
Damage Description and Timeline: November 19, 2020: Sun River Bridge SB

↙↓ Representative images of the type of damaged **T4 units** on the NB Sun River Bridge.

The top image is a glue-only reflector (left passing lane) bent on both sides.

As seen with the rest of the images, most of reflectors are impacted in the upper corner at the oncoming traffic side.

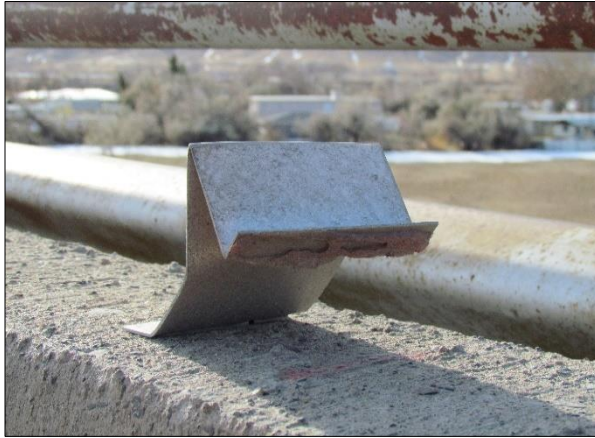
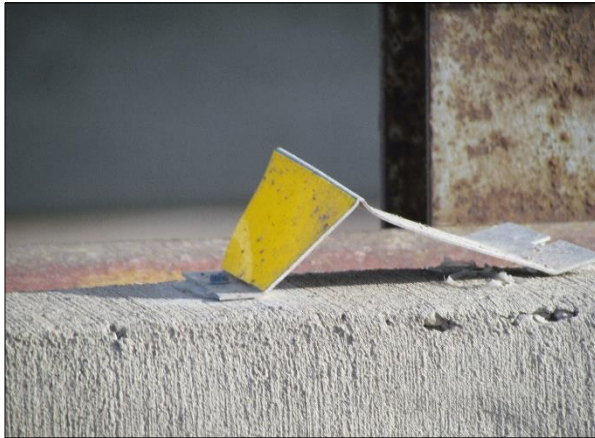
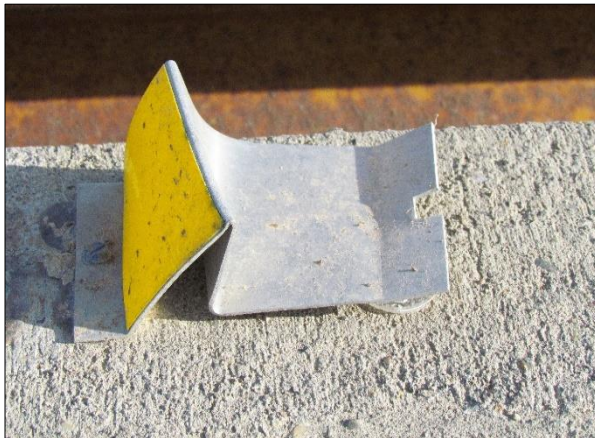
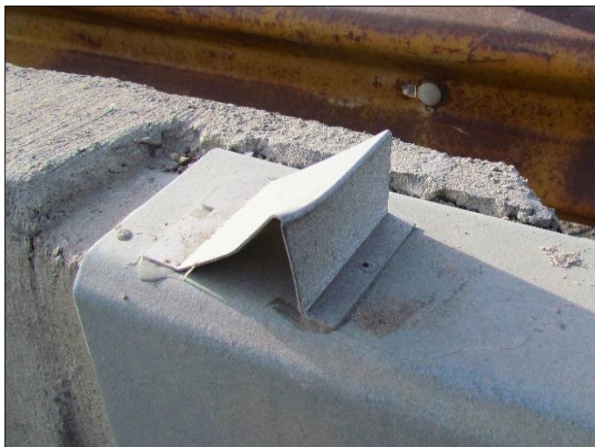
Damage Description and Timeline: November 19, 2020: Emerson Jct. Bridge SB

↙↓ Representative images of the type of damaged **T1 units** on the SB Emerson Jct. Bridge.

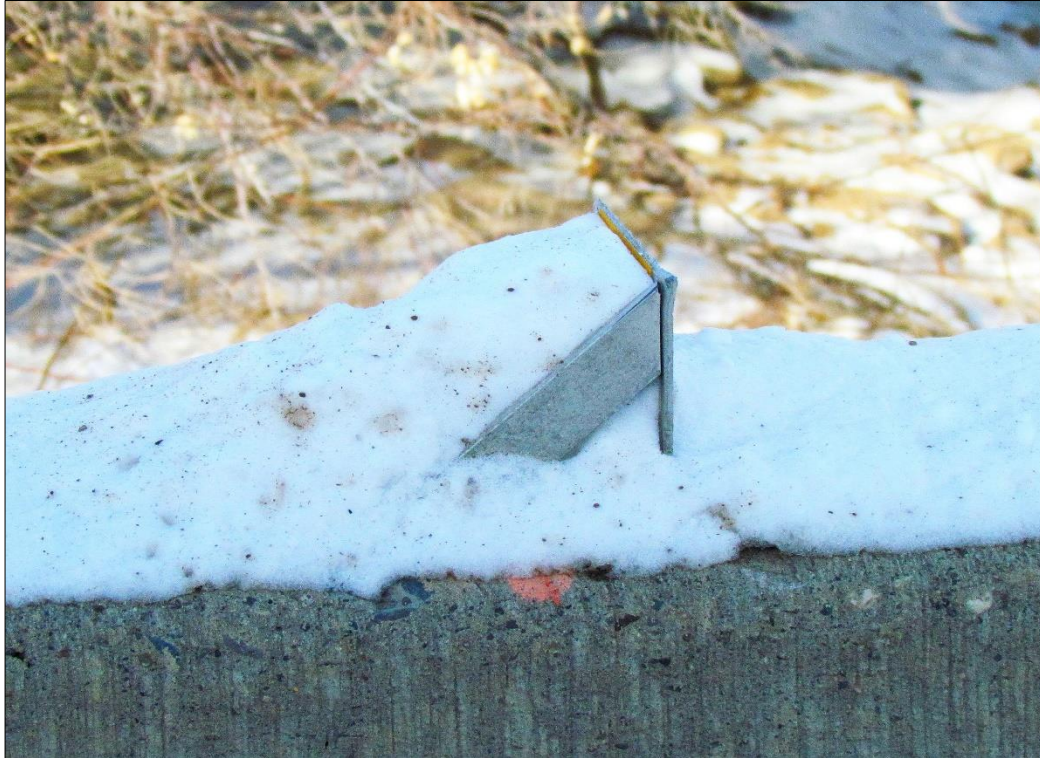
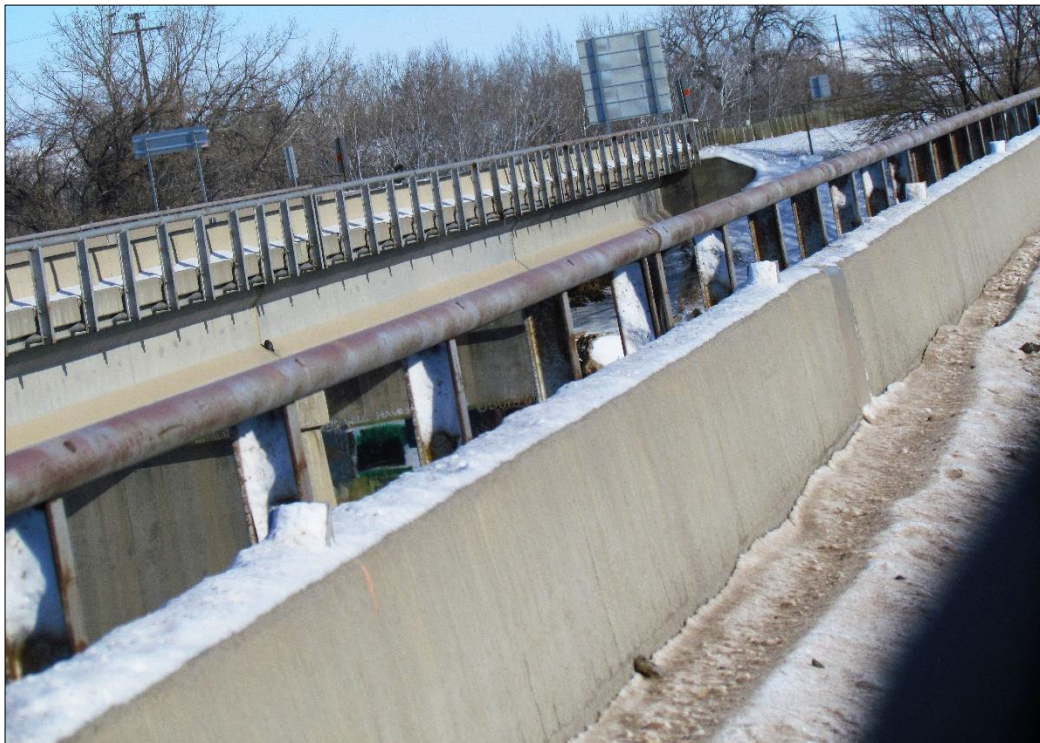
Supplemental: T3 Unit

↑↓ To date it has been observed that units T1, T2, and T4 shed accumulated snow and ice at *relatively* the same rate, apart from unit **T3** (Sun River Bridge-Northbound). Although structurally the most durable prototype being tested, its somewhat box design does create the environment to capture and hold snow and ice longer than the other units.
