EXPERIMENTAL PROJECTS CONSTRUCTION REPORT AND ANNUAL EVALUATION

CONTECH® A-2000 POLYVINYL CHLORIDE (PVC) PLASTIC PIPE

Project Name: Checkerboard - Martinsdale (CN 4803000)

Project Number: STPP 14-2(20)63

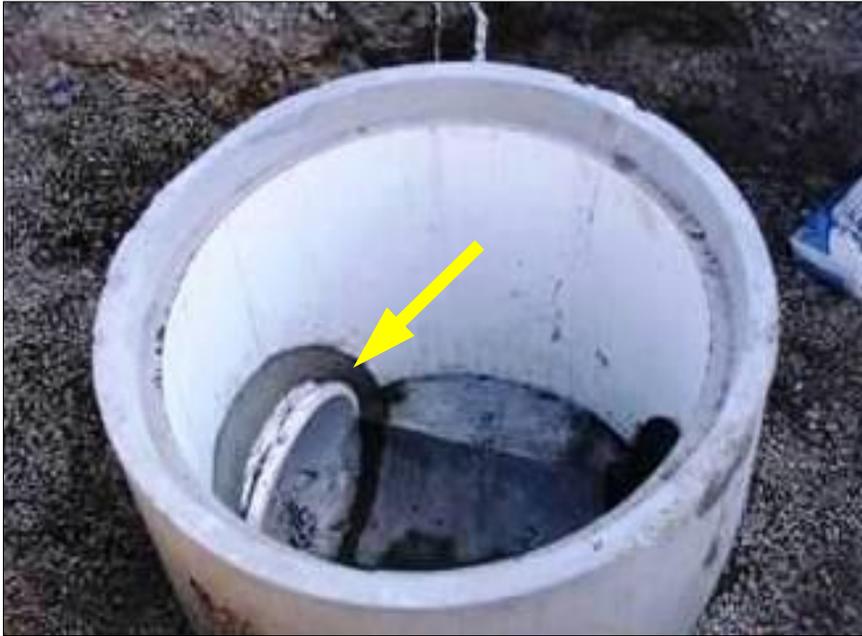
← Research was unable to capture the grouting procedure of the pipe to the manhole on-site.

This file photo is an example of what a completed grouting will look like (yellow arrow).

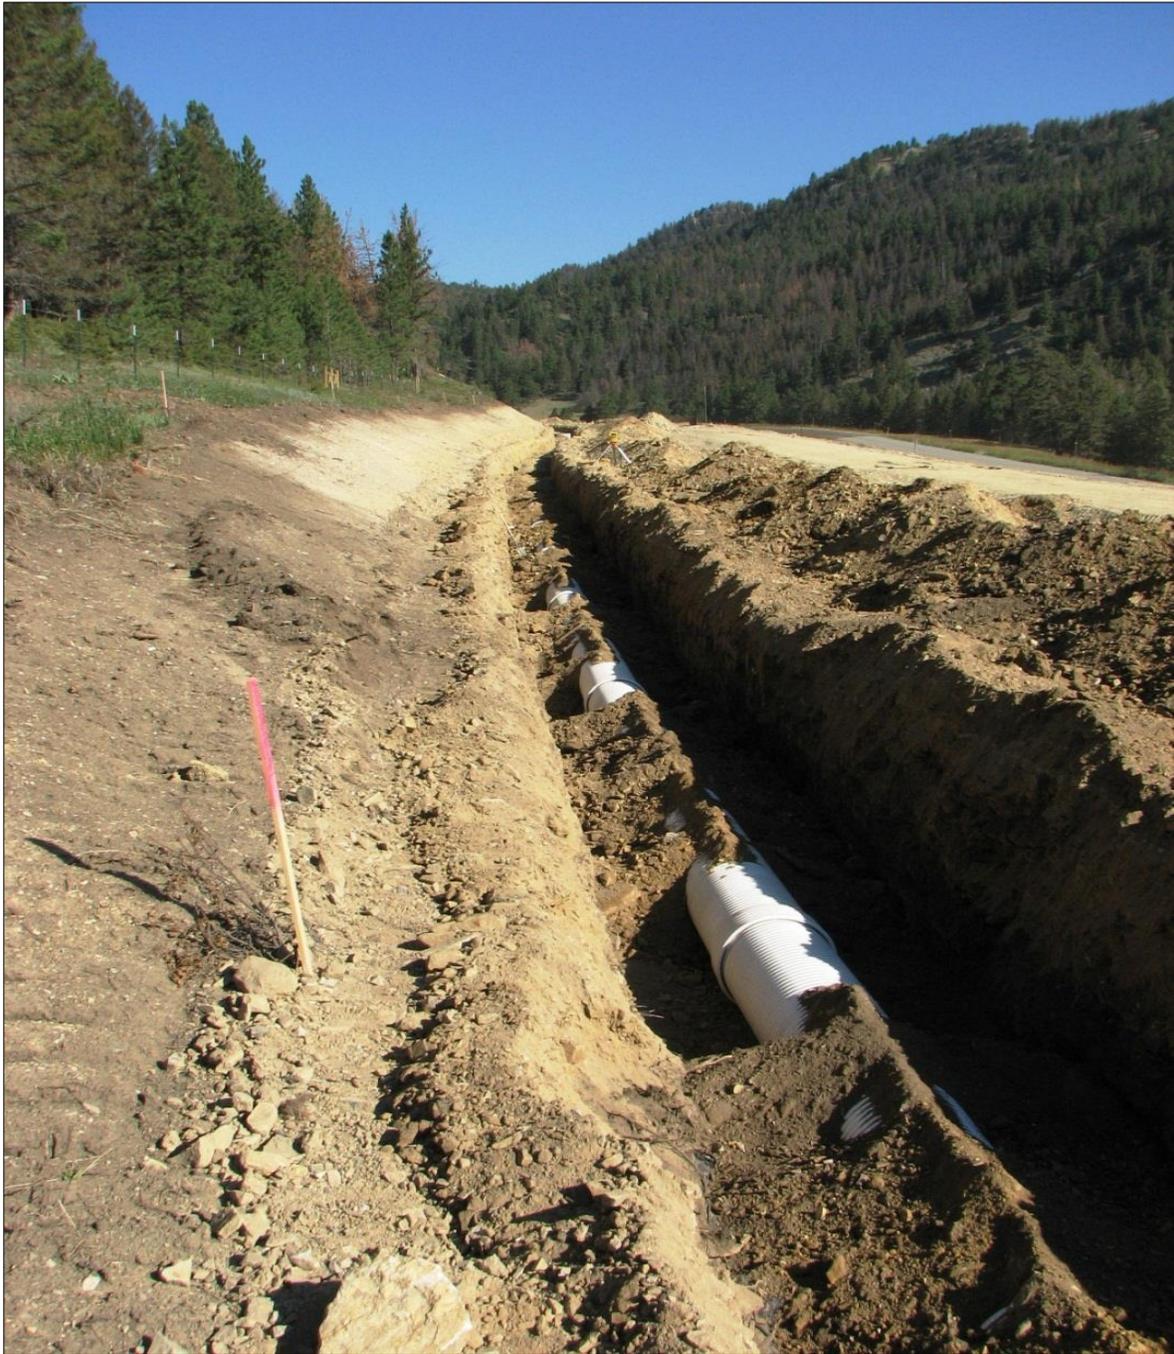
- ↑ As stated earlier in this report, the contractor was using the excavated trench material as fill for the A-2000 pipe. No bedding was prepared or haunching process observed during installation.

The Contech representative on-site was concerned that there may not be sufficient haunching to insure proper density and side wall support to prevent deflection of the PVC pipe once the fill and compaction was complete.

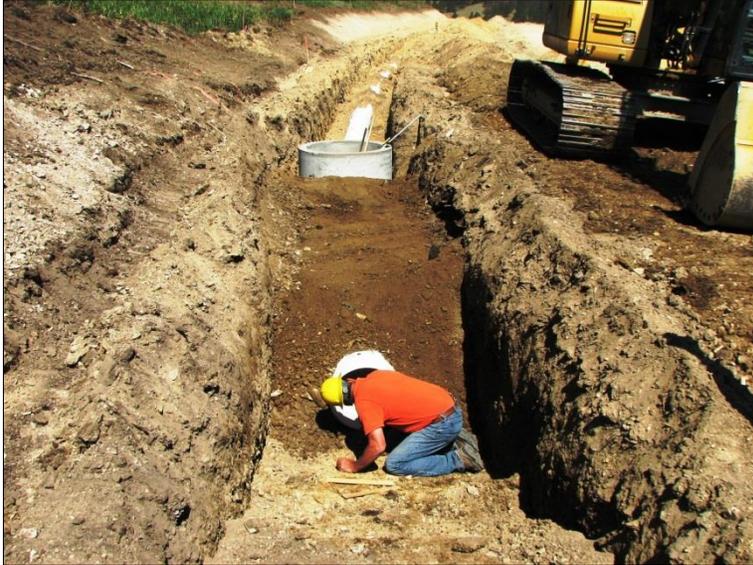
← In order to determine if using the trenched material as fill, and with the contractors planned method of compaction which may affect the integrity of the pipe, the Contech representative asked if a 20' section of the trench be filled as it would for the entire project to determine if any deflection may be observed. Here the contractor has placed the fill and internal measurements are taken prior to compaction.

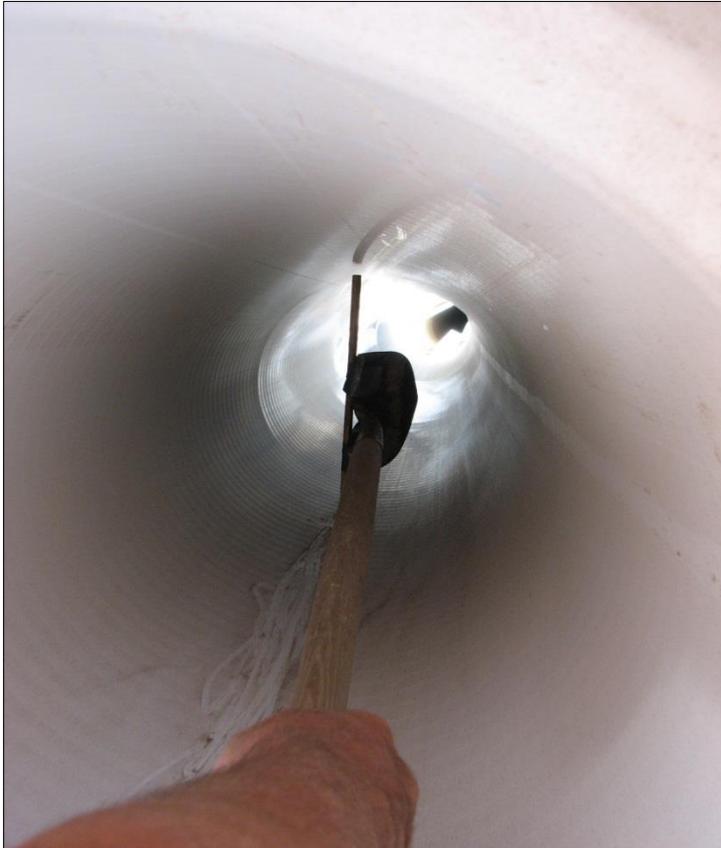
In this image the survey stick (affixed to the blade of a shovel) which was measured and cut to detect deflection up to 1.5% (approximately .27"/7mm) of the inside diameter of 18"; is run through the pipe to a depth of approximately 7 ft. No visual indication of deflection was observed.

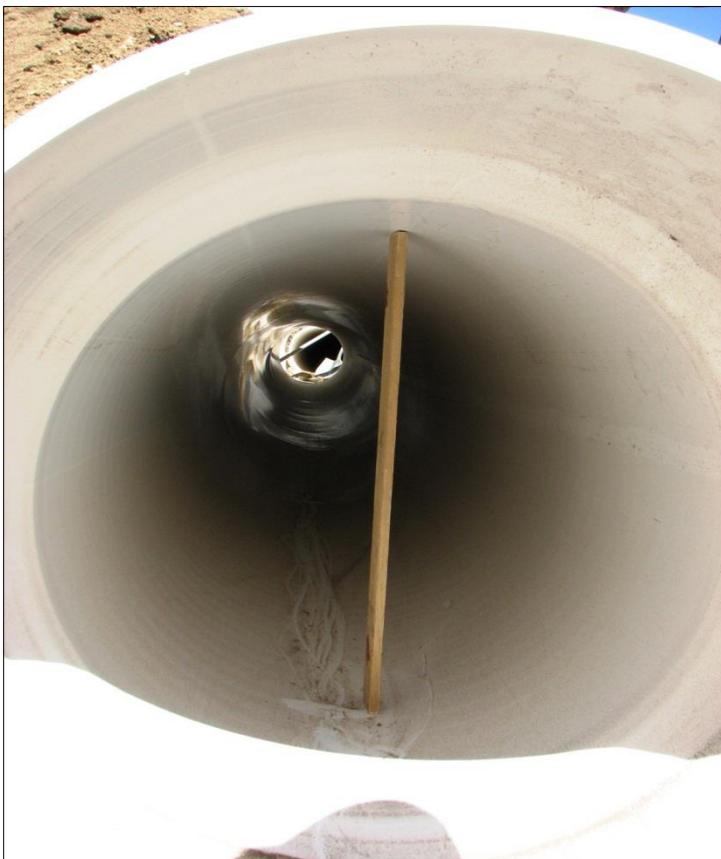
← This section of survey stick was cut to approximate 18" and run through the pipe in the same manner as indicated in the previous image. No visual deflection was observed.

Note: This was a very simplistic method to test for deflection and representative of a very small fraction of the entire length of the pipe layout and may not be indicative of current or long-term performance of the pipe in this application.

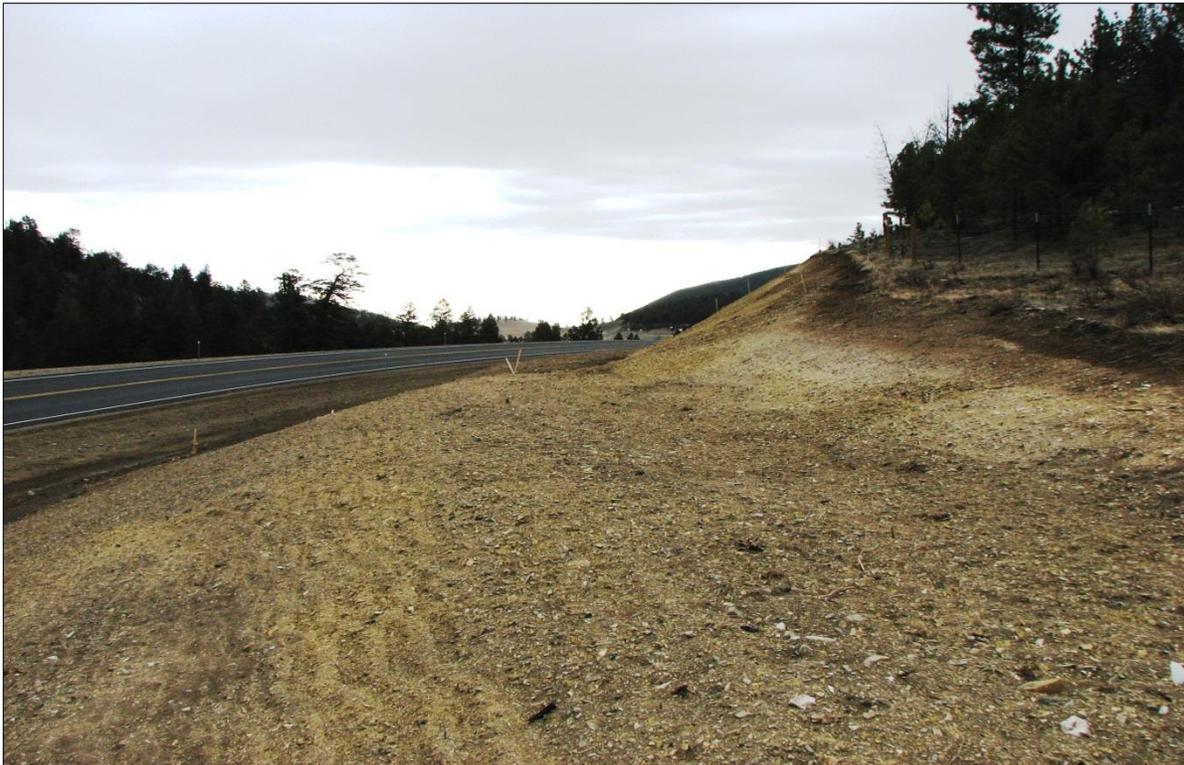
A site inspection of the 18" (46 cm) A-2000 was conducted on April 2, 2013 by research staff. A walk through of the approximately 2084 ft. length section showed no evidence of visual disturbance on the surface or surrounding area of the irrigation line or the manhole connections. Page 18 of this report has representative images of the April 2013 inspection.

↑ View east: Start of approximate location at the west end of the 18" A-2000.

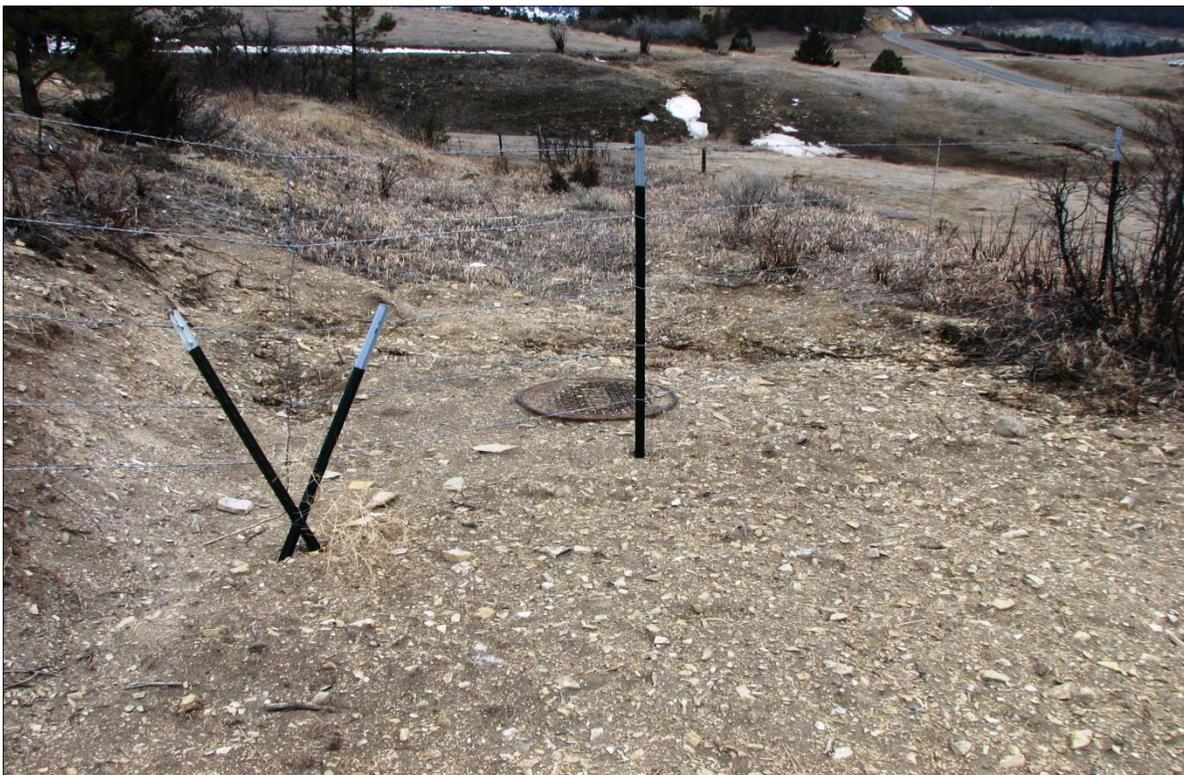
↓ View west: Manhole connection at the existing 15" PVC and 18" A-2000 pipes.

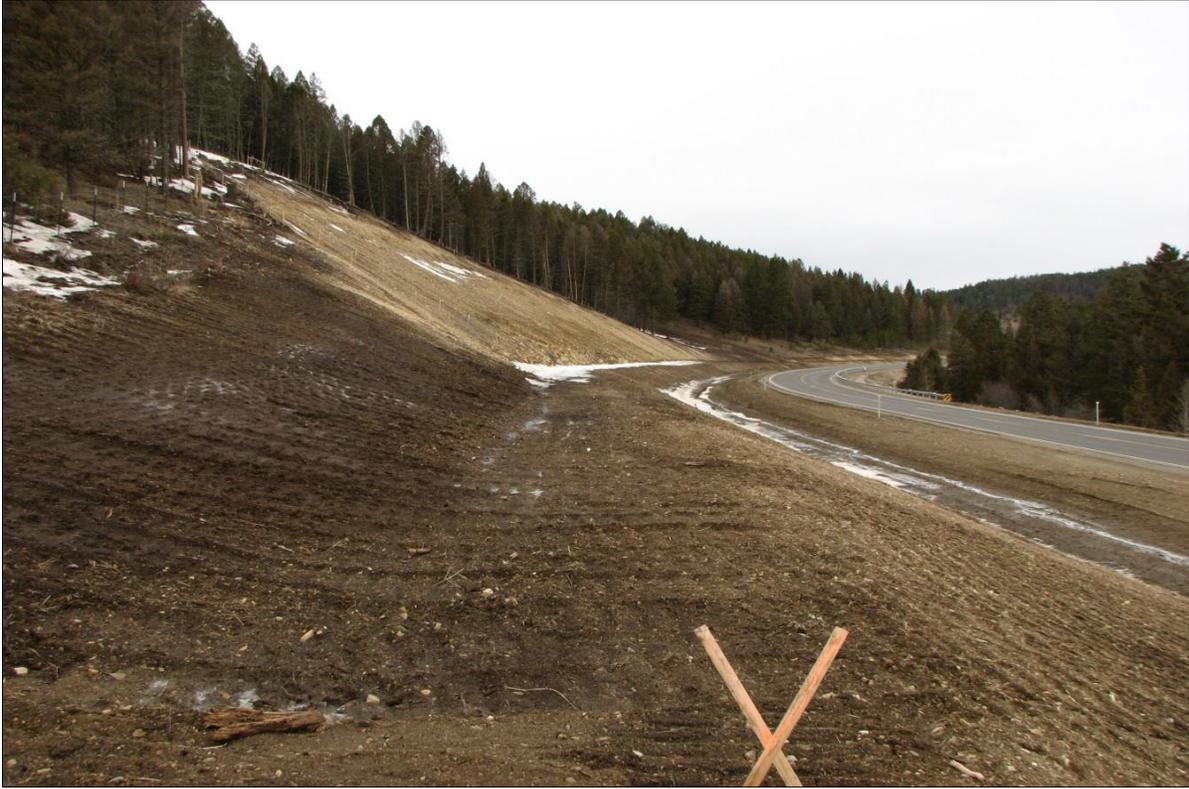
↑ View west: Start of approximate location at the east end of the 18" A-2000.

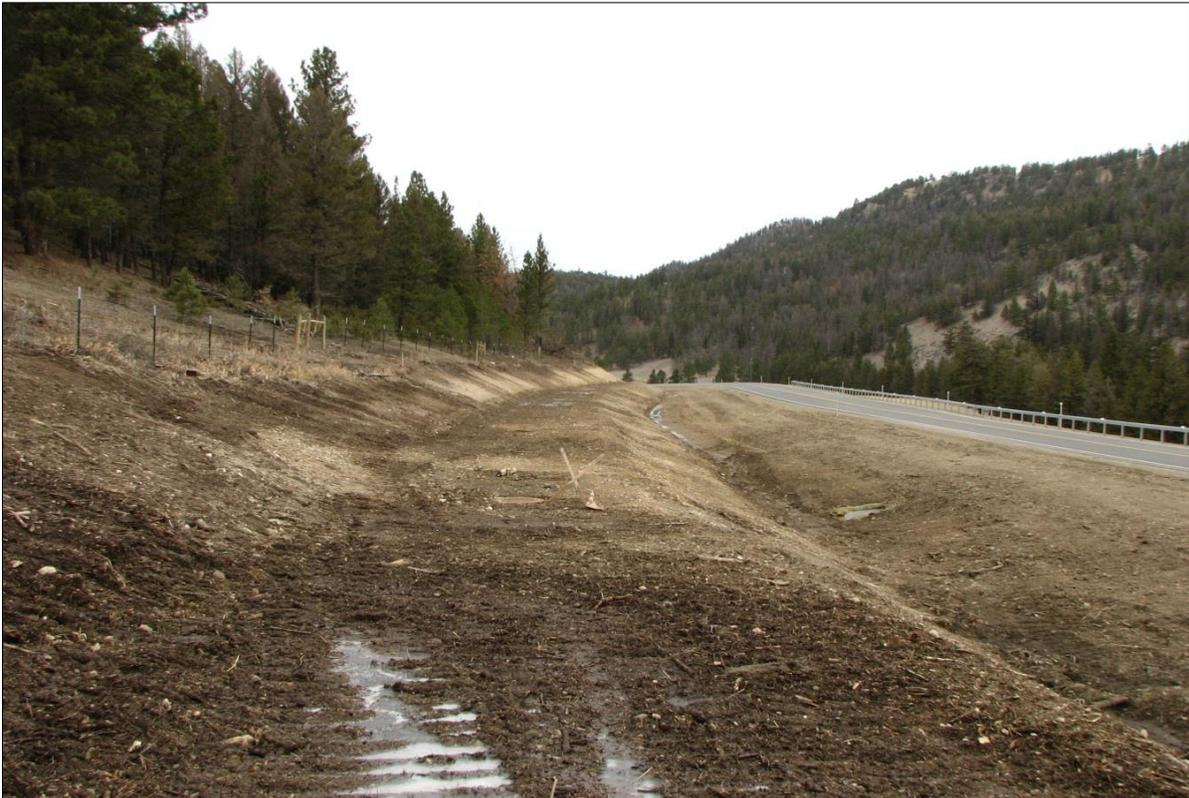
↓ View west: Midway point of the 18" A-2000 section.

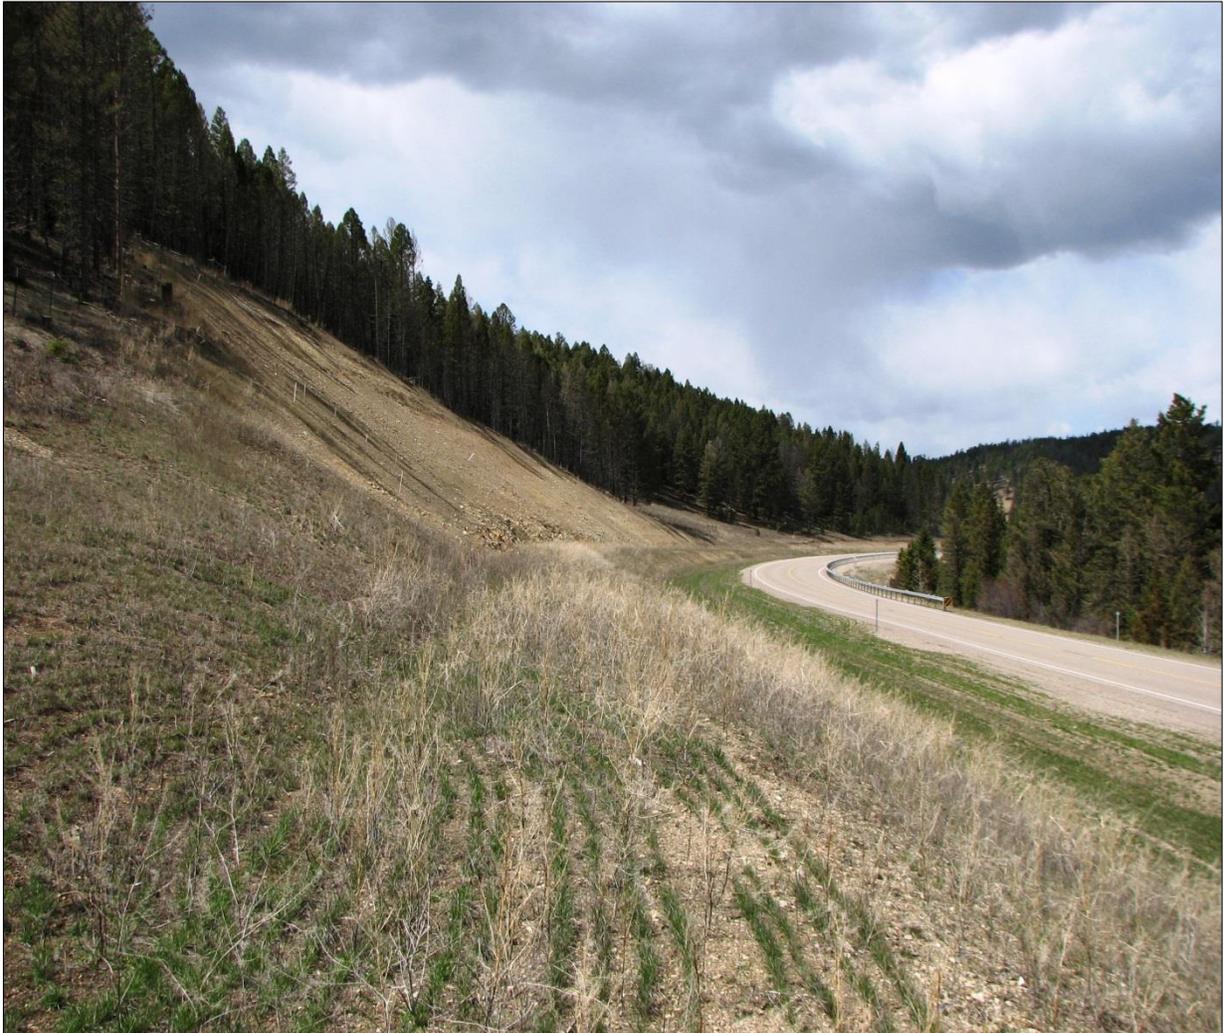
A site inspection of the 18" (46 cm) A-2000 was conducted on May 15, 2014 by research staff. A walk through of the approximately 2084 ft. length section showed no evidence of visual disturbance on the surface or surrounding area of the irrigation line or the manhole connections. Page 20 of this report has representative image of the 2014 inspection. District staff has reported no incident involving pipe performance since installation.

↑ View west: Start of approximate location at the east end of the 18" A-2000.

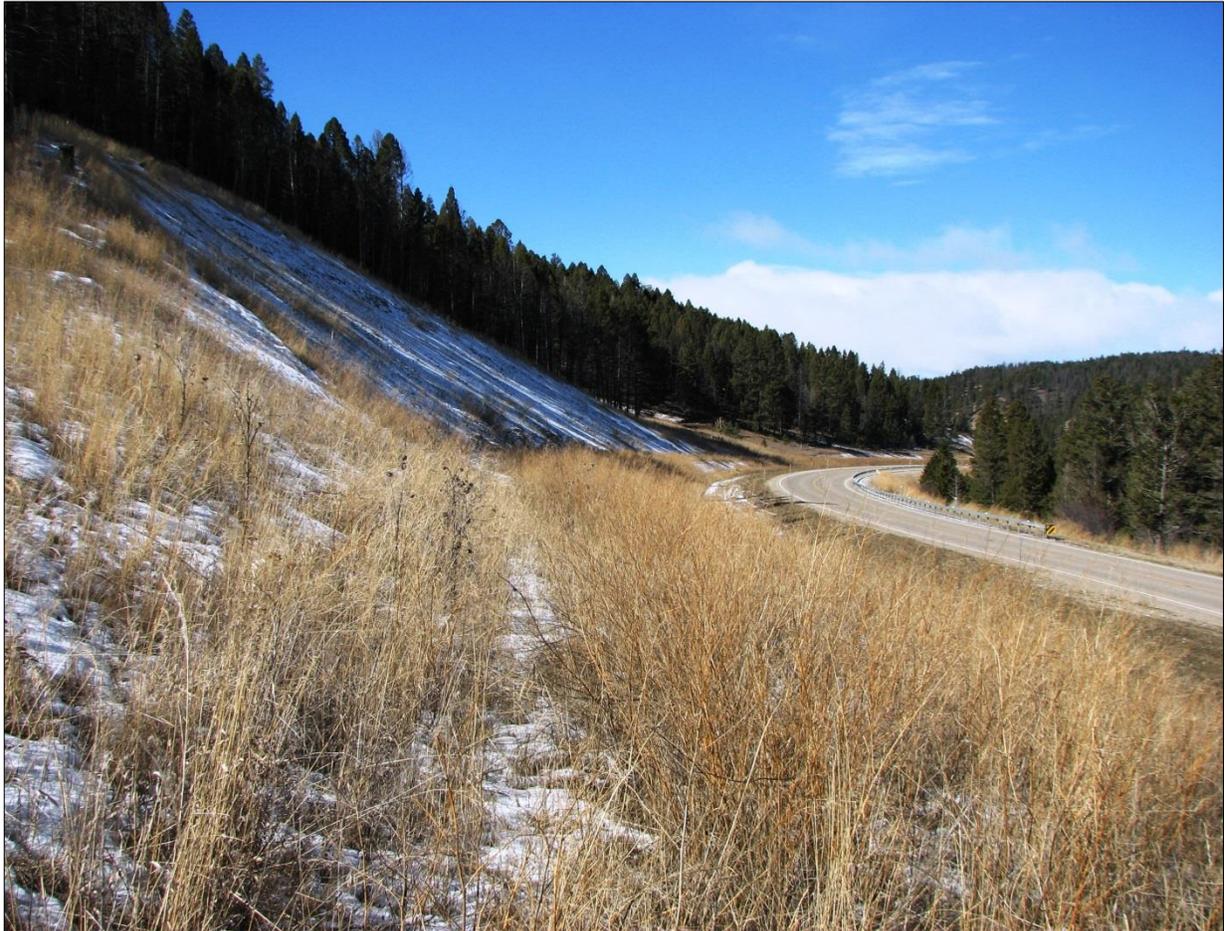
Same report as stated in May 2014. Page 21 of this report has representative image of the 2015 inspection. District staff has reported no incident involving pipe performance since installation.

↑ View west: Start of approximate location at the east end of the 18" A-2000.
