EXPERIMENTAL PROJECT CONSTRUCTION REPORT AND FINAL EVALUATION

CONTECH RIBBED ALUMINUM BOX CULVERT (ABC)

Project Name: Jct. US 2 – North Belknap Crossing

Experimental Project No. MT-12-01

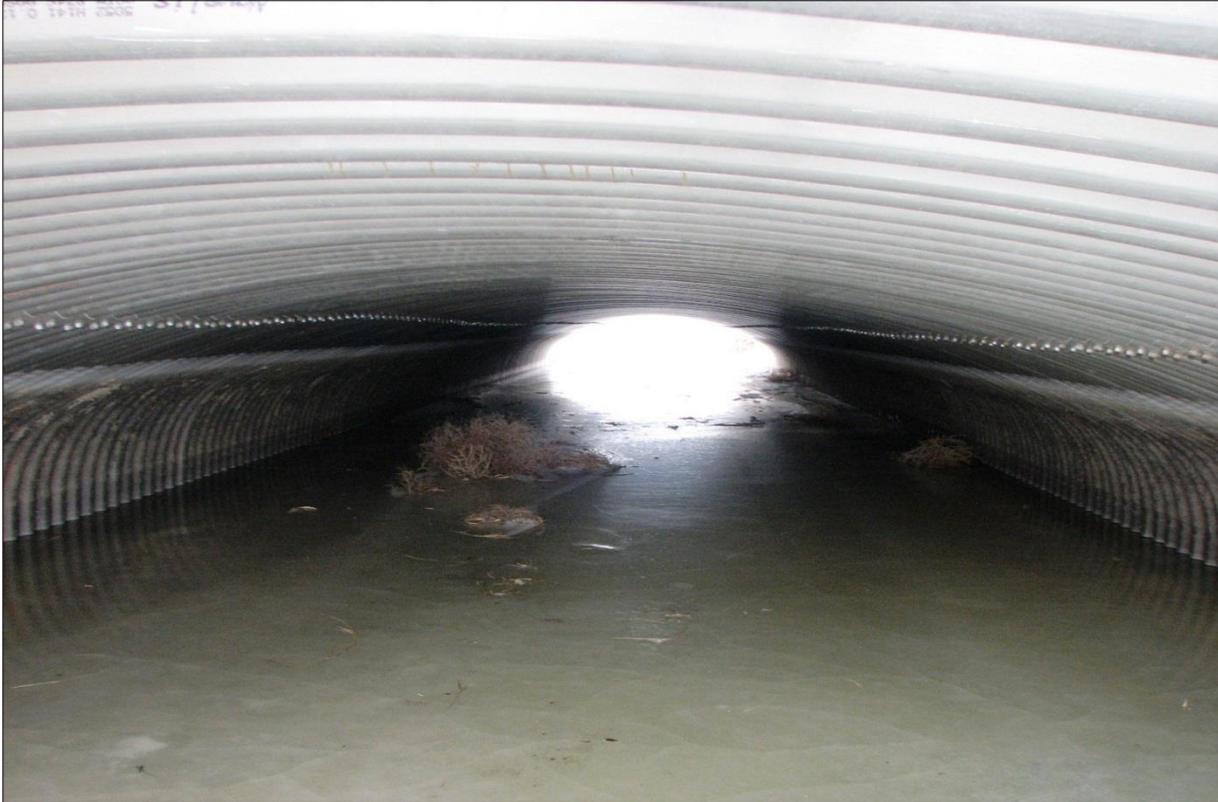
↑ Interior view of the culvert on west end looking east.

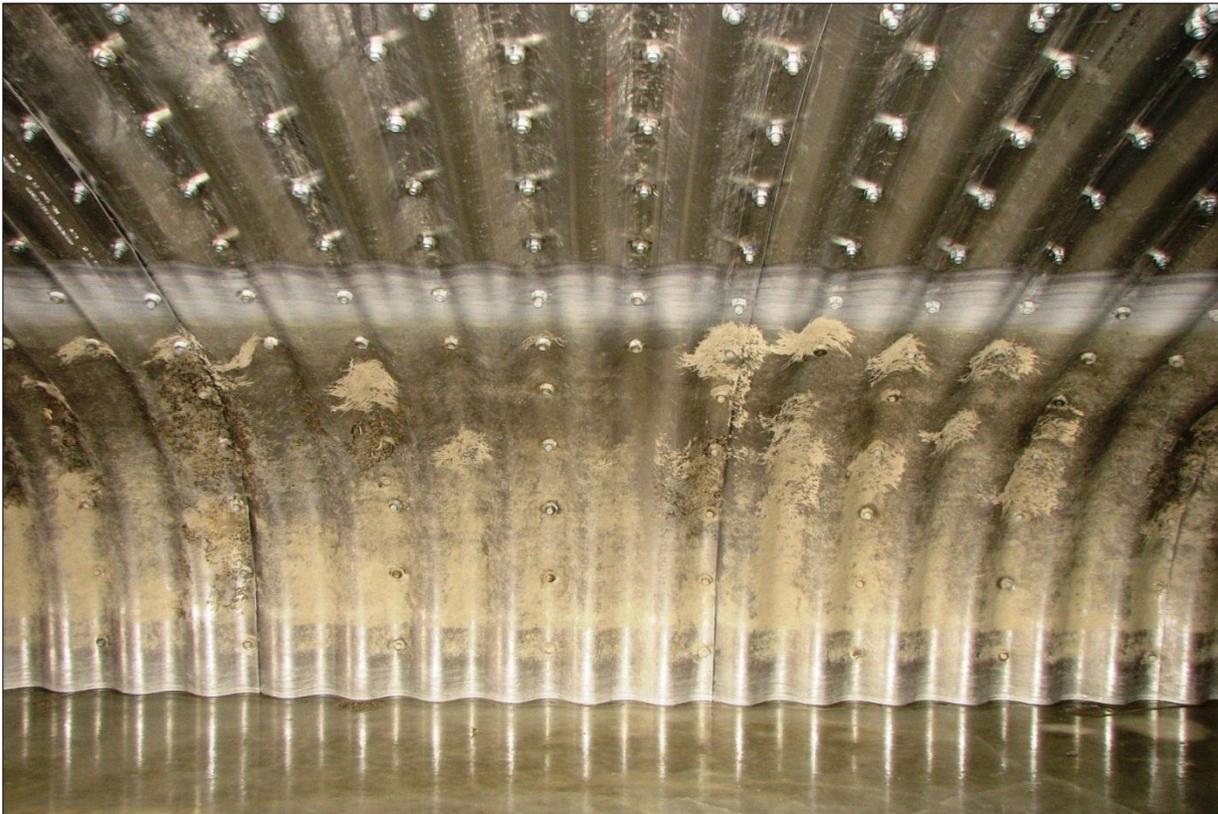
↓ View of interior side wall. Water level stain is clearly seen near top of culvert.

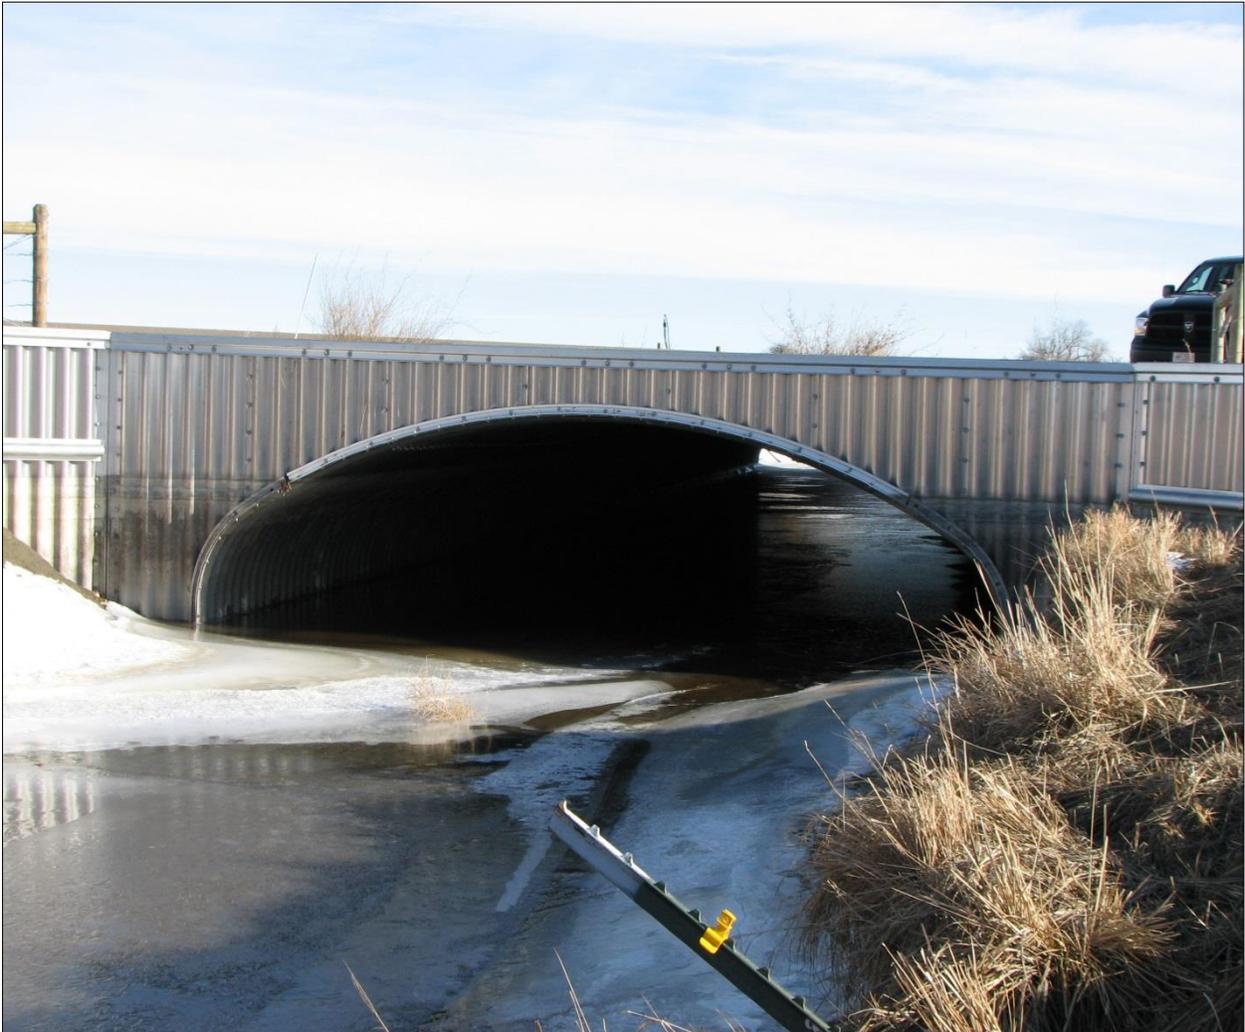
↑ View inlet; west side of culvert.

Due to the thinness of the ice a walk-in interior inspection was not possible. However the researcher was able to gain bank access (inlet and outlet) to see within the culvert to ascertain if any distress (bending or buckling of the shell plate) was noticeable.

No issues were detected in this inspection, all components were visually intact.

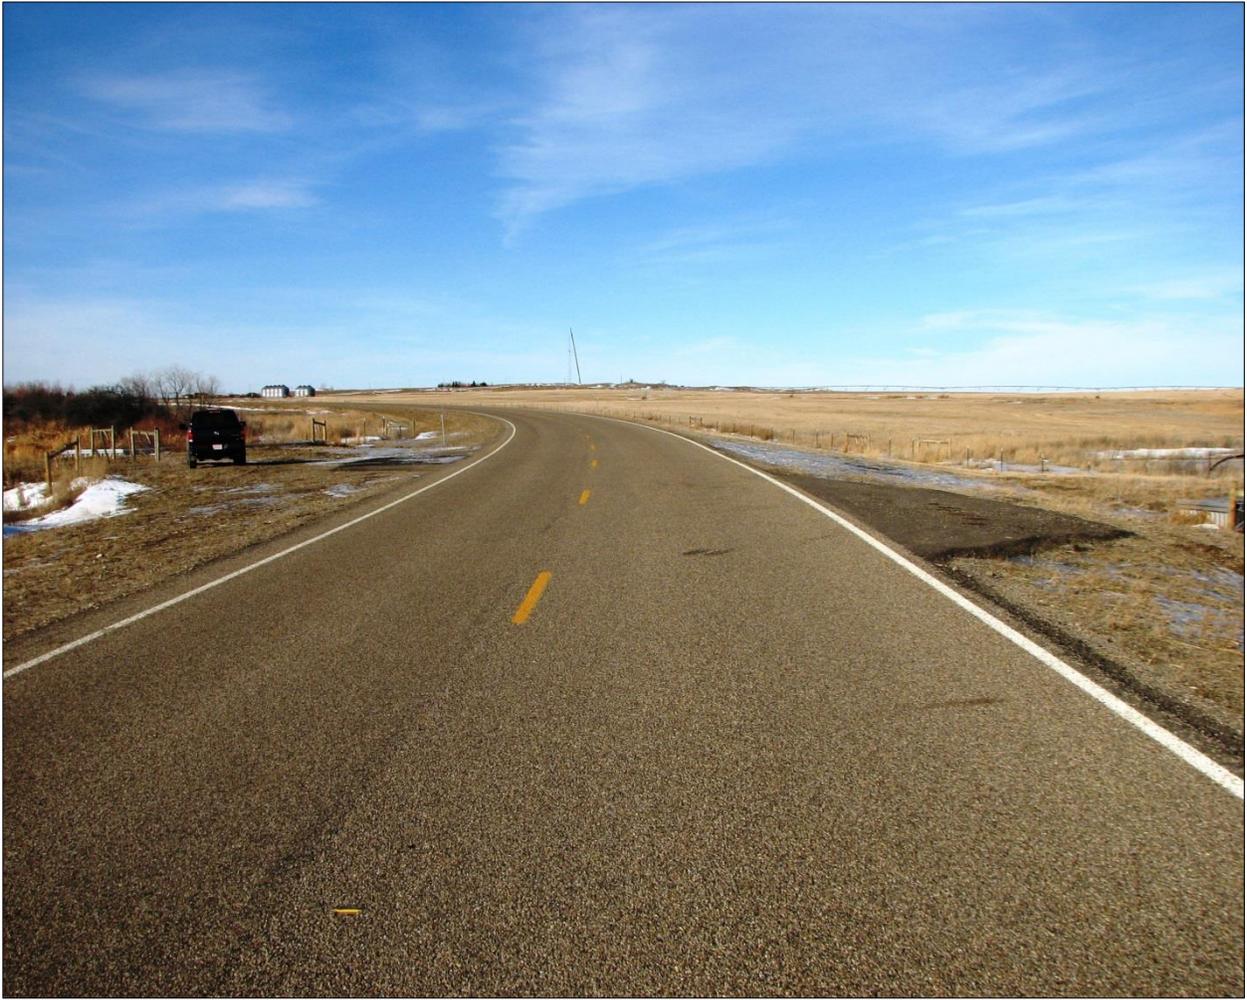
↑ View north. No issues with the roadbed were observed.

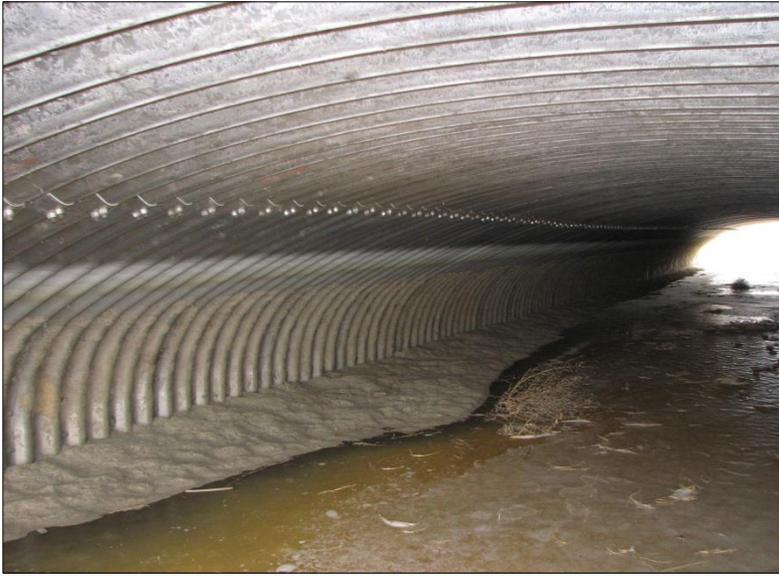
← Interior view of culvert at inlet.

The light colored material at the side wall of the culvert is accumulated sediment.

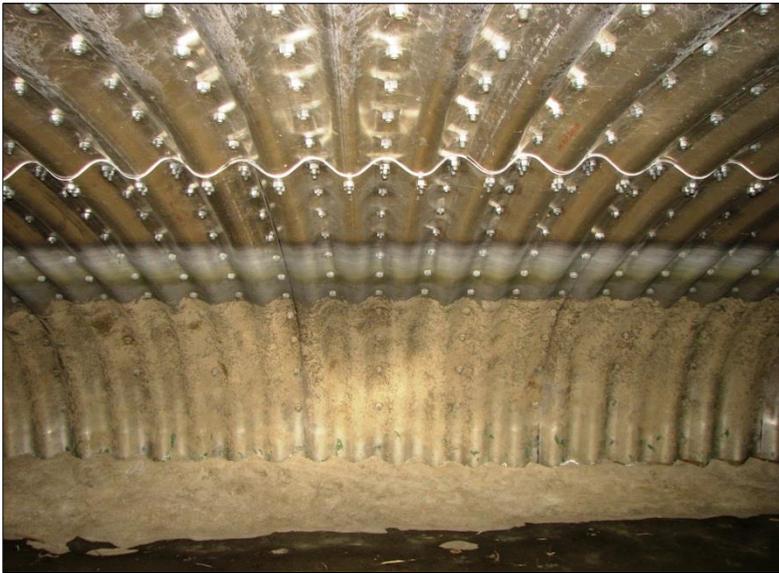
← View of interior sidewall.

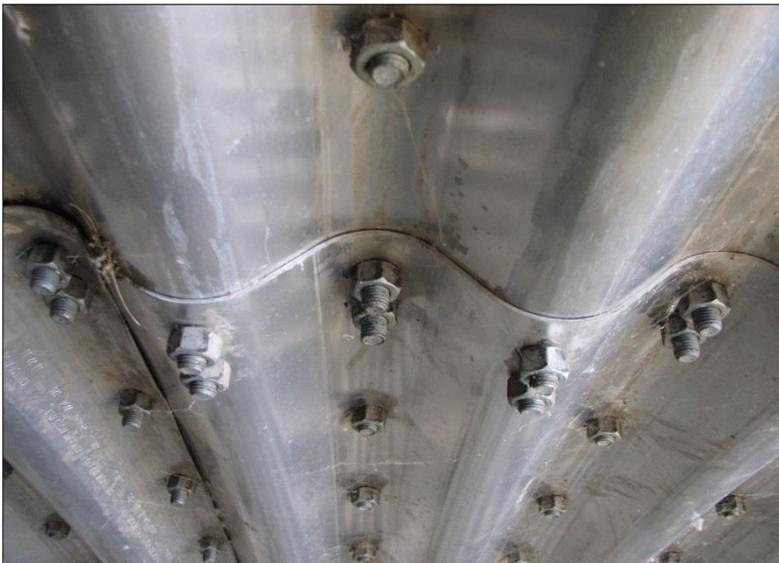
← Close up of plate/rib connections.

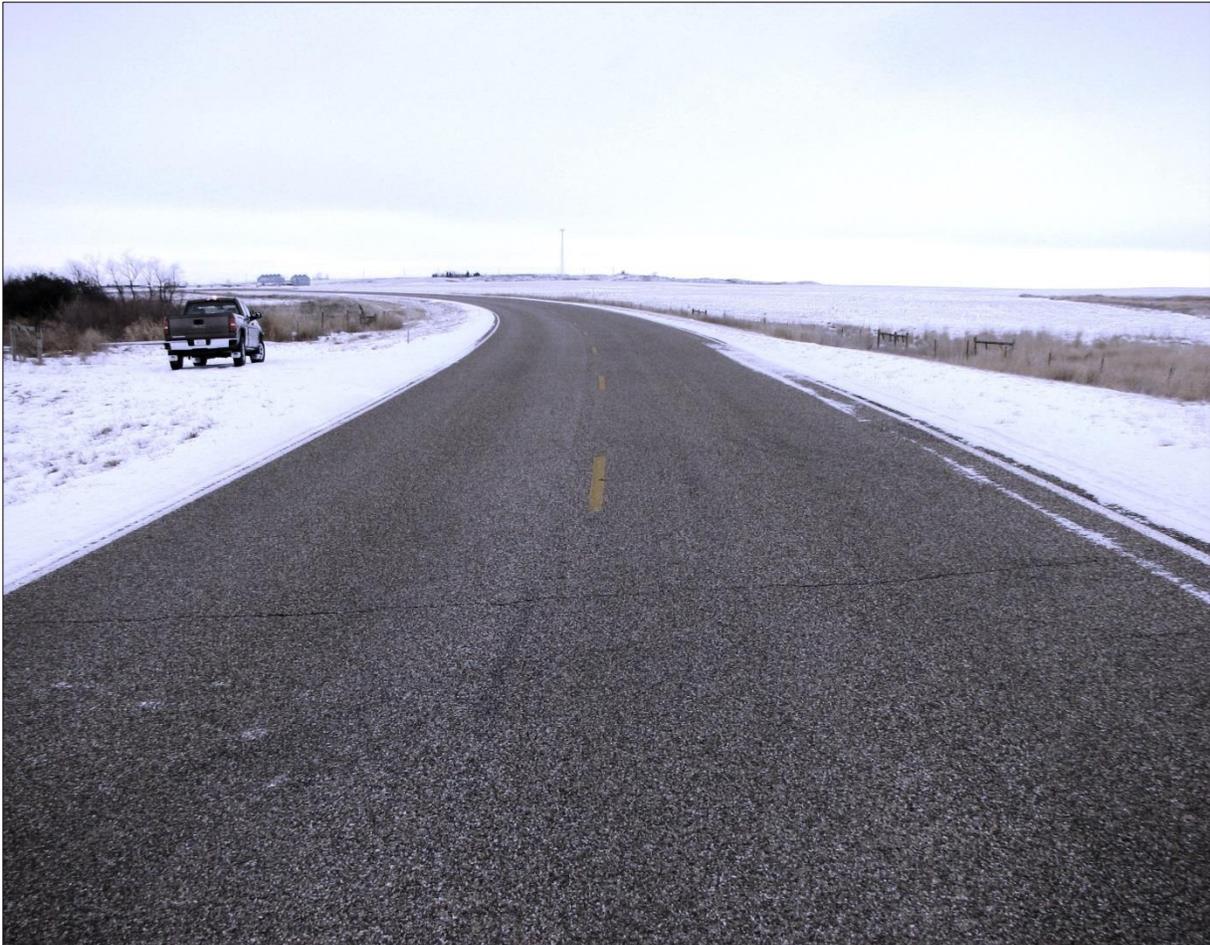
↑ View north. No issues with the roadbed were observed.

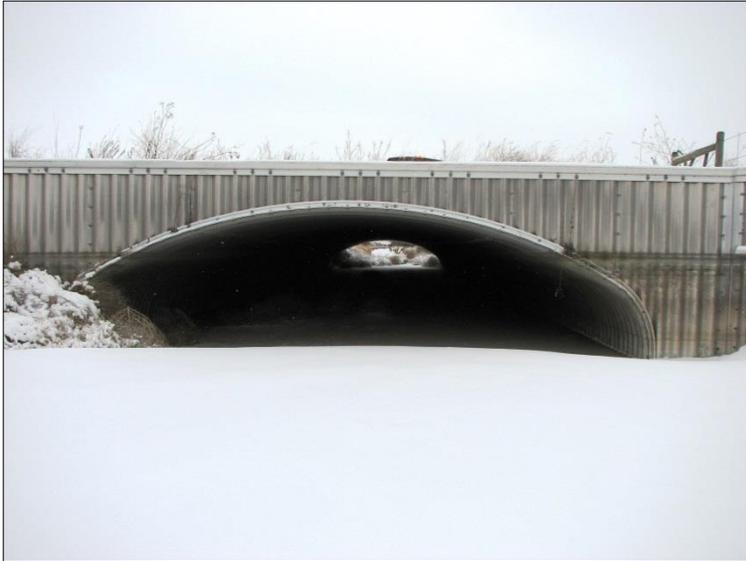
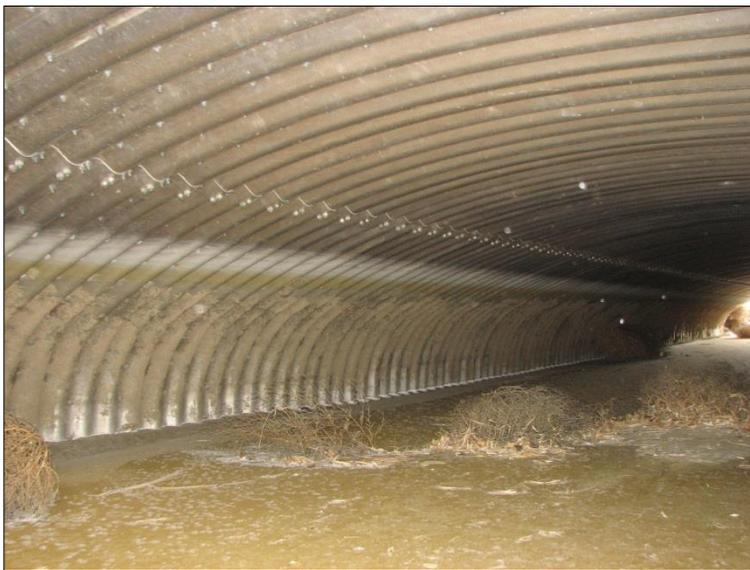
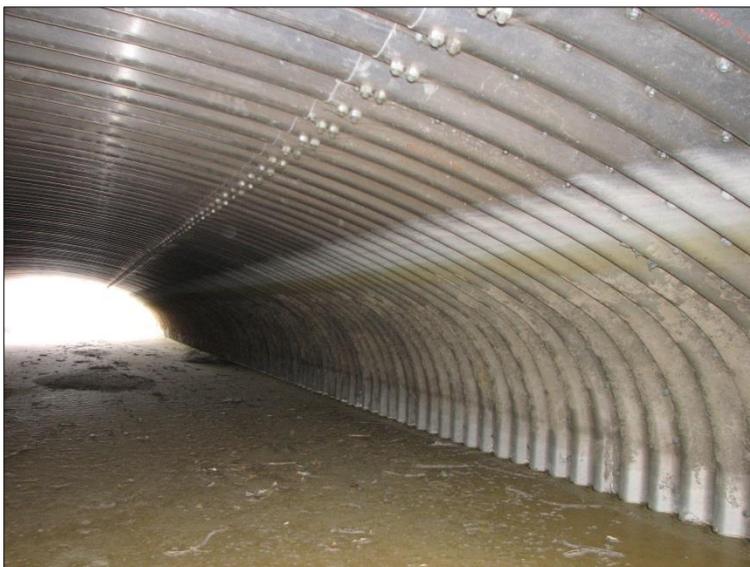
↔ As stated earlier in the report, the ABC unit is in the same condition as reported in 2016. No performance issues to convey.

These images represent the general condition of the culvert.

The roadway over the culvert had no visible distress.

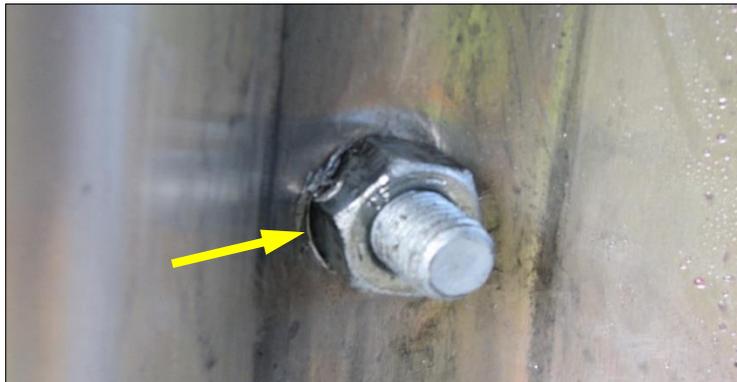
← Over torquing the nut has punched through the soft skin of aluminum shell plate.

← Those nuts which did pierce or deform the skin were fitted with washers.

Note that this condition was very minor in occurrence. Once the Contractor and crew were aware of the over-torquing problem, they quickly rectified the situation by applying the correct torque application.

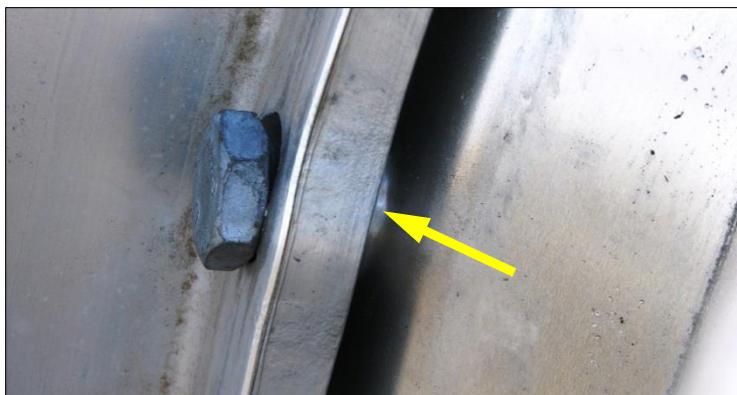
← Here you can see the aluminum skin extruding due the excess torque of the nut (exterior view of shell plate to rib attachment).
