**EVALUATION OF AN AUTOMATED FIXED ANTI-ICING DEVICE FOR USE ON
BILLINGS DISTRICT BRIDGE DECK**

EVALUATION REPORT

Project name: West Laurel Interchange

Project Number: IM STPHS 90-8(152)433

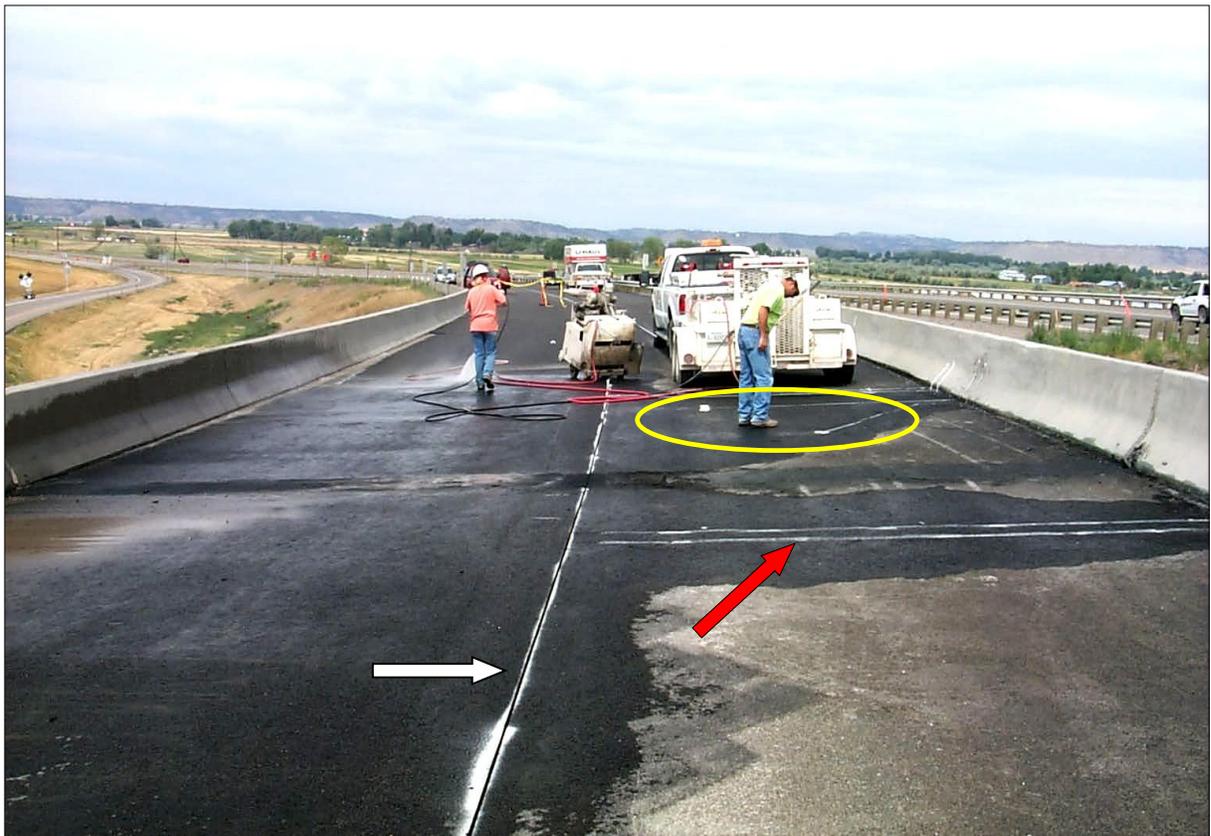
View looking west on eastbound deck: Technicians have delineated where the piping, spray heads, and sensors will be located as seen by the white paint. In this image they have just completed routing out the asphalt cement (AC) pavement to install the hardware. The AC millings are being washed out of the routed channels.

The white arrow shows where the pressure tubing and spray nozzles will be located on the centerline. The red arrow shows the supply product lines. The yellow circle area is where the sensors will be installed.

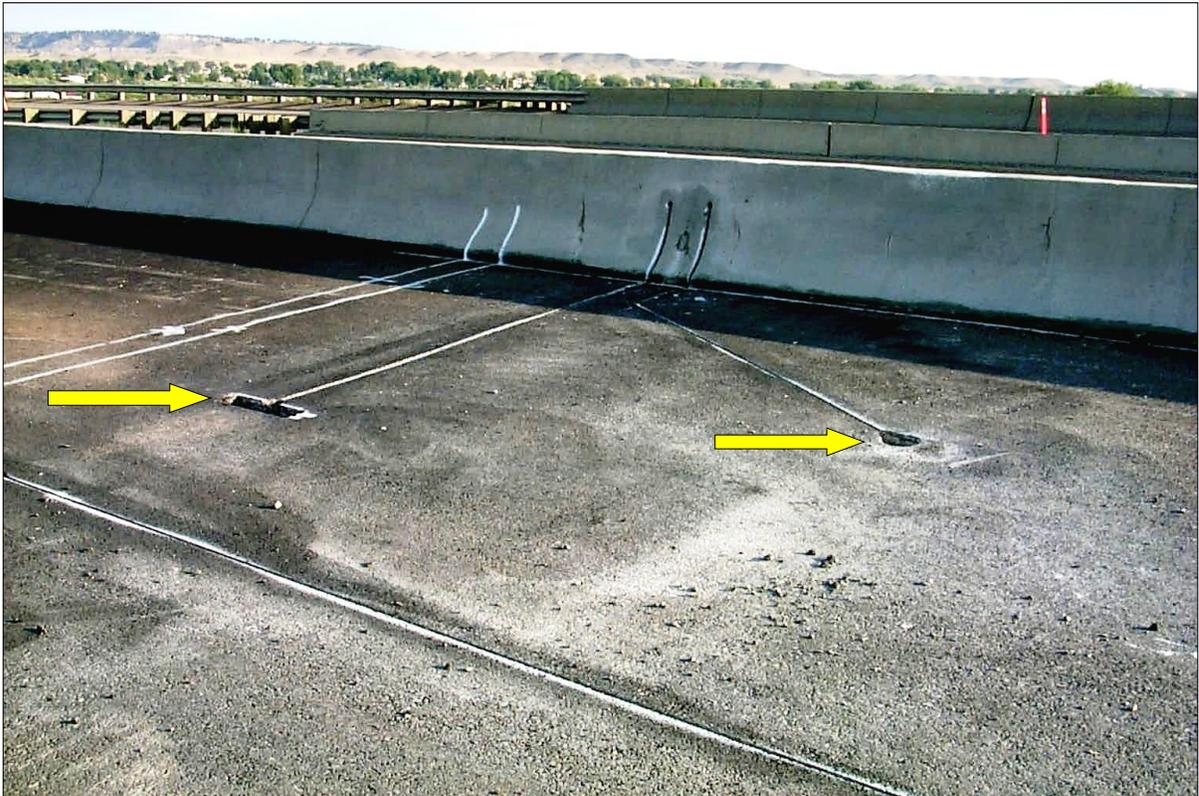
↑ Here is a closer view of the sensor locations prior to installation (yellow arrows).

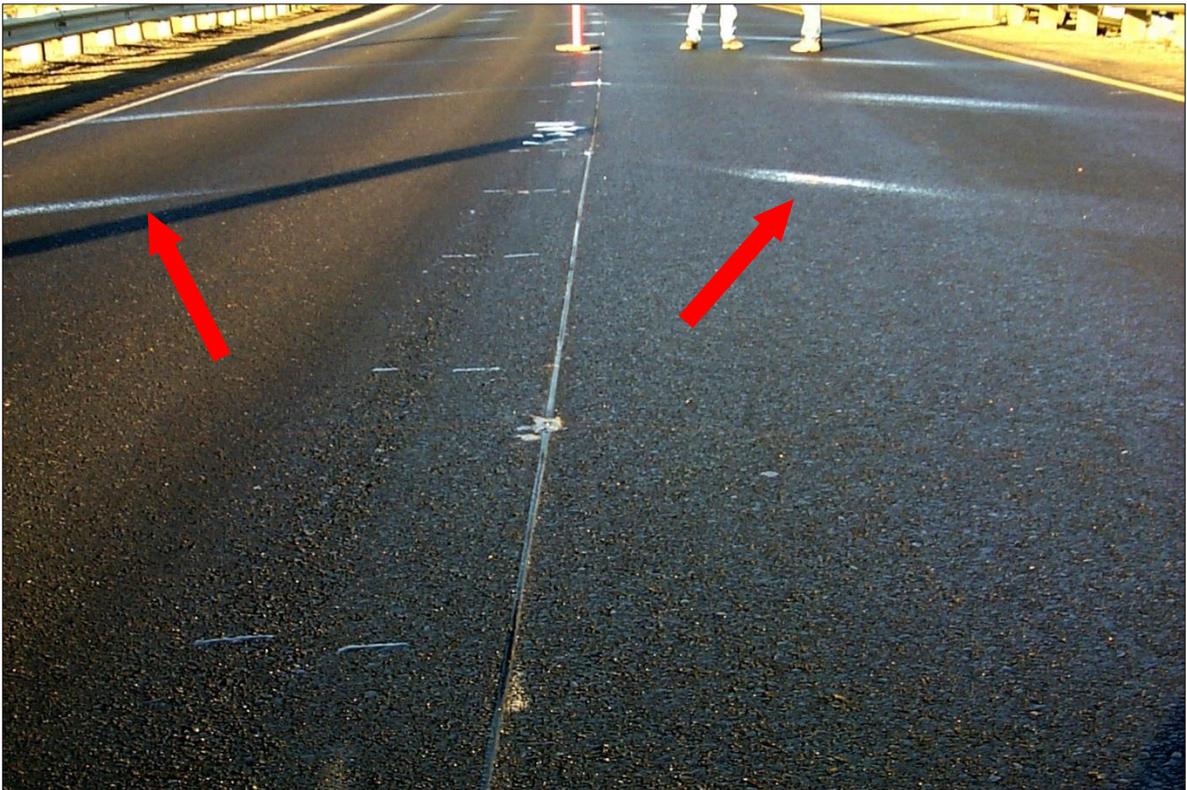
↑ The spray nozzles and piping have been cemented and cured. This also shows an initial test of the system as you can see the wet areas on the pavement (red arrows).

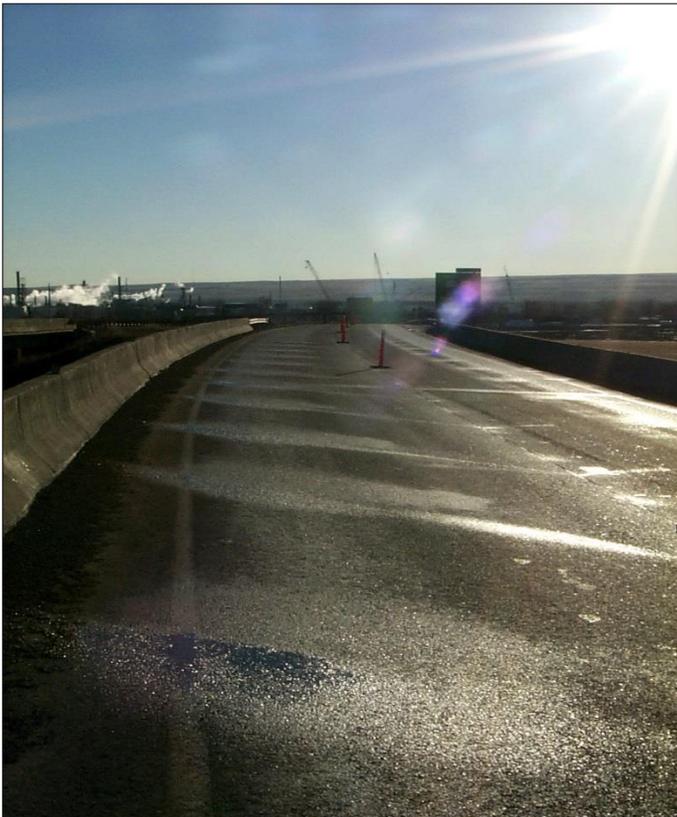
← This image is the east view over the span during the FAST system spray test. As stated earlier, a limited amount of chloride is applied. Where other anti-icing systems depend on larger quantities of product to cover the road surface to mitigate the formation of ice, the FAST system relies on the pick-up action of vehicle tires to assist in transmission of the anti-icing chlorides.

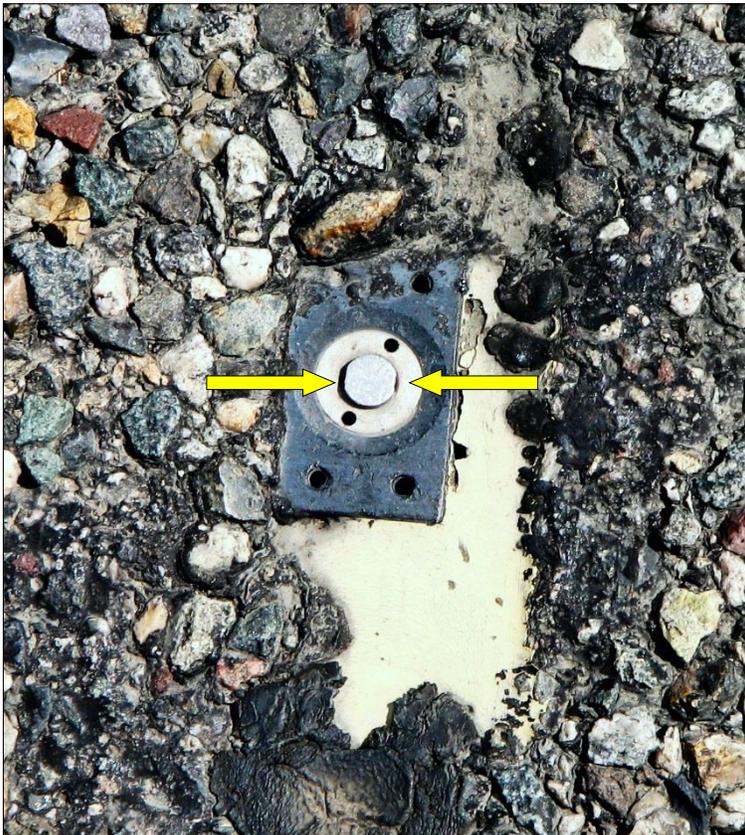
← Condition of Micro-spray nozzle after seal & cover (chip seal) application. Yellow arrows denote where anti-icing is dispensed.

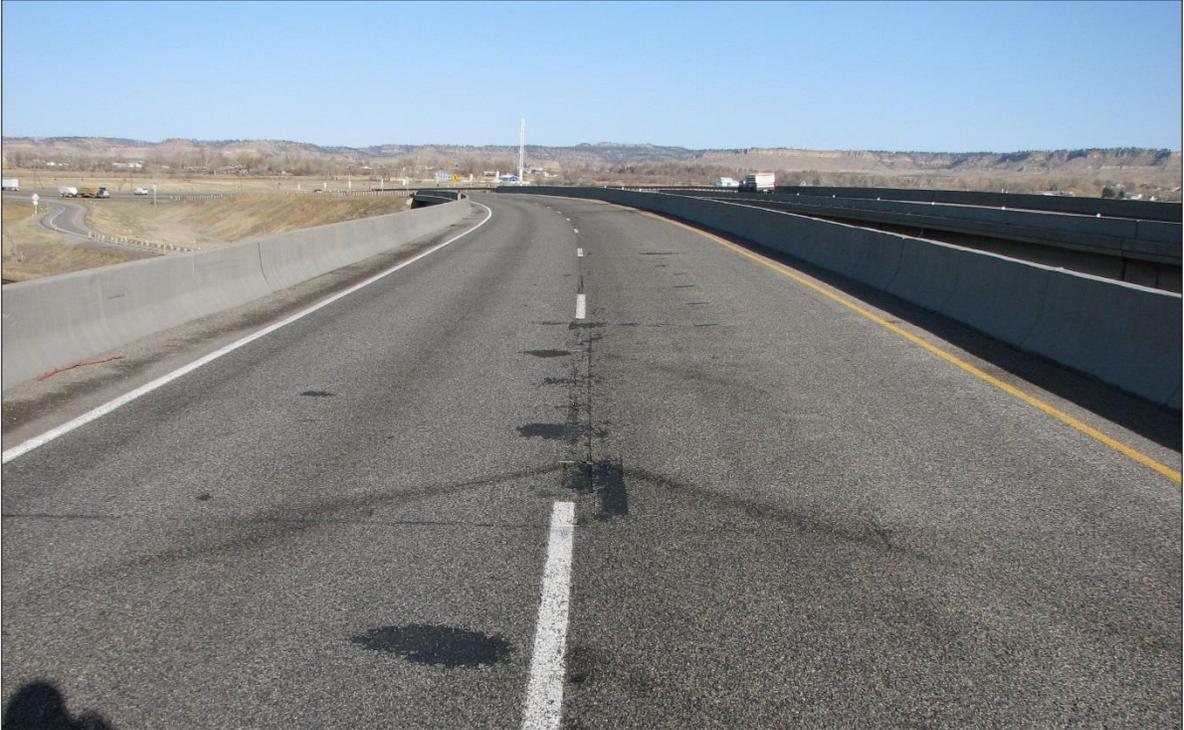
↑ Condition of deck August 2008 – view west.

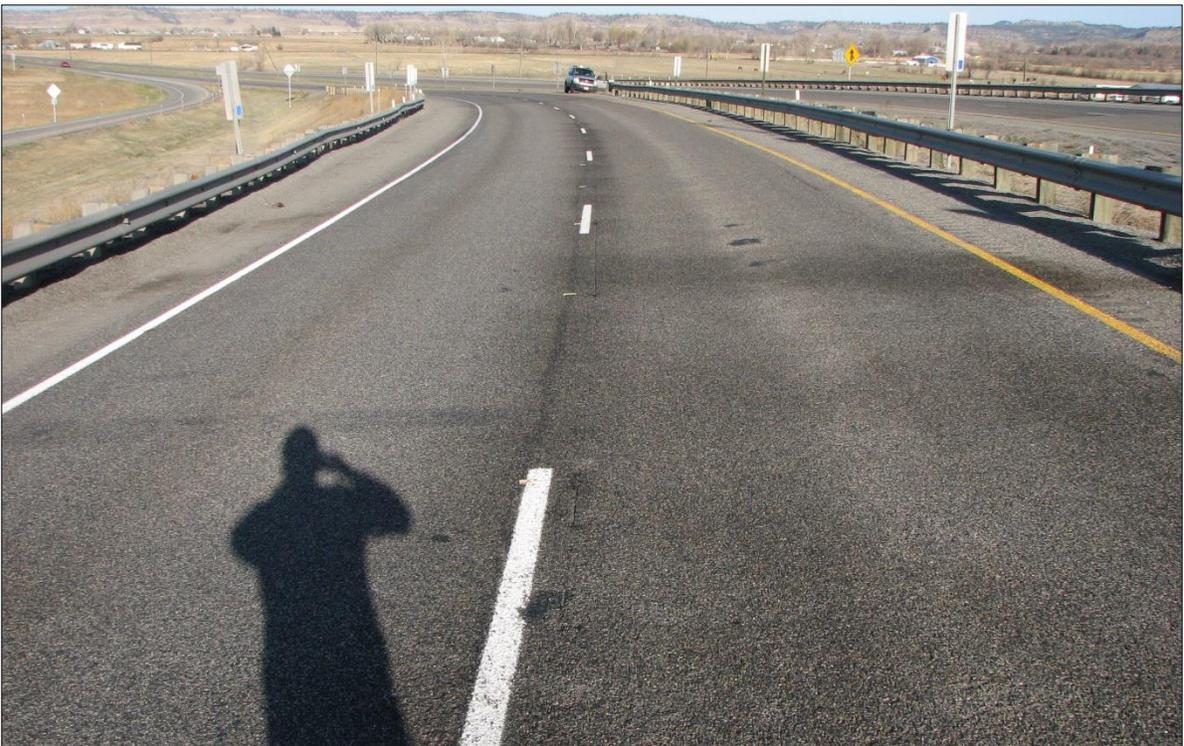
↑ Condition of approach August 2008 – view west.

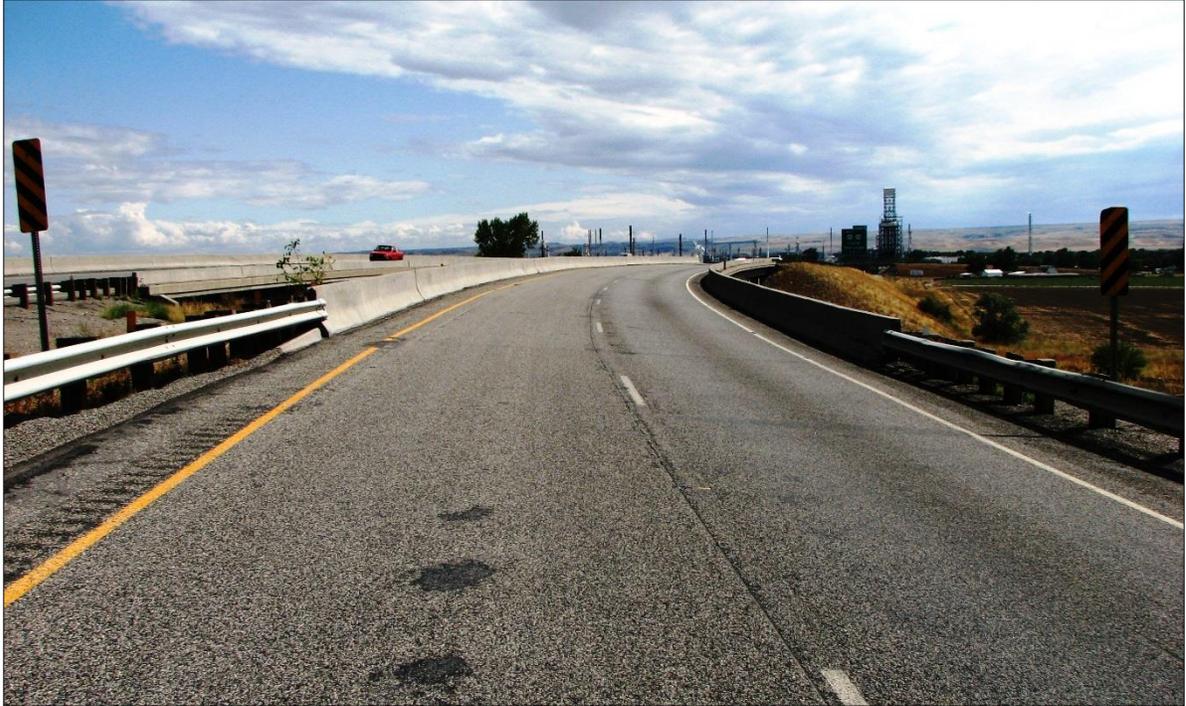
↑ Condition of deck August 2009 – view east.

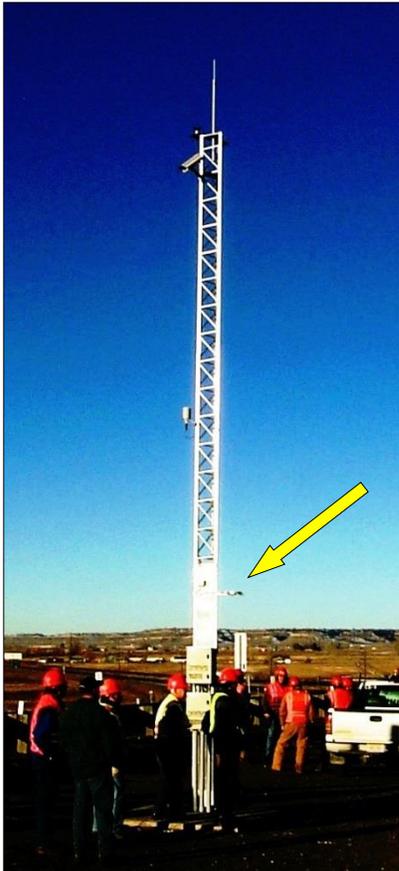
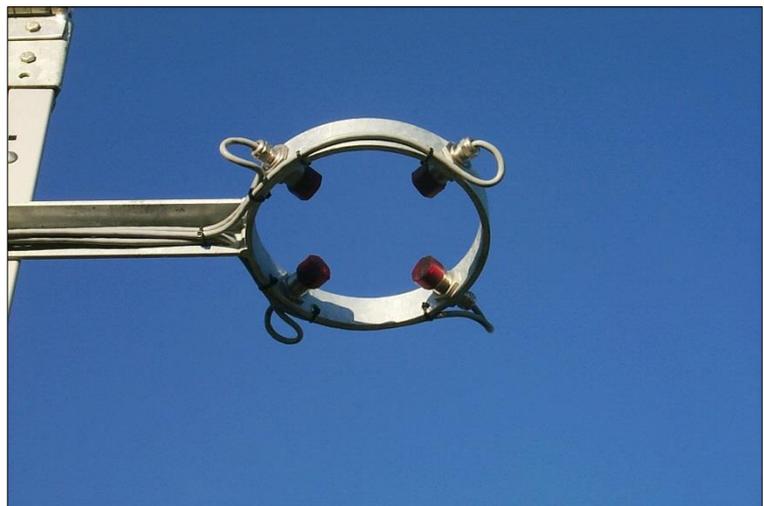
← Representative image of the RWIS: Note the yellow arrow shows the original location of the precipitation sensor. It was found at this height that overspray from passing snow plows would coat the sensor with debris and diminish its effectiveness. The sensor was relocated higher up the RWIS and since has not been an issue. The image below is the close-up of that sensor.
