Experimental Feature Evaluation  
 January 2023

<b>Experimental Feature:</b>	T15 Base One Soil Stabilization
<b>Location:</b>	Glendive District, Valley County, City of Nashua, MT Hwy 117
<b>MDT Project Name:</b>	Milk River – North
<b>MDT Project Number:</b>	STPP 17-1(10)11[5157]
<b>Experimental Project Number:</b>	MT-18-05
<b>Principle Investigator:</b>	Chad DeAustin, Experimental Project Manager (ExPM)
<b>Technical Contact:</b>	Jacquelyn Smith
<b>Construction Date:</b>	June/July 2018
<b>Date of Inspections:</b>	September 2019, May 2020, May 2021, September 2022

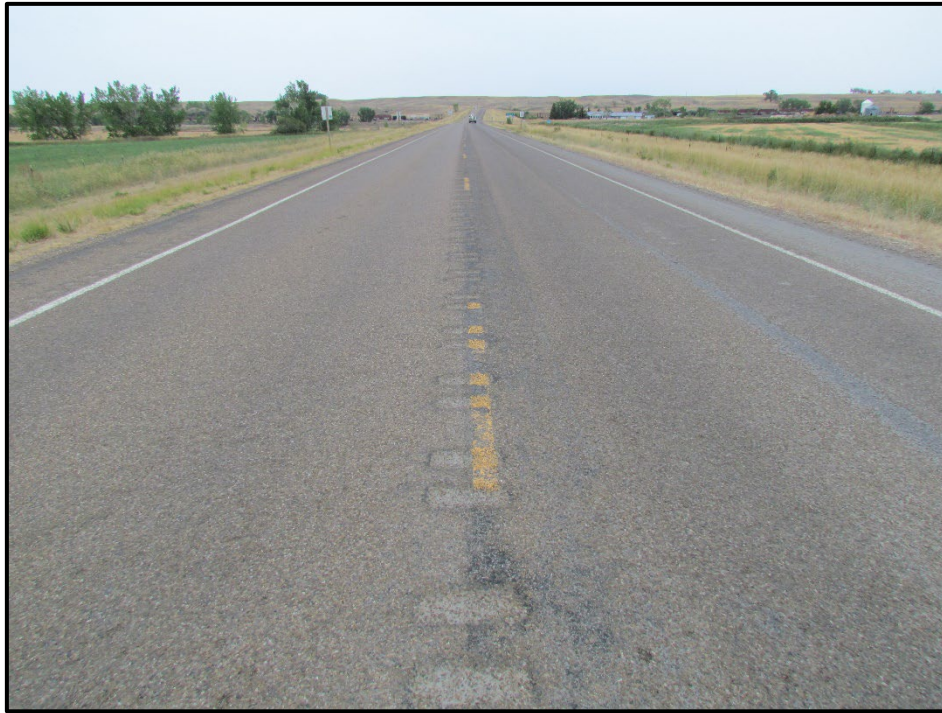
↑ Example of pavement conditions in section 1, view north.

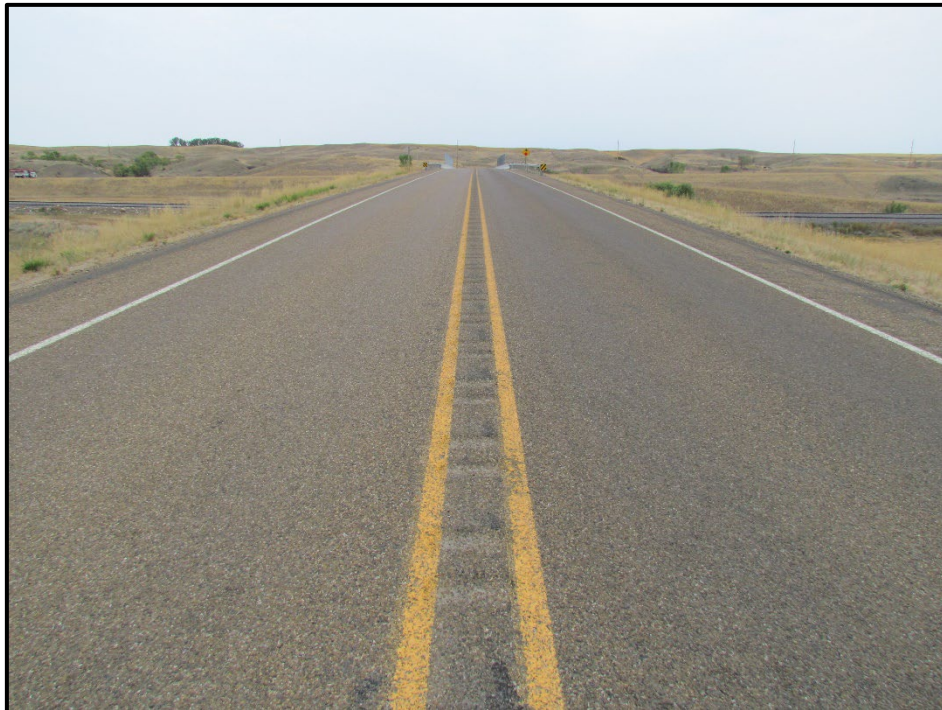
↑ Example of pavement conditions in section 2, view north.

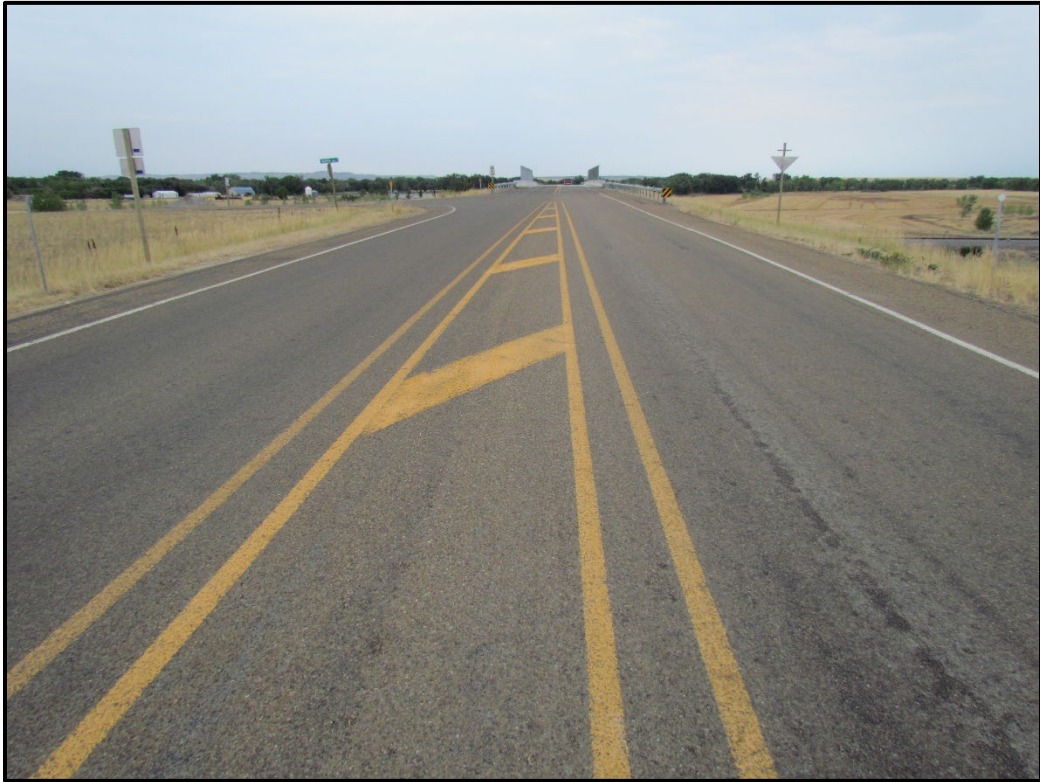
↑ Example of pavement conditions in section 4, view south.

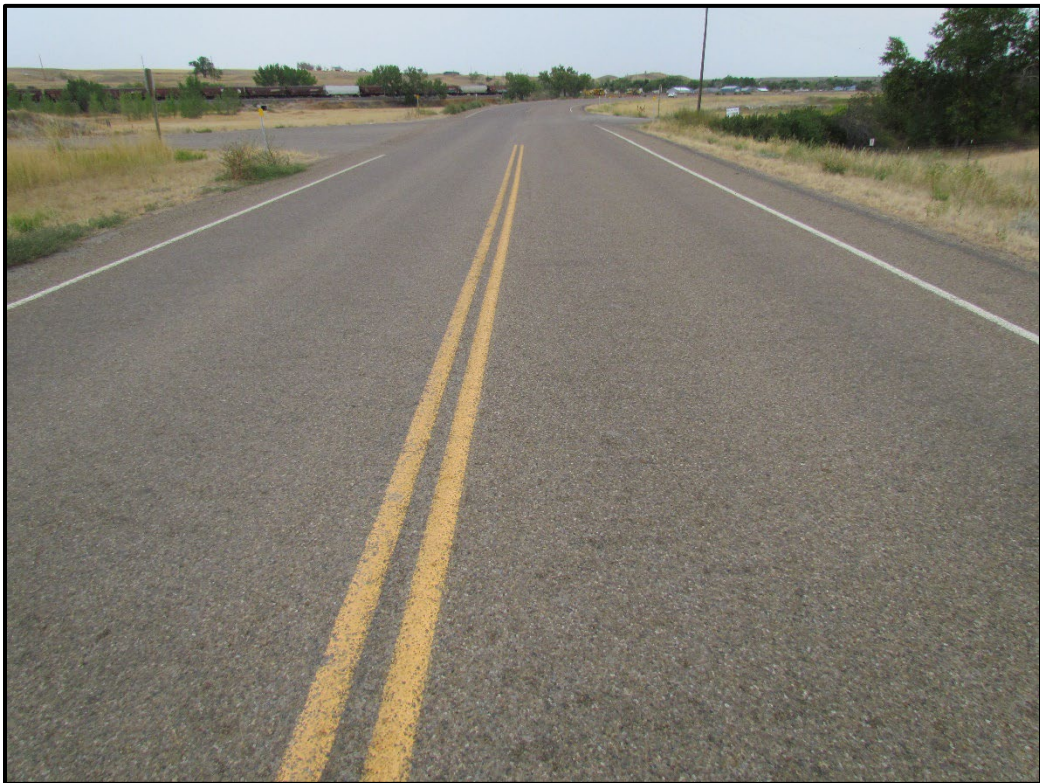
↑ Example of pavement conditions in section 5, view east.

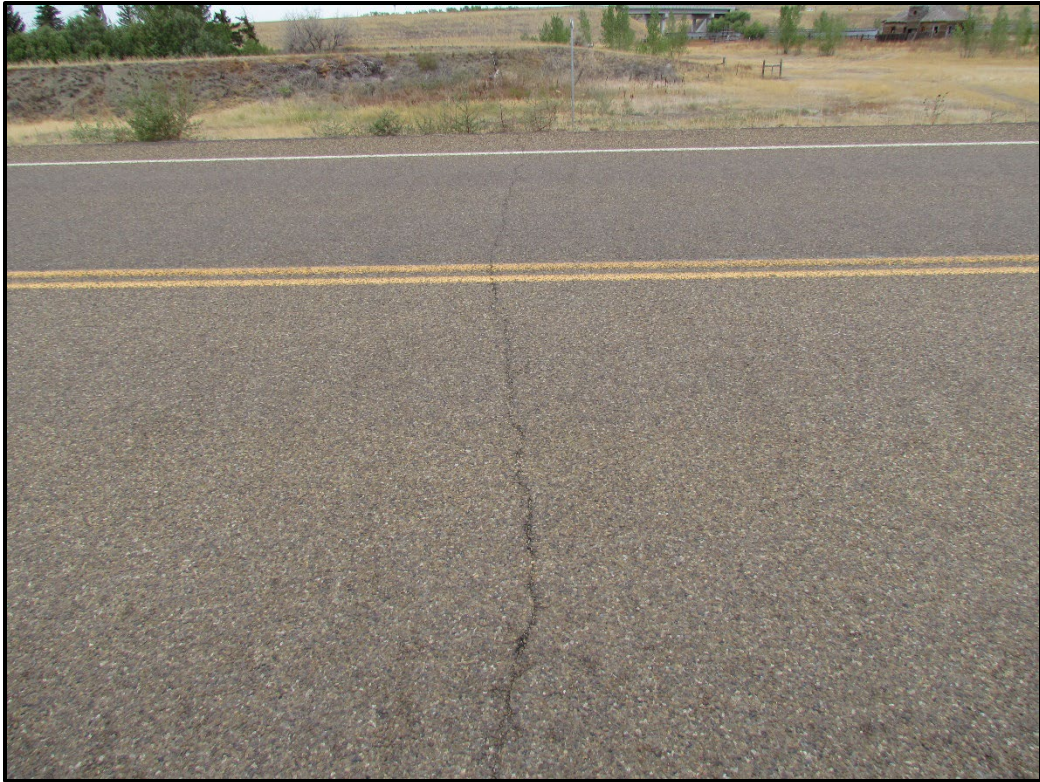
↑ Transverse view of a crack noticed in section 5.

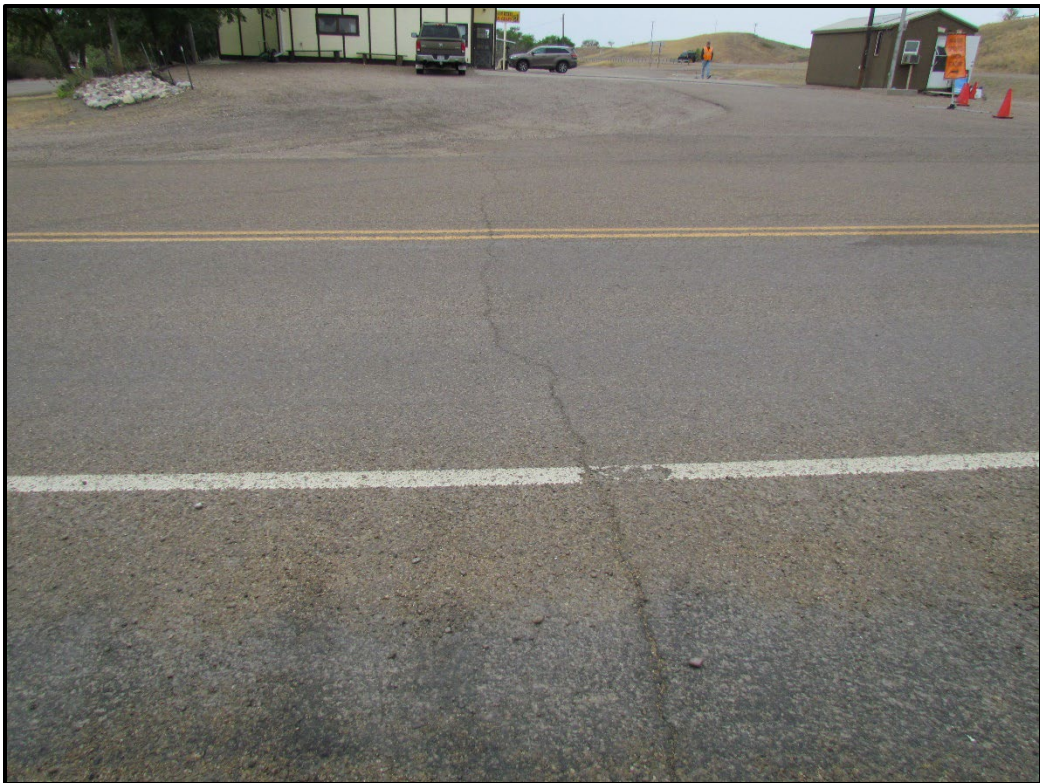
There was little to no change noticed through the project. A few transverse cracks were noticed during the site visit, the most were seen in section 6.

↑ Transverse view of a crack noticed in section 6.

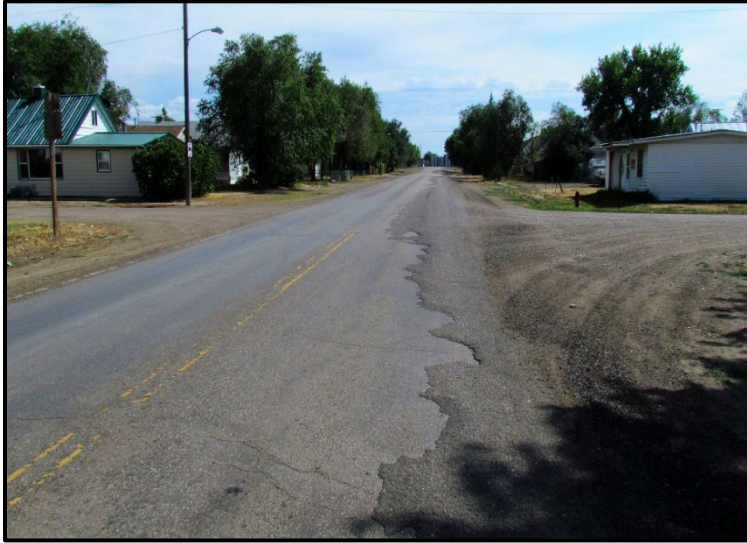
← Representative images of pavement condition prior to reclamation. Areas of visible fatigue, distress, and excessive patching. Area is north end near US Hwy 2 of Sargent St., view south towards town.
