EXPERIMENTAL PROJECTS FINAL REPORT

3M WET REFLECTIVE CERAMIC ELEMENTS AND POTTERS VISIMAX PLUS: NEW BEAD TECHNOLOGY FOR ADDED RETROREFLECTIVITY IN ALL WEATHER PAVEMENT MARKINGS

Project Name: Rockvale - Laurel

Experimental Project No. MT-12-12

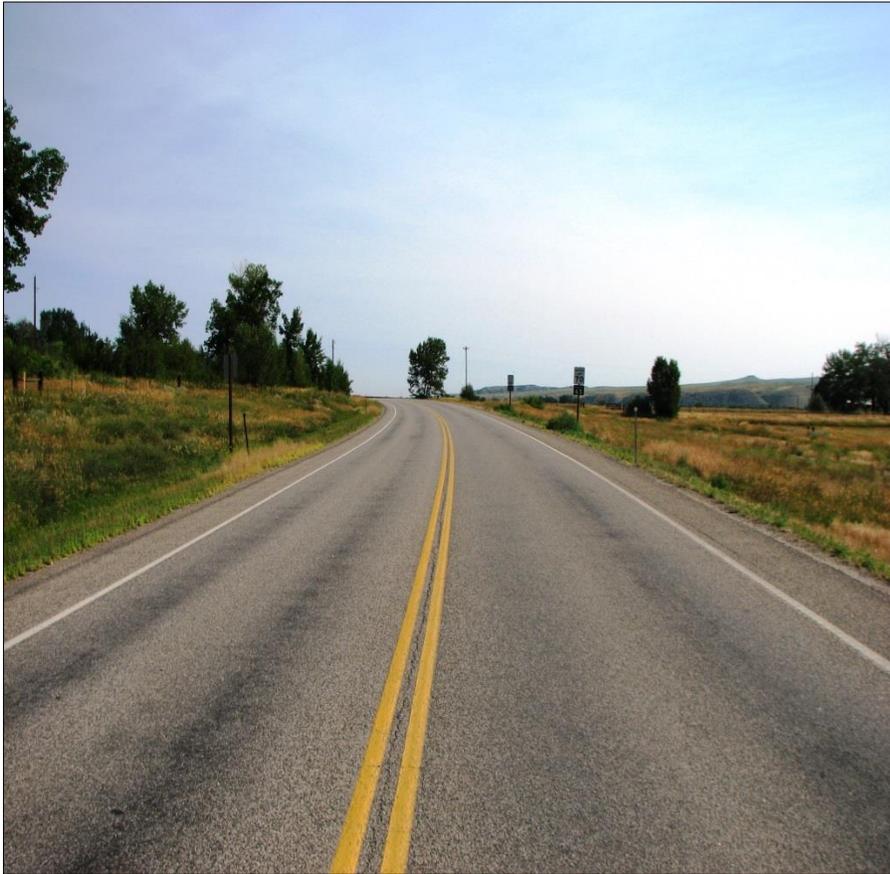
← Representative image taken in July of 2013 prior to new pavement markings application. View north.

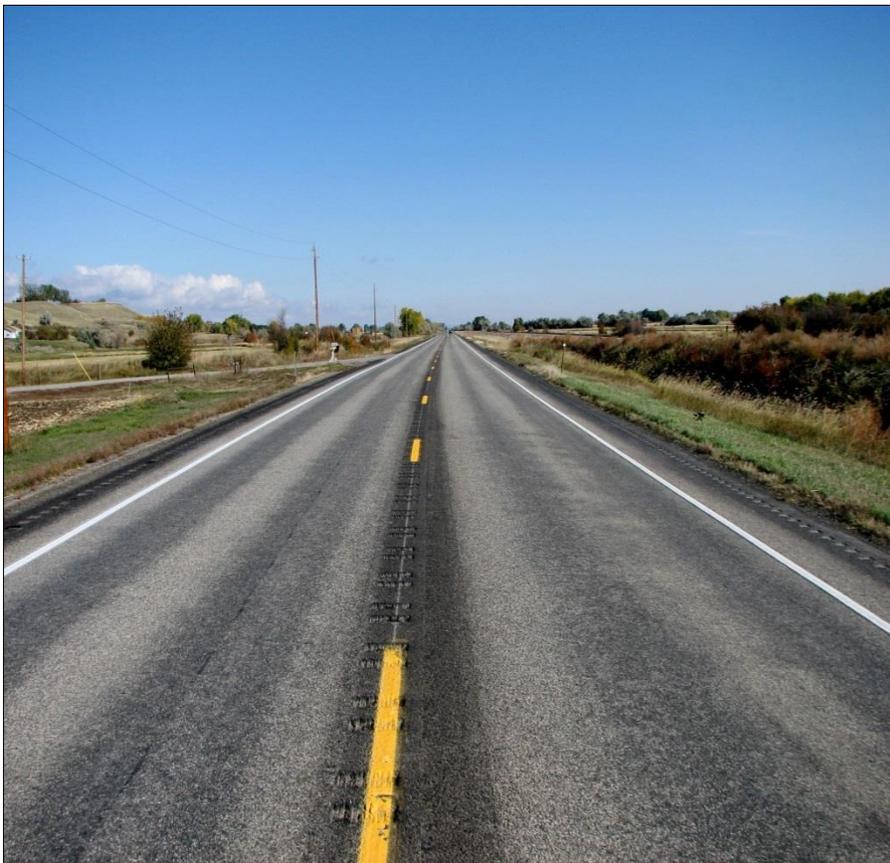
← Representative image taken in September of 2013 after pavement markings application, showing added centerline and shoulder rumble strips. View north.

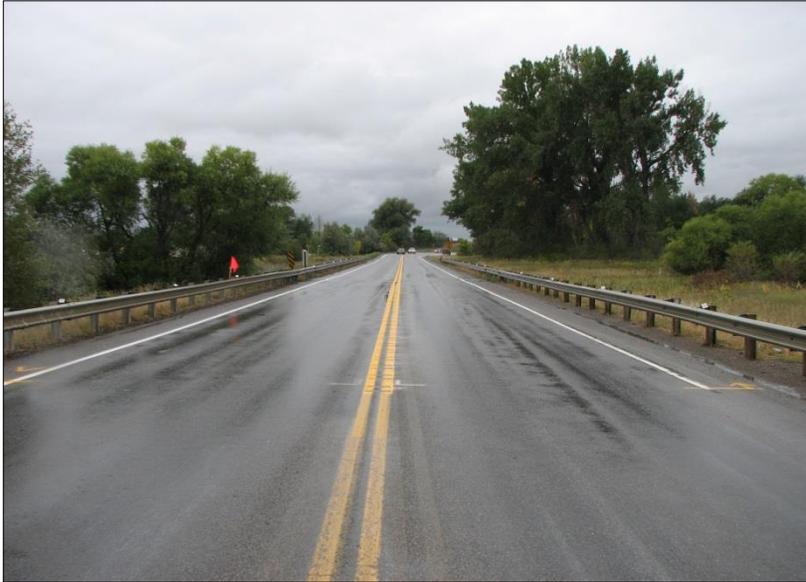
← Beginning of VISIMAX PLUS pavement markings at reference point 53 looking south.

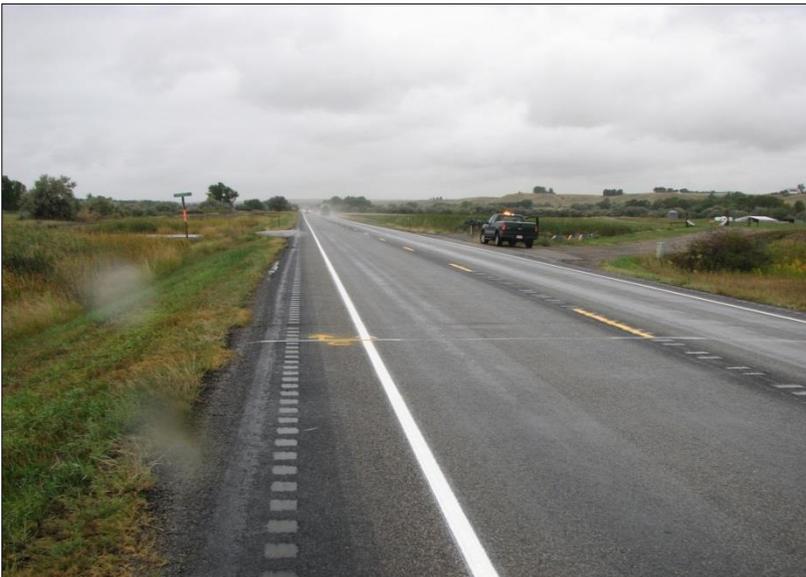
← Beginning of Control (Type 2) pavement markings at reference point 49 looking south.

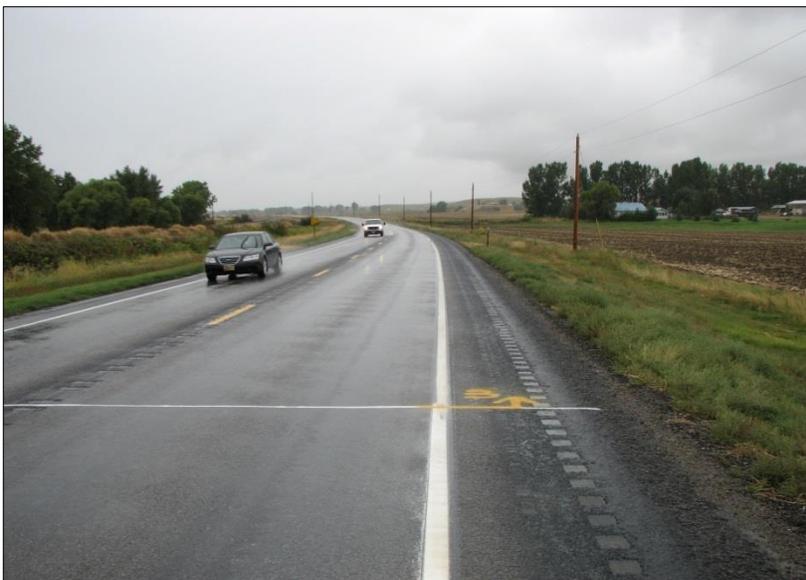
← Beginning of 3M Wet Reflective Elements pavement markings at reference point 47 looking south.

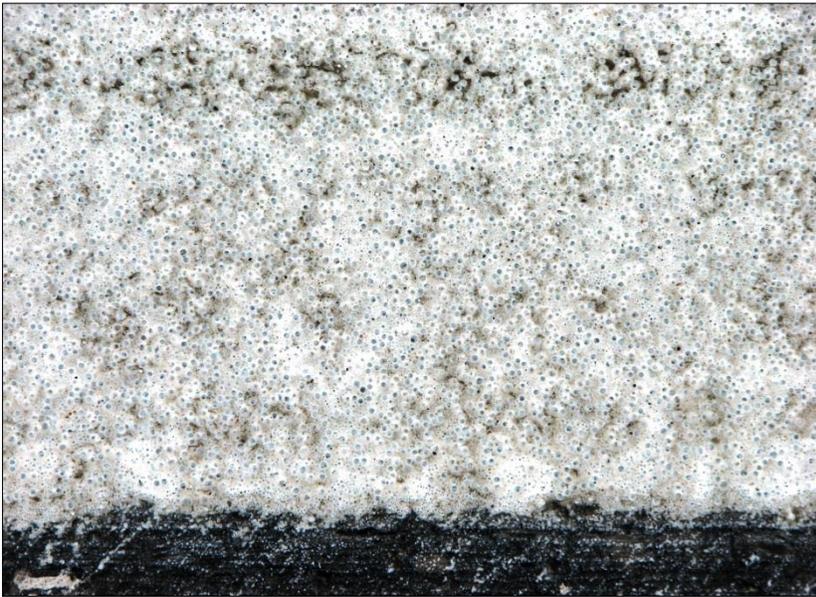
← Close-up of the VISIMAX PLUS white pigmented pavement markings.

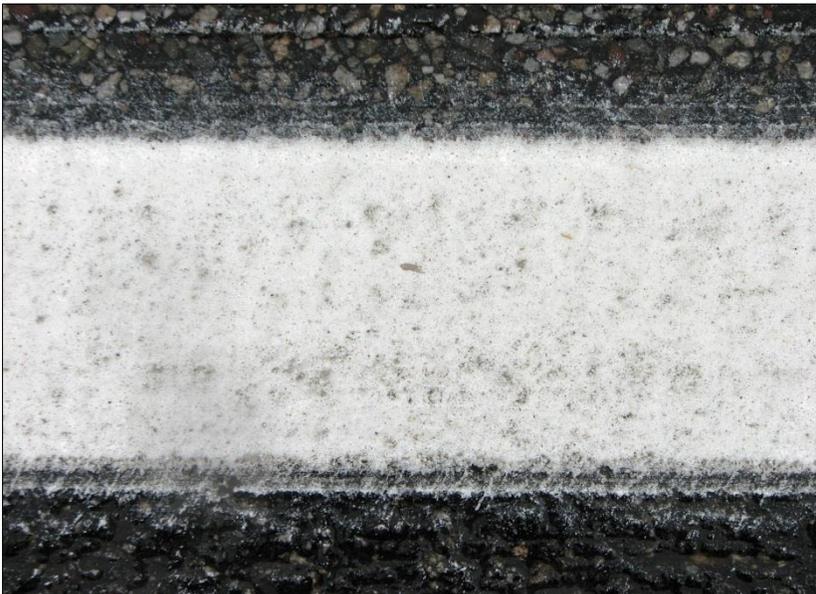
← Close-up of the Control (Type 2) white pigmented pavement markings.

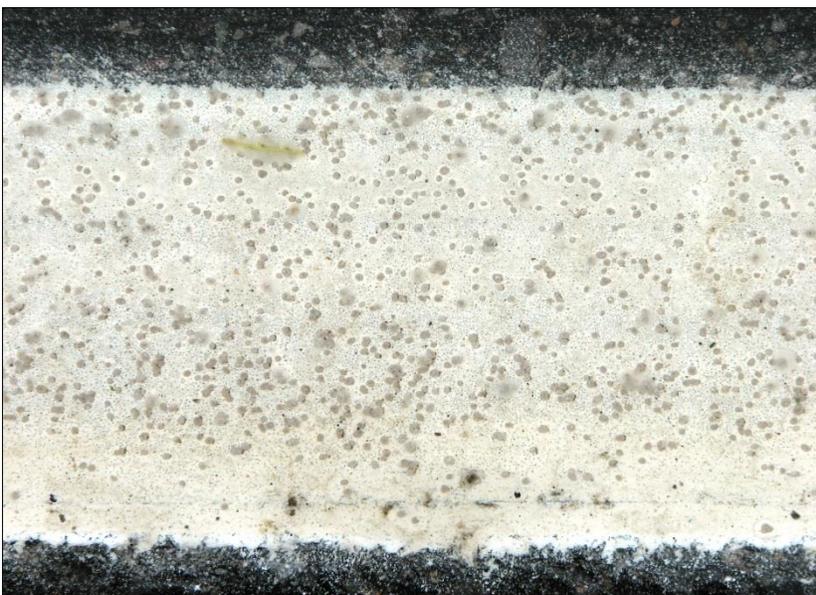
← Close-up of the 3M Wet Reflective Elements white pigmented pavement markings.

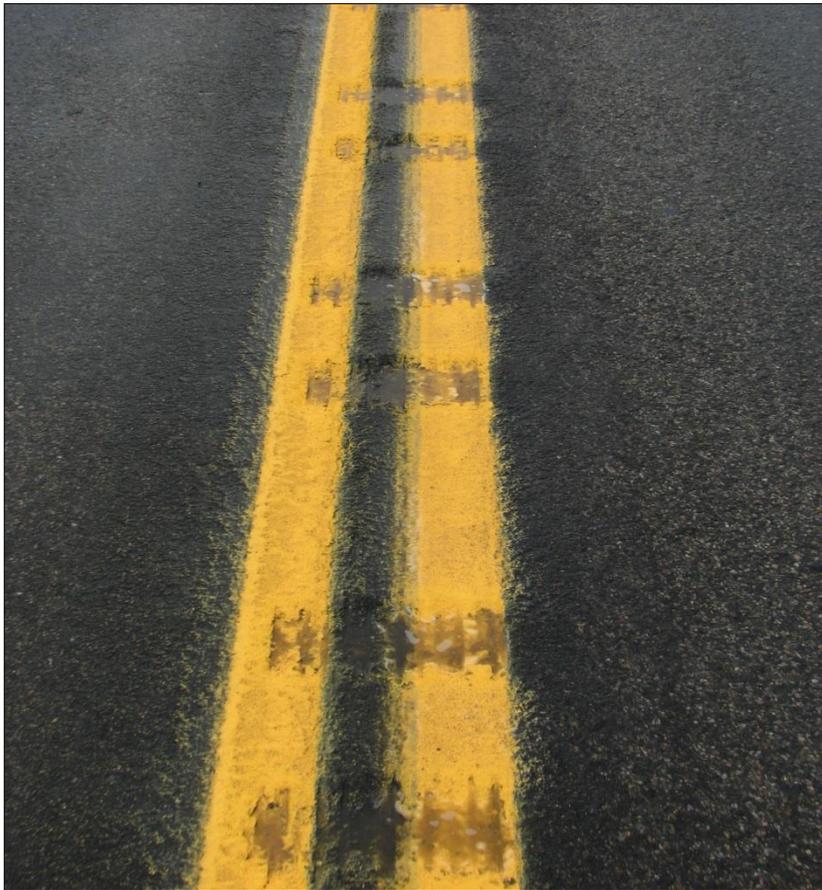
← Representative image of no-passing stripes placed over center-line rumble strips (wet condition).

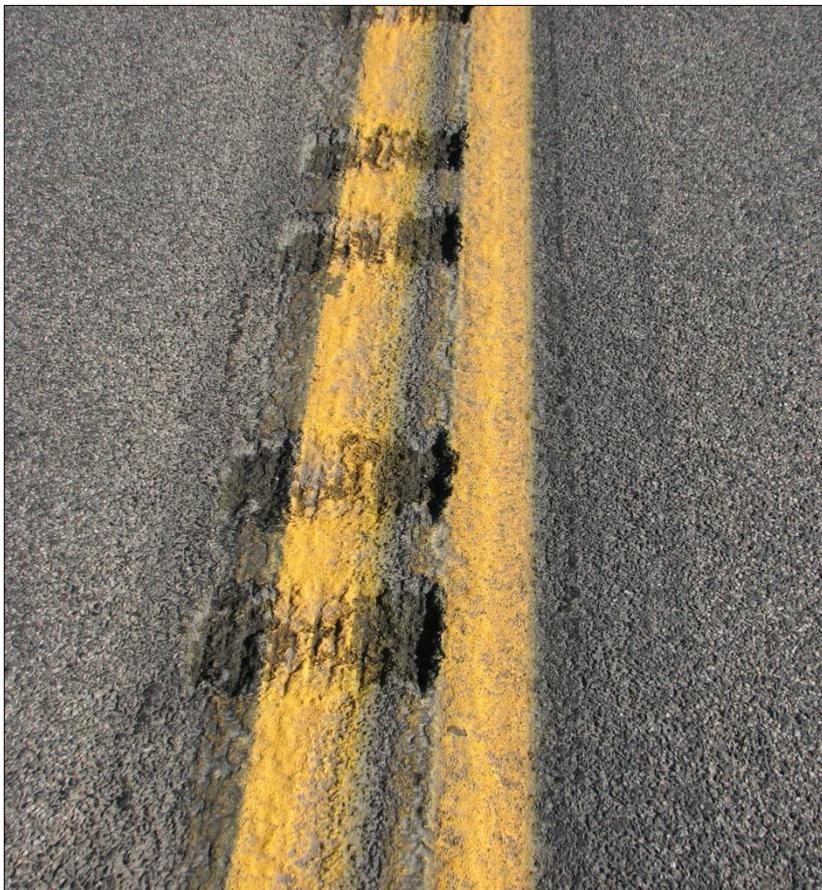
← Representative image (taken in mid-October 2013) of no-passing lane stripes placed over center-line rumble strips (dry condition).

Note that centerline striping did not receive a 60 mil recess groove treatment.

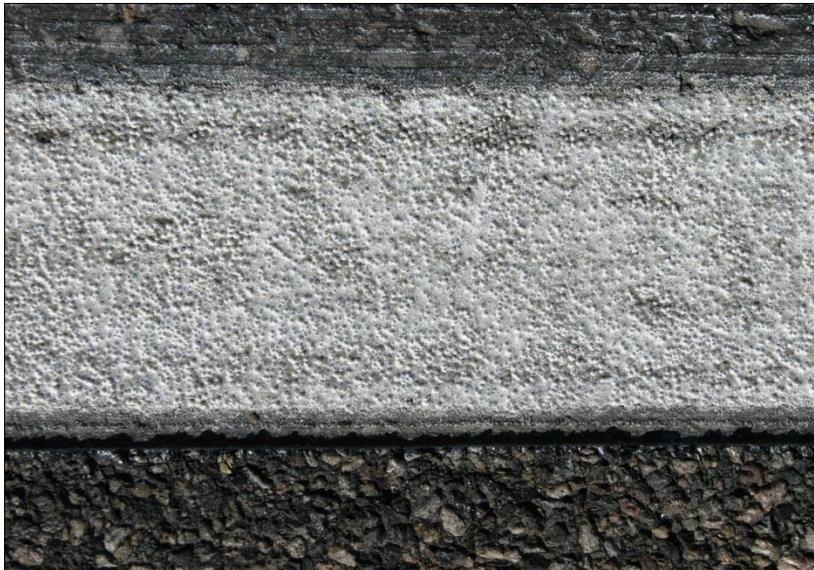
← Close-up of the VISIMAX PLUS white pigmented pavement markings.

Note that (for the most part) the pavement stripe falls well within the parameters of the 60 mil recessed groove; which should aid in the durability of the stripe. This is indicative of all three (3) sections on the project.

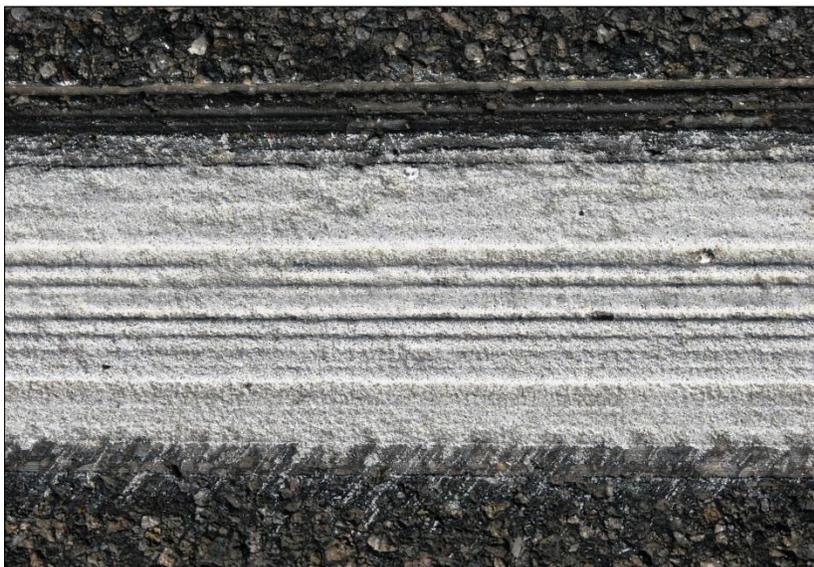
← Close-up of the Control (Type 2) white pigmented pavement markings.

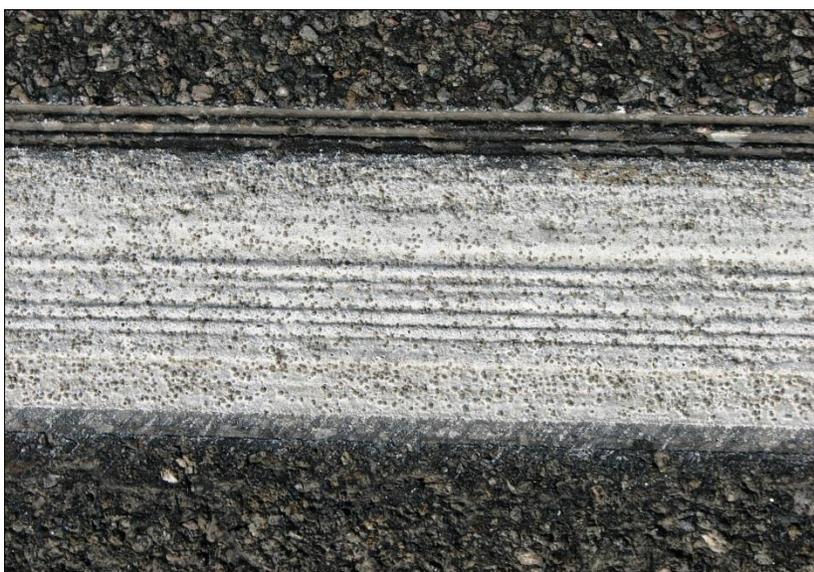
← Close-up of the 3M Wet Reflective Elements white pigmented pavement markings.

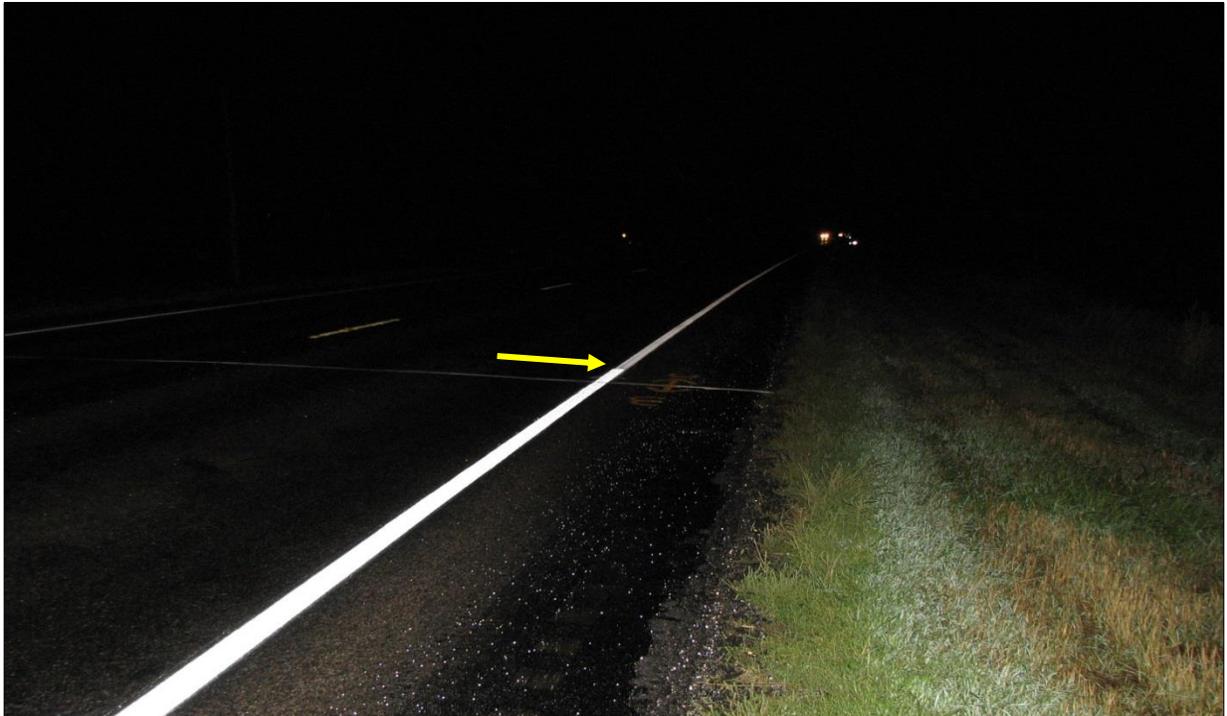
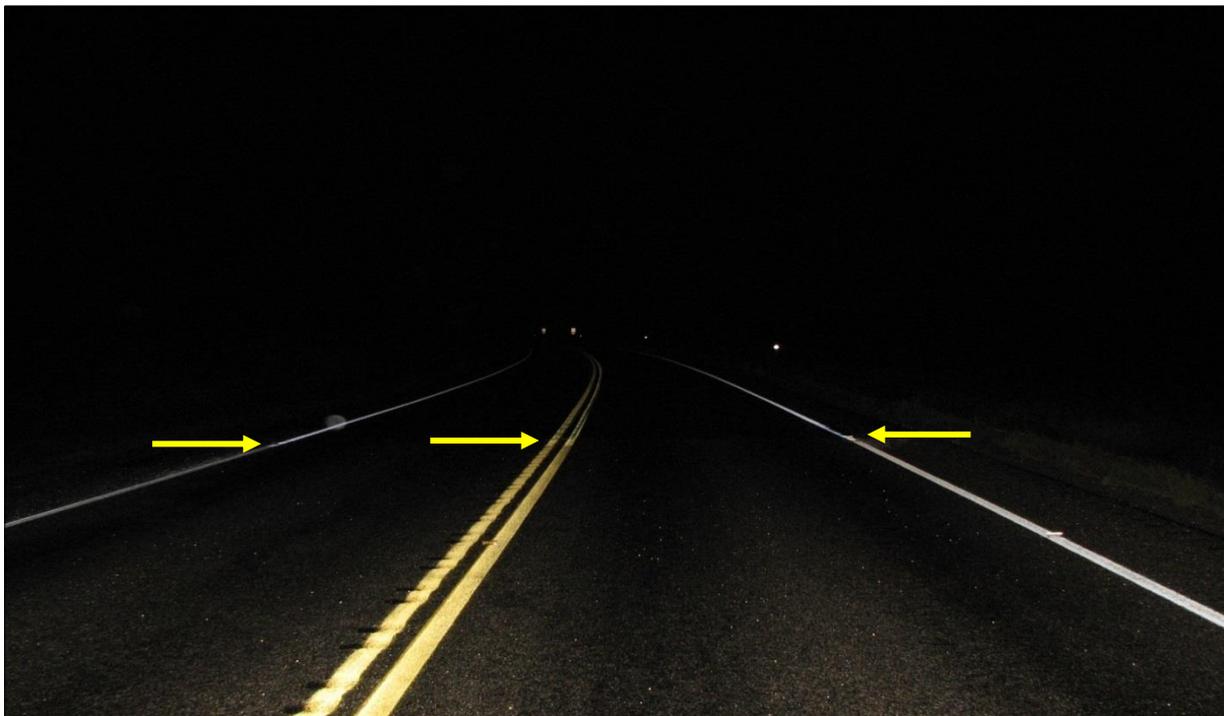
↑ This is the transition of the 3M striping and control section at approximately RP 47 (yellow arrow); view east. It was actively raining at the time. ↓ The image below is the transition of the conventional striping and 3M striping at approximately RP 43.

Although difficult to see in these images; during actual field observation, the difference in luminosity and contrast between the 3M and control section was apparent under wet, nighttime conditions.

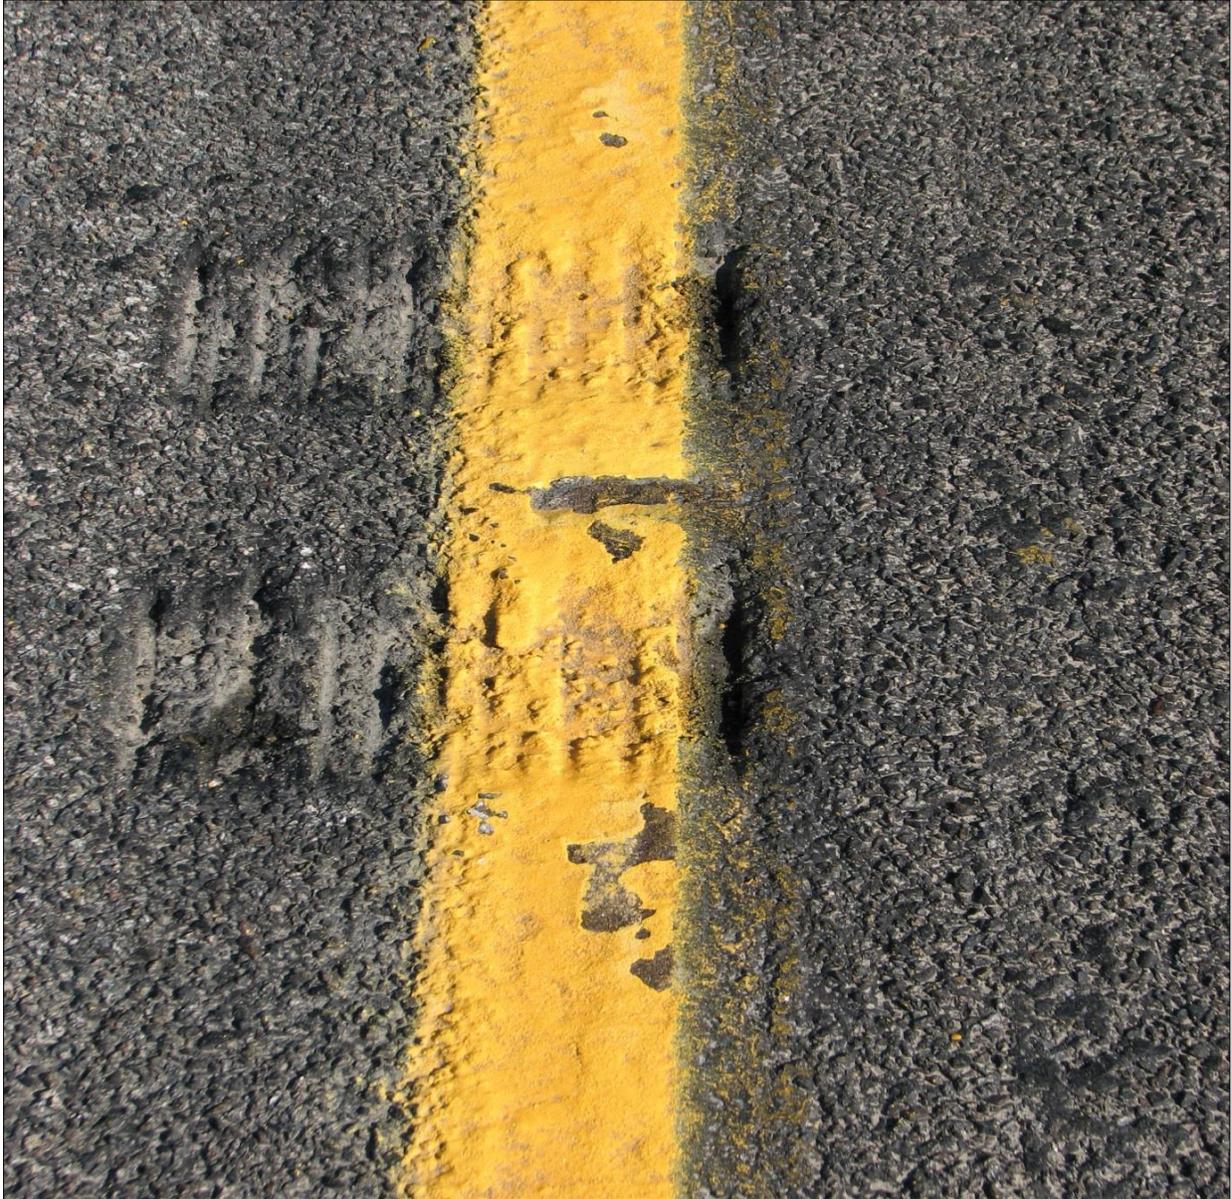
↑ This image taken on October 15, 2013 of the centerline markings is showing distress of debonding of the striping binder to the pavement surface commonly associated with snow plow damage or some other type of metal to binder contact.

District Maintenance staff reported in November they are noticing more of this kind of distress and since it is not in a milled groove is expected to increase over time.

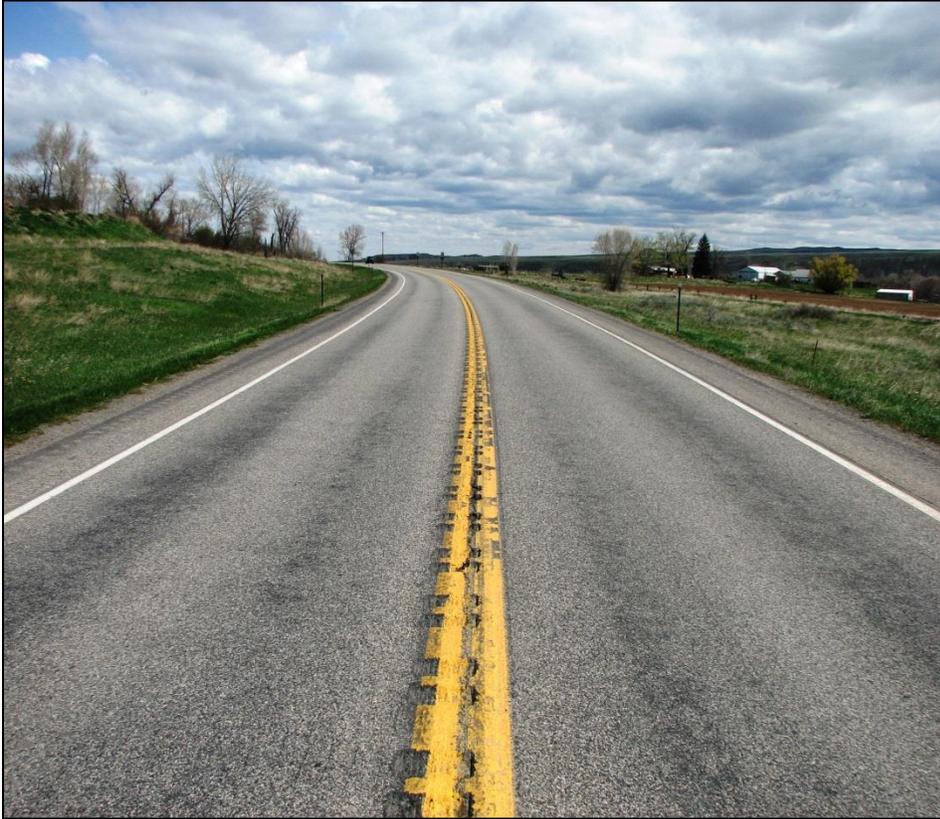
← Beginning of the 3M section at reference point 43; view east.

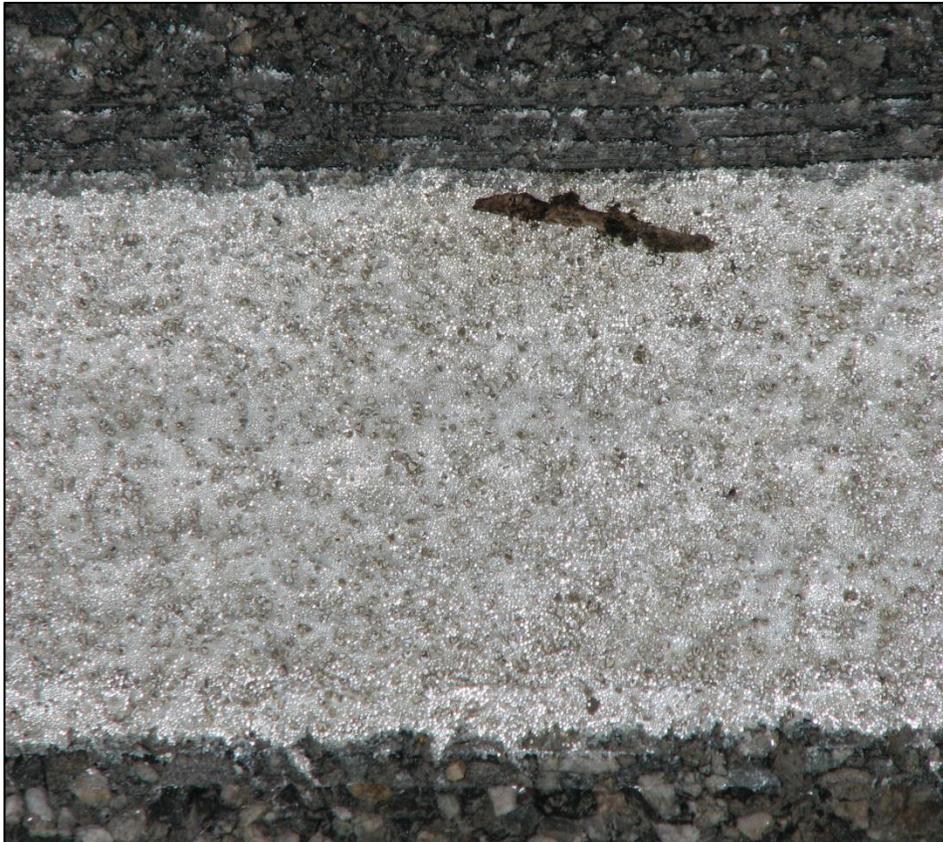
← Close-up of 3M Elements marking.

This image is representative of the overall condition of the stripe on the project.

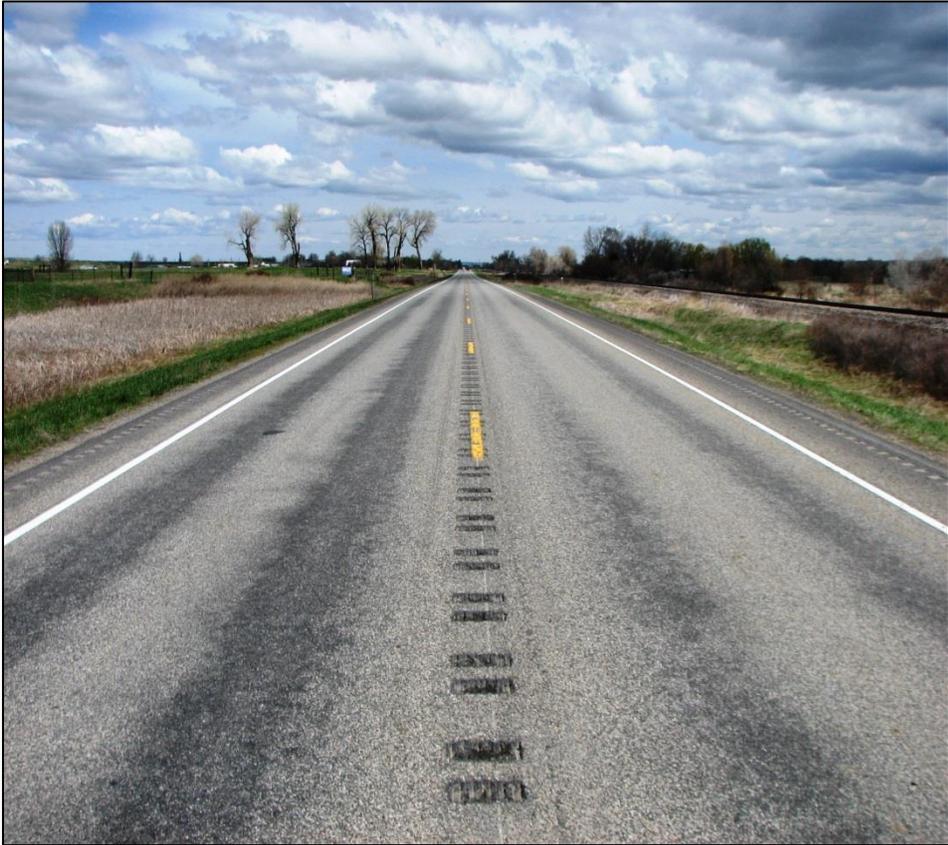
← Beginning of the Visamax section at reference point 49; view east.

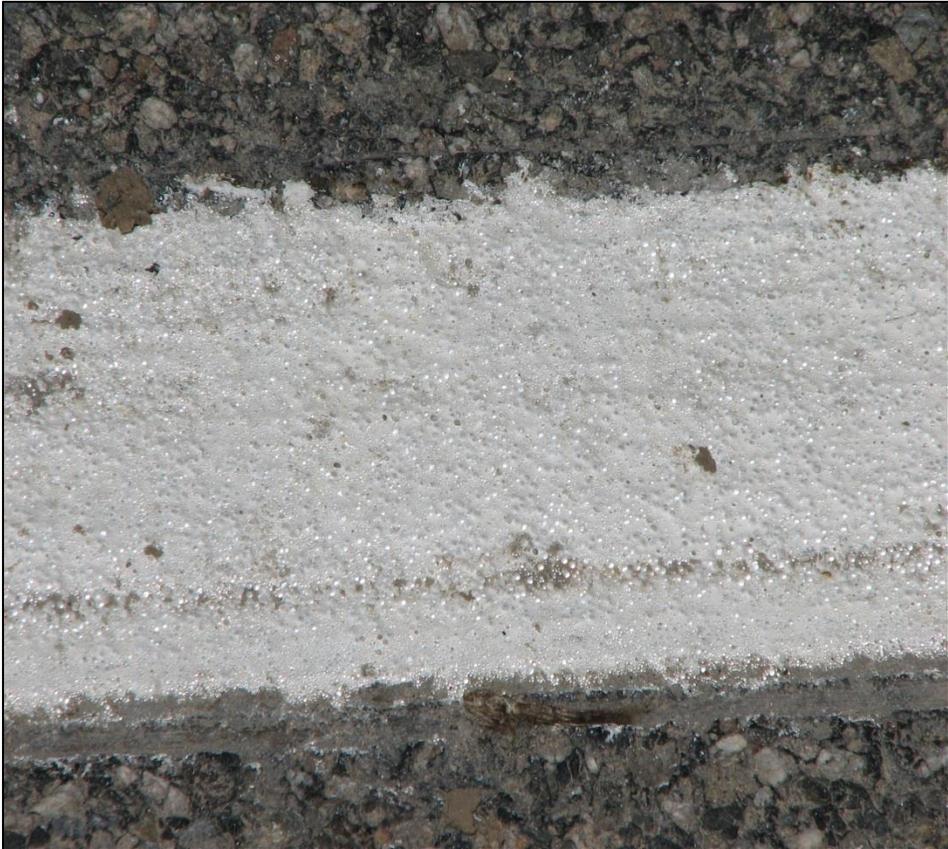
← Close-up of Visamax marking.

This image is representative of the overall condition of the stripe on the project.

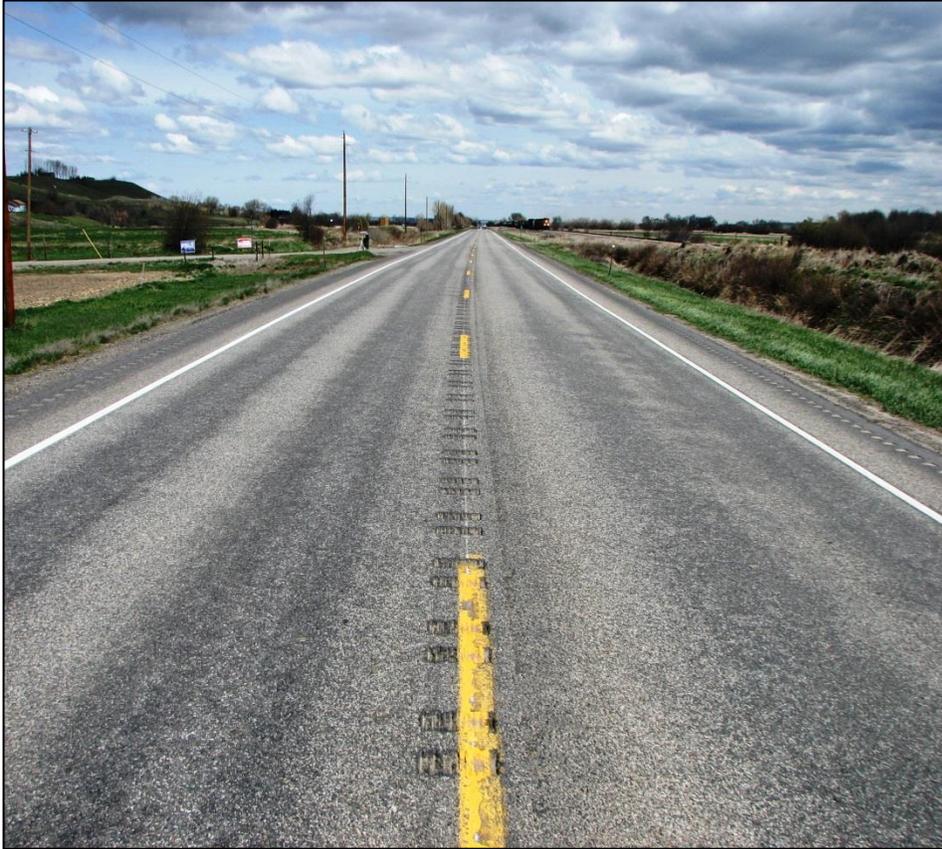
← Beginning of the Type II control section at reference point 47; view east.

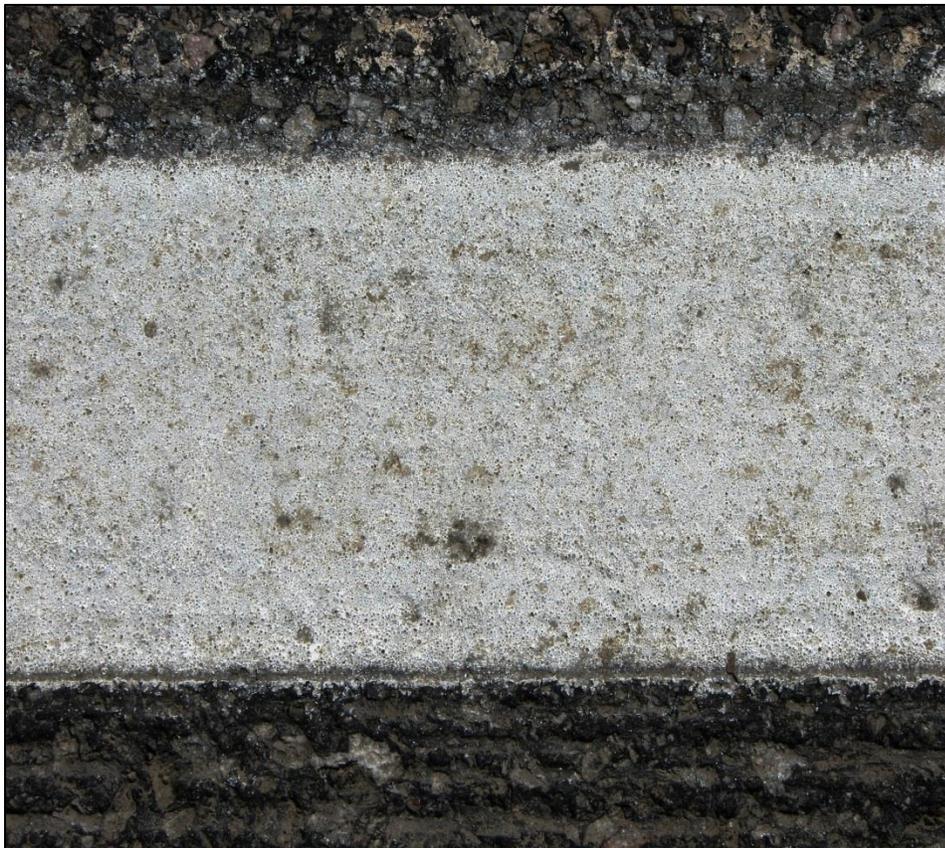
← Close-up of Type II marking.

This image is representative of the overall condition of the stripe on the project.

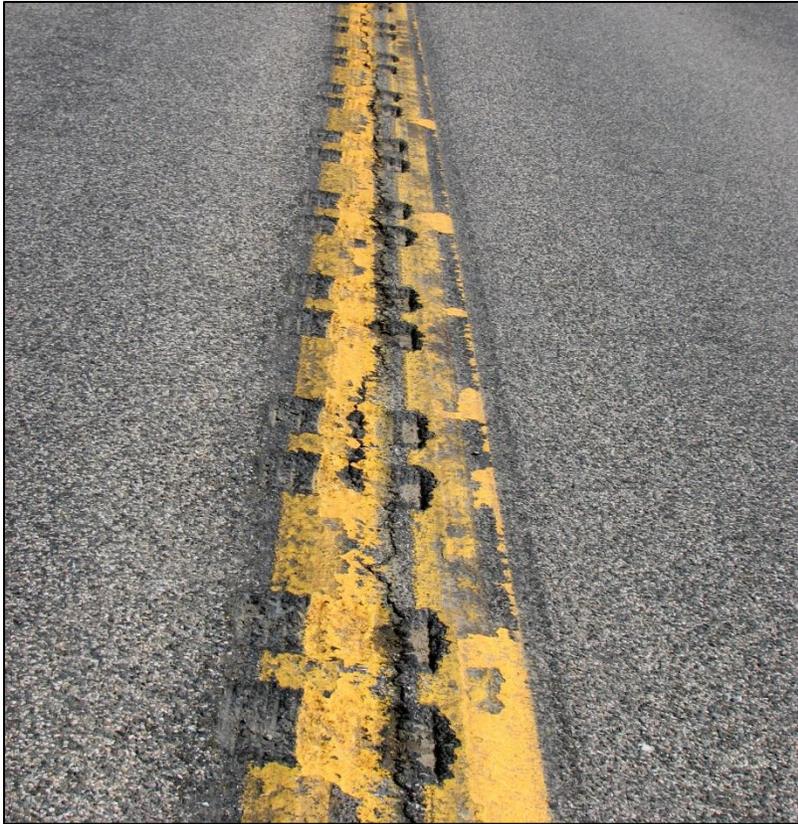
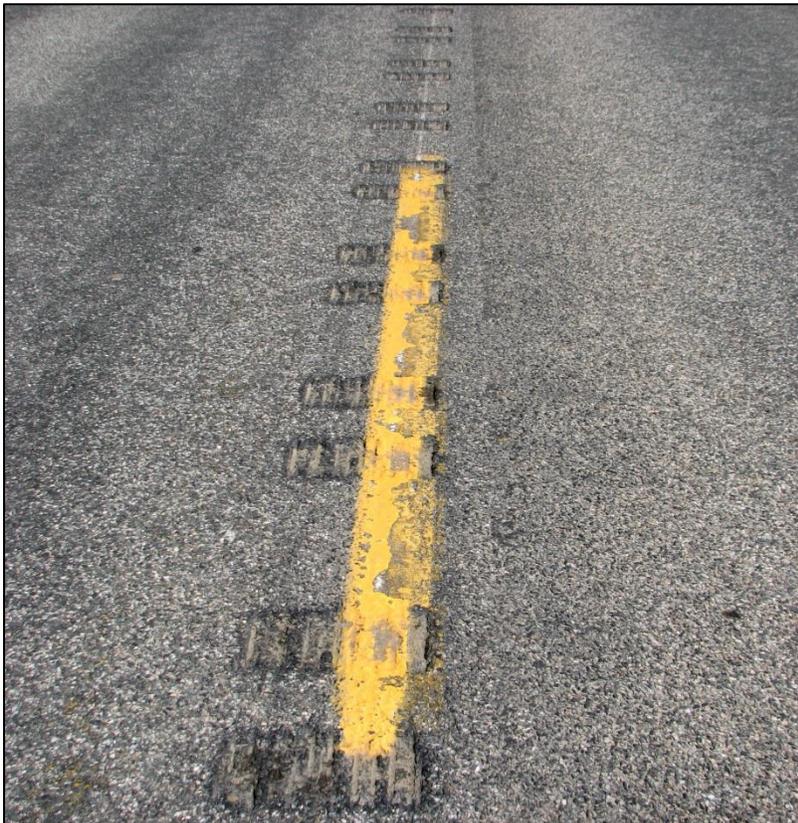
↩↓ Images representative of the general condition of the stripe over rumble strip on the project.

Loss of binder to pavement due to assumed snow plow passes.

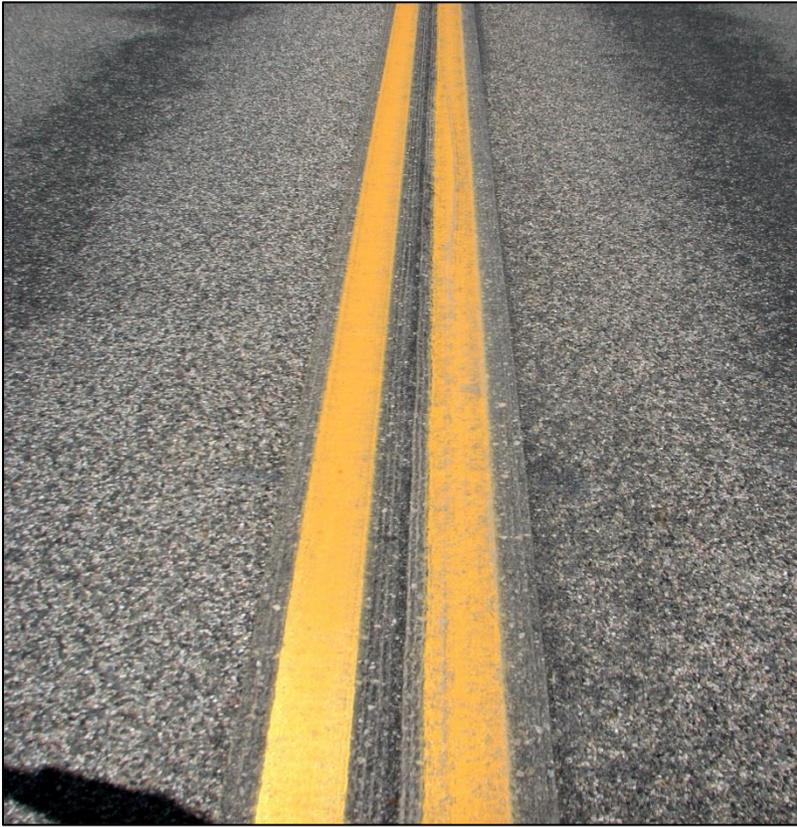
← There was a small linear section of no-passing zone that received a 60 mil grind within the 3M Element section. As seen in the 2014 inspection, the stripe is in good condition.

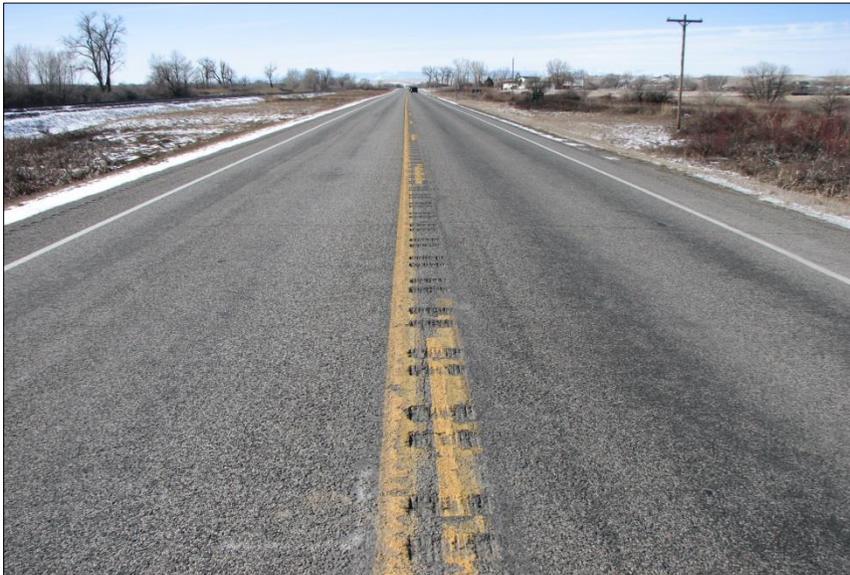
← Overview of 3M Elements section; view west near mile point 47.

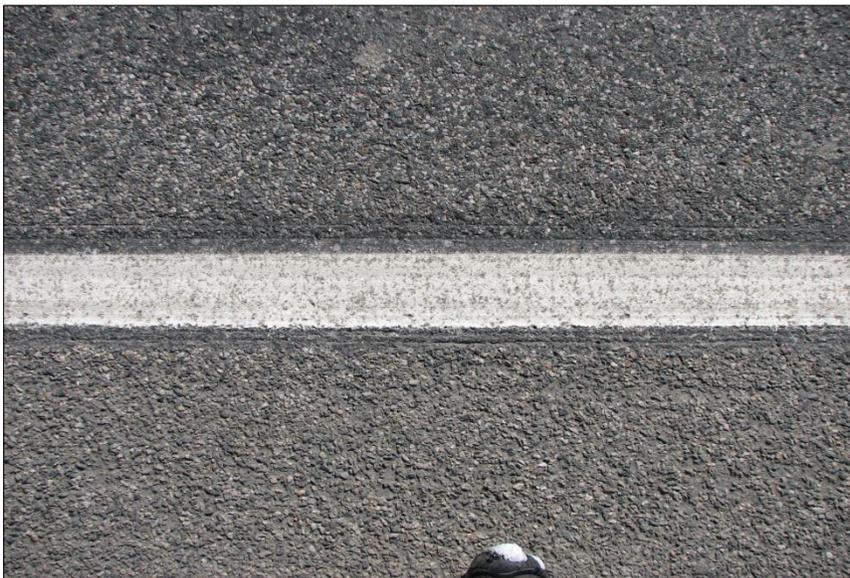
← Close-up of 3M Elements marking.

This image is representative of the overall condition of the stripe on the project.

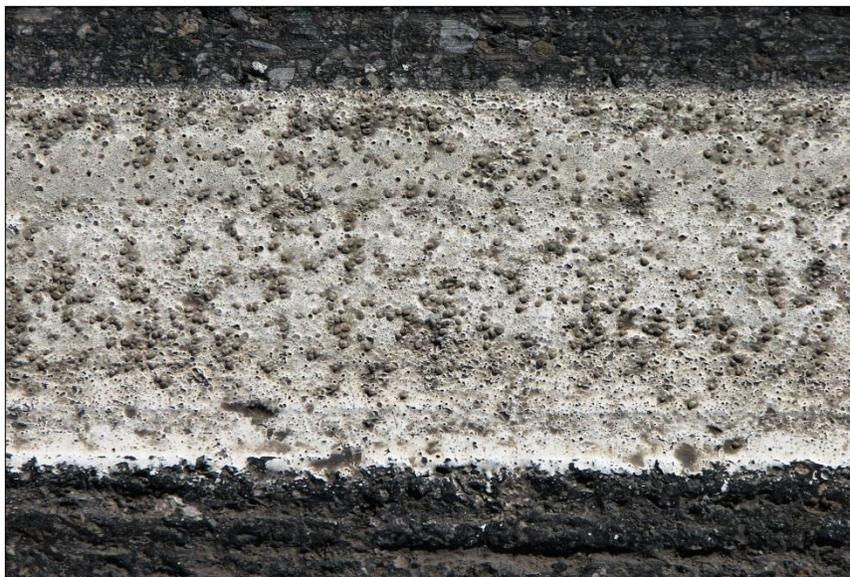
← Additional close-up of 3M Elements marking.

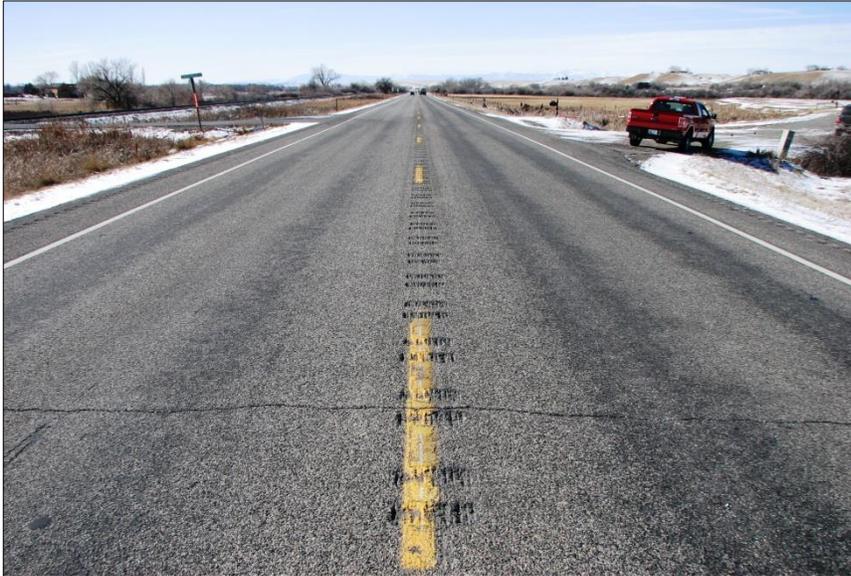
← Overview of Type II Control section; view west near mile point 49.

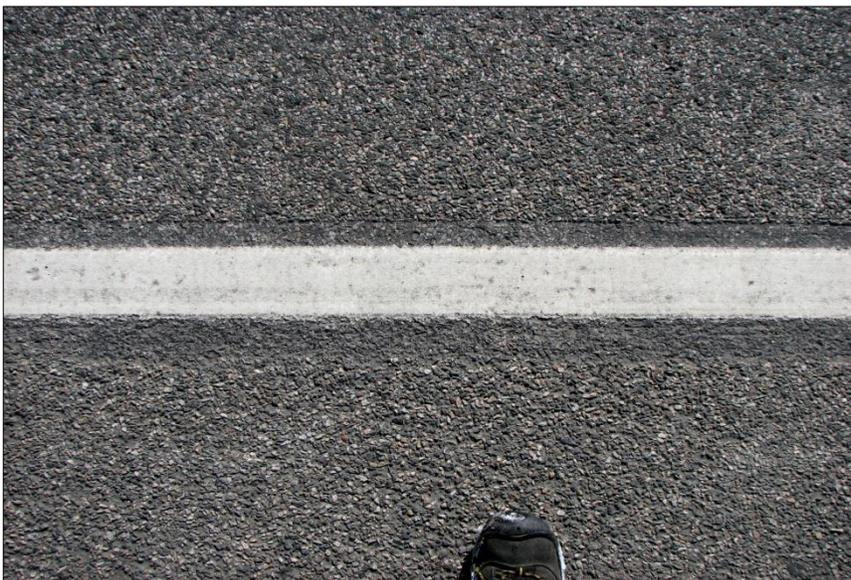
← Close-up of Type II marking.

This image is representative of the overall condition of the stripe on the project.

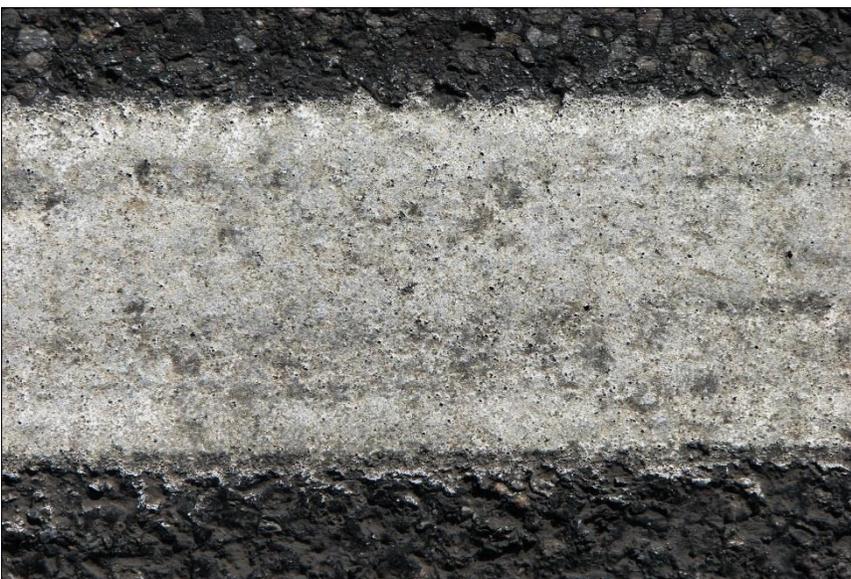
← Additional close-up of Type II marking.

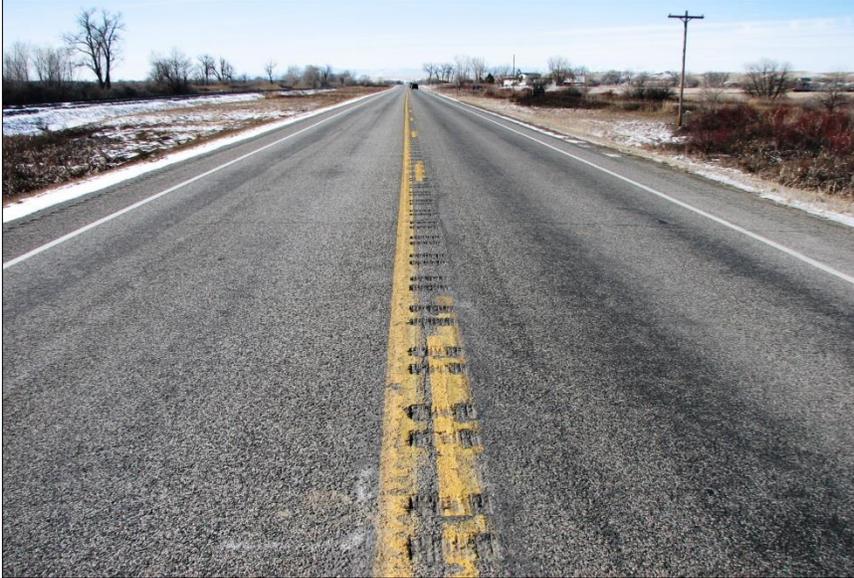
← Overview of VISIMAX PLUS section; view west near mile point 50.

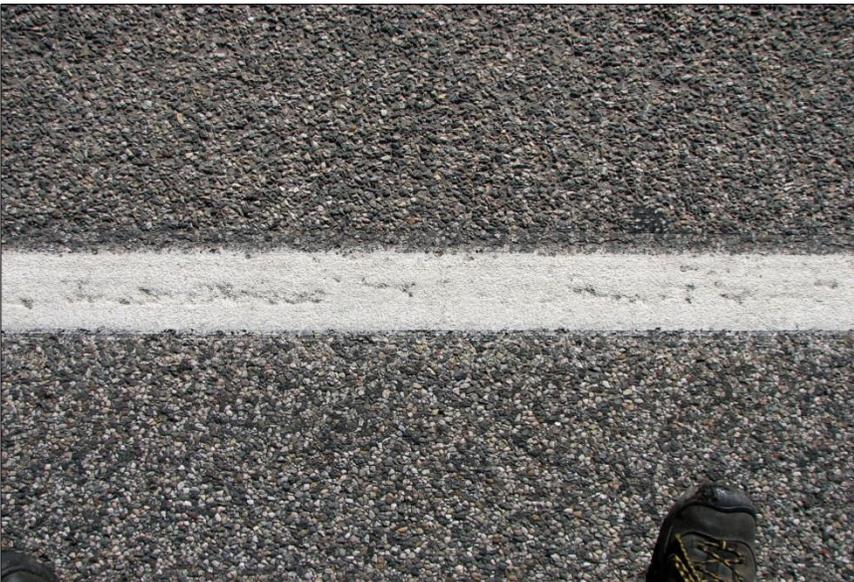
← Close-up of VISIMAX PLUS marking.

This image is representative of the overall condition of the stripe on the project.

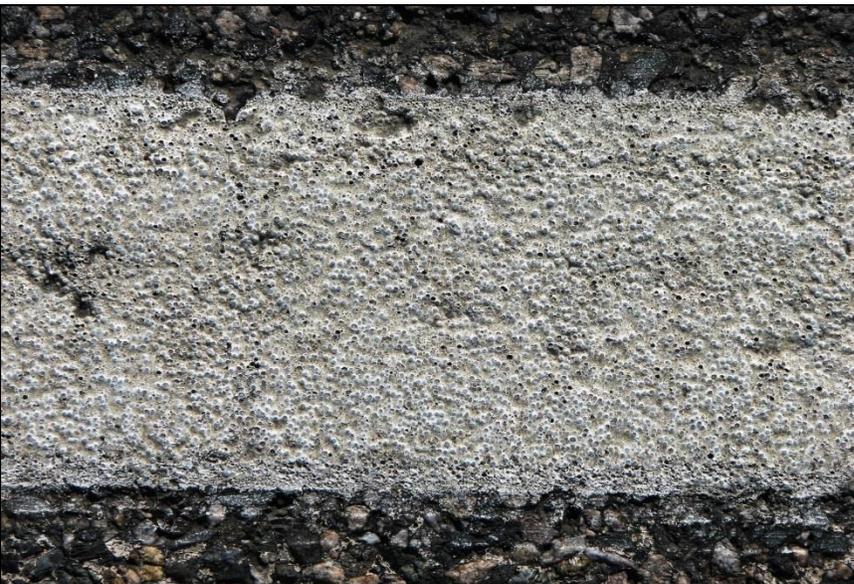
← Additional close-up of VISIMAX PLUS marking.
