EXPERIMENTAL PROJECTS FINAL REPORT

3M WET REFLECTIVE CERAMIC ELEMENTS AND POTTERS VISIMAX PLUS: NEW BEAD TECHNOLOGY FOR ADDED RETROREFLECTIVITY IN ALL WEATHER PAVEMENT MARKINGS

Project Name: Rockvale - Laurel

Experimental Project No. MT-12-12

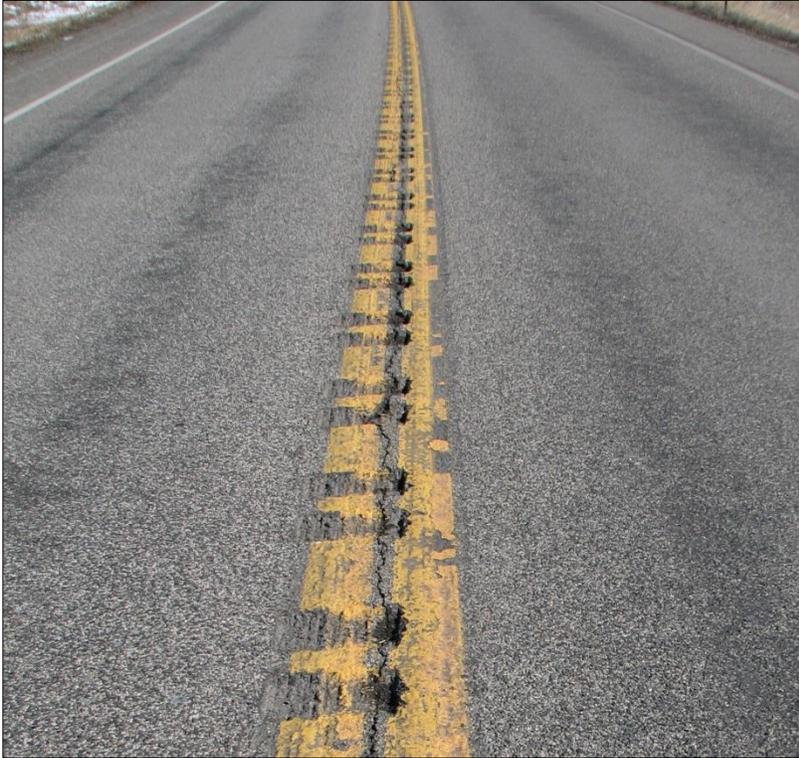
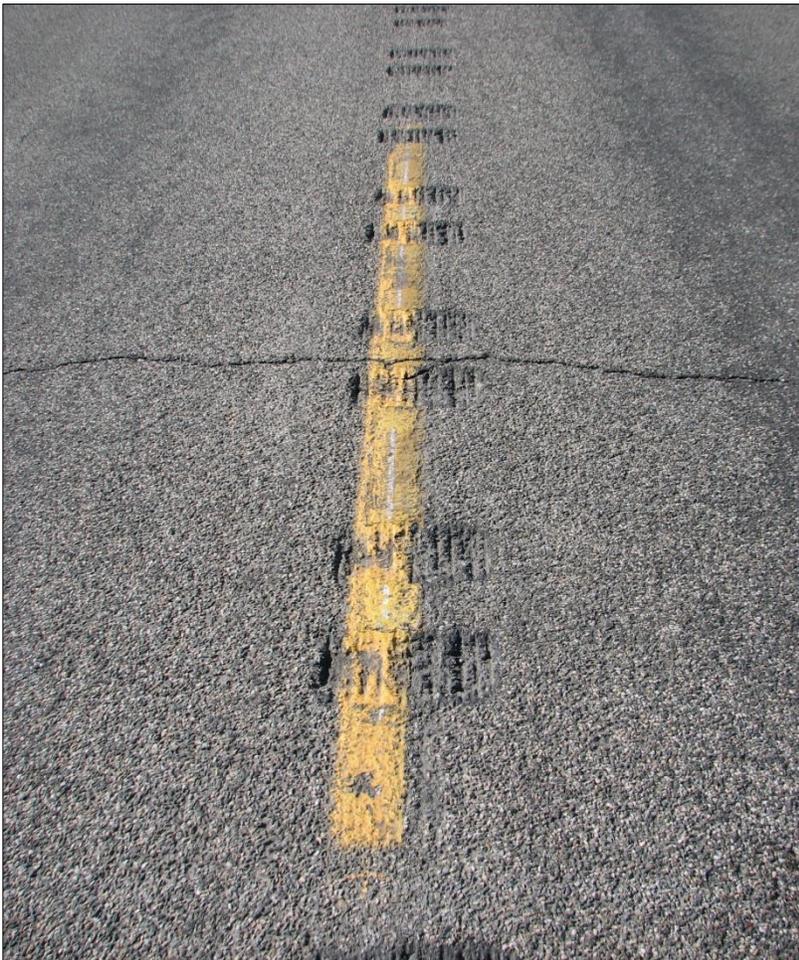
↙↓ Images representative of the general condition of the stripe over rumble strip on the project.

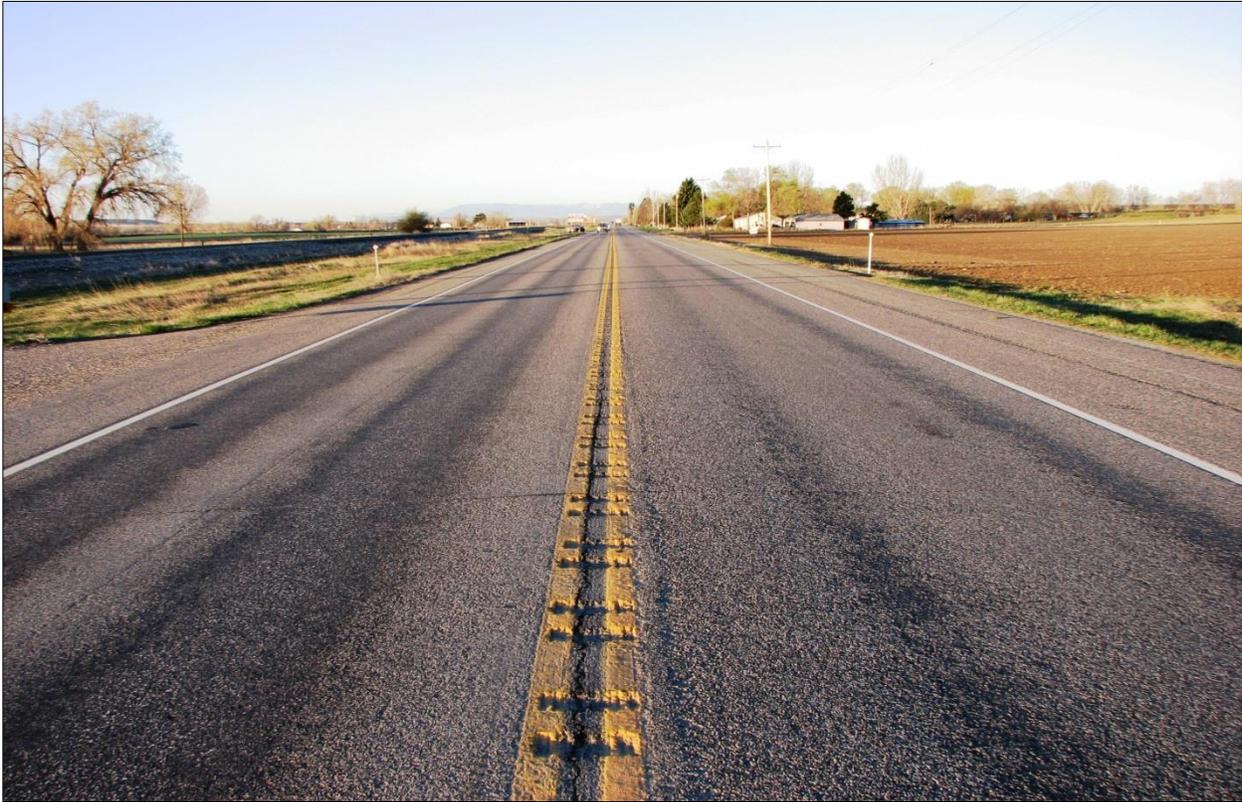
↑ Overview of Visamax Plus section, view south: Approximate mile post 52.

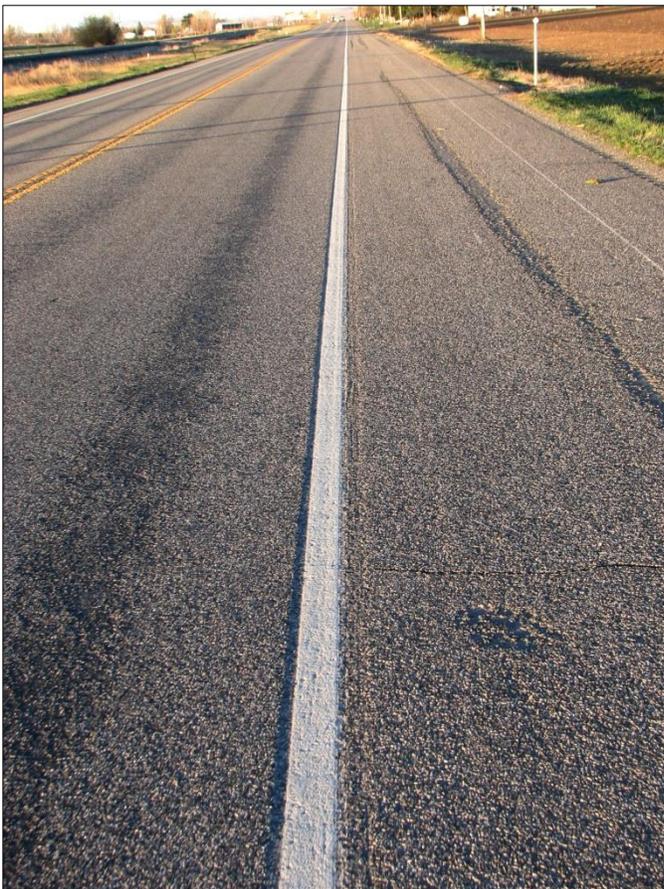
← Representative image of the condition of white stripe indicative of the entire section.

The applied 60 mil grind depth, to date, appears to protect the stripe from plow pass damage as compared to the un-milled centerline stripes.

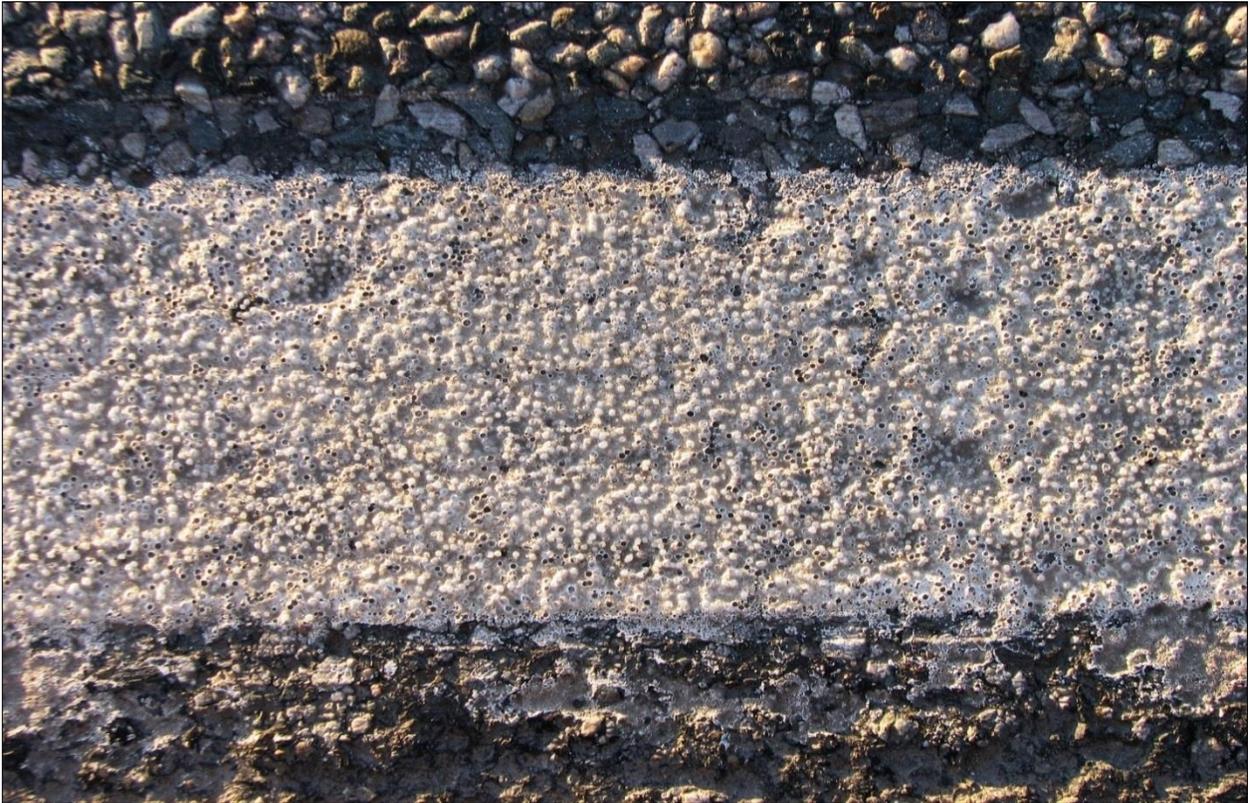
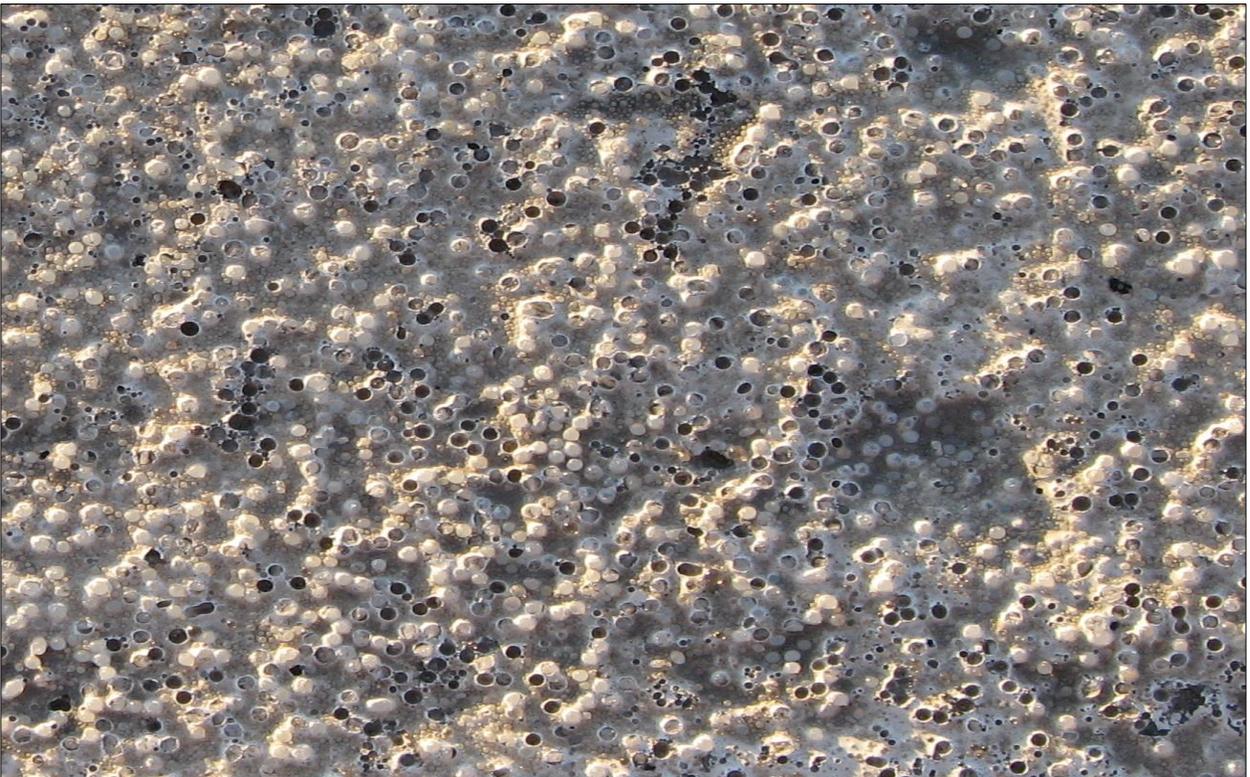
↕ Several close-ups of the Potters Visamax 50/50 blend with type II beads. Visually, it appears a small proportion of the larger bead spheres have debonded from the binder; either from inadequate embedment, environmental factors, vehicle tire impact; or successive plow passes may be wearing the pavement surface to a point where top contact with the recessed stripe is now beginning to take place.

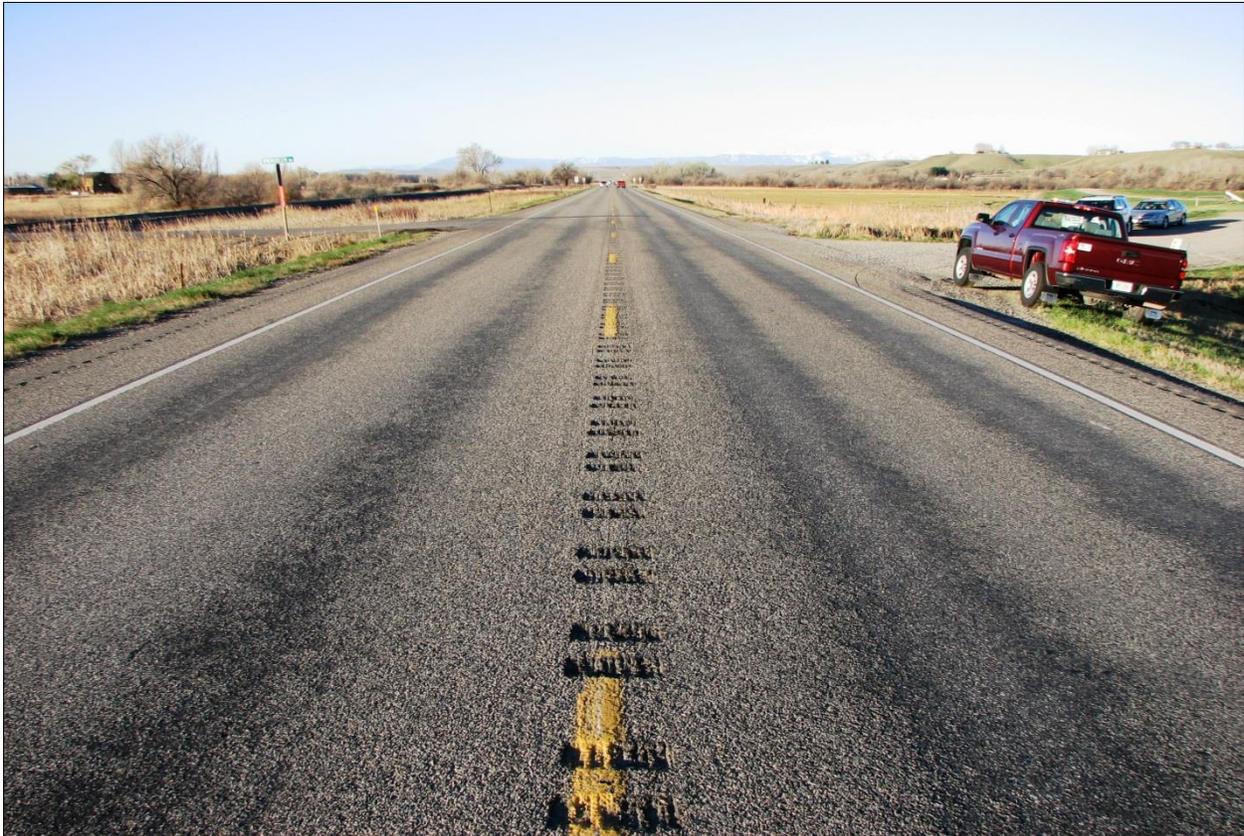
↑ Overview of Type II control section, view south: Approximate mile post 49.

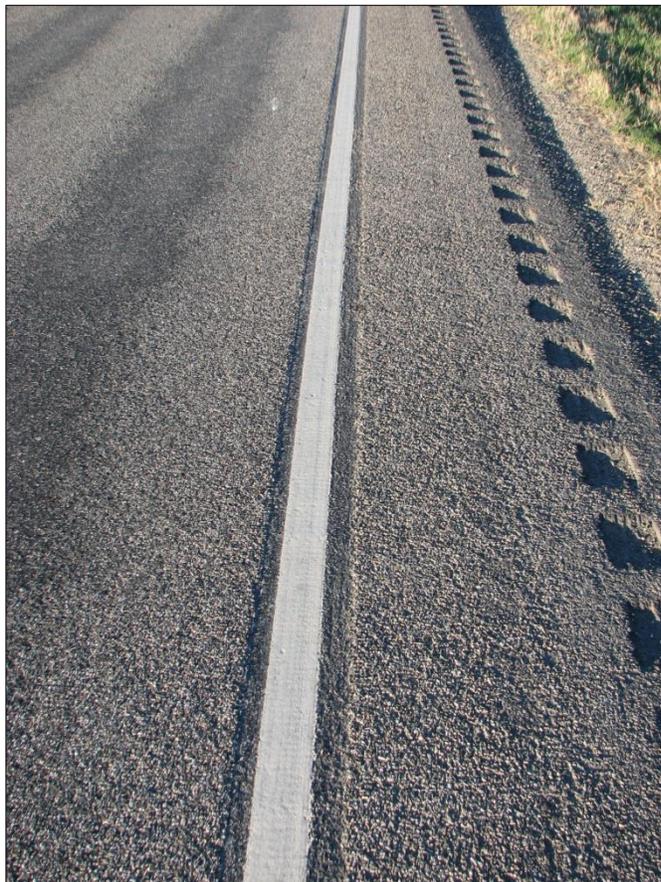
← Representative condition of the white stripe indicative of the entire section.

The applied 60 mil grind depth, to date, appears to protect the stripe from plow pass damage as compared to the un-milled centerline stripes.

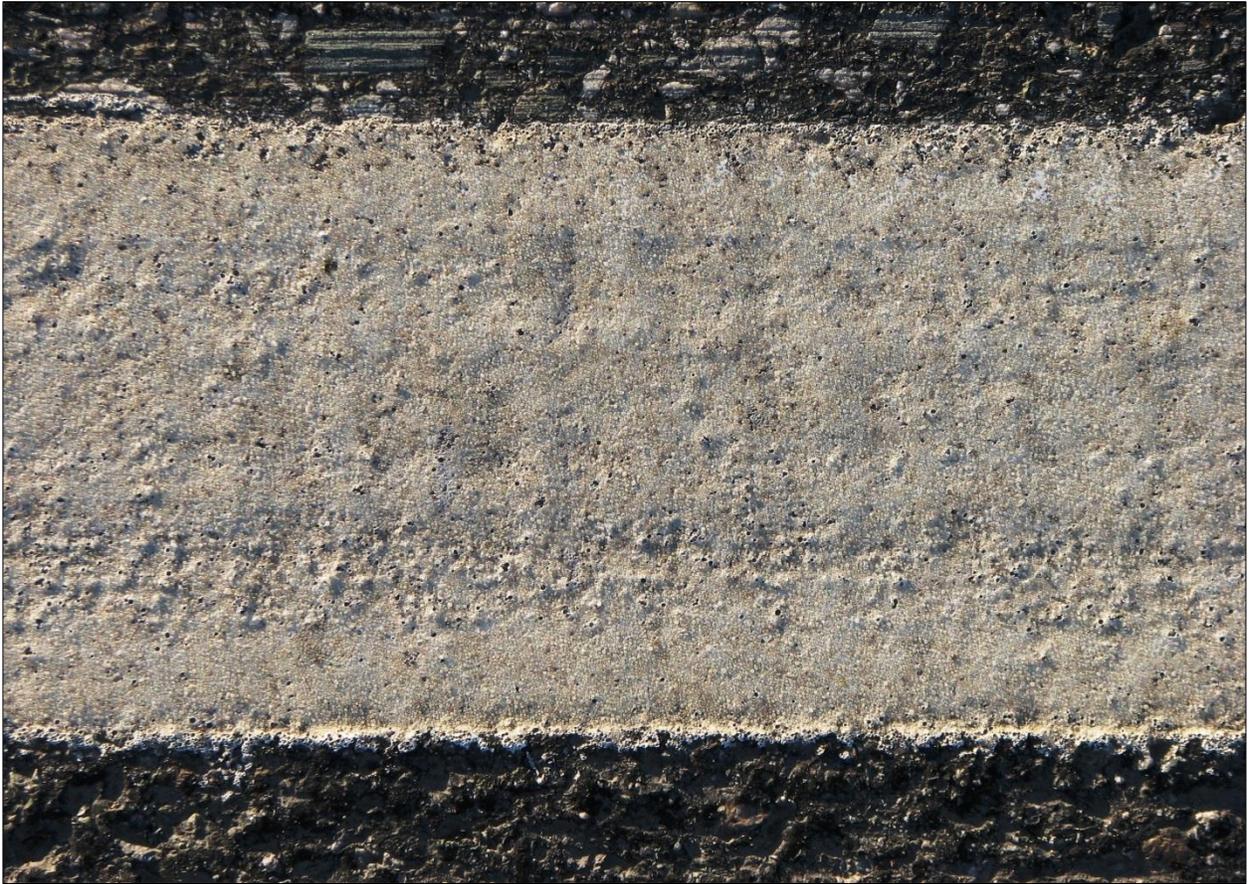
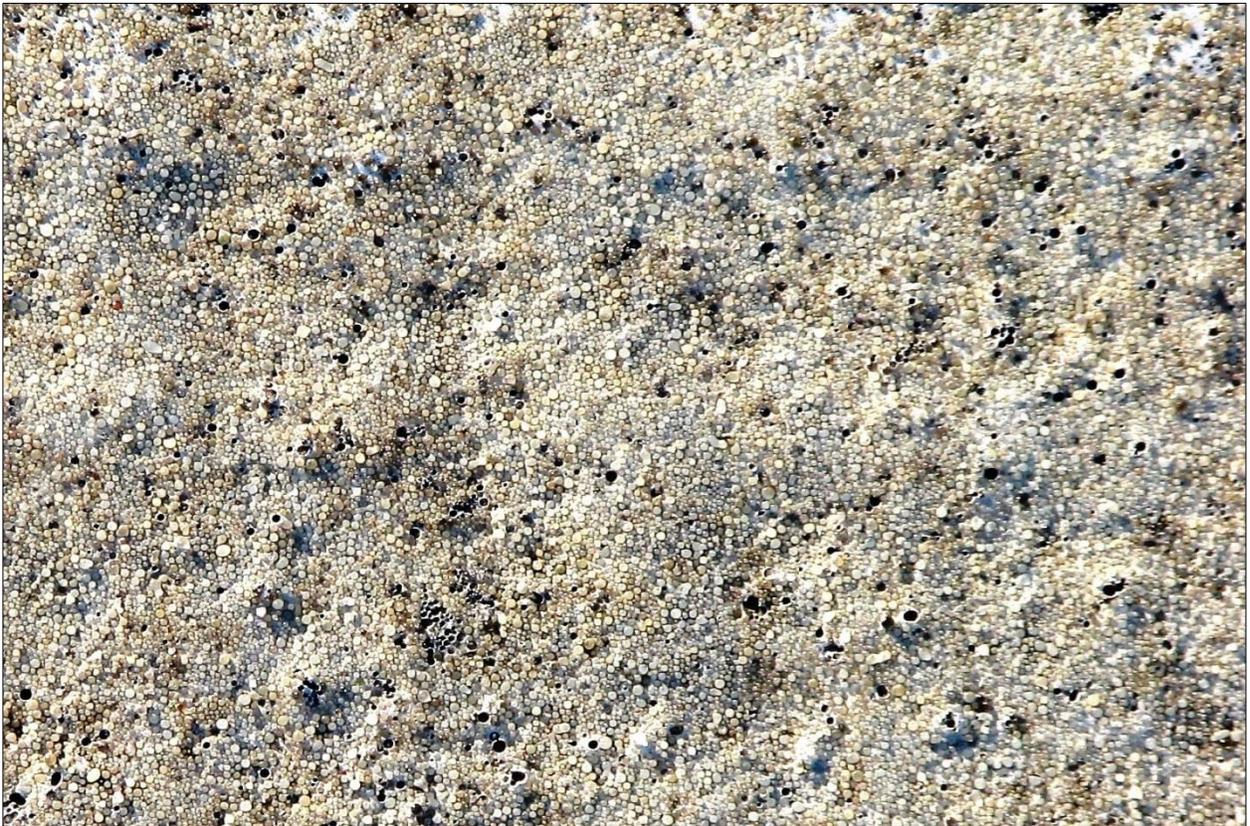
↑↓ Several close-ups of the type II bead section.

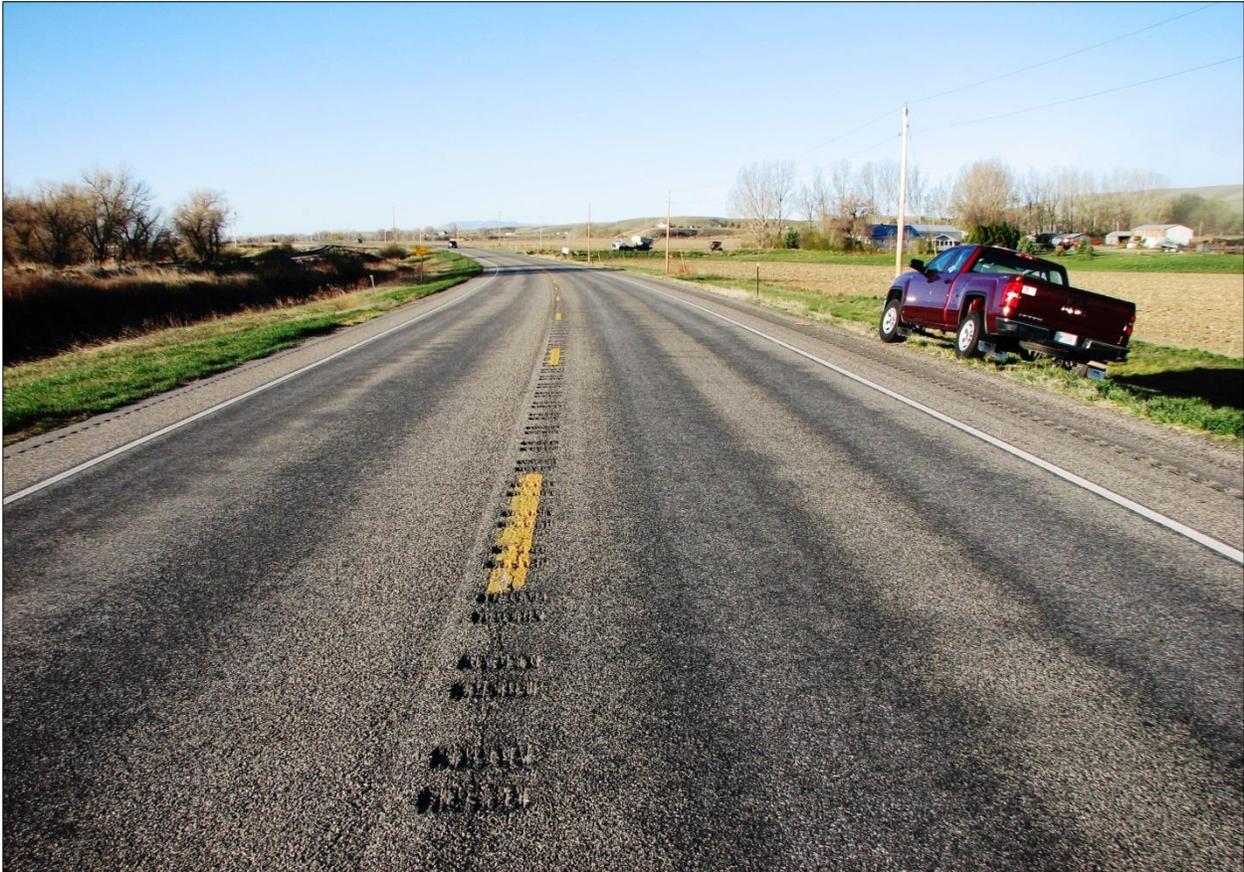
↑ Overview of 3M Elements section, view south: Approximate mile post 47.

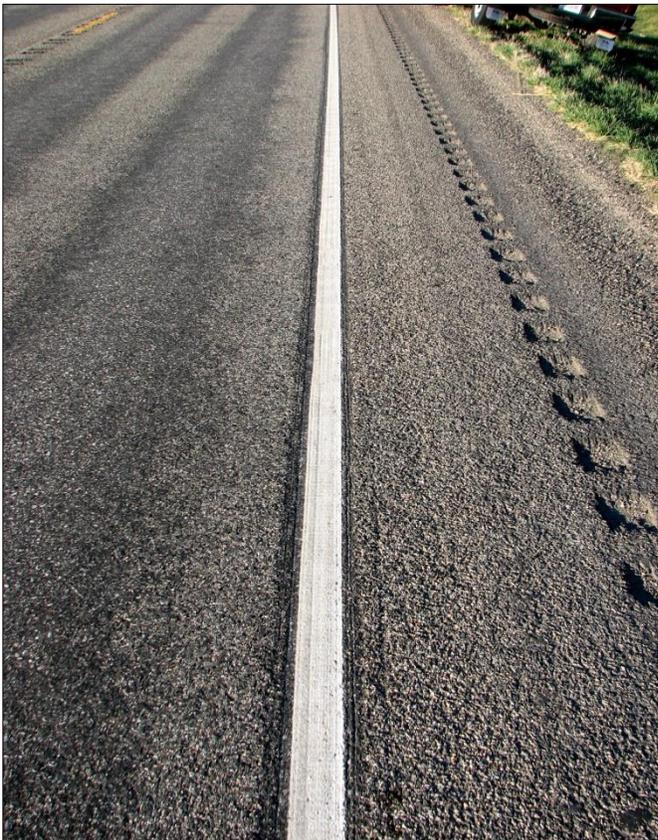
← Representative image of the condition of white stripe indicative of the entire section.

The applied 60 mil grind depth, to date, appears to protect the stripe from plow pass damage as compared to the un-milled centerline stripes.

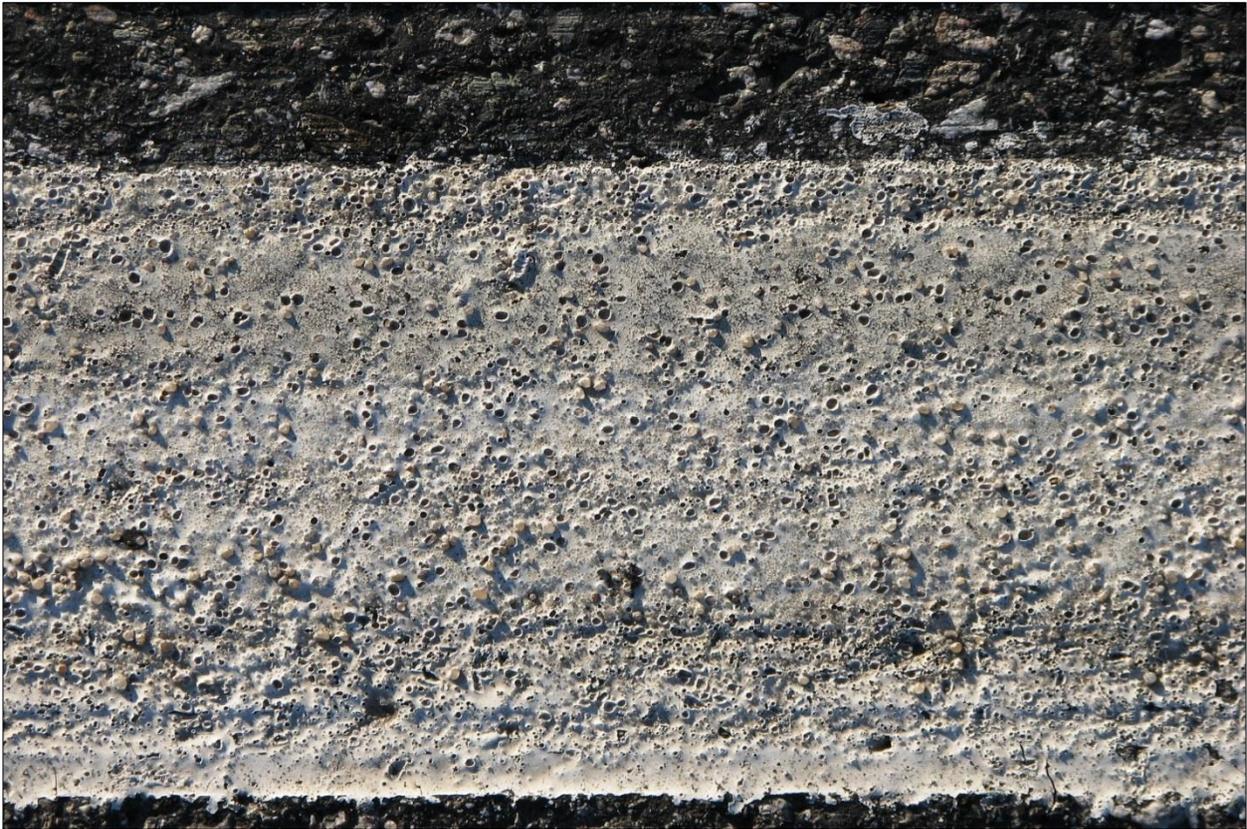
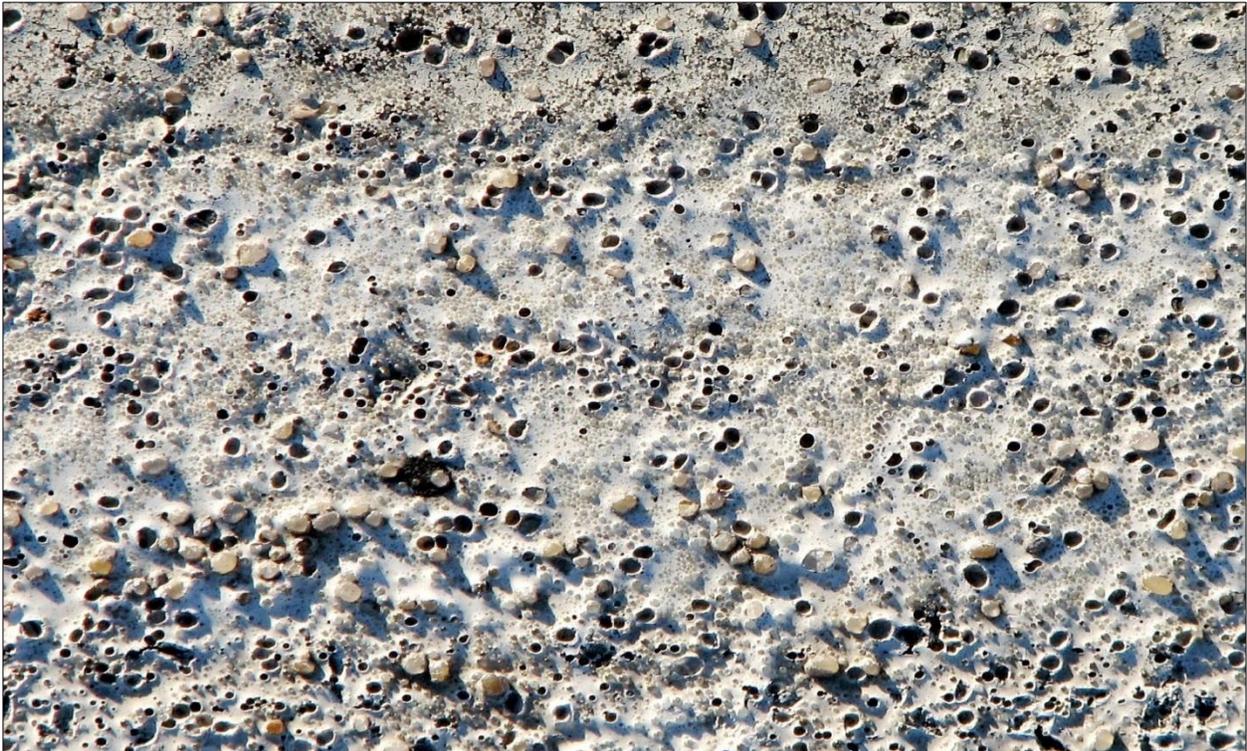
↑↓ Several close-ups of the 3M Elements 30% blend with type 2 beads. Visually, it appears a proportion of the larger bead elements have debonded from the binder; either from inadequate embedment, environmental factors, vehicle tire impact; or successive plow passes may be wearing the pavement surface to a point where top contact with the recessed stripe is now beginning to take place.

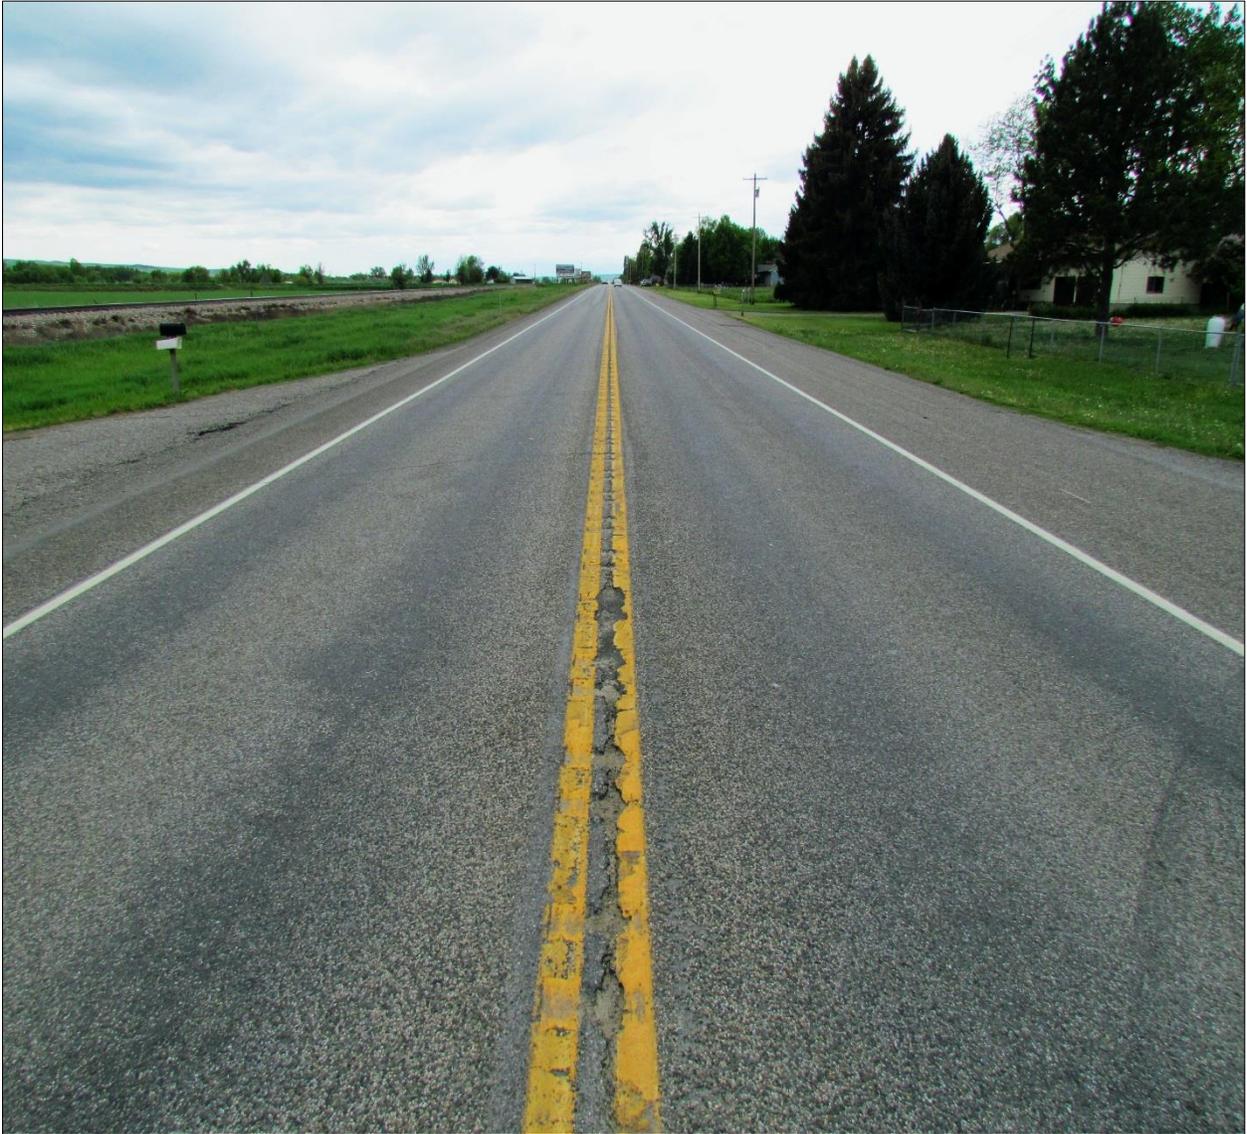
- ↑ Representative image of project pavement marking condition; approximate reference point 51, view west.

All project sections (visually) were in the same condition as reported in 2016. Recessed fog line (white stripe) was in good shape, intact throughout the entire length of the project.

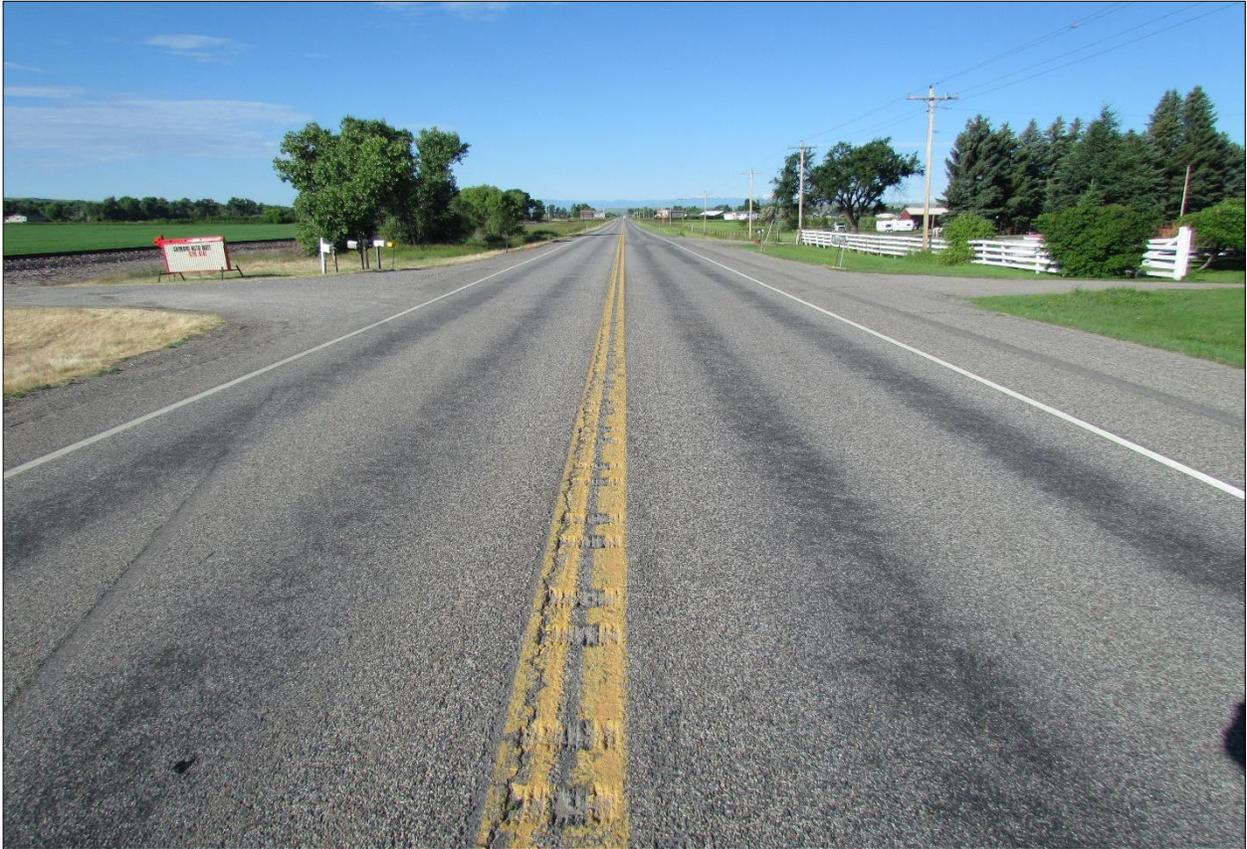
↑ Representative image of project pavement marking condition; approximate location Carbon/Yellowstone County line (view south).

All project sections (visually) were in the same condition as reported in 2017. Recessed fog line (white stripe) was in good shape, intact throughout the entire length of the project sections.

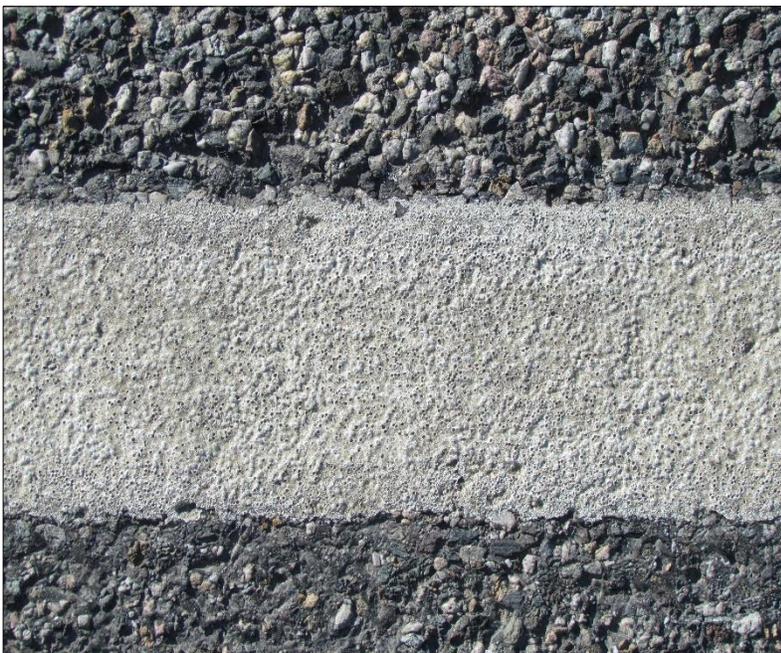
← Representative image of fog line condition on project.

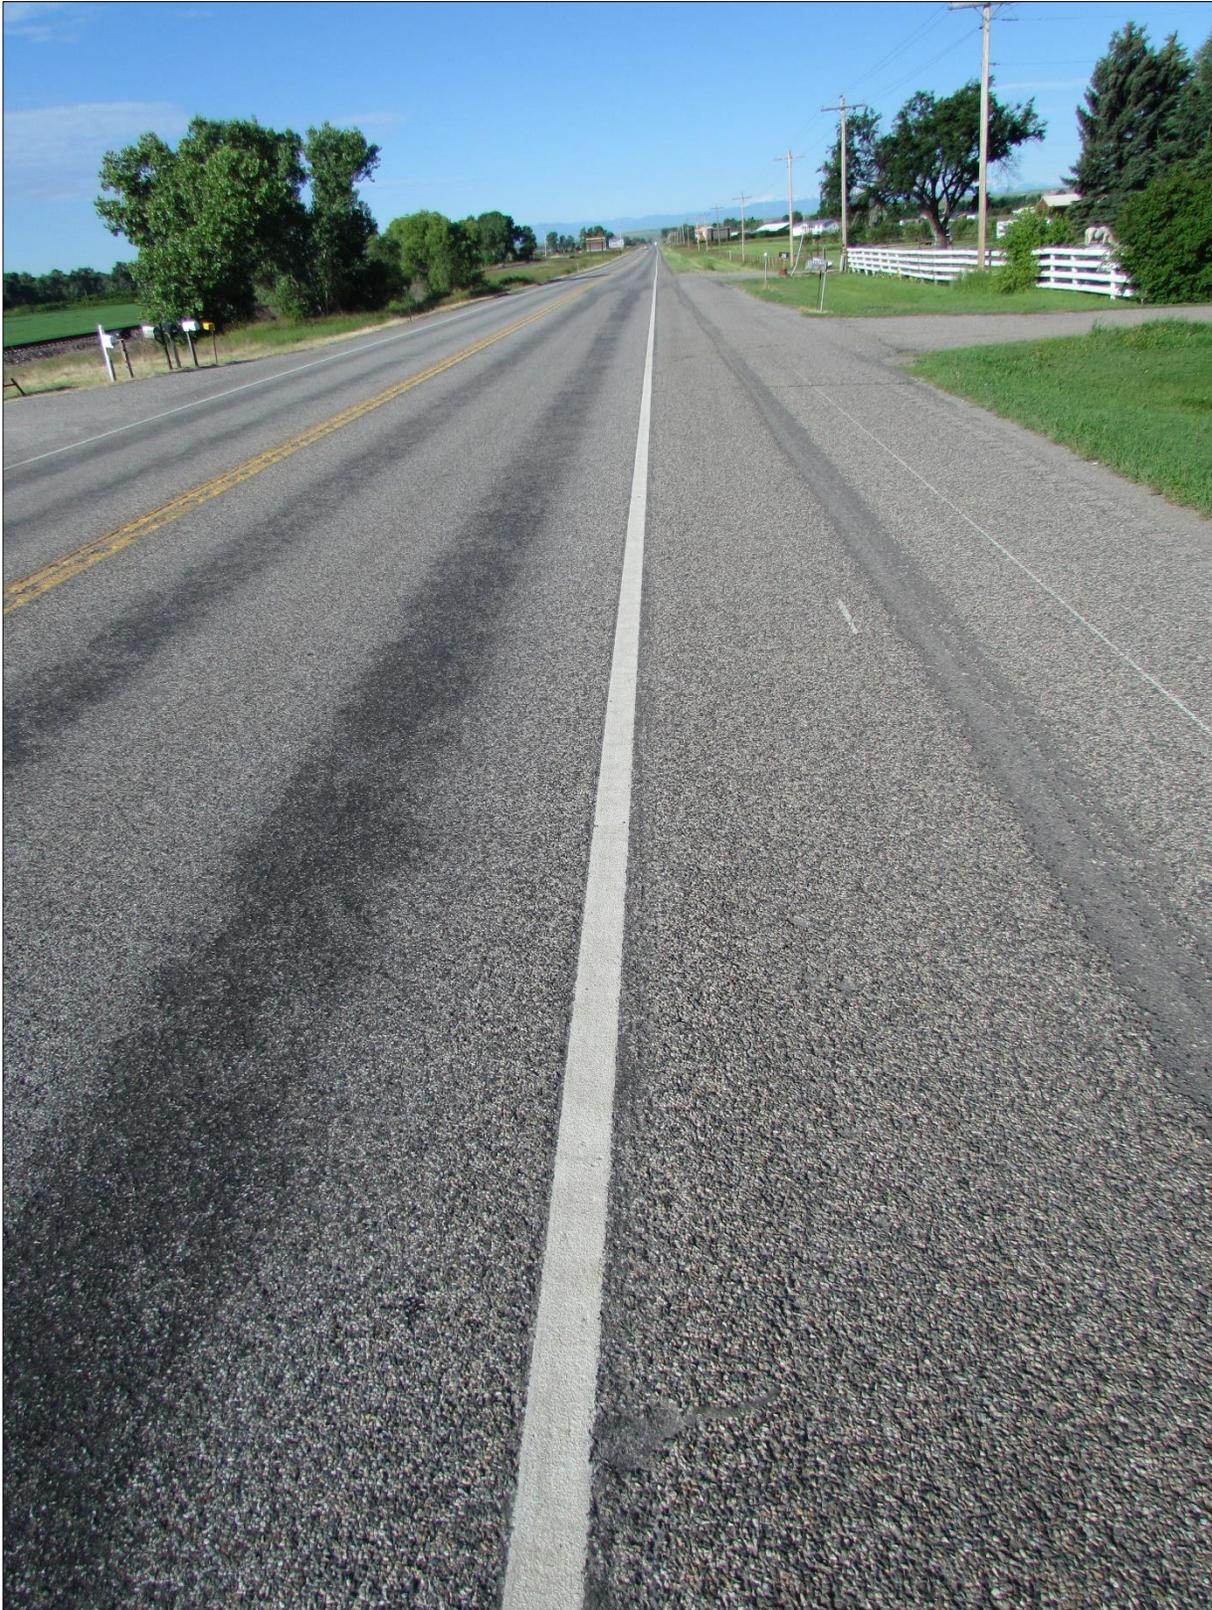
↑ Representative image of 60mil recessed fog line stripe. This has kept the stripe (on all sections) intact since installation in 2013.
