Montana Department of Transportation
Research Program

FINAL REPORT

Detectable Warning Devices (Truncated Domes) for use by the Visually Impaired

Project No.: STPU 5201(11)

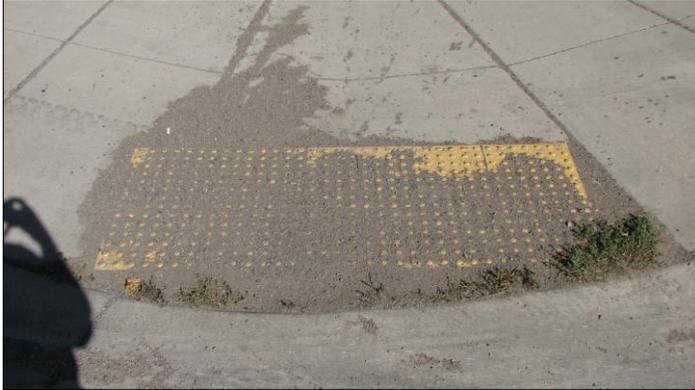
Installation 1A: Located on the northeast corner at the intersection of the east entrance to the Expopark adjacent to 5th Ave. N.W.

Adhesion fair. Interior seams beginning to curl up. 10% loss of domes on leading edge of mat due to blade damage. Minimum wear on domes. Color good. Accumulation of debris diminishes the tactile function of the device

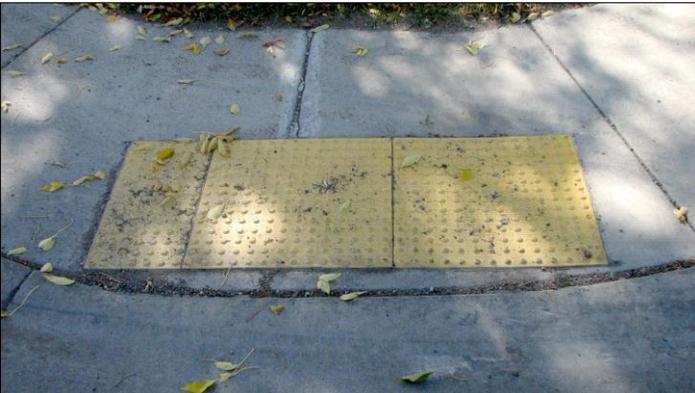
Installation 1B: Located on the southwest corner of the intersection 4th Ave. N.W. & 6th St. N.W.

Adhesion fair. West interior seam continues to curl and accumulate debris. Perimeter seam still tight. Color good. Minimum wear on domes.

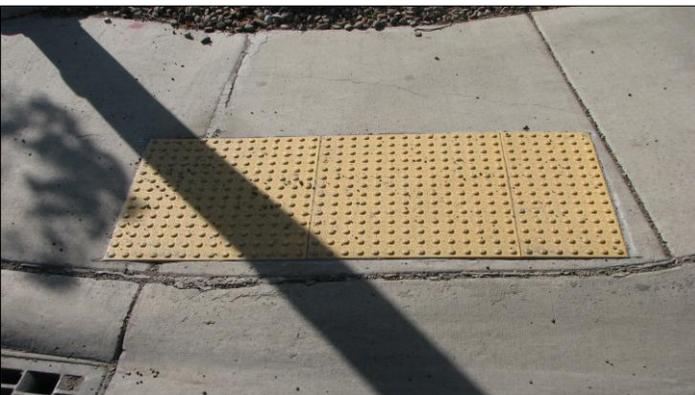
Installation 1C: Located on the southwest corner of the intersection 5th Ave. N.W. & 6th St. N.W. This treatment connects the east-west pedestrian walkway.

Same condition as 1B, has suffered minimum dome loss.

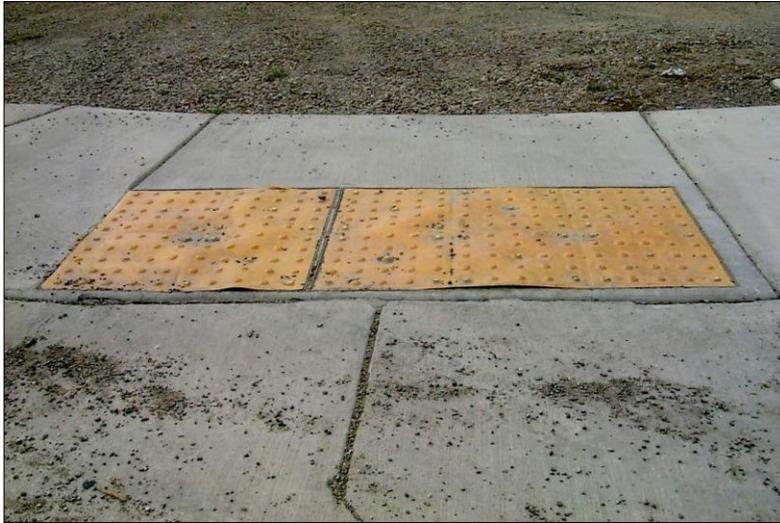
Installation 2: Located on the southwest corner at the intersection of 6th Ave. N.W. and 6th St. N.W.

This treatment performed poorly since construction. Approximately 35% of dome relief has been lost through use of a shovel or blade apparatus during the 2004-05 winter. Domes are wearing rapidly. The edges within the treatment and perimeter are beginning to lose adhesion. The tactile response is spongy, substantial air pockets beneath the mat, severe loss of adhesion. The setting pins are breaking off. Color is good. This treatment has been determined as a trip hazard and has been removed.

Note that this device was improperly installed and most likely led to its premature failure.

Image is condition of device prior to removal

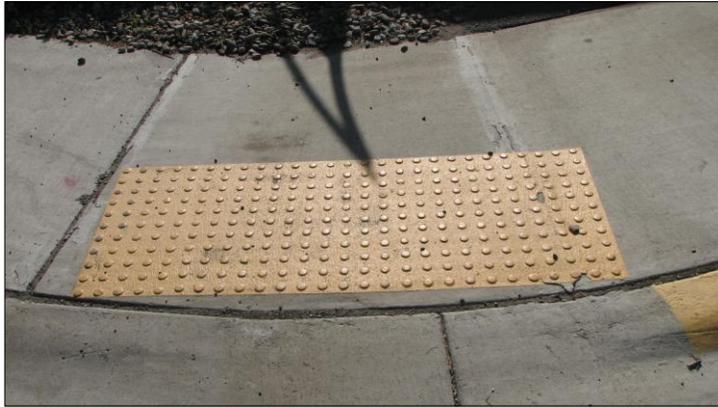
Installation 4A: Located on the southwest corner of 5th Ave. N.W. and 6th St. N.W.

This treatment connects the north-south pedestrian walkway.

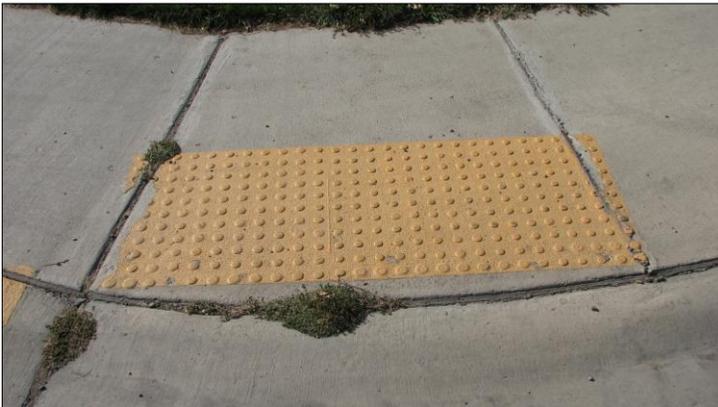
Installation 4B: Located on the northwest corner of 5th Ave. N.W. and 6th St. N.W.

This treatment connects the east-west pedestrian walkway.

South end of treatment deteriorating at mortar joint.

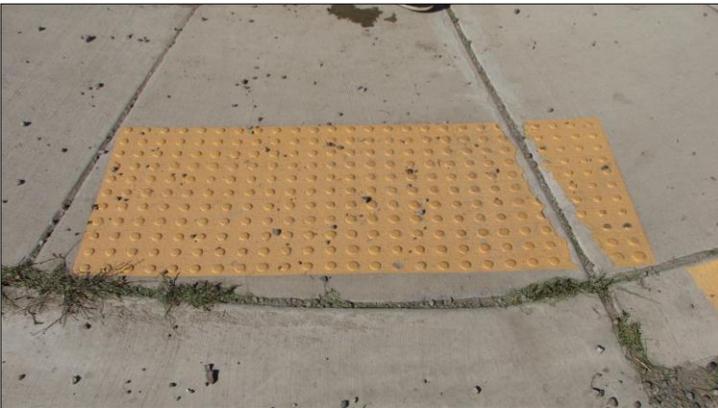
Installation 4C: Located on the northwest corner of 2nd Ave. N.W. and 6th St. N.W.

East mortar joint failing.

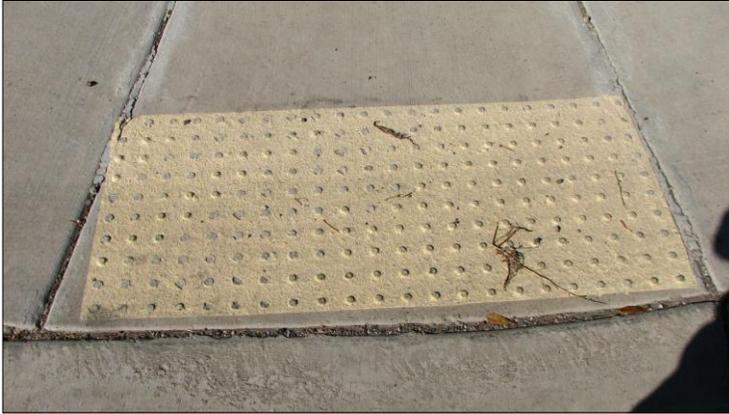
Installation 5A: located at northwest intersection of 1st Ave. N.W. and 6th St. N.W.

50% loss of domes.

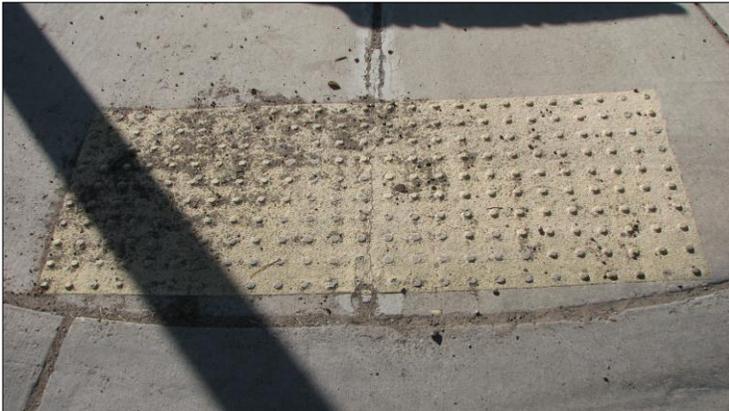
Installation 5B: Located at the southwest intersection of 3rd Ave. N.W. and 6th St. N.W.

40% loss of domes.

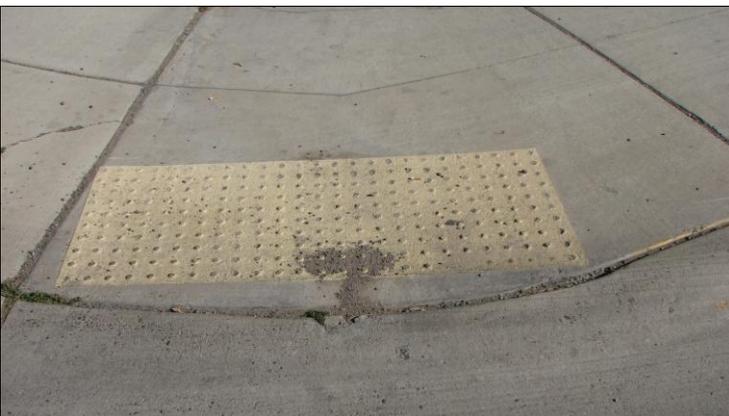
Installation 5C: Located on the southeast corner of the east Expopark entrance and 6th St. N.W.

60% loss of domes.

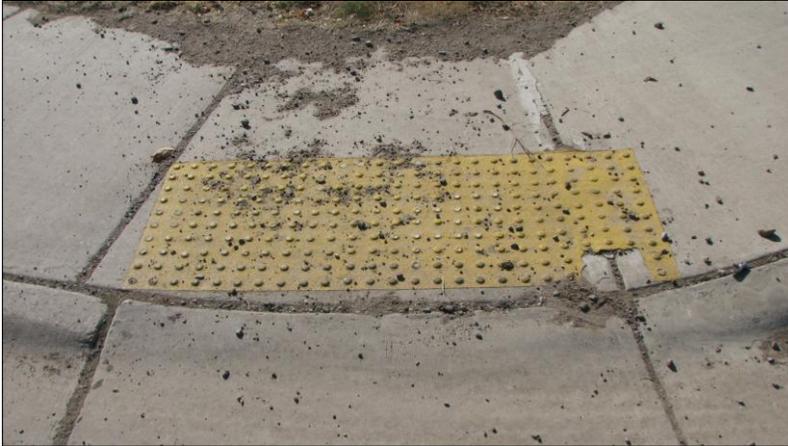
Installation 6A: located on the southwest corner of the intersection 2nd Ave. N.W. and 6th St. N.W.

All installations were in poor condition at the time of inspection. Treatment 6A is continuing to lose adhesion around the edges of the mat. The anti-skid coating over the top of the rubber domes with treatment 6A & 6B is continuing to flake off. It is unclear if this is a result of blade damage, sunlight deterioration or through the action of freeze-thaw. Substantial dome loss by blade damage is apparent on both sites.

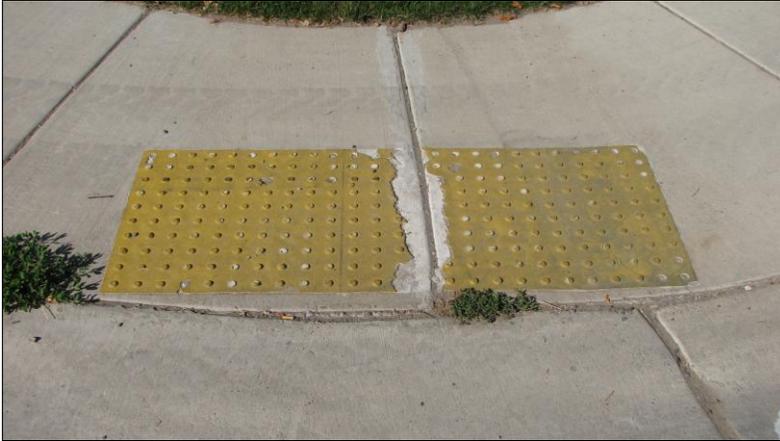
Installation 7: Located on the northwest corner of the intersection of 3rd Ave. N.W. and 6th St. N.W.

This treatment is failing rapidly. The surface of the mat has continued to rip and tear. There is substantial dome loss since the 2006 evaluation. Edges are loosing adhesion. Color is fair. At this time it is not a trip hazard.
