EXPERIMENTAL EVALUATION FINAL REPORT

Thin-Whitetopping Bonded Composite

Location: Glendive, Montana – Dawson County

Project No.: STPP 20-1(6)0, P-20, C000020; Highway 16, Milepost 0-0.6

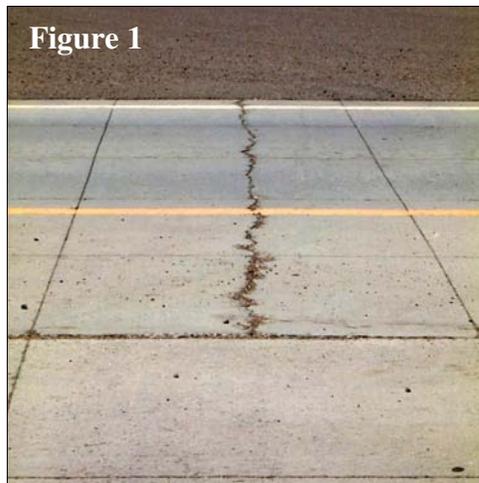
Figure 1

A visual inspection of the entire project was performed to document all types of surface cracking and distress. Photographic documentation of some of the cracks, recent repairs, as well as a representative crack map is included in this report. Note that the crack map is strictly an interpretation of progressive distress during the evaluation phase of the project, it is not to scale. Currently three transverse cracks are present on this project, all in the southbound lane. Location as follows (footage counted from the south end of the project going north), #1 at 1244' (541m), #2 at 1380' (420m), and #3 at 1480' (451m), see crack map at end of report. Note that these cracks developed soon after

placement during construction. These cracks have widened since construction and are rated as severe in nature (example of crack in figure 1). Incompressible debris (rocks, friables etc.) is entering the cracks and will accelerate the deterioration of the fracture with freeze thaw events, however no debonding of the asphalt and PCCP layer was observed with any of the existing transverse cracks in this evaluation. No additional transverse cracking has occurred since construction.

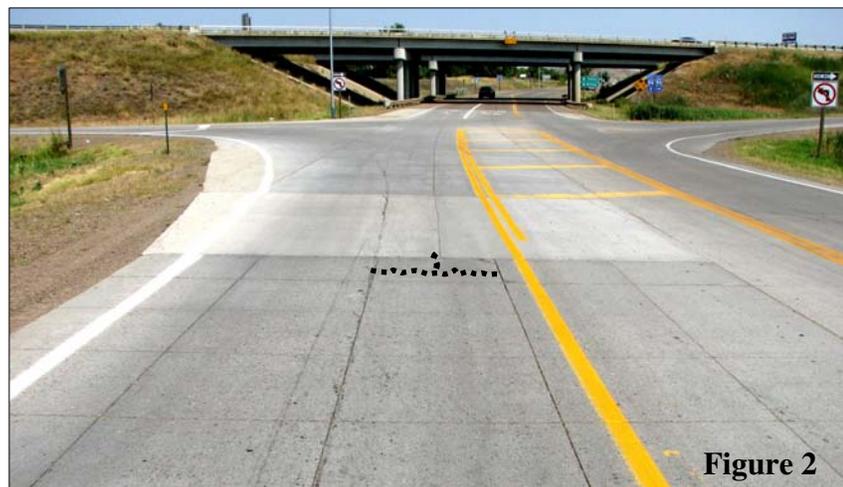
Figure 2

During this analysis several more panels have cracked, located at the north edge of the southbound lane of the project; adjacent to the recent full-depth repair (figure 2, crack panel shown as black line in image). In this

type of cracking which is indicative of this kind of pavement treatment, without an autopsy of the panel, it is difficult to determine the various causes of cracking. It could entail debonding of the PCCP from the asphalt concrete, structural failure of the underlying AC layer, which visually, has not been seen, or possibly overloading of the composite panel or sympathy cracking. In addition, panels that have previously cracked are at or near the curb edge adjacent to areas where turning movements of heavy trucks are traveling onto the gravel curb and onto the edge of the PCCP pavement. The lack of support may have allowed cracking at these locations (refer to the crack map at the end of this document). Figure 3 (located midway on southbound side) shows how the lack of curb supports can allow panels to crack and shift from heavy loadings. Figure 4 shows the extent of cracking in 2008.

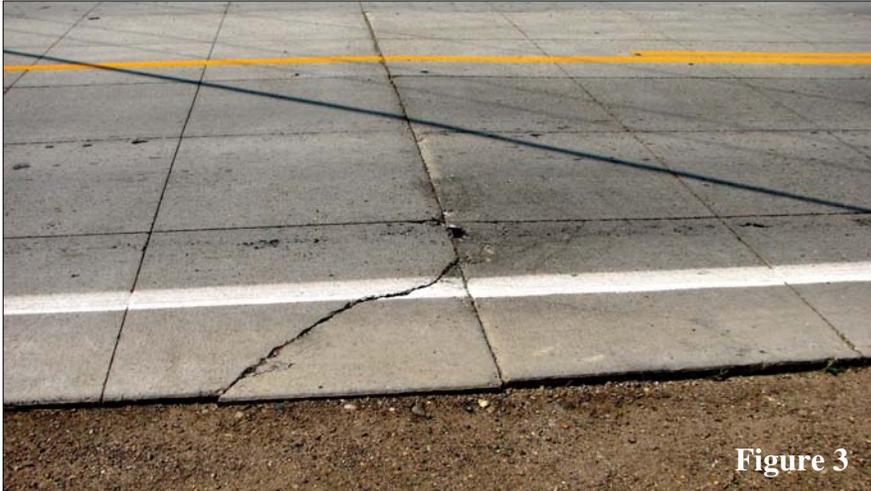
Figure 3

Fifteen panels were affected at the north and south end of the project on the southbound lane. In fall of 2005 both these areas were repaired due to the extent of the panel cracking. The repair involved removal of the existing PCCP and asphalt layers and replaced with full-depth PCCP.

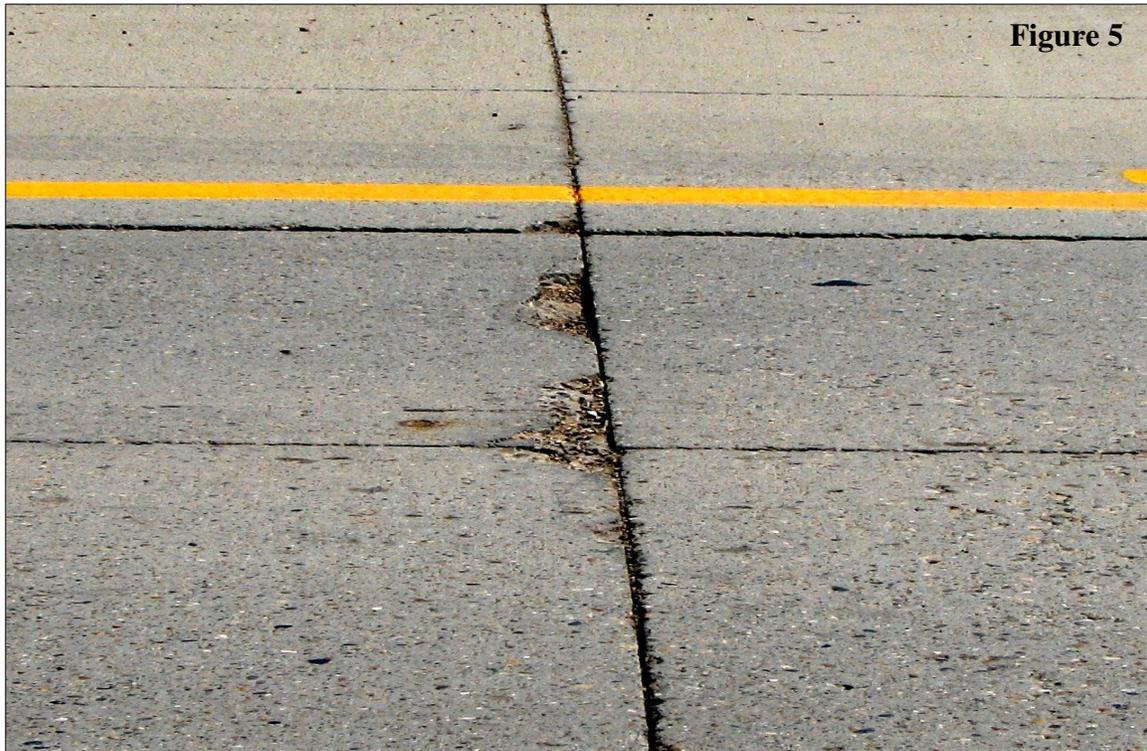
Several areas on the project are showing signs of wear and tear with slight spalling at panel saw cuts, to date minimum occurrences but gradually appearing. Figure 5 is an example of the spalling.
