Montana Department of Transportation  
Helena, Montana  
Research Program

## **Experimental Whitetopping Final Report**

Location: Great Falls, Montana; Northwest Quadrant of Intersection of N. W. Bypass & 3<sup>rd</sup> St. N. W. (U5206 & U5203). Three southbound lanes of 3<sup>rd</sup> St. N. W.

Evaluation Date: July 2004

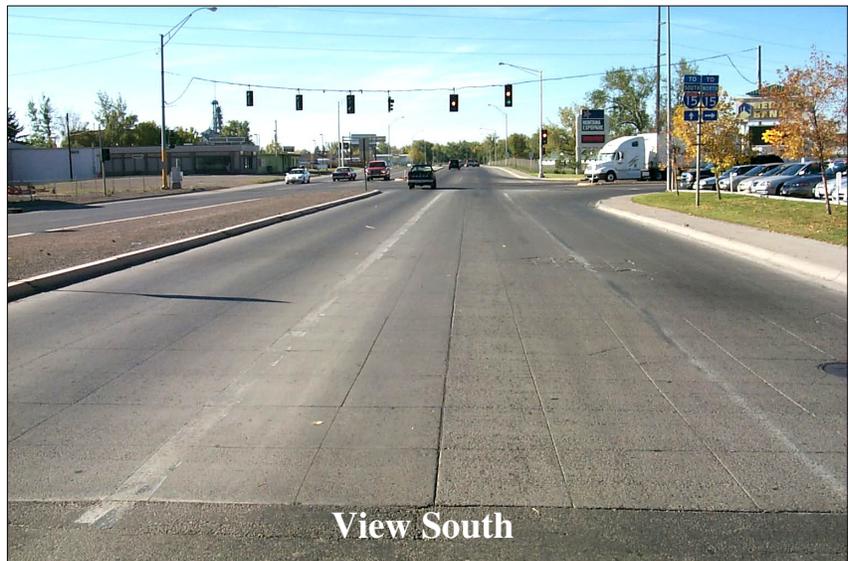
This Whitetopping project was initially constructed in fall of 1999 to alleviate the continued heavy rutting and shoving of the asphalt concrete at this intersection. During late summer of 2000, a small portion of the right-turn lane developed severe cracking. This was initially documented in the fall of 2000 evaluation report on this project. This failure of the pavement Due to failure

of the AC layer and subgrade) occurred at a rapid rate, estimated at 3-6 weeks. The failed section comprised five panels longitudinally and three panels transversely, approximately 10' x 15' located in the right-hand turn lane. This section went through the entire 2000-2001 winters

in this condition, withstanding freeze-thaw cycles, traffic and maintenance snow removal. The failed area was removed and repaired in the spring of 2001.
