FINAL REPORT

GEOSYNTHETIC REINFORCED SOIL - INTEGRATED BRIDGE SYSTEM (GRS-IBS)

Location: Highway 89 (P-3/C000003), Pondera County-South Fork Dry Fork Marias River Crossing

Project Type: Geosynthetic Reinforced Soil - Integrated Bridge System Installation (GRS-IBS)

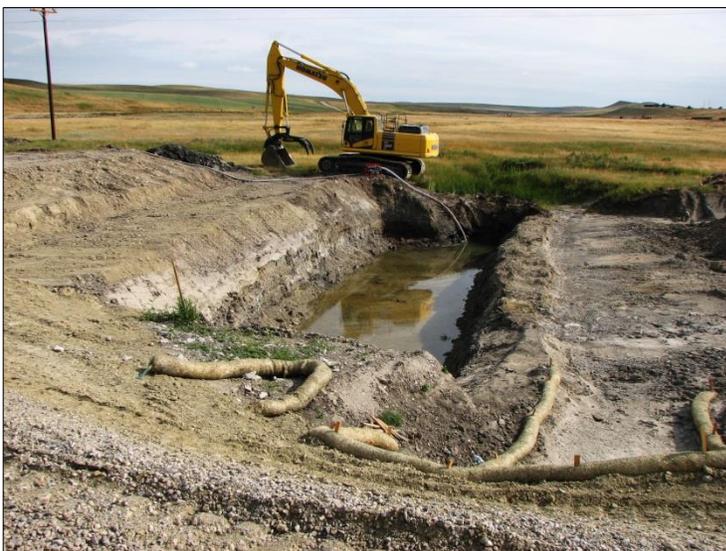
← Excessive soil saturation within the GRS abutment sites required the contractor to install a trench in order to drain or wick the water to the base of the channel, where a sump pump removed the standing water.

Once the area was determined adequately drained and stable the trench was filled.

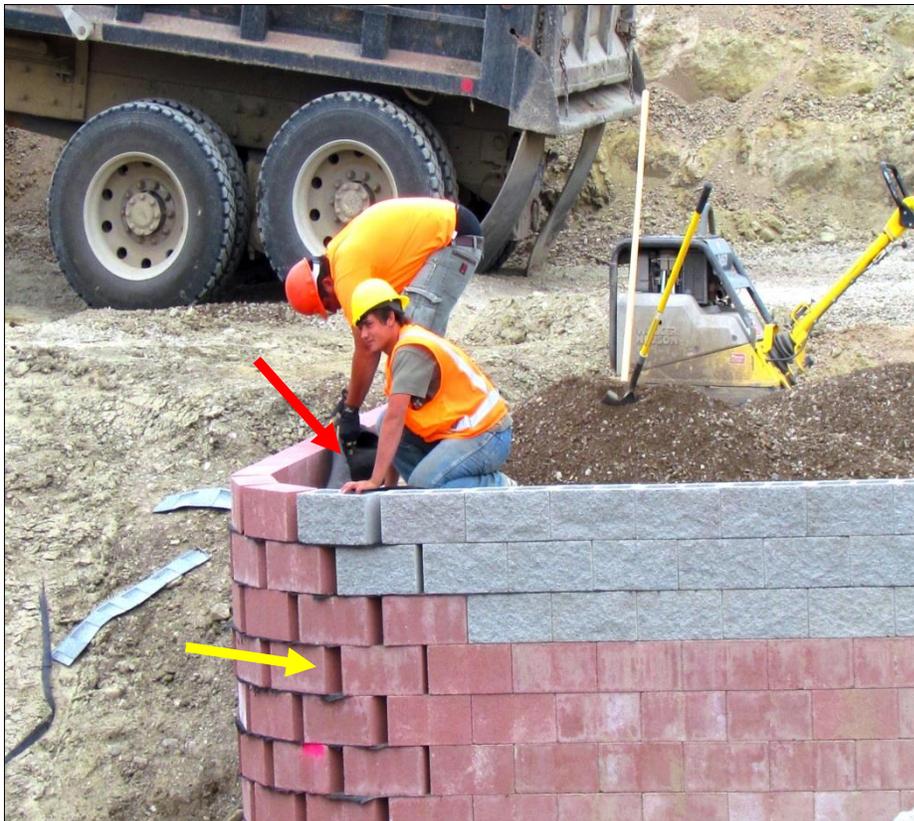
← Since this may be the first GRS constructed with a radius design at the abutment corner, the block manufacturer could only supply conventional rectangular CMU block. This created a frontal gap at the radius (yellow arrow).

Because of this gap, it was determined to apply a separation fabric on the interior vertical face (red arrow) in an effort to mitigate any potential movement of fines to the exterior of the radius.

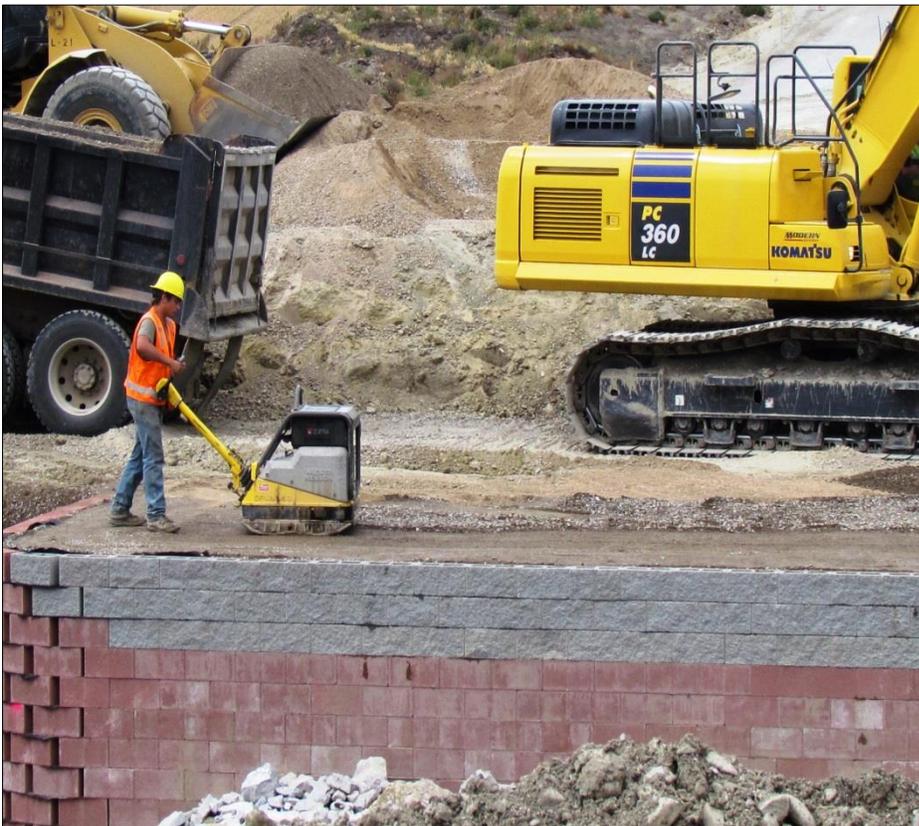
Due to compaction some of the hollow core facing blocks were pushed outward and needed to be pounded back flush with the facing wall. These occurrences were minor.

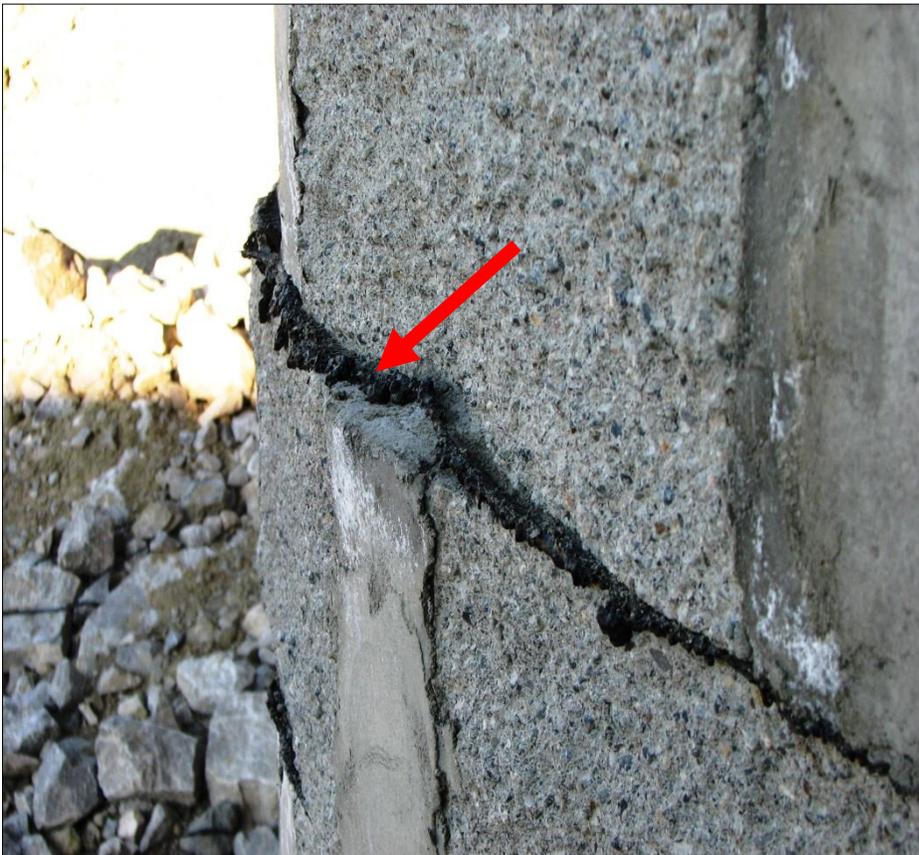
← The Mirifi fabric was removed as much as possible by knife or scissors, however much still remained as seen in previous images.

The contractor elected to use a propane torch to burn and/or melt the remaining sections of geosynthetic material from the abutment facing blocks (red arrow).

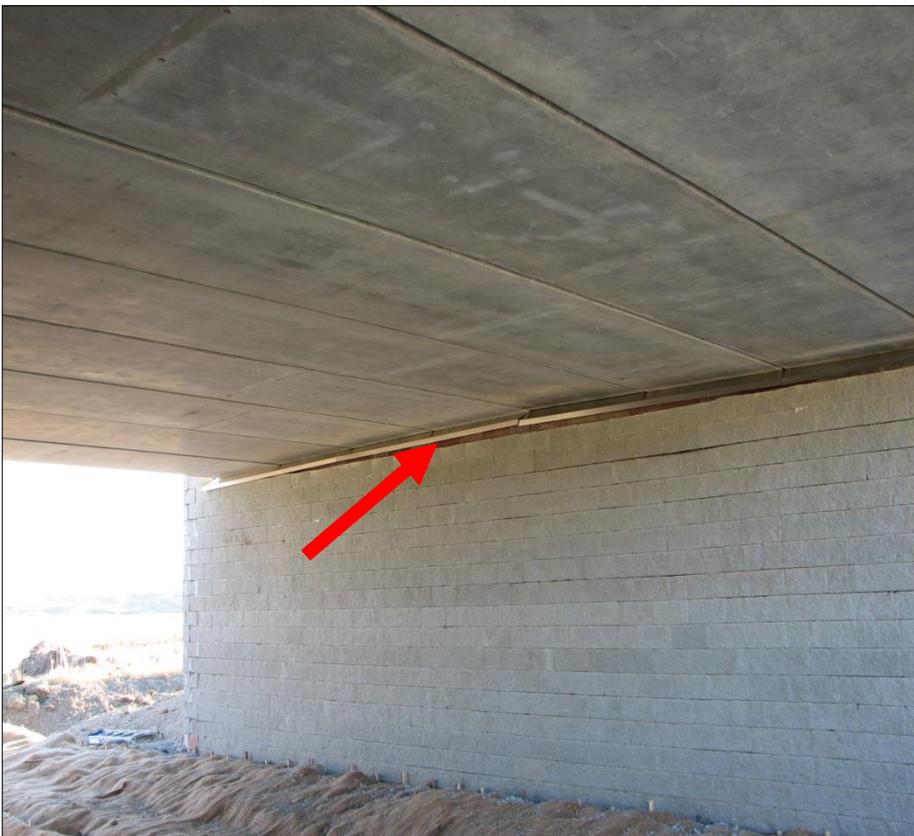
Note the gap between the aluminum fascia and facing blocks (red arrow).

The fascia is meant to cover the top facing block as a protective lip. To date the decision is to attach an extension to the fascia to compensate for the gap.

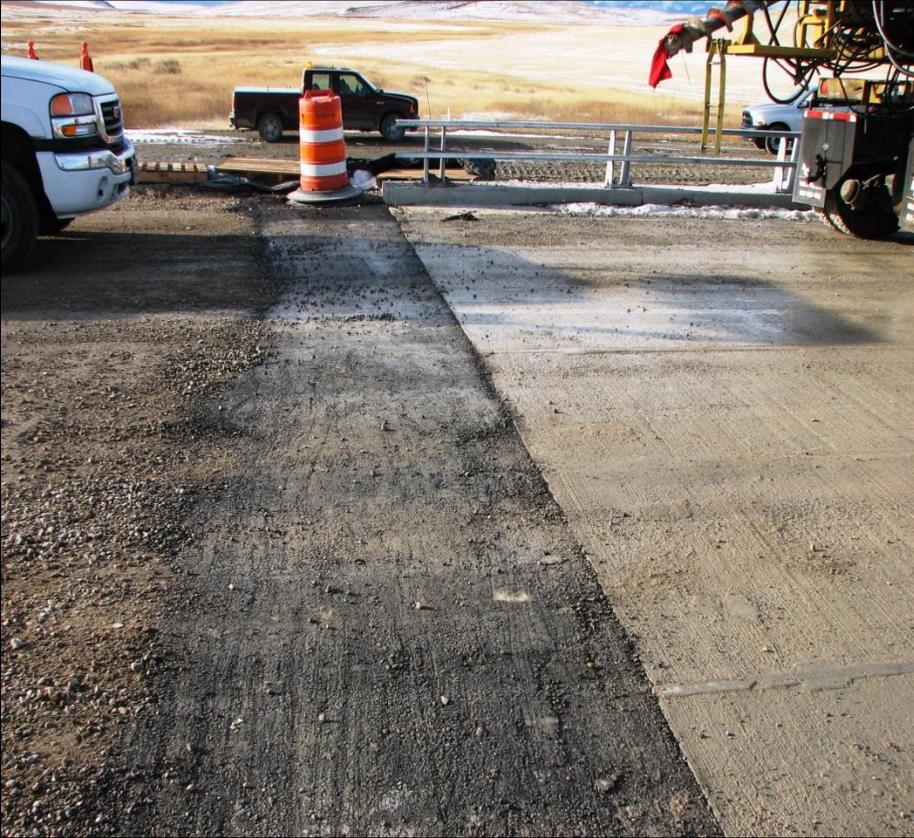
← As stated earlier, an approach length of approximate 3 ft. of asphalt cement (AC) was added in an effort to protect the slab during plowing over the winter.

The AC is of low quality and already exhibits signs of distress. It is anticipated the approach will maintain its integrity until it is paved next spring.

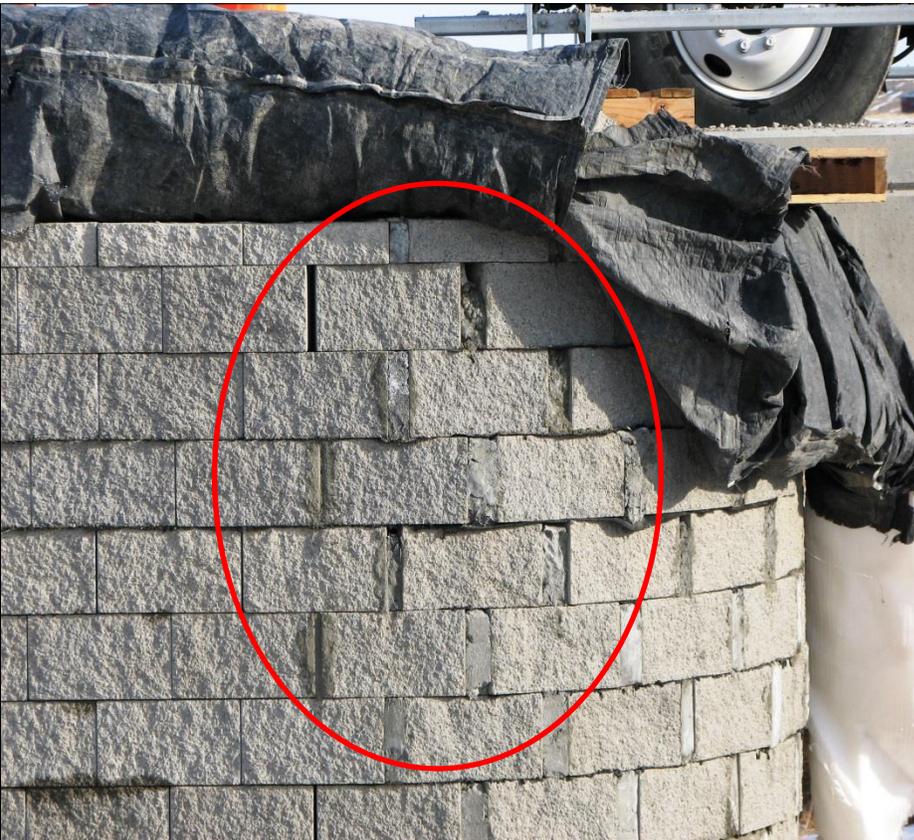
← In areas around the wingwall the quality of the grout patching of the radius gaps is substandard near the top layers as seen in this image.

Also, geotextile material between the facing block layers is still visible.

Future site inspections will verify if these issues were corrected.

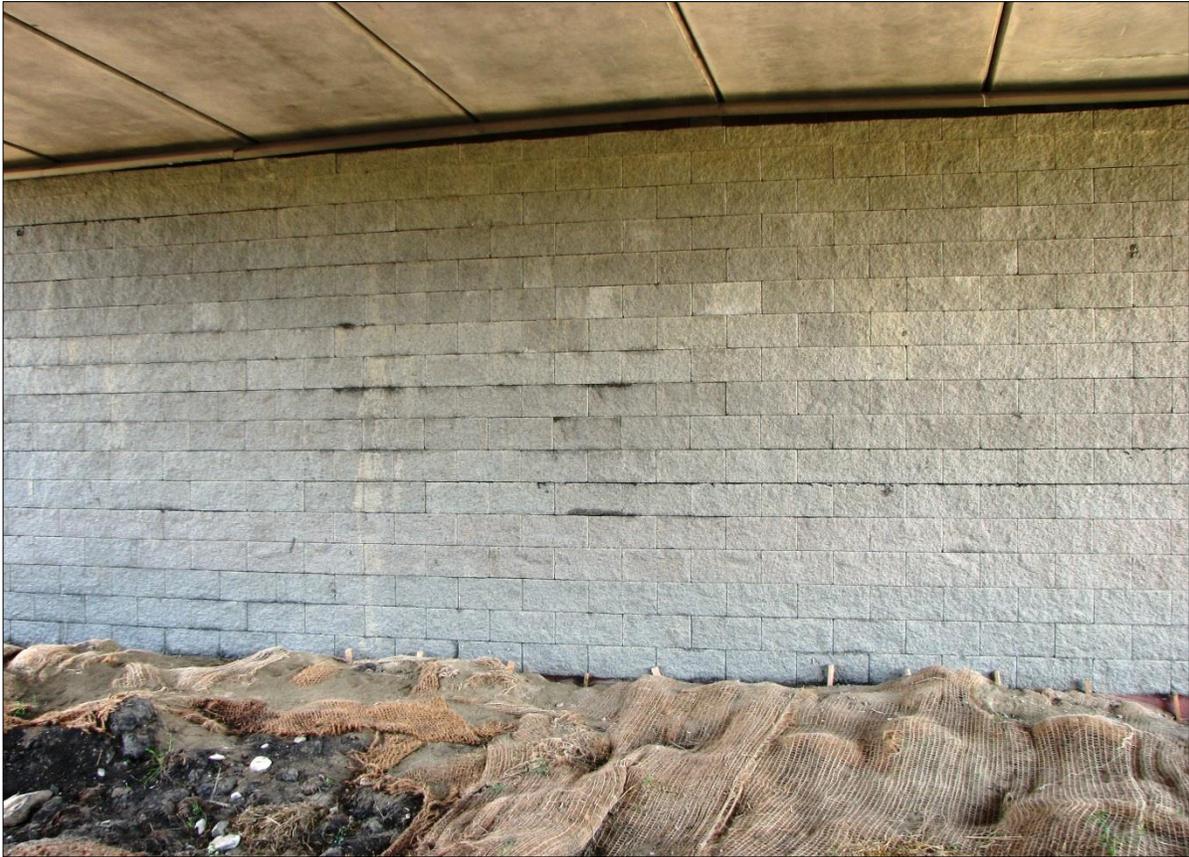
↑ North GRS abutment; active weeping is seen in the is view. This is considered normal for this design.

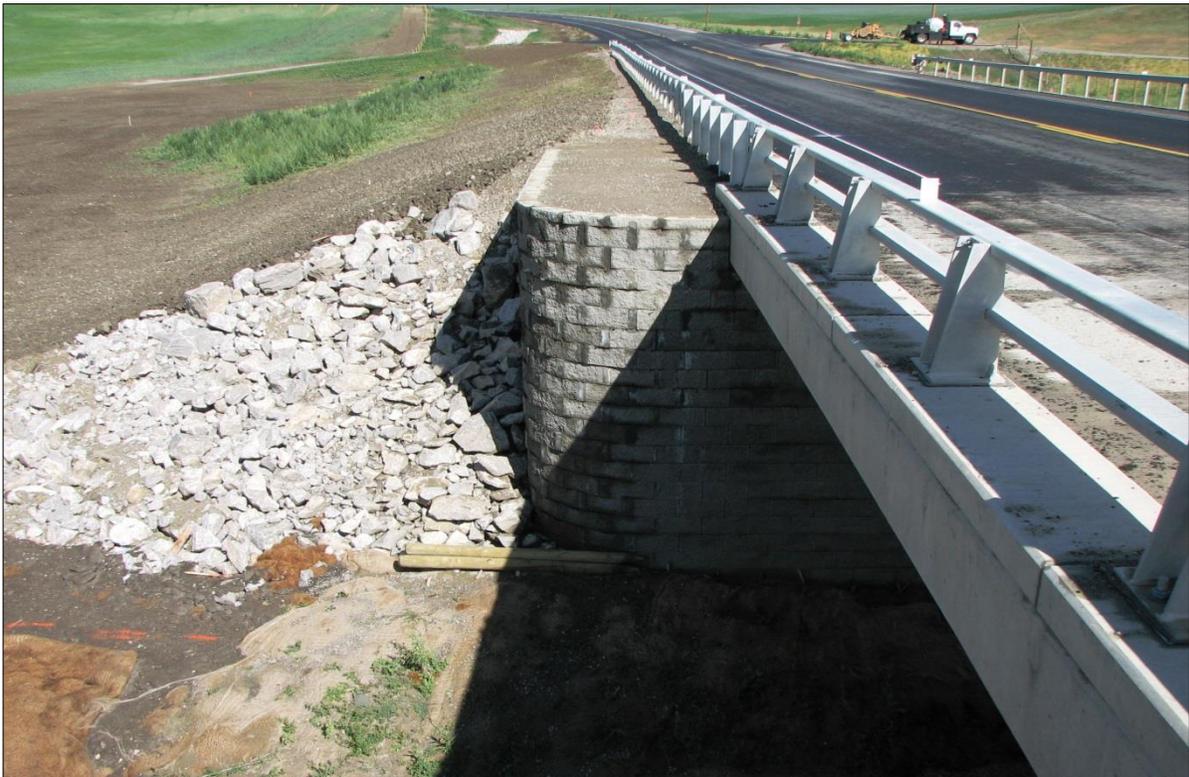
↓ The gaps in the wing wall radius have all been patched with mortar.

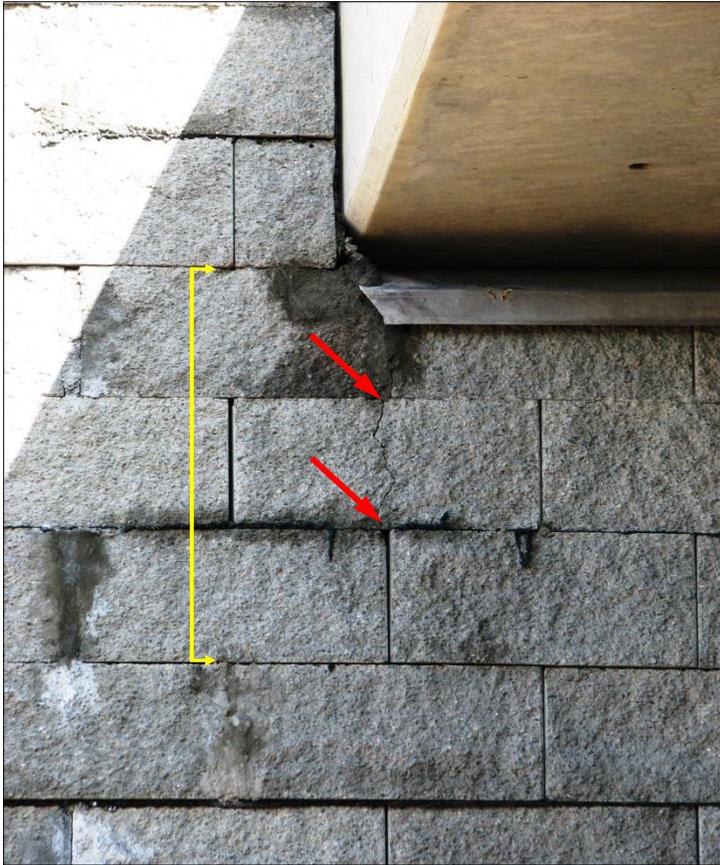
Five of the CMU hollow core blocks had cracks (refer to page 30). All to date were in the top tier layers which were rebarred pinned and set with class DD concrete. Note that all cracks emanate from the junctions of two blocks down through the center of the adjacent block beneath. Future inspections will document if this trend continues.

← Cracking has been noticed on the CMU face block.

The location of this crack is just below the deck slab on the north abutment, west side.

The red arrows show the extent of the crack.

Per specifications, the top three rows of CMU hollow core (at the beam seat) were pinned with no. 4 rebar and set with class DD concrete (yellow bracket).

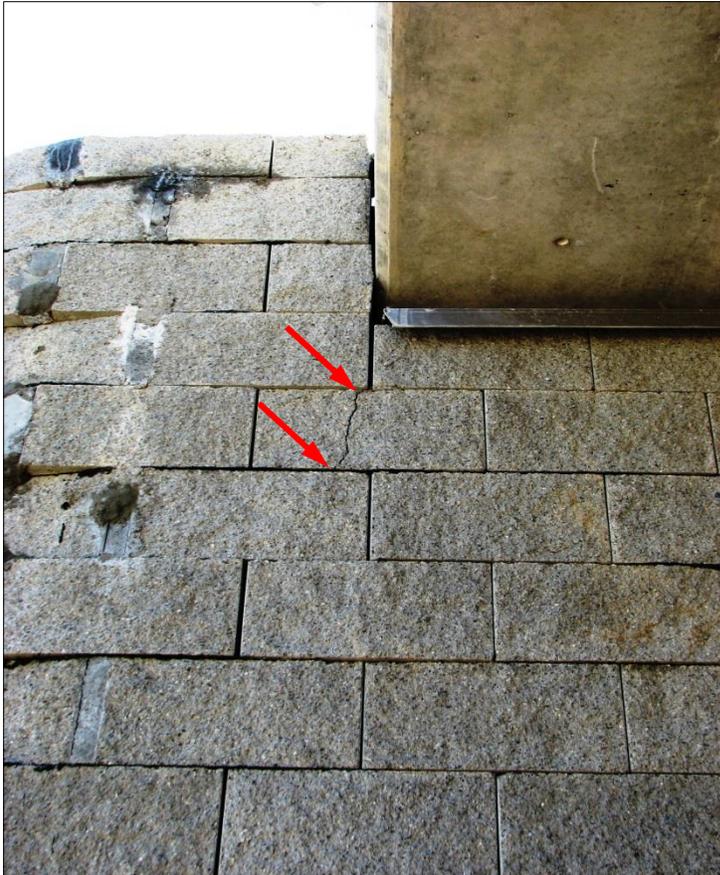
← Another crack located at the edge of the beam seat at the south abutment, east side.

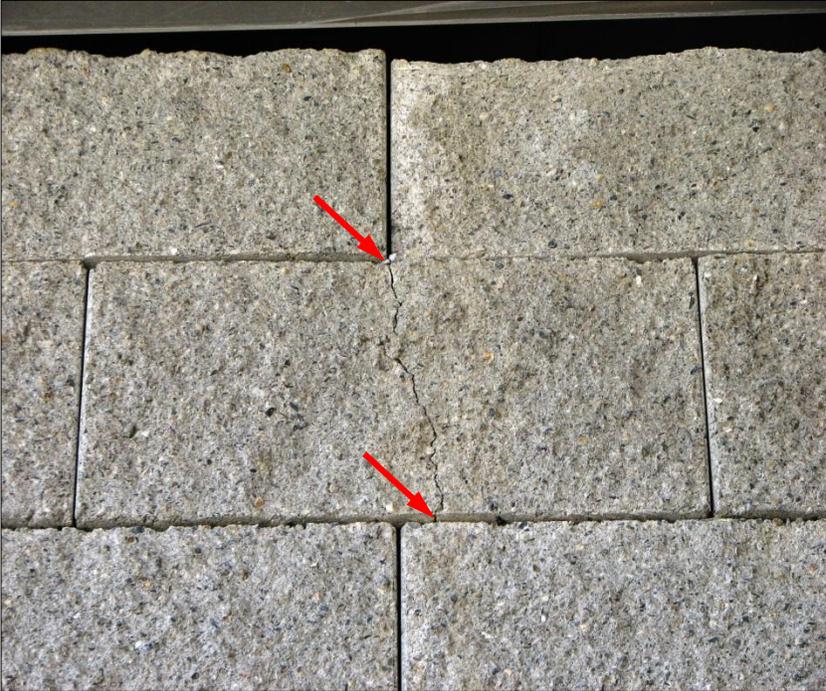
← This cracked block is located center near the top of the south abutment.

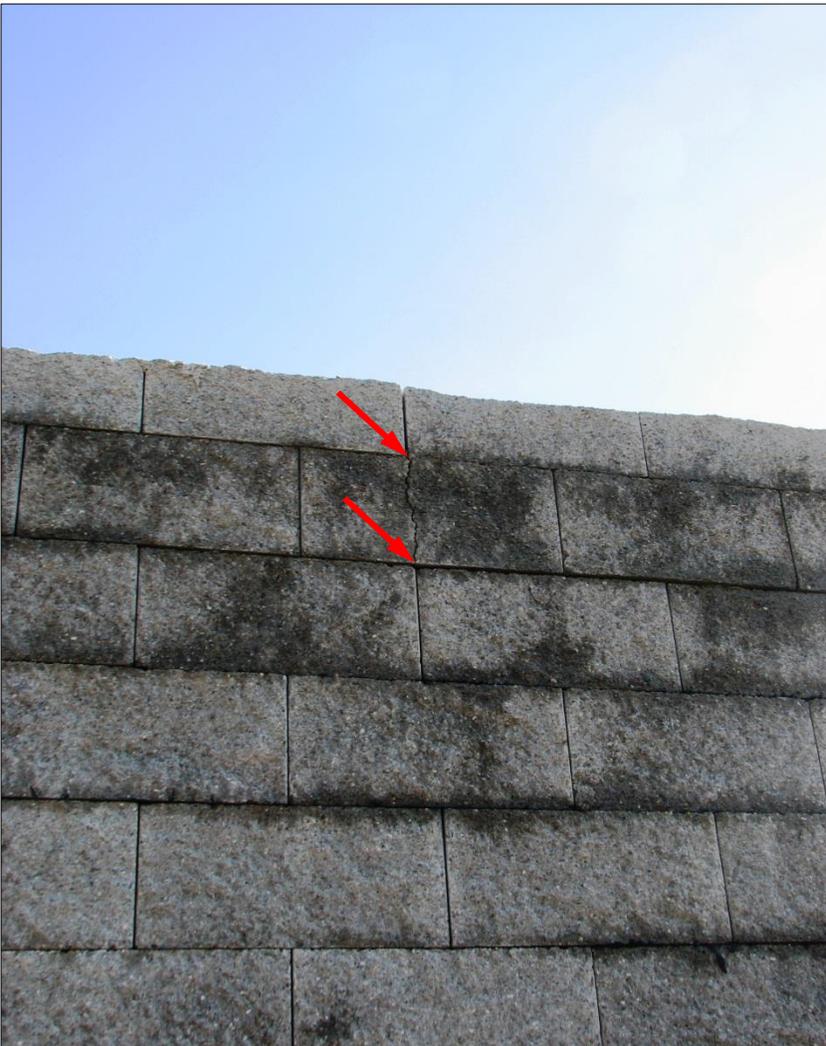
← Another cracked block was located on the northwest wingwall.

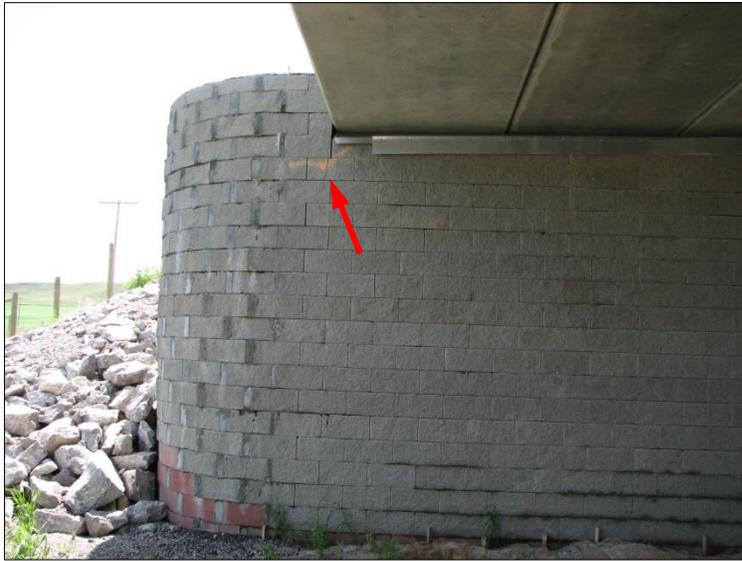
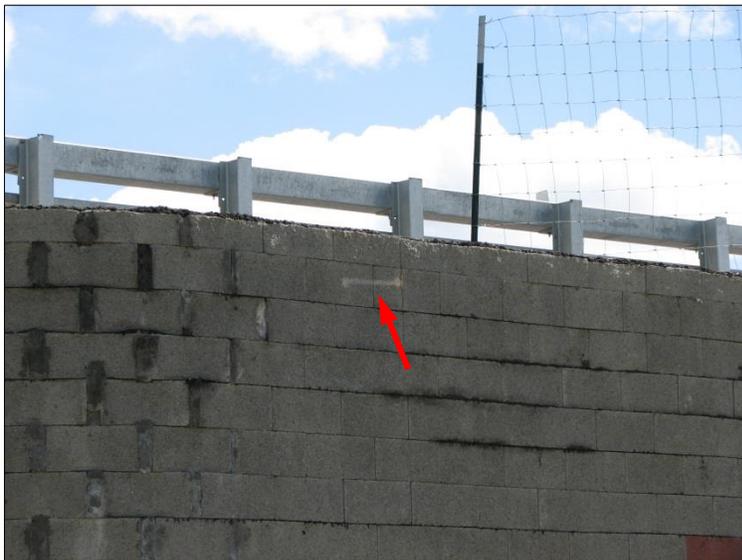
Pavement approaches to slab transition are smooth. As noted in the 2014 inspection several of the fascia CMU blocks were cracked. Several more have cracked; MDT staff has sprayed paint as a locator on the current visible cracks. To date this block cracking is not seen as an indicator of performance.

← ↓ As documented in the 2014 inspection, several fascia blocks developed cracks (red arrows).

All cracks are located near the top layer of block, or at the edge of the abutment placement.

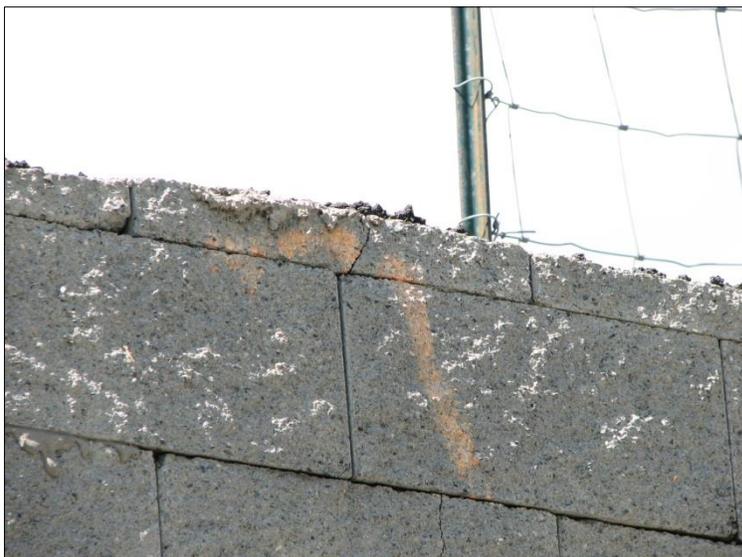
← MDT District staff has applied paint to visible cracked blocks for reference.

To date about seven (7) blocks have developed cracks since installation.

At this time, it is not considered a performance issue.

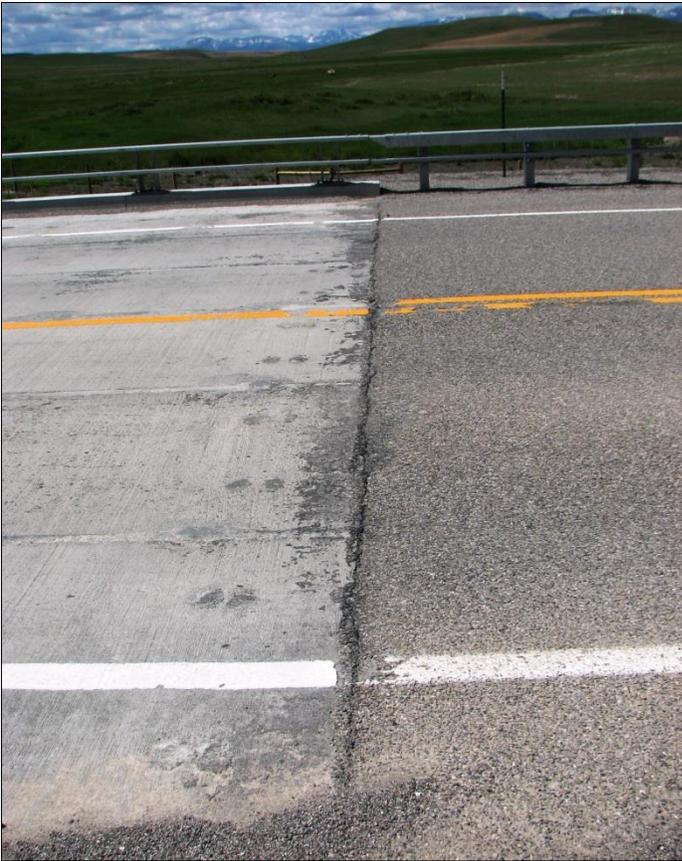
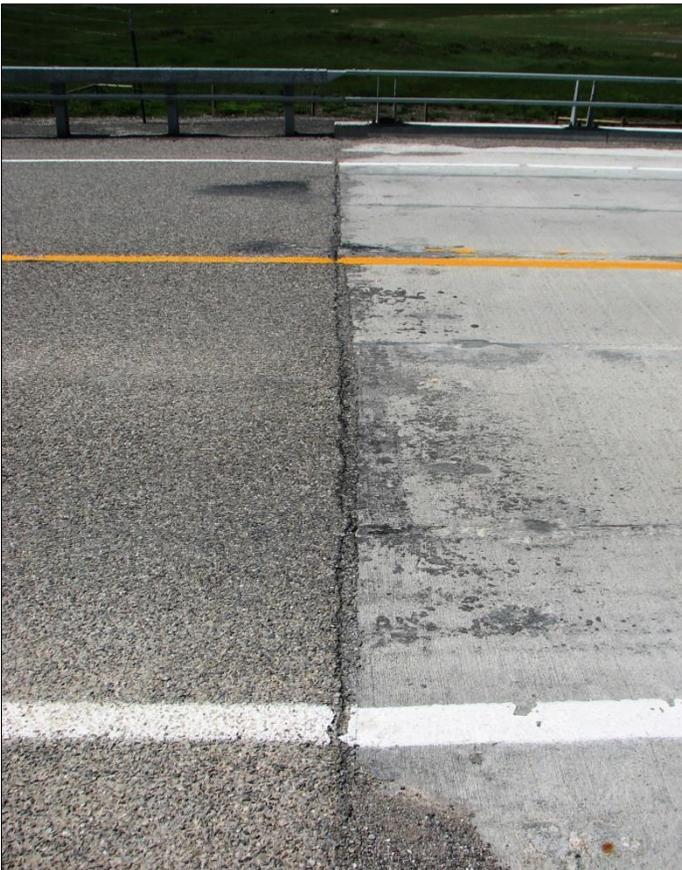
← Pavement approach to slab is a smooth transition.

Top photo is the north end, bottom photo; south end of deck

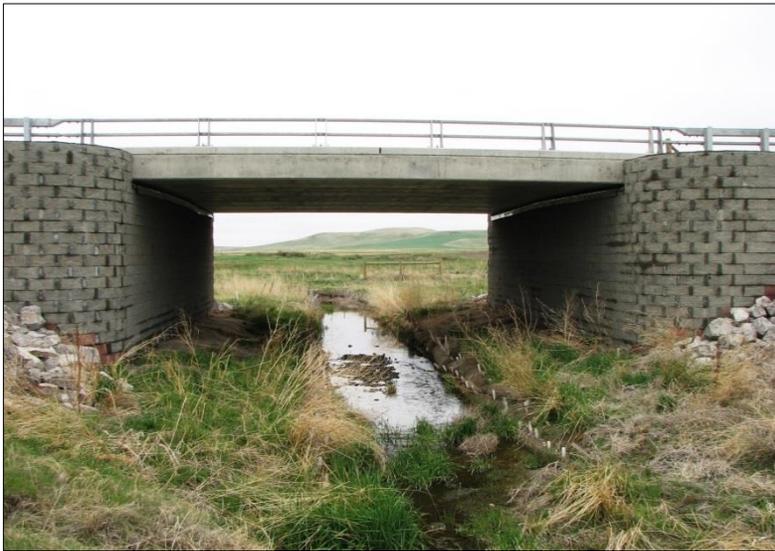
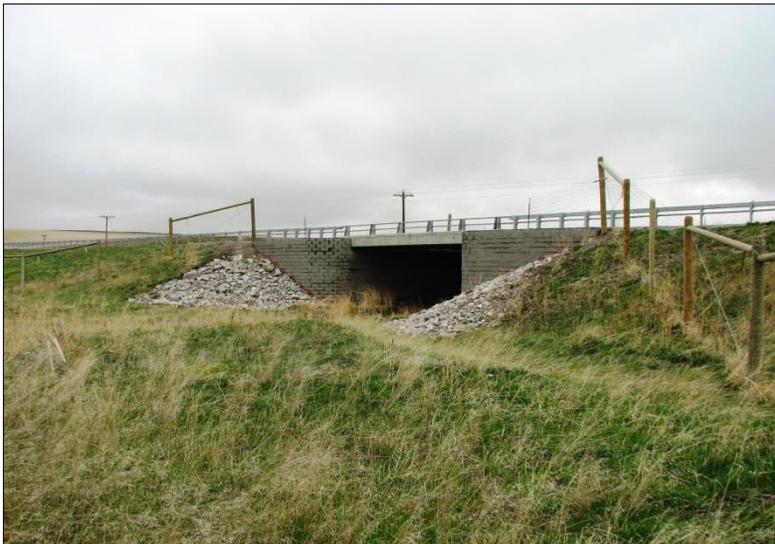
↙ GRS Bridge: Same general condition as reported in the 2015 inspection, no visual anomalies. No additional fascia CMU block cracking observed. East view; west side of structure.

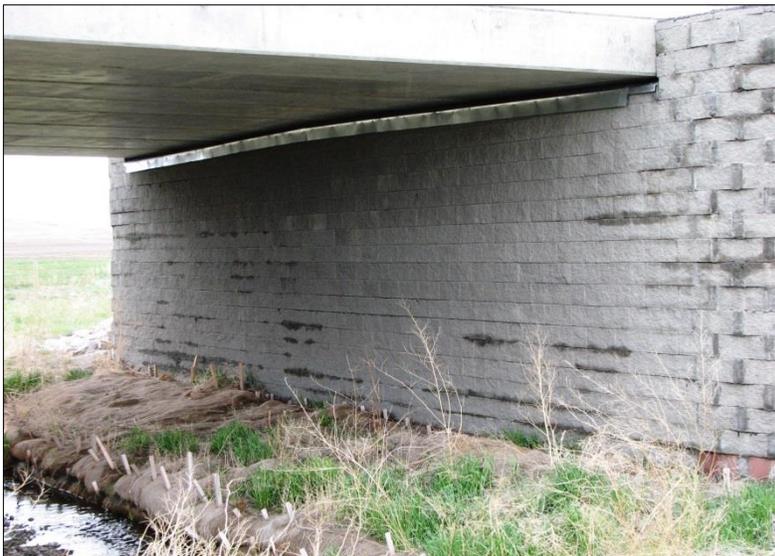
↙ South abutment. Areas of weeping through joints in fascia block; which is considered normal for this type of design.

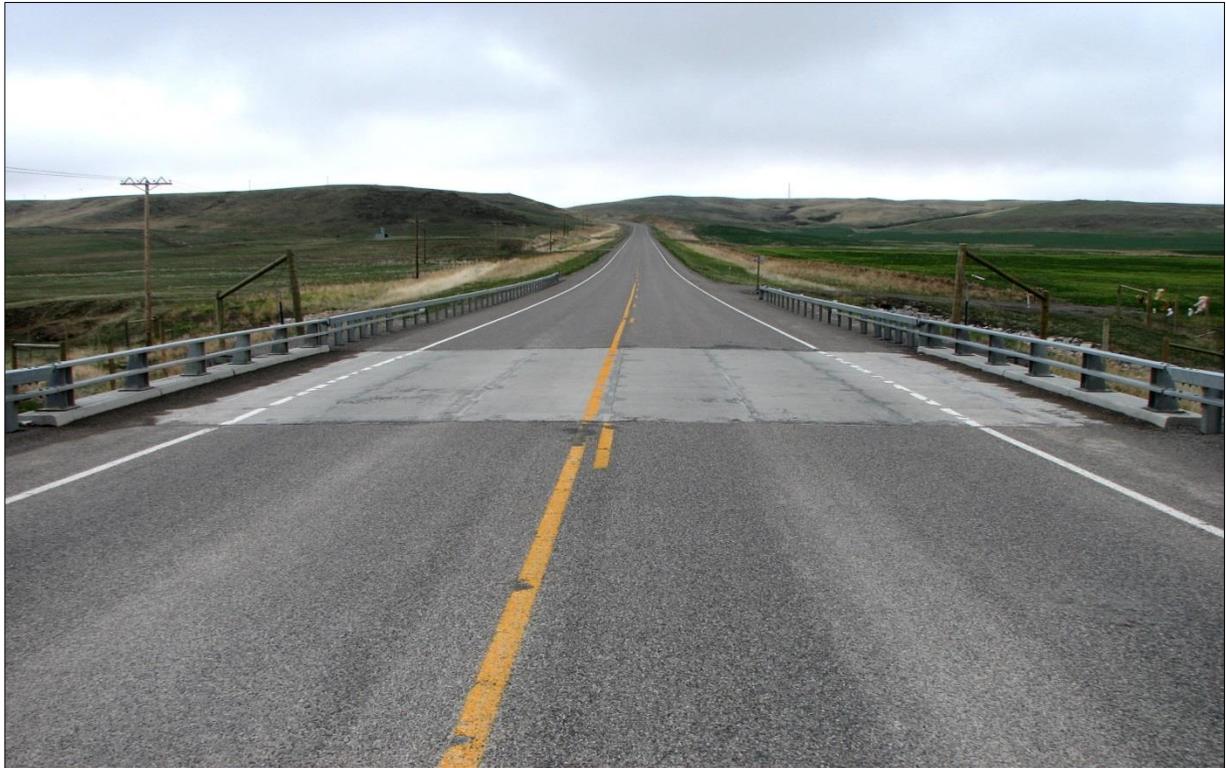
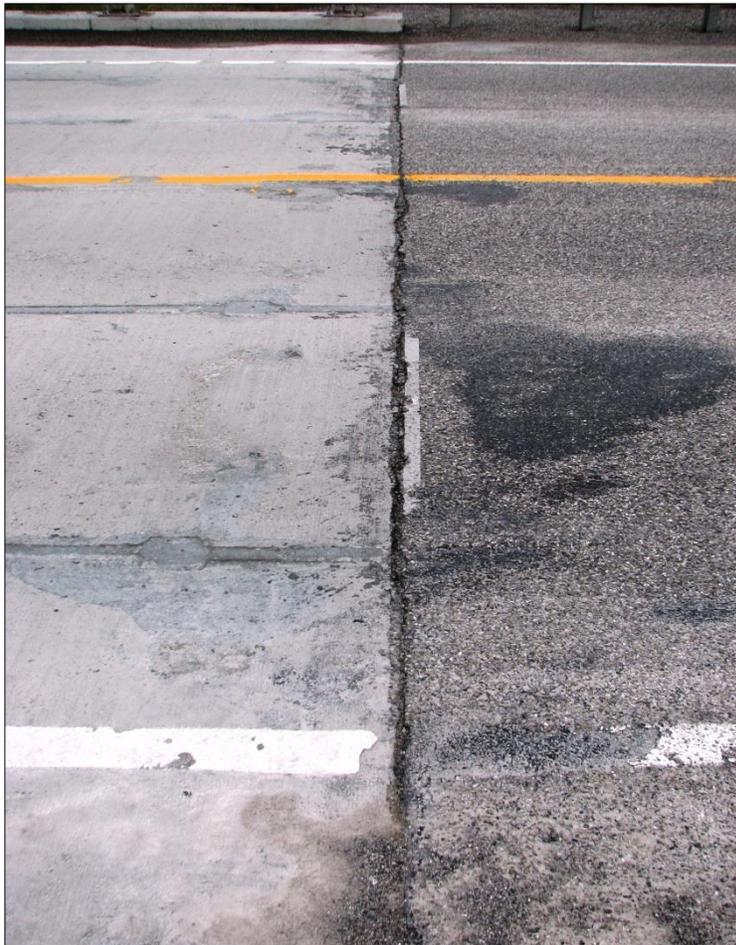
↑ View south; slab to deck approaches maintains a smooth transition.

← View of south end deck to slab joint.
