EXPERIMENTAL CONSTRUCTION REPORT

Jointbond Asphalt Cement (AC) Joint Stabilizer

Project Name: Bridger Canyon-UPN 8112000

Experimental Project: MT-19-5

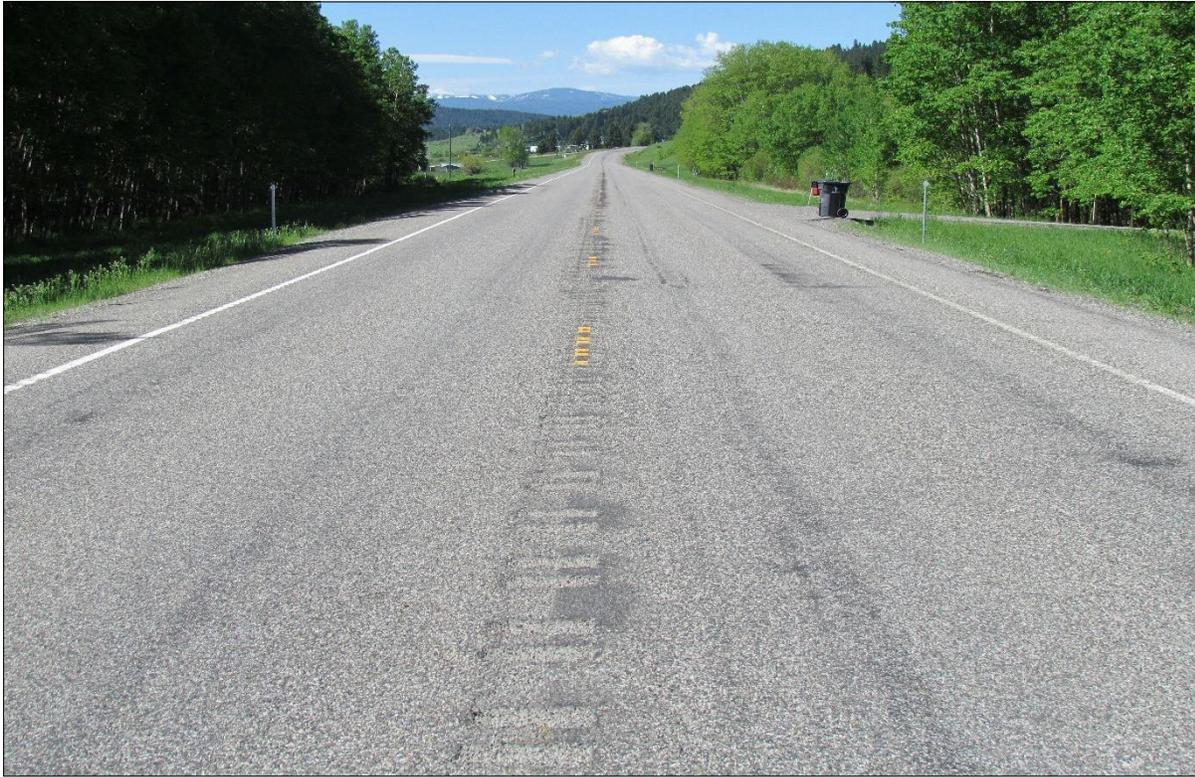
↑ Representative image of project centerline prior to striping.

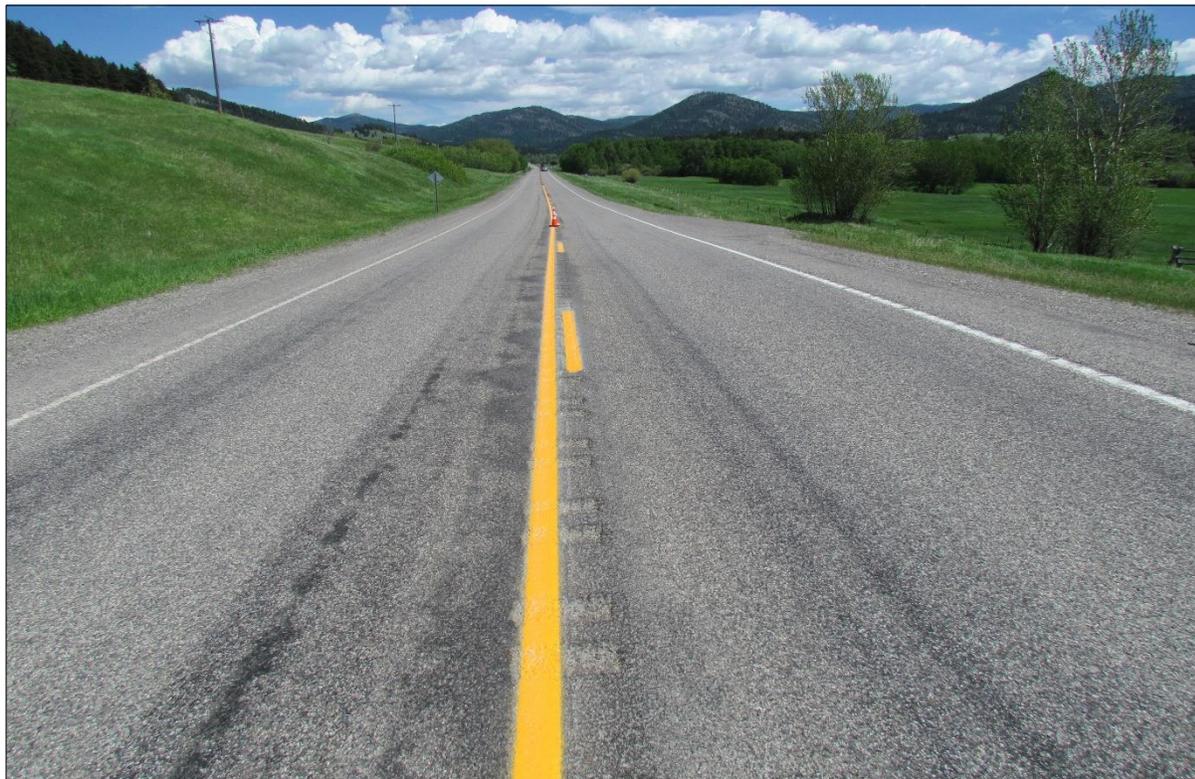
↓ Recently striped roadway placed approximately one week prior to JB application.

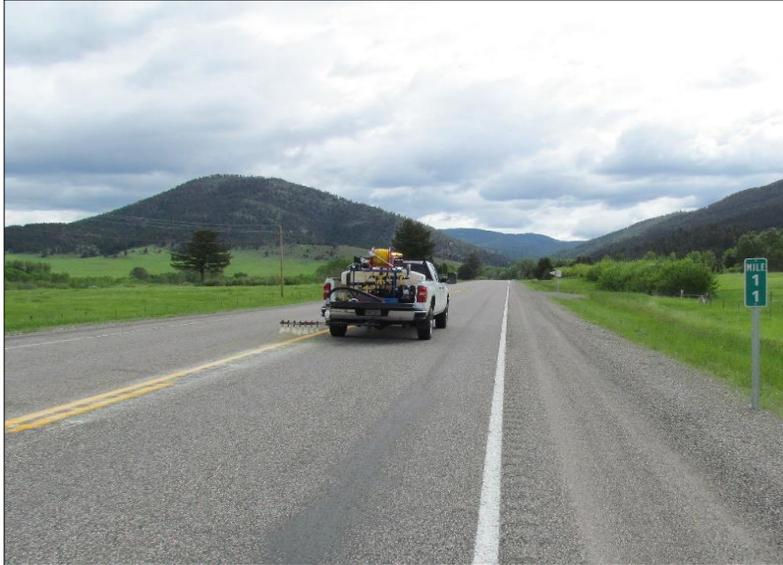
← Jointbond application starting at reference point 11, view north.

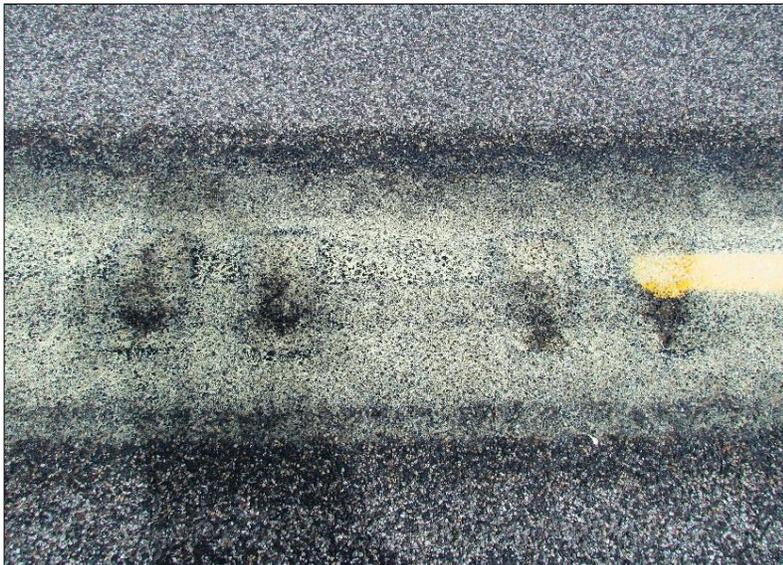
← Close-up of JB showing a uniform distribution along the longitudinal construction joint and an area from 1 to 1.5 feet on both sides of the joint.

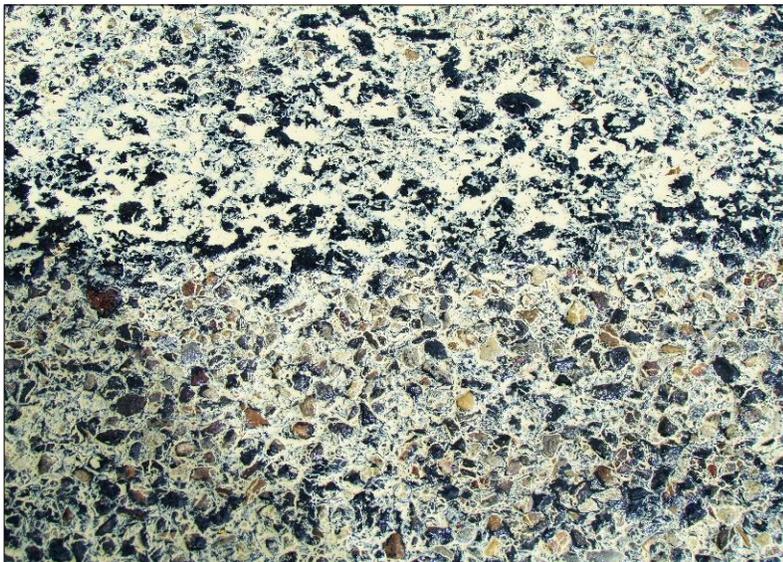
← Closer view of JB application directly after placement.

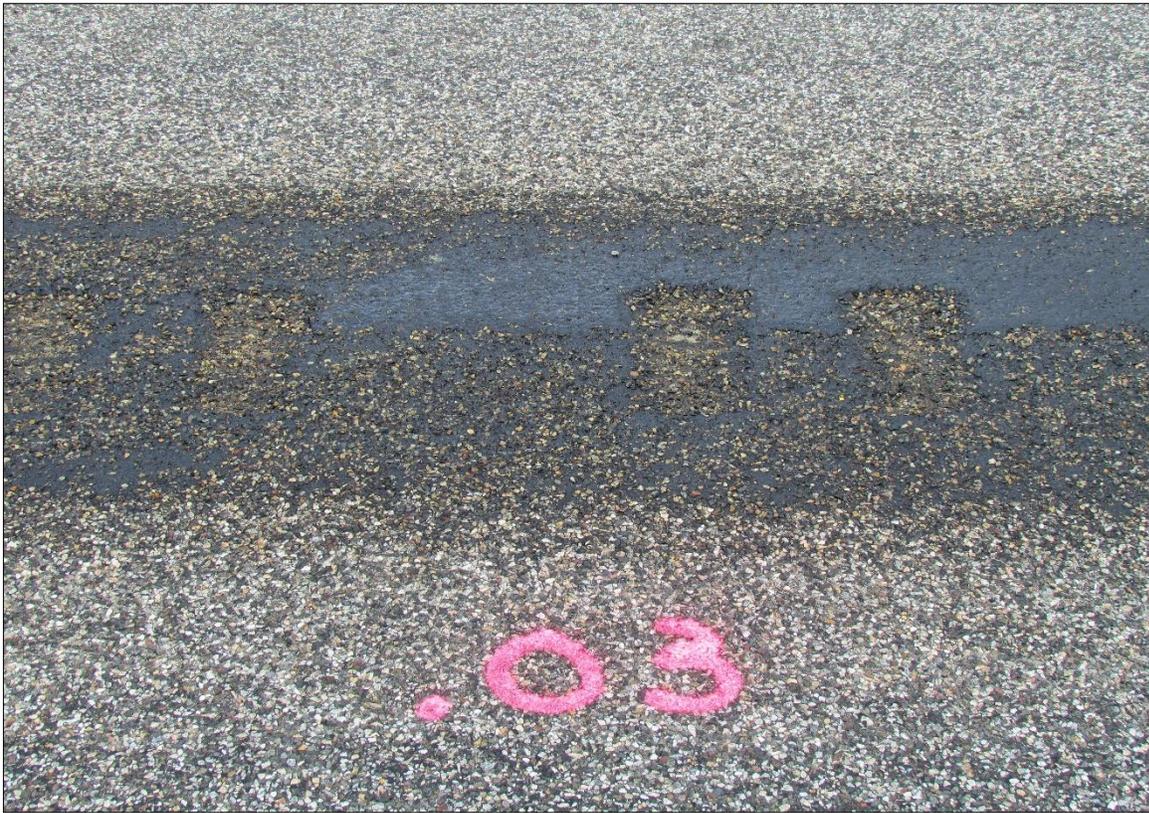
↑ Appearance of JB approximately 30 minutes after application.

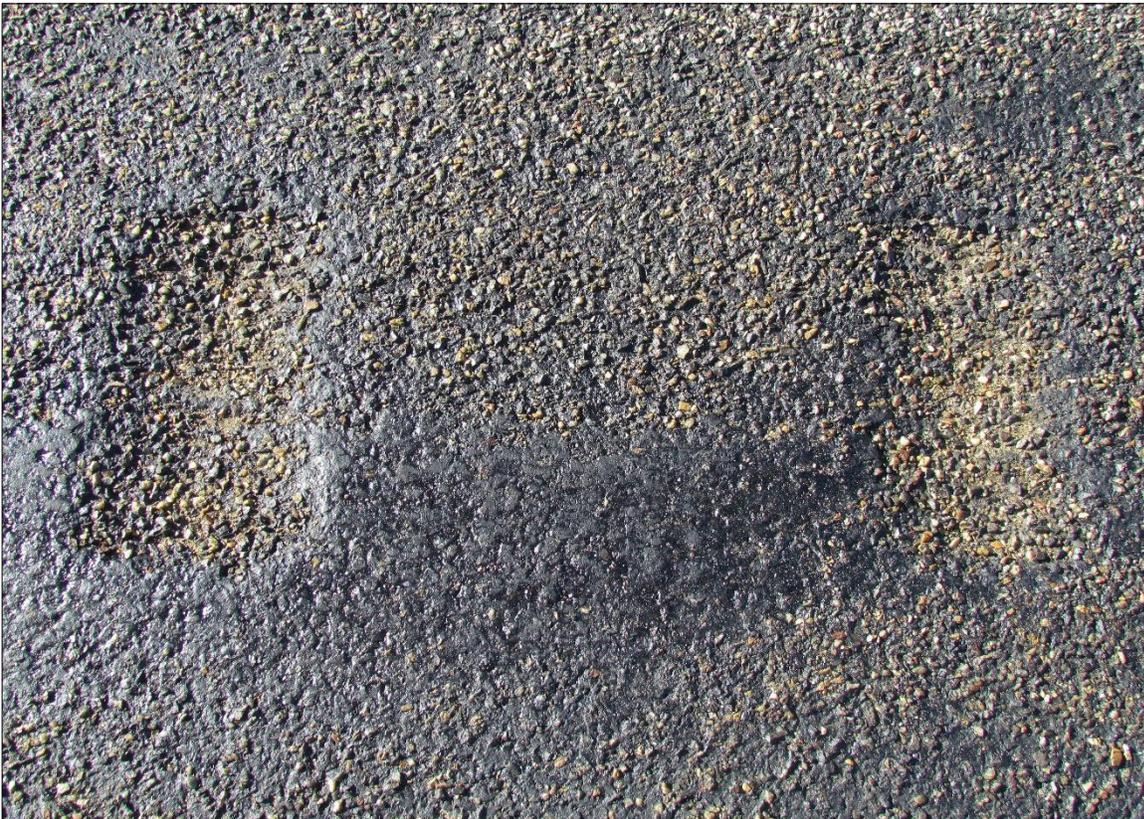
Also, there was a concern that after application of the JB, areas of the chip seal that had been scraped smooth by plowing (exposing the emulsion seal) might present a safety hazard since the stabilizer created a slippery surface during the curing phase. After about 90 minutes it was tacky enough not to be considered detrimental to the travelling public (refer to page 8).

↓ Appearance of JB approximately 90 minutes after application.

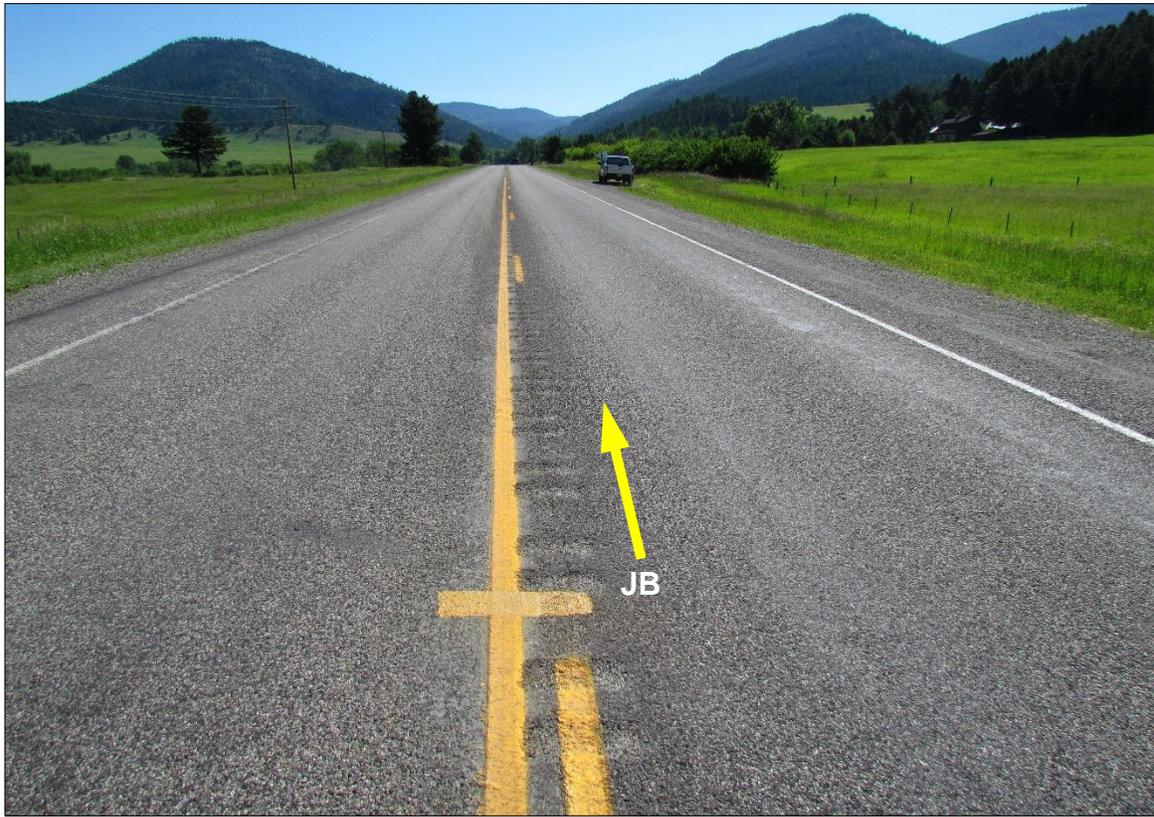
↑ Appearance of JB approximately 2 weeks after application.

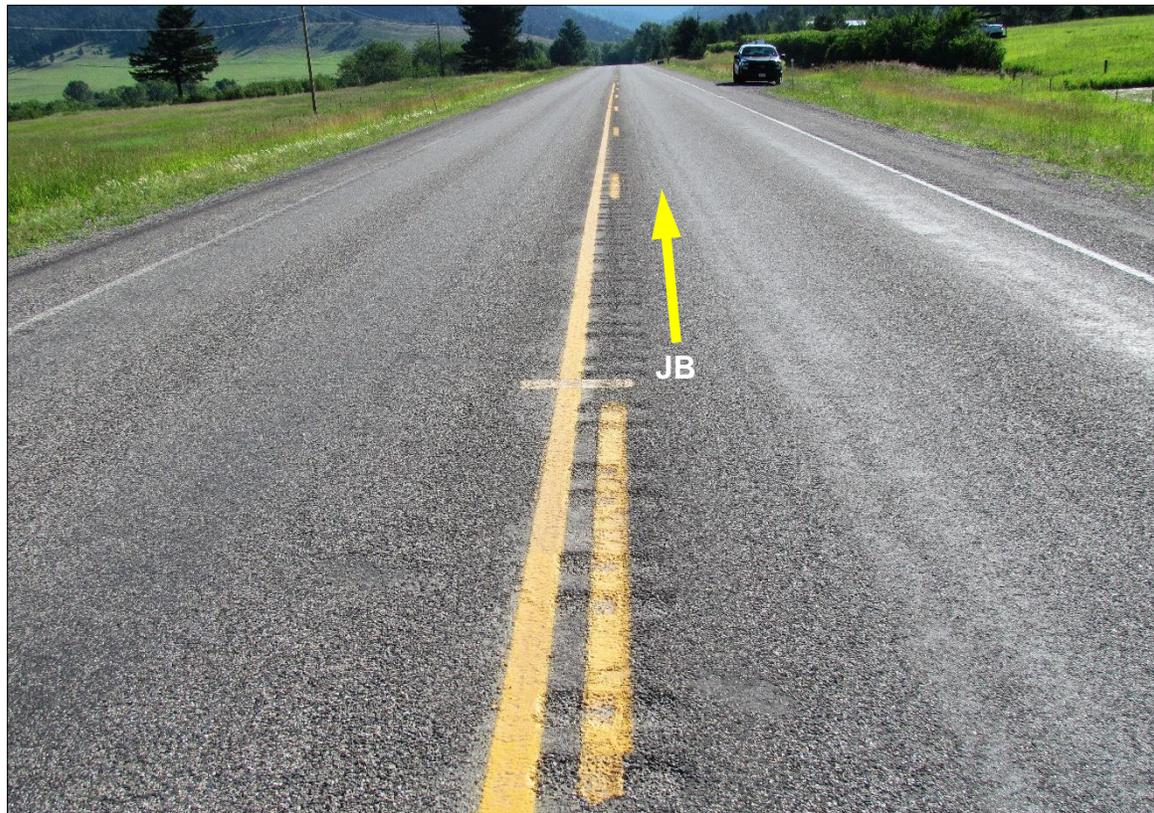
↓ Appearance of JB approximately 6 weeks after application.

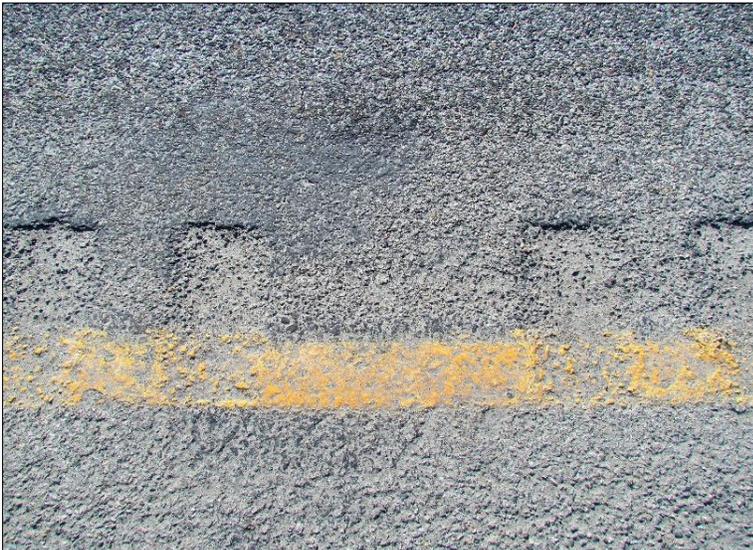
← Representative image of Jointbond application on project.

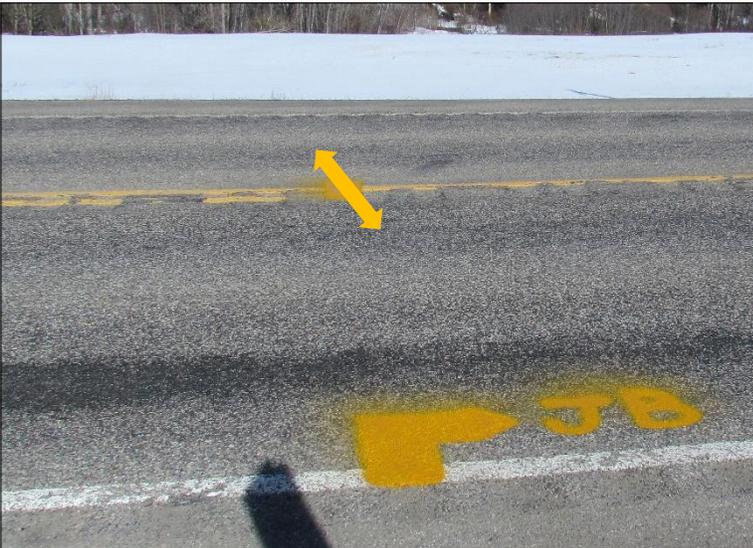
← Demarcation of Jointbond (JB) application (yellow arrow); at this point in the project timeline the JB is not visibly detectable on the surface.

Any documentable distress may not be apparent for several seasons.

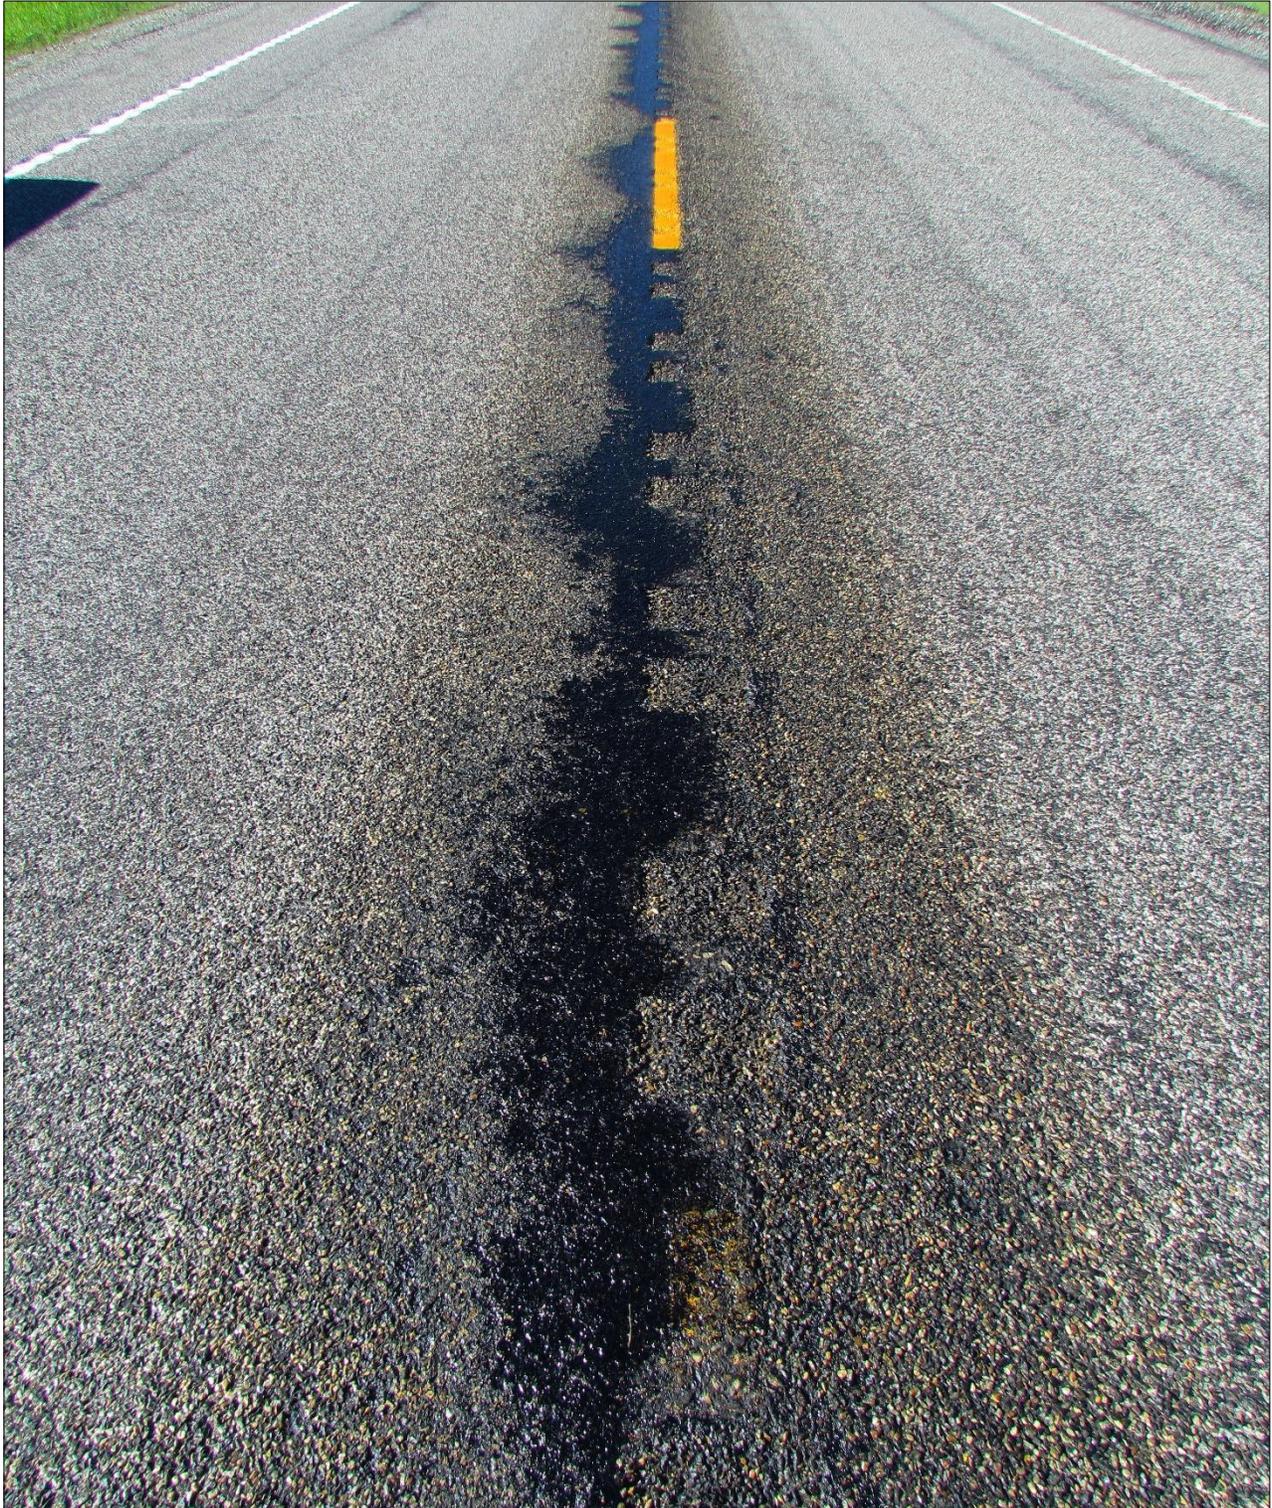
- ↑ During application, there was a concern that the JB produced a very slick surface on the exposed seal emulsion after application which may impart a safety issue especially for motorcycles. Within 60 minutes the surface became tacky and after about 90 minutes the product firmed to a point it was no longer considered a problem.
