EXPERIMENTAL EVALUATION FINAL REPORT

Thin-Whitetopping Bonded Composite

Project No.: STPP 1-2 (93)121, East Idaho St.

Evaluation Date: August 2010

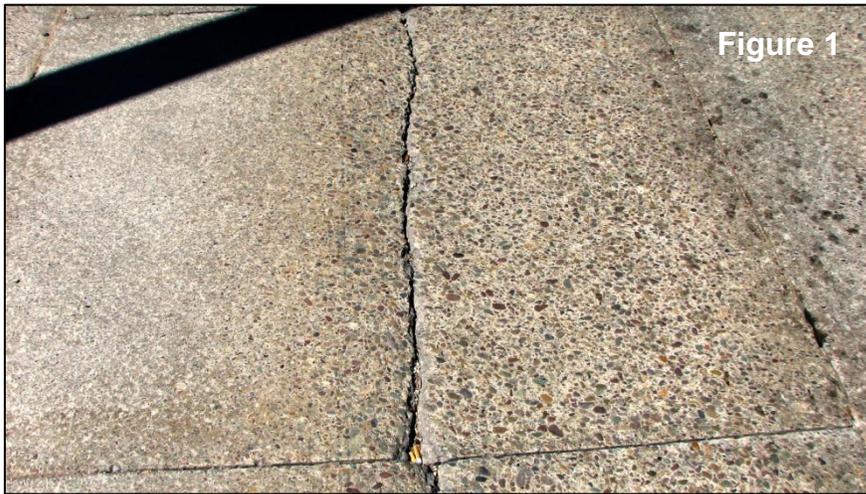
Figure 1 is an examples of the in-lane, moderate severity crack. It has been estimated that this project contains over 4200 sawed panels with an approximate forty-two (56) panels exhibiting minor cracking since construction which represents approximately .013% of the entire project.

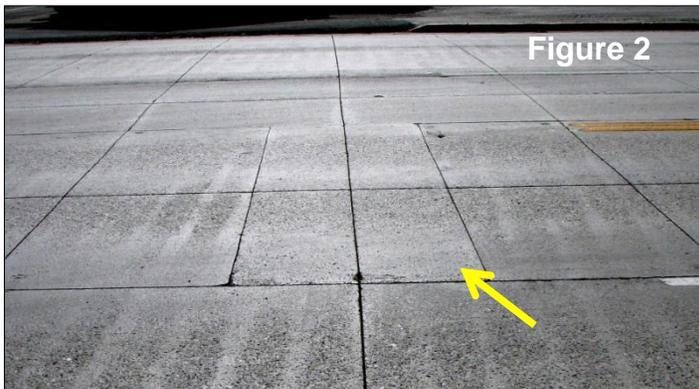
Figure 2, (yellow arrow) shows the area of the doweled PCCP patch placed during construction due to unconsolidated concrete by lack of adequate vibration (as documented in the 2000 construction report). Visual observation of traffic moving over this section displayed no faulting or movement of the

slab. At this time, no visual surface distress was noticed. This repair is approximately located in the center section of the westbound lanes 2 meters past the intersection of 6th Avenue EN and East Idaho St.

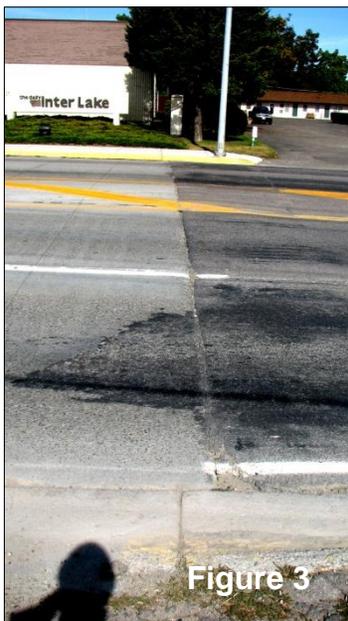
Figure 3 is showing the east-end transition area of the project. It is important to point this feature out due to the innovative way this approach was placed, please refer to the construction report for details. No evidence of distress to the east or west transitions was noticed during this evaluation. Transfer of load from AC to PCCP is intact.

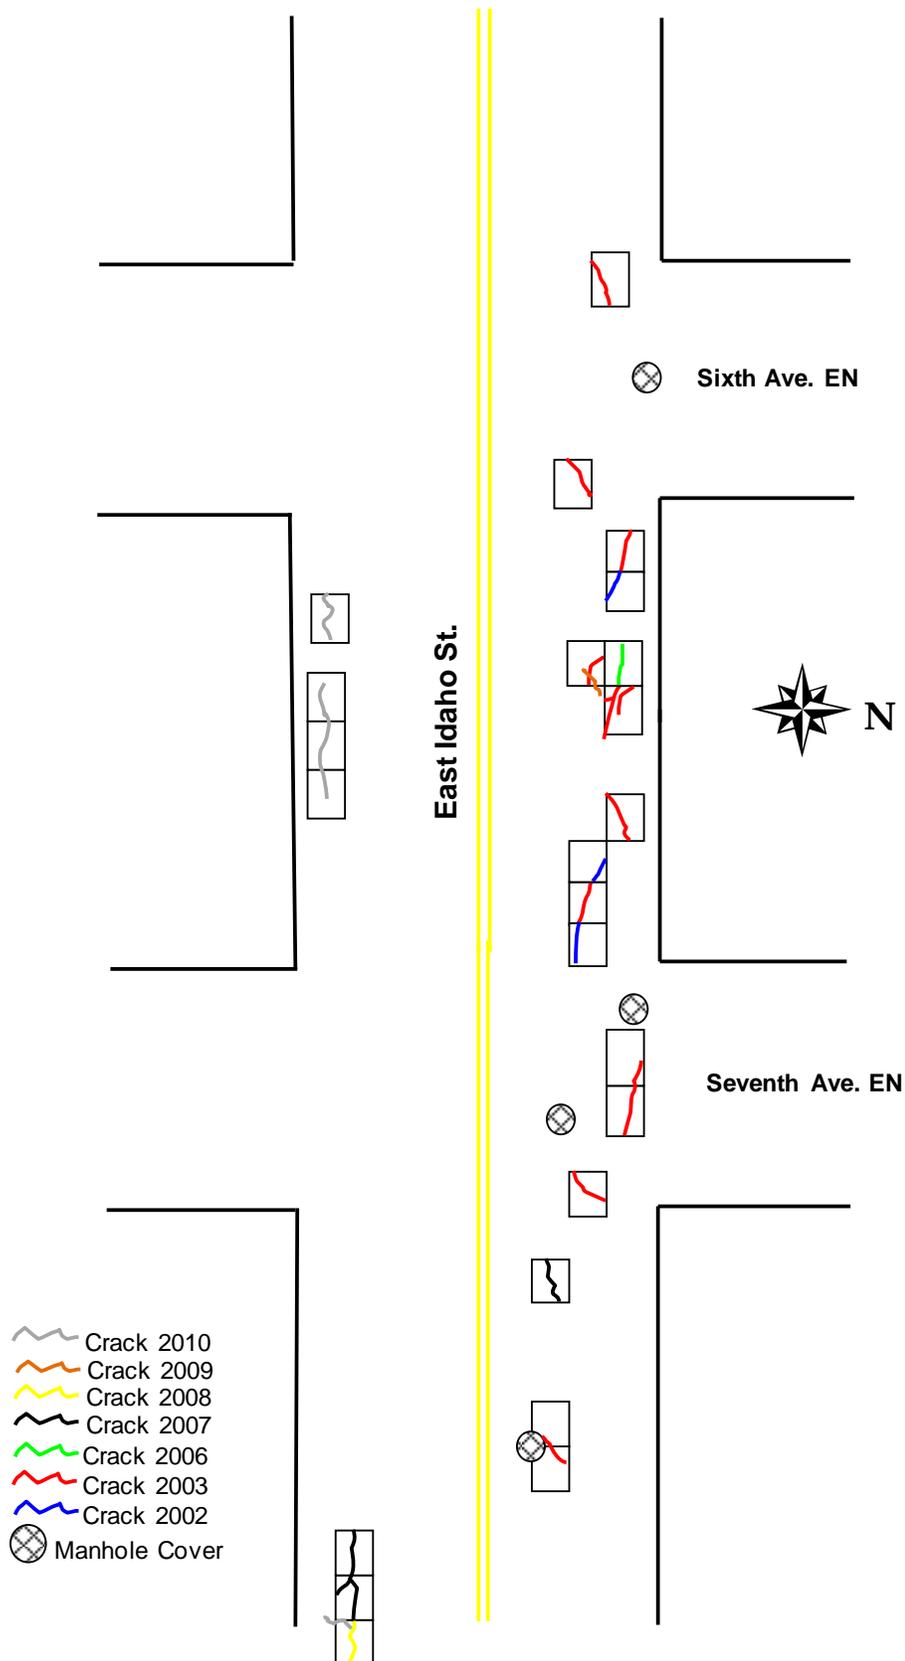
Thin-Whitetopping Overlay Composite - STPP 1-2(93)121 East Idaho St., Kalispell Montana
 Representative Project Crack Map - Approximate Location - Not to scale
 Note: Crack map only shows portion of project which contains distress information

The following pages are panel crack maps to represent accumulative distress over the duration of the analysis time frame (2000-2010). These are not to scale. Note that the maps show only that portion of the project that currently contains distress information. There were no distress to report during the 2001, 2004, and 2005 site inspections.
