## ANNUAL EXPERIMENTAL EVALUATION REPORT

### Thin-Whitetopping Bonded Composite

Project No.: STPP 1-2 (93)121, East Idaho St.

Evaluation Date: June 2006

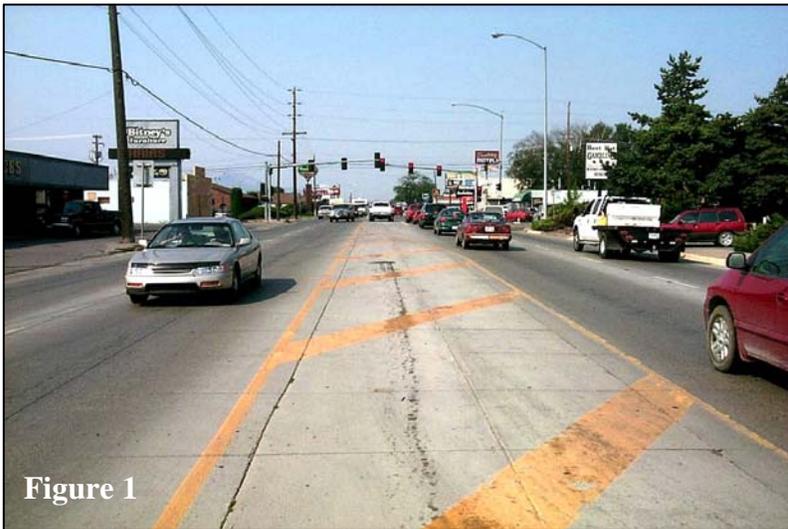
Figure 1 is an overview, looking west at the whitetopping section.

The overall appearance of the whitetopping is good. Fifteen cracked panels were documented in the 2004 report. Seven additional panels were documented during this evaluation. All cracks are hairline in nature with no vertical displacement or debonding of the

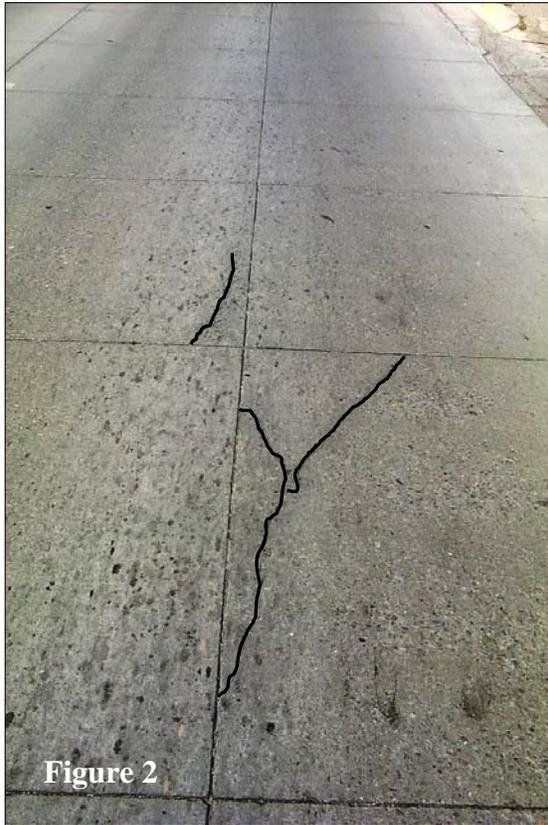
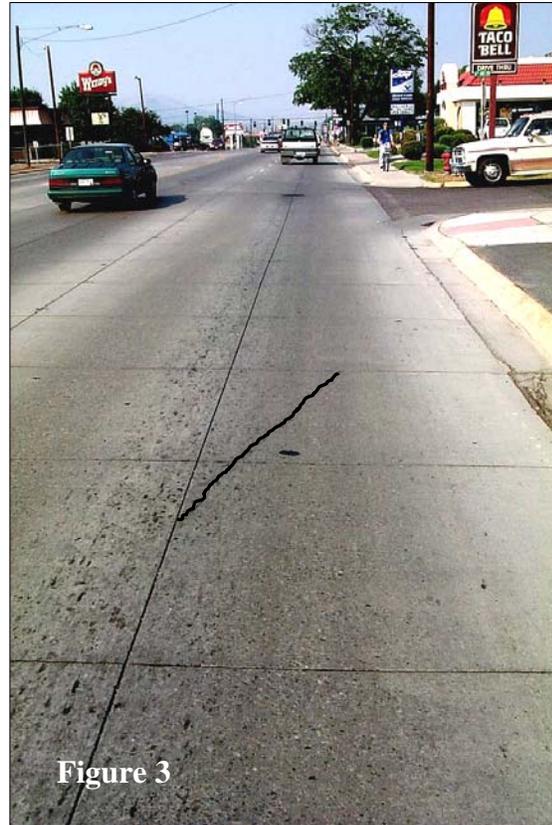
composite panels. At this time, there is no indication of a pattern or reasons for the randomness of the cracked panels; therefore, it is premature to attempt to ascertain a cause. It should be noted that the majority of the cracking occurs on the north half of the project

(which was placed first) between the streets of 8<sup>th</sup> Ave. EN and 6<sup>th</sup> Ave. EN. The south half of the project has just begun to exhibit panel cracking. Refer to the crack maps at the end of this report for a general representation of cracked panel locations and the relationship of how the crack is located within the panel itself. The crack map is strictly an illustration of approximate crack locations within the project. It is not to scale.

Figures 2 & 3 are examples of the in-lane, hairline cracks. A black line has been superimposed over the images to better see the lay of the crack. It has been estimated that this project contains over 4200 sawed panels with only an approximate twenty-two panels exhibiting minor cracking since construction.

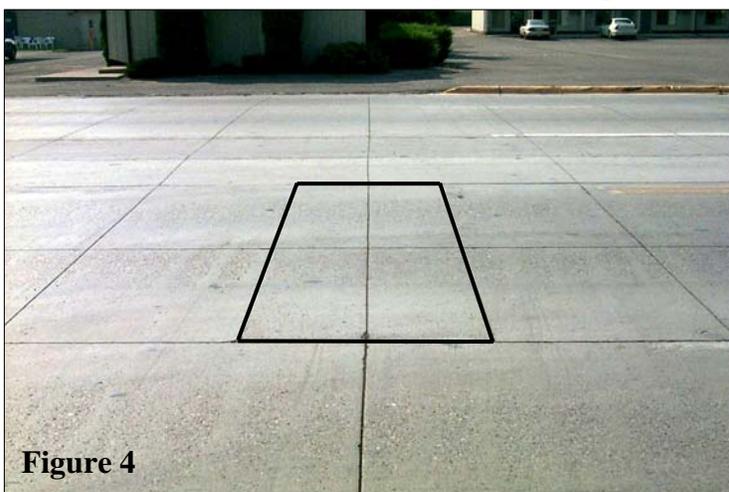
Figure 4 shows the performance of the doweled PCCP patch placed during construction due to un-consolidated concrete by lack of adequate vibration (documented in the 2001 fall construction report). The black outline is the area of repair.

Visual observation of traffic moving over this section displayed no faulting or movement of the slab. At this time, no visual surface distress was noticed. This repair is approximately located in the center section of the westbound lanes 2 meters past the intersection of 6<sup>th</sup> Avenue EN and East Idaho St.

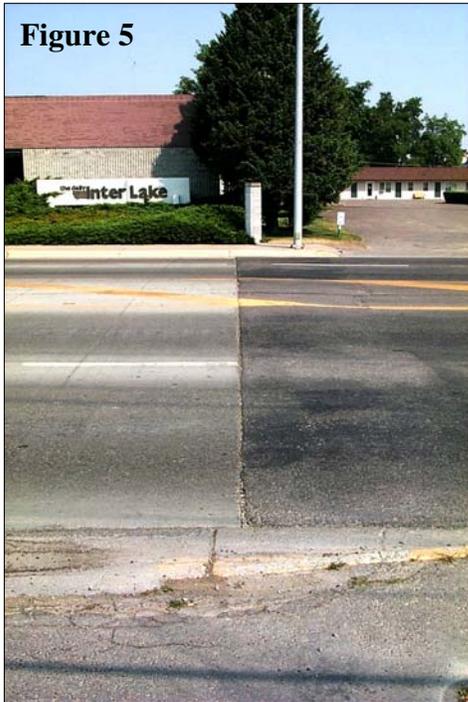
**Figure 5**

Figure 5 is showing the east-end transition area of the project. It is important to point this feature out due to the innovative way this approach was placed, please refer to the fall 2000 construction report for details. That report and additional information can be located on the MDT Research Internet website at:

[http://www.mdt.mt.gov/research/projects/kal\\_whitetopping.shtml](http://www.mdt.mt.gov/research/projects/kal_whitetopping.shtml). No evidence of distress to the east or west transitions was noticed during this evaluation.

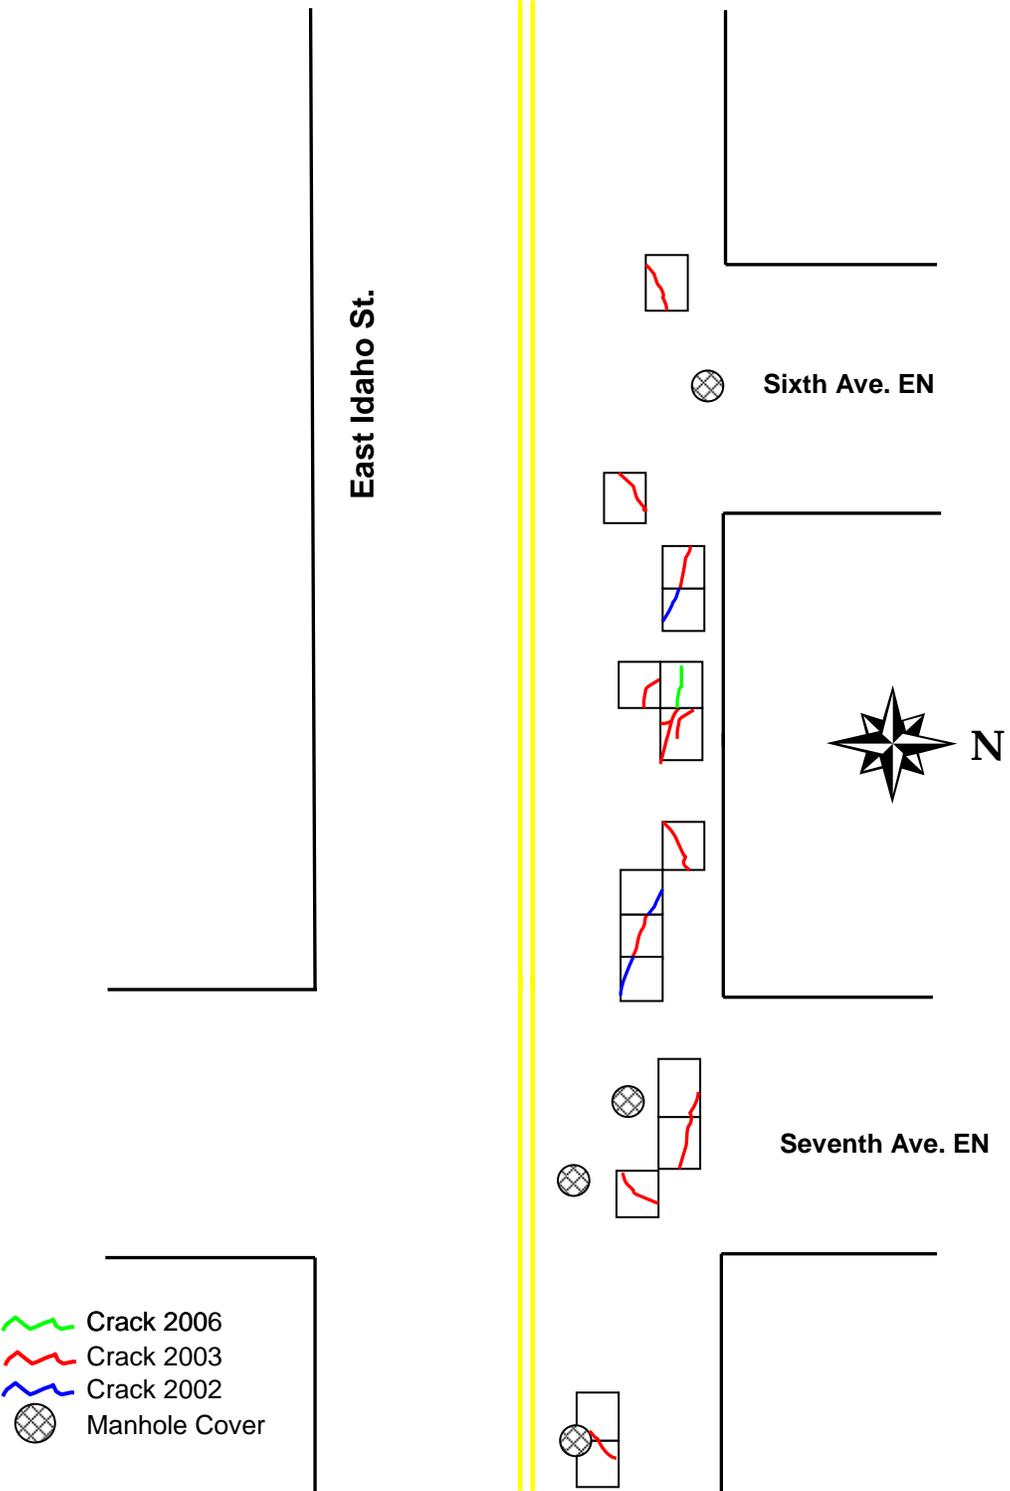
Thin-Whitetopping Overlay Composite - STPP 1-2(93)121 East Idaho St., Kalispell Montana  
Representative Project Crack Map - Approximate Location  
Note: Crack map only shows portion of project which contains distress information

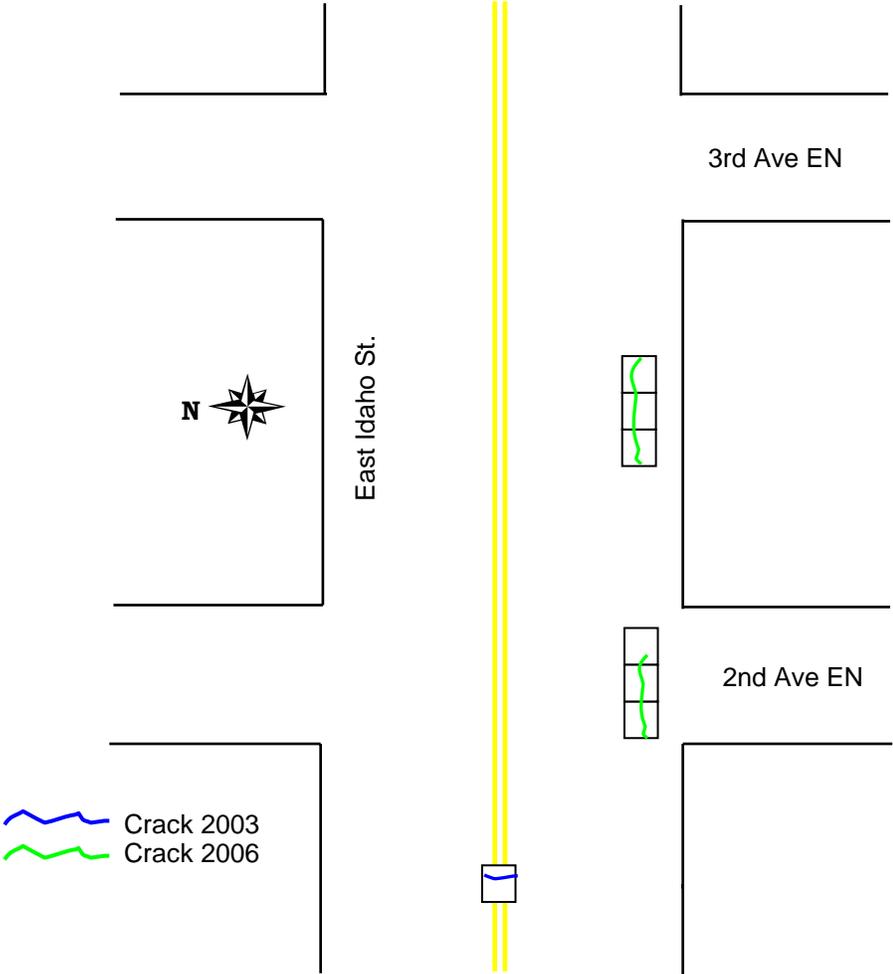
Thin-Whitetopping Overlay Composite - STPP 1-2(93)121 East Idaho St., Kalispell Montana  
Representative Project Crack Map - Approximate Location  
Note: Crack map only shows portion of project which contains distress information
