## ANNUAL EXPERIMENTAL EVALUATION REPORT

### Thin-Whitetopping Bonded Composite

Project No.: STPP 1-2 (93)121, East Idaho St.

FHWA No. Experimental Project MT 00-02

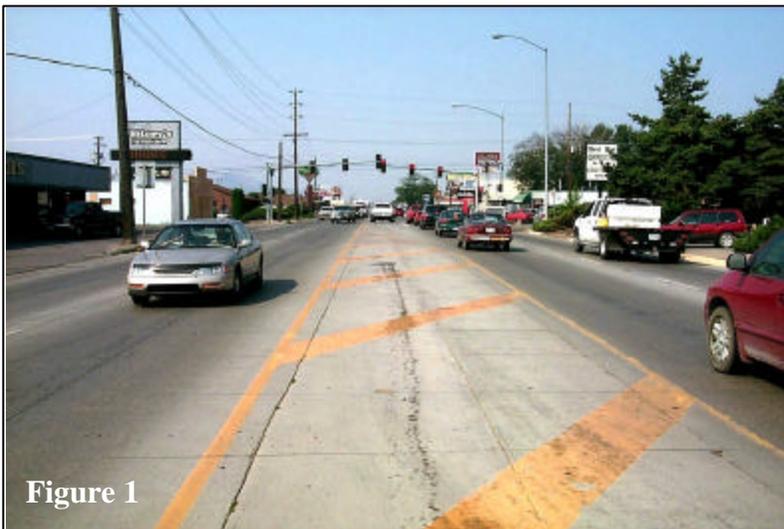
Figure 1 is an overview, looking west at the whitetopping section.

The overall appearance of the whitetopping is good. Thirteen cracked panels were documented in the 2002 report. Two additional panels were found during this inspection, making the

estimated totals at (currently) fifteen cracked panels. All cracks are hairline in nature with no vertical displacement or debonding of the composite panels. At this time, there is no indication of a pattern or reasons for the randomness of the cracked panels; therefore, it is

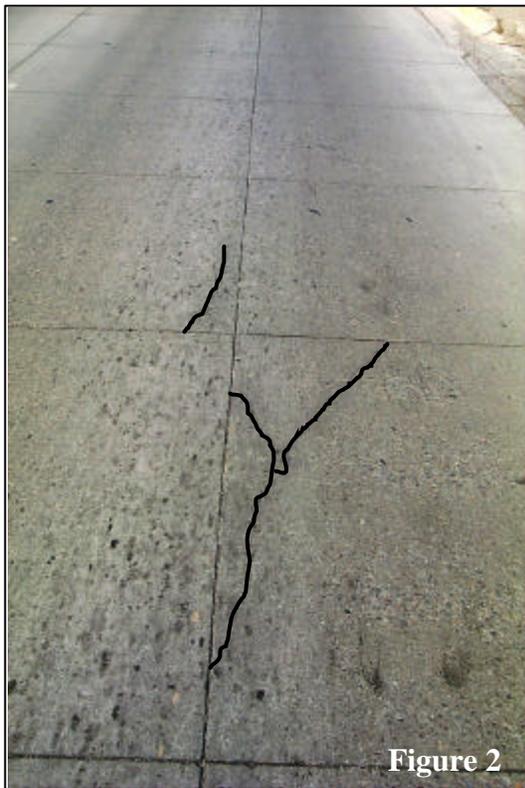
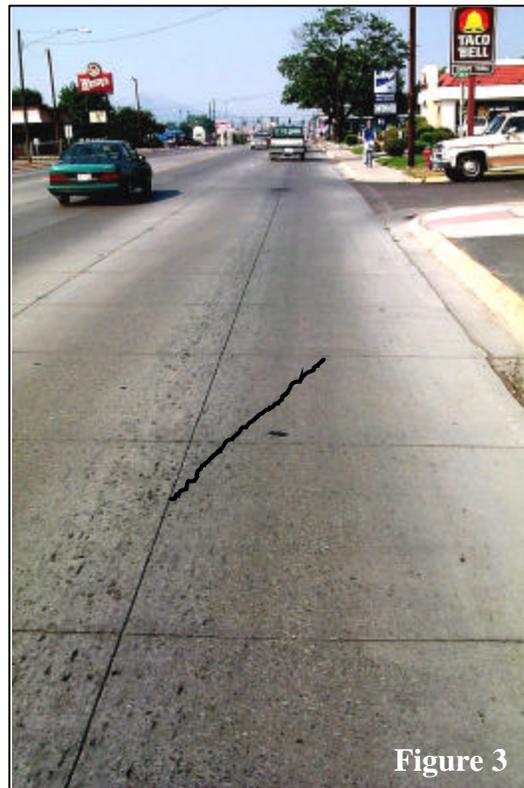
premature to attempt to ascertain a cause. It should be noted that the majority of the cracking occurs on the north half of the project (which was placed first) between the streets of 8<sup>th</sup> Ave. EN and 6<sup>th</sup> Ave. EN. The south half of the project is exhibiting almost no cracking at all. Refer to the crack map at the end of this report for a general representation of cracked panel locations and the relationship of how the crack is located within the panel itself. The crack map is strictly an illustration of approximate crack locations within the project. It is not to scale.

Figures 2 & 3 are examples of the in-lane cracking. A black line has been superimposed over the images to better see the lay of the crack. It has been estimated this project contains over 4200 sawed panels with only fifteen panels exhibiting minor cracking.

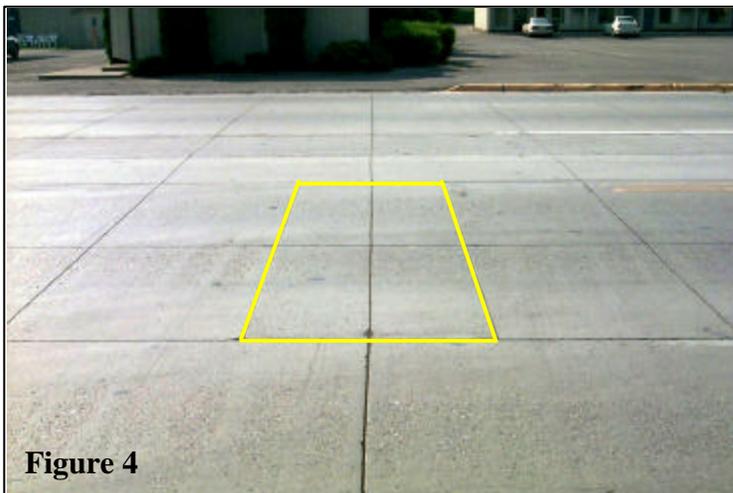
Figure 4 shows the performance of the doweled PCCP patch placed during construction due to unconsolidated concrete by lack of adequate vibration (documented in the 2001 fall construction report). The yellow outline is the area of repair. Visual observation of traffic moving over this section display no faulting or movement of the slab. At this time, no visual surface distress

was noticed. This repair is approximately located in the center section of the westbound lanes 2 meters past the intersection of 6<sup>th</sup> Avenue EN and East Idaho St.

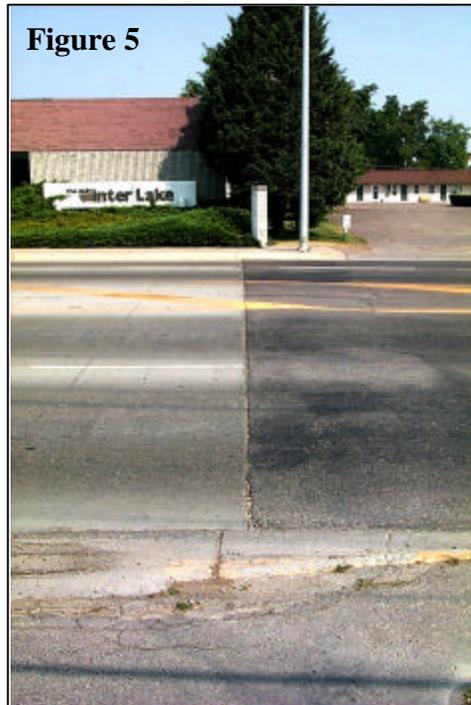
Figure 5 is showing the east-end transition area of the project. It is important to point this feature out due to the innovative way this approach was placed, please refer to the fall 2001 construction report for details. That report can be located on the MDT Research intranet website at: <http://mdtinfo/research/projects/eps1.shtml>. No evidence of distress to the transition was noticed during this evaluation.

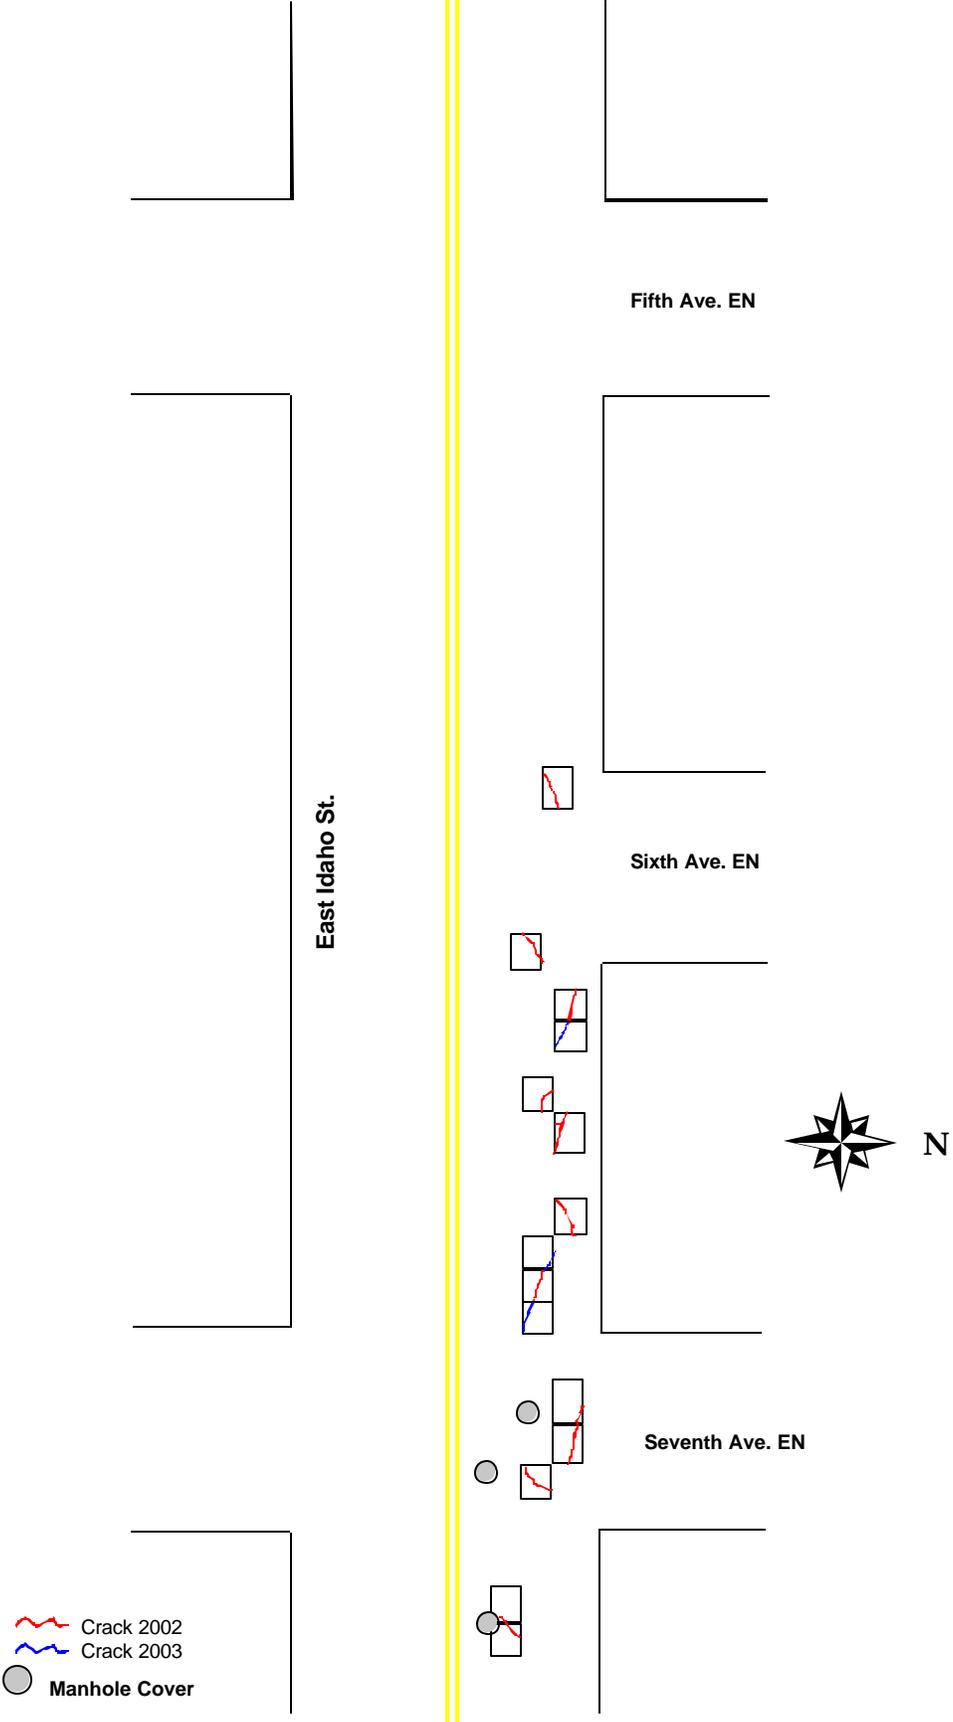
Thin-Whitetopping Overlay Composite - STPP 1-2(93) East Idaho St., Kalispell Montana  
Representative Project Crack Map - Approximate Location

Note: Crack map only shows portion of project which contains distress information
