ANNUAL EXPERIMENTAL EVALUATION REPORT

Thin-Whitetopping Bonded Composite

Project No.: STPP 1-2 (93)121, East Idaho St.

Evaluation Date: July 2009

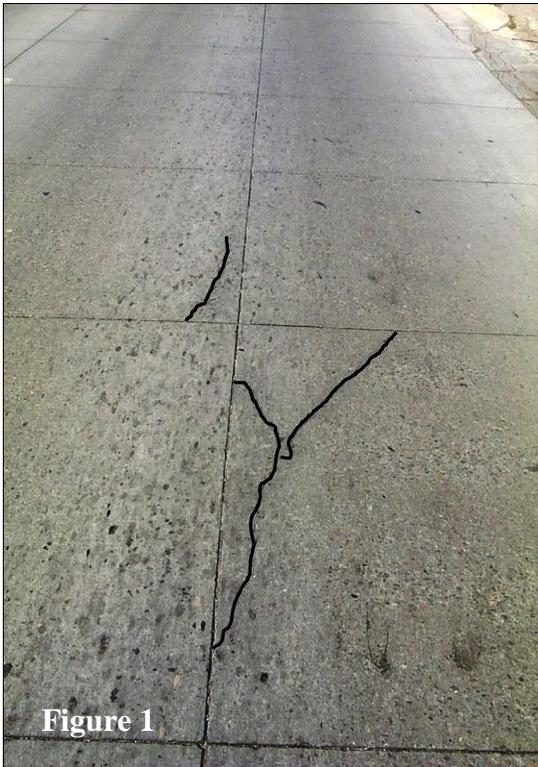
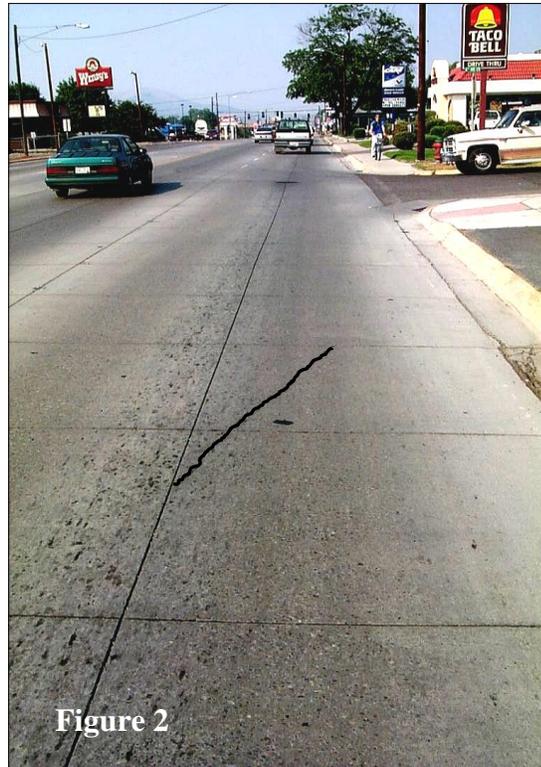
Thirty-one cracked panels were documented in the 2007 report. Seven additional panels were documented during this evaluation. The majority cracks are hairline in nature with no vertical displacement or debonding of the composite panels. Several cracks appeared to be at a .25-.50 inch wide width or more. At this time, there is no indication of a pattern or reasons for the randomness of the cracked panels; therefore, it is premature to attempt to ascertain a cause. It should be noted that the majority of the cracking occurs on the north half of the project, west-bound (which was placed first) between the streets of 8th Ave. EN and 6th Ave. EN. The west half of the project is beginning to exhibit panel cracking. Refer to the crack maps at the

Figures 1 & 2 are examples of the in-lane, hairline cracks. A black line has been superimposed over the images to better see the lay of the crack. It has been estimated that this project contains over 4200 sawed panels with an approximate forty-two (42) panels exhibiting minor cracking since construction which represents approximately .01% of the entire project.

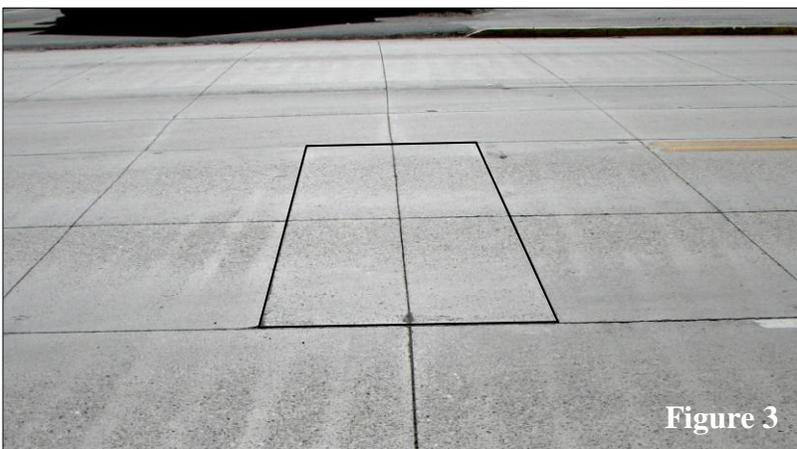
Figure 3 shows the performance of the doweled PCCP patch placed during construction due to unconsolidated concrete by lack of adequate vibration (documented in the project construction report). The black outline is the area of repair. Visual observation of traffic moving over this

section displayed no faulting or movement of the slab. At this time, no visual surface distress was noticed. This repair is approximately located in the center section of the westbound lanes 2 meters past the intersection of 6th Avenue EN and East Idaho St.

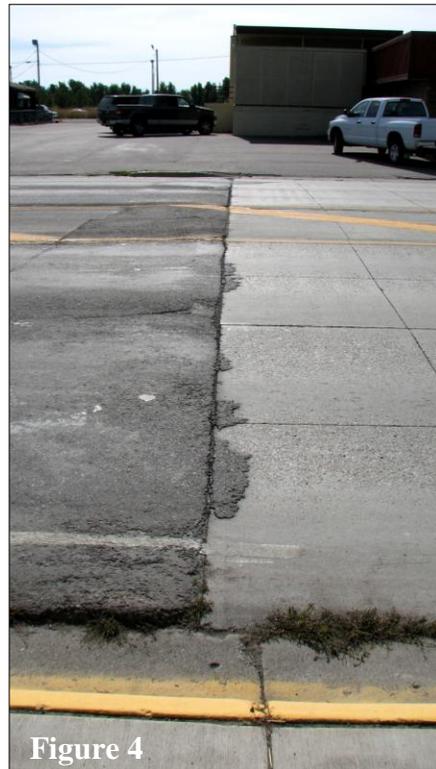
Figure 4 is showing the east-end transition area of the project. It is important to point this feature out due to the innovative way this approach was placed, please refer to the construction report for details. No evidence of distress to the east or west transitions was noticed during this evaluation.

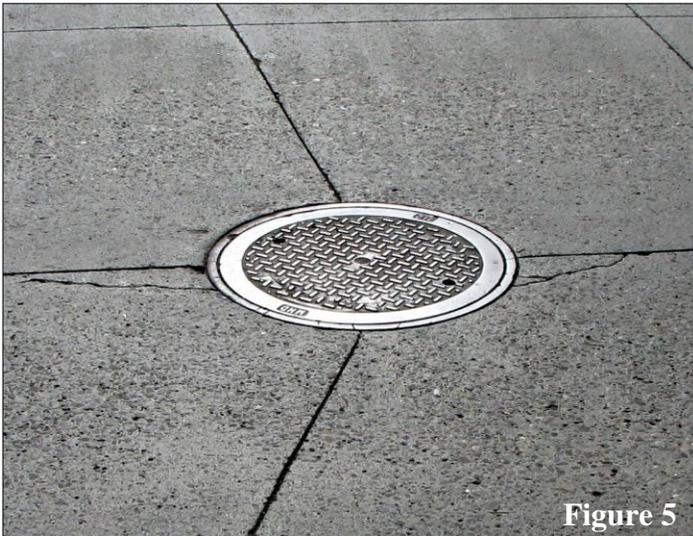
Minor spalling is beginning to appear but at a frequency that is not an issue to date. It was observed that cracking is beginning to appear around several of the manholes on the project. No debonding or faulting has been seen with traffic moving over those items. Figure 5 is an example of that distress.

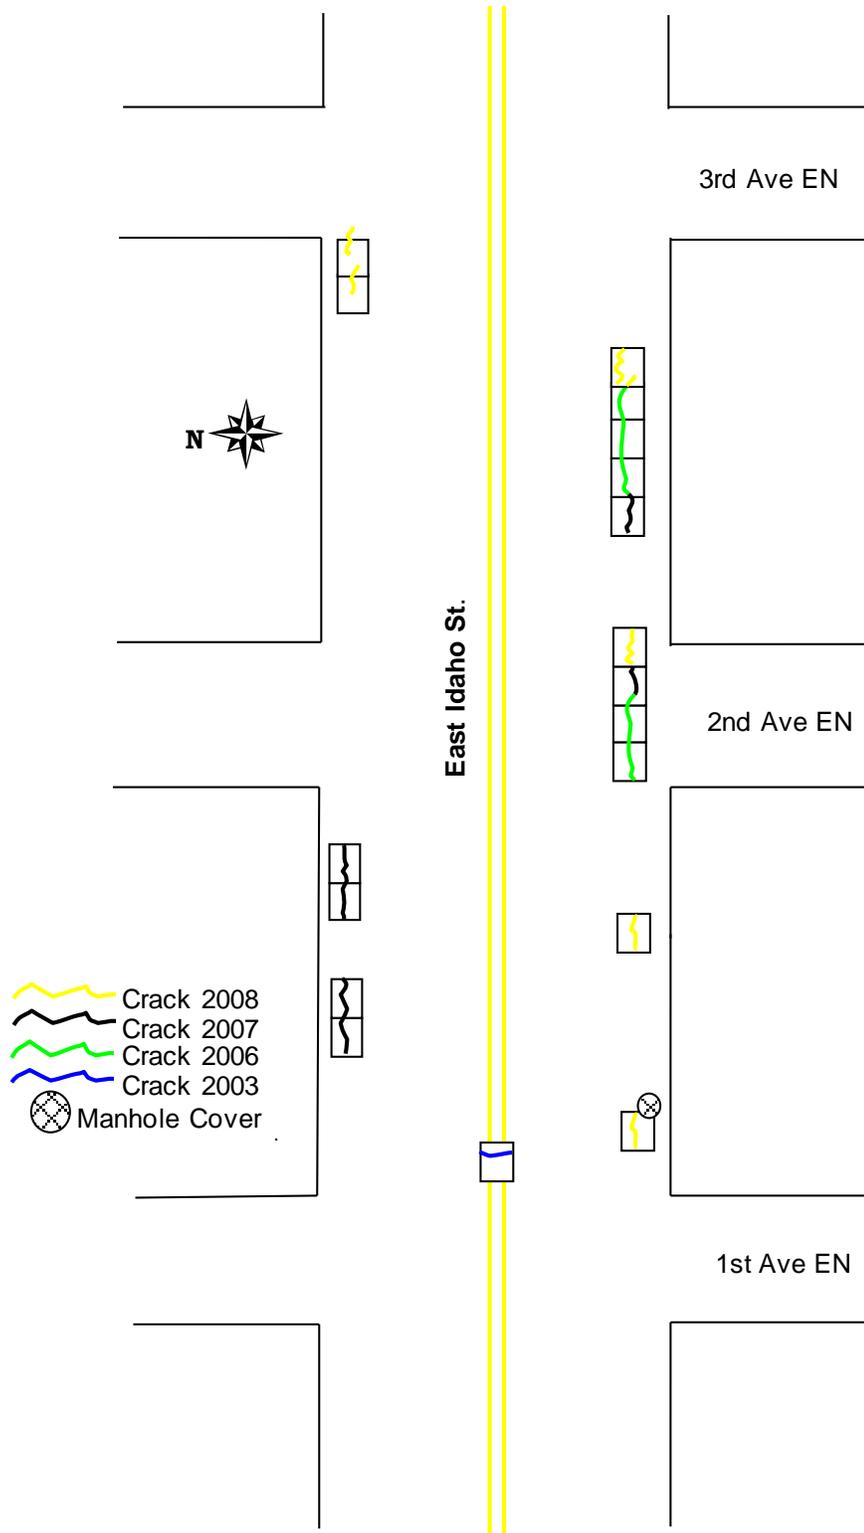
Thin-Whitetopping Overlay Composite - STPP 1-2(93)121 East Idaho St., Kalispell Montana
Representative Project Crack Map - Approximate Location - Not to scale
Note: Crack map only shows portion of project which contains distress information

end of this report for a general representation of cracked panel locations and the relationship of how the crack is located within the panel itself. The crack map is strictly an indication of approximate cracked panel locations over time within the project. It is not to scale.
