EXPERIMENTAL PROJECTS CONSTRUCTION REPORT

Evaluation of Durable Traffic Pavement Marking Tape (PMT)

Project Name: Lyndale Intersections

Experimental Project: MT-14-02

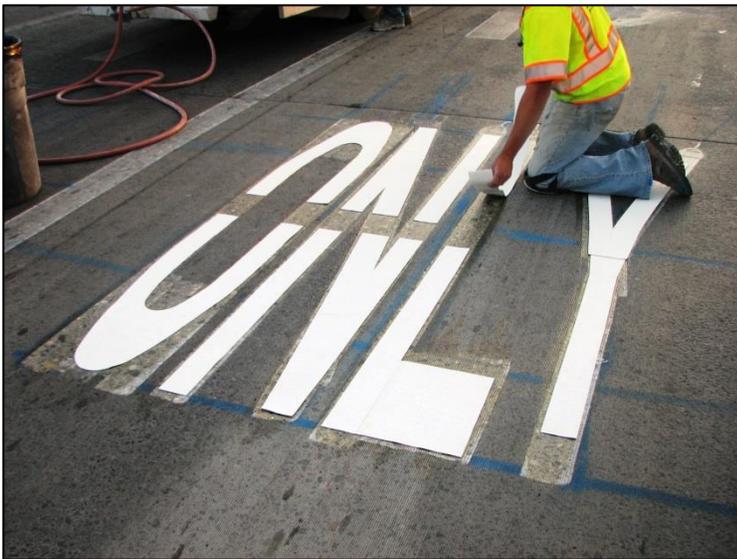
← The ONLY legends did not meet the Manual on Uniform Traffic Control Devices (MUTCD) requirements and had to be modified in the field.

Here you can see the gap in the letters needed to make the legend in compliance.

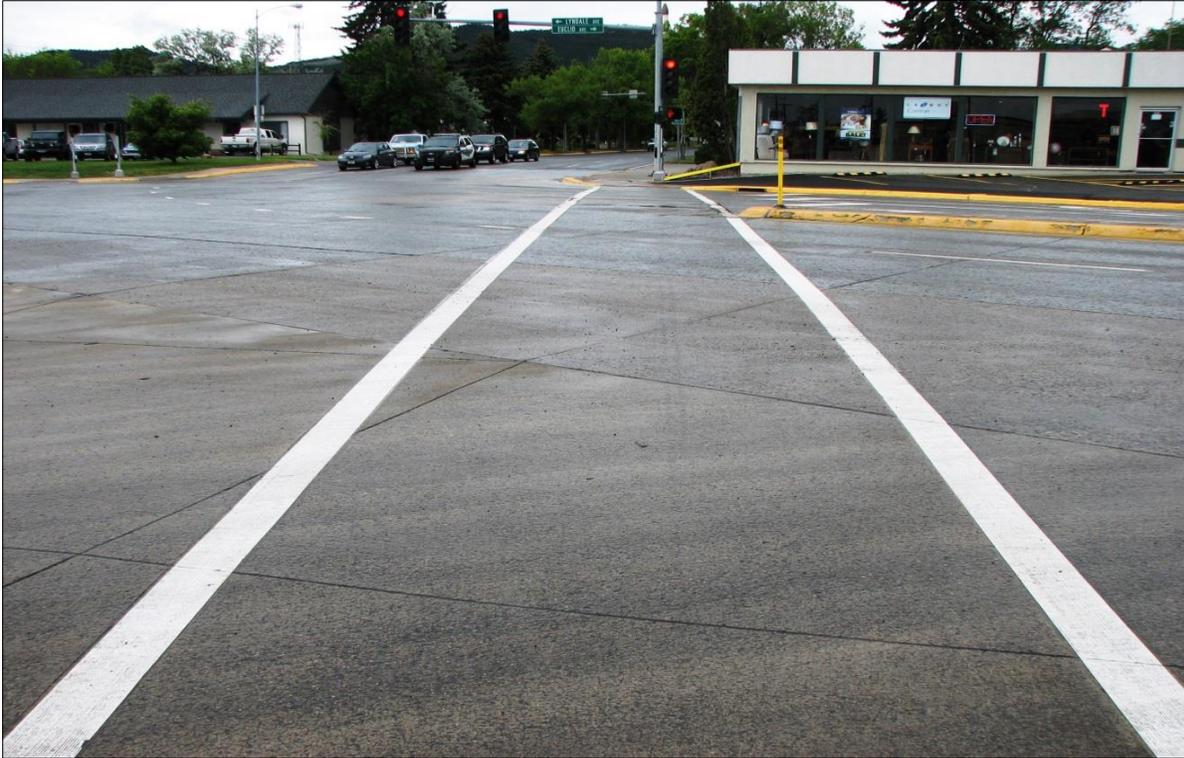
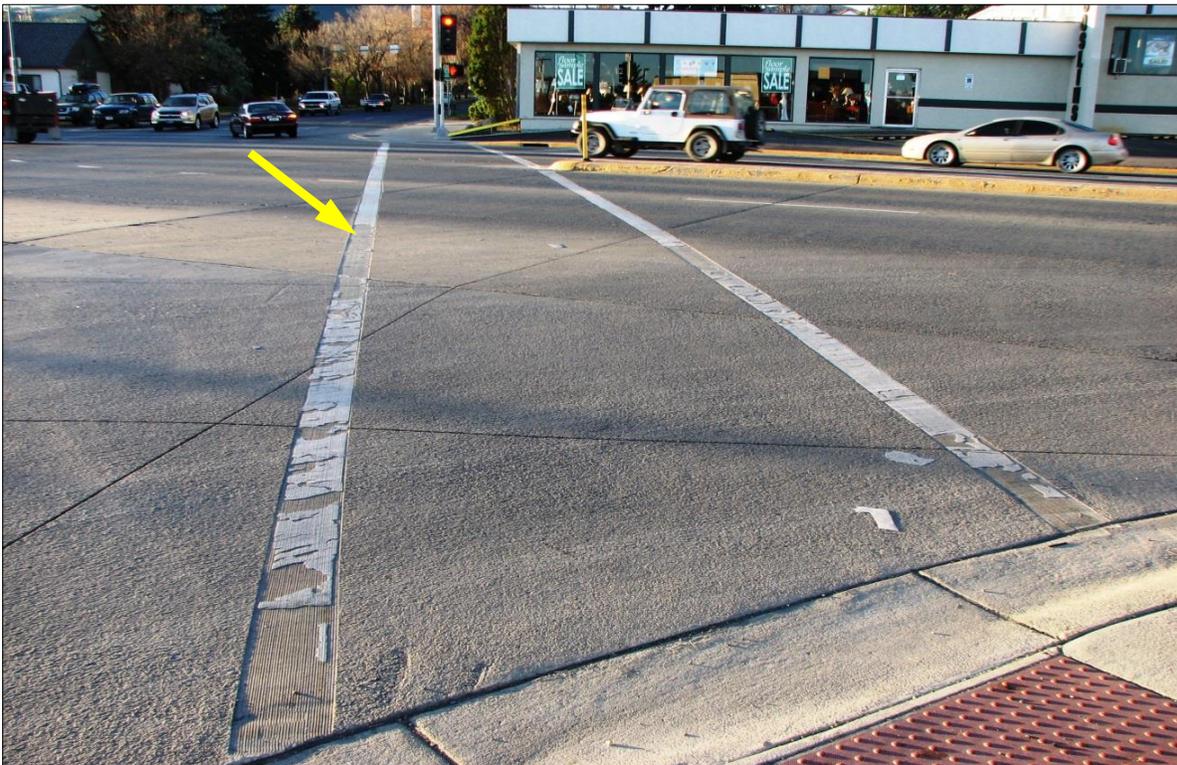
↑ Image of Euclid Ave: westbound, west side pedestrian lines shortly after installation.

↓ Same location approximately 4 months after installation. Initial tearing and delamination began in the travel lane (yellow arrow) and progressed to the curb.

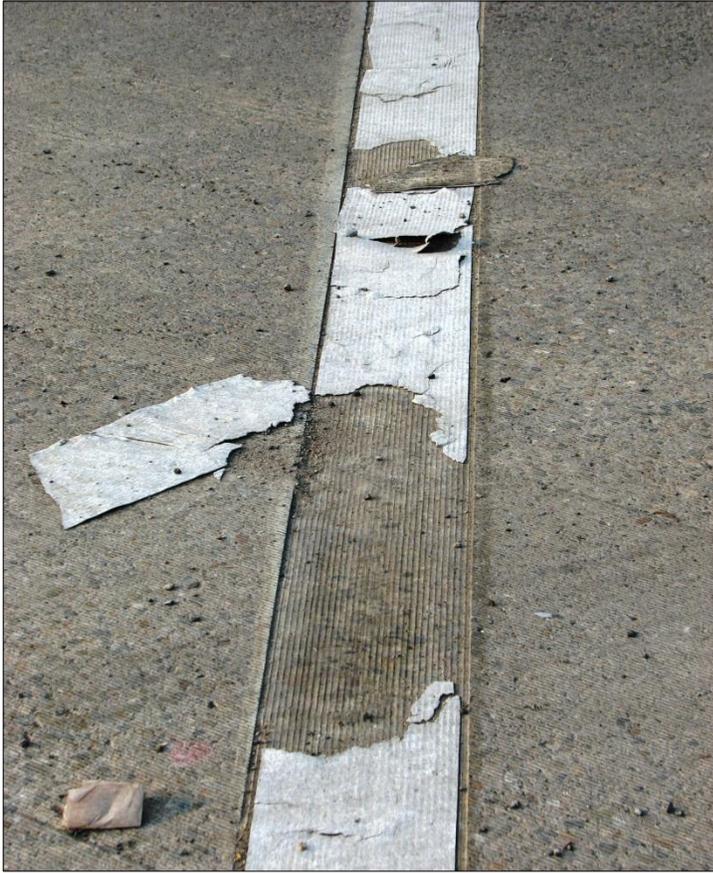
← A closer view of the pedestrian line tape damage.

Once the tape cracked or tore continuous vehicle traffic would eventually cause the tape to separate from the grooved pavement.

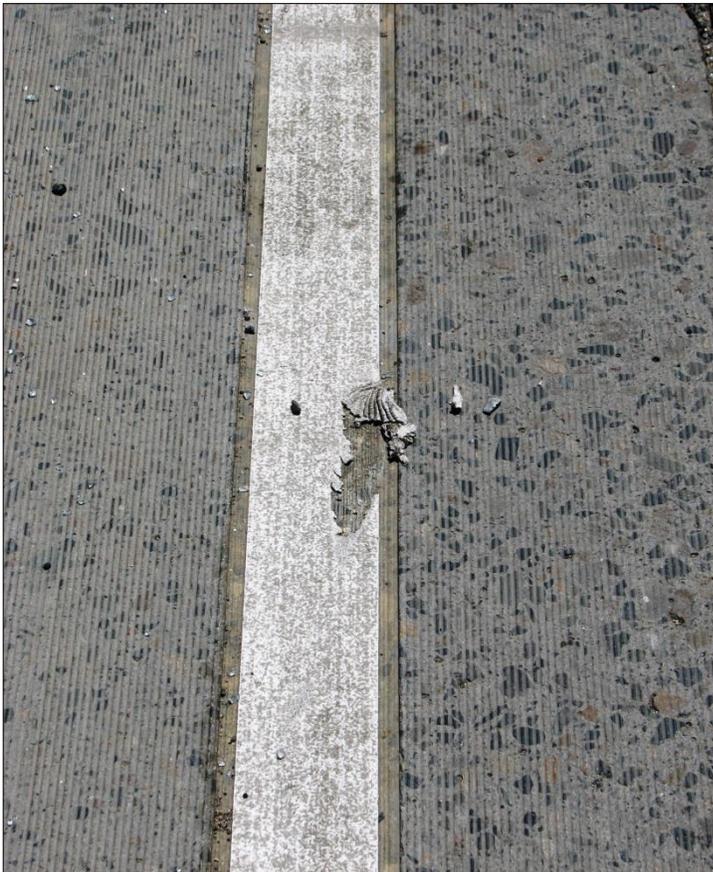
← An example of a torn section of tape on an edge line.

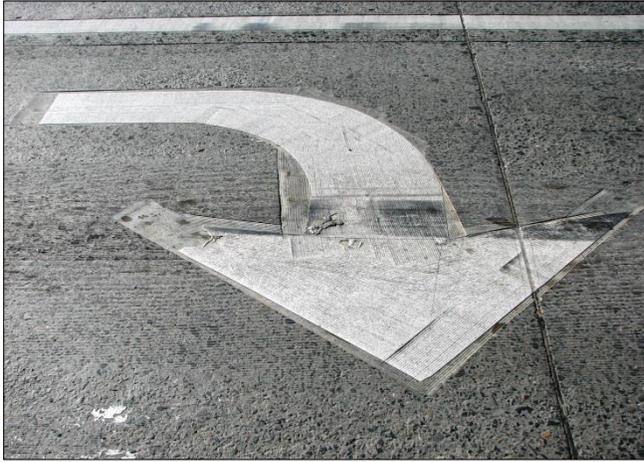
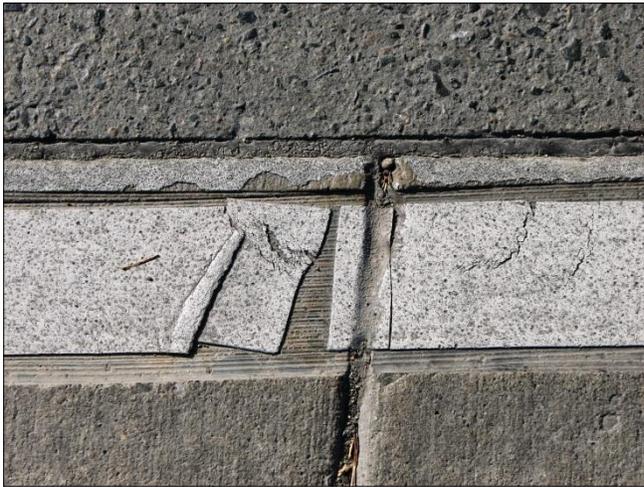
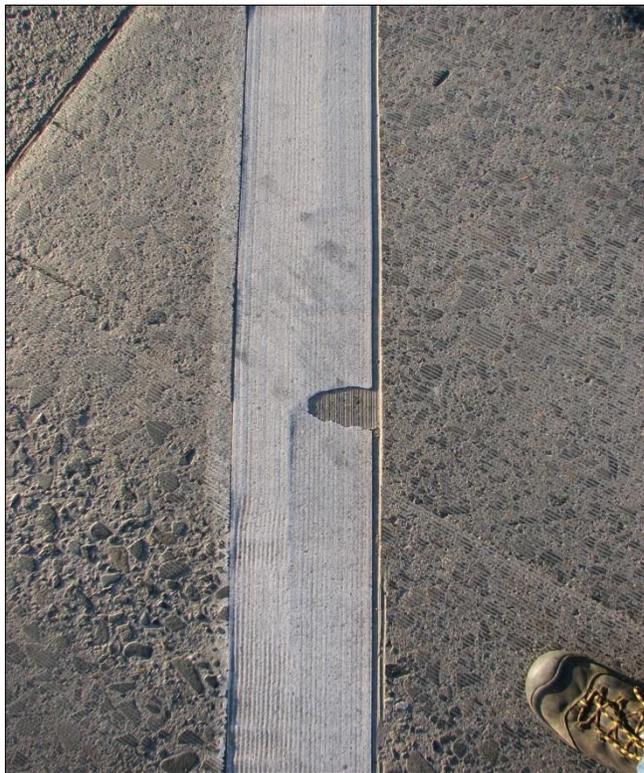
↩️ More examples of the type of tape distress with the Swarco project.

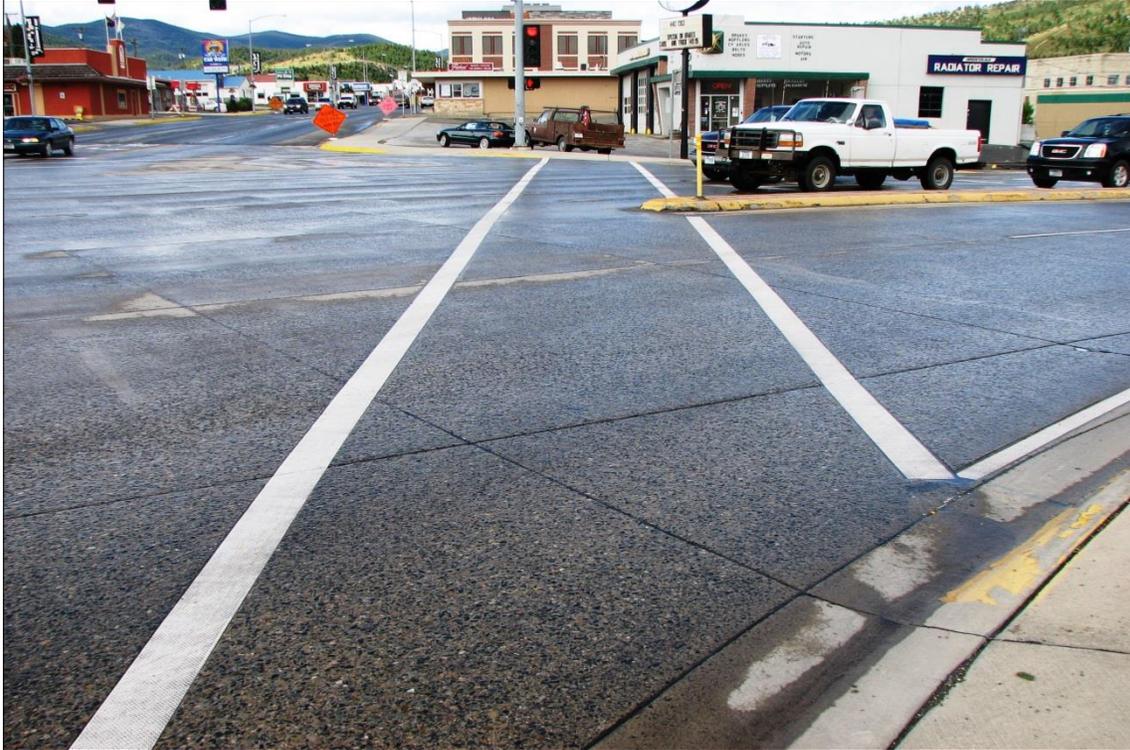
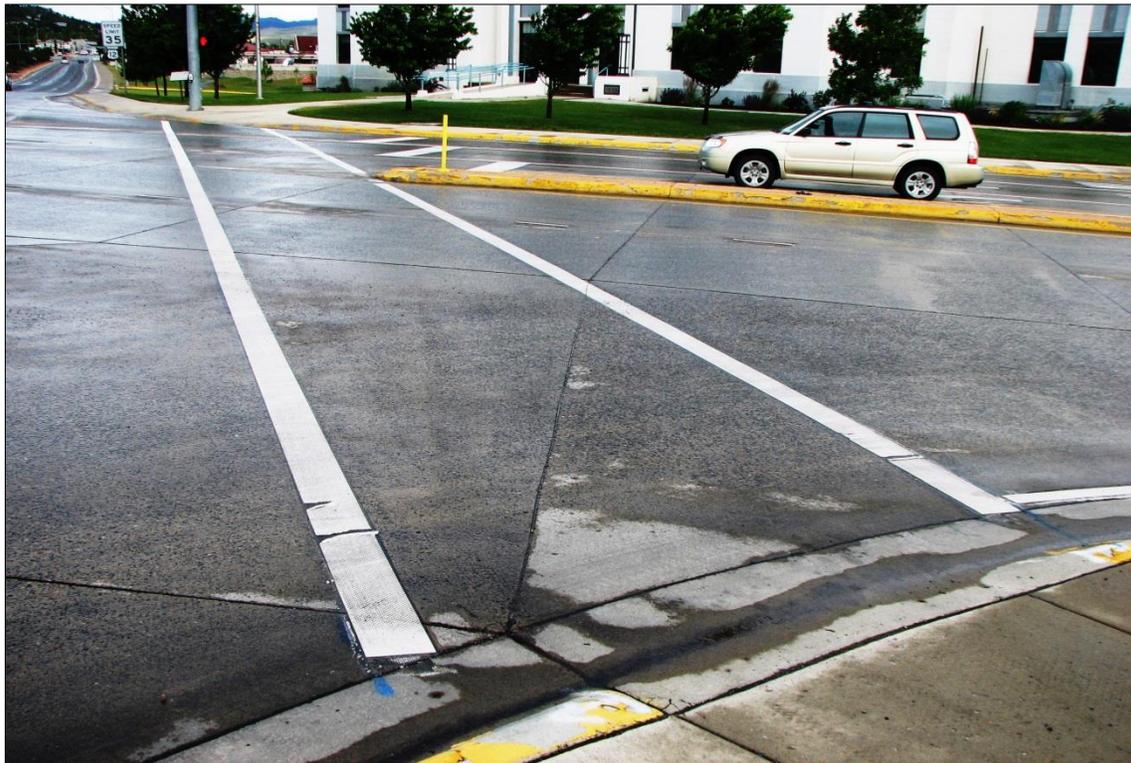
↑ Image of West Lyndale: westbound, west side pedestrian lines shortly after installation.

↓ Right turn from West Lyndale onto Last Chance Gulch: Turning movements are stretching and tearing the pedestrian lines.

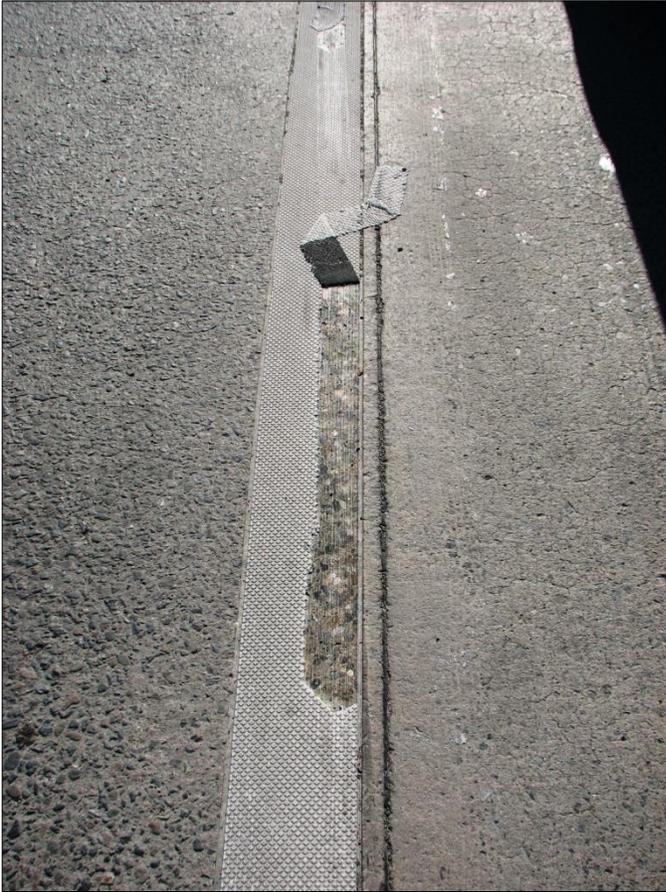
← Sample image of a friction tear most likely caused by sudden braking of a vehicle.

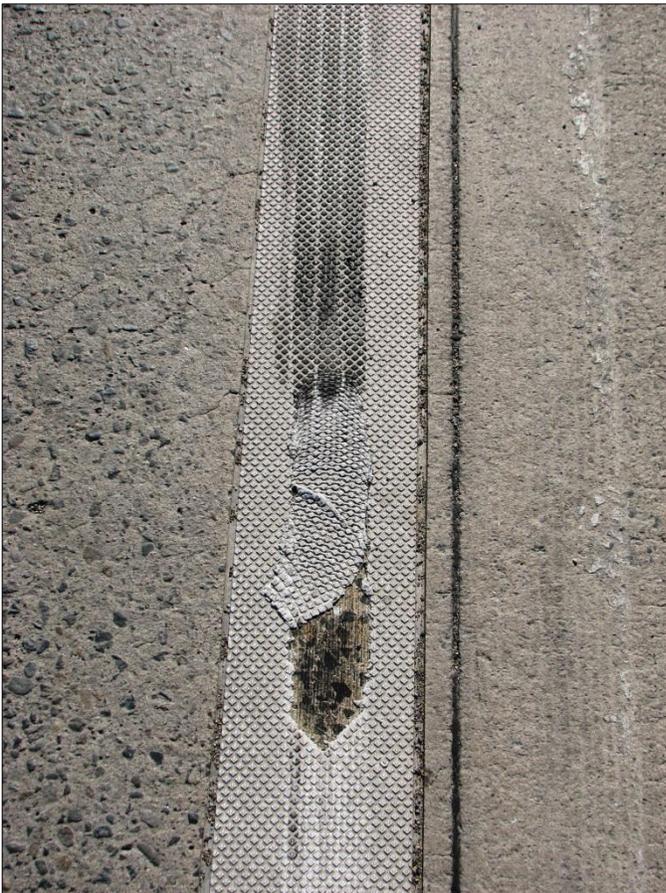
← Damaged caused by sudden braking by a vehicle is apparent in this image.

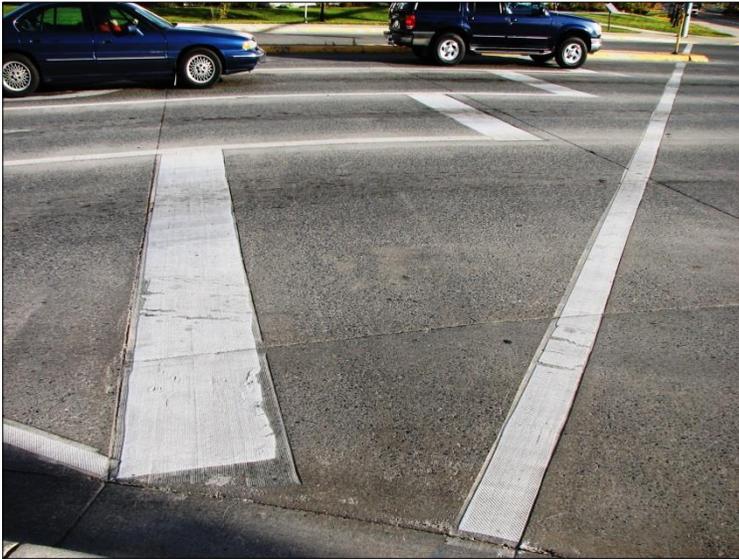
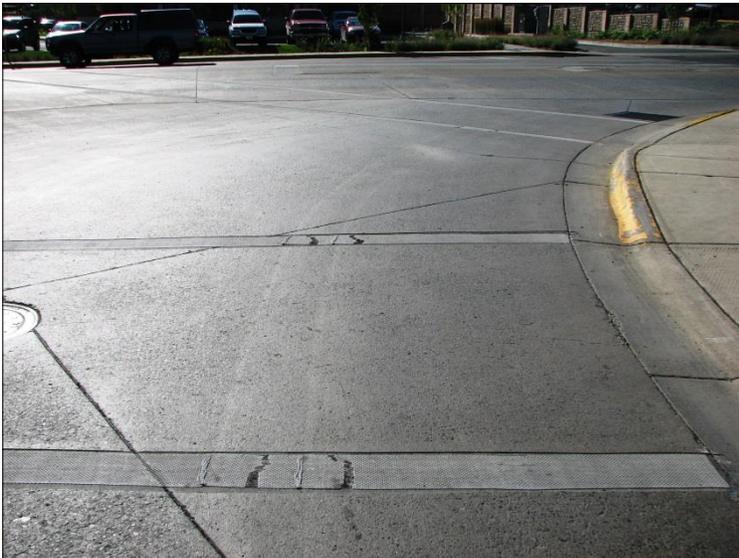
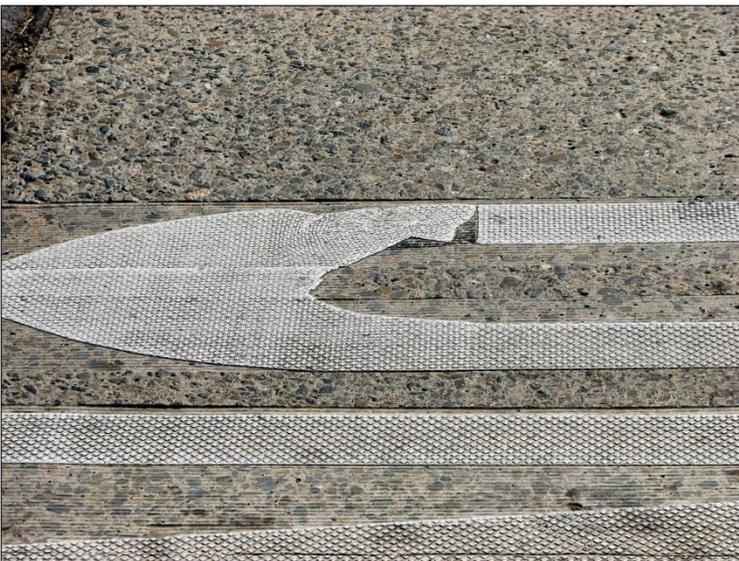
↙ ↘ More examples of the type of tape distress with the 3M Stamark project.

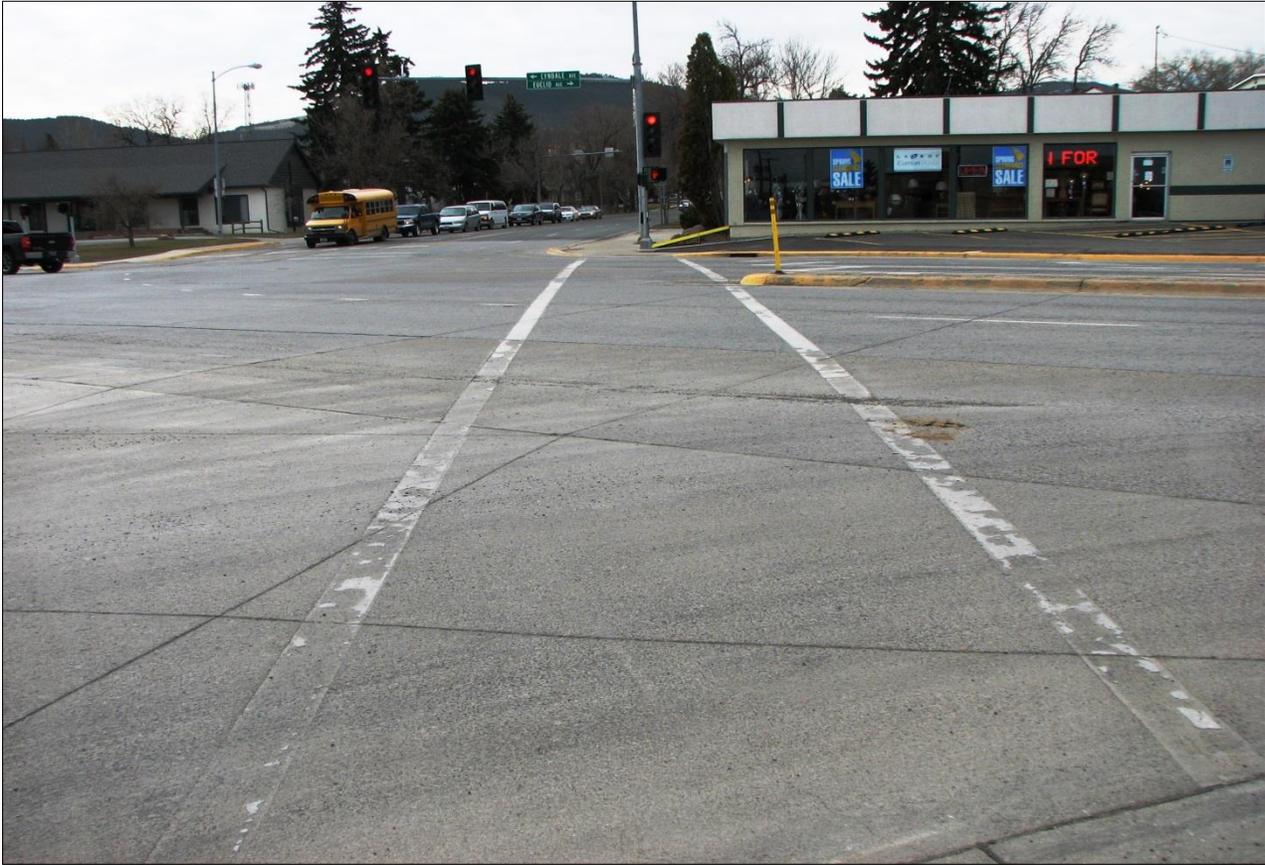
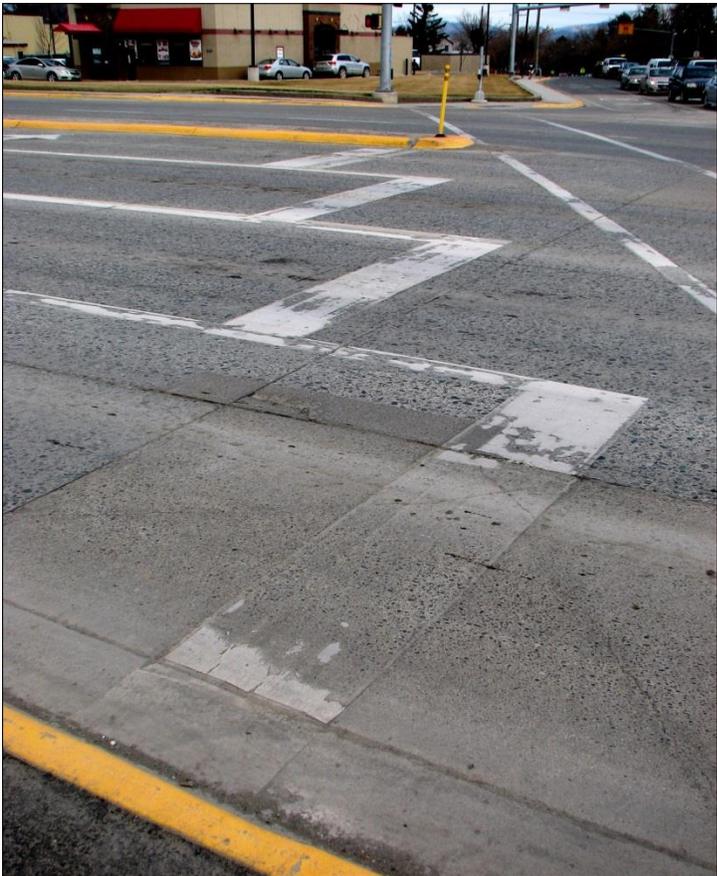
← ↑ As seen in earlier inspections, the pavement tape continues to degrade especially in areas with the most direct tire to tape contact.

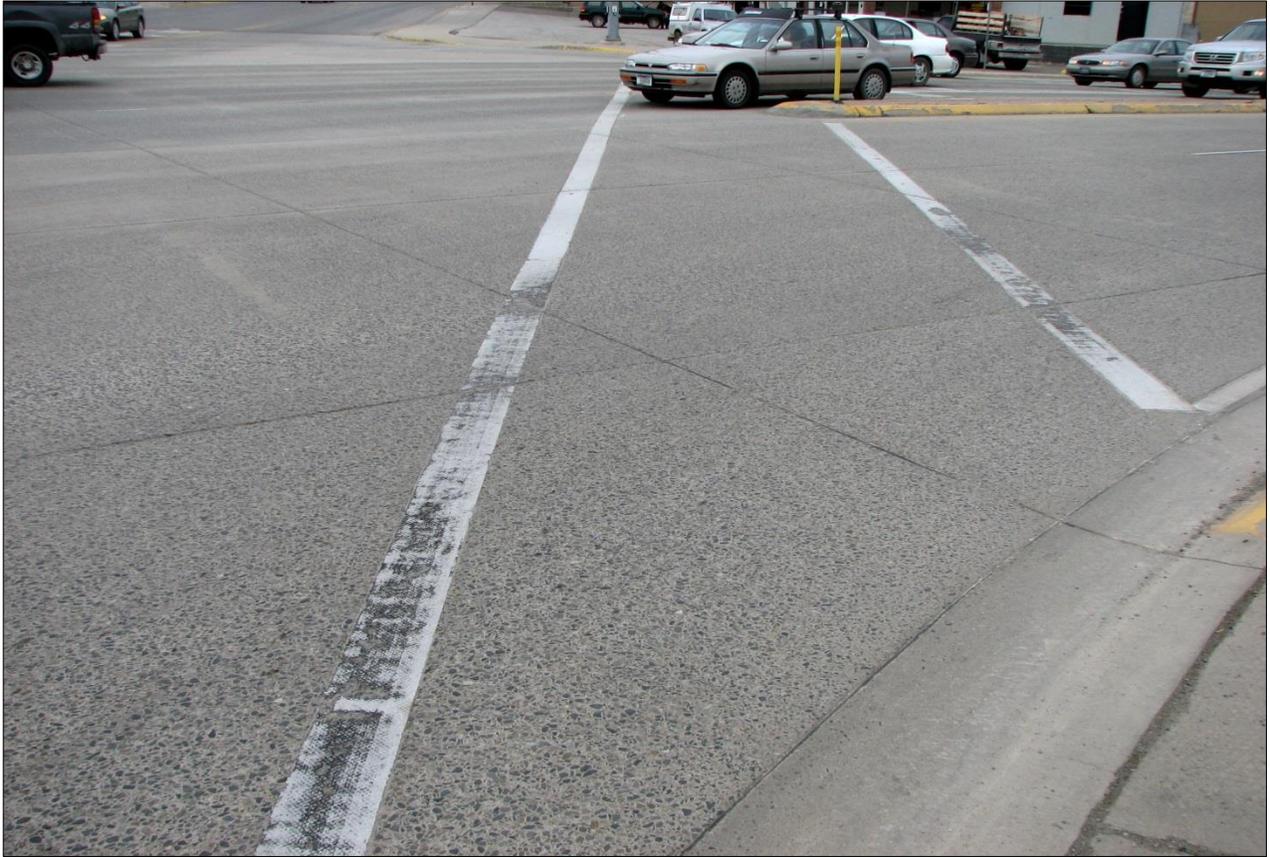
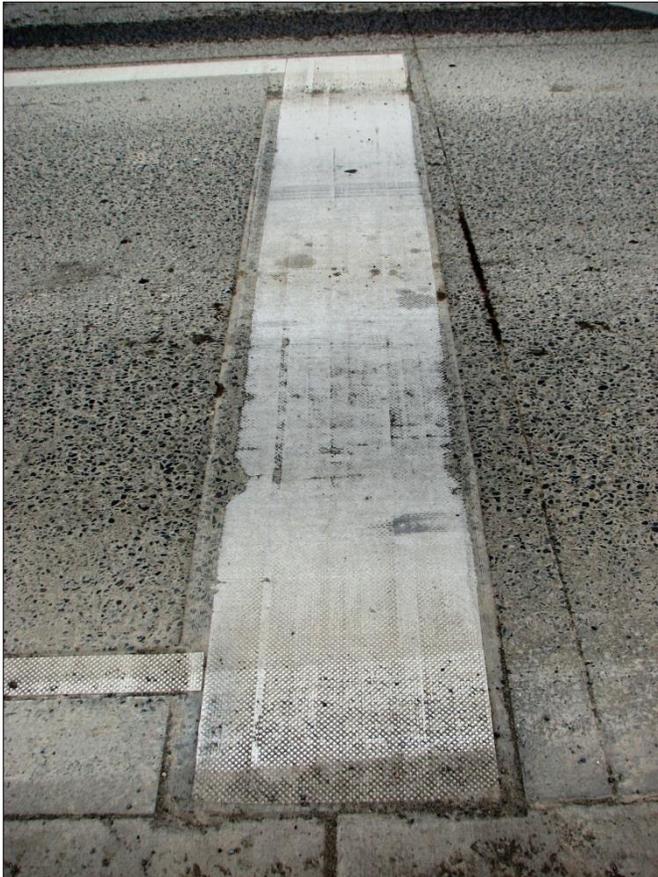
← ↑ General representation of continued pavement tape deterioration.

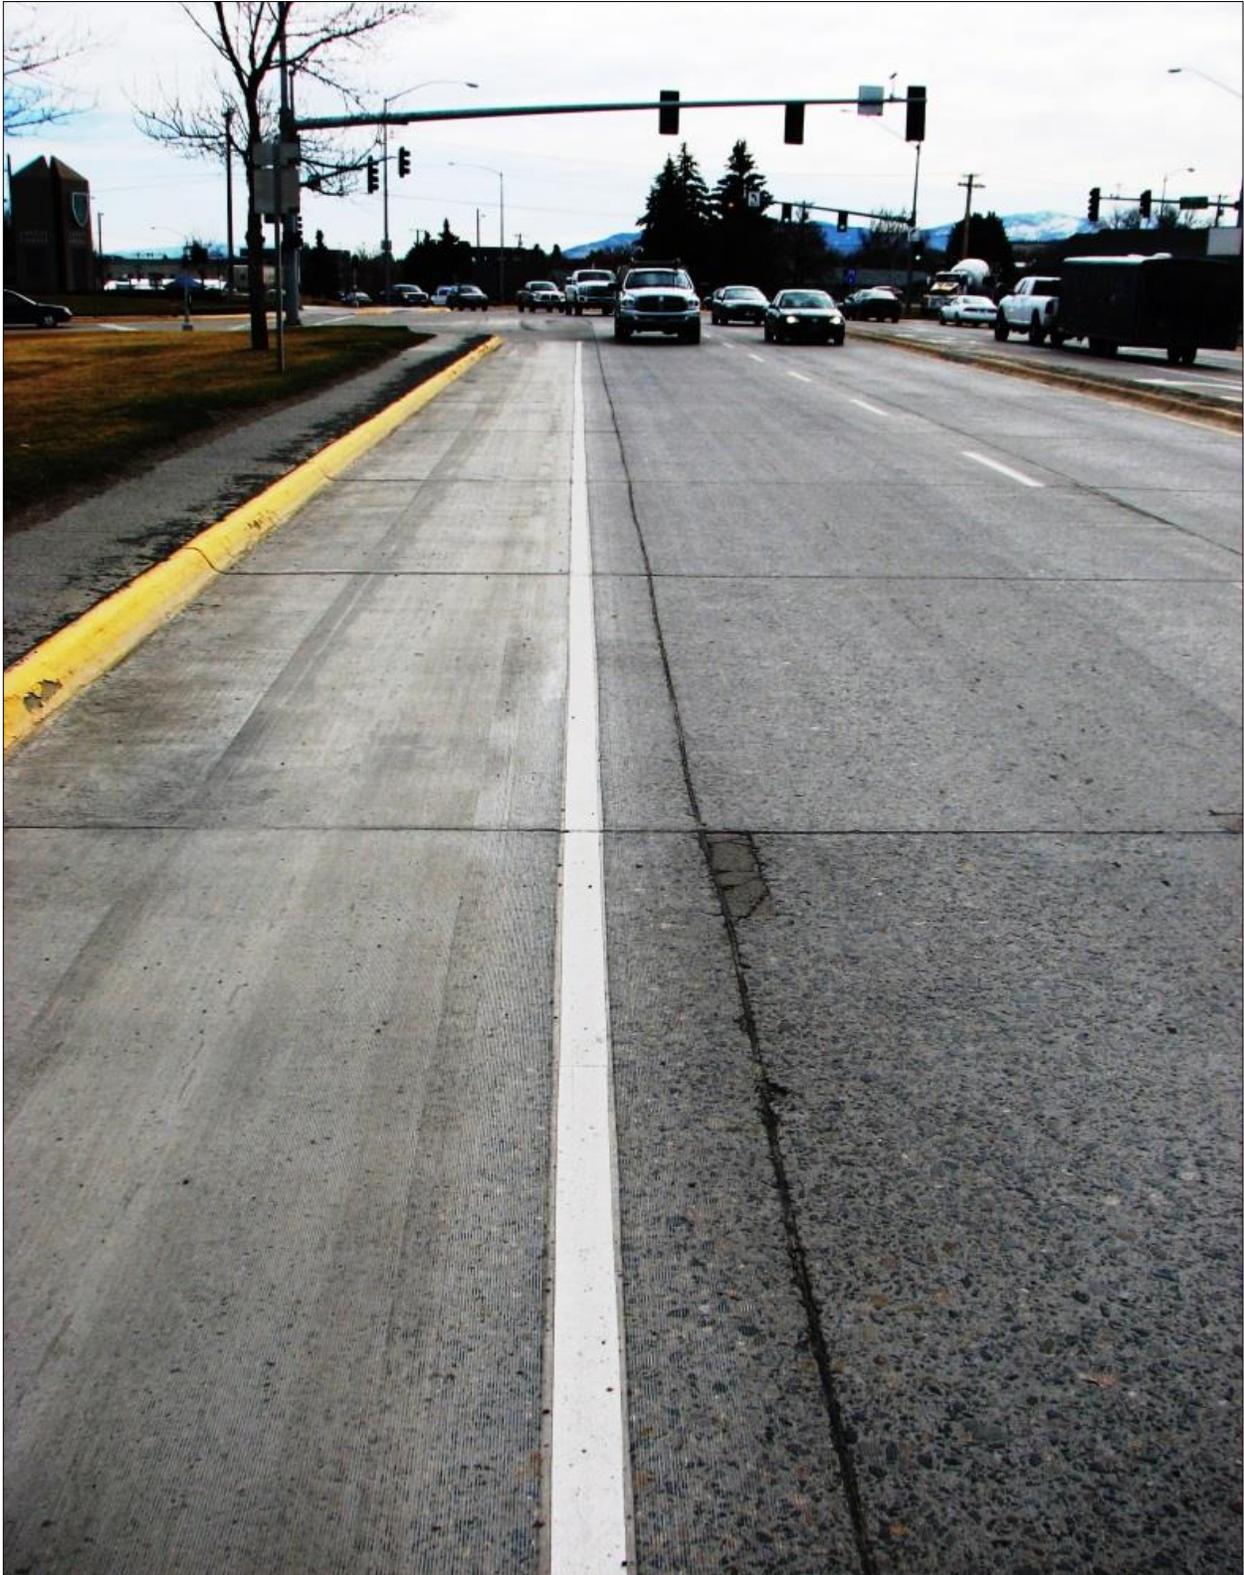
Pavement lines such as the example below of the 4" white edge line Swarco tape (and as applicable with the 3M Stamark) where tire to tape contact is at a minimum, or not subjected to stop and start friction as related to the transverse markings; are generally in good condition at both project sites.

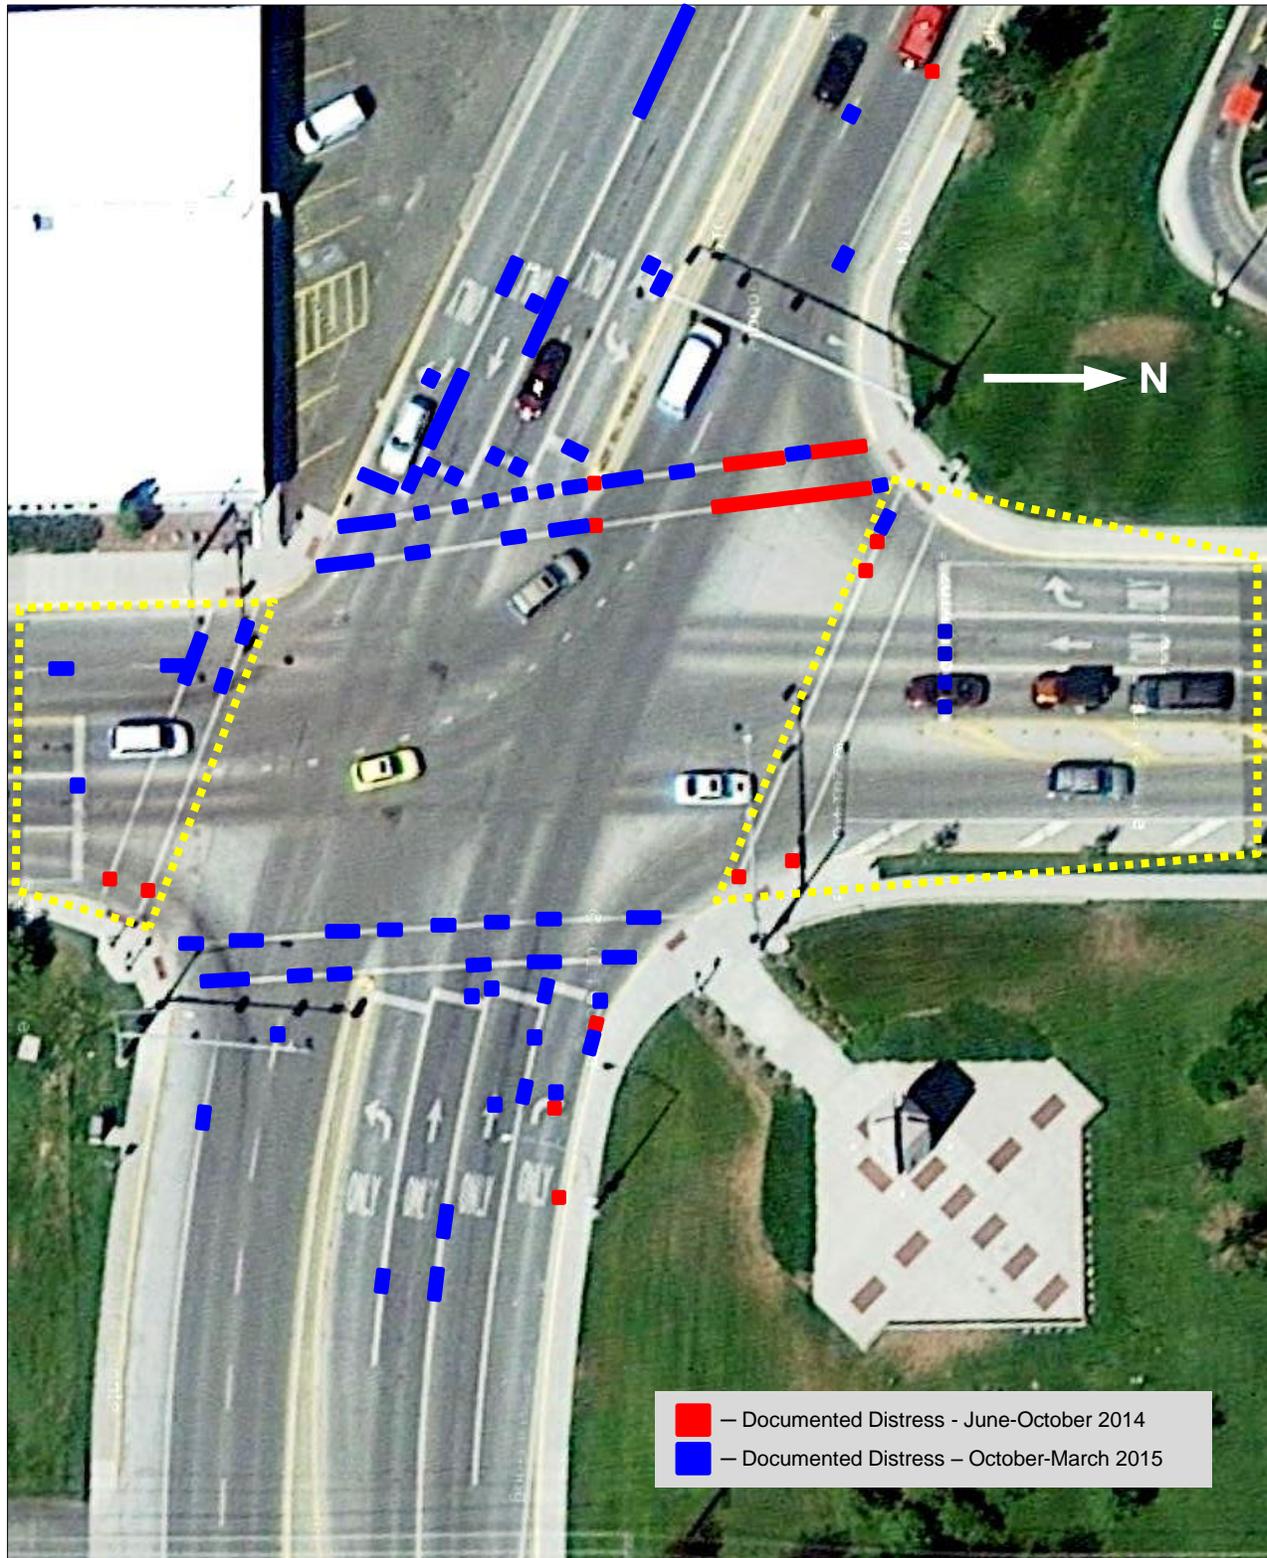
Swarco Director 25 Pavement Tape Defect Locations: West Lyndale & Euclid

Overview indicating areas where tape distress has been documented to date. Note the intersection area outlined in yellow (North Benton) received the 3M Stamark pavement tape. Locations are strictly for reference. This map is not to scale.

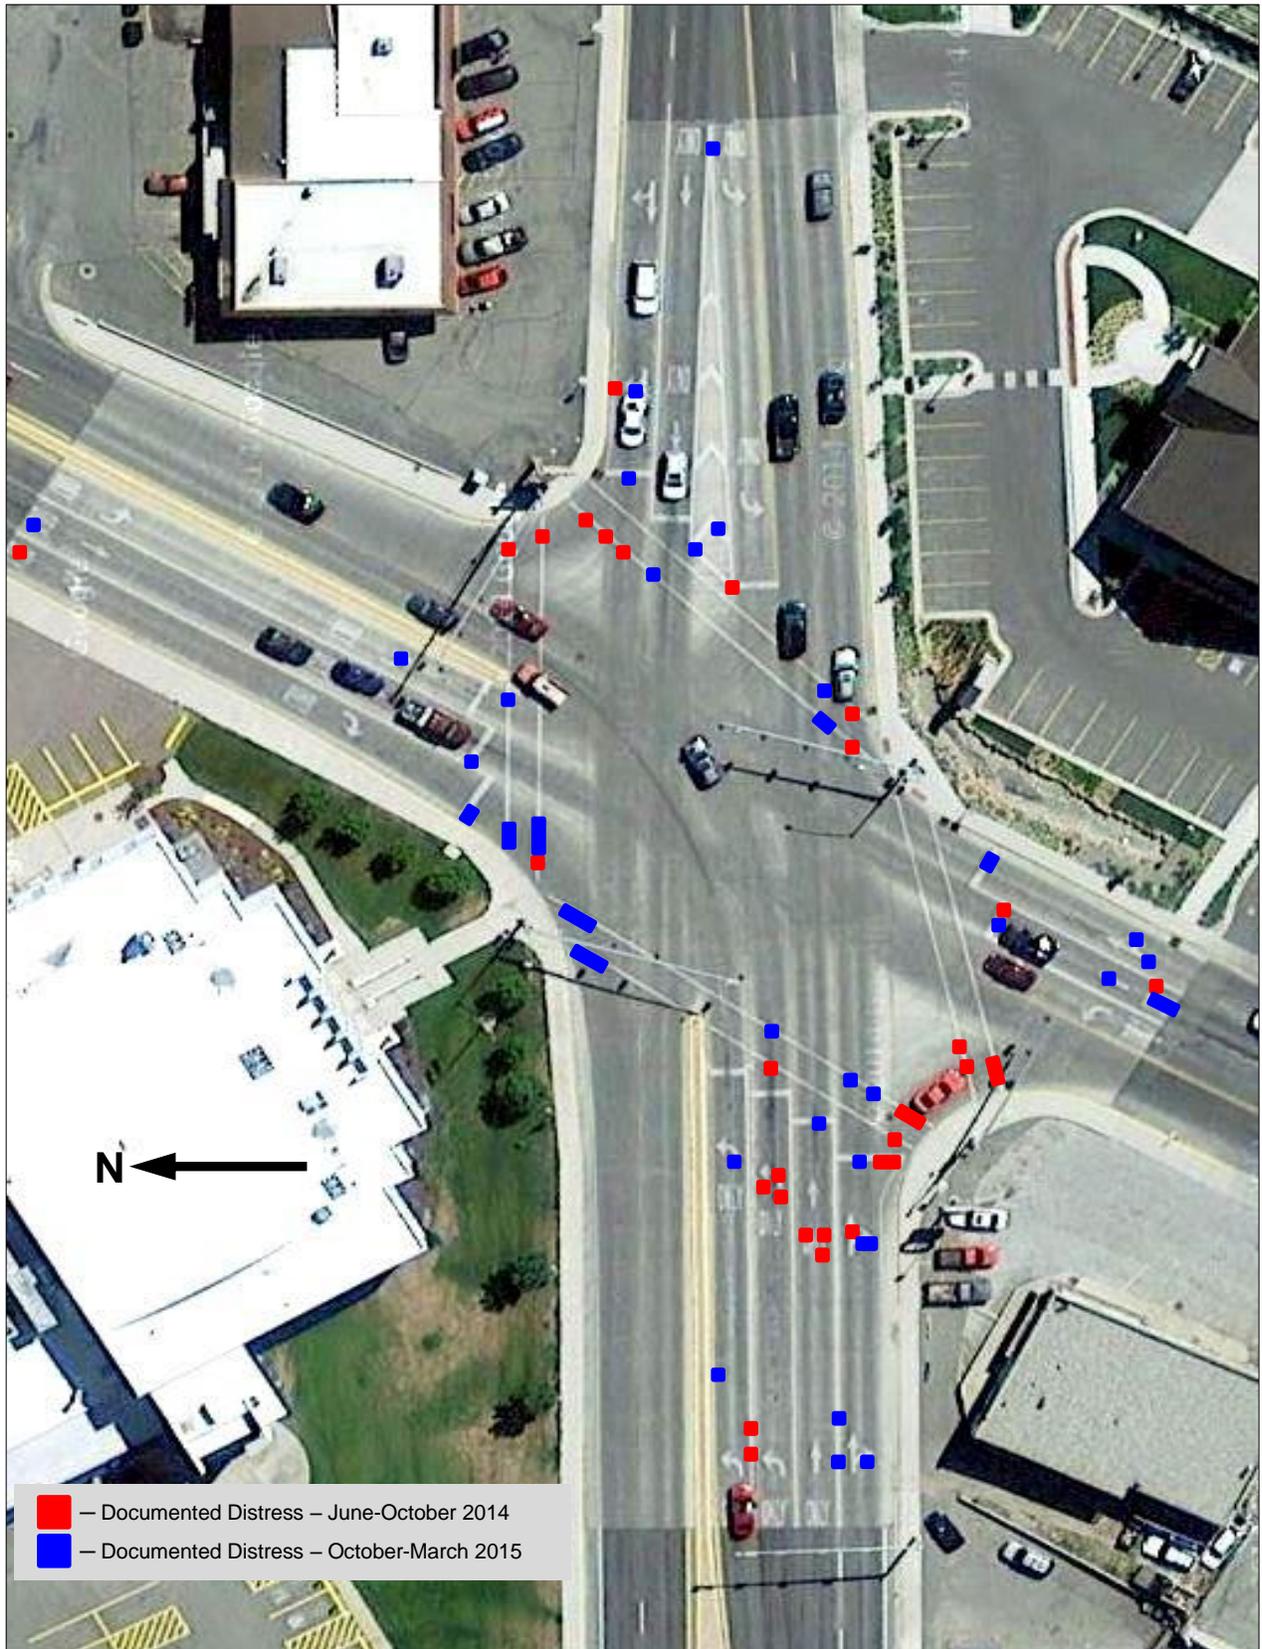
3M Stamark Pavement Tape Defect Locations: West Lyndale & Last Chance Gulch

Overview indicating areas where tape distress has been documented to date. Locations are strictly for reference. This map is not to scale.
