## EXPERIMENTAL PROJECTS FINAL REPORT

### HIGH FRICTION SURFACE TREATMENTS (HFSTs) FOR BRIDGE DECKS

- FHWA Project Number:** MT-12-10/13-01/14-05
- Principal Investigator:** Craig Abernathy, Experimental Project Manager (ExPM)
- Date of Installations:** <sup>1,2,3</sup>June 2014/<sup>4</sup>June 2015

- Date of Inspections:** March 2015/April-May 2016/May-October 2017/April 2018  
April 2019/April & May 2020

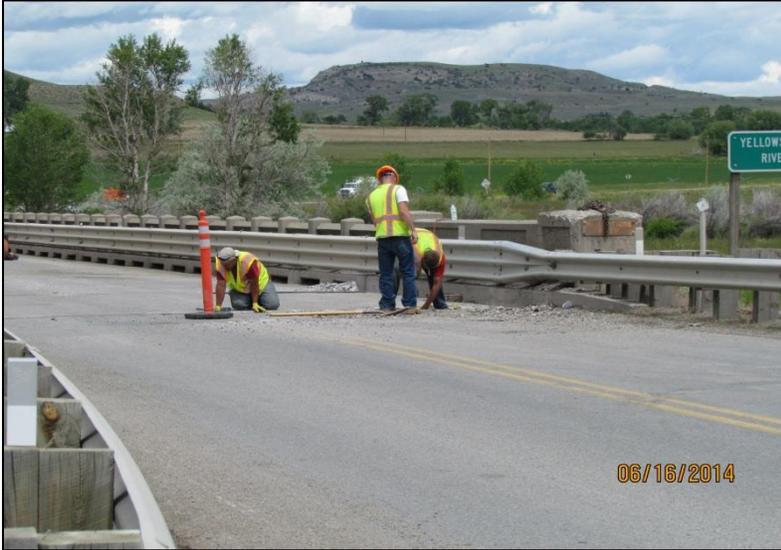
↙ Sample images of average deck surface condition. Most of the deck exhibited polished aggregate, minor pop outs and longitudinal cracking.

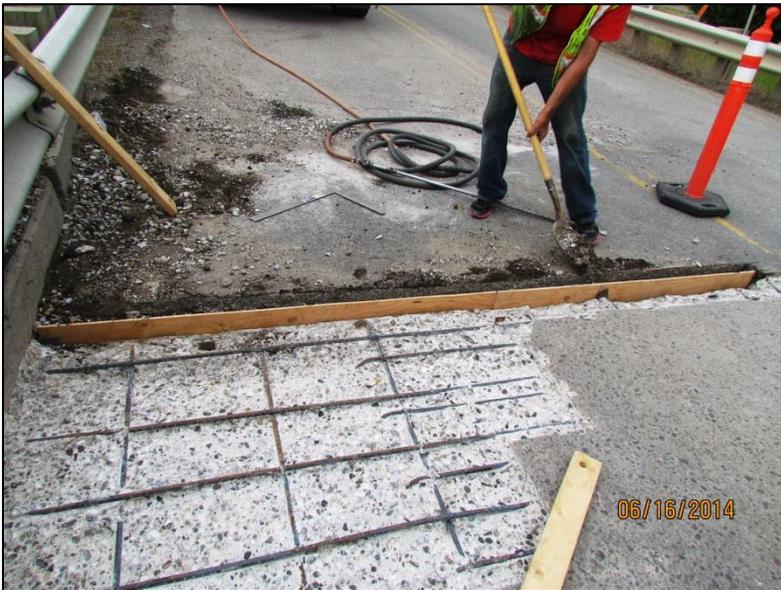
← Portions of the deck (mainly on the south end) needed repair due to deterioration of the deck surface.

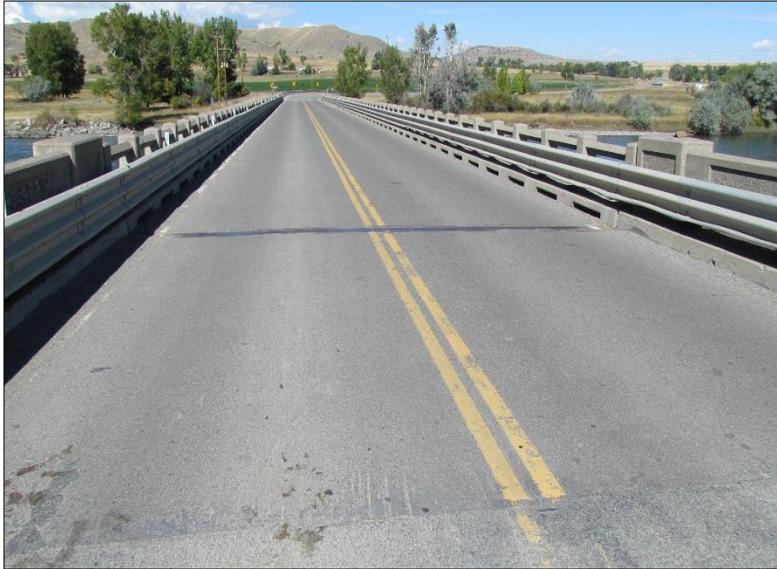
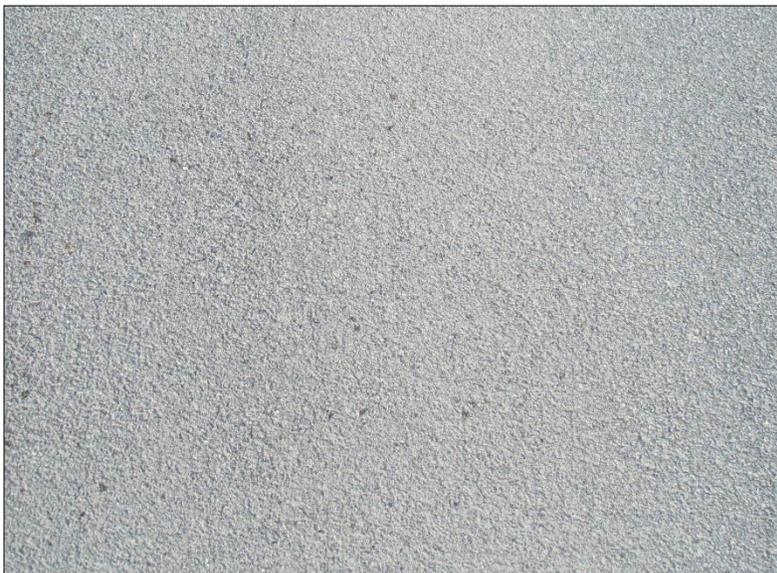
**Big Timber – Dayton Superior Unitex: August 2017**

No areas of raveling or debonding visible. However, the surface textures appear polished with noticeable pock marks indicative of loss aggregate (lower image is close-up of surface texture).

The topical condition of the HFST deck treatment is uniform, and may be attributed to snowplow activity

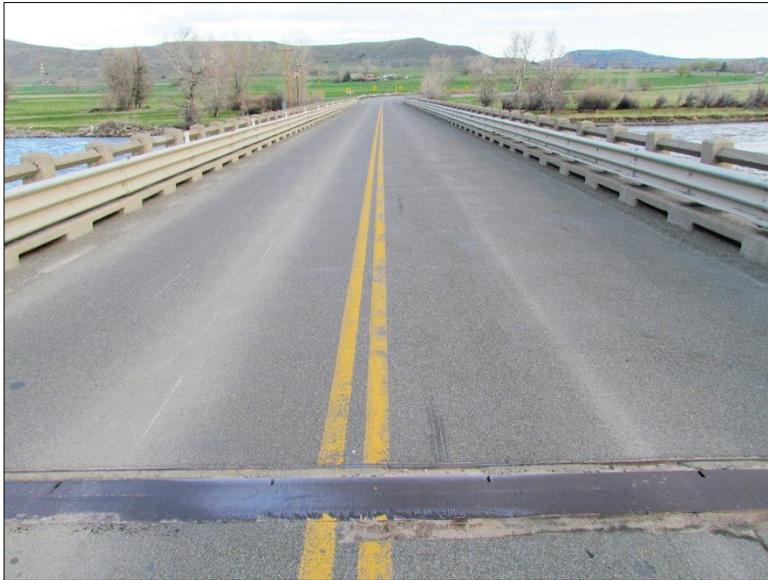
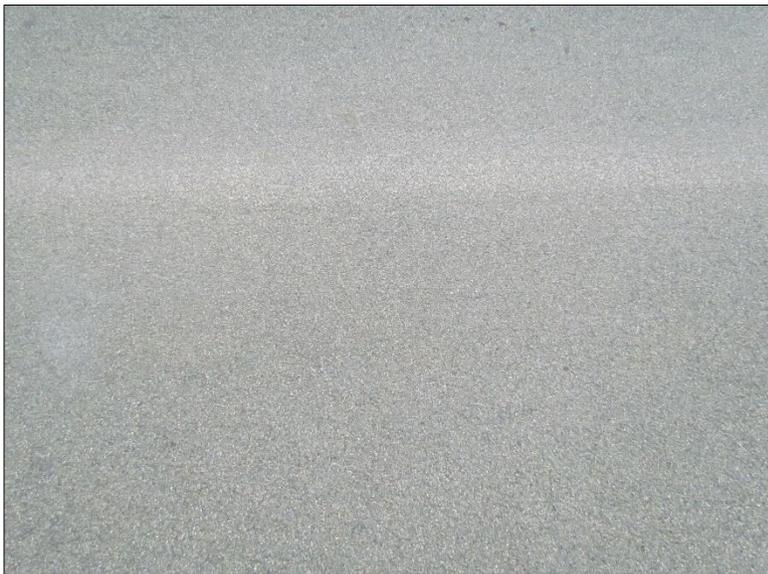
**Big Timber – Dayton Superior Unitex: May 2018**

As reported in 2017; no areas of raveling or debonding visible. However, the surface textures appear polished with noticeable pock marks indicative of loss aggregate (lower image is close-up of surface texture).

Visually the topical condition of the HFST deck treatment is uniform and may be attributed to snowplow activity and/or general traffic attributes.

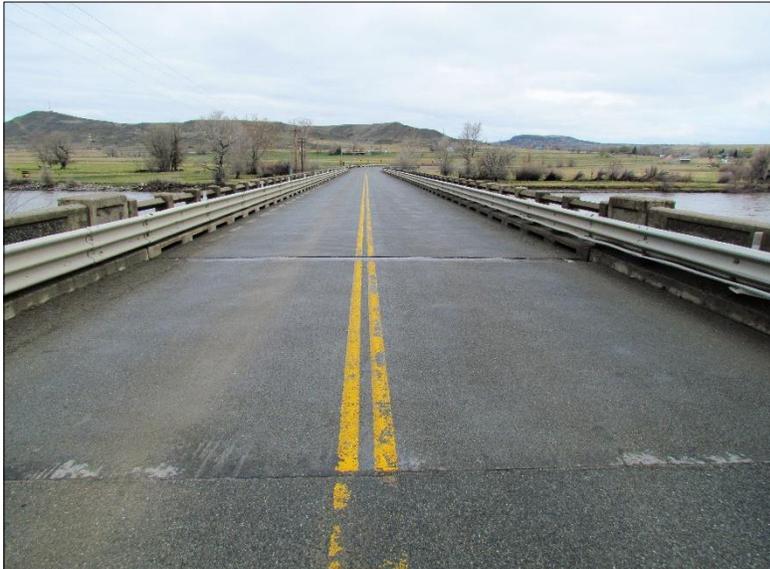
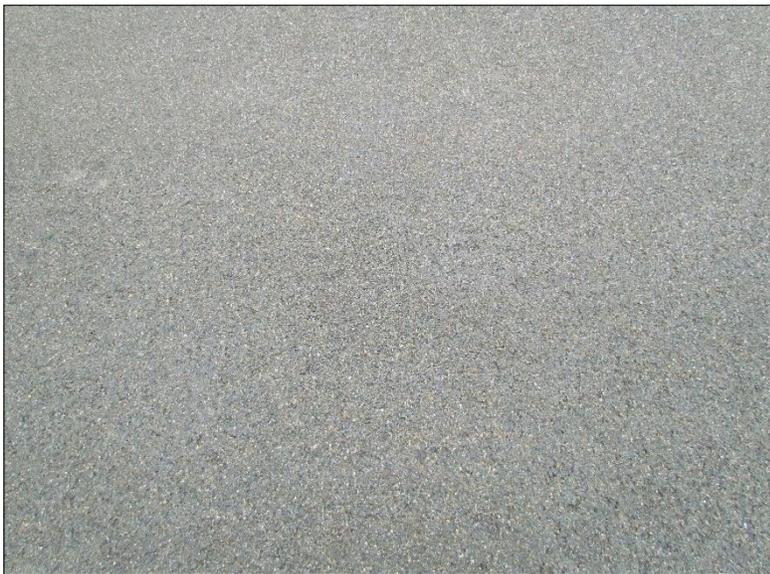
**Big Timber – Dayton Superior Unitex: May 2019**

As reported in 2018; no areas of raveling or debonding visible. However, the surface textures appear polished with noticeable pock marks indicative of loss aggregate (lower image is close-up of surface texture).

Visually the topical condition of the HFST deck treatment has topical aggregate pop-outs and surface polishing and may be attributed to snowplow activity and/or general traffic attributes.

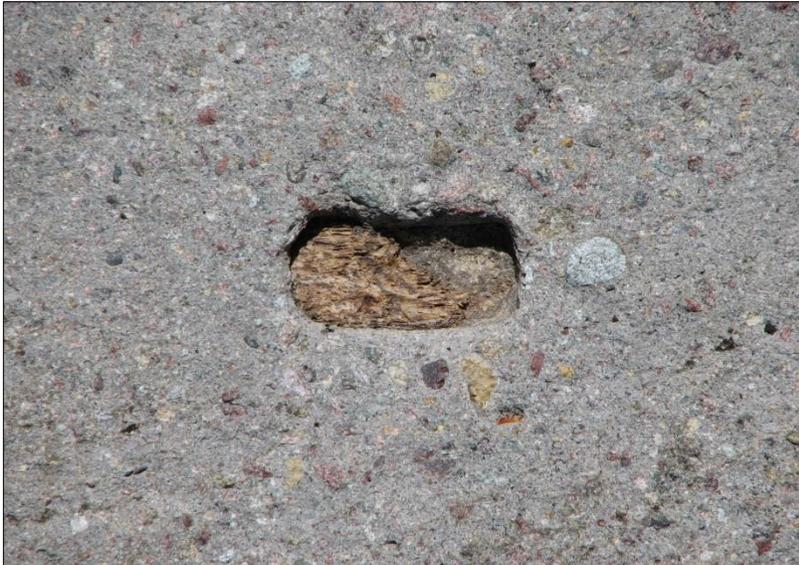
↙ Wood fragments were seen embedded in the deck concrete of enough quantity to be noted in this report.

At this time, this issue is not considered detrimental to the polymer performance.

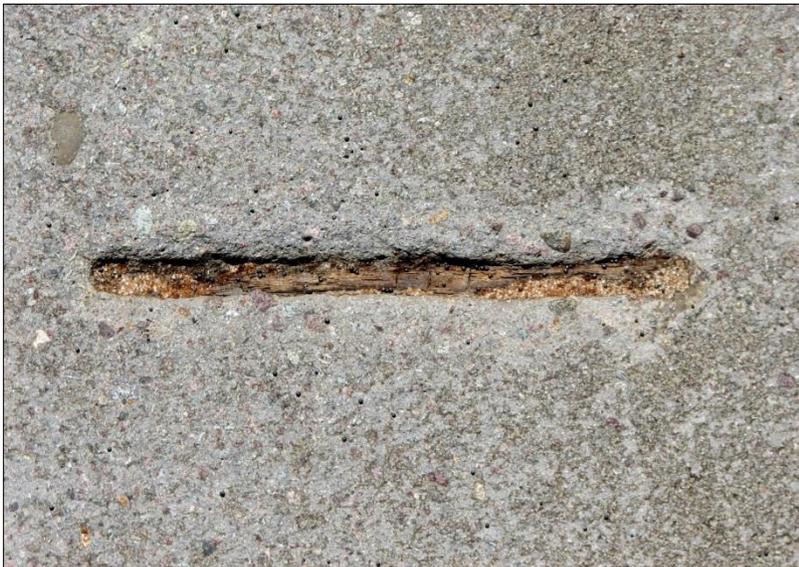
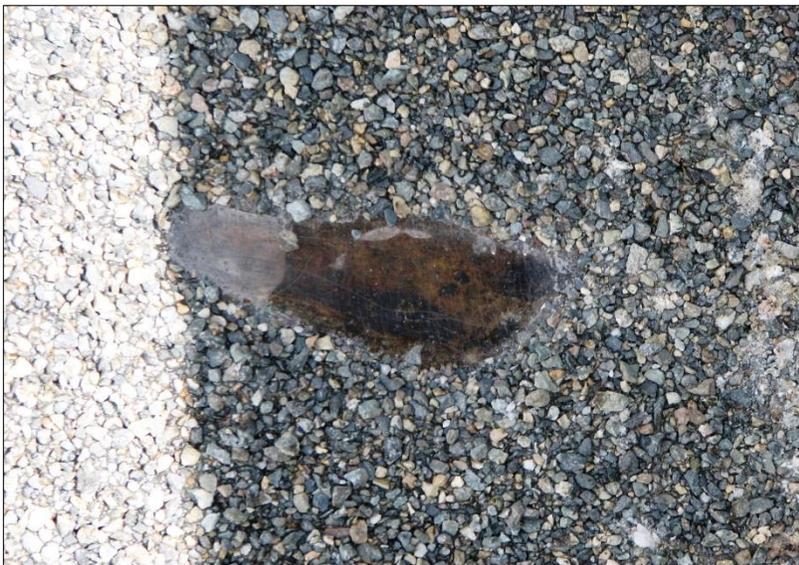
↙ After the first course had cured and swept, this hole (assuming a wood chip) did not have any stone embedded on the epoxy surface.

To date, no explanation can be found for this anomaly.

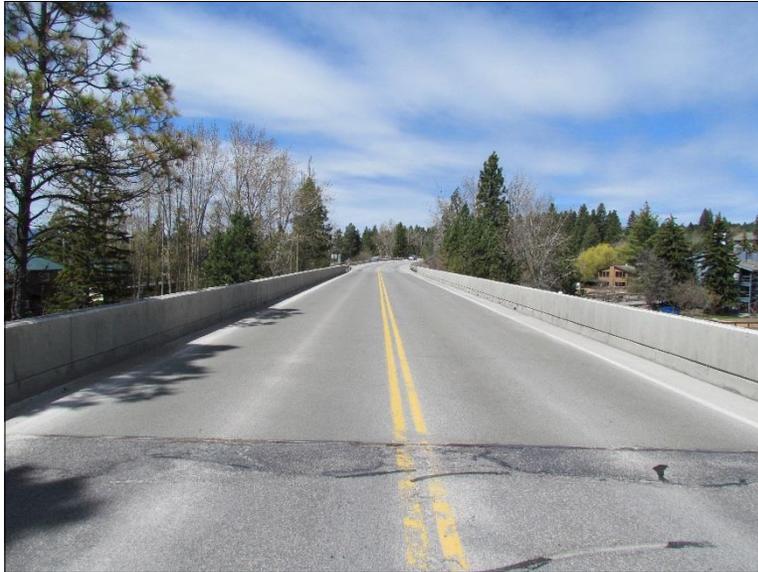
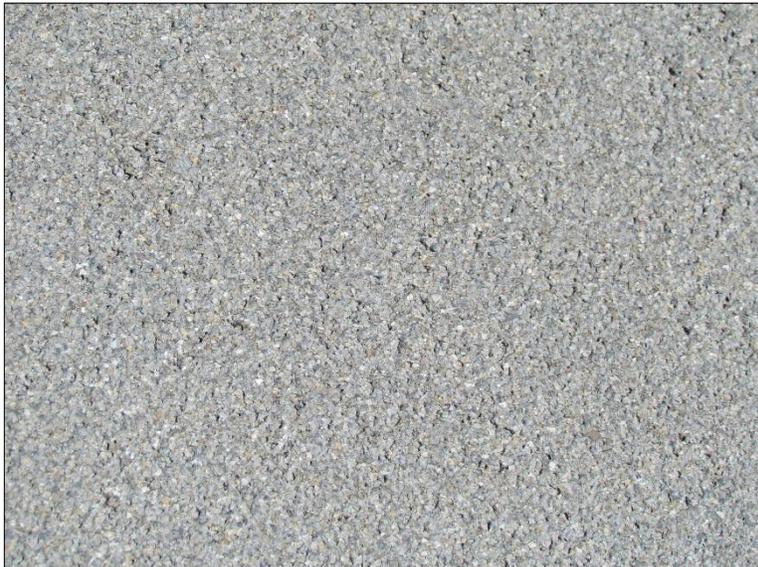
**Bigfork Project/Dayton Superior – June 2017:**

No areas of raveling or debonding visible. However, the surface textures appear polished and less textured since the last inspection, with noticeable pock marks indicative of loss aggregate (lower image is close-up of surface texture).

The topical condition of the HFST is uniform across the deck and may be attributed to snowplow activity.

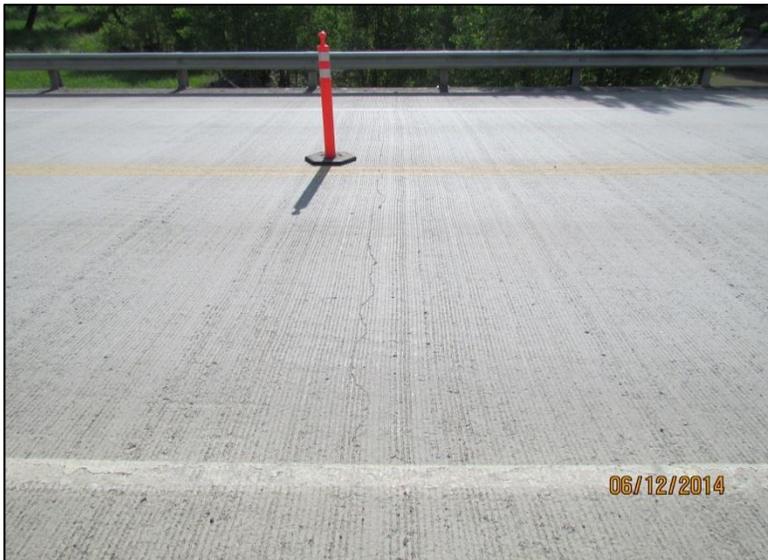
← Representative image of condition of deck surface prior to treatment.

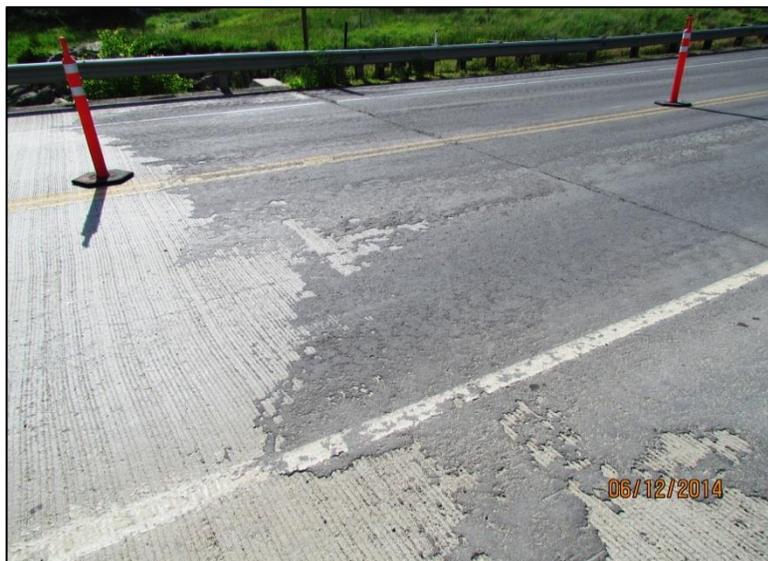
← A previous maintenance patch placed a layer asphalt cement (AC) beyond both approaches of the PCCP deck which will require removal prior to the HFST.

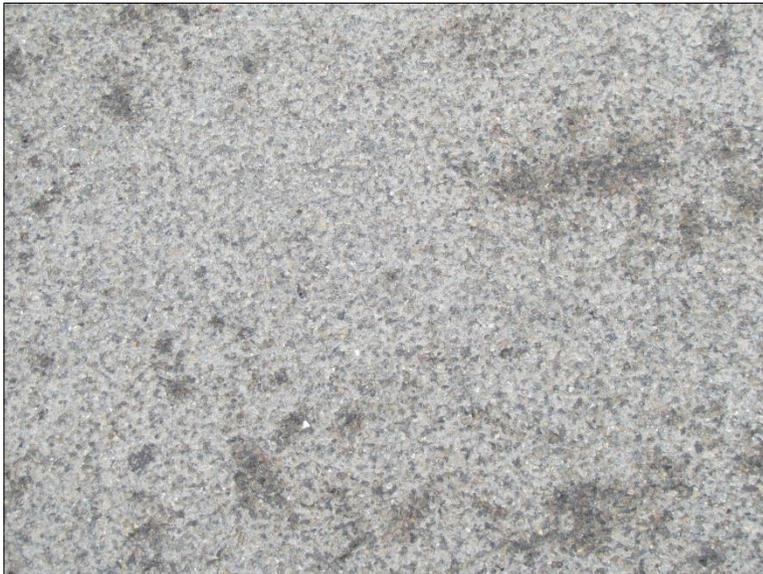
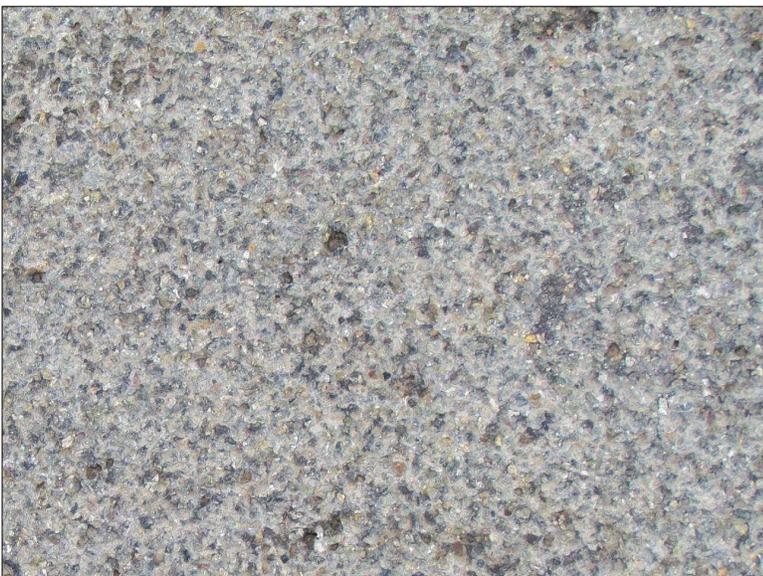
No areas of raveling or debonding visible. However, the surface textures appear polished and less textured since the last inspection, with noticeable pock marks indicative of loss aggregate (lower image is close-up of surface texture).

The topical condition of the HFST may be attributed to snowplow activity.

Current skid test numbers are at 53 for the deck surface.

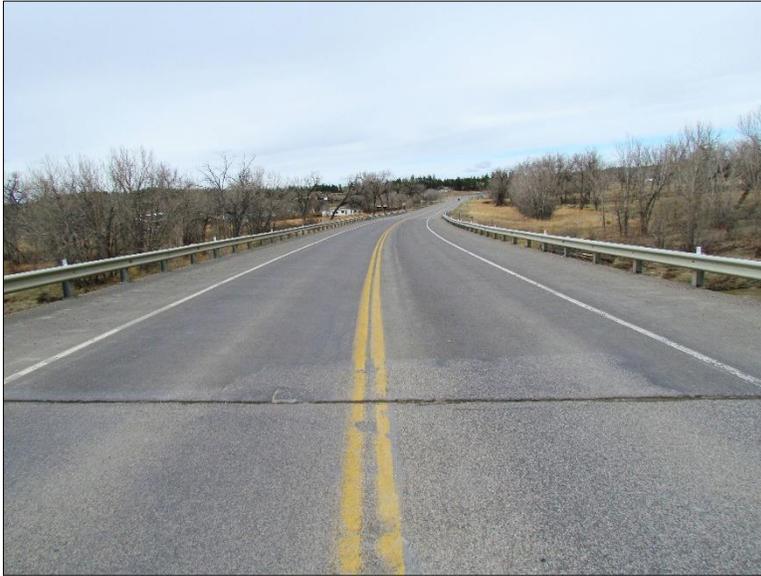
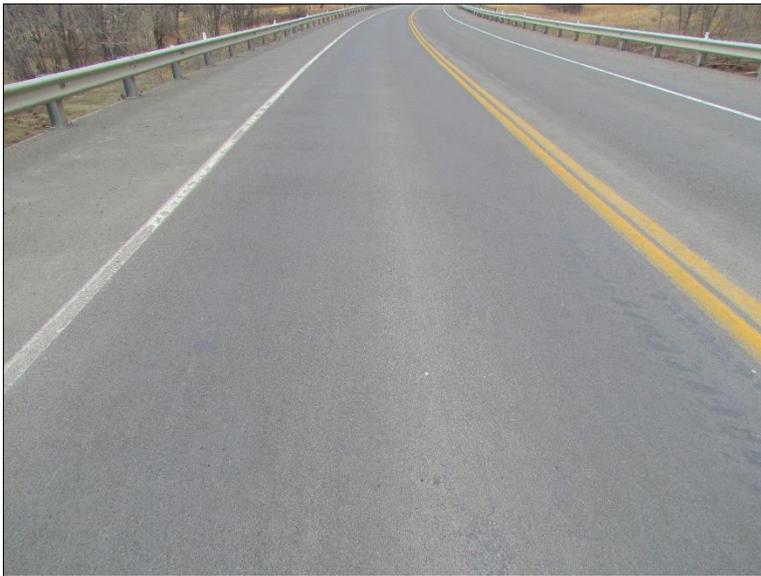
**Roundup – Poly-Carb 135 Safe-T-Seal/163 Flexogrid Overlay: April 2019**

No areas of raveling or debonding visible. However, the surface textures appear polished and less textured since the last inspection, with noticeable pock marks indicative of loss aggregate (lower image is close-up of surface texture).

The topical condition of the HFST may be attributed to snowplow activity and/or other traffic attributes.

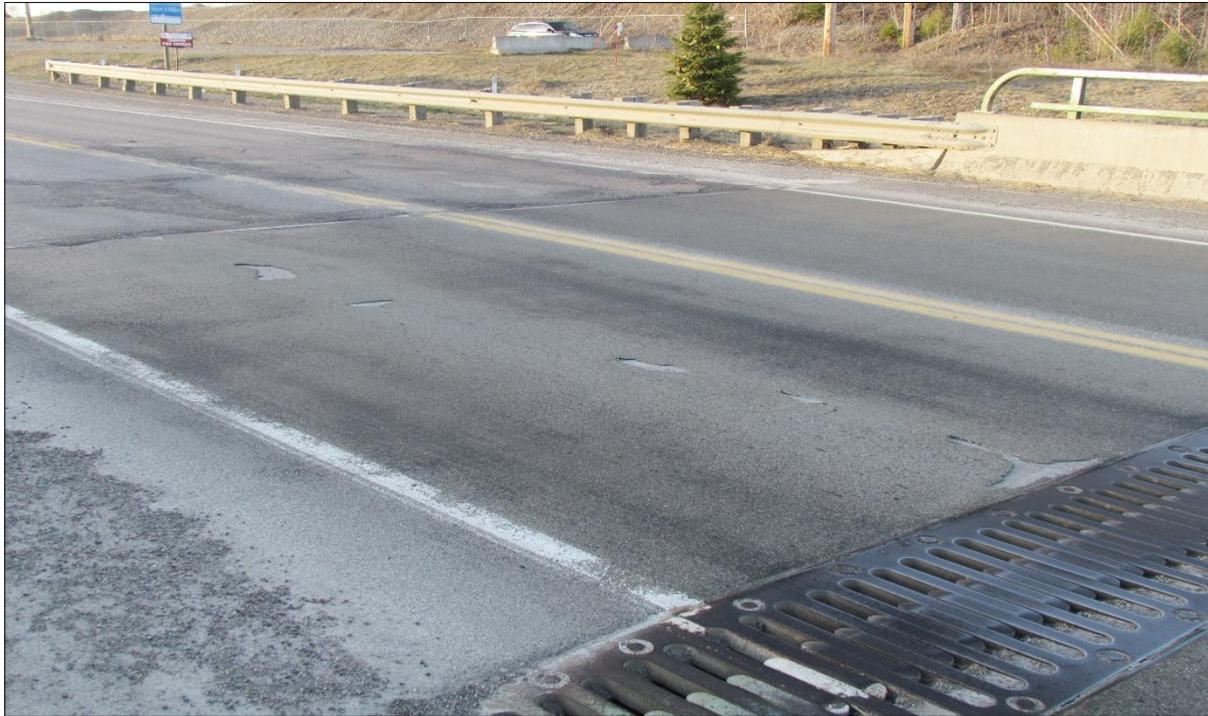
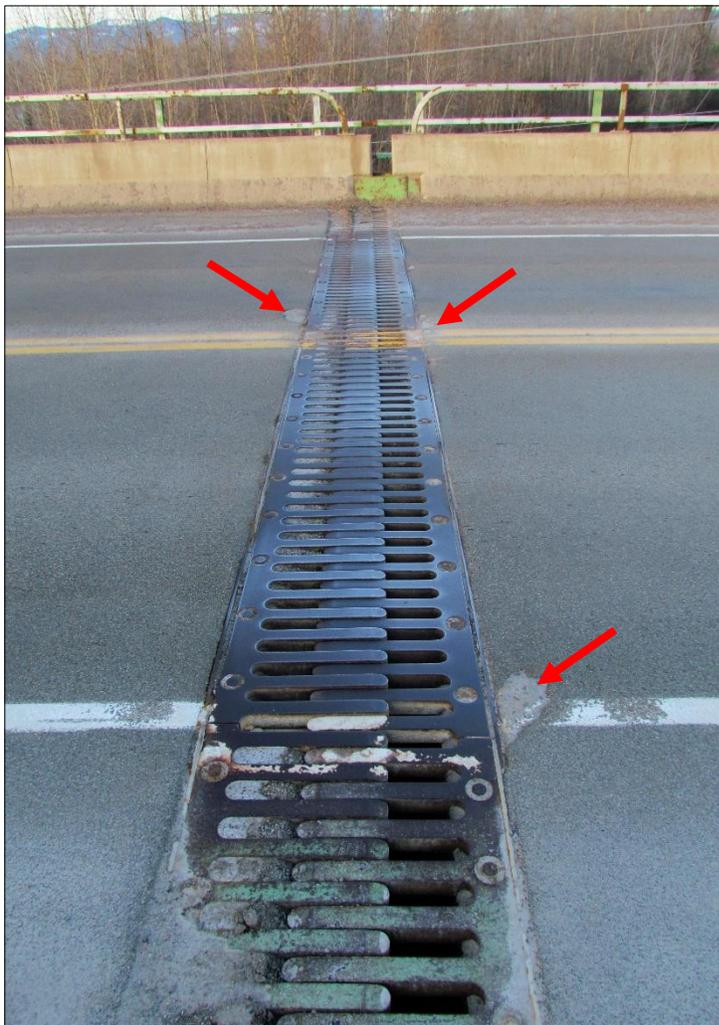
↑ During the spring 2018 inspection, several delamination's of the HFST were noted: specifically, at the east end approach in the westbound lane.

In September of 2018, due to poor skid numbers and increased delamination of the polymer overlay the District elected to repair the failed sections and apply another single layer lift to the deck. Page 65-68 details some of the repair; additional information will be added to this report when made available.

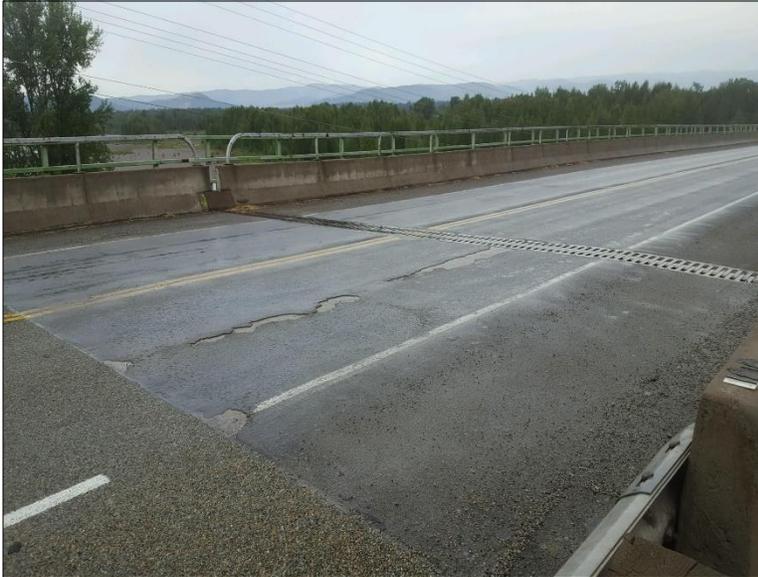
← Due to the progressive deterioration of skid resistance mainly in the wheel paths; the District elected to repair the delaminated areas and to reapply a single layer of the Unitex polymer to the entire deck.

The east span approach was chain dragged in both lanes to determine the extent of the polymer delamination and level of repair.

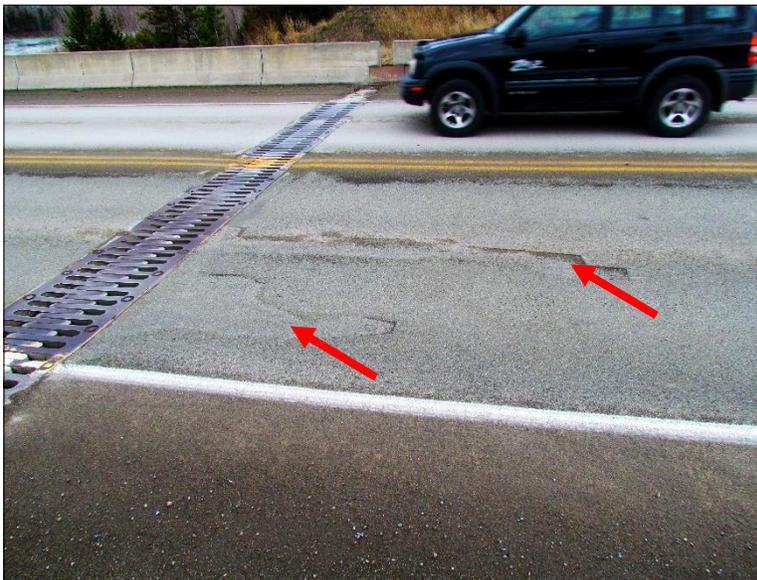
← Areas of repaired delamination's; eastbound/east end of deck approach.

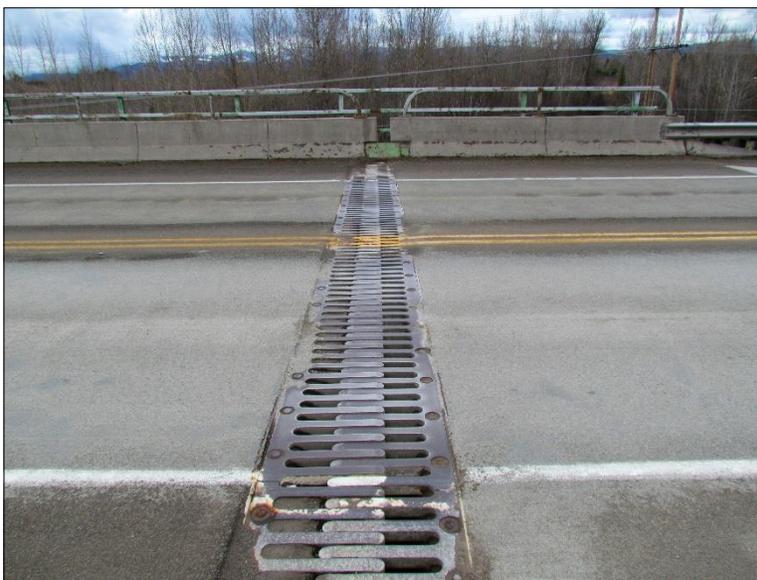
← Areas of repaired delamination around the finger plate joints; west end of deck (refer to page 62).

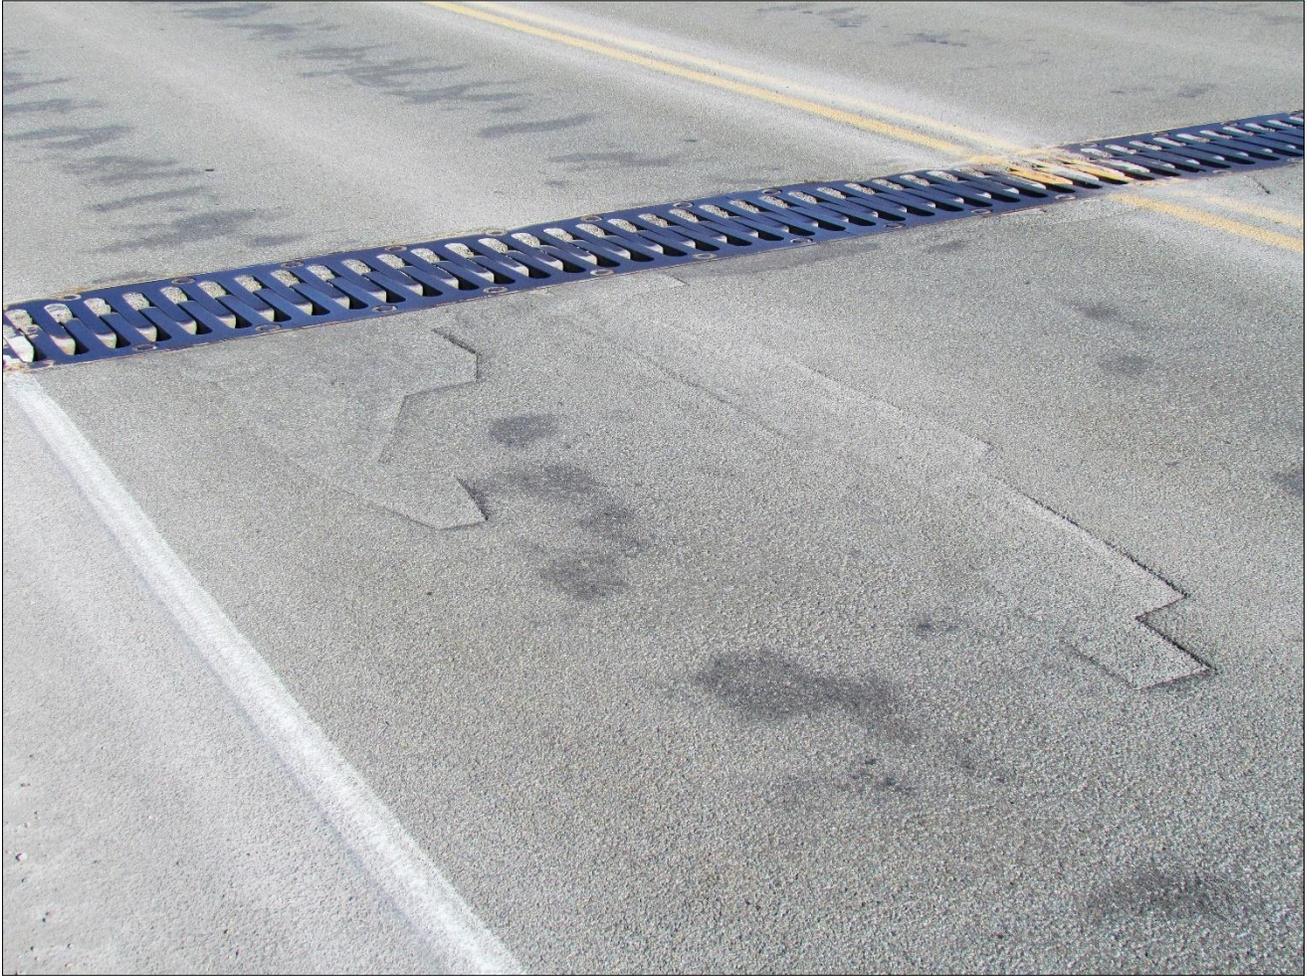
↑ Repaired section and reapplication of deck overlay conducted in September 2018, eastbound lane, west end.
