## EXPERIMENTAL PROJECTS CONSTRUCTION REPORT

### PROFILE WALL PVC PIPE STORM DRAIN TRUNKLINE & LATERALS IN MAINLINE APPLICATION

**Project Name:** Tatro Street-Miles City

**Experimental Project:** MT-12-11

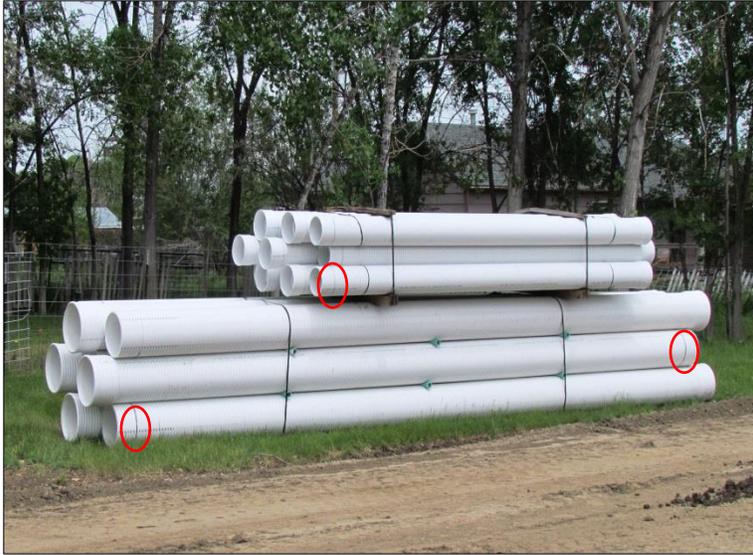
← PVC pipe delivered; bundled and stacked.

Notice a black line is applied on the perimeter of the pipe near the spigot end, (examples shown by red circles).

These marks are an indicator when the spigot is homed (or inserted to the proper length) properly into the bell connection.

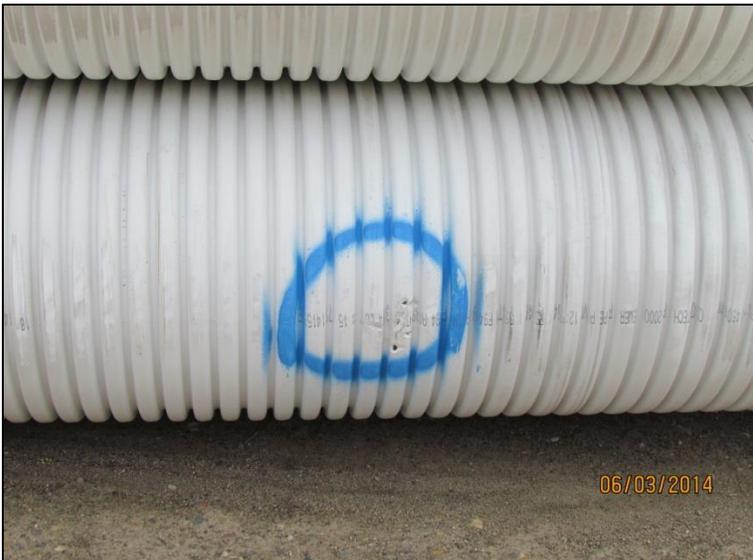
← PVC sections that are found with defects are marked for identification.

Damaged pipe were cut to fit and used for manhole or culvert connections when a shorter length is required.

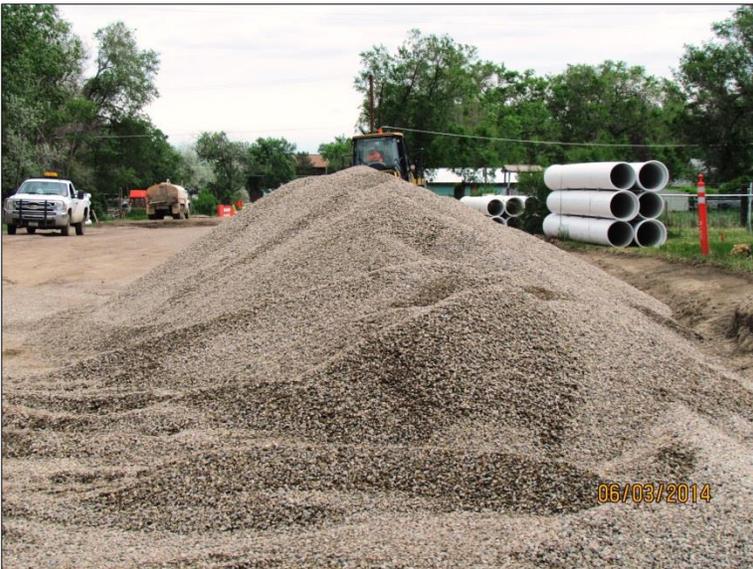
← An example of the bedding material stockpiled onsite.

This material was designed to negate or minimize the need for compaction underneath the pipe.

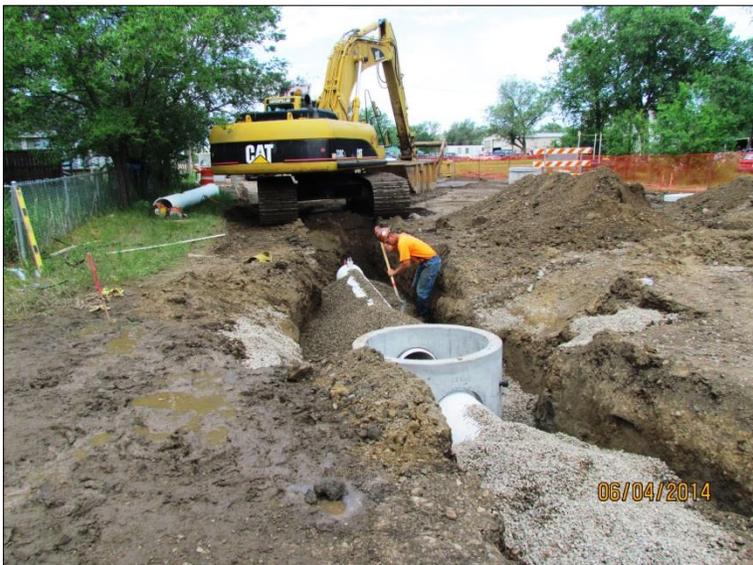
← The fill material is applied and haunched when needed to secure the pipe.

The aggregate was layered approximately twelve inches (12") over the top of the PVC.

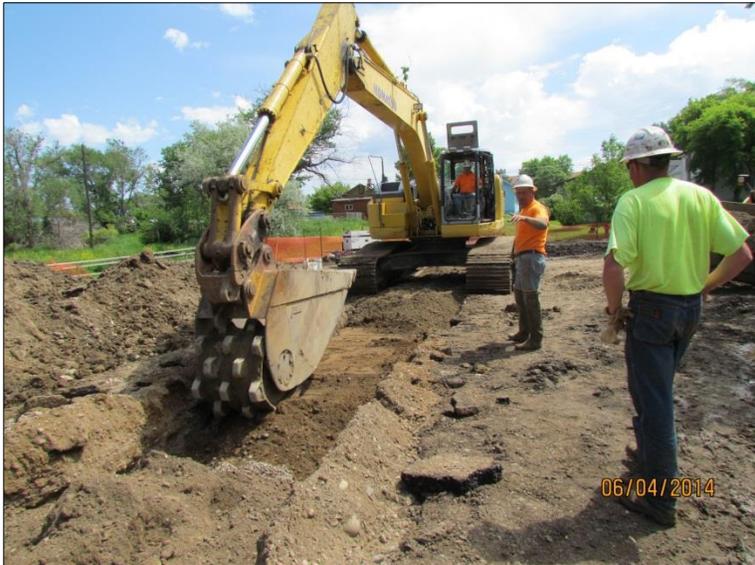
← The sheep's foot/bucket was also used for compaction, but was discontinued early in the process due to poor compaction performance.

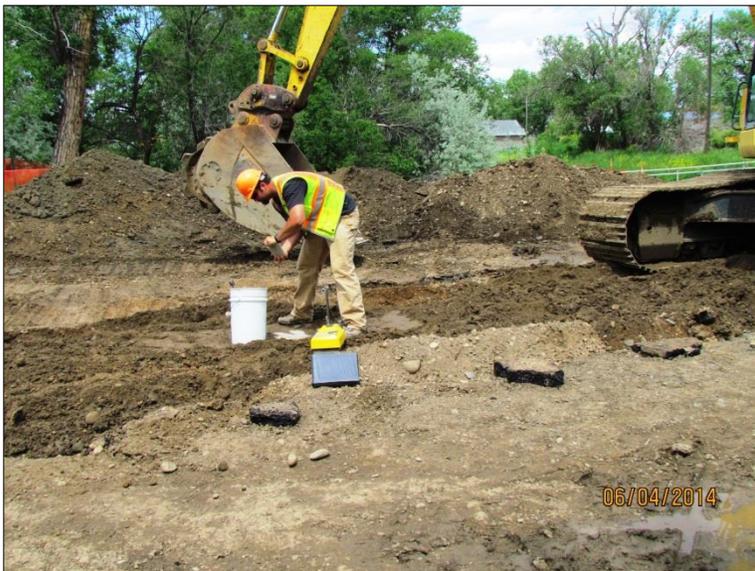
← Density gauge testing was conducted to confirm compaction at 95 percent (%).

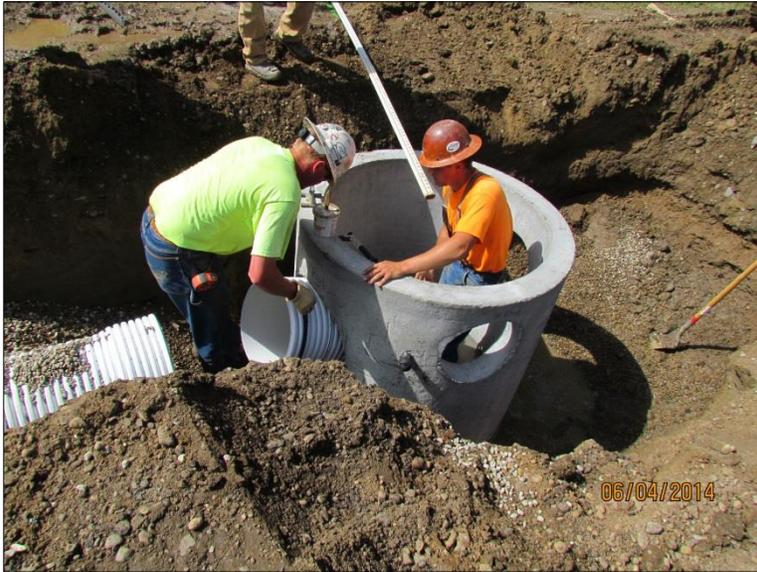
← For most manhole and culvert connections, full sections of pipe were used.

This particular installation a shortened section of PVC pipe was used.

Gaskets are shipped loose and require field installation on the pipe spigot.

Single-grooved gaskets were used on this installation.

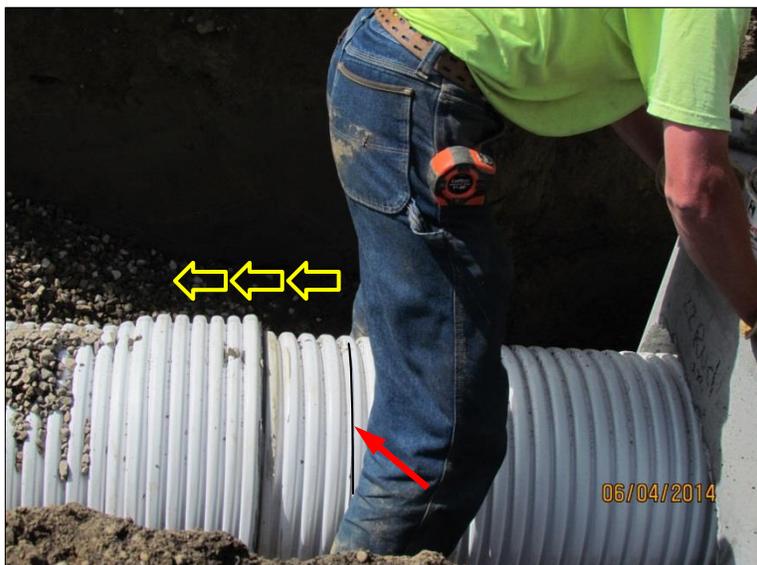
← Workers push the spigot into the bell end until resistance is met or the 'home' line is reached (defined by red arrow).

This represents how all PVC connections were done.

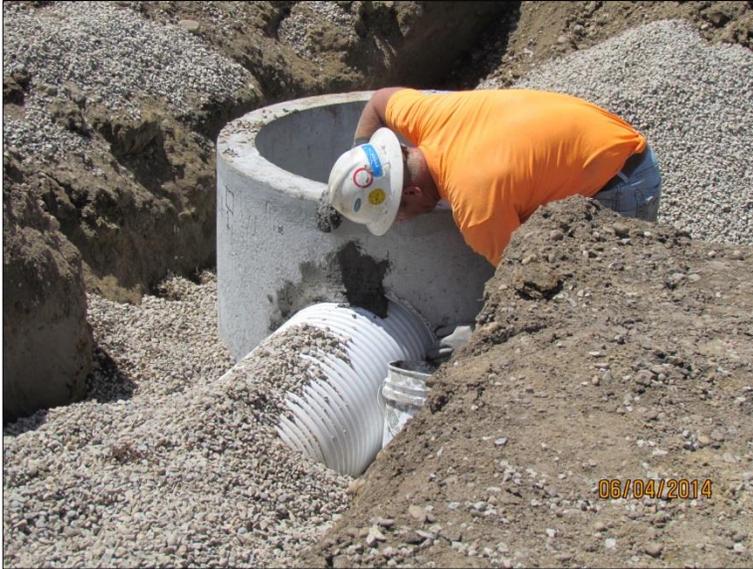
↙ Example images of the PVC grout connections with the manhole and box culvert systems.

Application of the grout was applied in the interior as well.

The mortar used was Quikrete Commercial Grade Non-shrinking Precision Grout.
