## **EXPERIMENTAL PROJECT**

### **EVALUATION OF RECYCLED PLASTIC MATS AS WEED PREVENTION AND EROSION CONTROL AROUND GUARDRAILS**

#### **Annual Report**

**Project name:** Great Falls N & S

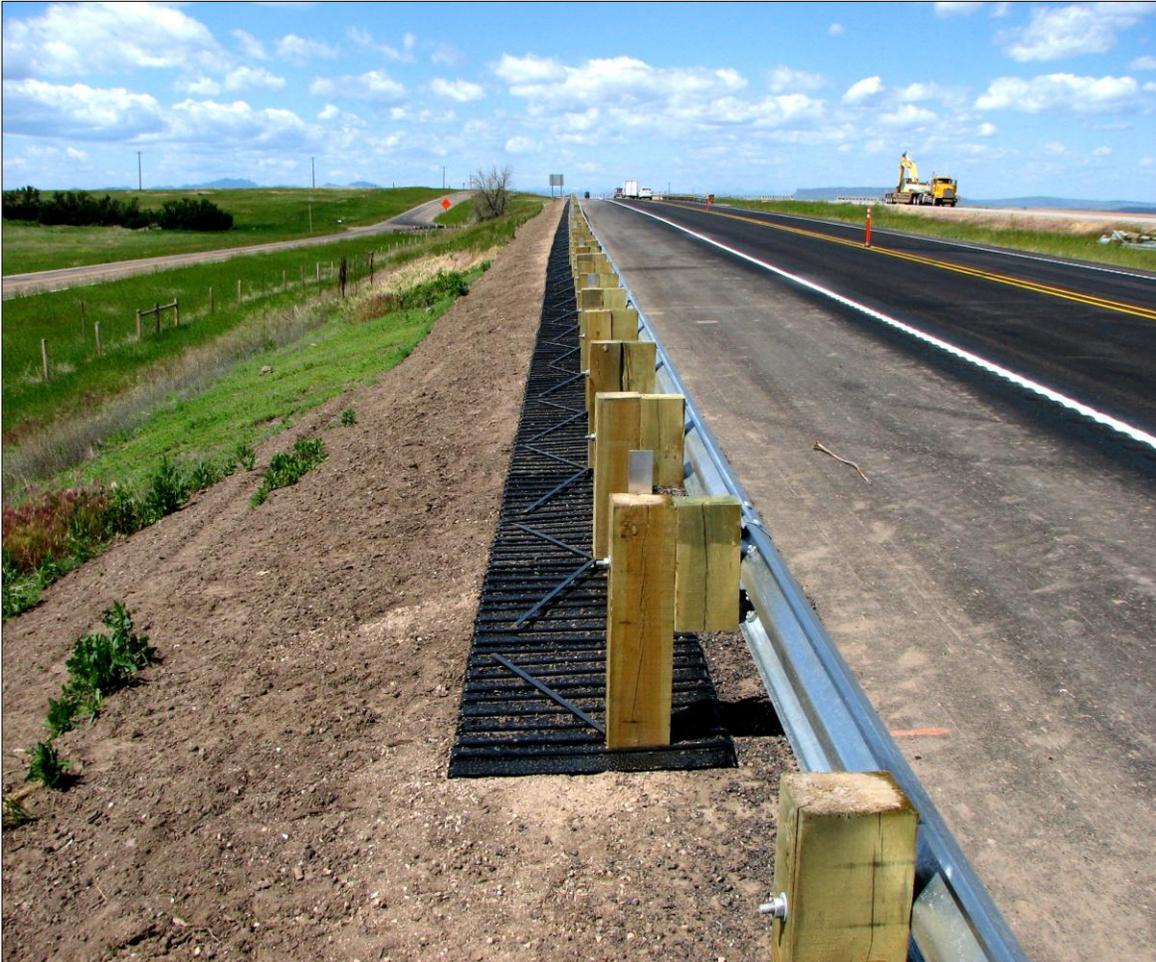
Representative image of the completed installation of the UWC on the northbound guardrail sections. Prior to placement an herbicide is applied to kill any remaining vegetation and root systems. Weed mat sections are on average 43.8 cm (17.25") in width, 61 cm (24") in length and a thickness of 3.2 mm (0.125"). Each panel overlaps 1 inch with a 3 inch per panel expansion and contraction. Each panel rotates 3 degrees for maximum of 12 degrees per post-to-post guardrail system. The mat is made of 100% recycled high-density polyethylene plastic (HDPE) with black carbon additives. The mats have molded apertures for use if the product is staked to the ground. In this application metal brackets were fabricated and attached to the guardrail posts to assist in keeping the mats in place.

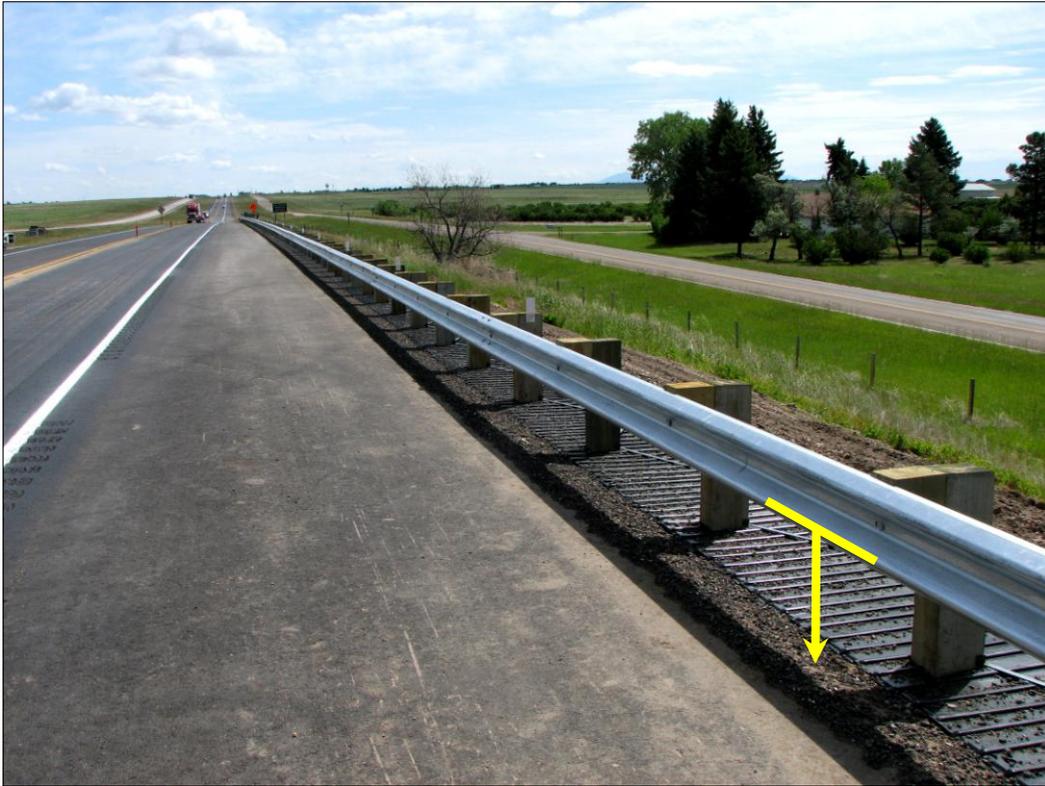
Above: View of completed UWC on northbound shoulder. View is to the north. Note how the mat installation (yellow arrow) is placed back far enough from the edge of the rail as not to hinder snow plowing.

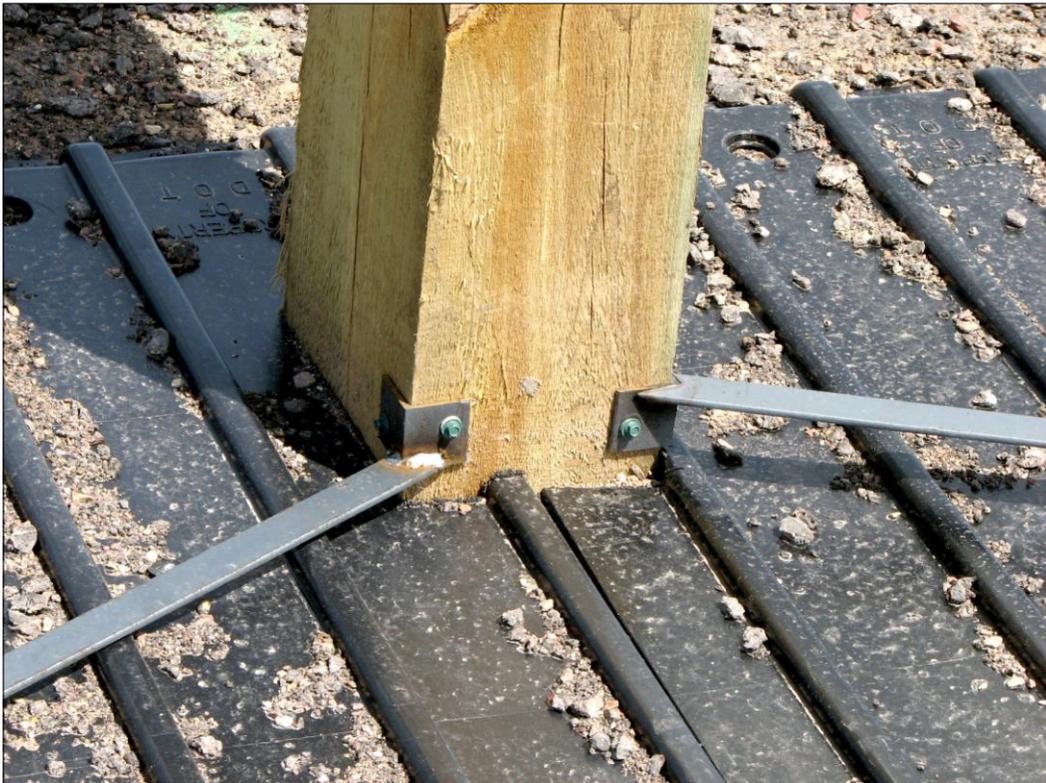
Below: Close-up of bracket placement.

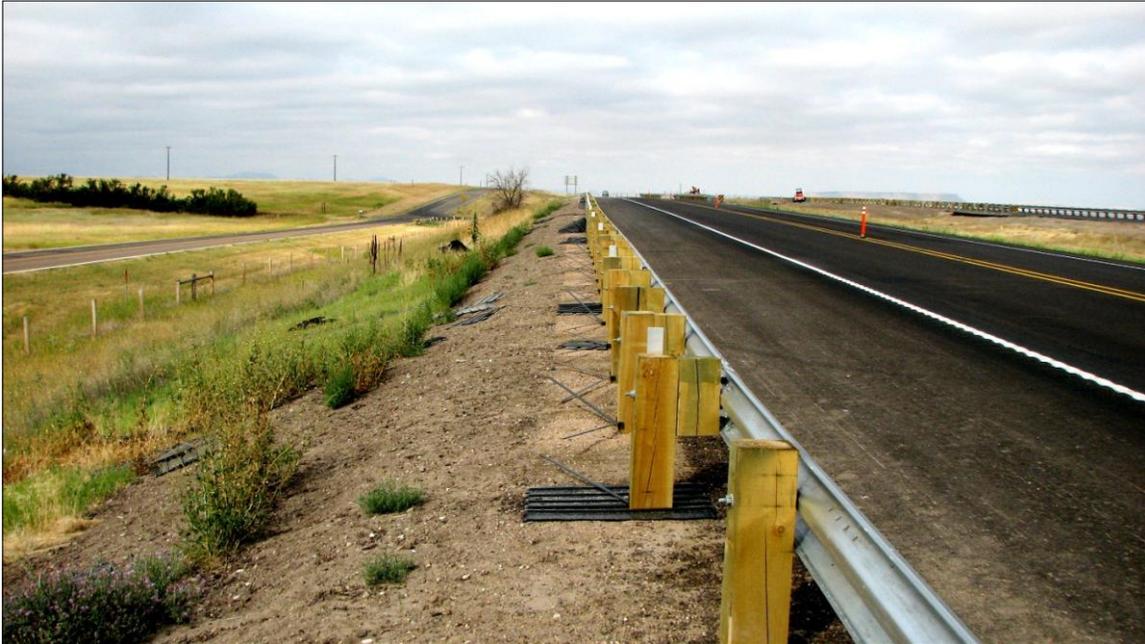
In August 2007 Research was notified that a high wind event had created a failure with the UWC supporting brackets. Over half of the mats (north half of the northbound lane) were displaced by wind as seen in the above image.

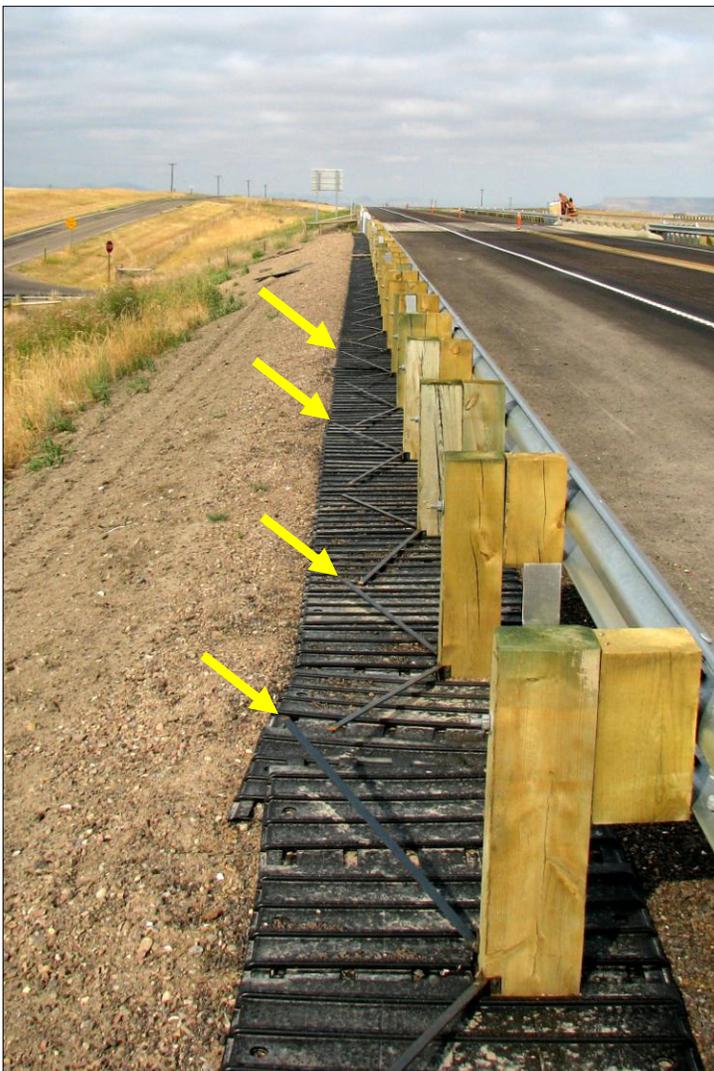
The image on the left shows that the south end (near the overpass) fared better. However, you can see (by the yellow arrows) that some of metal brackets are bent upwards by the force of the wind (apparently) pushing up the mats. Most of the panels were salvageable and were reconnected with a redesigned bracket as seen in the next section.

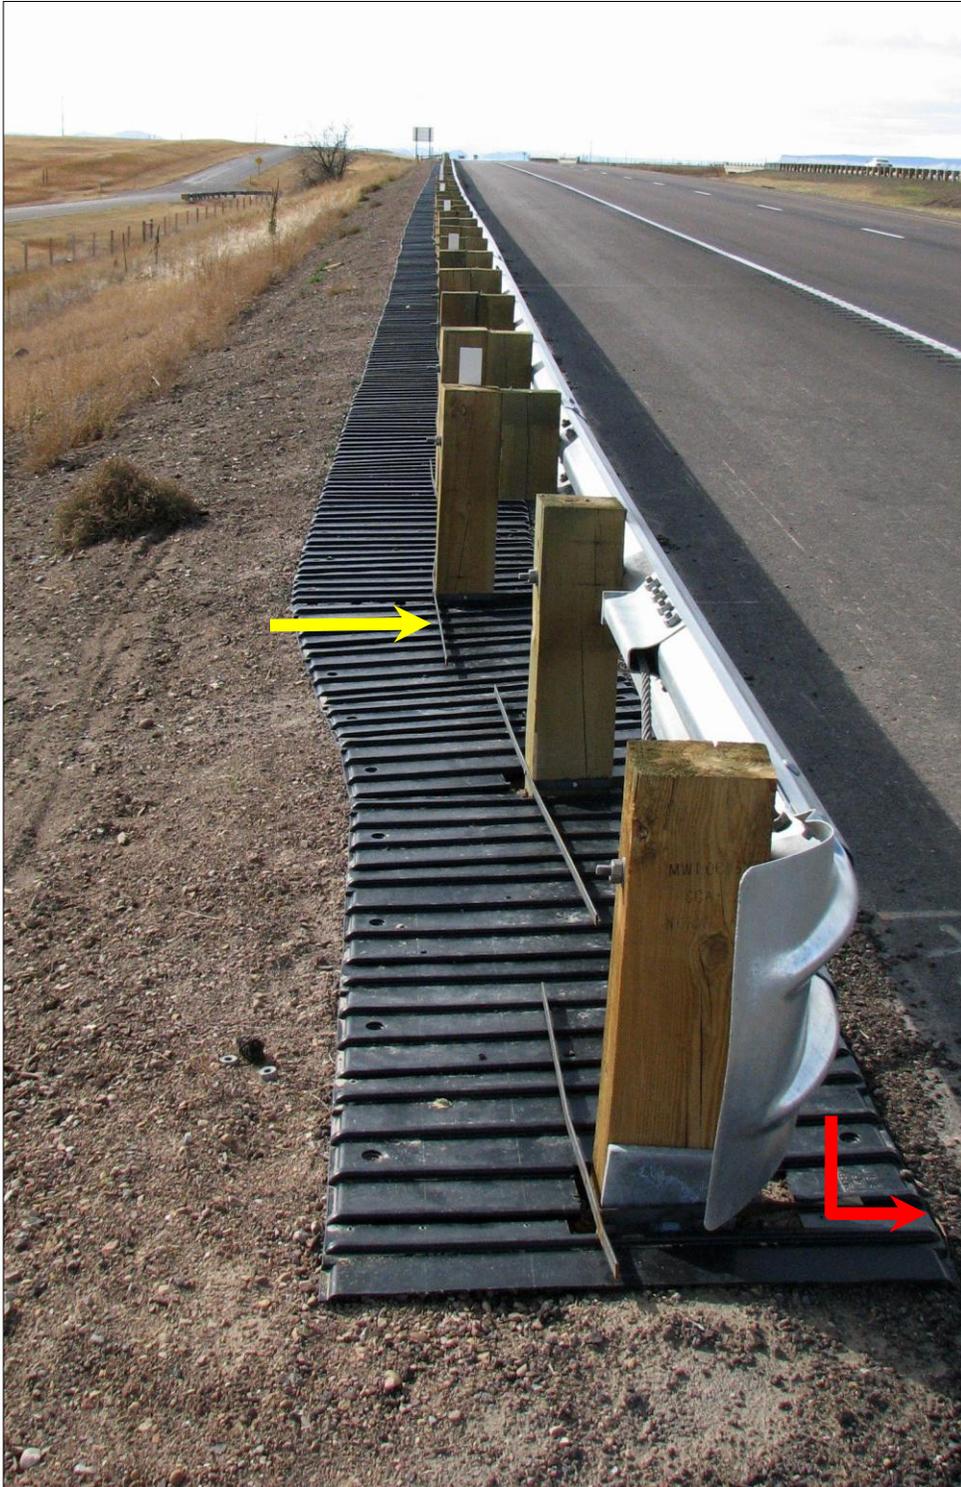
The District reinstalled the UWC mats in September 2007. The metal brackets were redesigned in an effort for a more secure placement. Note that the installation was extended to the end of the guardrail. The initial installation ended the mat placement denoted by the yellow arrow. As seen in this image, by moving the mats to the end of the guardrail it has inadvertently placed the mats beyond the edge of the rail (red arrow).

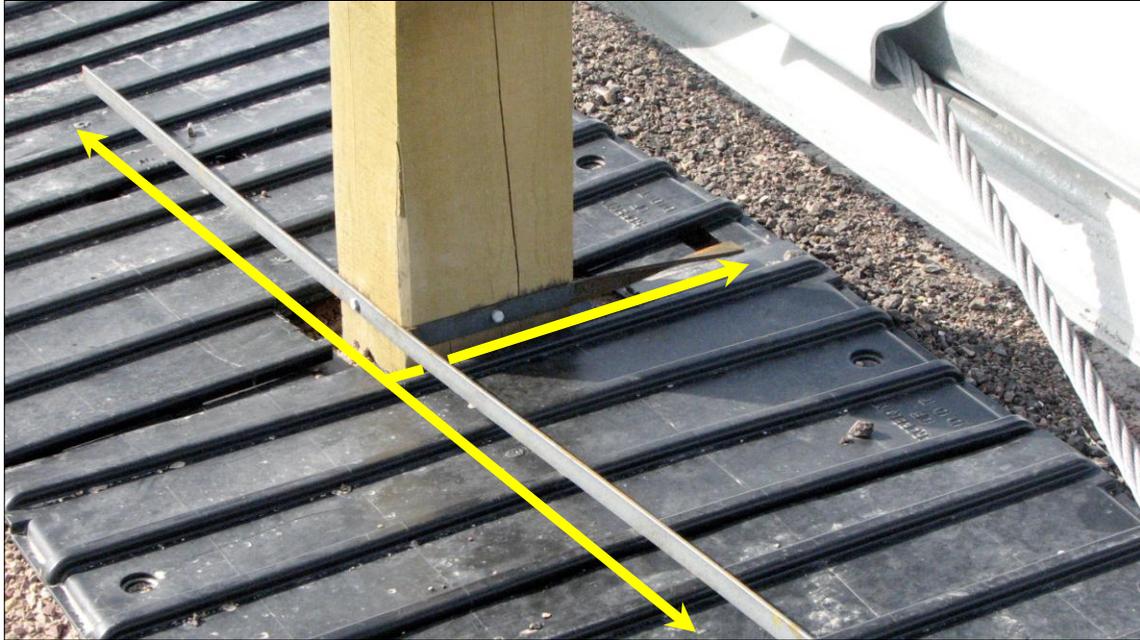
Above: Close-up of the new bracket design. The 'T' shape and double bolt attachment may offer more stability than the previous single bar angle bracket.

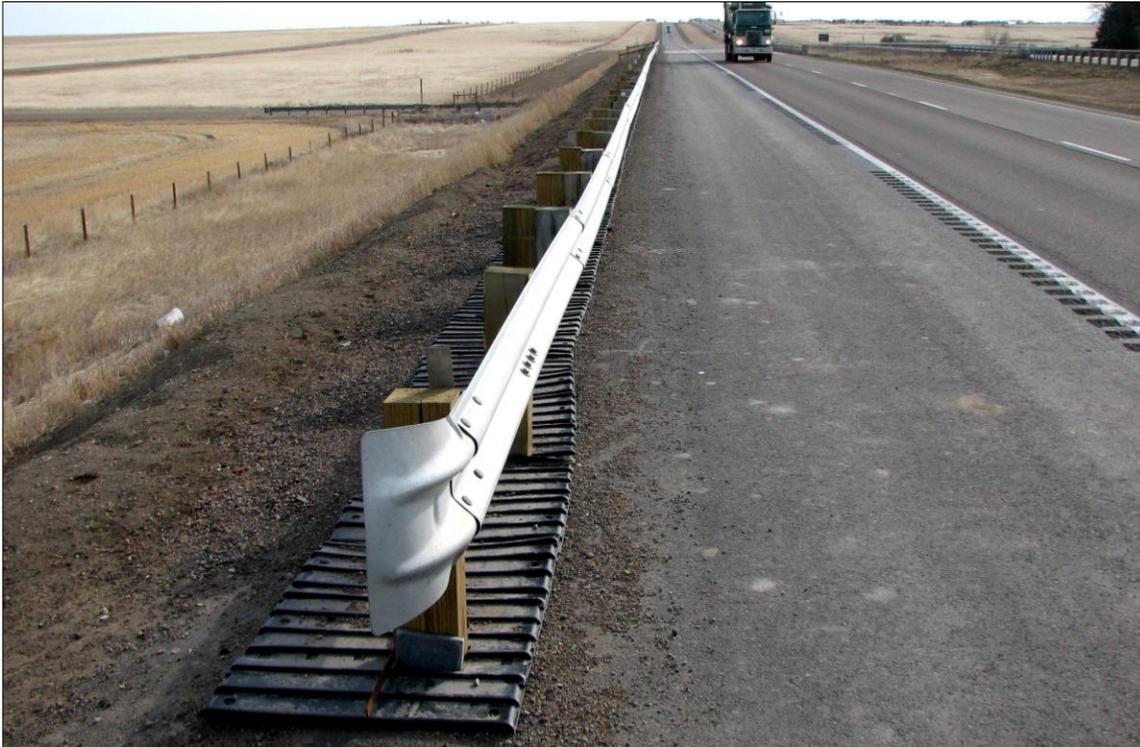
Southbound guardrail: Image of UWC with the new bracket design

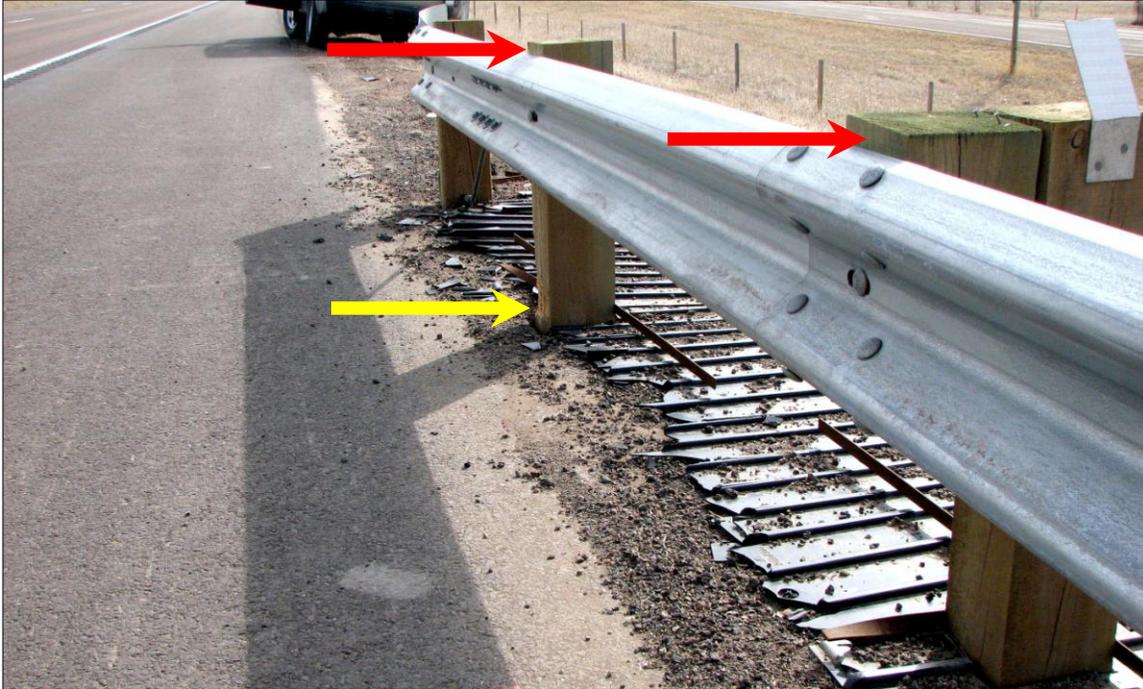
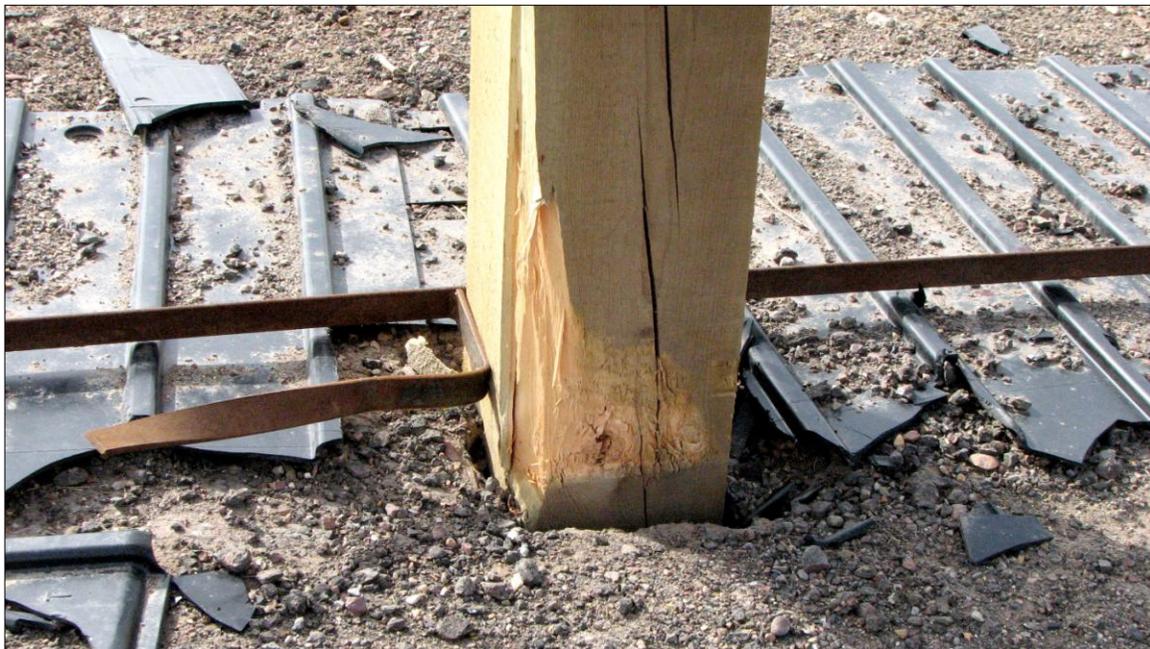
In early April 2008, the District again notified Research of damage to mats on north end of the northbound lane guardrail. Based on documentation at the time it appears that the mats were struck by some moving object which fragmented the shoulder edge of the mats. As noted earlier in this report, the UWC was extended to the end to the guardrail which placed the leading edge of the mat beyond the boundary of the rail due to the change in post design as indicated by the red arrows. Further evidence of damage by moving object was the gouge in the guardrail post (yellow arrow) and bending of the UWC bracket. The image below is a close-up of the damage.

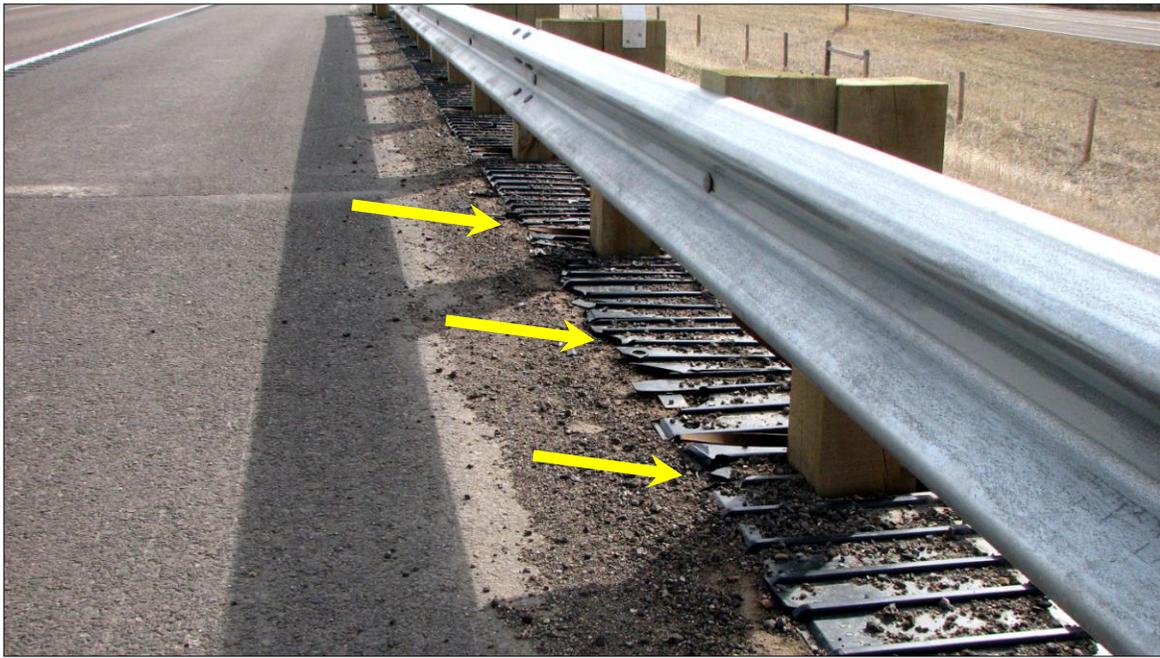
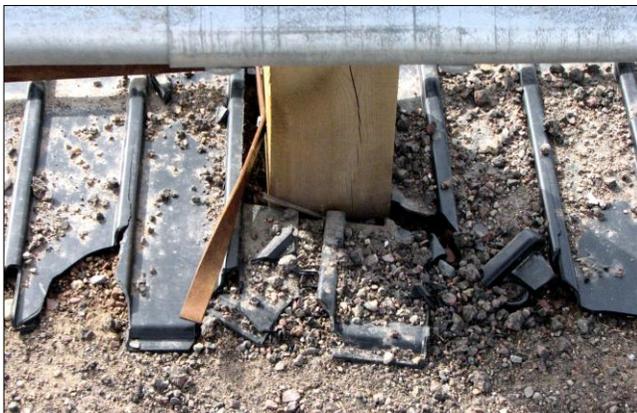
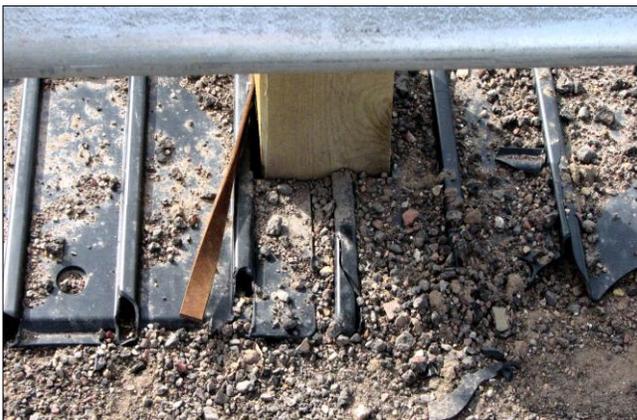
Additional damage has occurred in other areas of the UWC mats as seen in these images. Since the shoulder edges of the mats are set back from the leading edge of the rail it is difficult to ascertain the cause.

Speculation may surmise that accumulated snow, ice, and sanding material on the roadway shoulder, while being cleared by a snow plow; may be forcing that mass against the mats and supporting brackets creating pressures that are fracturing the UWC and deforming the brackets without the plow blade coming in contact with the UWC.

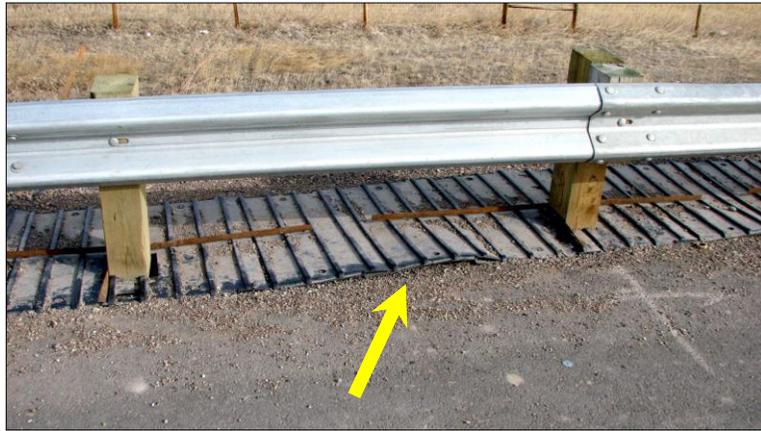
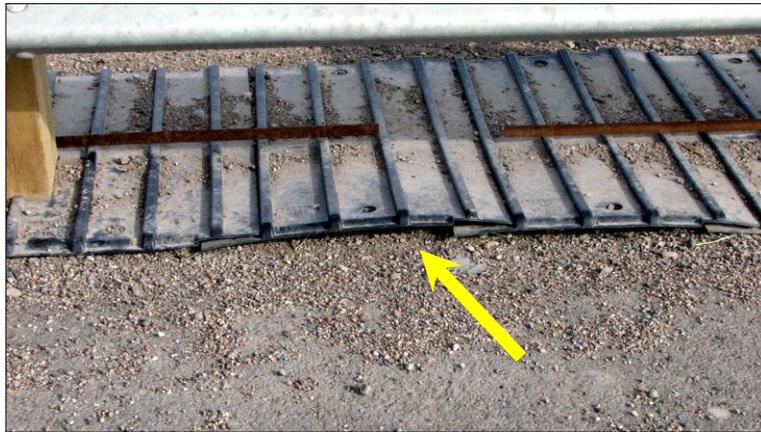
Curling of the edges of the UWC mats has been documented at various locations of the installation as indicated by the images on the right. This edge curling is appearing on both sides of the mat, but to date, predominately on the shoulder side. This may be a condition caused by extreme temperature swings, sunlight deprecation or a combination of both. Amplified curling on the shoulder side may be from snow, ice and/or particulates being forced under the mat by plowing activity, deforming the mat. This will be reported on in future analysis.

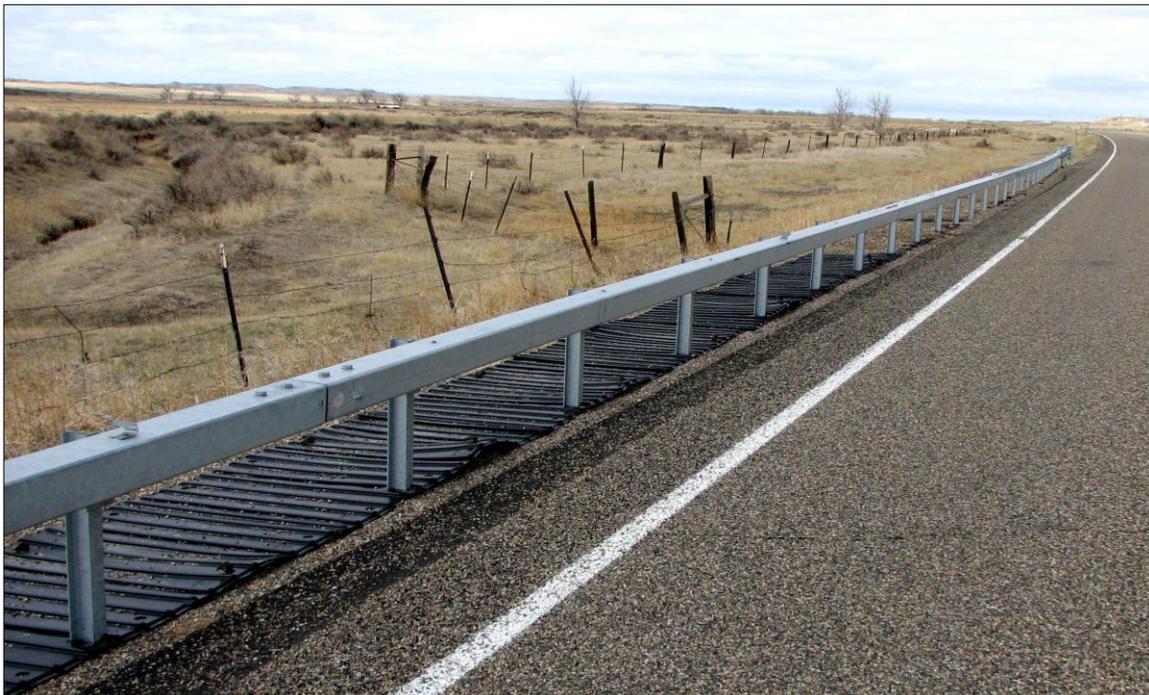
Below is another example with curling of the UWC mat installed on Highway 59 (P-18) approximately 10 miles north of Miles City. Date of installation is unknown.
