**ANNUAL EVALUATION REPORT**

**Cold In-Place Recycle (CIR) Koch™ Process CIR-EE**

Location: Red Lodge, Montana – Carbon County, Highway 212 (P-28) Milepost 91-101.6

Project No.: Red Lodge North STPP 28-2(22)70

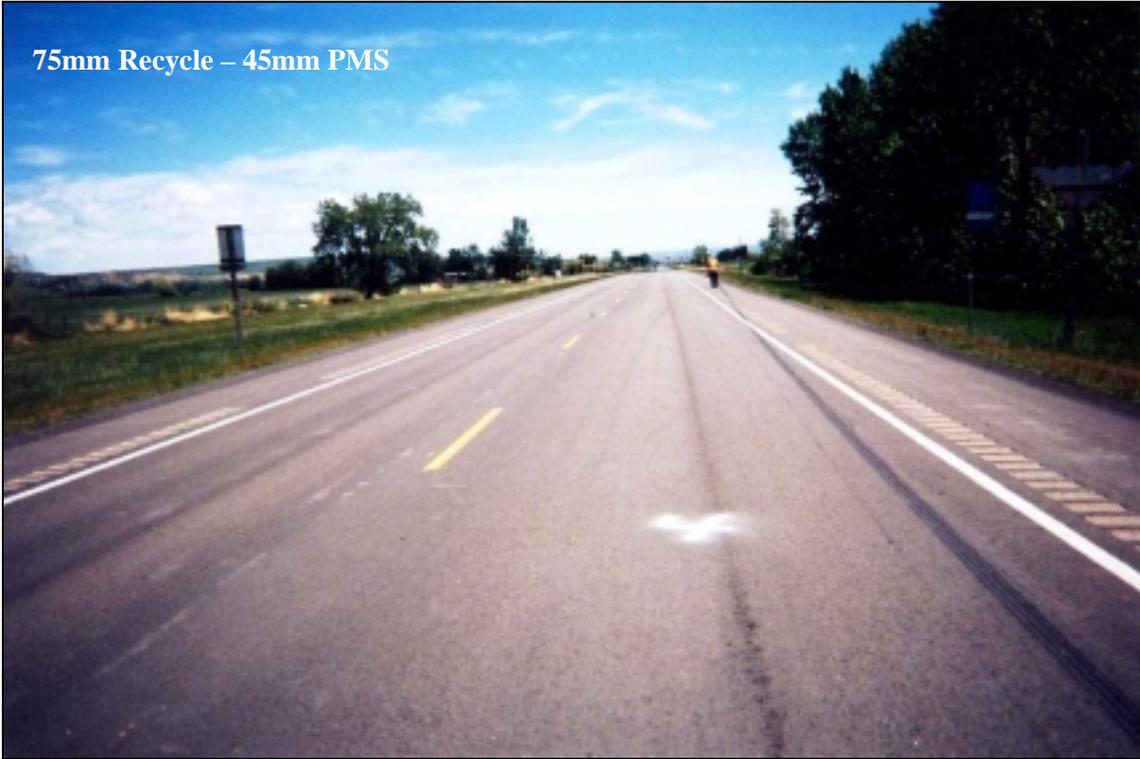
75mm Recycle – 45mm PMS

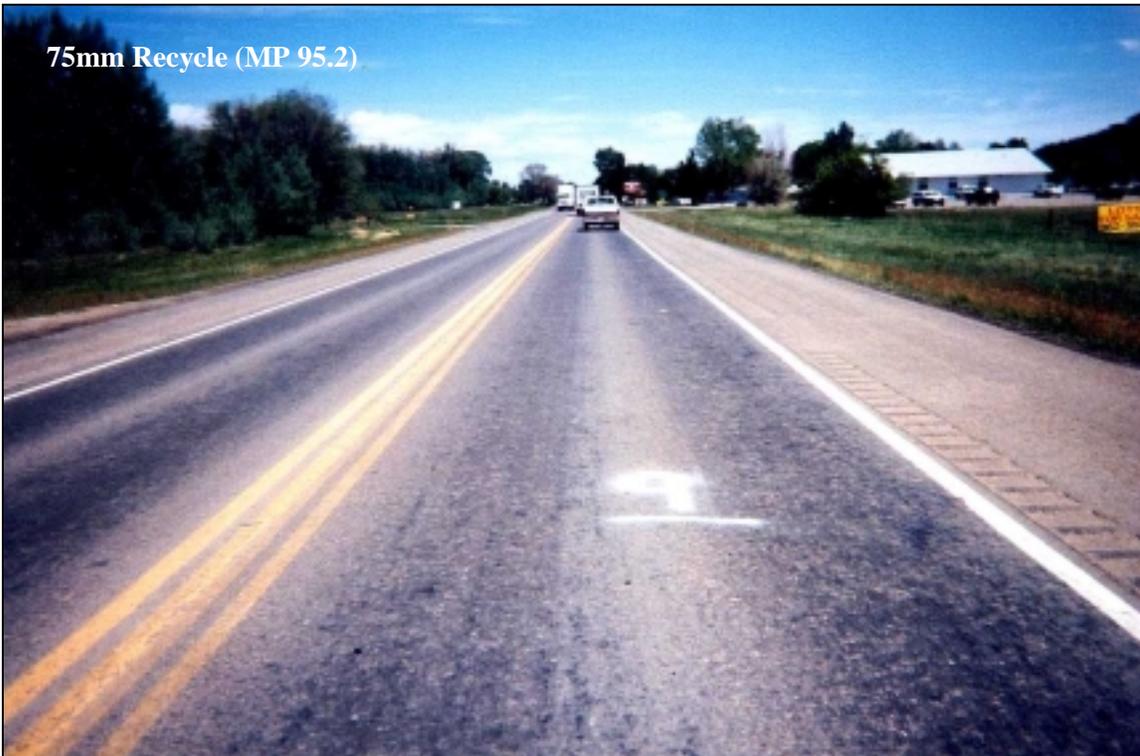
Visually all treatments except the 75mm recycles exhibited the same outward show, a good tight mat with uniform appearance. The straight 75mm recycle section did show flushing in the wheel paths. Material was tender enough to be picked out with a metal ruler and piled when rolled on the palm of the hand. The average air temperature that day was 80° F (27° C).

75mm Recycle (MP 95.2)

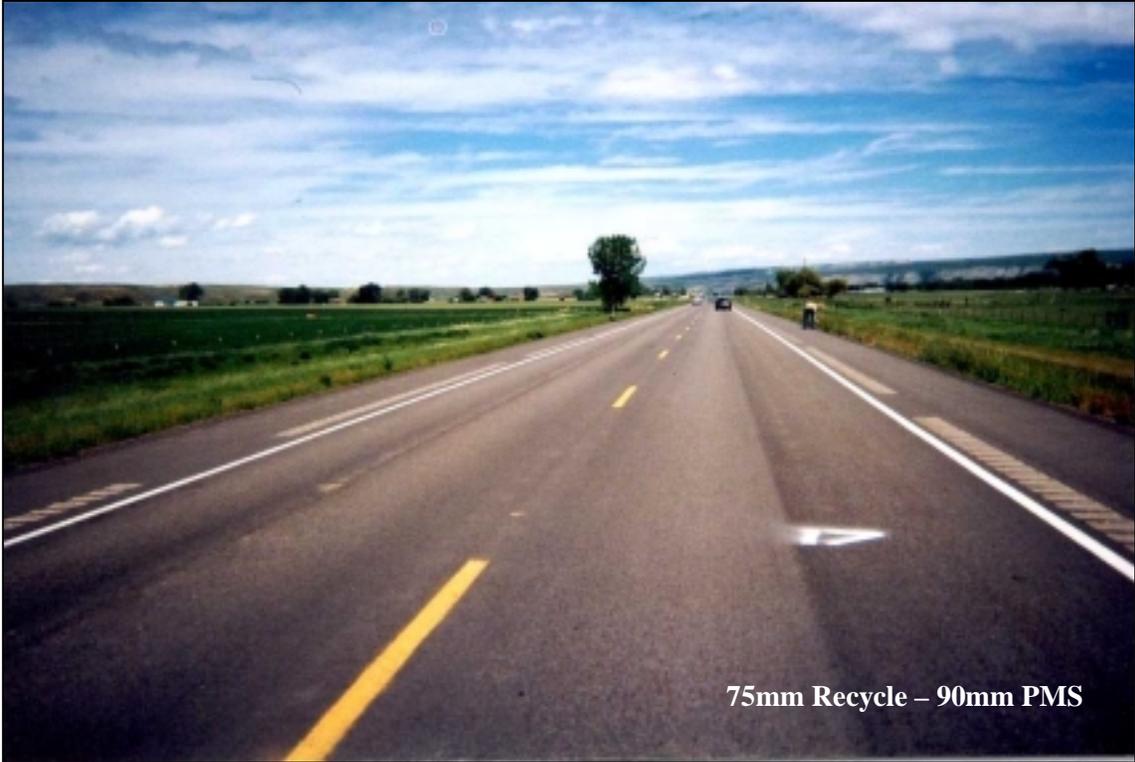
75mm Recycle – 90mm PMS
