## INSTALLATION REPORT AND ANNUAL EVALUATION

### The Use of 3D Synthetic Geocomposite for Added Subsurface Drainage Layer in Asphalt Cement (AC) Pavement

**Project Name:** Jct. Reynolds Pass - Quake Lake

**Experimental Project:** MT-15-02

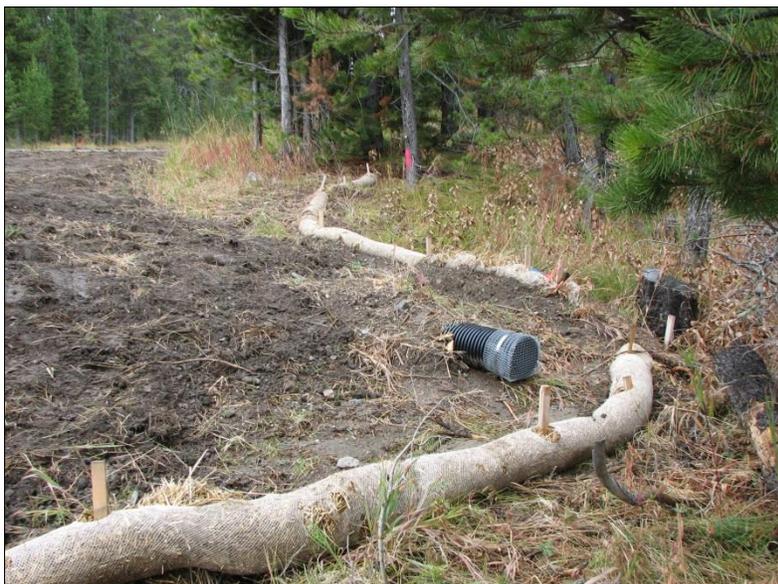
← Completed edge drain. The drain outlet was capped with a wire mesh to prevent animal intrusion.

Several weeks after the completed project, water was observed trickling out of the drain.

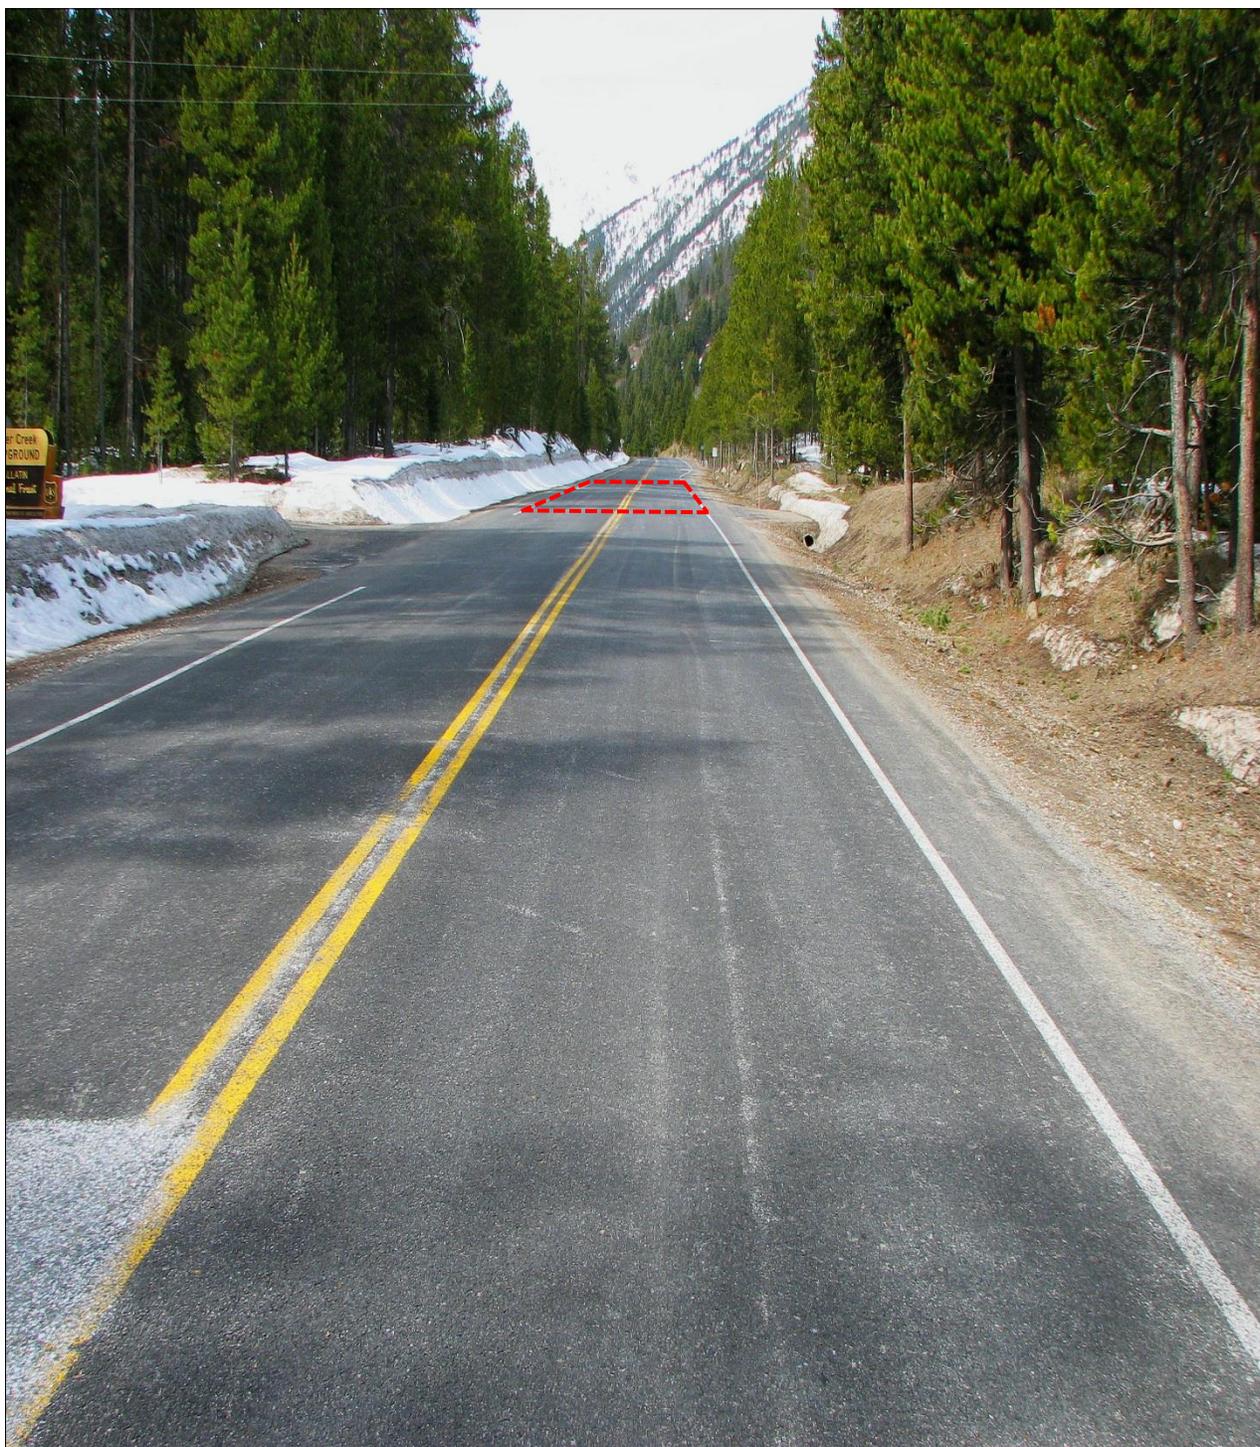
- ↑ Shot of project section in April; visually the pavement surface is tight with no visible distress to report to date (view north).

Note: Although difficult to see in this image, the pavement section outlined in red did have a slight rise (or bulge) due to perceived frost heave.

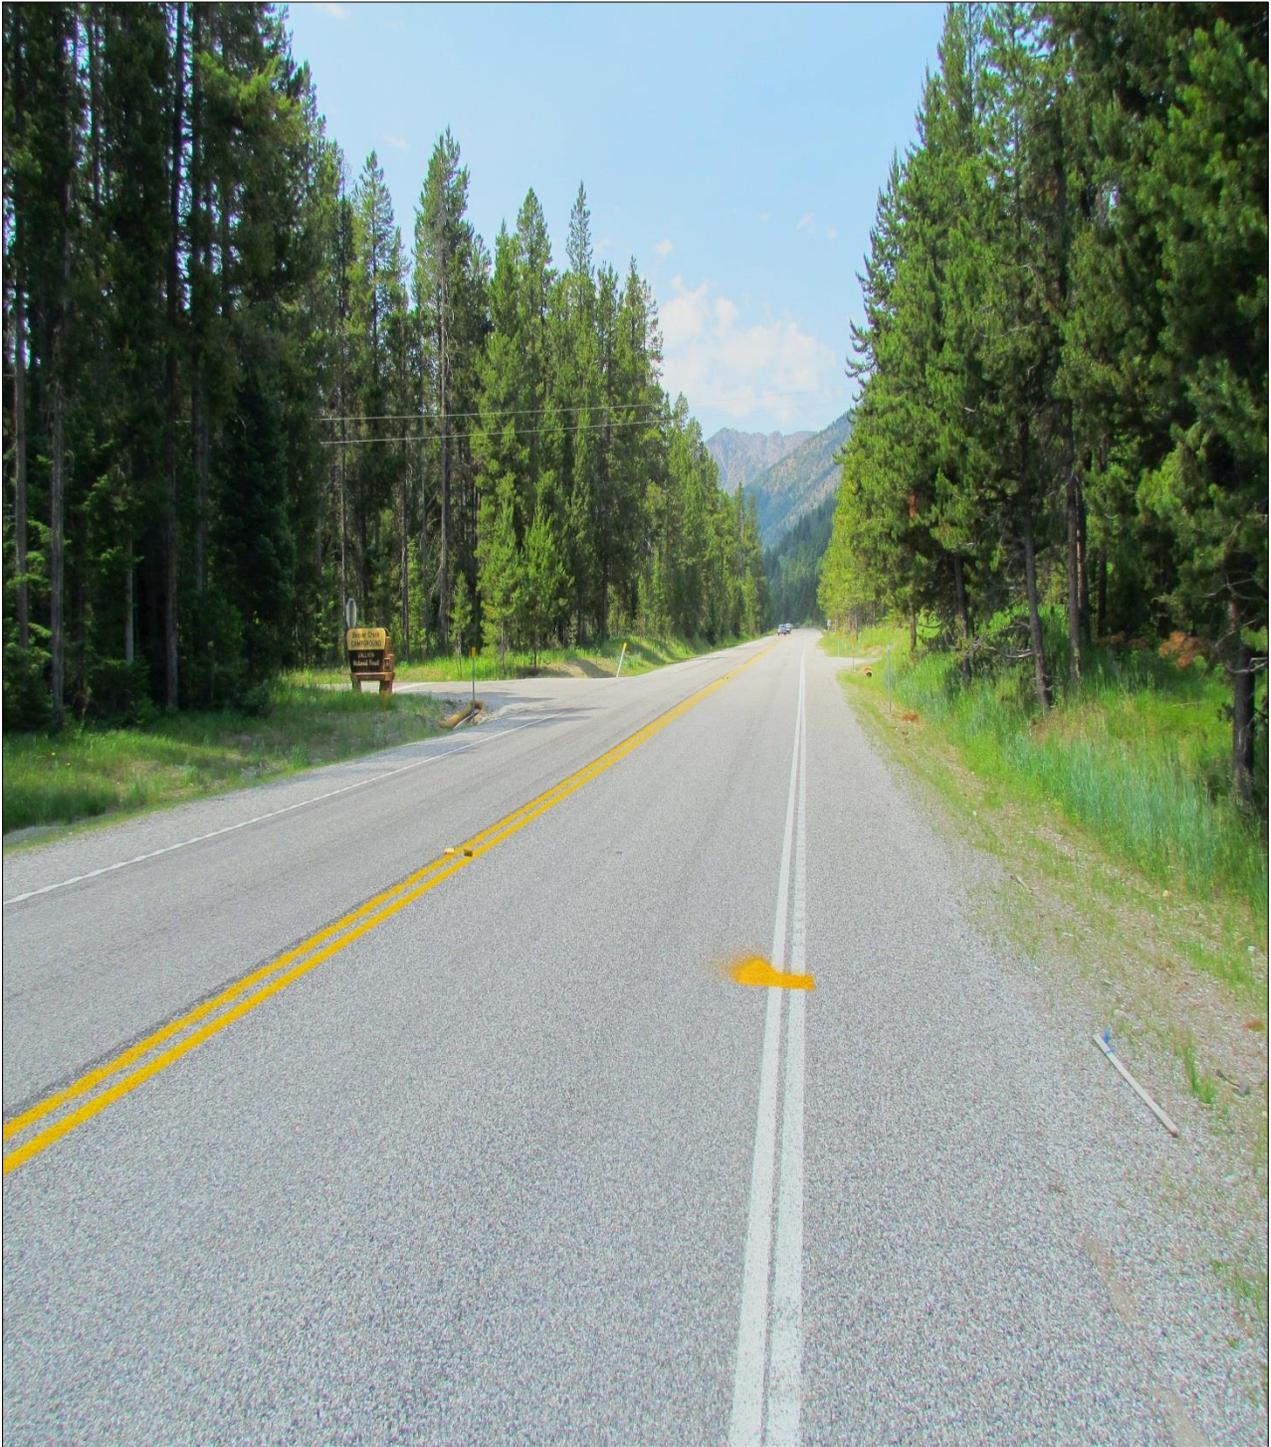
↑ Shot of project section in August, a seal & cover has been applied; the small section of frost heave as seen in the April site visit has receded with no (visual) detriment to the pavement surface (view north).

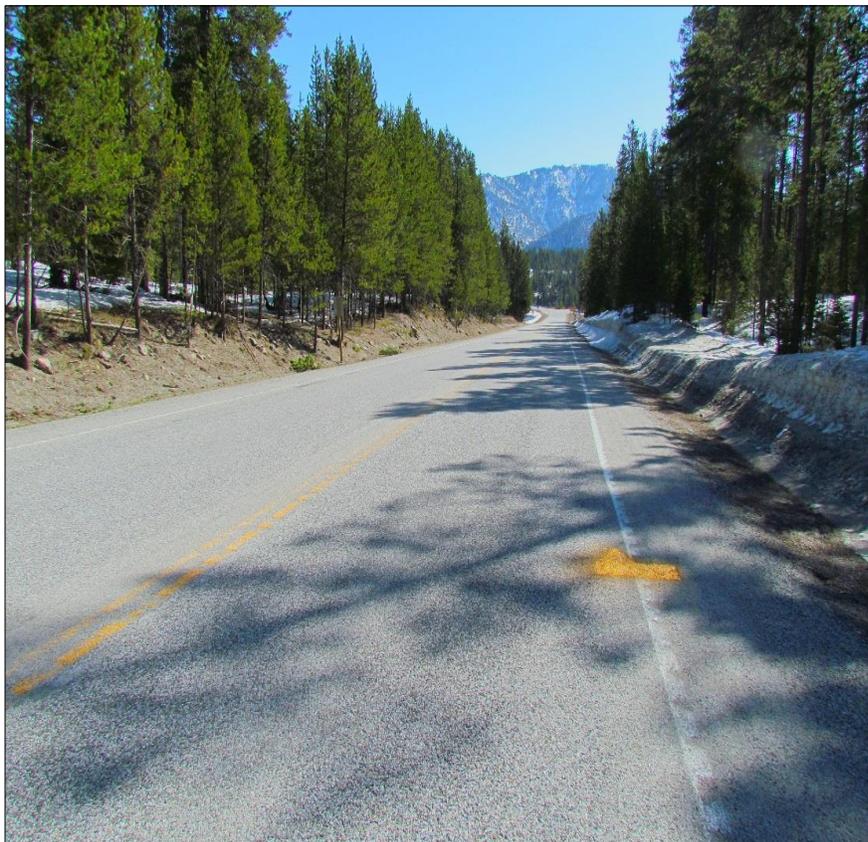
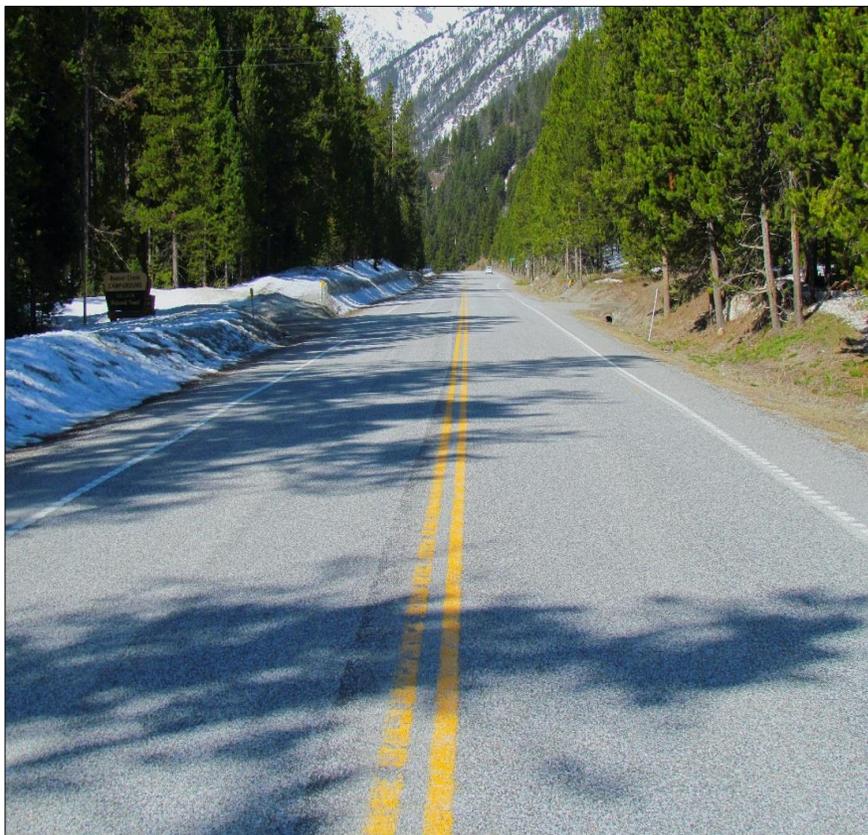
← ↓ Representative images of pavement section condition; views east and west respectively.

No additional distress to report during this inspection.

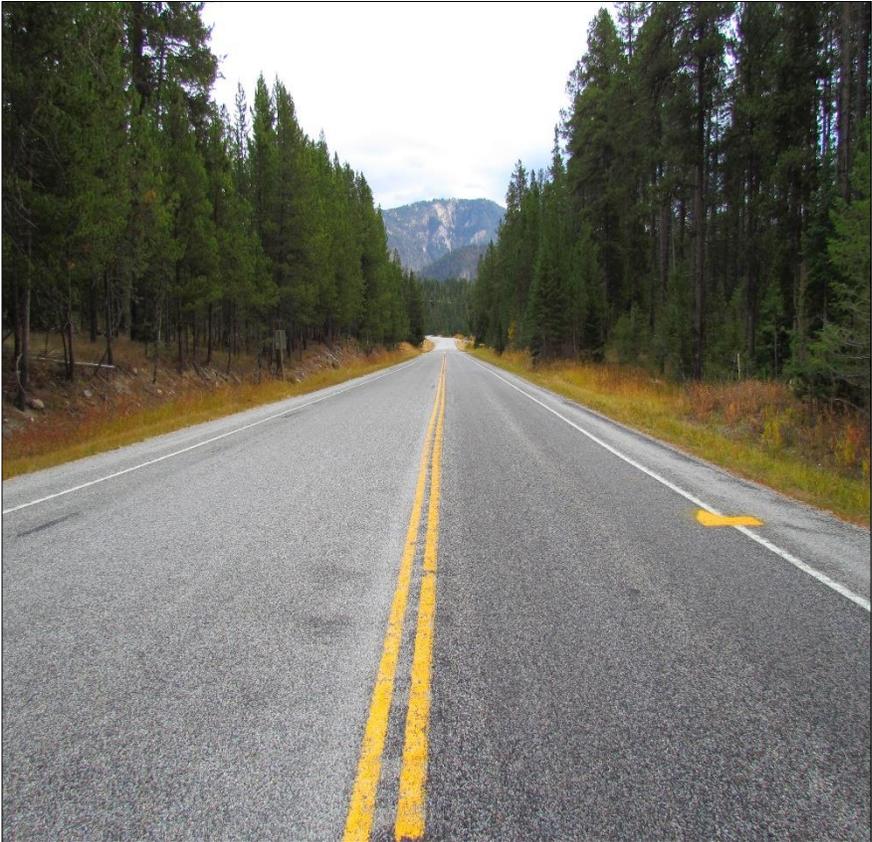
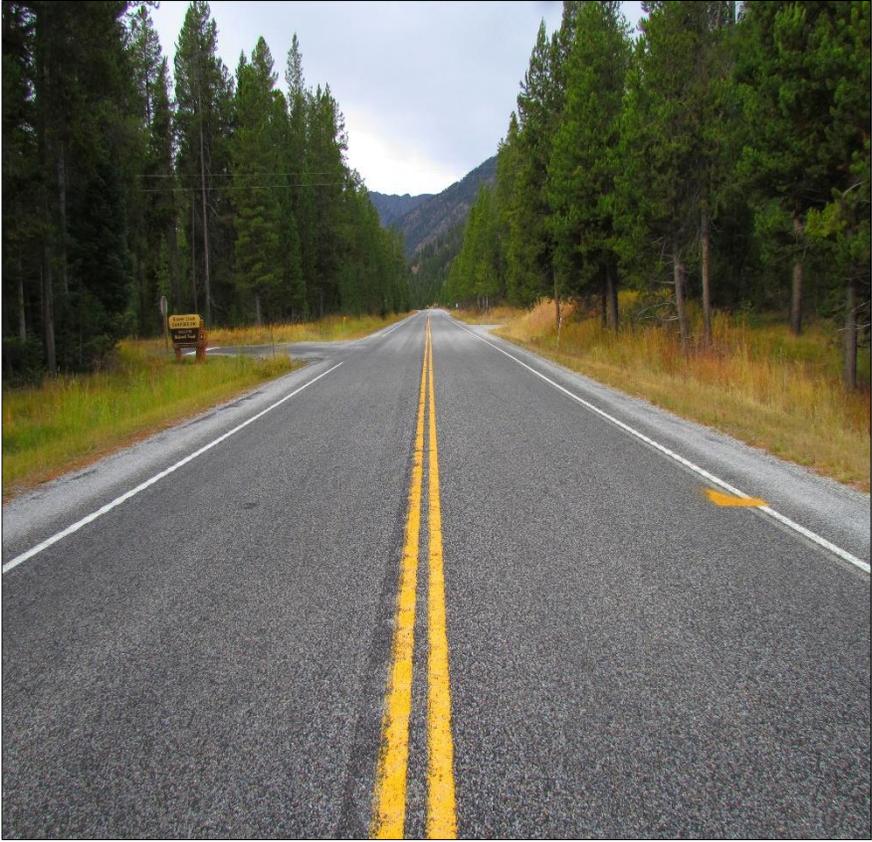
← ↓ Representative images of pavement section condition; views east and west respectively.

No additional distress to report during the fall inspection.

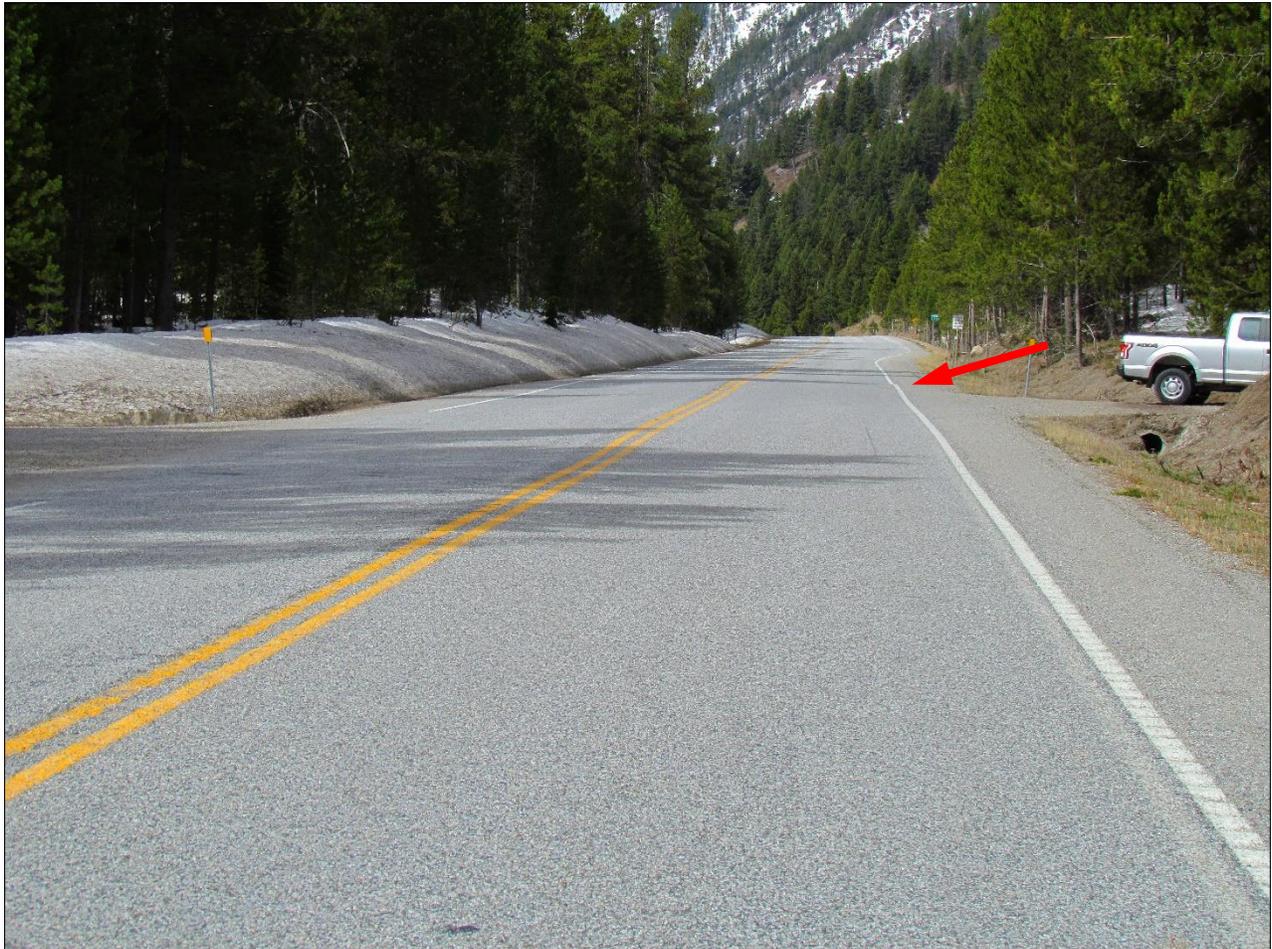
↑ Although difficult to see in this image there are several pronounced undulations in the roadbed with the red arrow pointing to the most noticeable.

This distress is located midway of the project as first documented in April 2017 (view west).

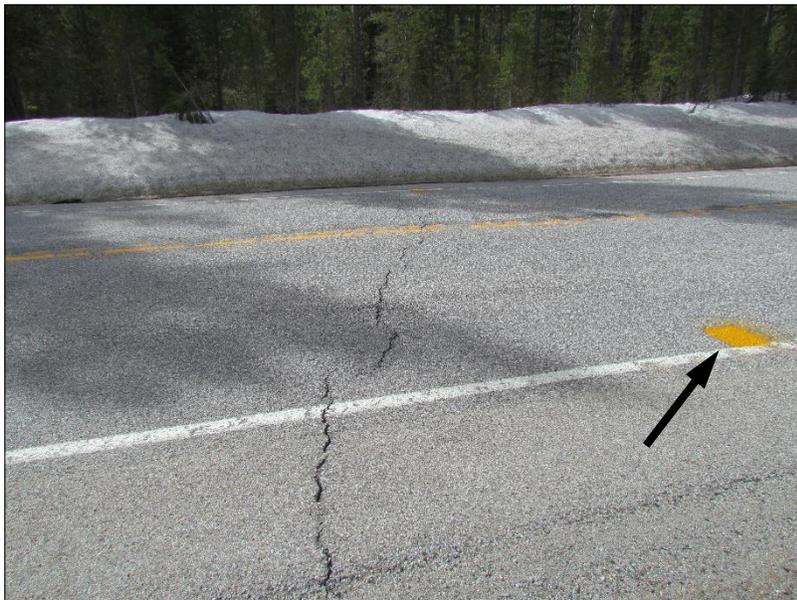
← The red arrow in the above image points approximately to a medium-severity transverse crack seen at left.

This heave area was outlined on the pavement by four yellow sprayed boxes (black arrow).

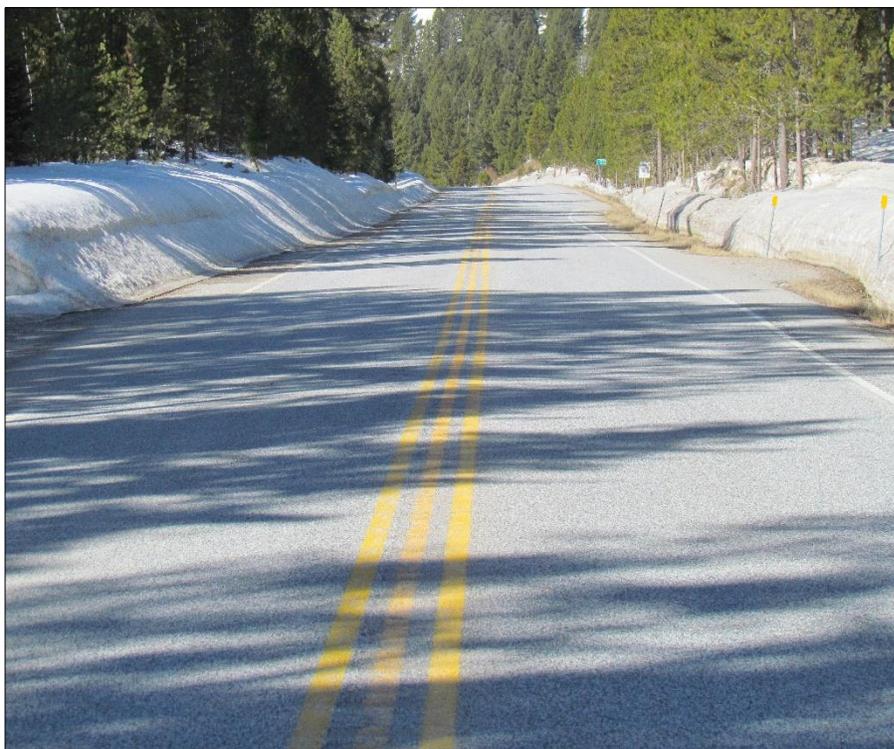
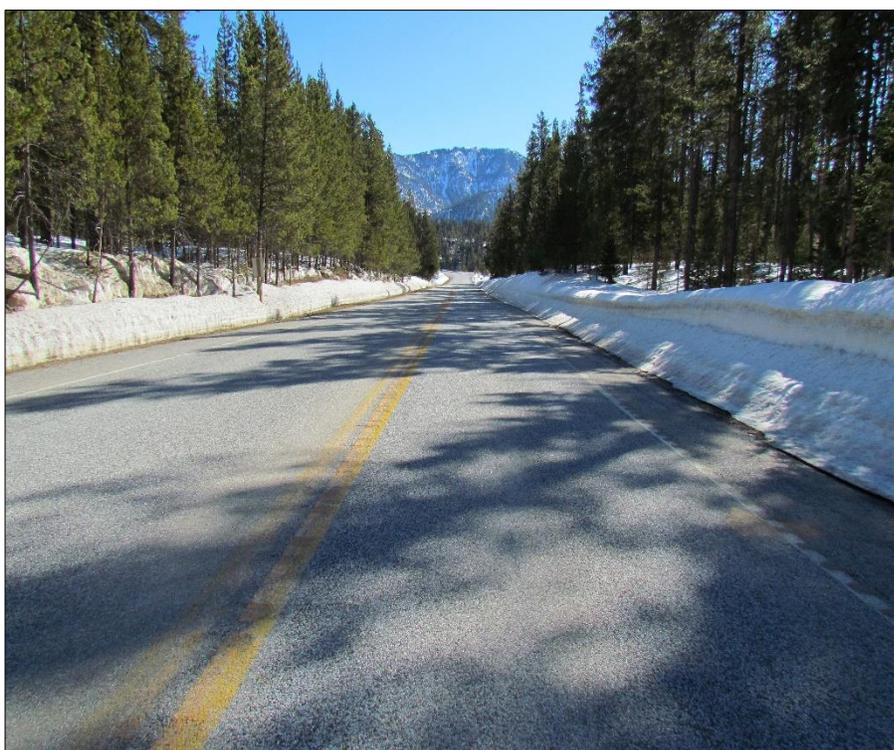
← Representative image of project during 2020 inspection. East end, view west.

← West end of project, view east.

↑ No additional distress to report since the May 2019 site evaluation. Next inspection will take place in spring of 2021.

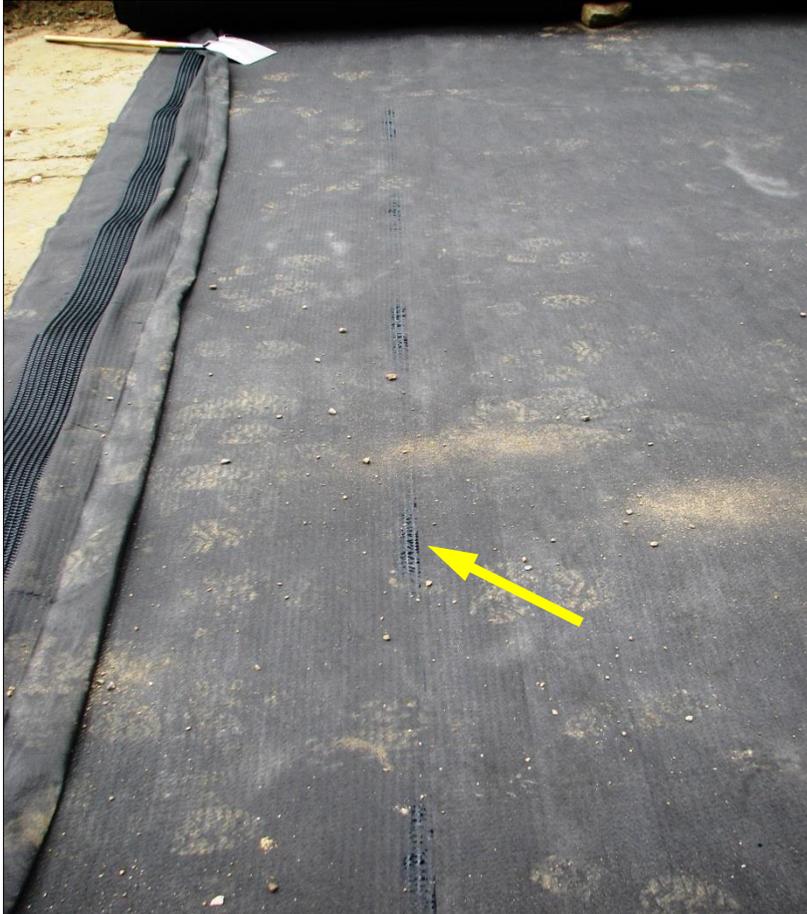
← One of the SSDL rolls was found to have a factory defect where the filter fabric has melted and exposed the geonet core.

Inspecting the SSDL determined the defect at the top layer of fabric only, and the bottom layer was not affected.

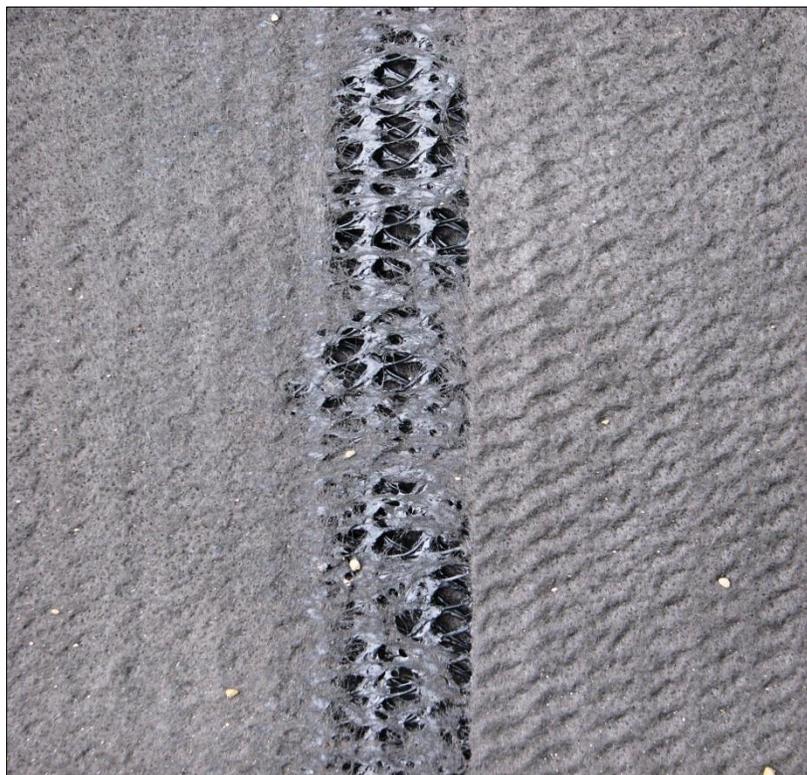
← Close-up of melted fabric layer and exposed core.

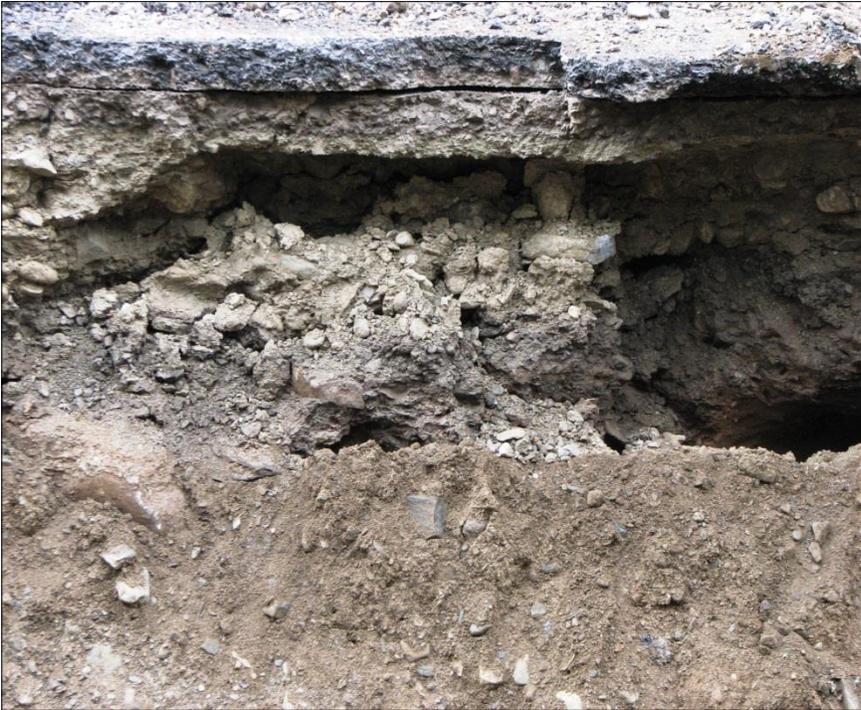
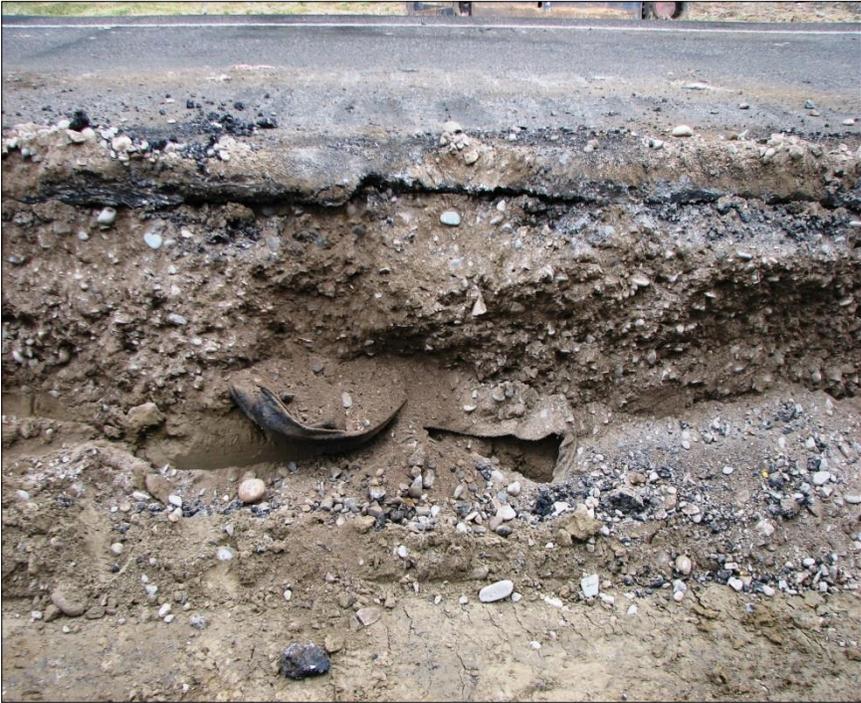
↙↘ Southbound excavated cross-section of roadbed; two photo examples of the previous repair constructed several years ago.
