DOCUMENTATION REPORT

APPLICATION OF ASPHALT SEAL COAT (OR FOG COATING) OVER EXISTING ASPHALT CEMENT (AC) MAT FOLLOWED BY FOG SEAL OVER CHIP SEAL (FSCS)

Location: Flathead County, US2/N1 (C000001)
Project Name: Marias Pass
Project Number: P.O. 311641
Project Description: Fog Seal – Seal and cover – Post Fog Seal
Principal Investigator: Craig Abernathy, Experimental Program Manager
Date of Documentation: August 2015

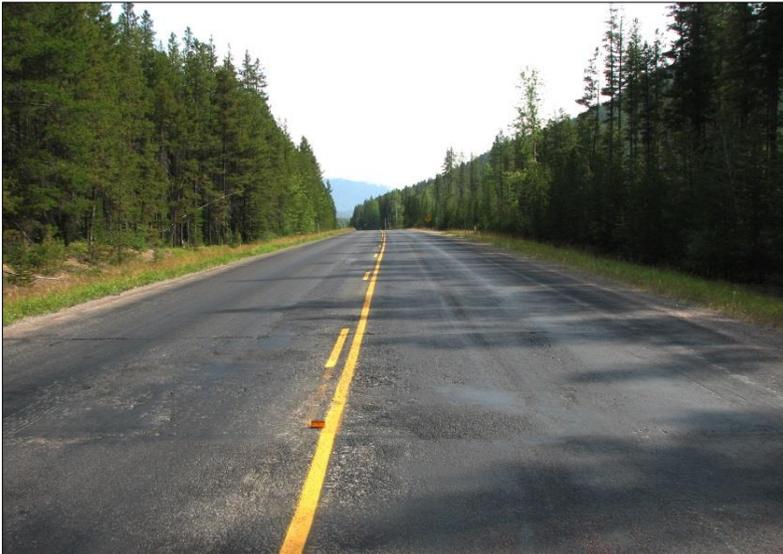
← Fog seal application to existing pavement; approximate reference point 190: View East.

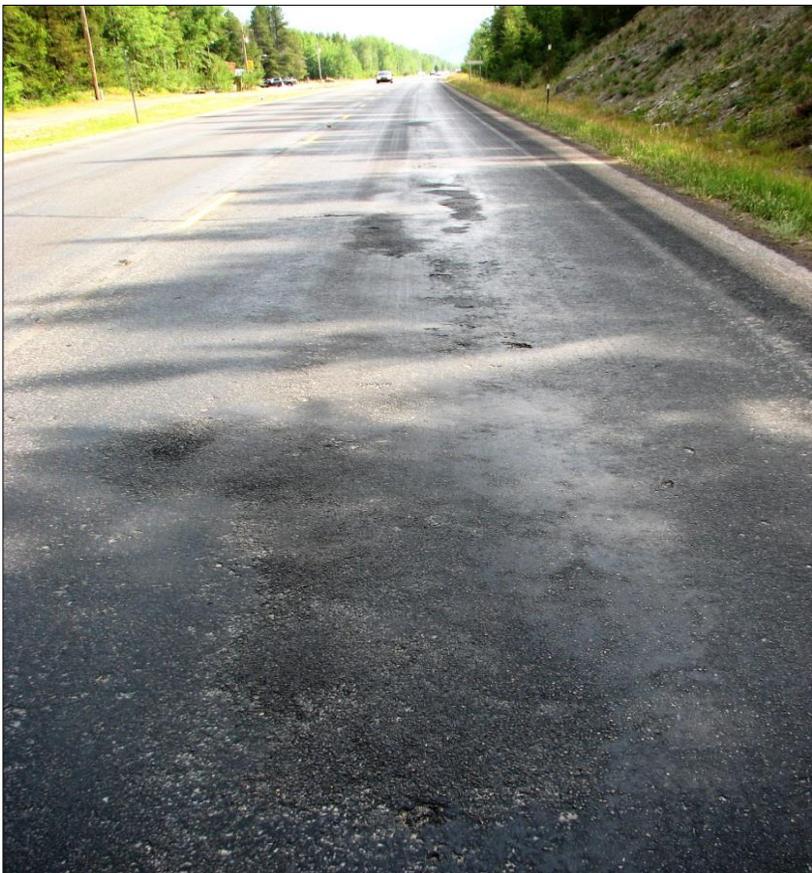
Lower image shows sections where velocity patching was applied.

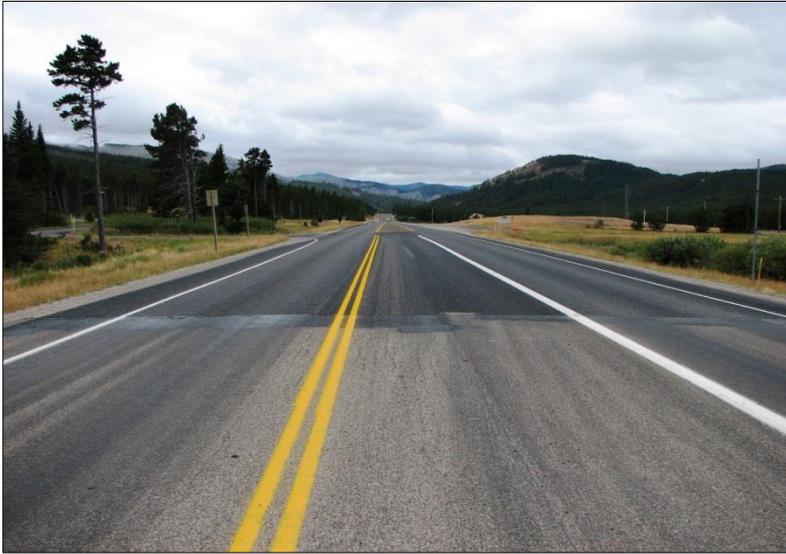
← FSCS application to existing pavement; approximate reference point 198: View West.

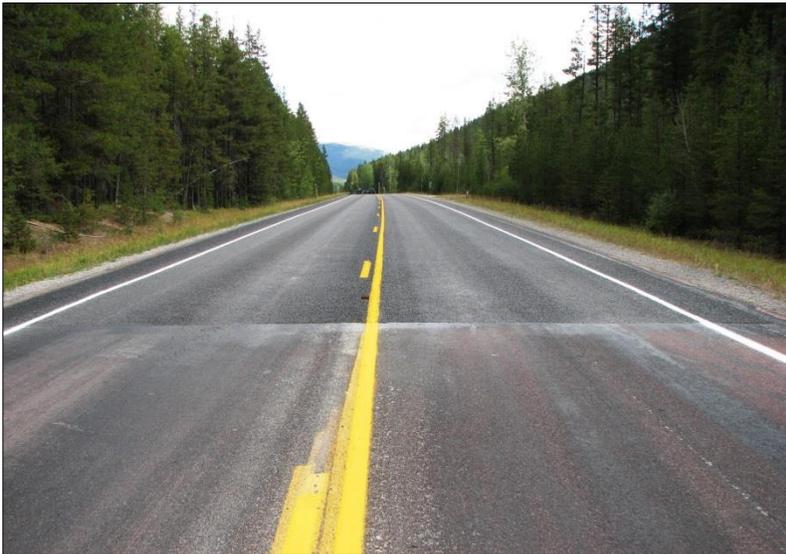
← FSCS application to existing pavement; approximate reference point 190: View East.

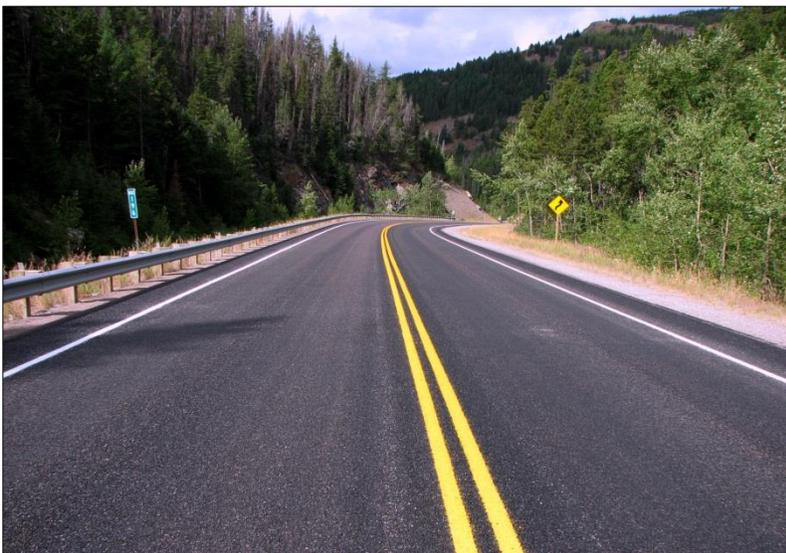
← Reference point 196: General condition of FSCS application to date.
