DOCUMENTATION REPORT

APPLICATION OF ASPHALT SEAL COAT (OR FOG COATING) OVER EXISTING ASPHALT CEMENT (AC) MAT FOLLOWED BY FOG SEAL OVER CHIP SEAL (FSCS)

Location: Flathead County, US2/N1 (C000001)
Project Name: Marias Pass
Project Number: P.O. 311641
Project Description: Fog Seal – Seal and cover – Post Fog Seal
Principal Investigator: Craig Abernathy, Experimental Program Manager
Date of Documentation: August 2015/May 2016

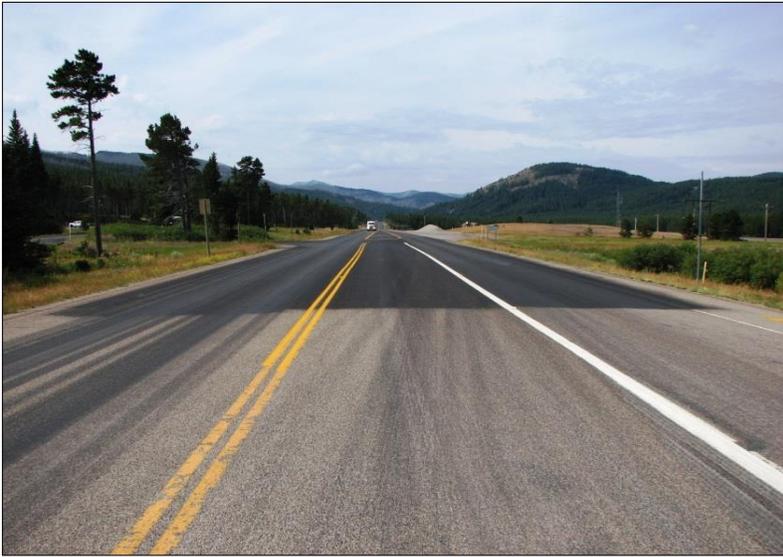
← Fog seal application to existing pavement; approximate reference point 198: View West.

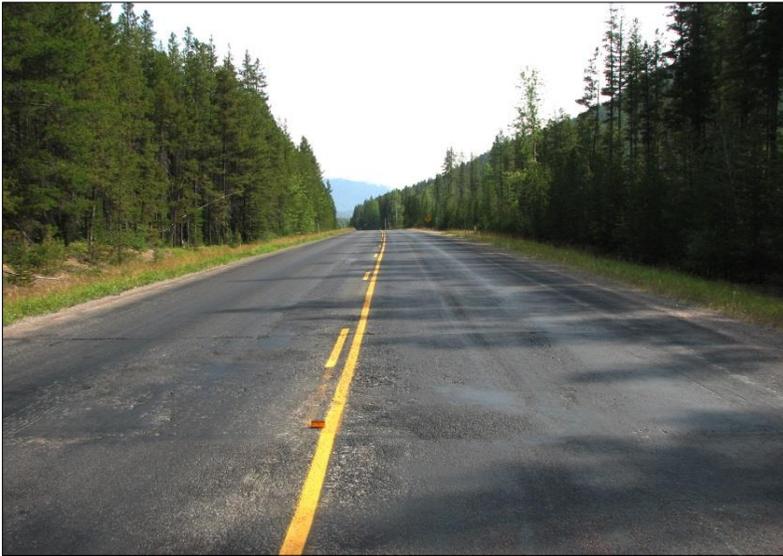
← Fog seal application to existing pavement; approximate reference point 190: View East.

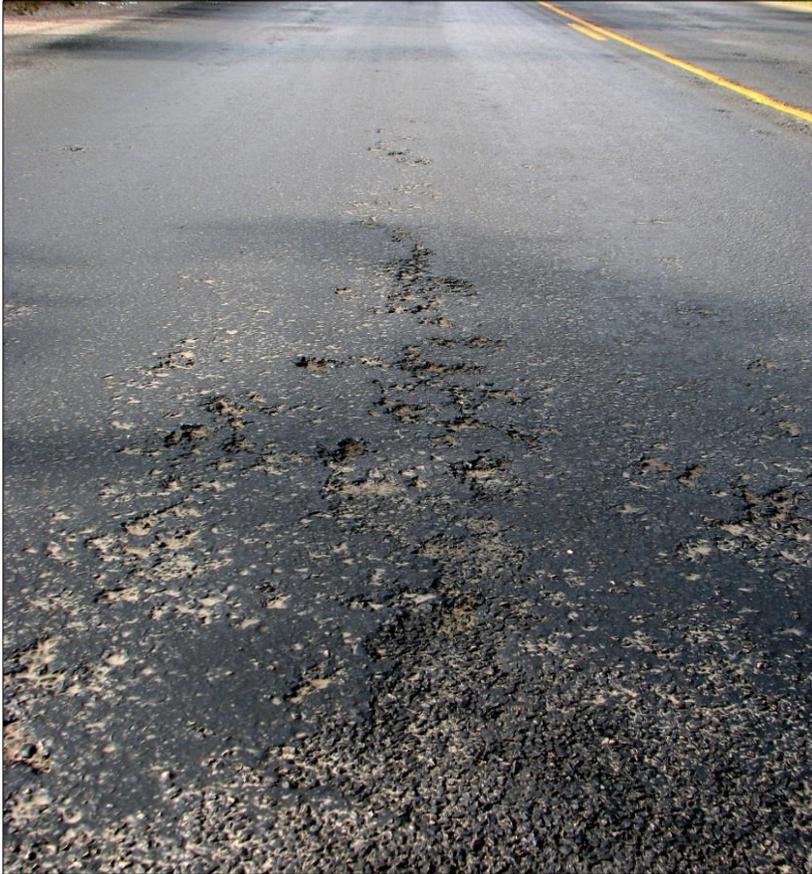
↙ Image of the type of raveling documented on the project; conversely there are areas of the project where currently the surface has a tight appearance.

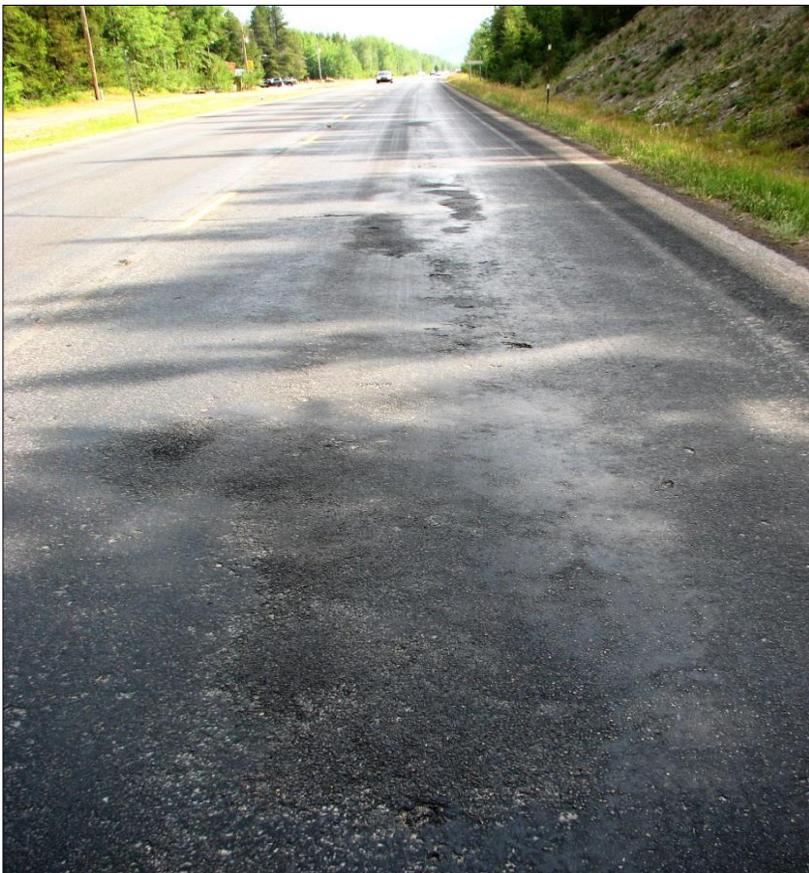
Lower image shows sections where velocity patching was applied.

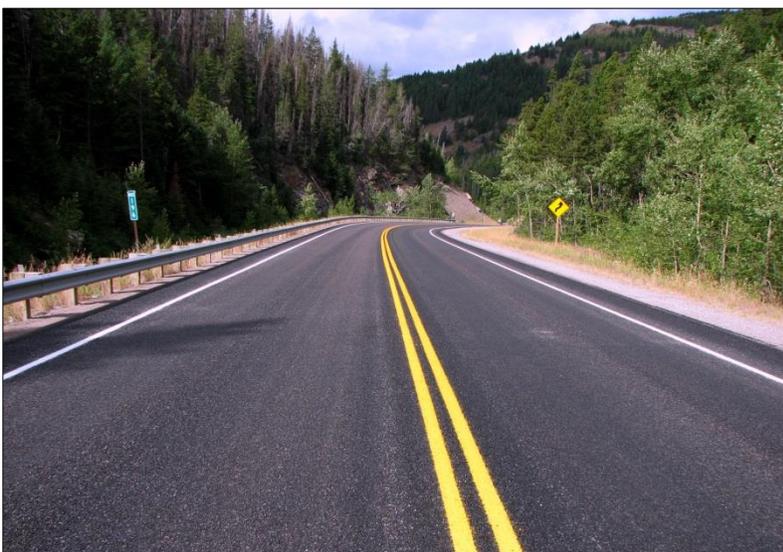
← Reference point 196: General condition of FSCS application to date.

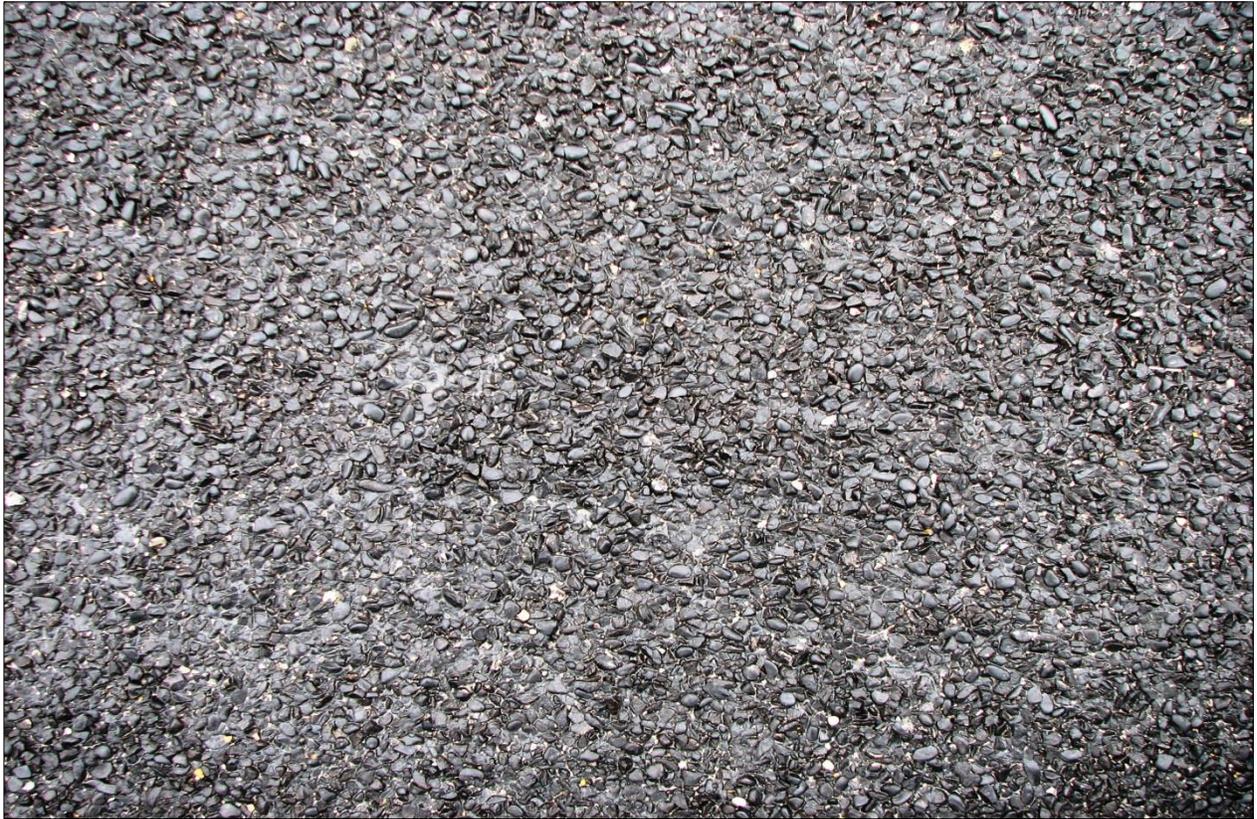
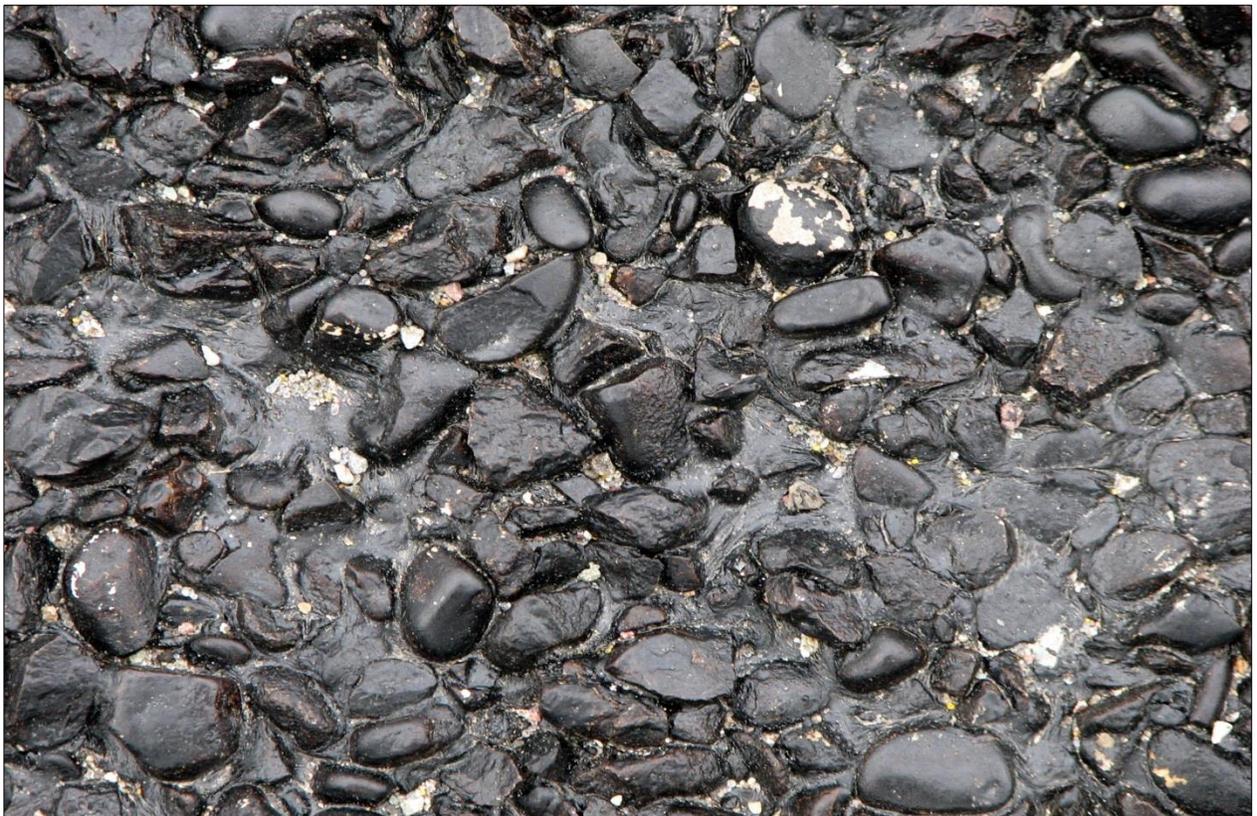
↕ Representative image of enhanced chip seal; on average (visually), the FSCS has a consistent application throughout the project. Chips are locked-in with a substantial bitumen layer.

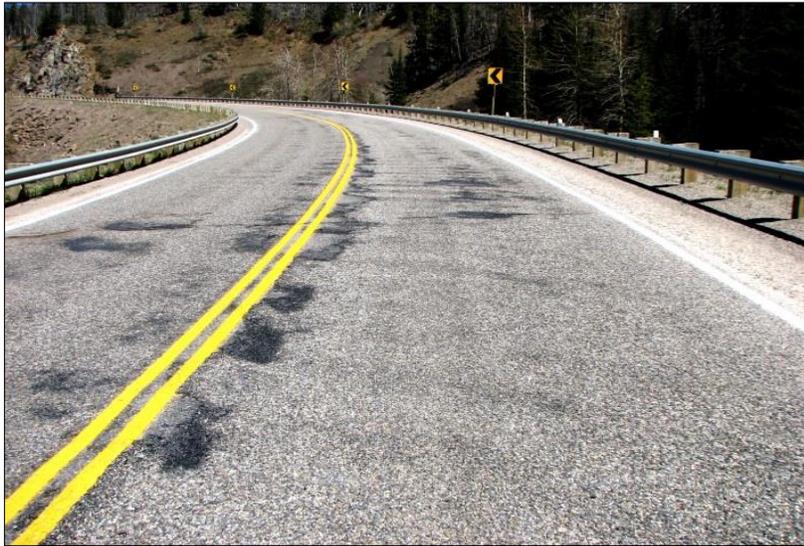
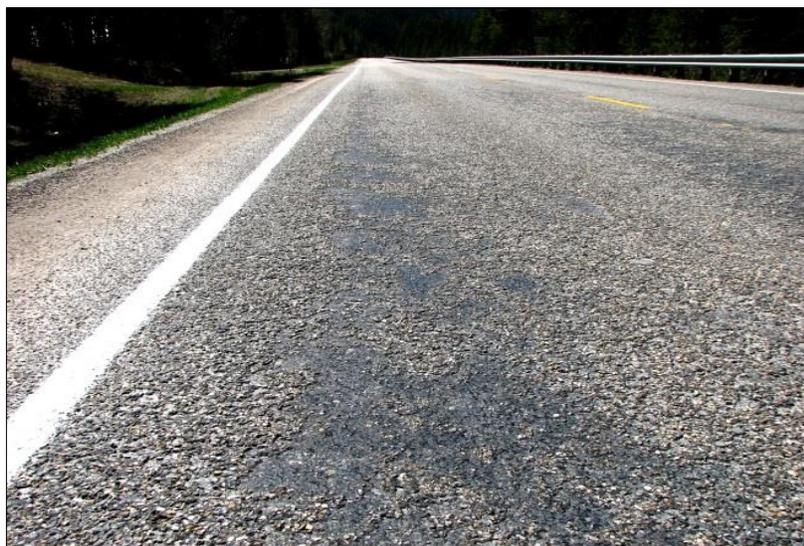
There are sections of the project which do exhibit distress in the form of topical aggregate loss due traffic loads, high frequency of snow plow activities, or environmental extremes. Currently it appears at some areas where velocity patching was performed the underlying pavement distress is reflecting through the FSCS treatment. This trend will be looked at with the next scheduled inspection in the spring of 2017, (see pages 7-9 for representative images of the project).

←↓ Several examples of aggregate loss documented during the inspection.

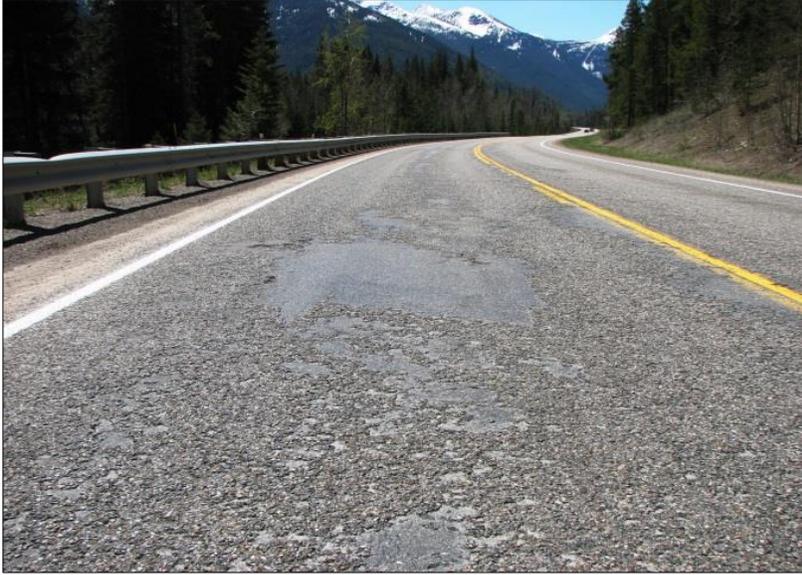
← Another section of pavement, where the loosening or stripping away of the FSCS cover material exposing the fogged base mat.

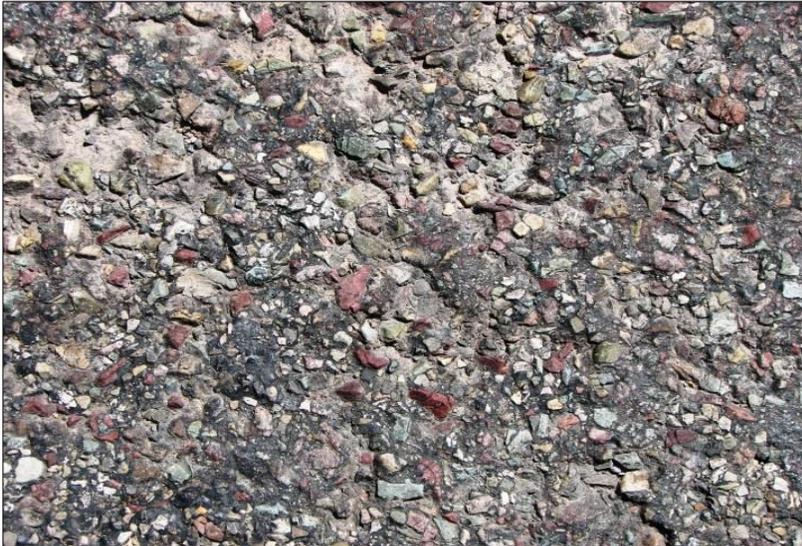
← Representative image (post FSCS) of patched section of raveling continued fragmentation at the surface.

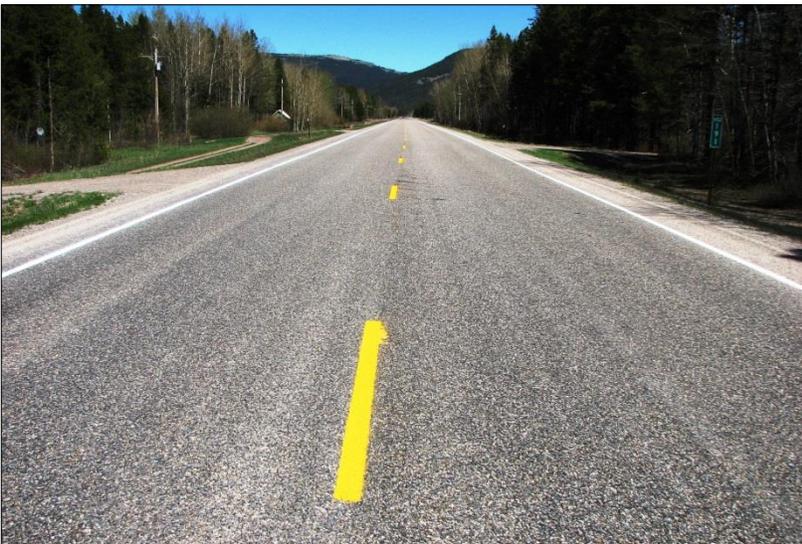
← As stated prior in the report, to date the majority of the pre-fogged FSCS pavement treatment is intact.

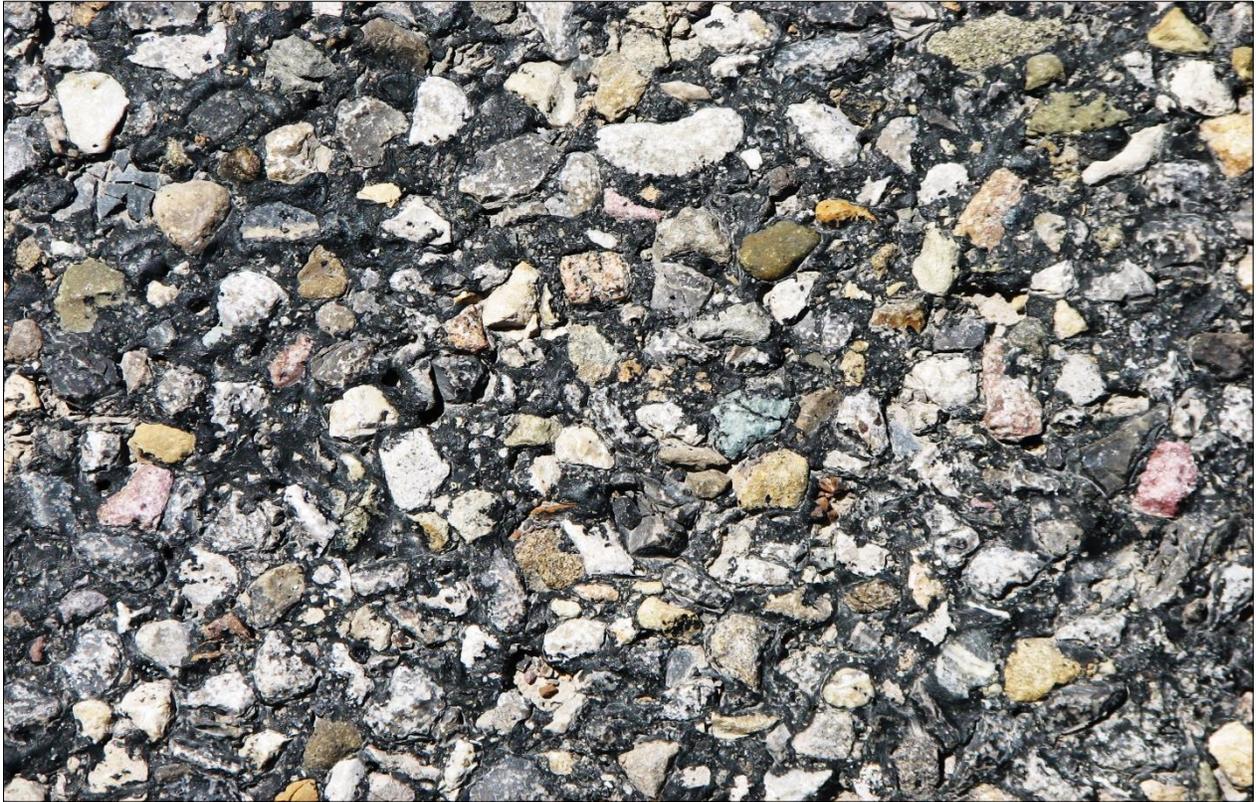
Visually, after the first winter season; the majority of the project is in good condition with surface conditions displaying a tight mat with the fogged surface appearing to have a good bond to the exposed aggregate matrix (see page 9 for a close-up of the surface texture). The topical layer of bitumen to the aggregate, apparent after application, (see page 6) has now for the most part flaked off which is normal.

↑ Representative image of surface texture indicative on most of the project.

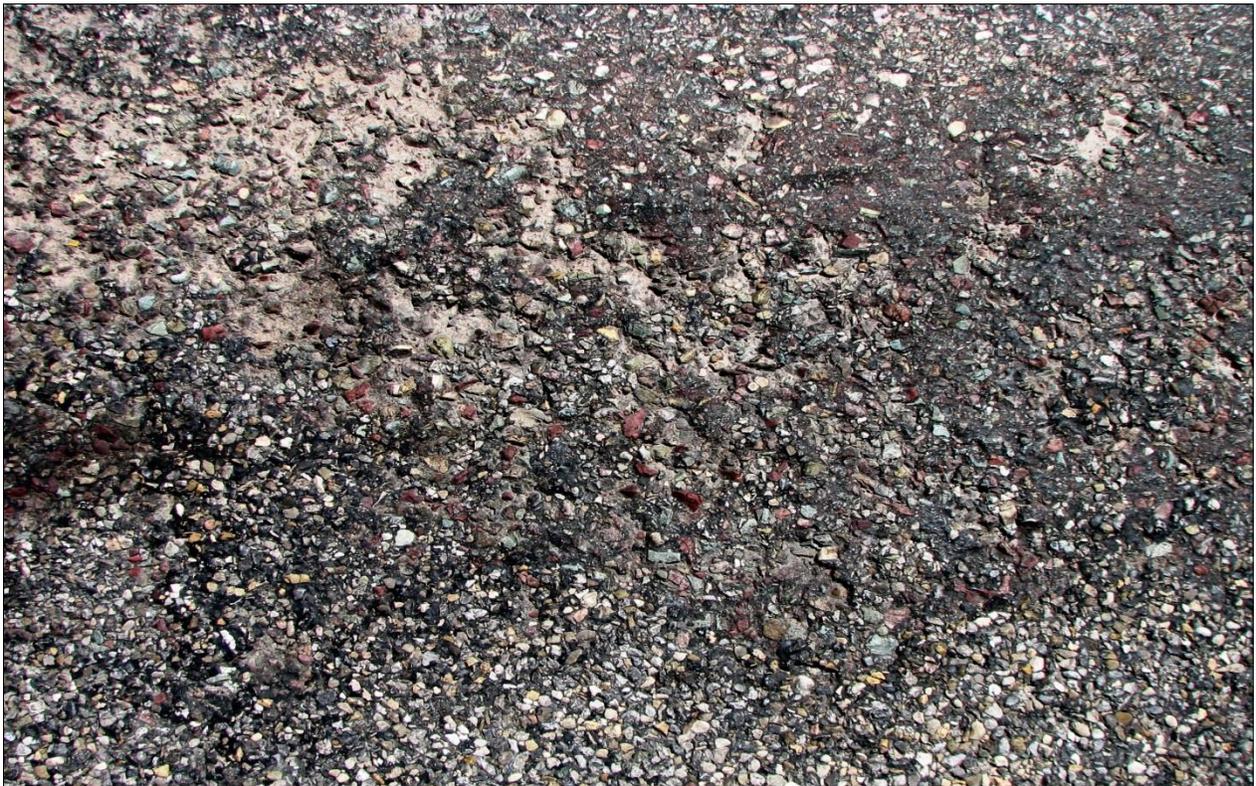
↓ Previously patched areas of raveled pavement are beginning to reflect through to the pavement surface.

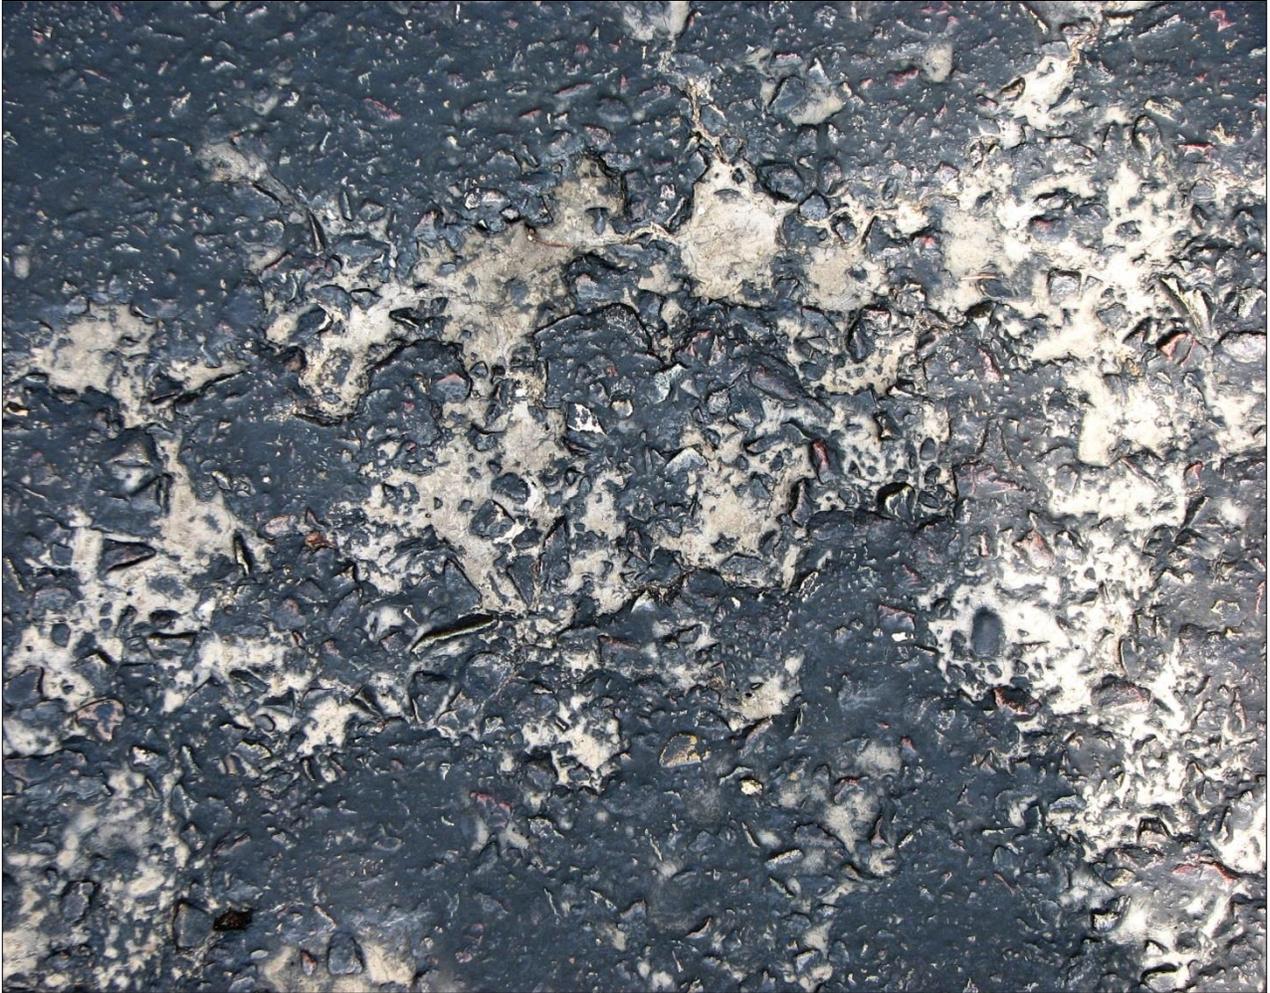
↑ Close-up of fog seal on existing pavement prior to the chips seal with added fog seal (FSCS): The pre-seal appeared to adequately coat and penetrate areas of existing raveling as well as the mat in general. Lighter color material is dust and sediment.
