## EVALUATION REPORT

### FIBER-REINFORCED POLYMER (FRP) PULTRUDED DECKING MATERIAL AND HELICAL ANCHORING SYSTEM FOR USE IN SNOW FENCE APPLICATIONS

Project No.: IM90-7(63)331

Description: Sixth semi-annual evaluation of remaining test section of snow fence using proprietary EZ-Deck Fiber-Reinforced Polymer (FRP).

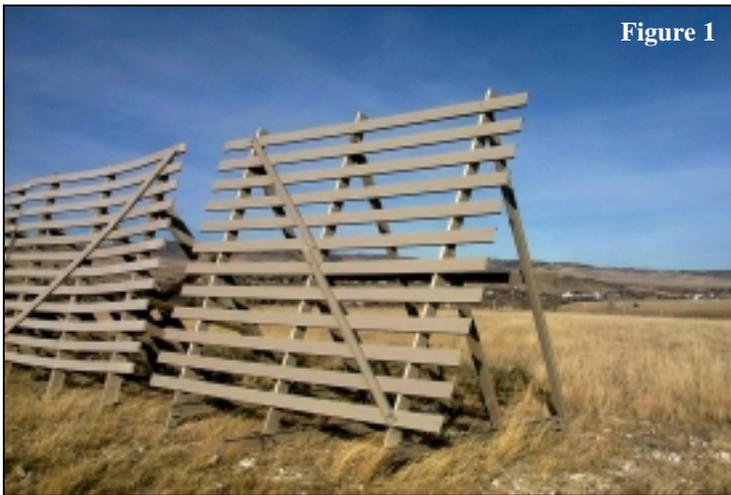
Inspections are held in early spring and late fall to document the environmental effects of seasonal extremes to the FRP material as well as stability of design. Figure 1 shows the remaining TS1 as seen on November 21, 2002.

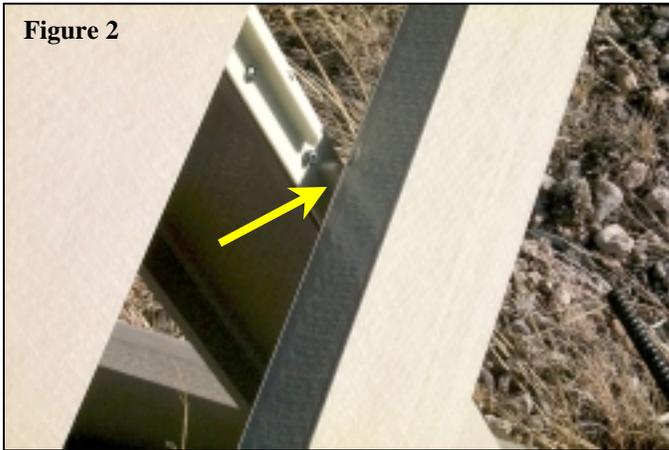
As detailed in the October 2001 inspection, on of the lower FRP planks, at the top of the center clip attachment seems to have broken or sheared off. Figure 2 shows a front view close-up of the broken clip. The screw used to help secure the plank to clip remains. The

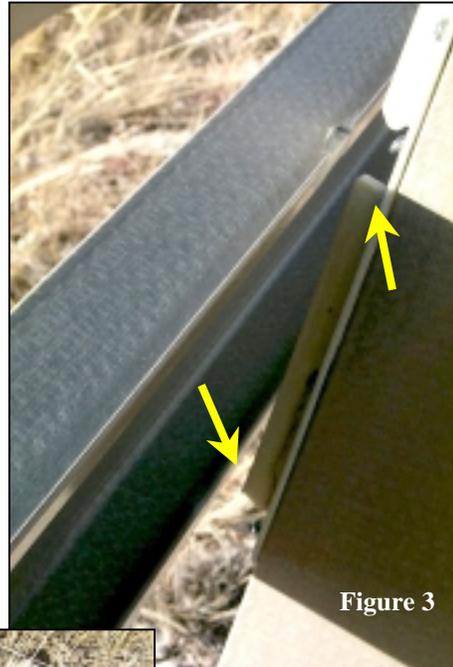
plank shows the damage from the screw head as it (apparently) was pulled away. The plank has deflected further away from the clip attachment since the last inspection (Figure 3, rear view). We can assume stress on the front panel from wind turbulence could have caused the separation. This occurrence is just on one clip attachment. The damage was not noticed on any other areas of the test section during this inspection. All other connections used to attach the FRP planking to the frames are intact, with no evidence of loose screws or chipping of the FRP rail attachments. Visual appearance of all the FRP material and plank connections shows no signs of deterioration from sun or wind degradation.

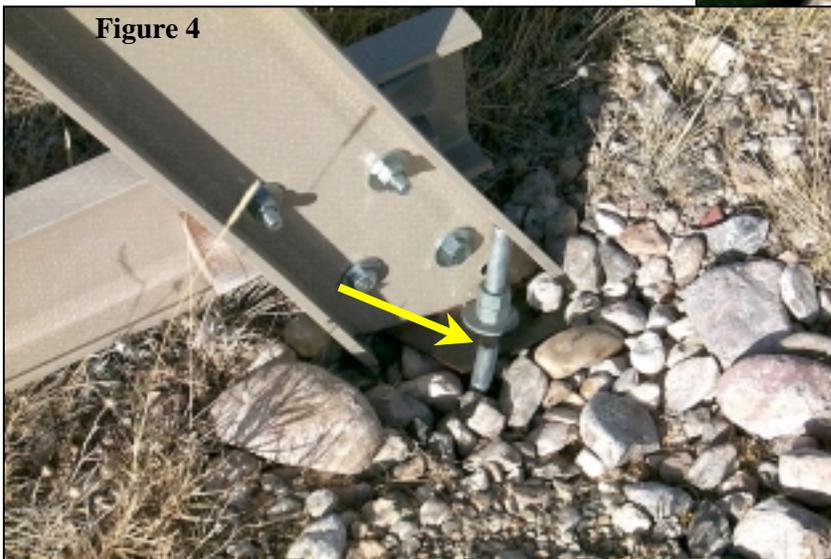
As noted in the October 2000 Report. The right, rear bolt attachment to the frame sill has broken (Figure 4). During this investigation, it was observed the sill had jumped once more to the left of the broken bolt of the rear ground support. This

broken sill support has, up to this time, not caused a catastrophic failure of TS1. Nor is there any evidence that this loose rear sill attachment may have caused stress that allowed the center clip bracket to shear off. It was also observed the right front frame to bolt attachment has bent slightly. This may be the result of the freedom of the rear connection, which is allowing the stress from wind turbulence to deflect the bolt. The sill frame will be closely monitored in future
