## EVALUATION REPORT

### FIBER-REINFORCED POLYMER (FRP) PULTRUDED DECKING MATERIAL AND HELICAL ANCHORING SYSTEM FOR USE IN SNOW FENCE APPLICATIONS

Project No.: IM90-7(63)331

Description: Third semi-annual evaluation of two test sections of snow fencing using two proprietary materials; EZ-Deck FRP and A. B. Chance Helical Anchoring System.

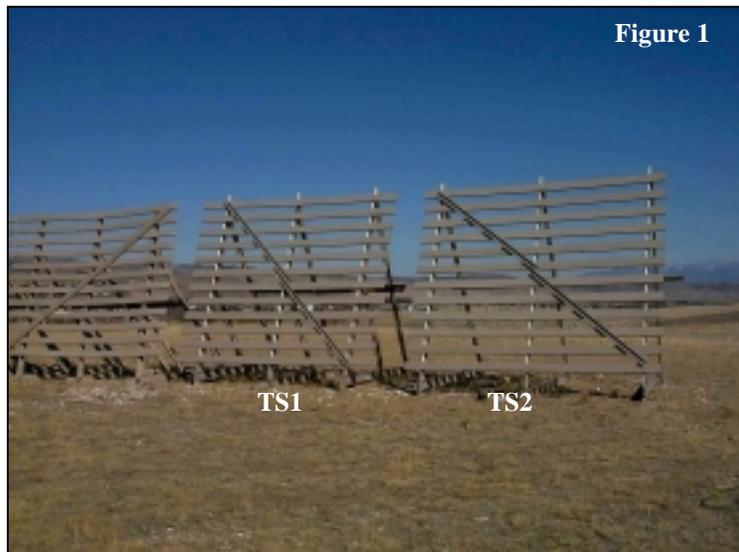
extremes of the FRP material as well as stability of design. Figure 1 shows sections TS1 & TS2 as seen in October of 2000.

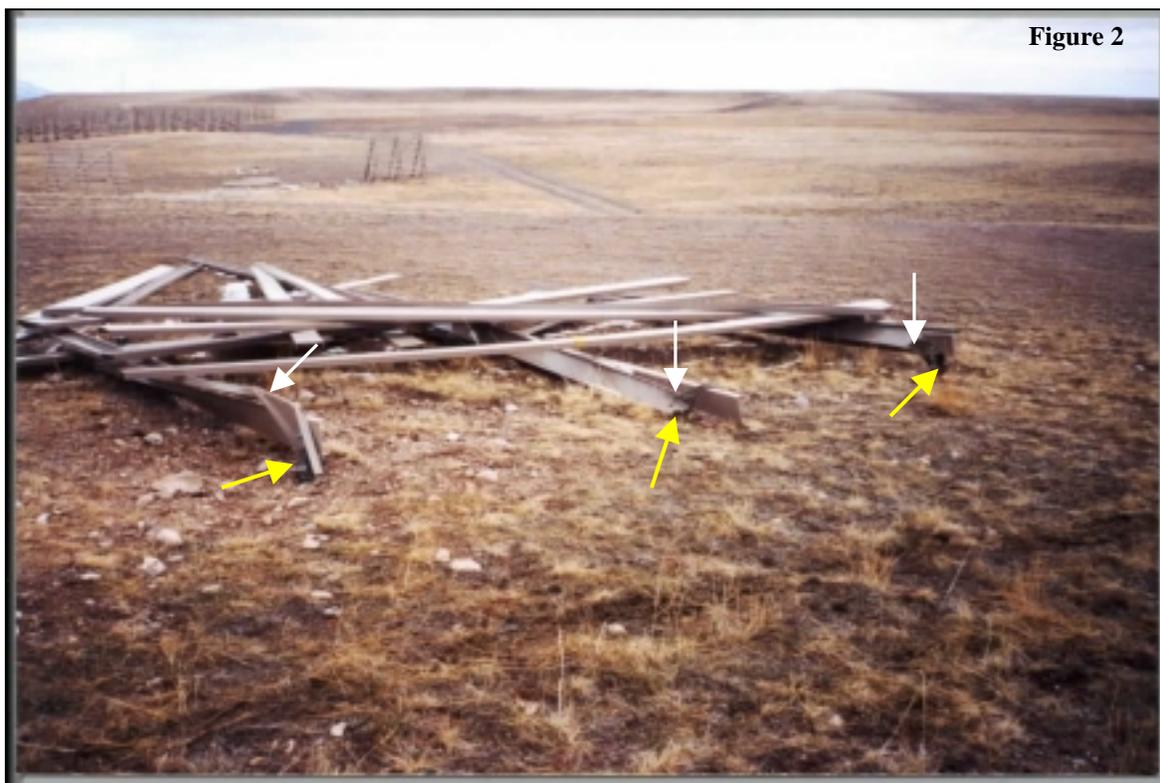
On all accounts, it has been stated that this section was seen collapsed on the ground viewed by MDT staff at the earliest date of March 2, 2001. We concur that sometime before this date and after the Fall 2000 evaluation this structure failed. Duane Rabine of Riverside Contracting supplied Research with images of the collapsed structure. With review by the experimental team, all evidence suggests that this was a wind-related failure. Figure 2 shows TS2 as collapsed.

The yellow arrows show the FRP material still attached to the end helical bracket bolts and the center sill connection. The white arrows show where the FRP material has fractured just above these connections. It is speculation only, but it has been suggested since this design had only three rear supports (as can be seen in figure 3) that one or more of these supports snapped under high wind. In turn breaking or twisting the front bracing to failure. TS1 (MDT design) has an additional three braces for support (see figure 4); this may be the reason this structure has not, at this time, been affected by high winds. It is noted that the helical anchors used to secure TS2 were not affected and are still in the ground.

Based on the supplied images and interviews with staff viewing the TS2 Section on the ground, it is our opinion that TS2 suffered structural failure due to high winds. Visually, TS1 is in the same condition as seen in the October 2000 evaluation and is rated as performing well. The helical anchors used in the TS2 section performed well during the structural failure in keeping the sill and bracing attachments in place. Regardless of

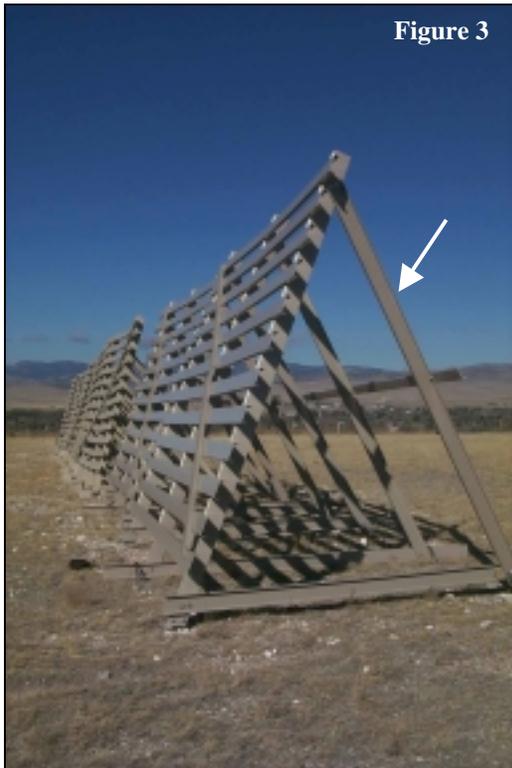
Upon arriving to the test section site, it was discovered that section TS2 had been removed. No other FRP material or helical attachments for this section were found at the test site. Remnants of the FRP clip attachments were scattered in the area. Section TS1

On the left is FRP TS2, above is FRP TS1.

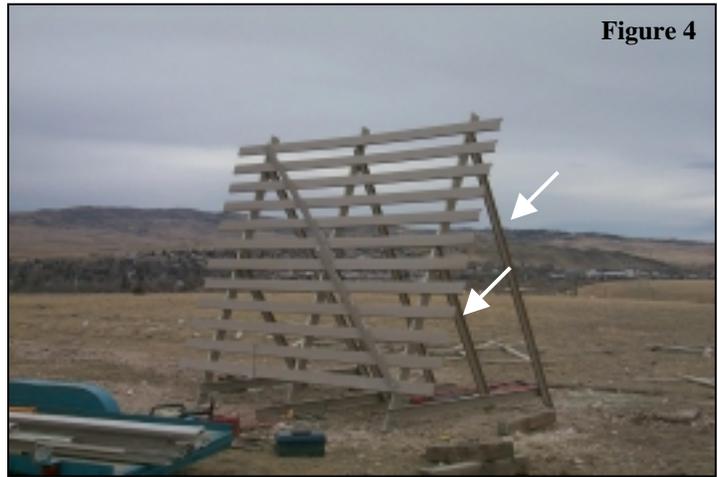
showed no degradation of material, all support hardware and attachments appeared to be in the same shape as was reported in the fall (2000) evaluation.
