Montana Department of Transportation  
Research Programs  
January 2015

**SHRINKAGE REDUCING ADMIXTURE (SRA) AND SYNTHETIC POLYOLEFIN FIBERS (SPF) TO REDUCE SHRINKAGE CRACKING IN BRIDGE DECKS**

**Project Name:** Br Deck Rehab / Repair 11 – East Belgrade Interchange – North

**Experimental Project No:** MT-12-12/14-03

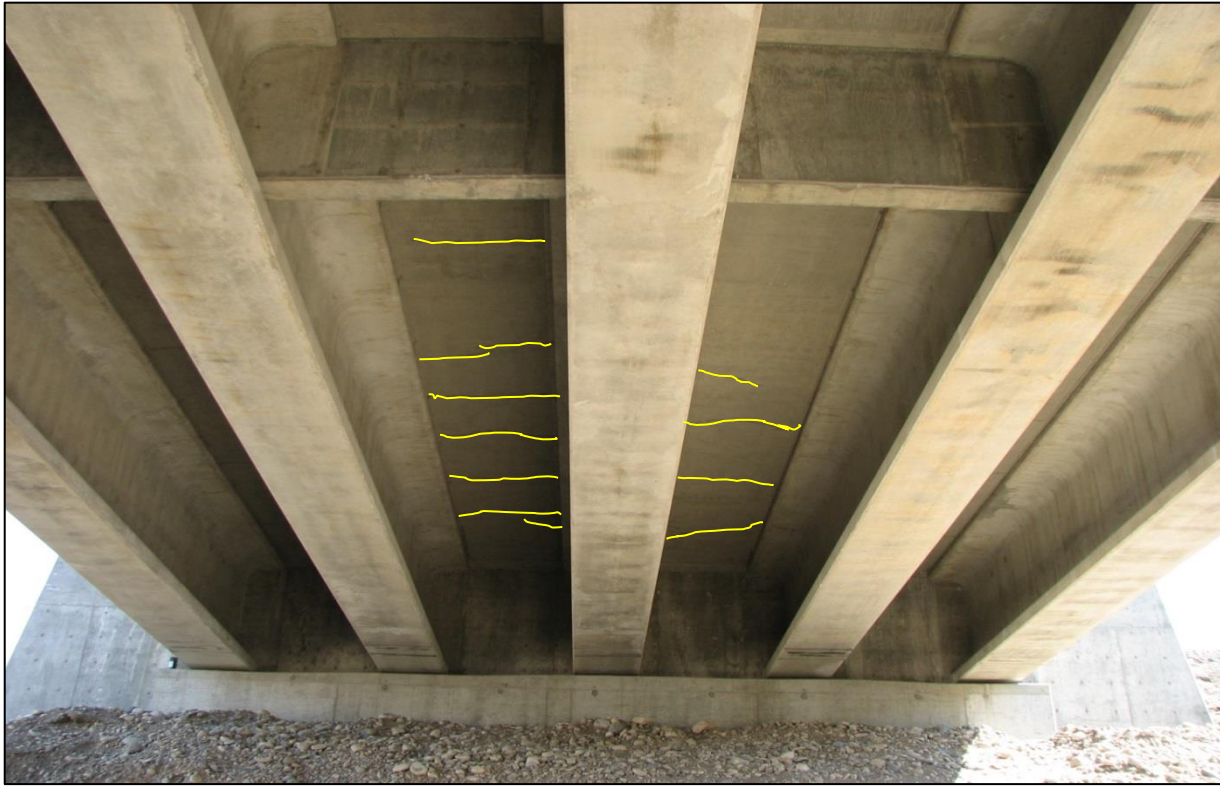
↑ West Bound Deck – East End: **SD Placement**; a yellow line is superimposed to better delineate the crack.

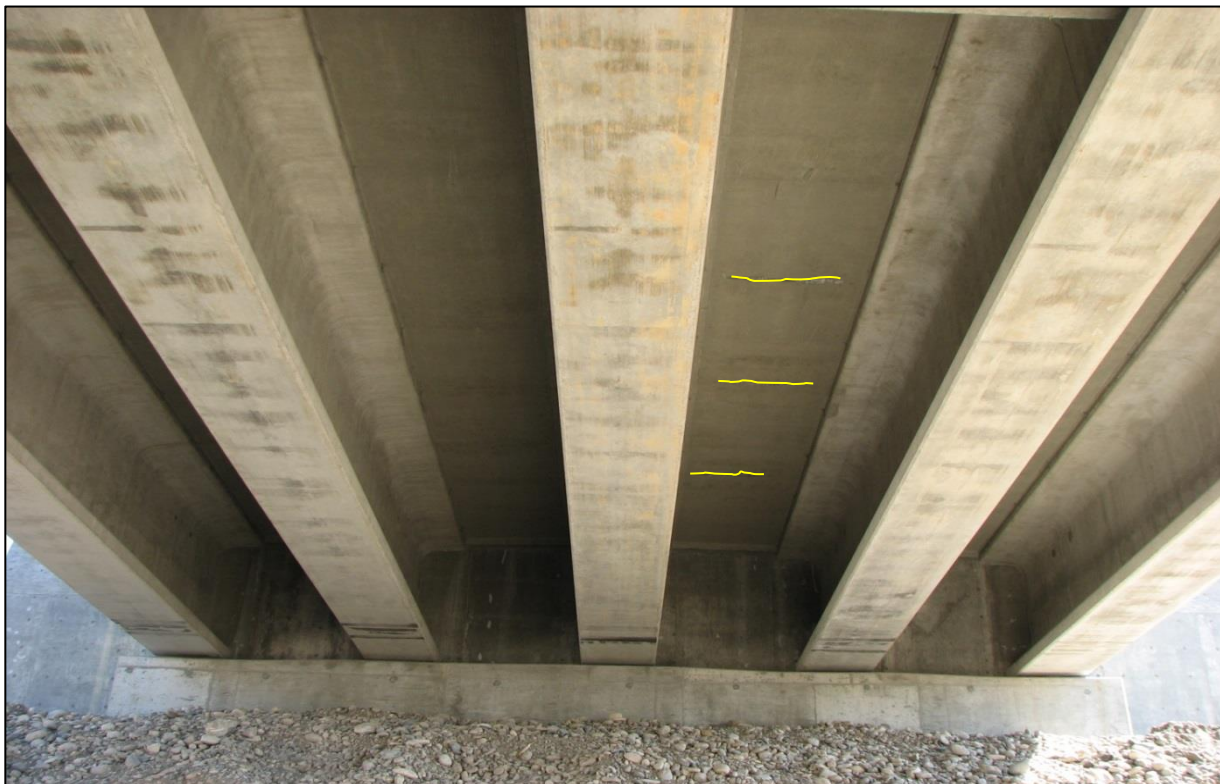
↑ East Bound Deck – East End: **SRA/SPF placement**.

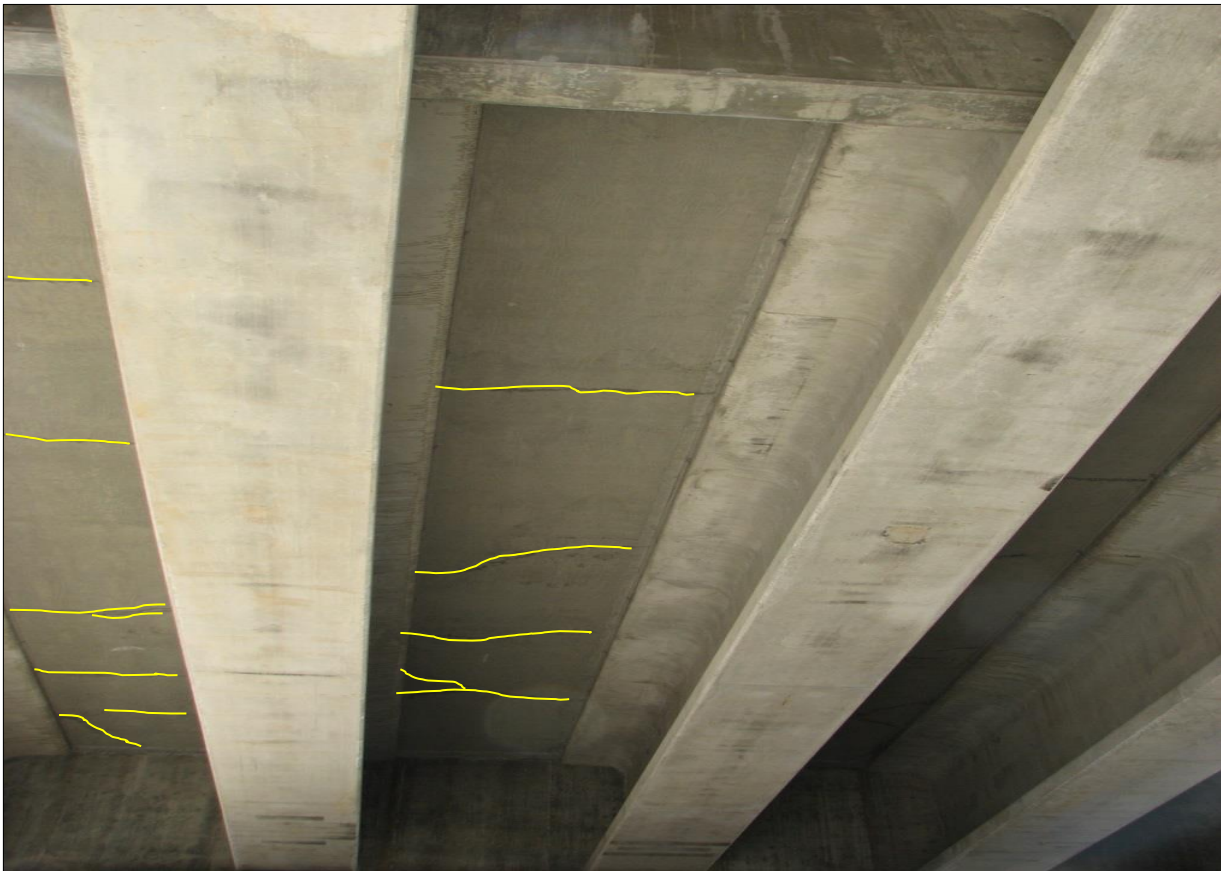
↑ West Bound Deck – **West End: SD placement**; south-side abutment end.

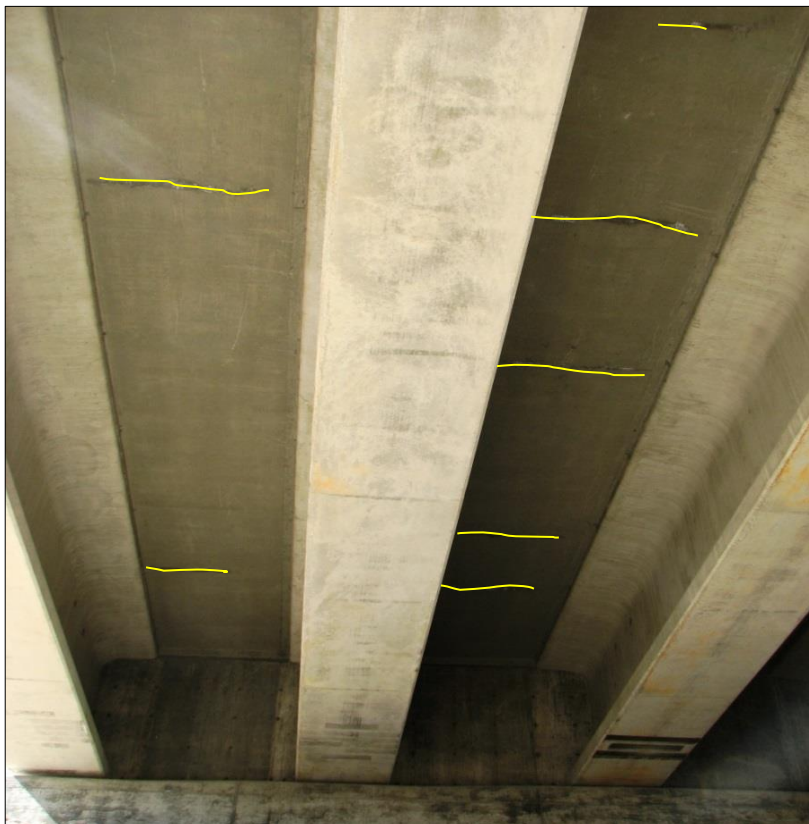
← East Bound Deck – **West End: SRA/SPF placement**; south-side abutment end.

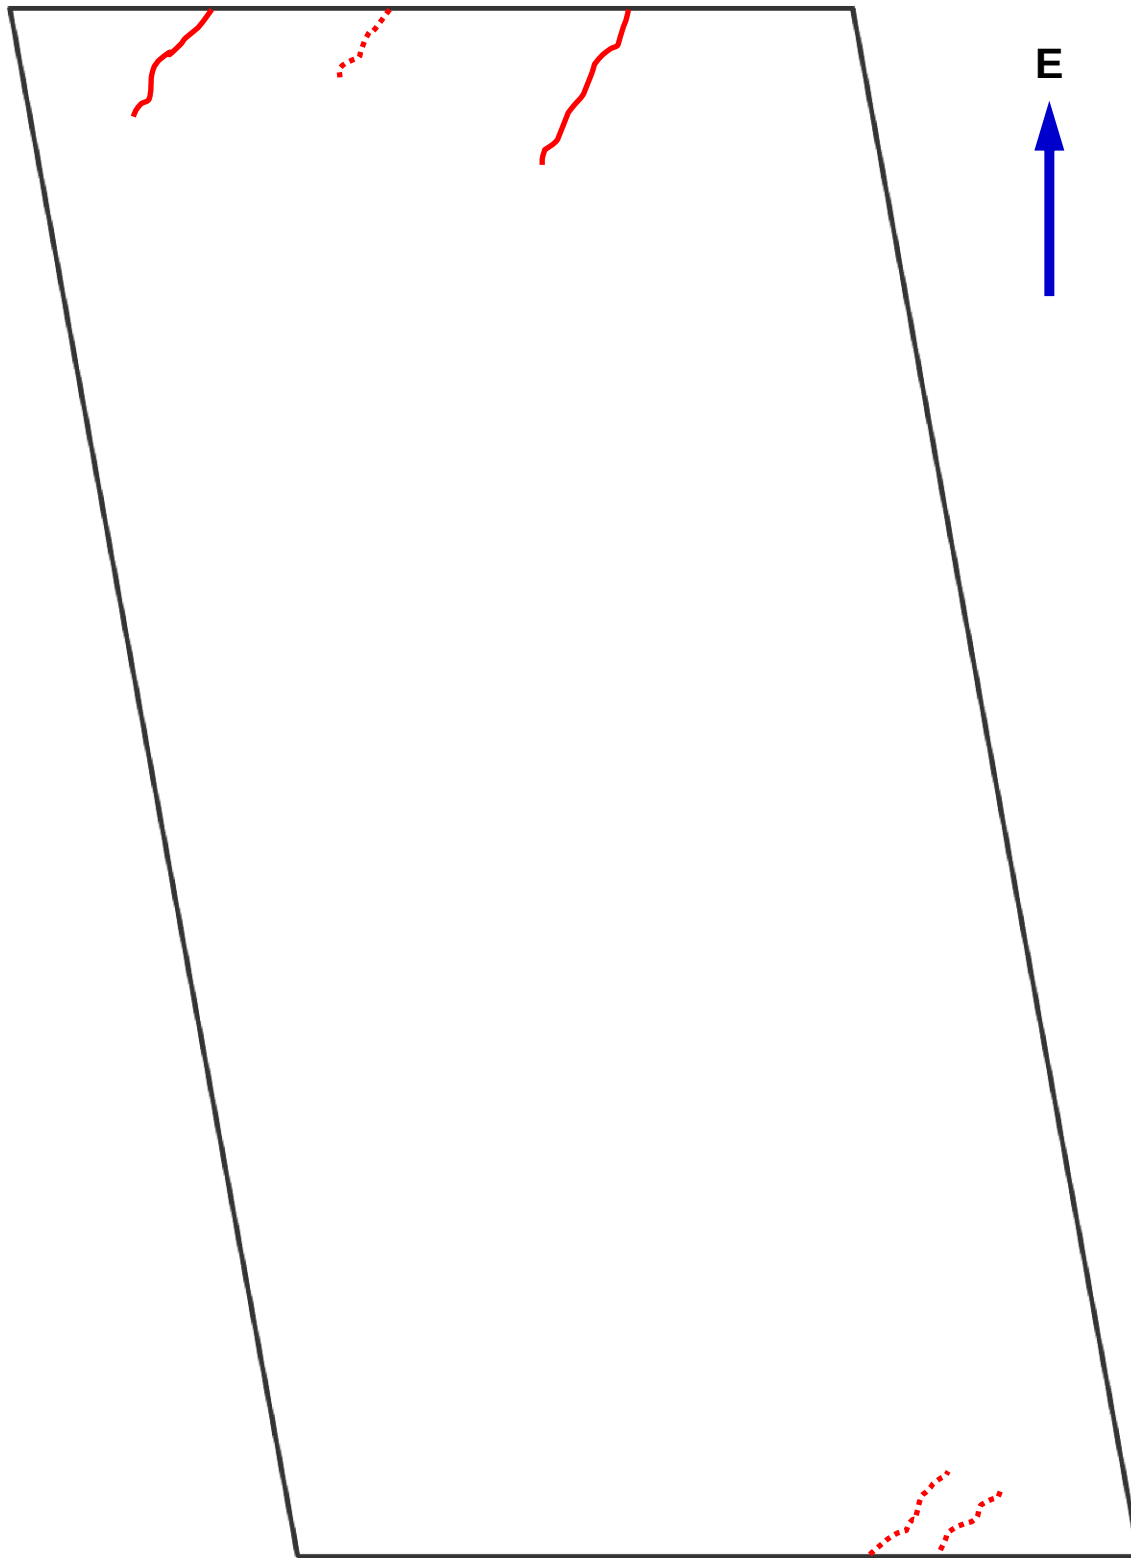
Hensley Creek – East Bound: **SRA/SPF** – Crack Map

**Hensley Creek:** The east bound SRA/SPF deck had two full depth cracks on the east end. Three underside cracks were visible with one on the east end and two on the west end of the deck.

..... Cracks underside only  
~~~~~ Full depth cracking

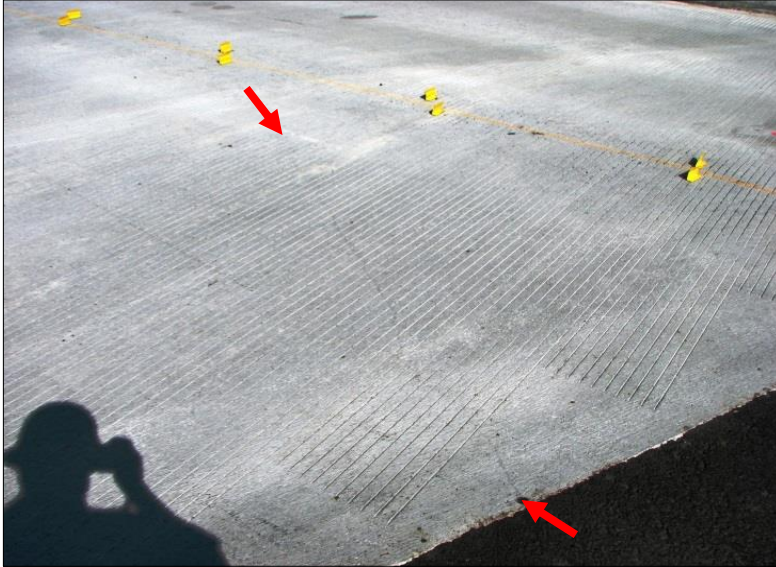
← View of east bound, east-end deck. Example of full depth crack in the travel lane.

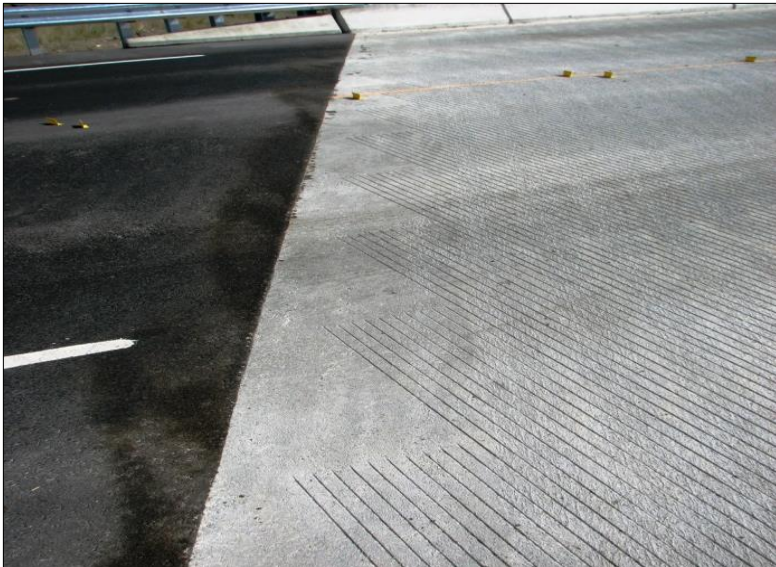
← Top side of west end of east bound deck; no visible cracking observed.

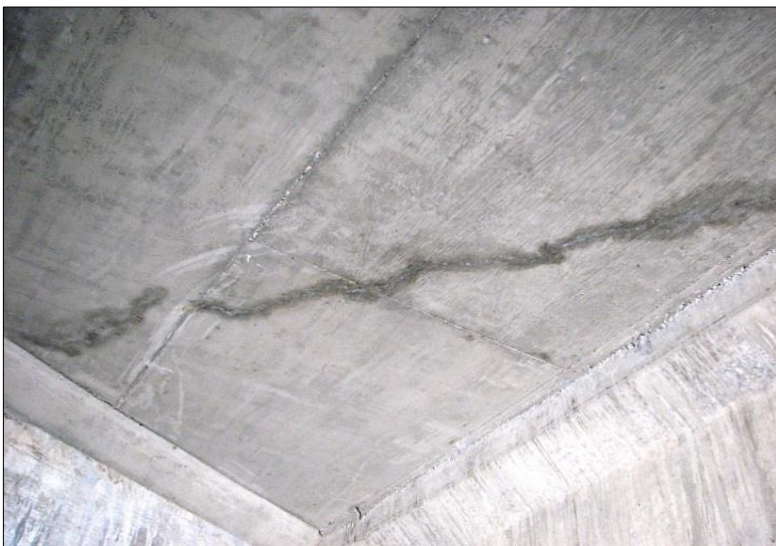
← Example image of full depth crack underside in the travel lane, east bound.

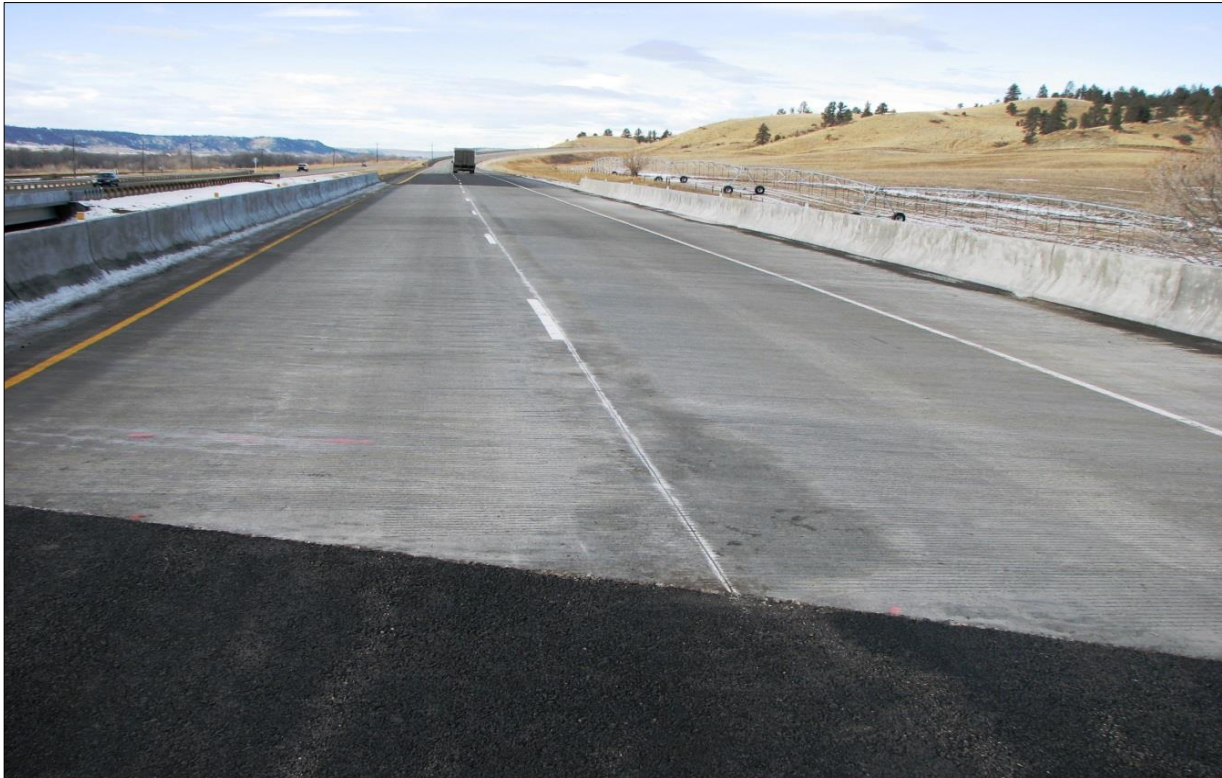
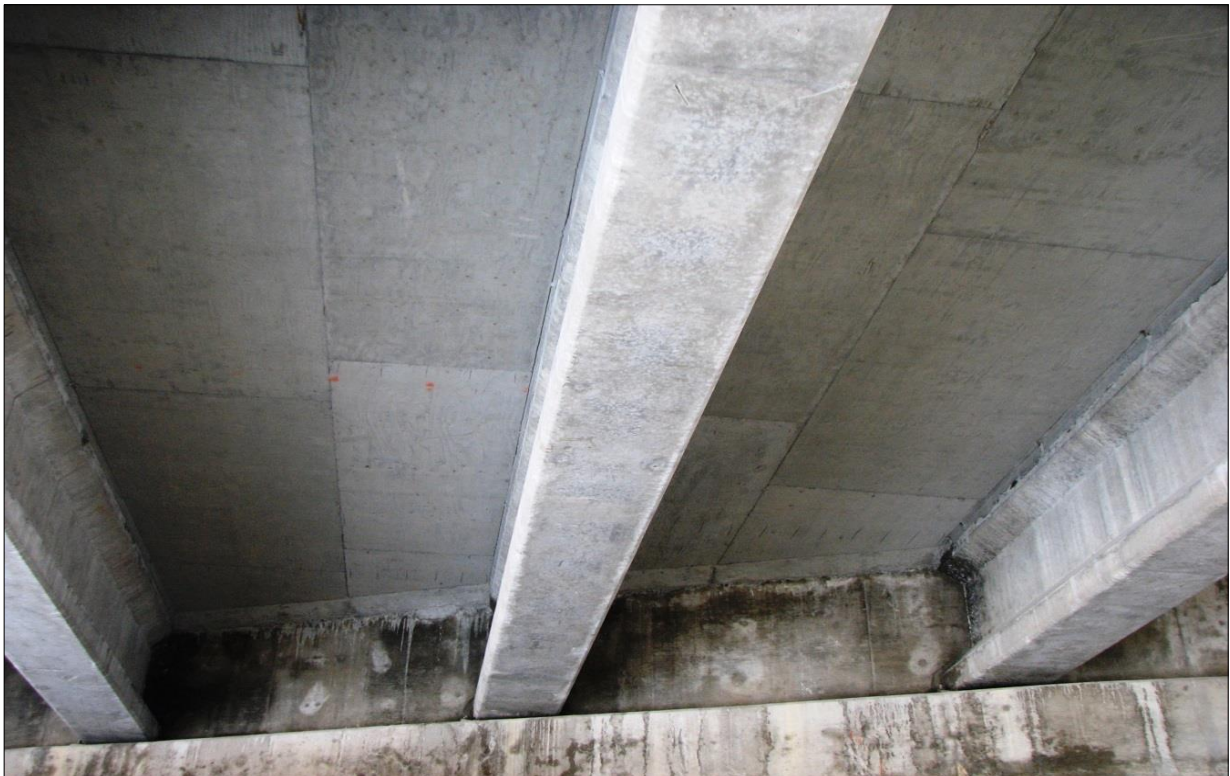
The west bound deck (SD) displayed no visible cracking top or bottom during the October inspection.

Note: During this inspection (late October) no cracks were visible either on the deck surface or beneath the deck.

↑ ↓ Representatives images of top and bottom of the west bound deck (view west), no cracking observed

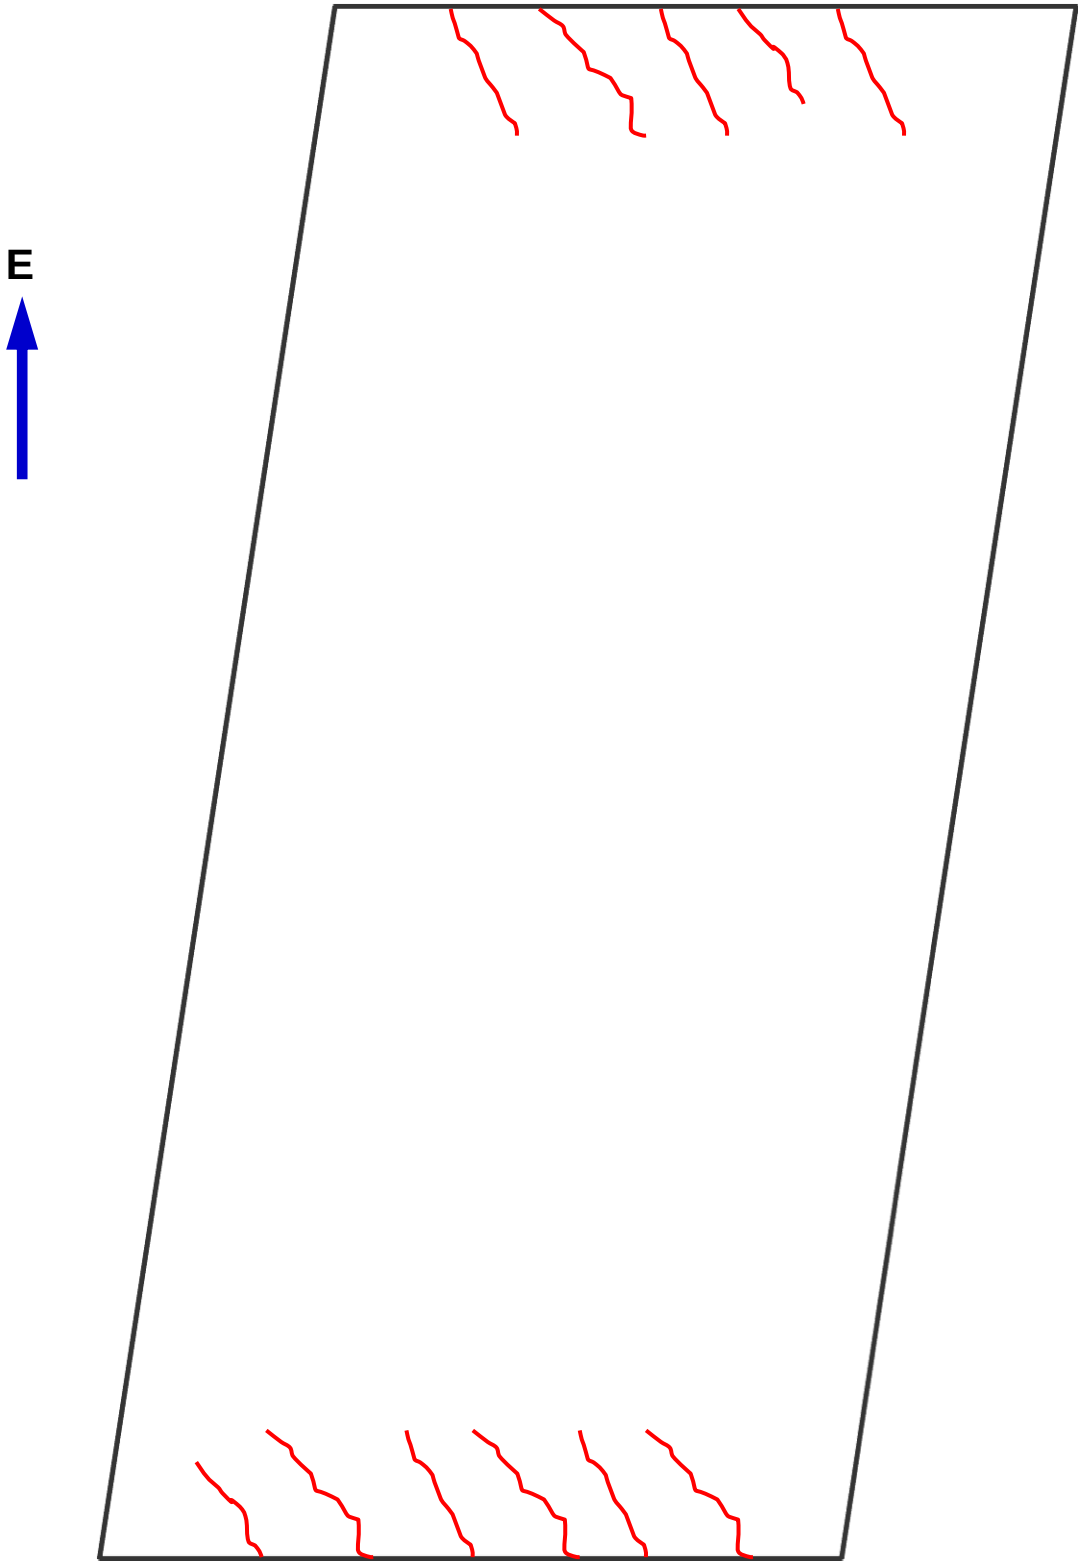
Keyser Creek – East Bound: SD – Crack Map

**Keyser Creek:** The west bound SRA/SPF deck had significantly less full depth cracking (three) than the east bound SD deck (eleven). There were four cracks visible on the underside of the deck not detected on the deck surface.

Full depth cracking

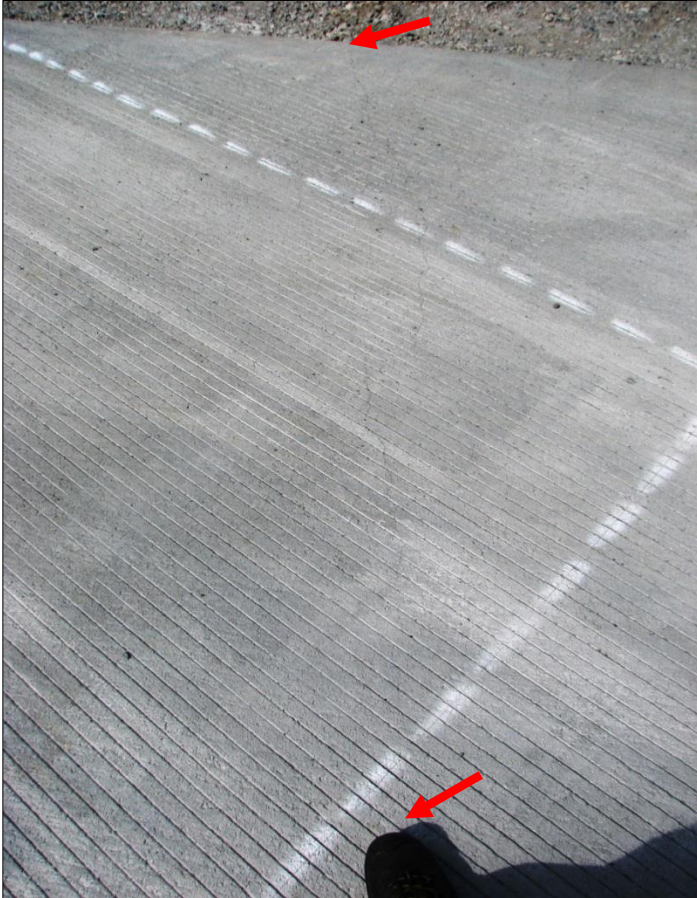
← Example image of full-depth crack, east end of deck.

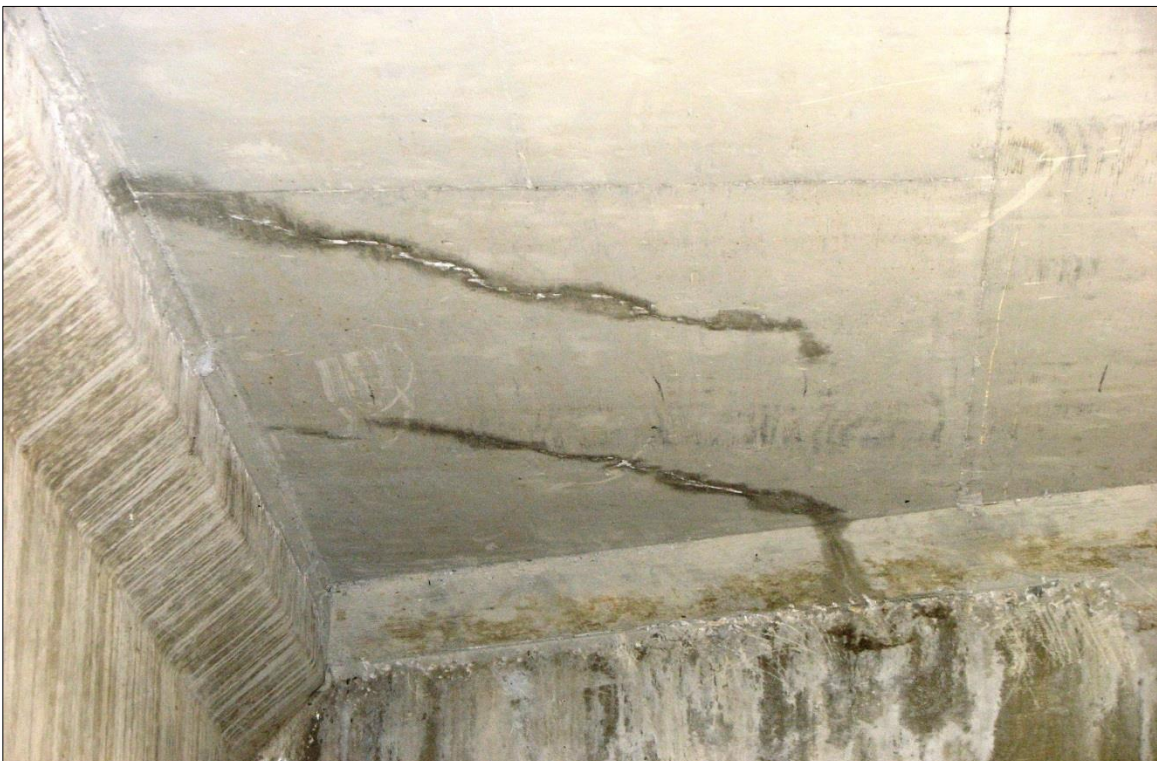
↓ Example of full-depth cracking under the deck, east end.

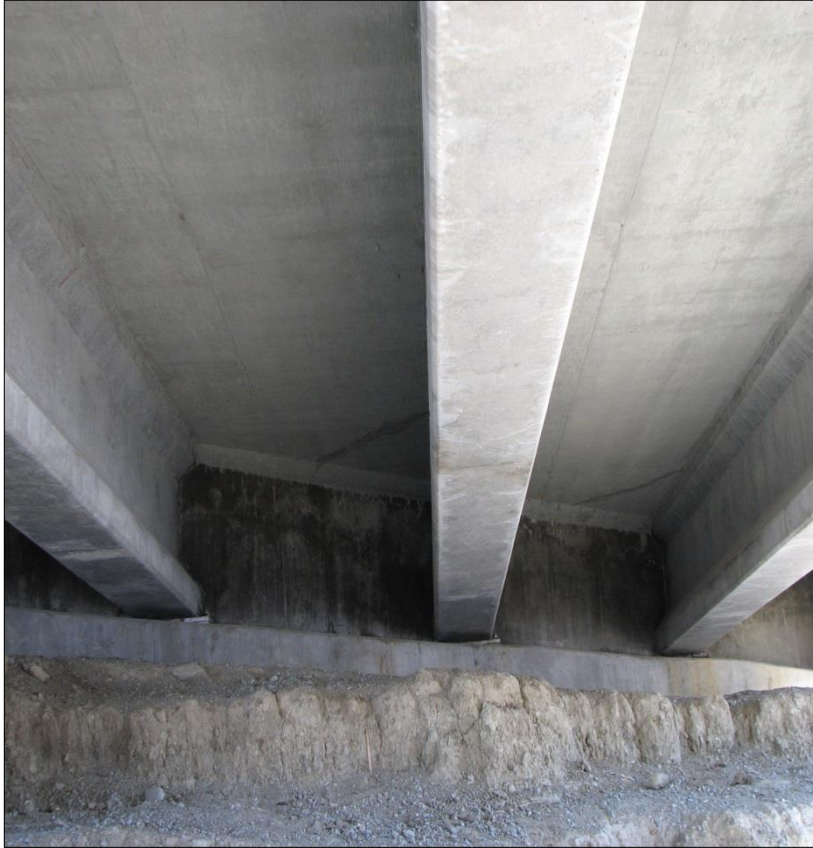
← Example image of full-depth crack, east end of deck; south side.

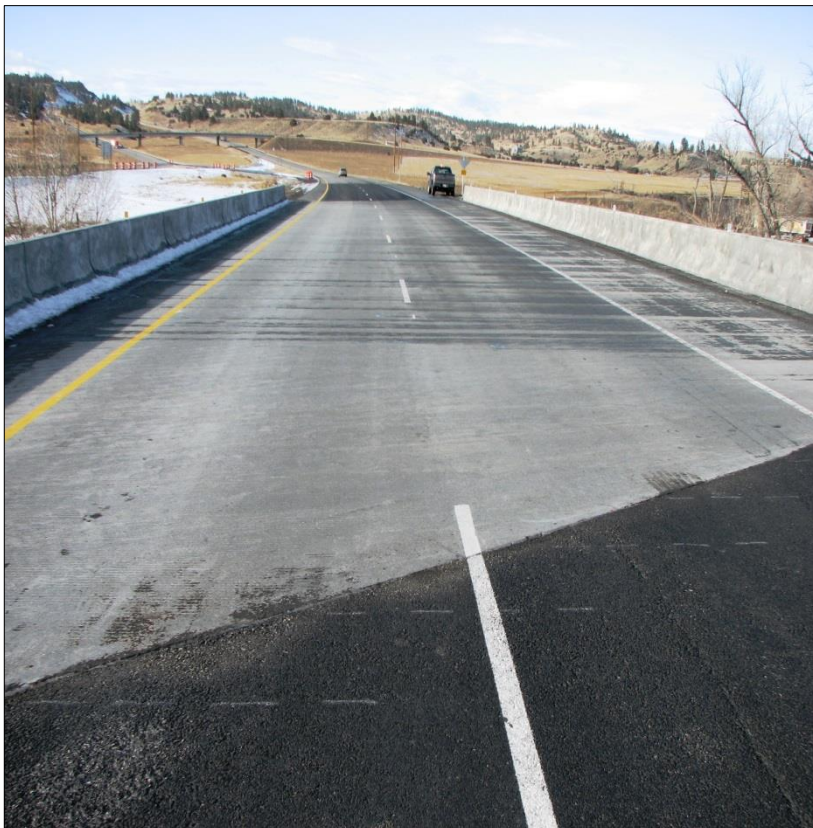
← Overview of deck; view west.

Deck cracking not visible with this image.
