**EXPERIMENTAL FEATURES PROJECT  
CONSTRUCTION REPORT**

**EVALUATION OF WARM MIX ASPHALT (WMA) PAVEMENT**

<u>Project Name</u>	<u>Project Number</u>	<u>Project Location</u>	<u>Project Length</u>
Monida-Lima (SB)	IM 15-1(109)0	Interstate 15, Beaverhead County, Butte District- approximate RP 0.0 to RP 17.1	17.1 miles

**FHWA Project Number:** MT 10-02

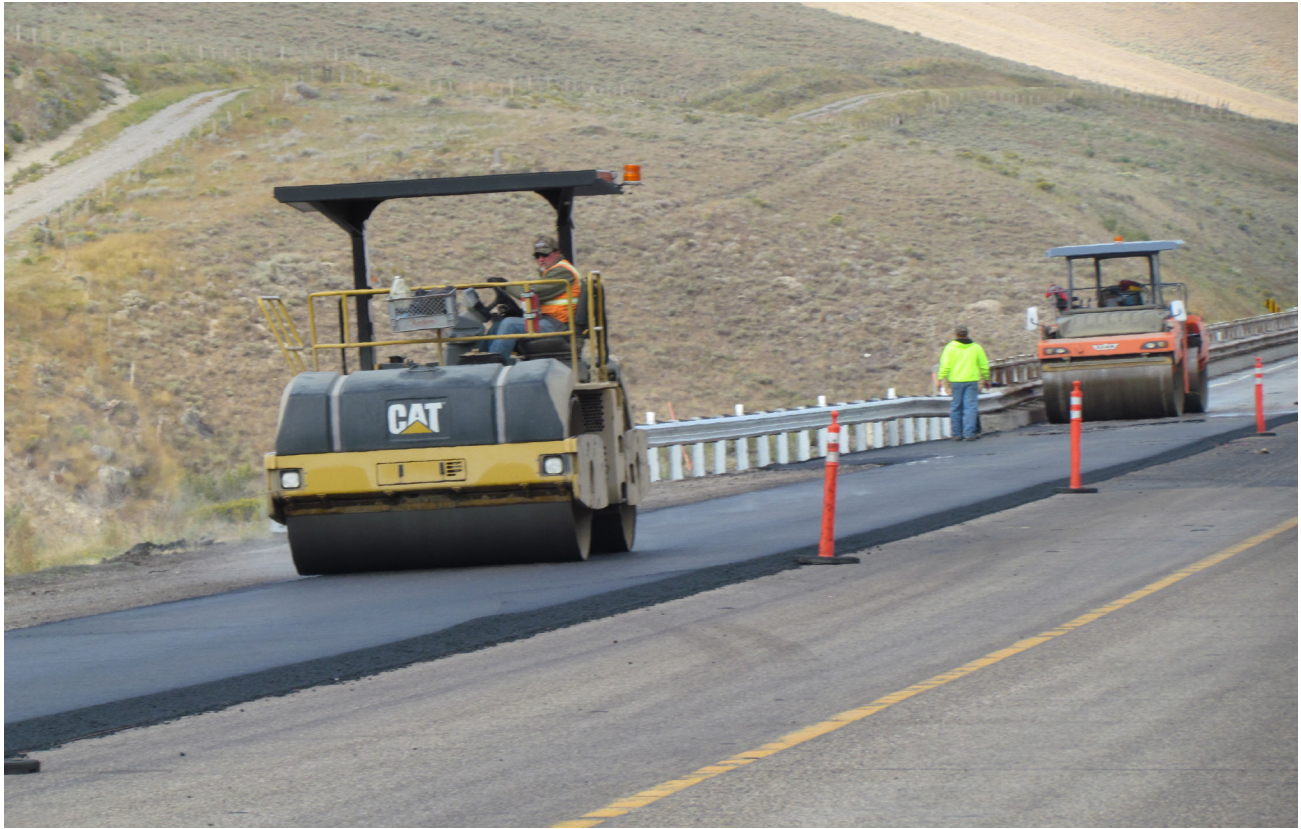
Figure 4- Beginning of Sasobit paving section, note the “wave” of plant mix in front of rollers

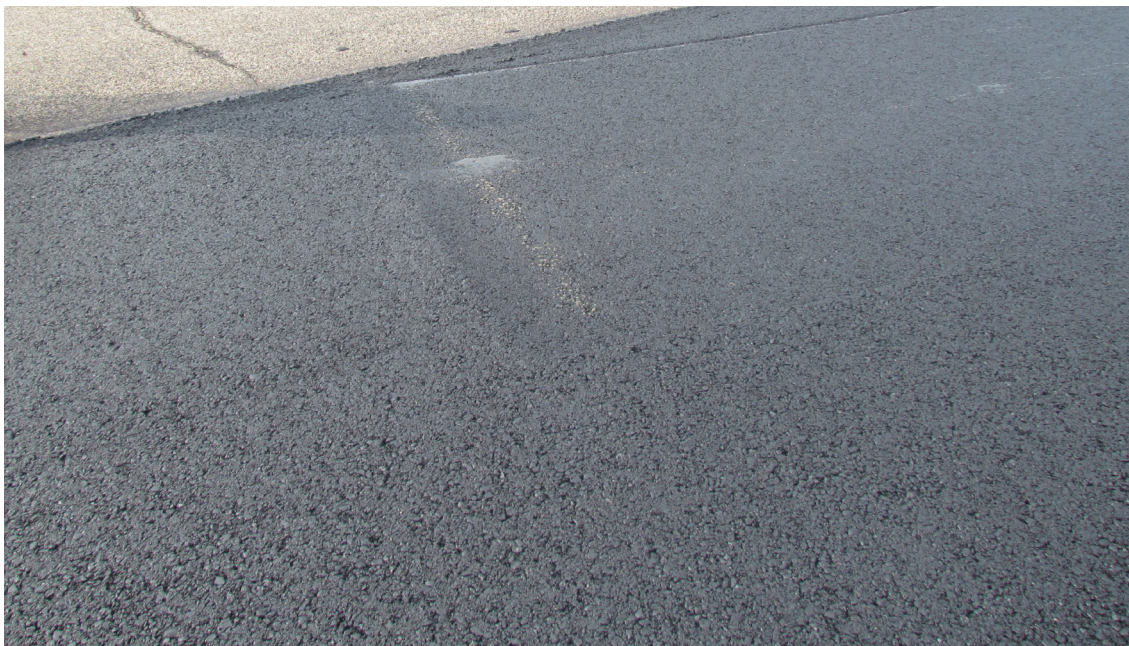
The Sasobit WMA application appeared to have issues with compaction when placed at high temperatures. Observed were excessive mat rollout to 15 feet instead of normal 12 feet, moisture on the plant mix, and a “wave” of

Figure 5- Beginning of Sasobit paving section when plant and placement temperatures were high

plant mix near the front of the roller during compaction. The contractor used an extra roller to try to counteract some of these issues. Once the temperature was brought down the plant mix was easier to work with and the previous issues were remedied. There was some cracking at the beginning of the Sasobit section due to the compaction issues with the higher temperatures. The contractor applied a tack coating to these areas to mend them by having traffic eventually knead out the cracks.

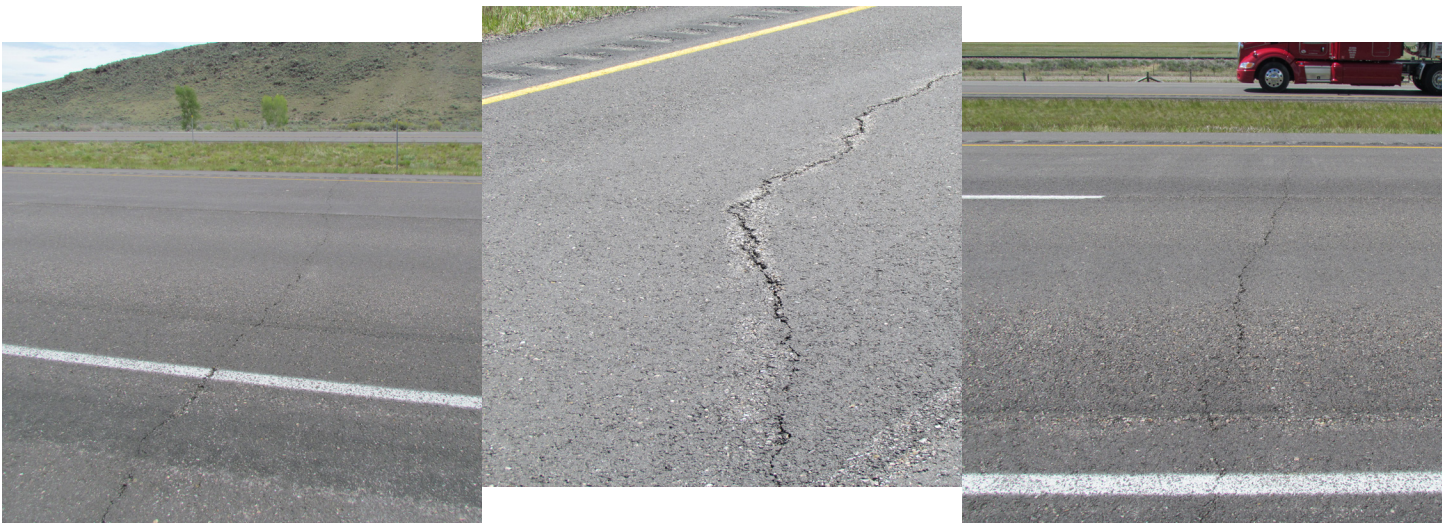
Research staff visited the the Monida-Lima site along with Butte District Construction and contractor staff to view reported cracking in the pavement. This visit was May 31, 2012 and the entire project had not received a seal coat application. Reflective cracking in the pavement was seen and documented throughout the whole project including each section of WMA technology and HMA in both northbound and southbound lanes (see Figure 11). After this review, the Butte District decided to perform crack seal work after the seal coat application. The entire project was sealed and covered July 2012.

Figure 11- Examples of surface cracking in hot mix asphalt pavement in southbound lanes (left), warm mix asphalt pavement (center), and hot mix asphalt pavement in northbound lanes (right)

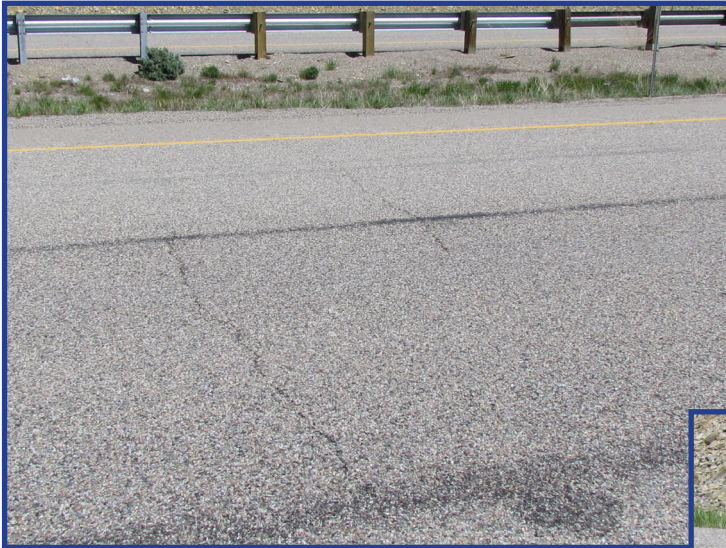
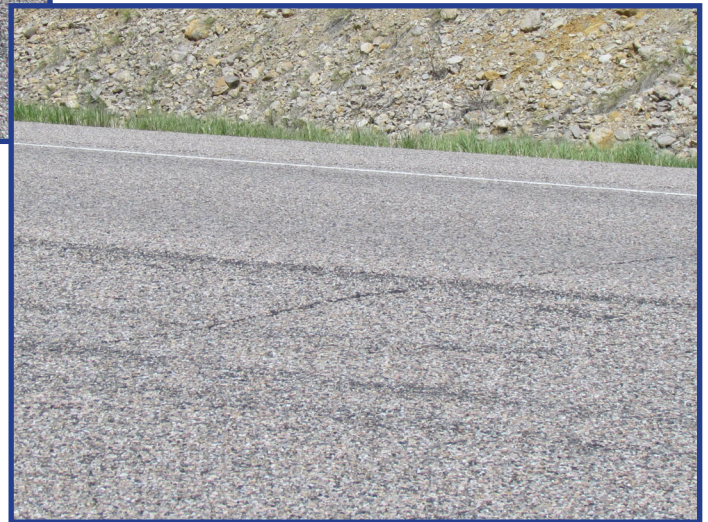
Research staff visited the project site May 2013. There was no visible difference between all sections of each WMA technology or the HMA pavement in either the southbound or northbound lanes. Reflective cracking was present and cover material from the seal and cover (done July 2012) was missing from the roadway throughout whole project. The figures below represent the visual condition of the pavement in the southbound and northbound lanes.

Figure 12- Examples of reflective cracking in warm mix asphalt pavement (top) and hot mix asphalt pavement in northbound lane (right)

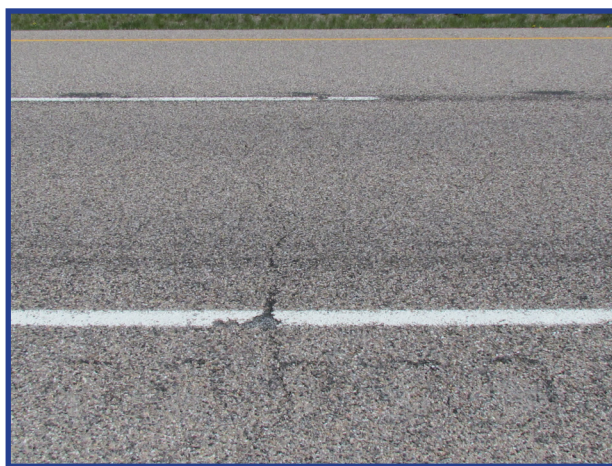
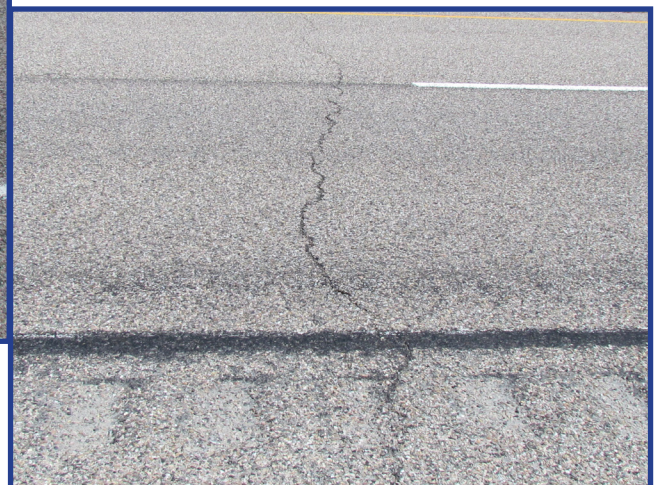
Figure 13- Examples of cover material loss along the roadway shoulder and center line in southbound lanes

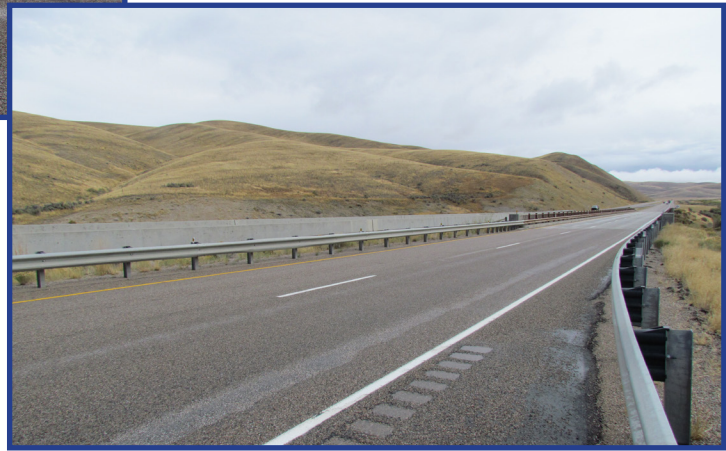
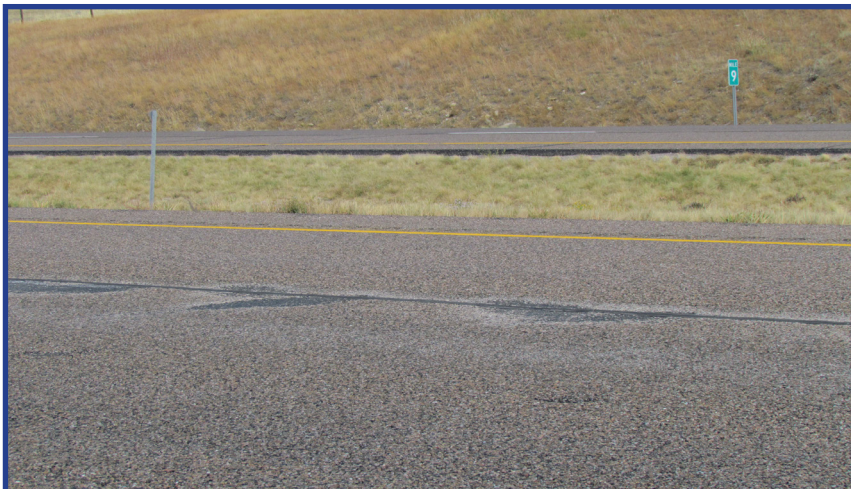
Figure 17- Evothrm treatment southbound shows cracking near the centerline and missing seal and cover material near RP 9

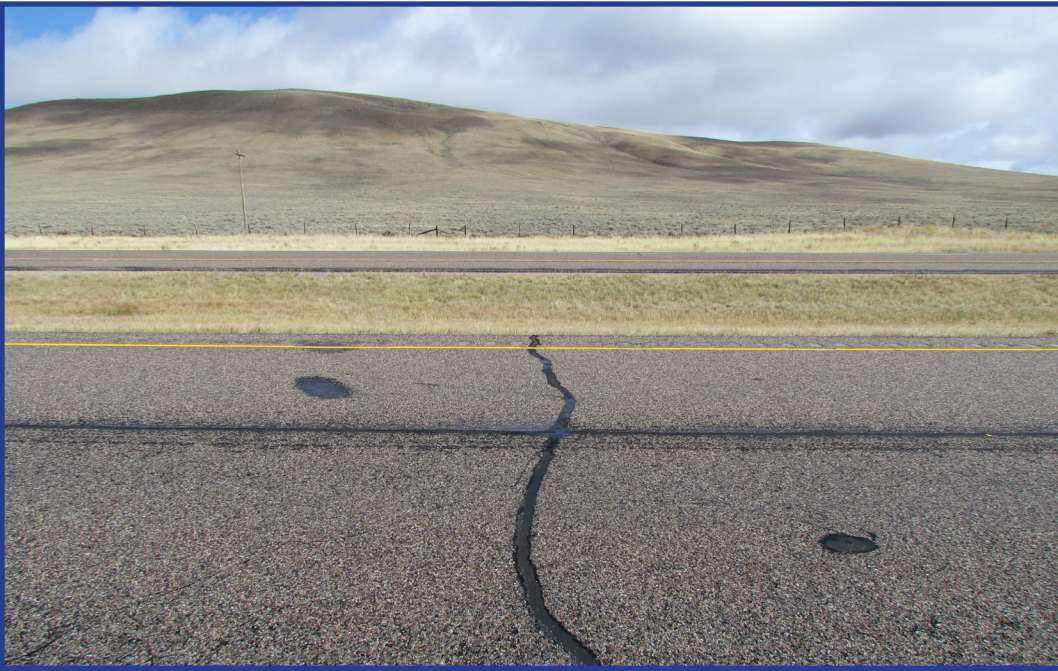
Figure 18- Reflective cracking and missing seal and cover material in southbound lane near RP 4.5

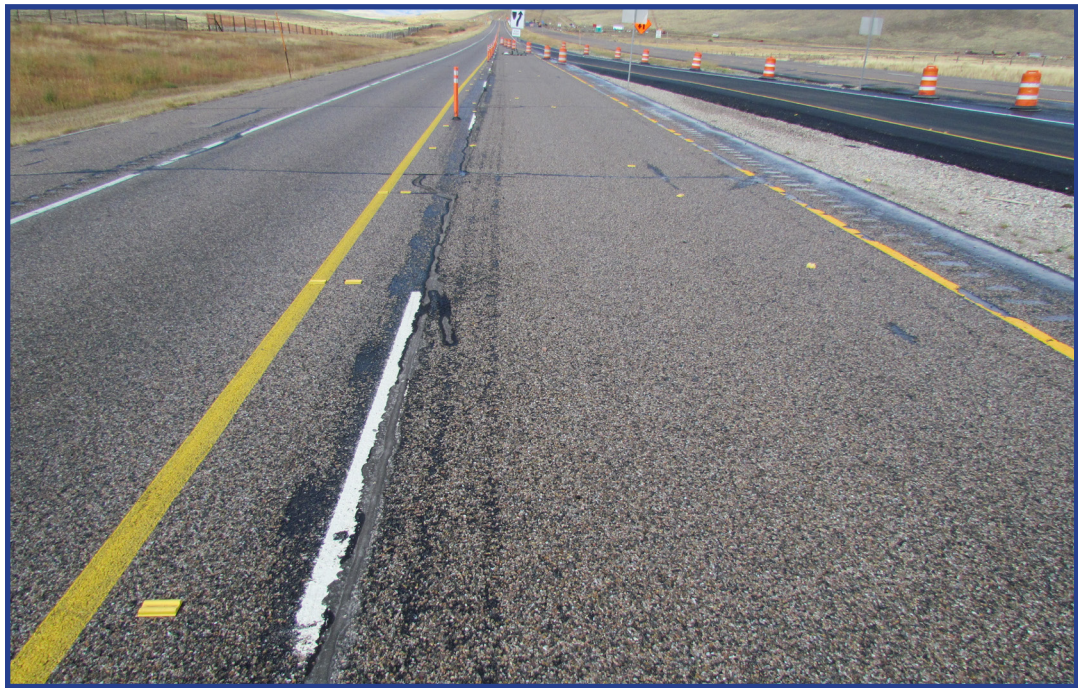
Figure 19- Foaming treatment southbound shows cracking near the centerline and missing seal and cover material near RP 1

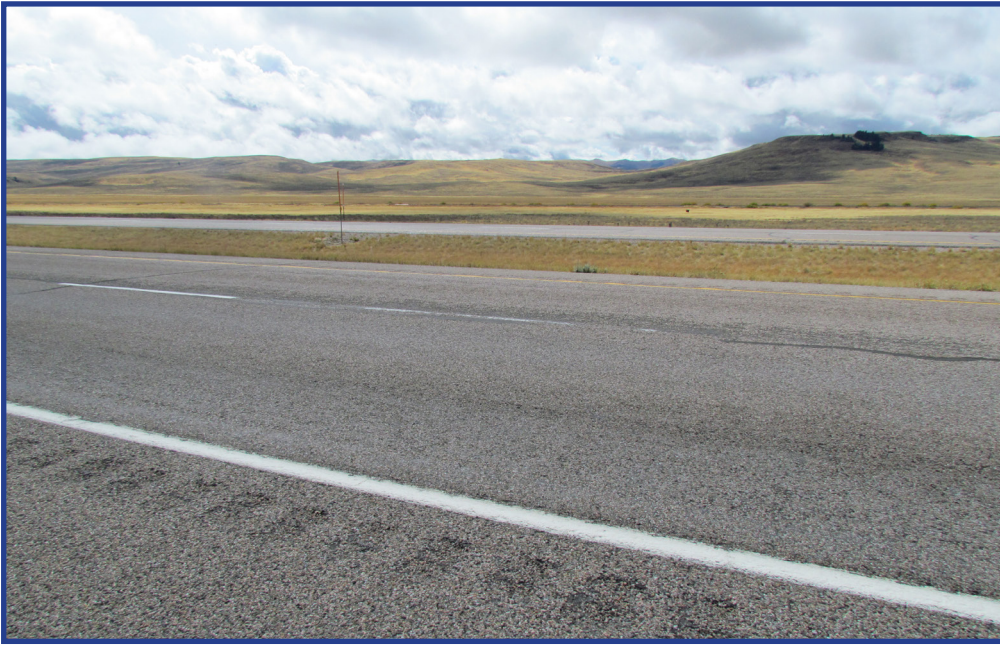
Figure 20- HMA northbound shows cracking near the centerline and missing seal and cover material near RP 5

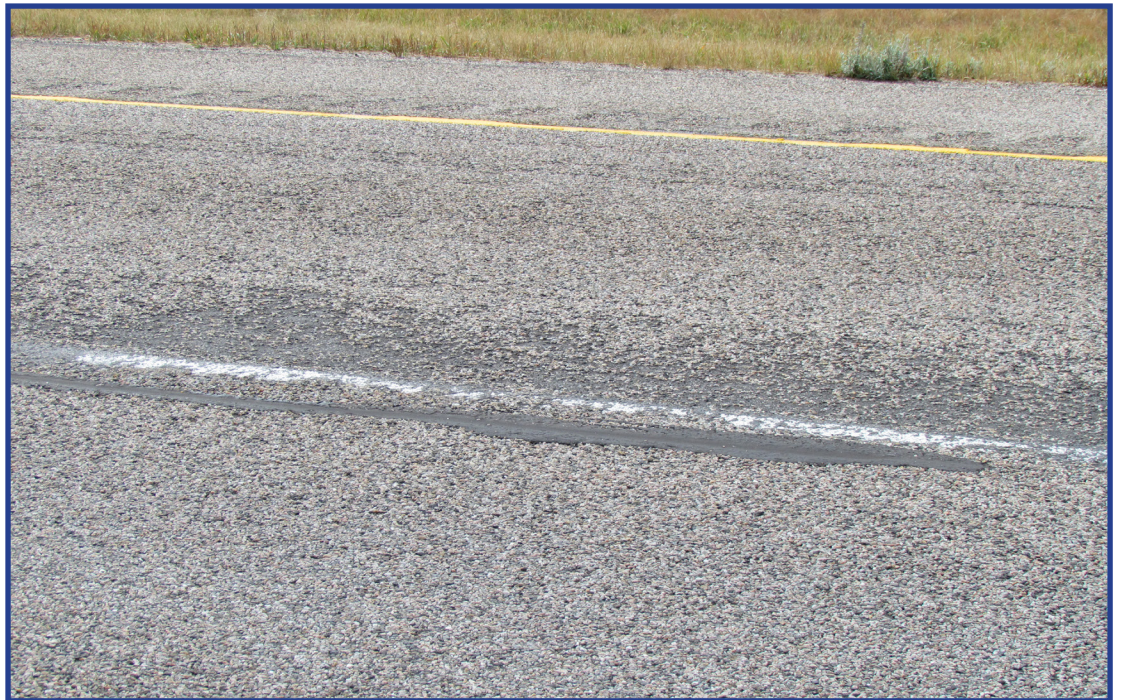
Figure 21- HMA northbound close-up shows cracking near the centerline and missing seal and cover material near RP 5

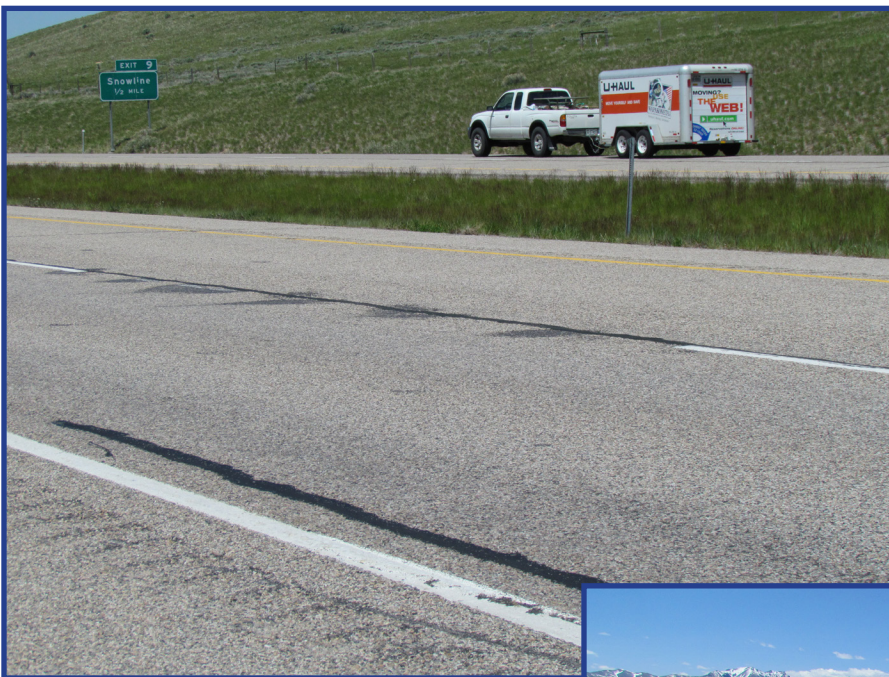
Figures 23 and 24- Evotherm treatment southbound (top) shows cracking near the centerline and missing seal and cover material and HMA northbound (right) shows the same conditions near RP 9

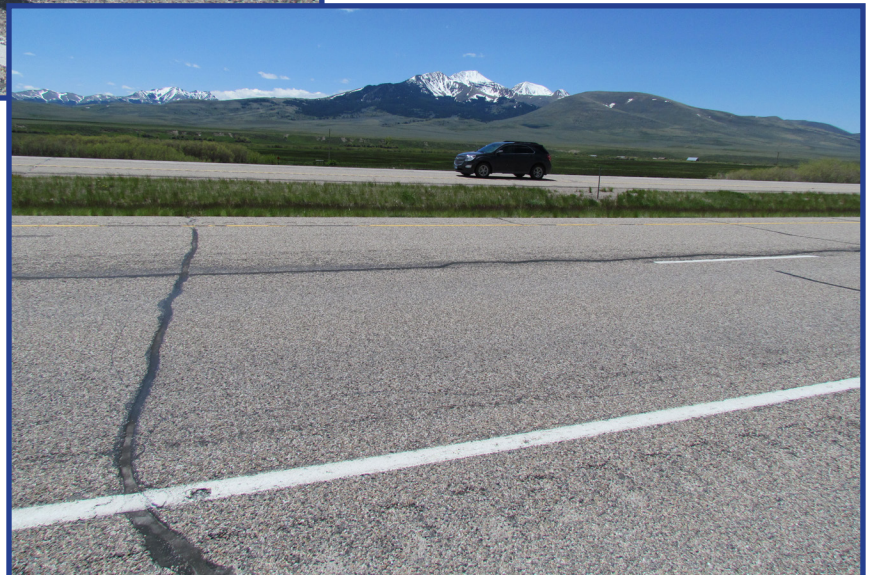
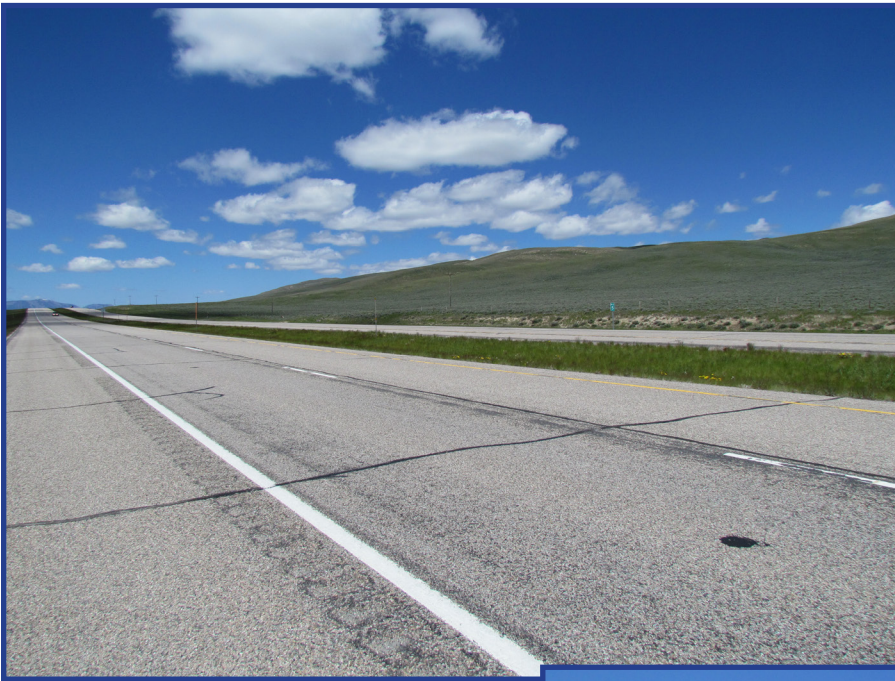
Figures 25 and 26- WMA treatment southbound (top) shows cracking near the centerline and missing seal and cover material and HMA northbound (right) exhibits similar conditions near RP 5

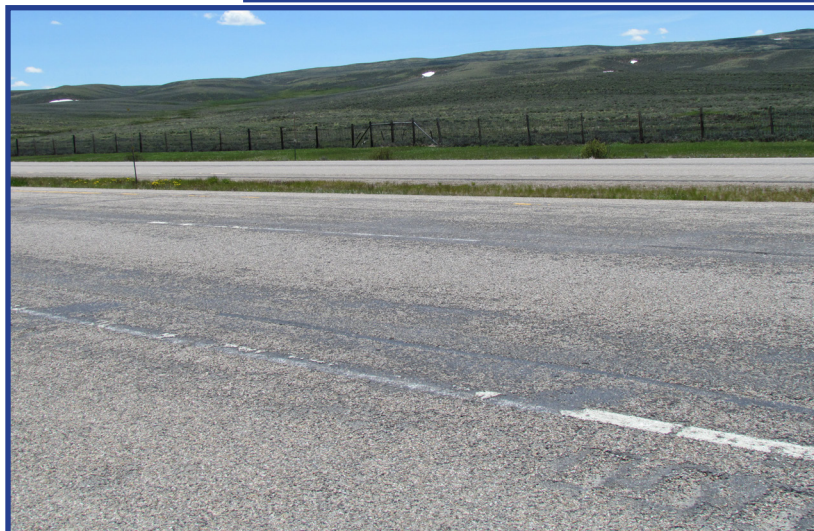
Some areas throughout the project had missing seal and cover material, such as near RP 1.5 where a bridge construction project from the previous year.

Figures 26- WMA treatment southbound shows missing seal and cover material near RP 1.5
