February 20, 2024

Load Rating Review
MDT Bridge 02939

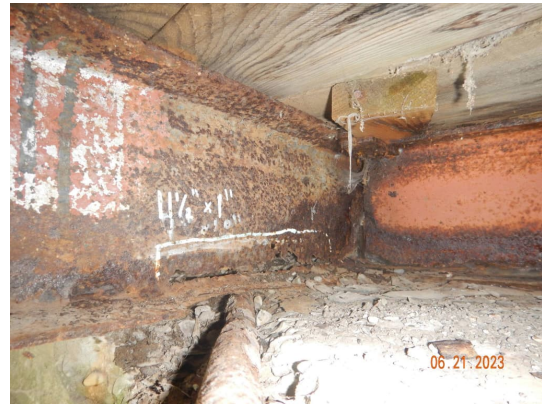
The steel stringers of this bridge exhibit widespread severe corrosion with up to 100% loss of section, particularly in bearing zones. The field notes indicate that Stringer 1 exhibits an area of complete section loss (holed through) over a length of 18 inches and a maximum height of 1 ½ inches with a 3-inch diameter hole in the web at the Abutment 1 end. Stringer 8 also exhibits an area with 100% section loss to the web at Abutment 1 (11 ½ inches long by 1 inch high, see Photo 1). These holes in the stringer webs over the bearing areas result in the loss of bearing capacity since the stringer reactions cannot be transmitted to the substructure.

Photo 1: Stringer 8 at Abutment 1

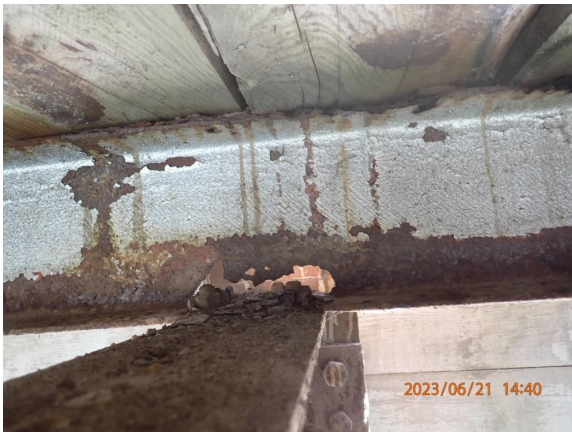
Photo 2: Stringer 8 at Floorbeam 2

Stringer 8 at Floorbeam 2 exhibits full loss of section in the base of the web over the floorbeam. The hole in the web is 8 inches long by up to 3 inches high (see Photo 2), and this deterioration has also resulted in zero bearing capacity in the current condition. The stringer is continuous over the floorbeam, but the web hole extends over the full length of the bearing (the top flange of the floorbeam) and renders the stringer incapable of being considered in a load rating model since it has no analytical capacity and is susceptible to web local yielding. Since this is a fascia stringer, there is also no ability to consider redundancy in the deck to bypass this “failed” stringer.

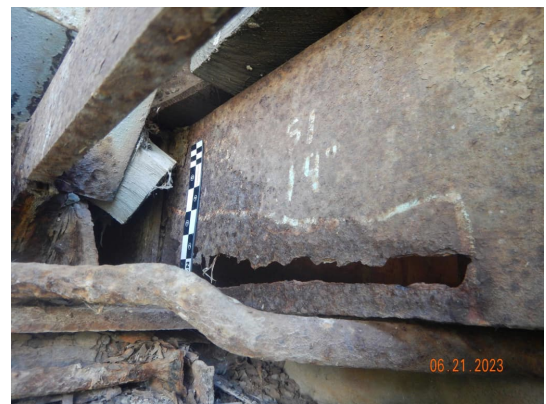
Both Stringers 1 and 8 exhibit holes in the webs at Abutment 2. The hole in Stringer 1 is 14 inches long by 3 inches high, while the hole in Stringer 8 is 14 inches long by 3 ½ inches high. In both cases, the stringers have lost full bearing capacity and cannot transmit bearing reactions to the substructure.

Photo 3: Stringer 1 at Abutment 2

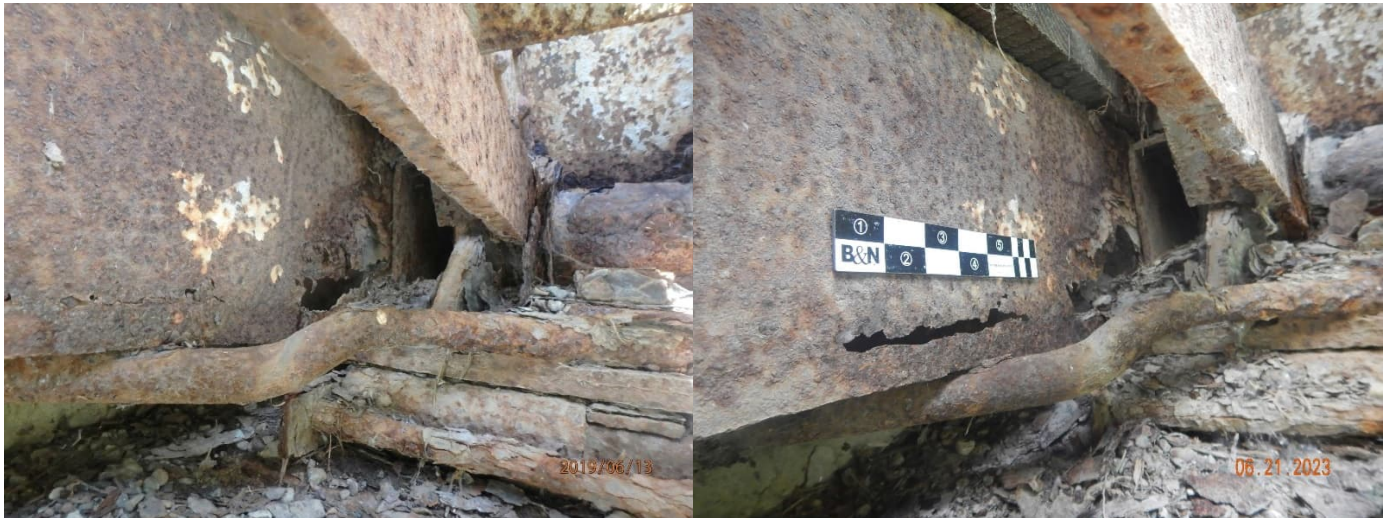
The section loss described above appears to be present and progressing over the past several inspection cycles. This deterioration progression is to be expected and is symptomatic of an end-of-life deterioration curve that typically accelerates toward local failures. As section loss progresses and material thicknesses are severely reduced, additional incremental section loss results in an acceleration in the percentage of material thickness lost. In addition, and perhaps more importantly, the corrosion process accelerates when active electrochemical

corrosion cells are present on the surface of the steel, as is the case throughout the steel members of this bridge. As an example, the images below (Photo 4) depict the progression of section loss documented at Stringer 8 (Abutment 2) over two inspection cycles, and the section loss has progressed toward the possibility of local failures due to a bearing capacity of effectively zero at this location, among others previously described.

Photo 4: Progression of Section Loss in Stringer 8 web at Abutment 2 (2019 to 2023)

Since several stringers have progressed to a full loss of section in bearing areas, resulting in zero bearing capacity, the current rating of the bridge can be considered 0 Tons by engineering judgment unless designed repairs are made to the deteriorated elements to restore their capacity (i.e. steel repairs, bearing stiffener installation, cribbing, etc.).

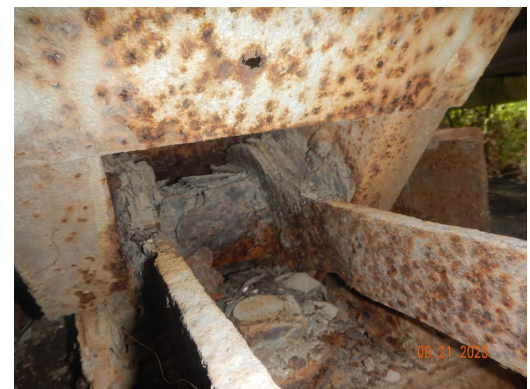
In addition to the severe stringer section loss, some of the truss eyebars also exhibit severe deterioration and reduced capacity. For example, member L1'-L0' at L0' (South Truss) is noted as having 1/4" average thickness remaining for the full height of the eyebar (Photo 5). This represents approximately 60% section loss from the original eyebar thickness (5/8"). The eyebar head also exhibits significant section loss, and the pin at this panel point, like others, appears to be compromised (see Photo 6 for another example of a deteriorated pin).

Photo 5: Eyebar section loss at L0' (South Truss)

The large holes in the stringer webs are symptomatic of accelerated corrosion that could lead to localized member failures. The active nature of the corrosion indicates that further section loss can be expected. Several members already appear to have a compromised bearing capacity, and crushing or web local yielding can be expected to occur in the near future without mitigation. Given the cumulative effect of the severe section loss and compromised fracture critical elements, it is advisable to restrict all vehicular traffic from this bridge unless designed repairs are made to the deteriorated elements to restore their capacity.

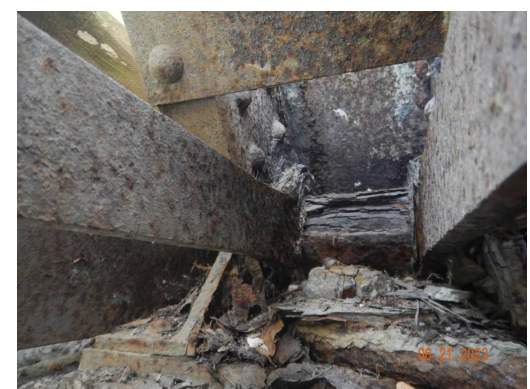
Photo 6: Severely corroded pin at L0 (South Truss)
