**MONTANA DEPARTMENT OF TRANSPORTATION  
(MDT)  
Investigation of Bridge Decks**

**Final Report**  
April 21, 2017  
WJE No. 2016.3598

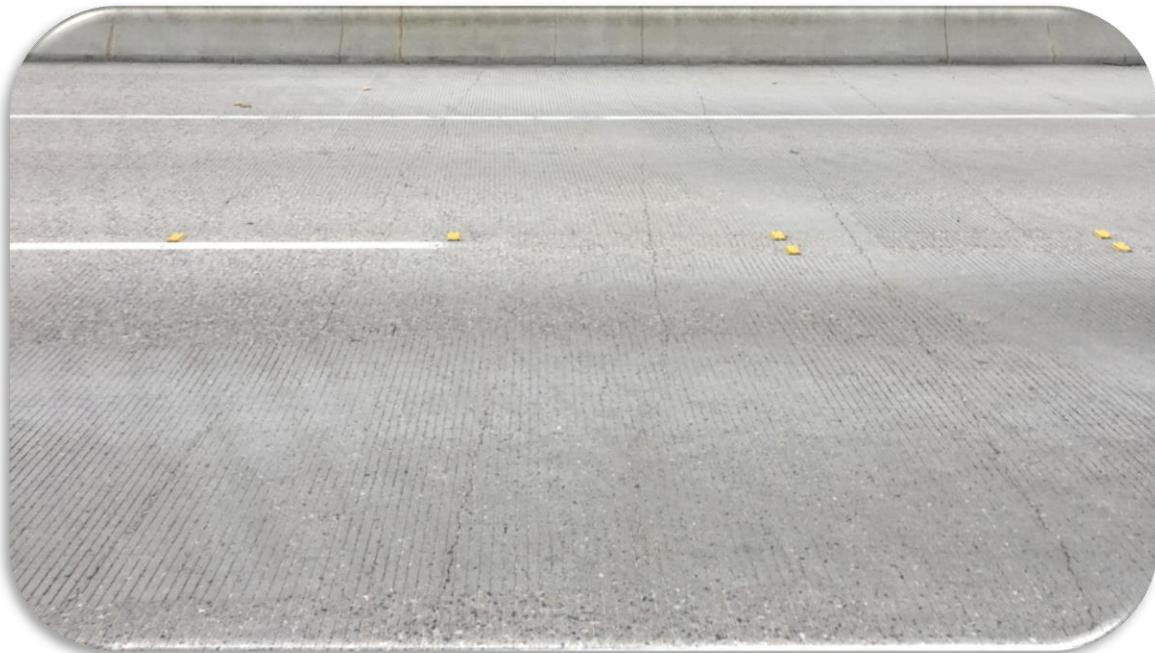
*Figure 6. Typical transverse cracking, spacing varies from 5 to 10 feet.*

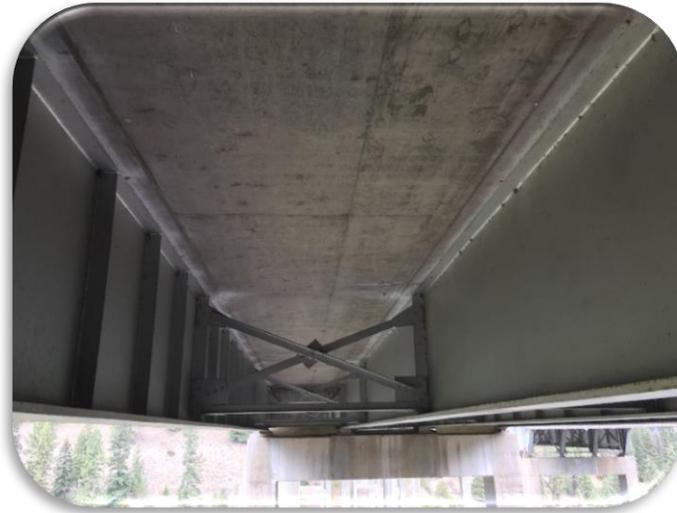
*Figure 22. Underside of Bridge 3. Little to no transverse cracking was observed.*

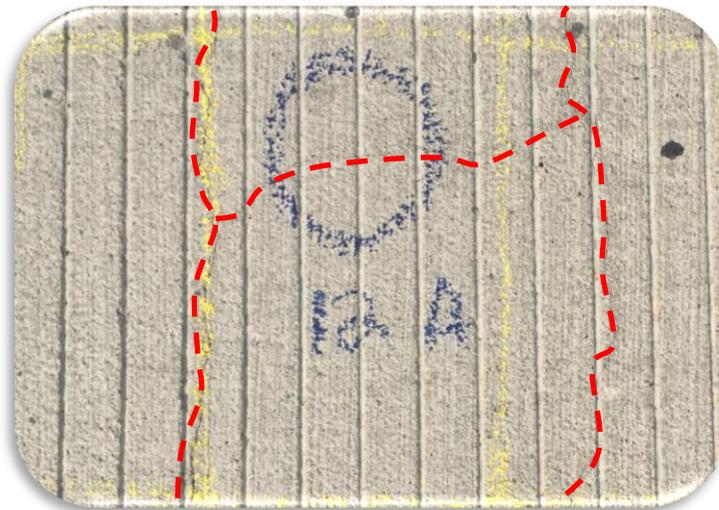
*Figure 27. Photograph showing early age development of cracking - Thompson River Bridge. Dotted red lines accentuate the tight transverse and “jump” crack. All cracks were less than 5 mils in width. Core 12A was extracted over the “jump” crack.*

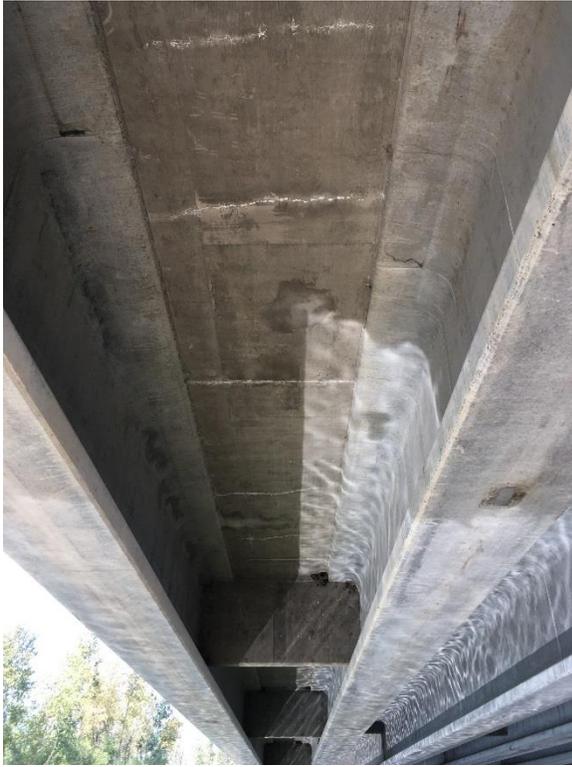
*Figure 4. Underside cracking between Girders G1 and G2. Cracks between these girders (beneath the pedestrian walkway) were generally more frequent and showed more efflorescence than cracks between the other girders.*

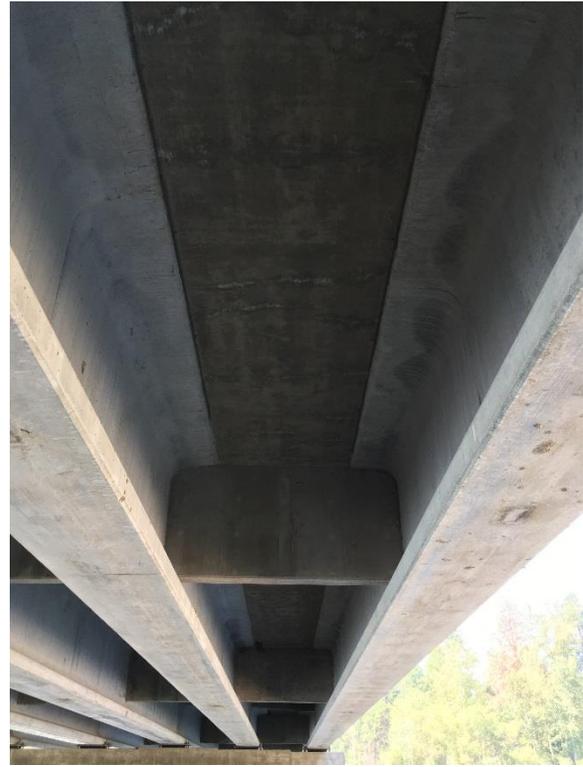
*Figure 5. Underside cracking between Girders G5 and G6.*

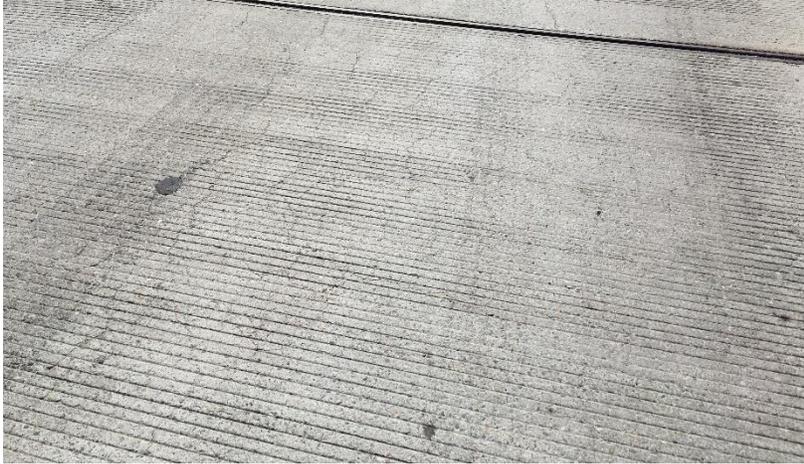
Figure 11. General crack appearance, Bridge 3. Cracks are similar in appearance to Bridge 2, but are generally tighter.

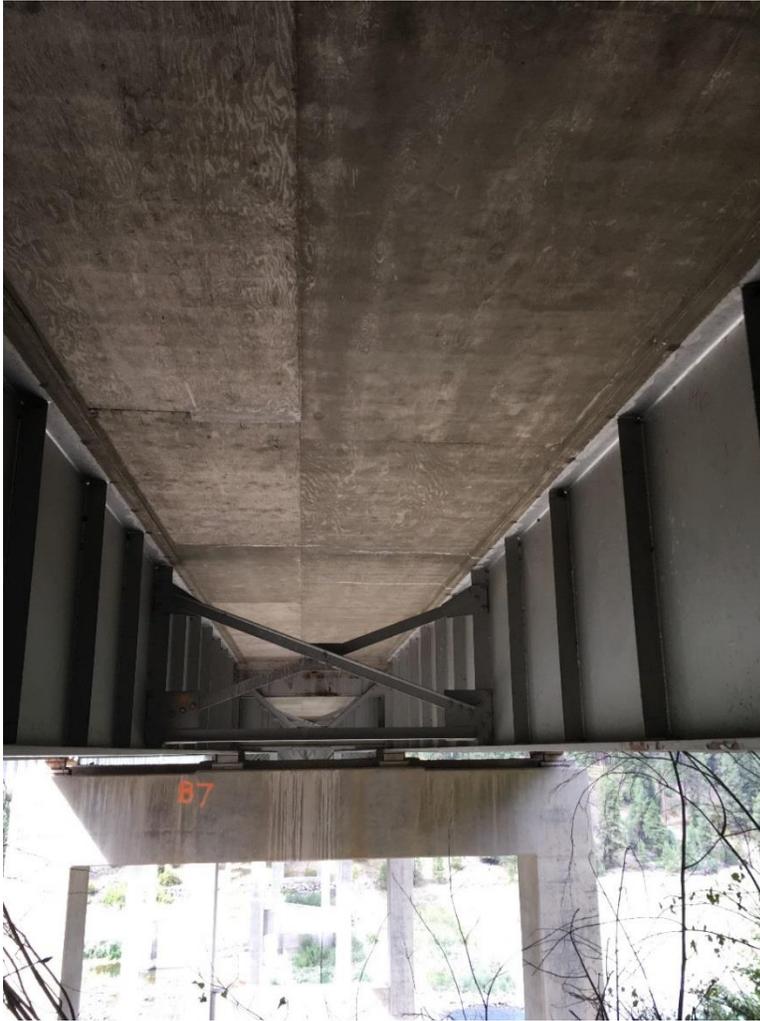
*Figure 14. Bridge 3 shows very little underside cracking and moisture leakage or efflorescence (original deck).*

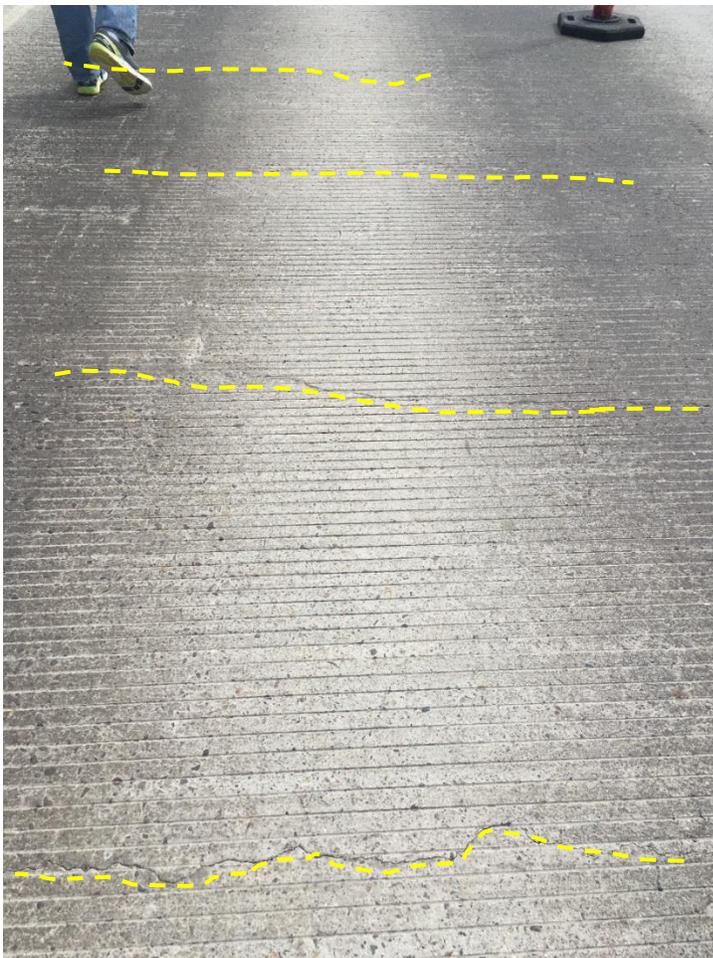
*Figure 15. Transverse cracks on Bridge 4 deck. Cracks are outlined.*

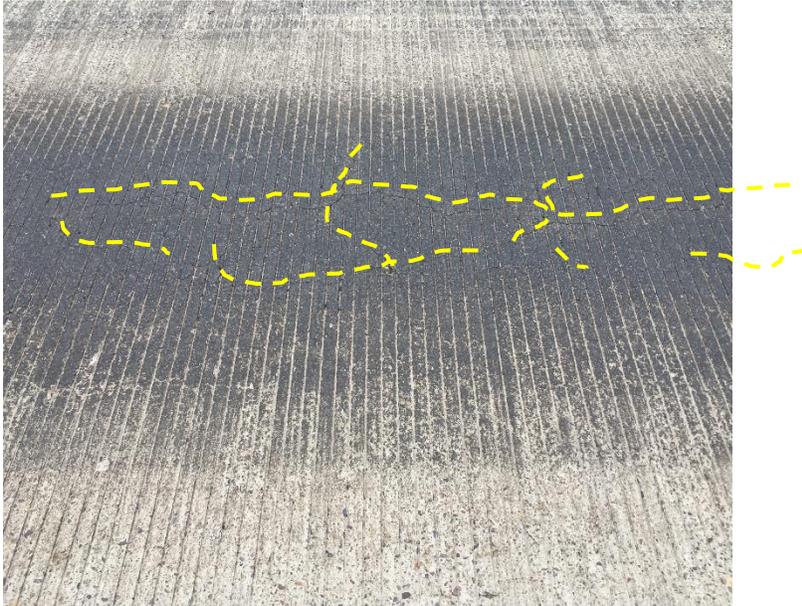
*Figure 16. Longitudinal cracks in Bridge 4 deck. Cracks were difficult to photograph due to asphalt residue in wheel paths.*

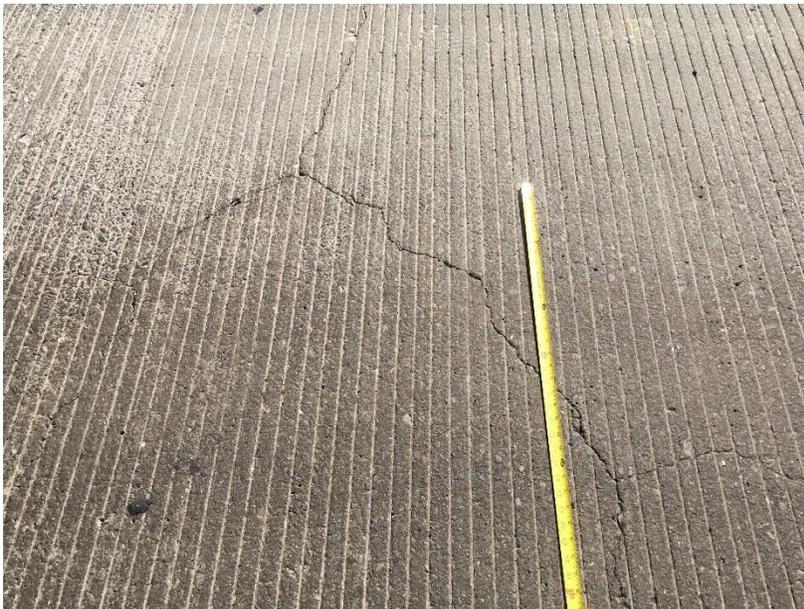
*Figure 17. Branching transverse cracks on Bridge 5 (surface grooving is transverse).*

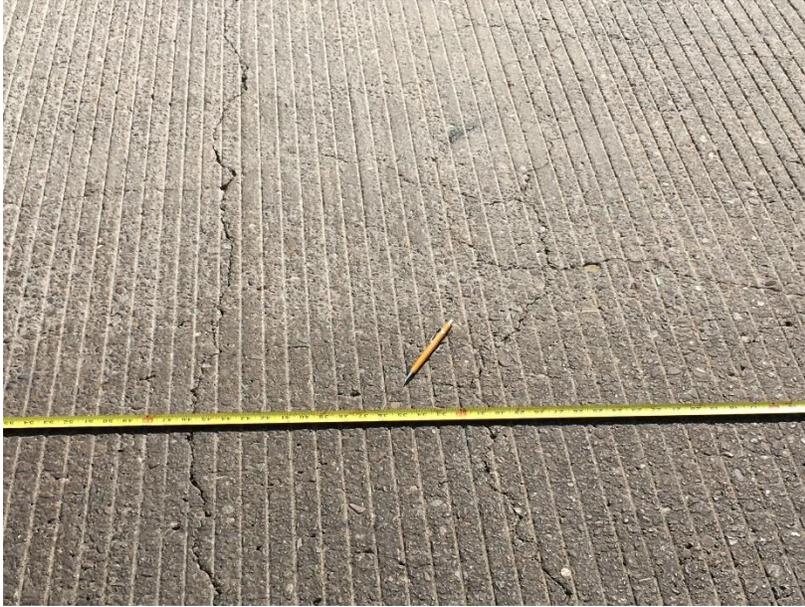
*Figure 18. Transverse and longitudinal cracks on Bridge 5 (surface grooving is transverse). The transverse cracks shown are spaced 1 ft. apart. Pen points to a hairline longitudinal crack bridging the two transverse cracks.*

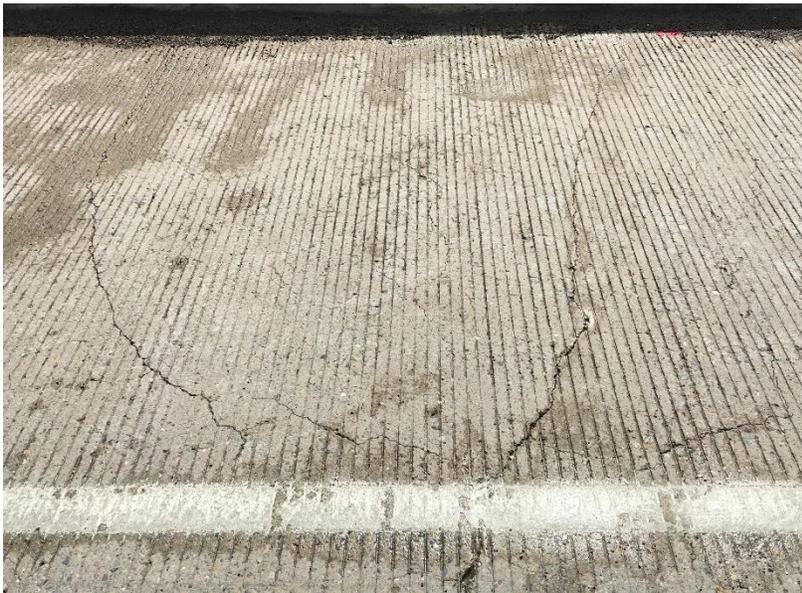
*Figure 19. General crack appearance, Bridge 6. Wide transverse cracks are accompanied by finer longitudinal cracks and hairline map cracks. Map cracks were only visible after deck surface was wetted.*

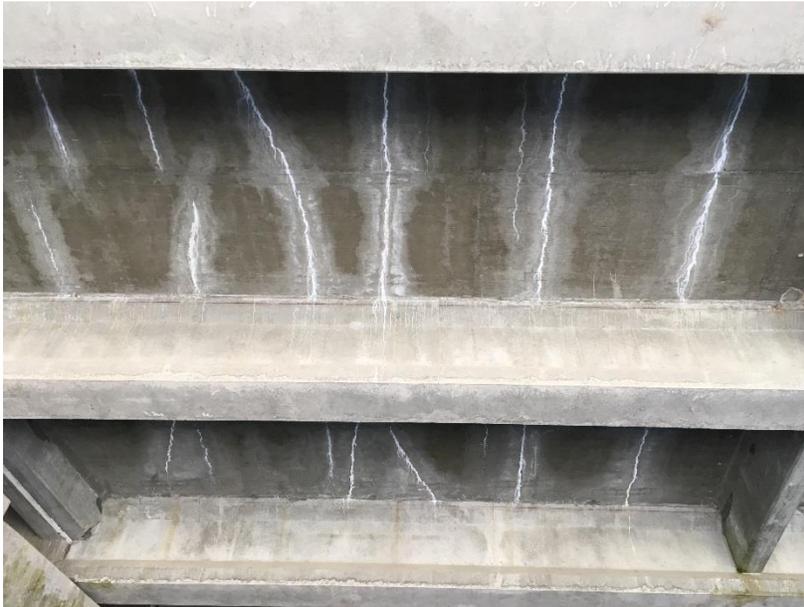
*Figure 20. General underside crack appearance, Bridge 6. Frequent transverse cracks are filled with thick deposits of efflorescence. Efflorescence extends onto the concrete surface several inches past crack opening.*

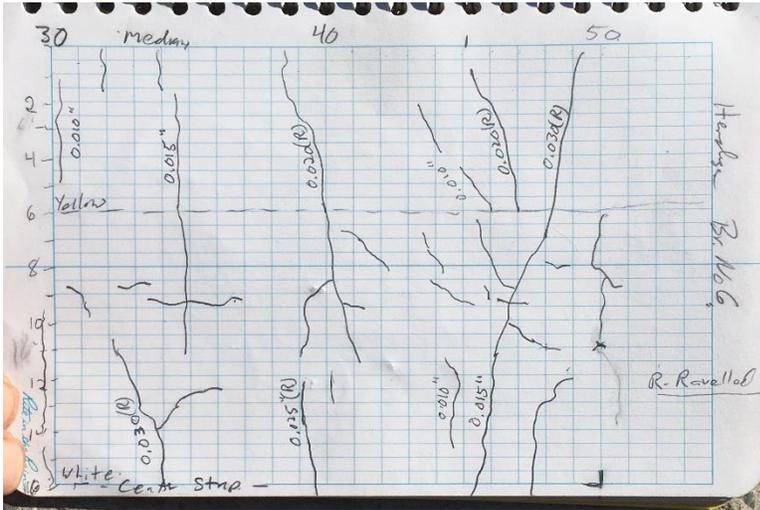
Figure 23. Sketch of cracks, 30' to 50', passing lane. Cracks are primarily transverse, 15-30 mil wide, and raveled ("R"). The long transverse crack between 45' and 50' is located over Pier 2.

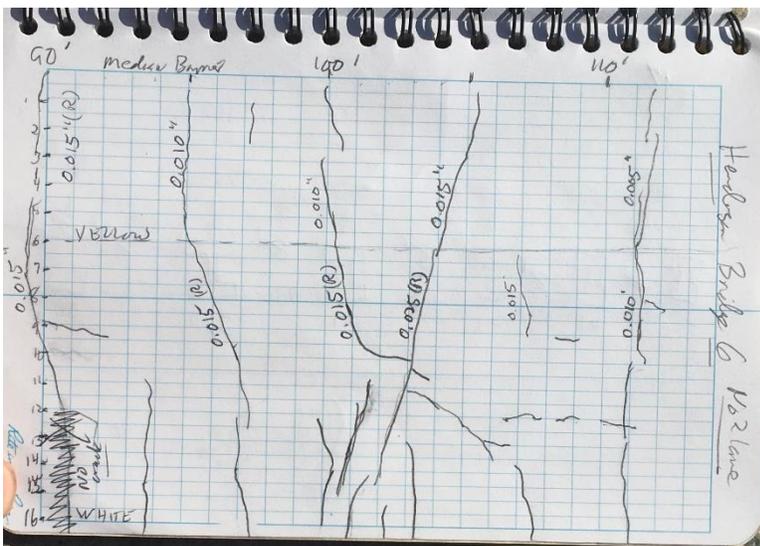
Figure 24. Sketch of cracks, 90' to 110', passing lane. Cracks were typically ~15 mil wide and raveled ("R"). The long transverse crack between 100' and 110' is located over Pier 3.

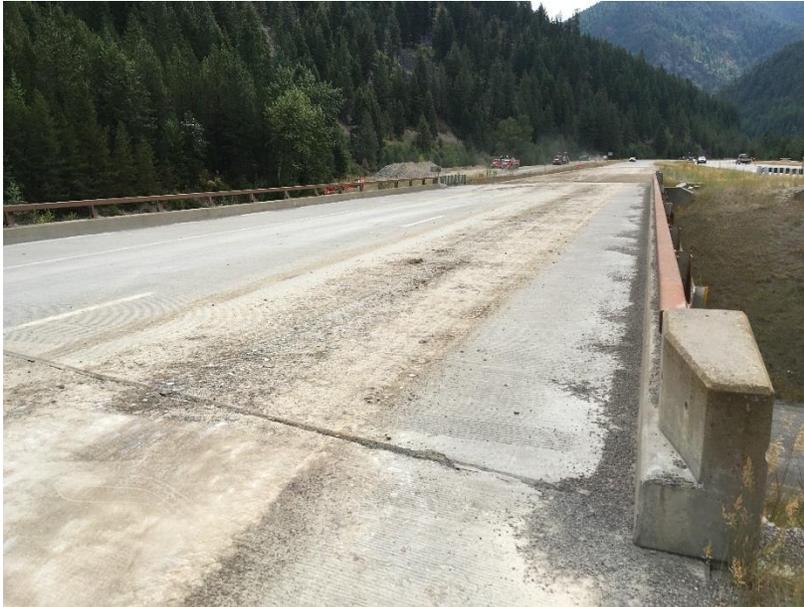
*Figure 25. General appearance of the WB bridge deck. Construction debris in the passing lane limited the scope of the cursory investigation, but no significant transverse or random cracks were observed.*

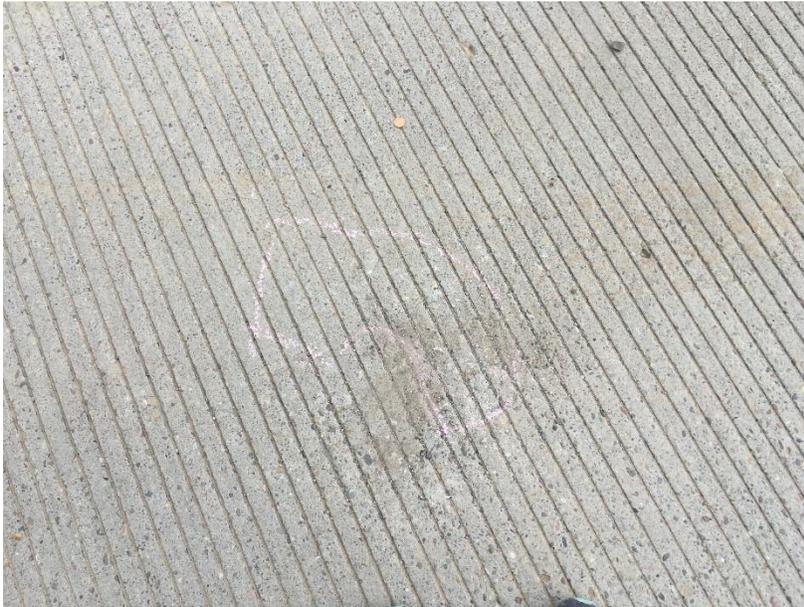
*Figure 26. Close-up view of the WB bridge deck. A small delamination (1' × 1') is outlined, but no significant transverse or random cracks were observed.*

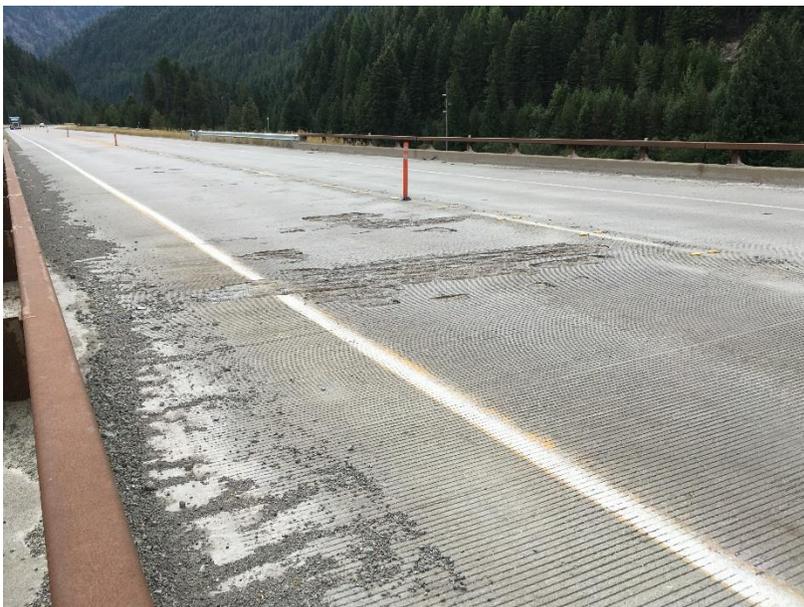
*Figure 27. Spalled concrete and exposed reinforcing bar, EB deck. No significant distress was observed on the WB deck.*

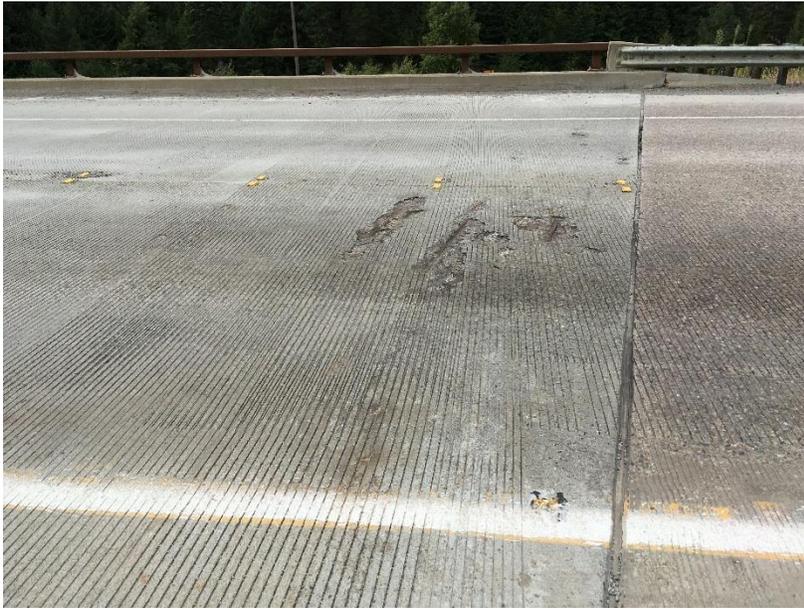
*Figure 28. Spalled concrete and exposed reinforcing bar, EB deck.  
No significant distress was observed on the WB deck.*

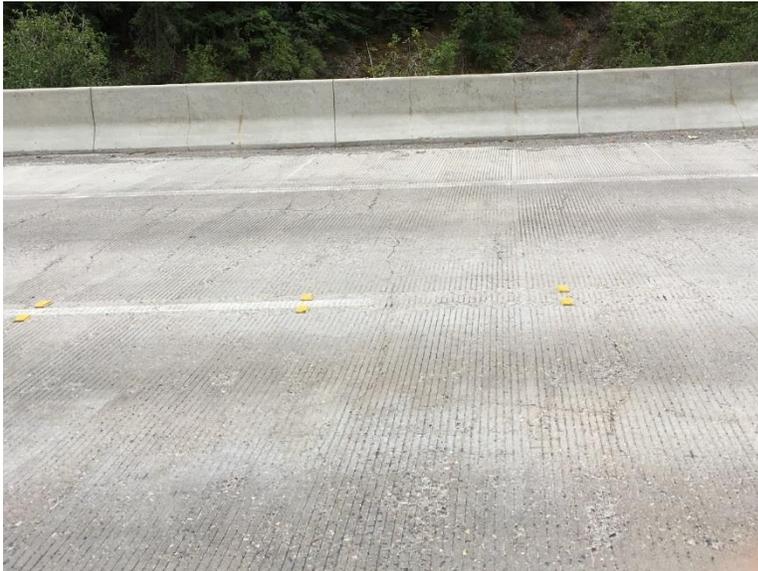
*Figure 29. General cracking on top surface of the deck. Transverse cracks are observed with high frequency.*

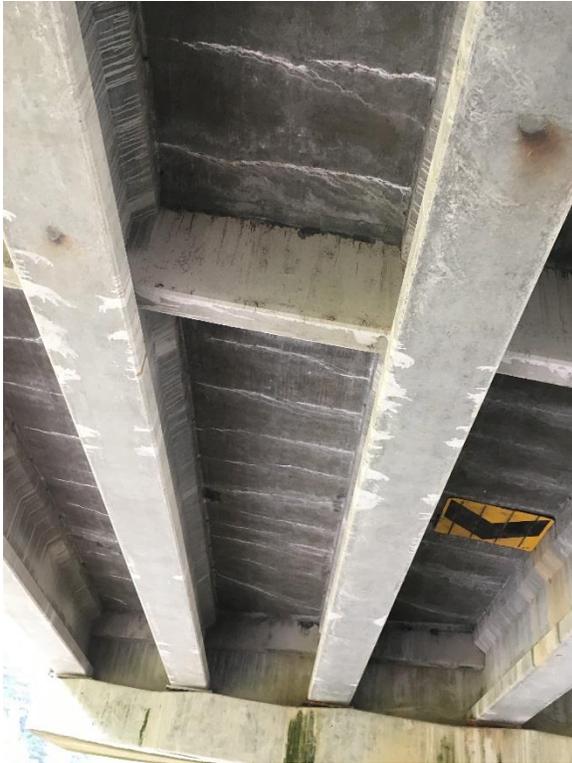
*Figure 30. General appearance of underside of deck. Frequent efflorescence-filled transverse cracks are visible. A road sign likely forms a full-depth repair.*

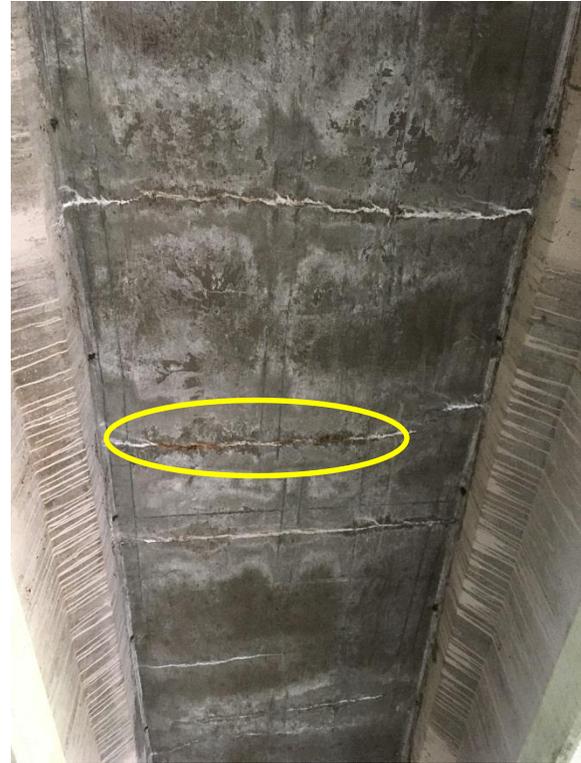
*Figure 31. Minor corrosion staining around a transverse crack (circled). Corrosion stains were observed for a small number of transverse cracks on the underside of the deck.*

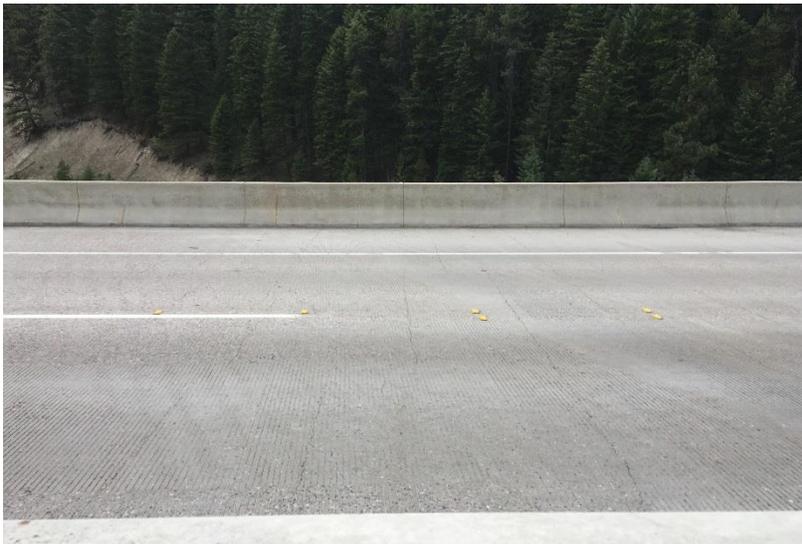
*Figure 32. Transverse cracks on EB deck.*

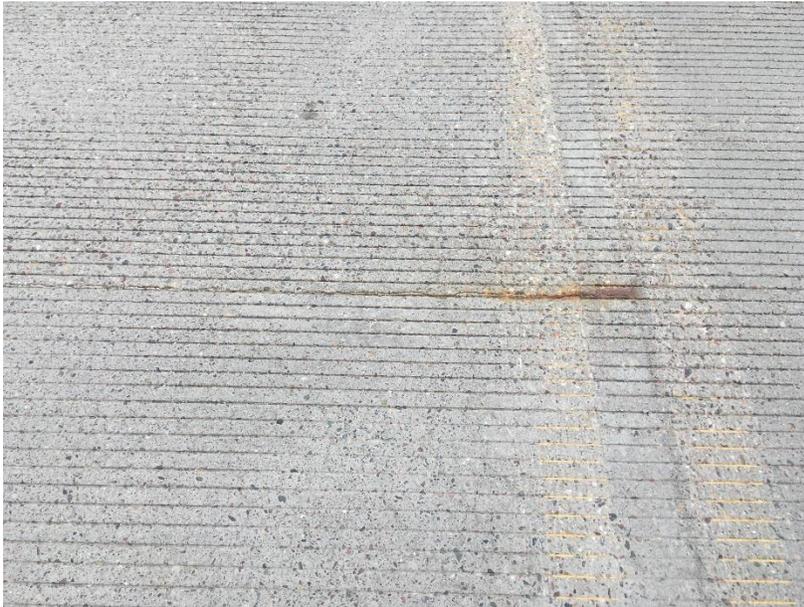
*Figure 33. Corrosion staining on top of deck. Corrosion staining was observed in two isolated locations on the top of the deck.*

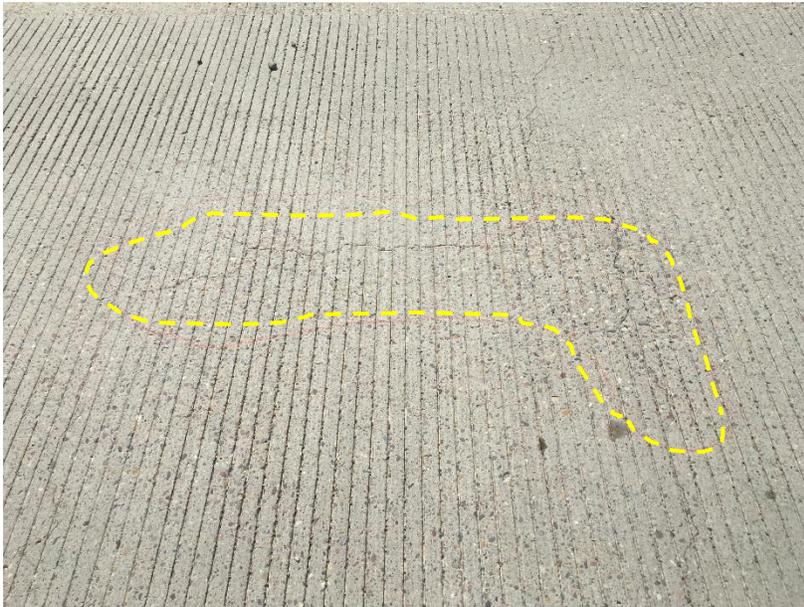
*Figure 34. WB deck overlay. A delaminated region around the transverse crack and branching longitudinal crack is outlined. Delaminations were observed around a small percentage of cracks in the overlay.*

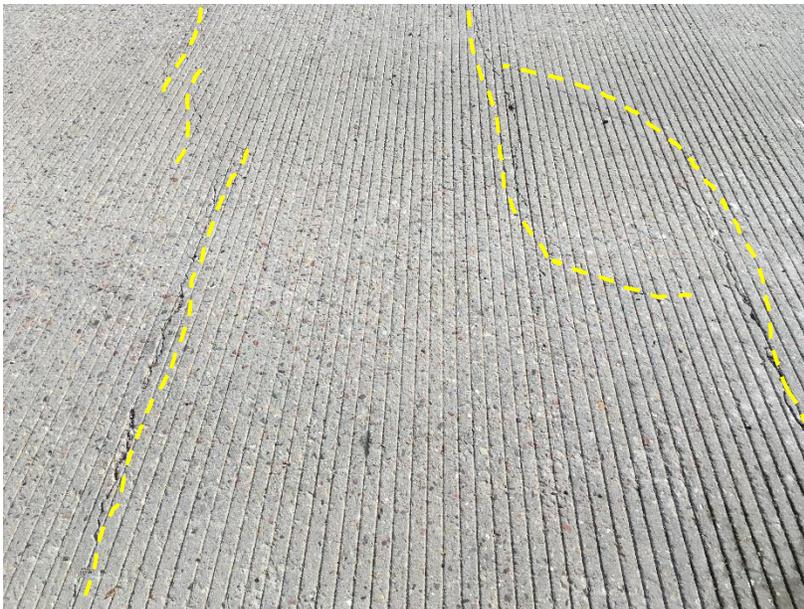
*Figure 35. General crack appearance, Bridge 10. Transverse cracks are outlined. As closely-spaced transverse cracks progress, they appear to bend or branch toward adjacent transverse cracks.*

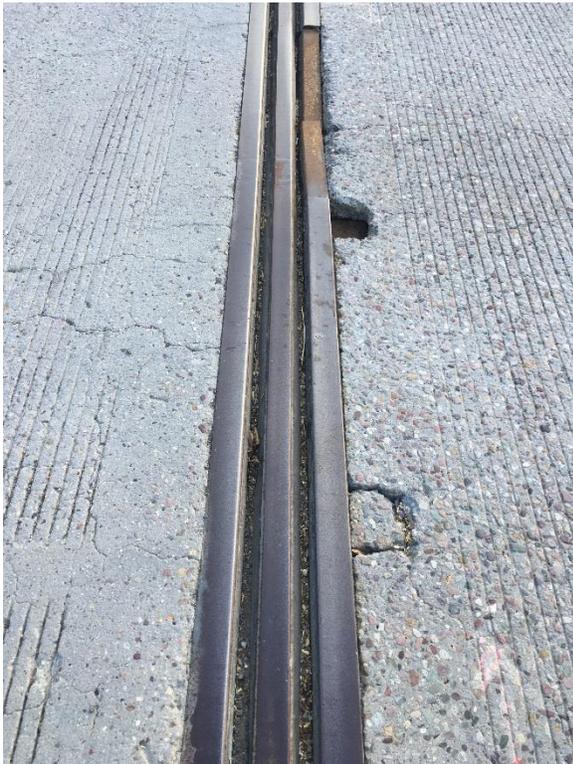
Figure 37. "Chunks" of concrete along expansion joint between Spans 5 and 6.

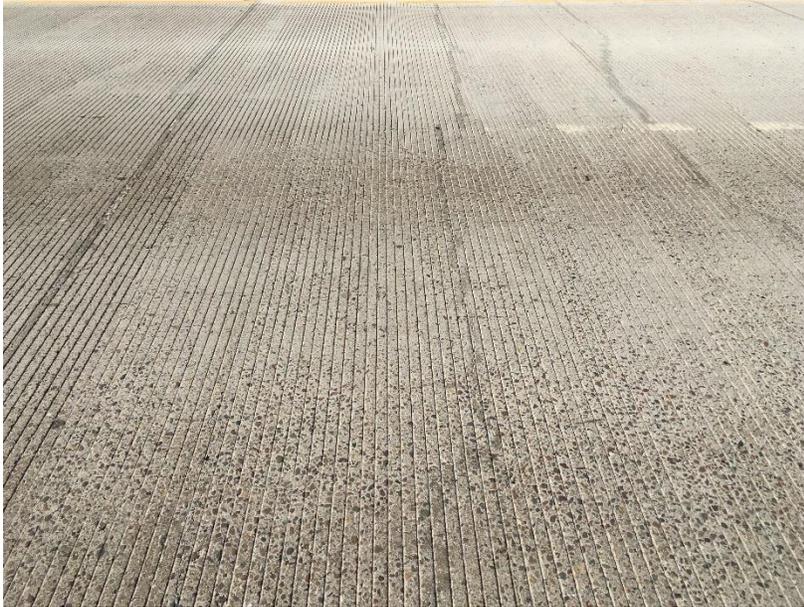
*Figure 38. General appearance of transverse cracks, Bridge 11. Cracks wider than ~10 mil were filled with a sealant (visible in photo).*

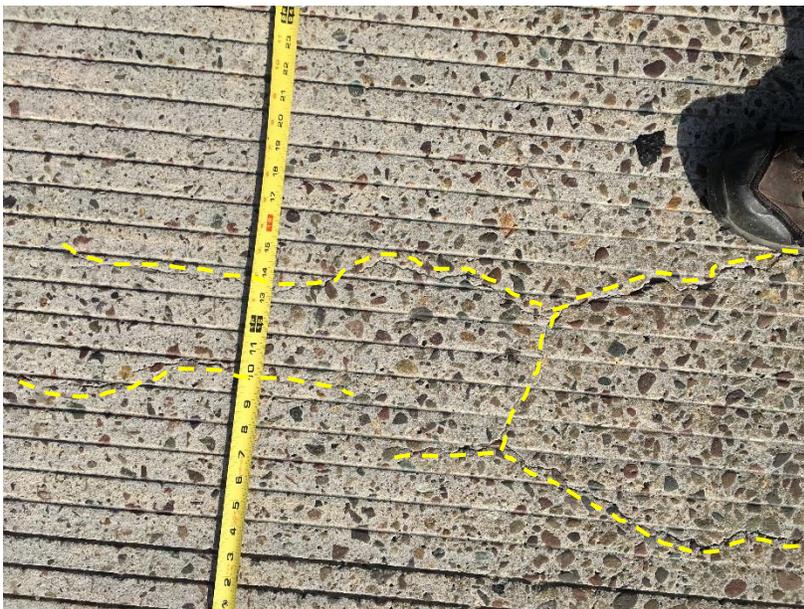
*Figure 39. Closely-spaced cracks on top surface of Bridge 11. Cracks are outlined.*

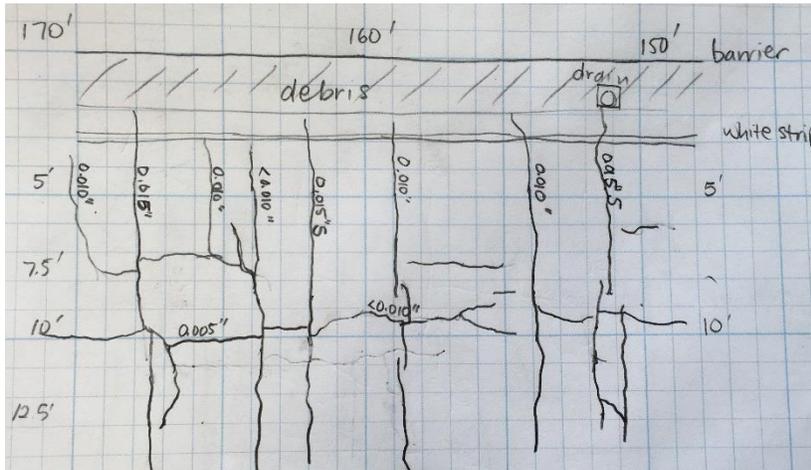
Figure 40. Sketch of cracks, 170' to 150'. Cracks are similar in location and frequency as on other bridge decks, but are tighter. Crack sealant ("S") was observed in cracks ~10 mil or wider.

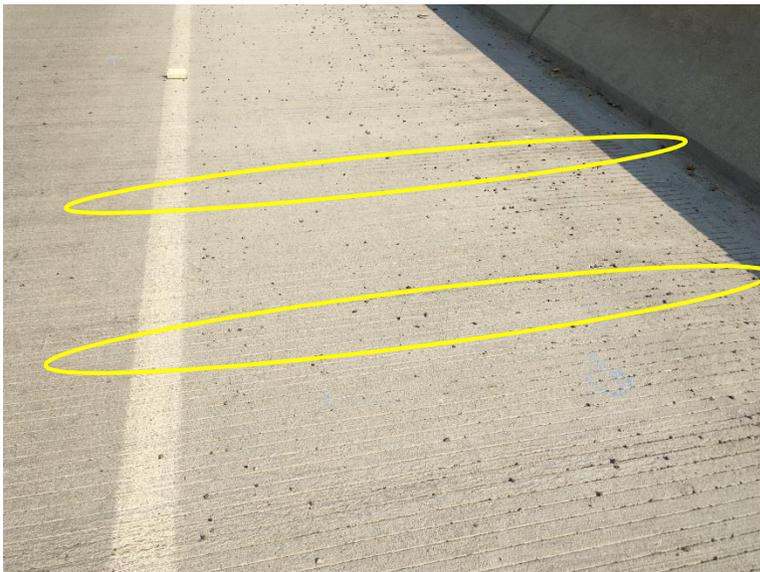
Figure 44. General crack appearance, Bridge 12. Cracks are generally too fine to see from photographs. The wider transverse cracks, circled, contain a crack sealant.

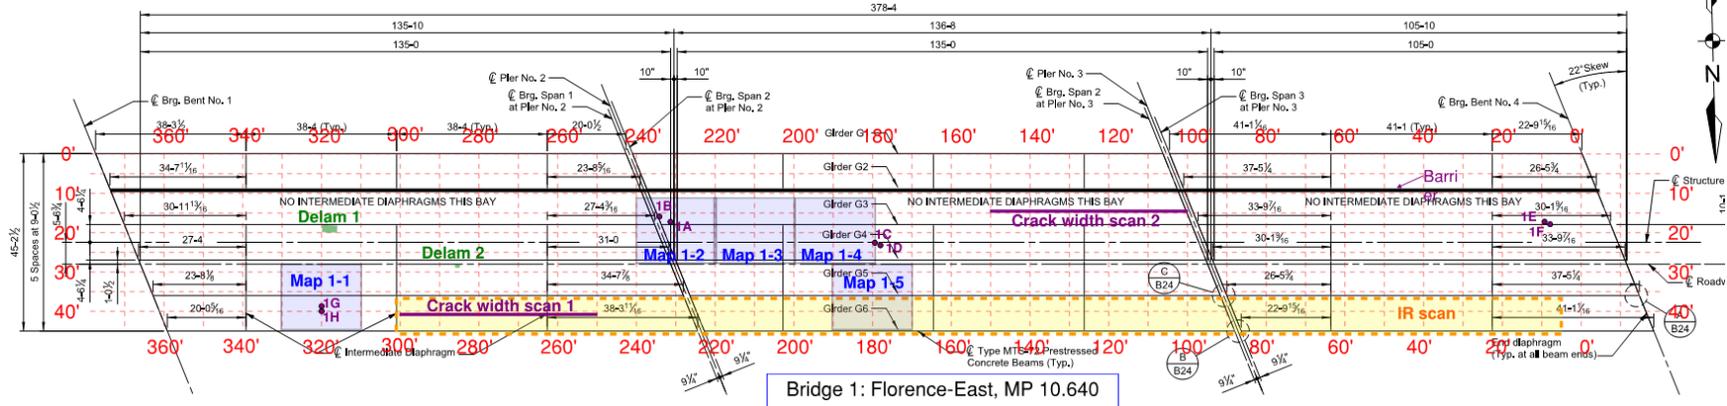
Figure 7. Annotated drawing of Bridge 1, Florence-East, MP 10.640. Station markings are shown in red. Cores are indicated by purple circles, delaminations by green polygons, crack maps by blue rectangles, and IR surveys by a yellow rectangle. Two small delaminations were identified in Span 1 of the deck.

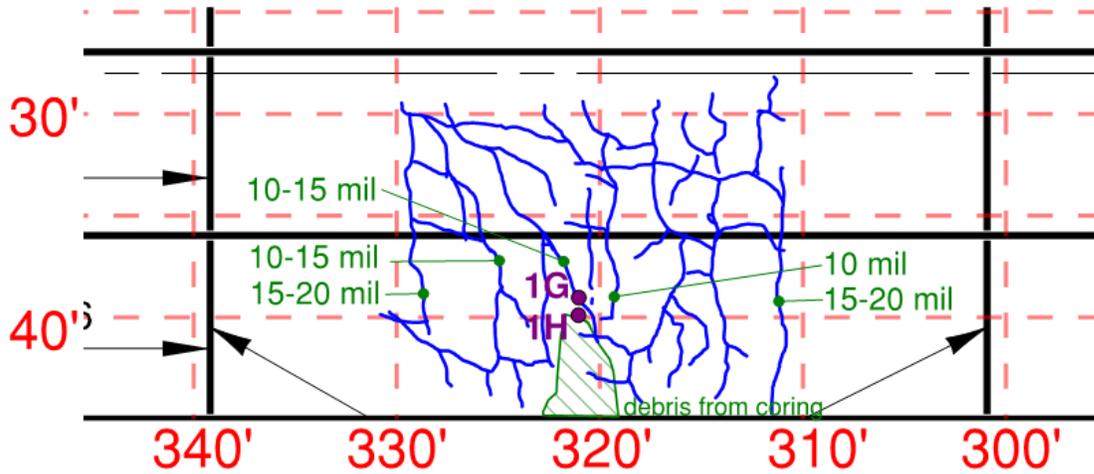
Figure 11. Crack map, Bridge 1, Map 1-1. Transverse cracks in this area measured 10-20 mil in width and were spaced at roughly 4-foot intervals.

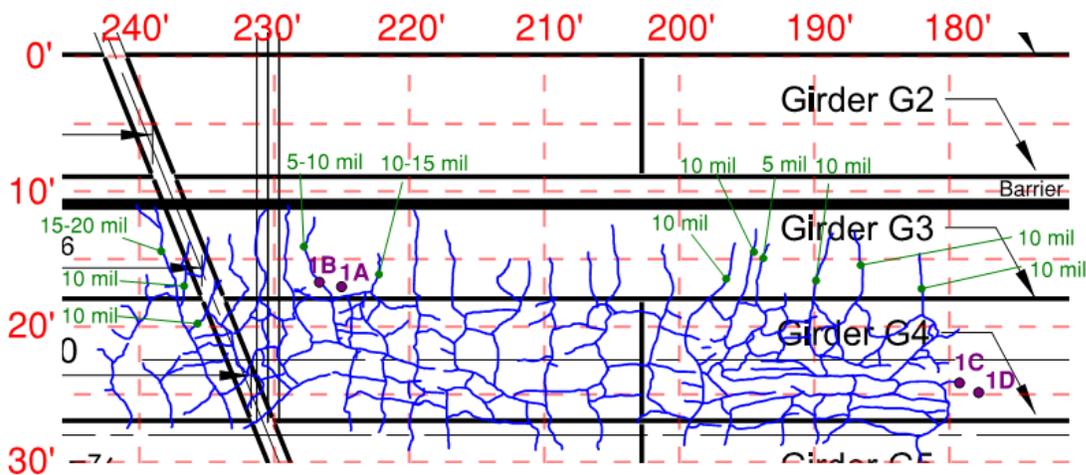
Figure 12. Crack maps, Bridge 1, Maps 1-2 (240' to 220'), 1-3 (220' to 200'), and 1-4 (200' to 180'). Transverse cracks in this area typically measured 10 mil in width and were spaced at 2- to 4-foot intervals. Dense map cracking was observed over large areas of the deck. The widest crack observed was over the pier; cracks in the vicinity of the pier were rotated relative to the transverse and longitudinal cracks observed elsewhere in the deck.

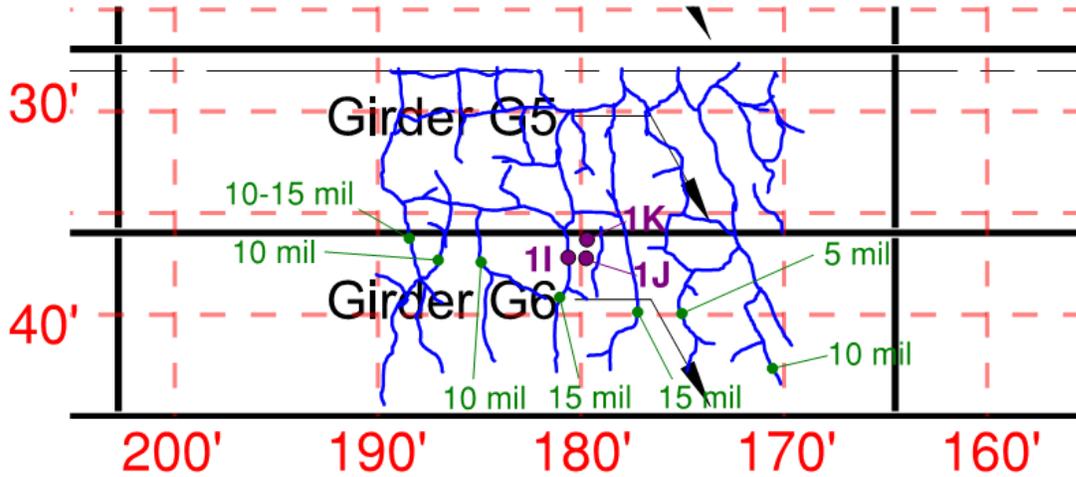
Figure 13. Crack map, Bridge 1, Map 1-5. Typical transverse cracks in this area measured 10-15 mil in width. Longitudinal cracks appeared primarily along girders G5 and G6.

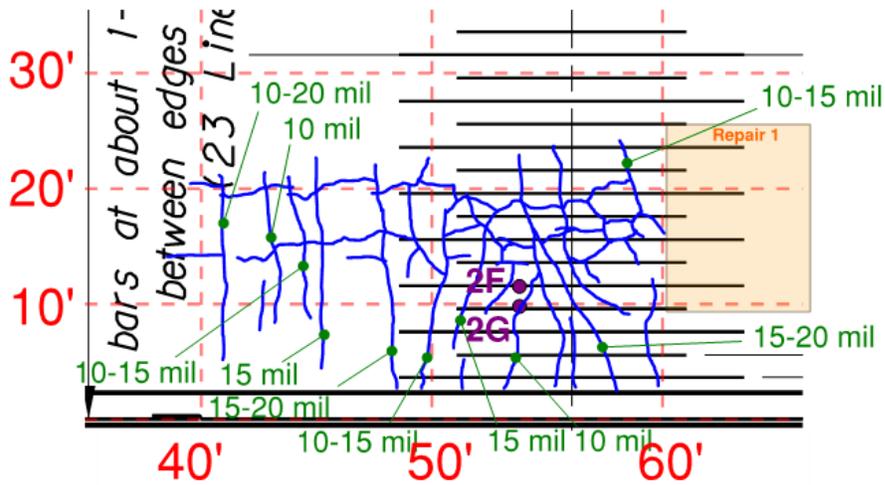
Figure 14. Crack map, Bridge 2, Map 2-1. Cracks in this area were primarily transverse (10-20 mil width), with longitudinal cracks along the girders at 16' and 22'. Some random cracking was also observed near the pier at 56'.

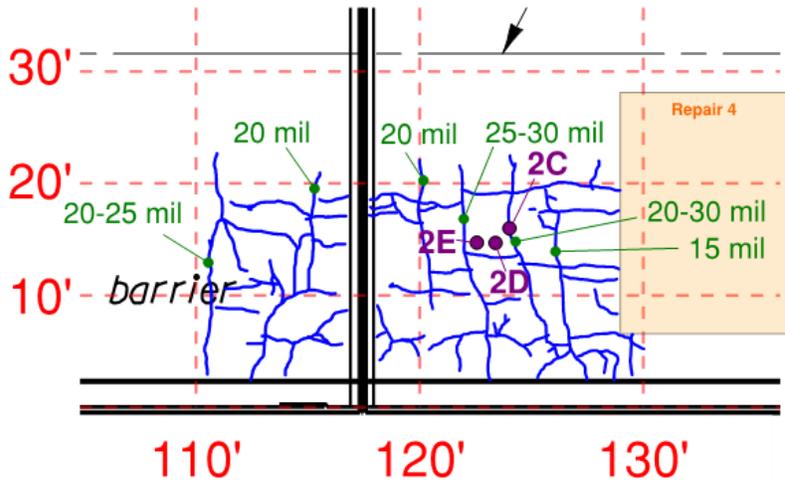
Figure 15. Crack map, Bridge 2, Map 2-2. Transverse cracks in this area measured 20-30 mil in width and were spaced at 2- to 4-foot intervals. Longitudinal cracks appeared primarily along the girders at 9' and 16' in Span 2 (left of expansion joint) and along the girders at 11' and 20' in Span 3 (right of expansion joint). Additional longitudinal cracks were also observed between the girders at 3' and 9' (or 10' in Span 3), with fine transverse cracks propagating outward from these longitudinal cracks.

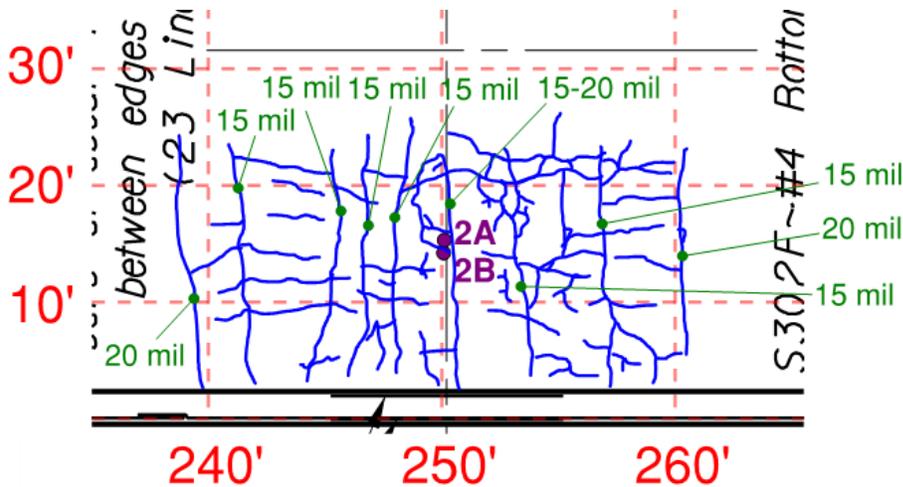
Figure 16. Crack map, Bridge 2, Map 2-3. Transverse cracks in this area measured 15-20 mil in width and were spaced at 2- to 4-foot intervals.

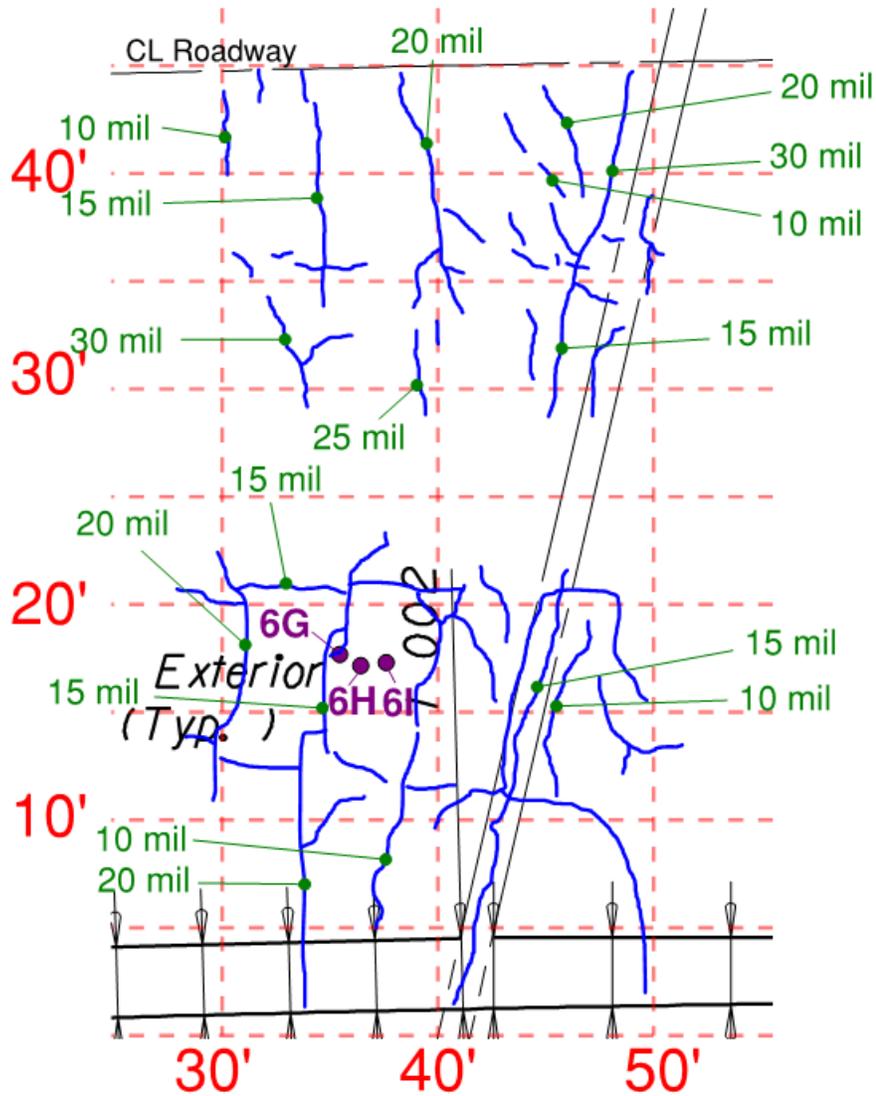
Figure 17. Crack map, Bridge 6, Maps 6-1 (passing lane) and 6-2 (driving lane). Transverse cracks in this area measured 10-30 mil in width and were more raveled than the cracks in the other bridge decks. Wide cracks propagated along the pier. A “jumping” crack is shown near core 6G.

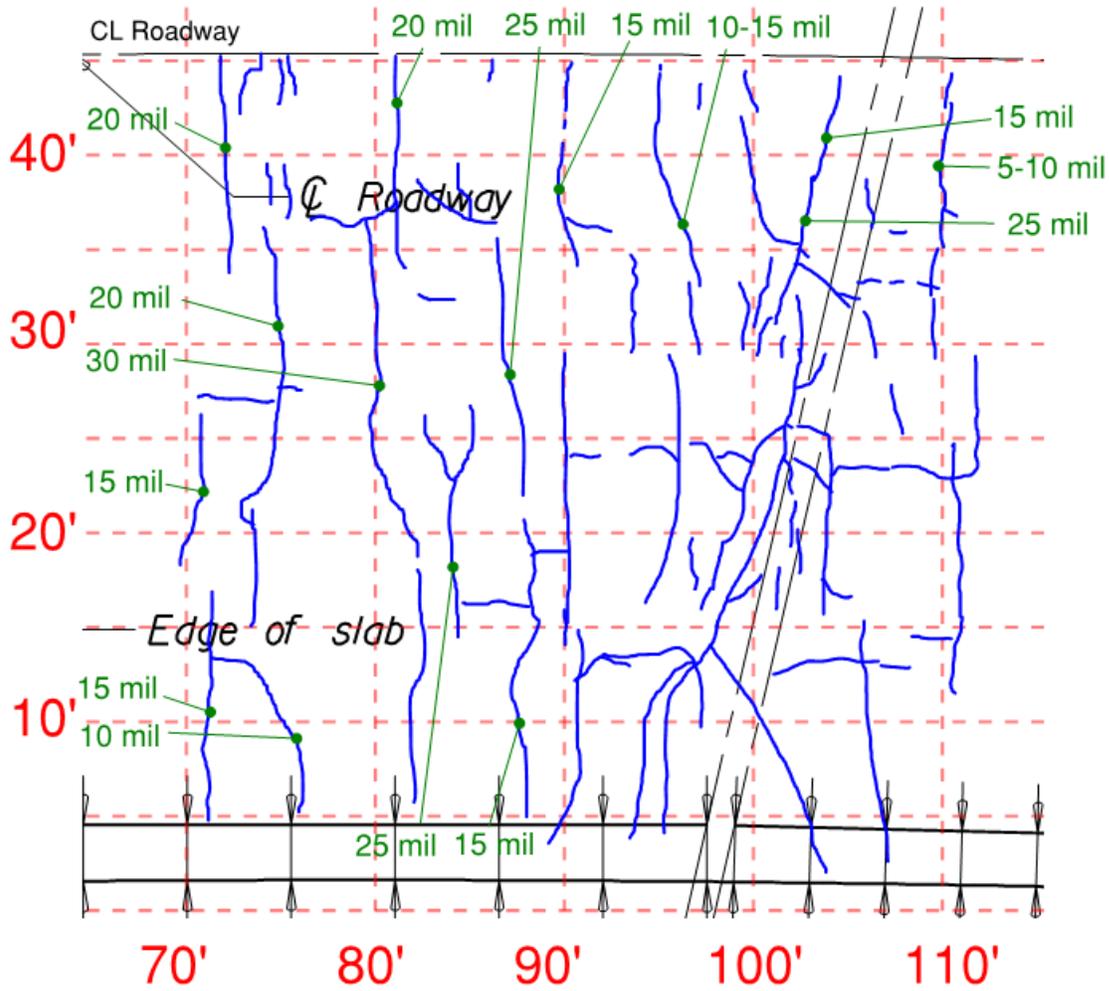
Figure 18. Crack map, Bridge 6, Maps 6-3 (passing lane, 70' to 90'), 6-4 (driving lane, 70' to 90'), 6-5 (passing lane, 90' to 110'), and 6-6 (driving lane, 90' to 110'). Transverse cracks in this area were raveled and measured 15-25 mil in width. Wide cracks propagated along the pier.

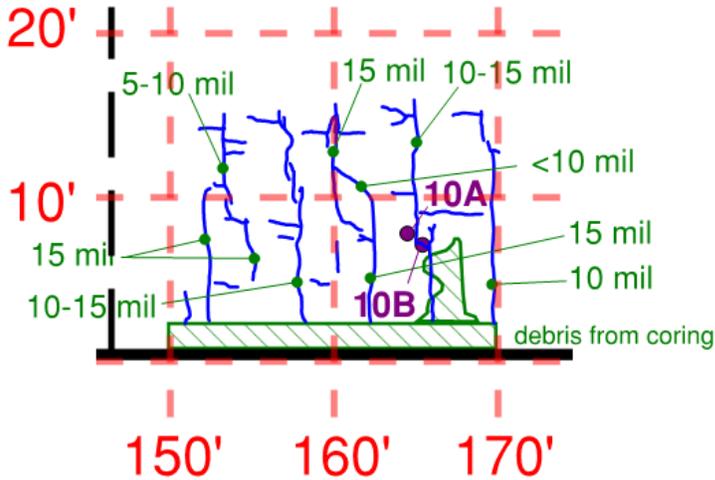
Figure 19. Crack map, Bridge 10, Map 10-1. Transverse cracks in this area measured 10-15 mil in width. A “jumping” crack is shown near core 10B, and a series of “jumping” crack is shown along the transverse crack at the 158’ station marking.

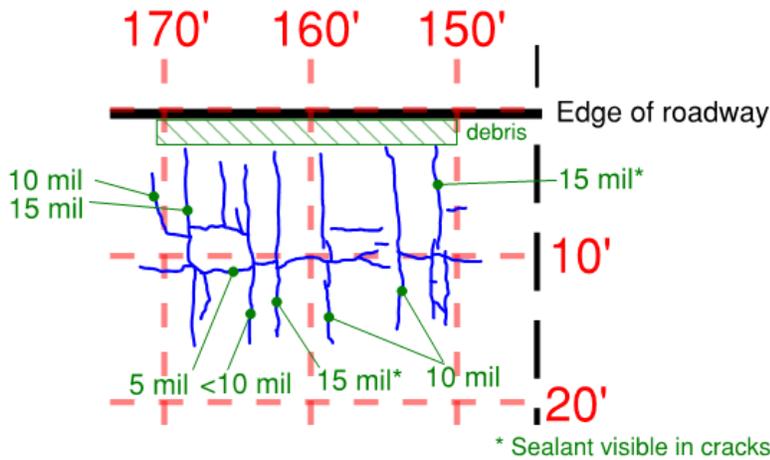
Figure 20. Crack map, Bridge 11, Map 11-1. Transverse cracks in this area measured 5-15 mil in width. A sealant was visible within the cracks measuring 15 mil in width. A longitudinal crack measuring 5 mil in width follows the girder at 10’.
