**MONTANA DEPARTMENT OF TRANSPORTATION  
(MDT)  
Investigation of Bridge Decks**

**Final Report**  
April 21, 2017  
WJE No. 2016.3598

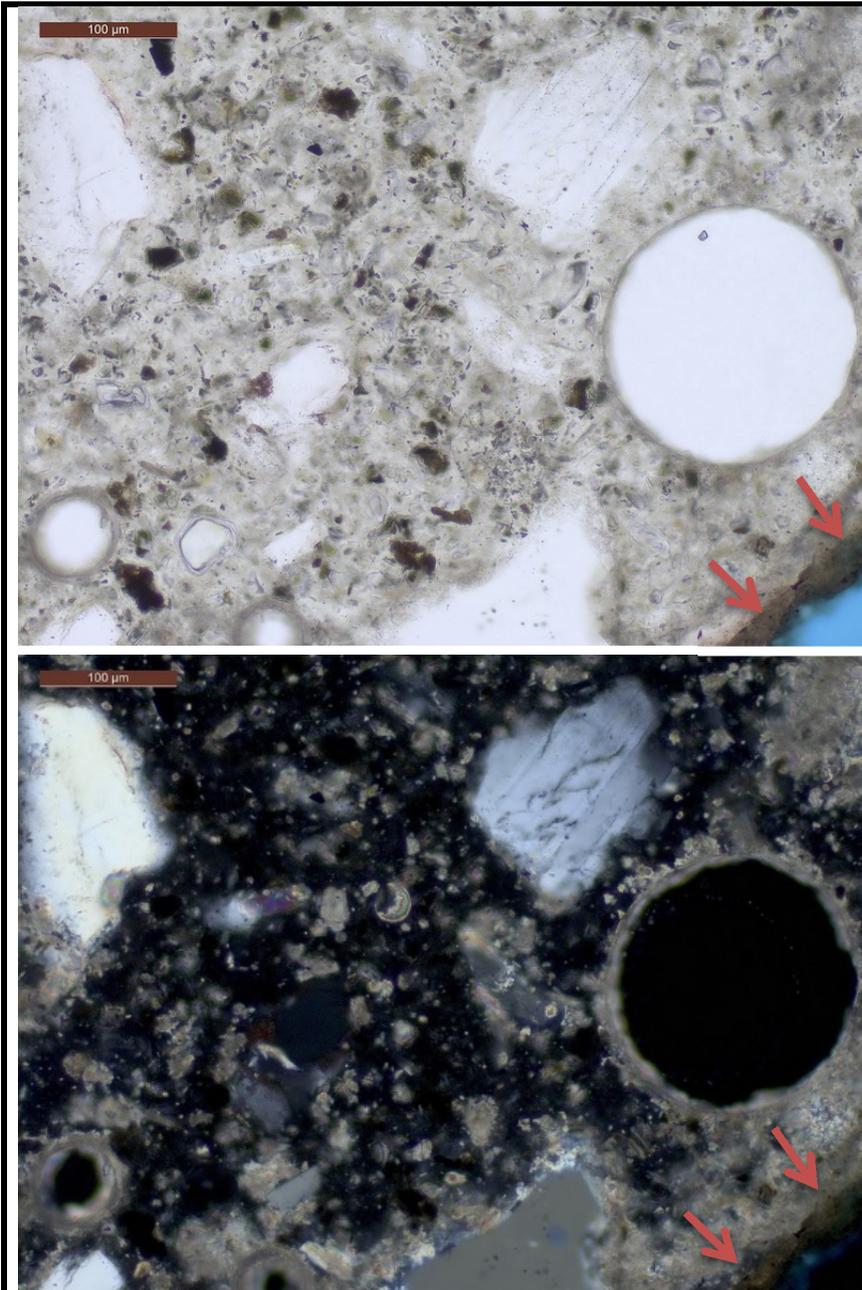
*Figure 7. Thin-section photomicrographs show a leached region near the major crack (arrows). Secondary carbonate lines voids and has re-crystallized in the body of the paste.*

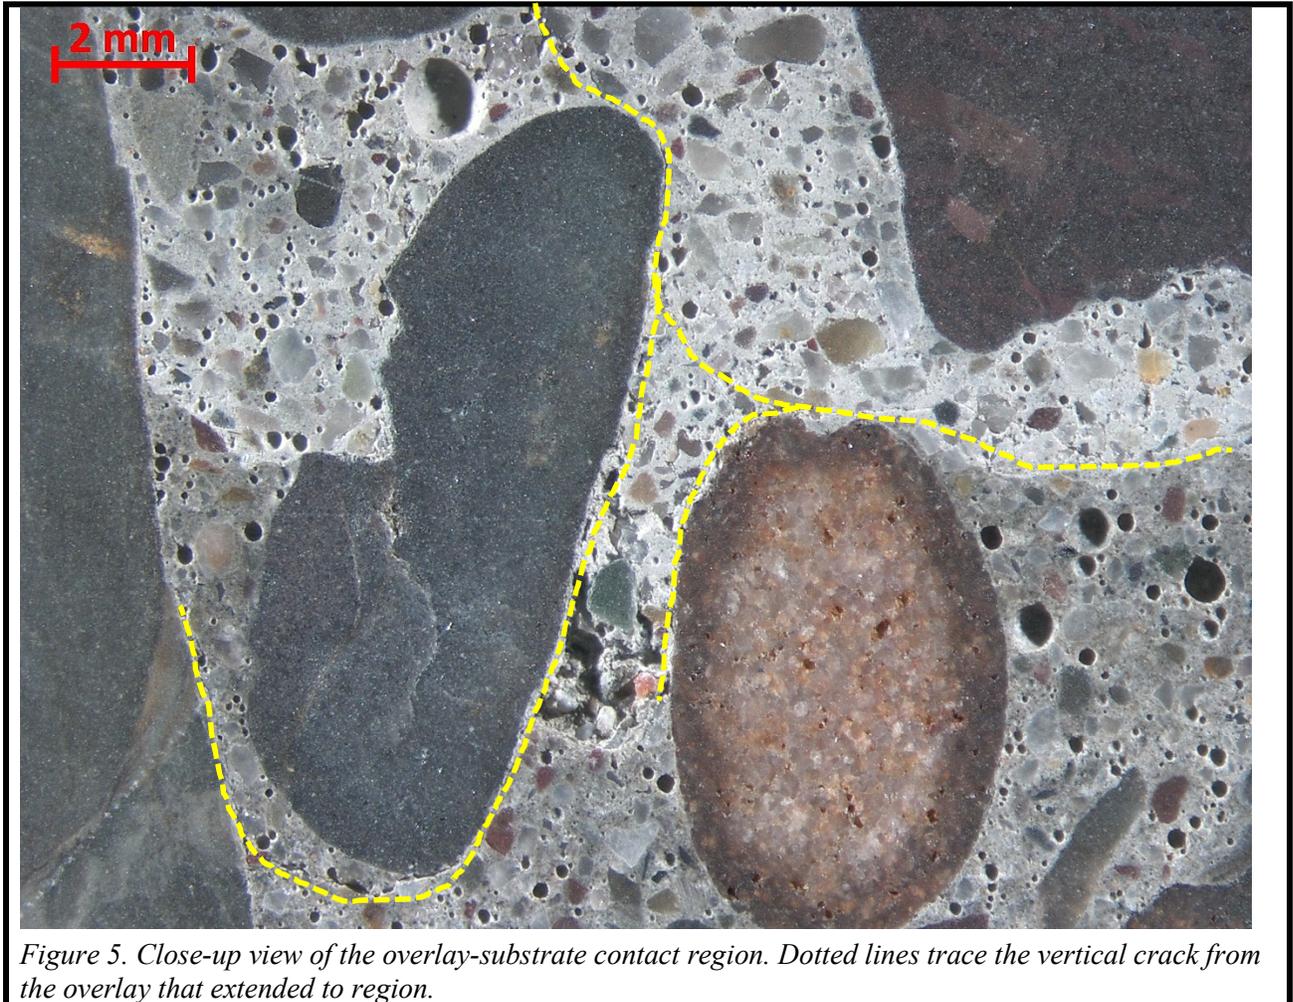
*Figure 5. Close-up view of the overlay-substrate contact region. Dotted lines trace the vertical crack from the overlay that extended to region.*

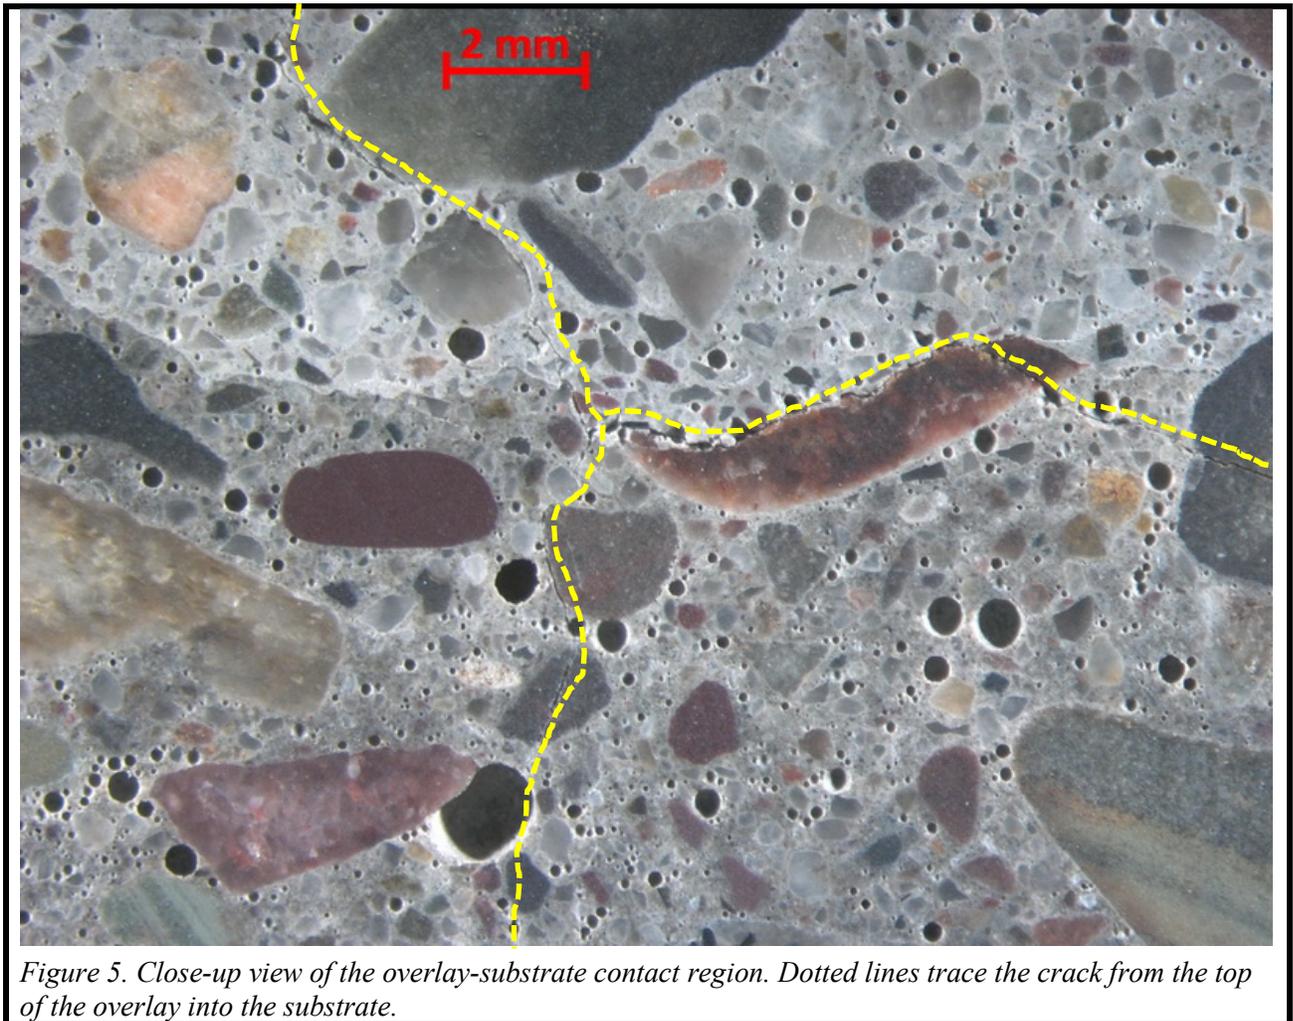
*Figure 5. Close-up view of the overlay-substrate contact region. Dotted lines trace the crack from the top of the overlay into the substrate.*

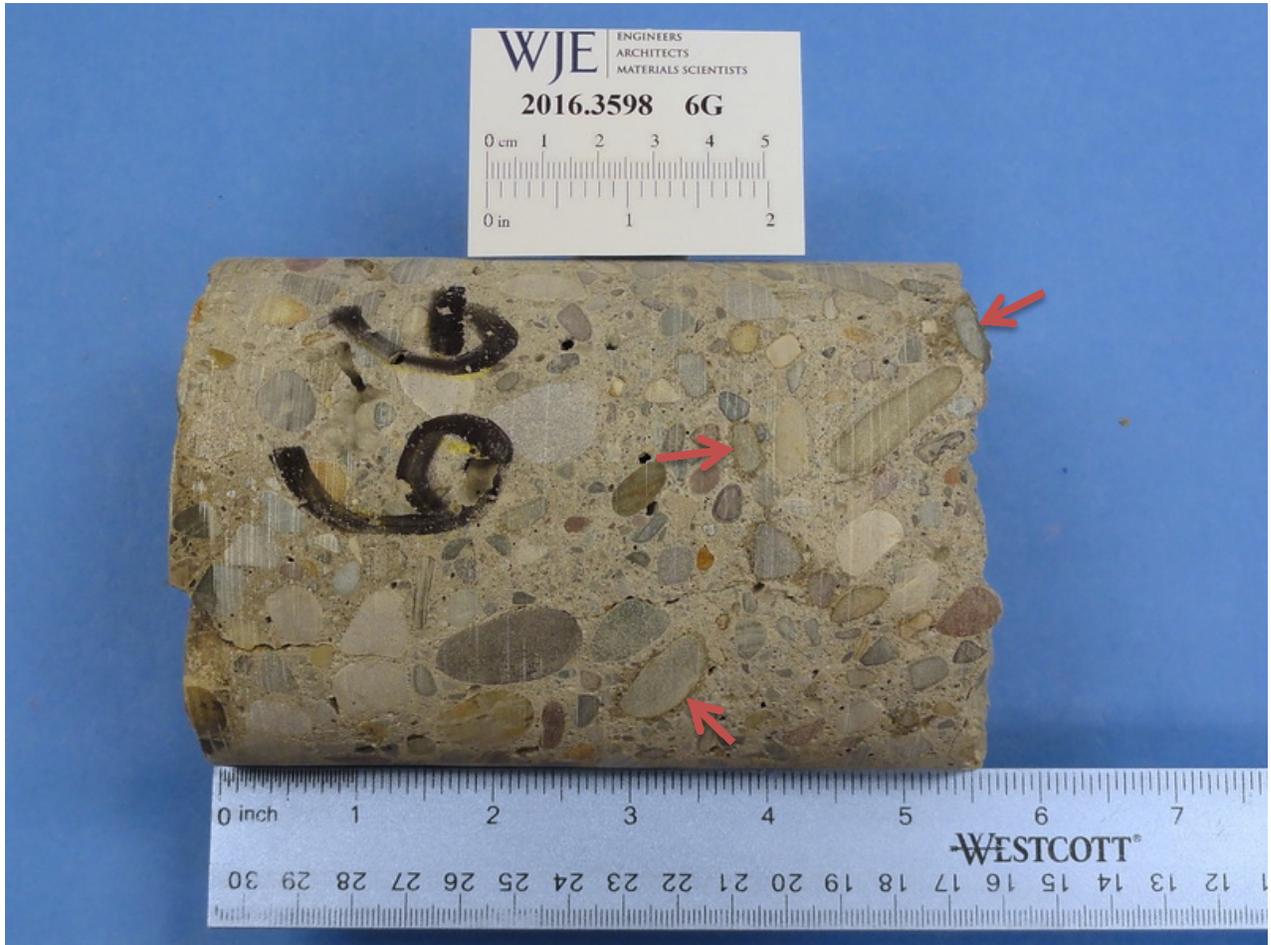
*Figure 1. Core 6G. Side view. Red arrows indicate aggregate particles that exhibited minor evidence of ASR. Wearing surface is on the left.*

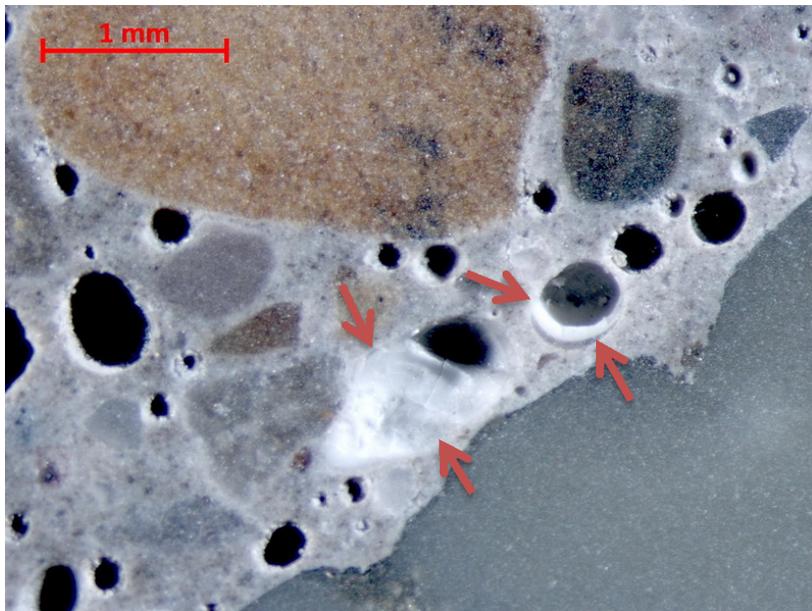
*Figure 5. Close-up view of the concrete showing alkali-silica gel lining two air voids (arrows).*

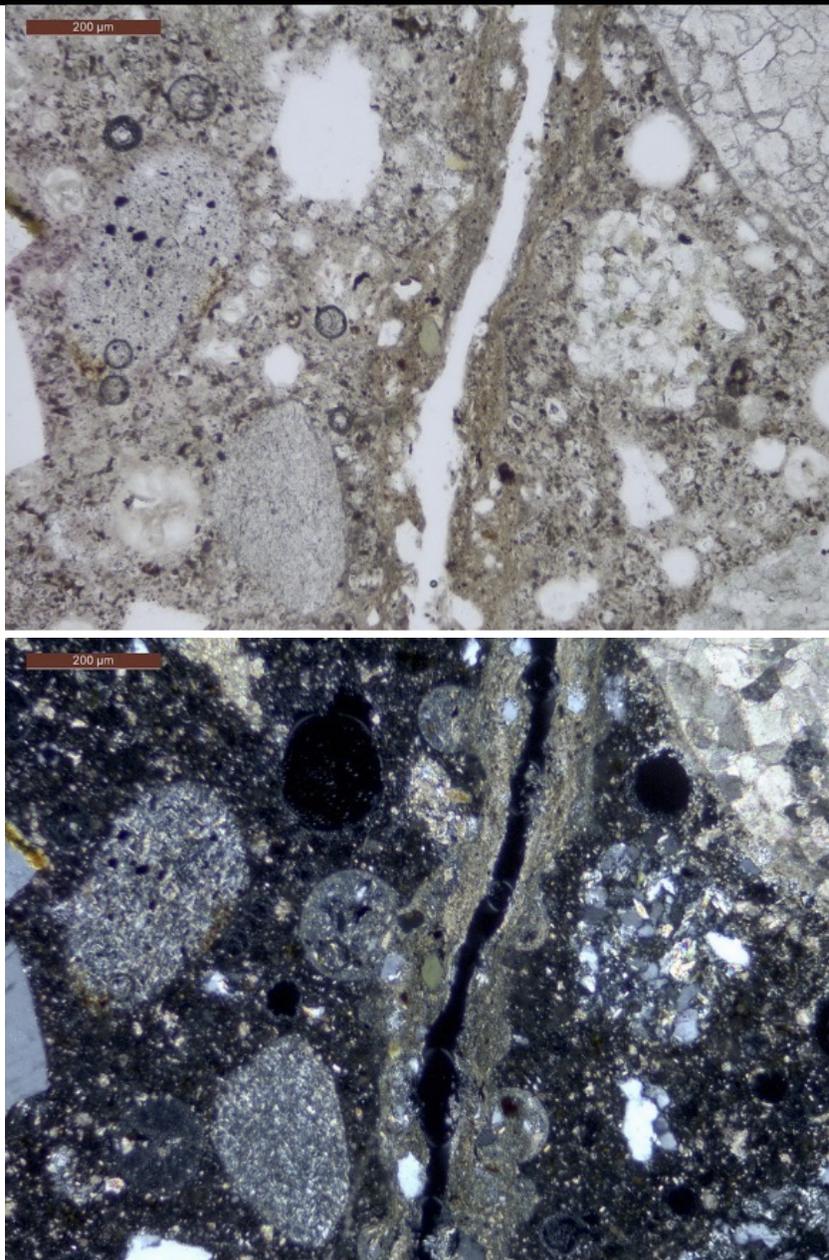
*Figure 6. Thin-section photomicrographs show the vertical crack lined with fine-grained brown deposits. Top photo: plane-polarized light. Bottom photo: cross-polarized light.*
