## AVIATION SYSTEM PLAN - 2015 UPDATE

### PAVEMENT CONDITION INDEXES

**A.I.P. 3-30-0000-013-2015**

### Montana Department of Transportation - Aeronautics Division

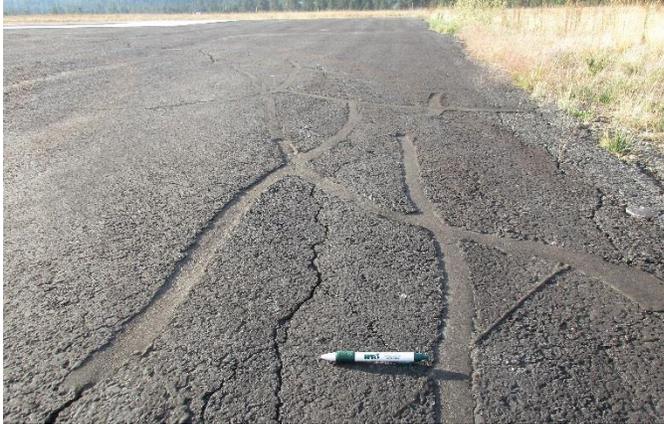
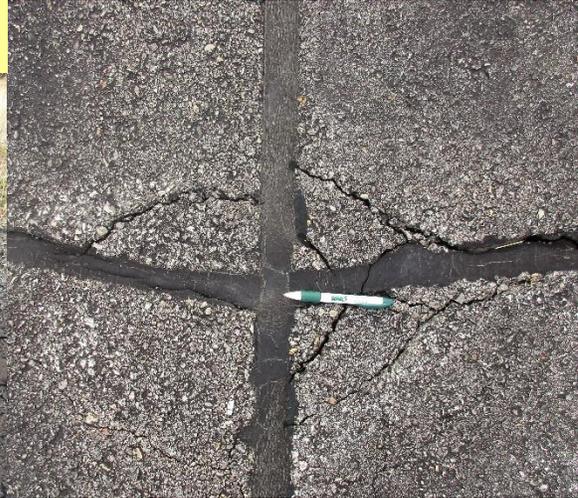
## Light

Fine parallel hairline cracks with few or no interconnecting cracks. No spalling.  
**Repair:** Do nothing / Surface seal / Overlay

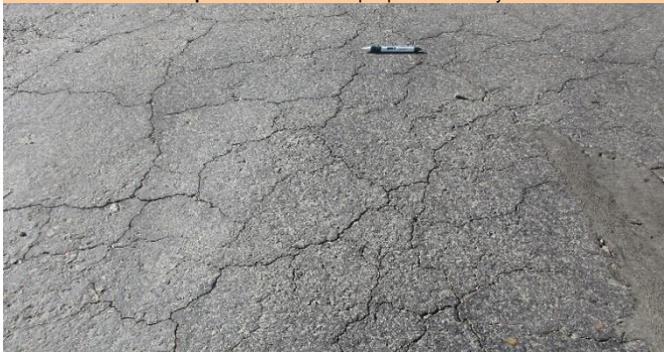
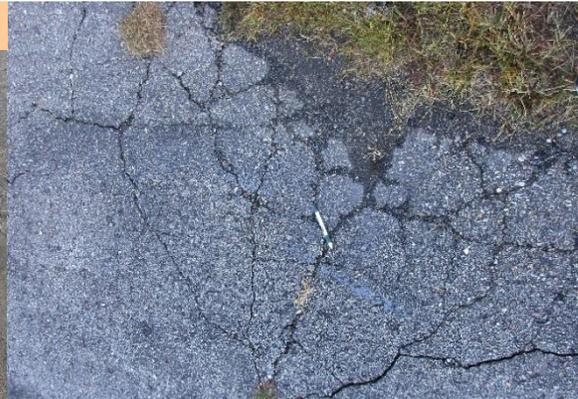
## Medium

Pattern or network of cracks that may be lightly spalled.  
**Repair:** Partial or full depth patch / Overlay / Reconstruct

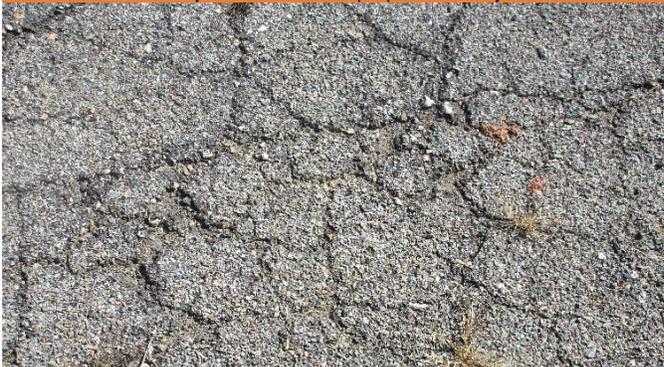
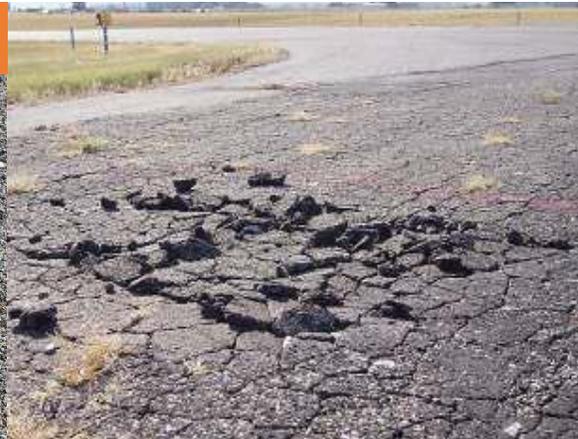
## High

Pattern or network of cracks with well defined pieces and spalled edges.  
**Repair:** Partial or full depth patch / Overlay / Reconstruct

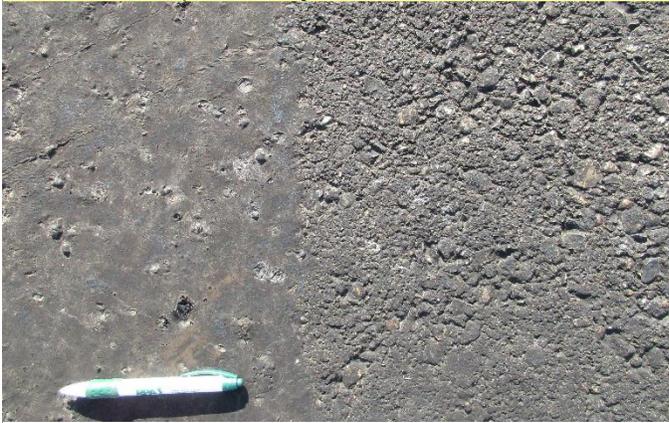
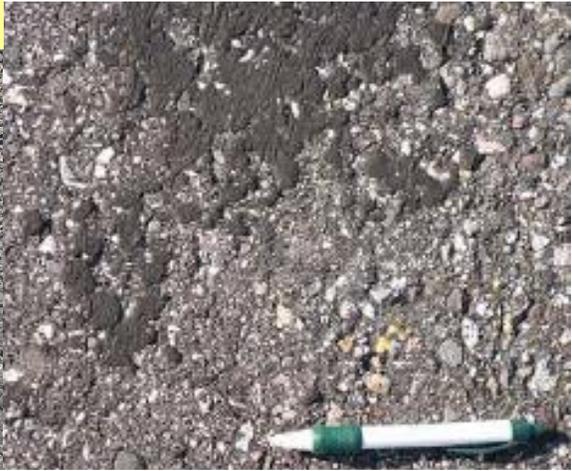
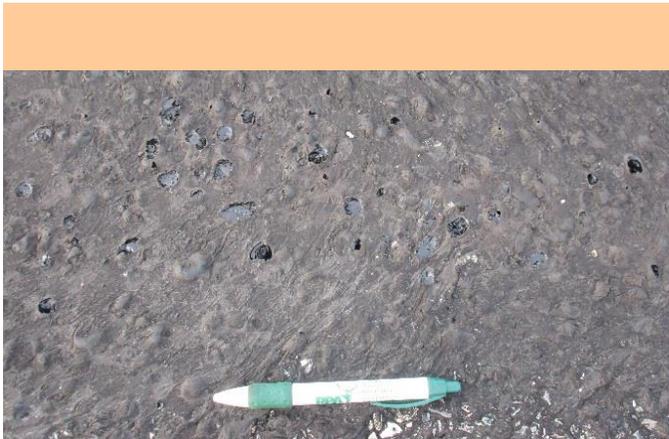
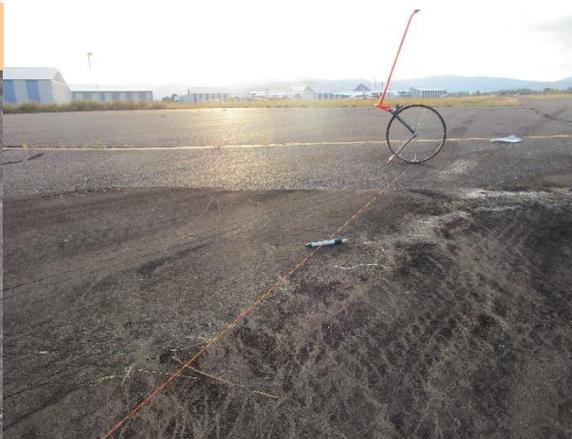
**Yes/No** Extensive enough to cause reduced skid resistance.  
**Repair:** Do nothing / Heat, sand & sweep

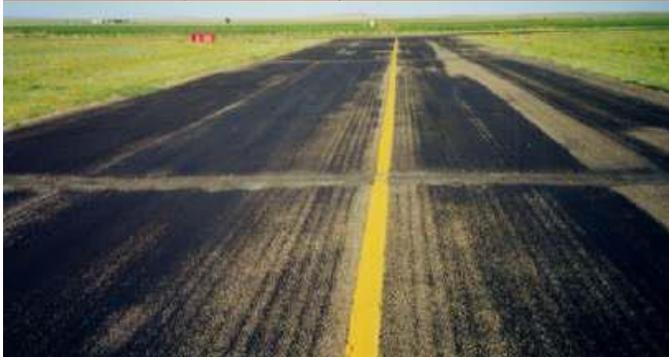
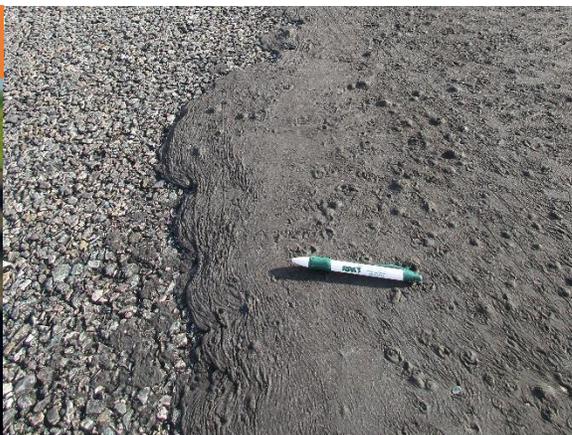
Severe global bleeding excessive enough to cause traction safety issues.  
**Repair:** Mill and overlay

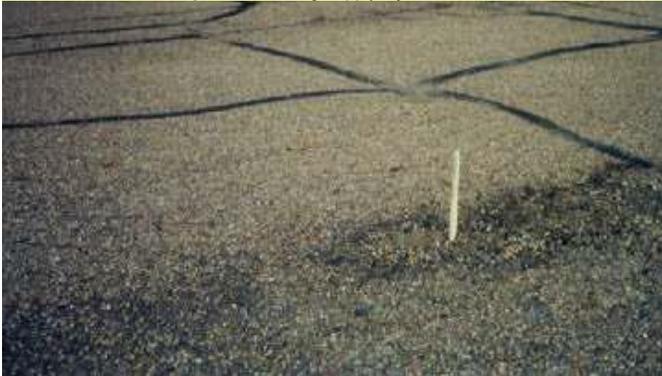
**Light** Non- or only lightly spalled blocks with no foreign object debris (FOD) potential. Nonfilled cracks have ¼ inch or less mean width and filled cracks have filler in satisfactory condition.  
**Repair:** Do nothing / Apply rejuvenator

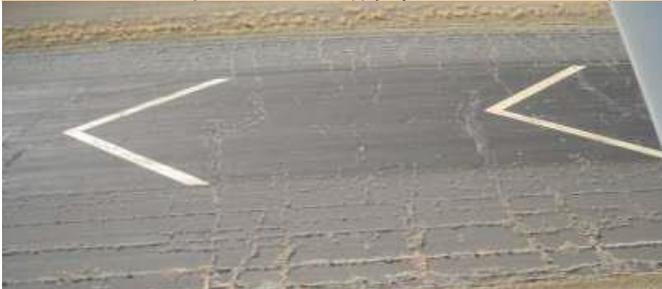
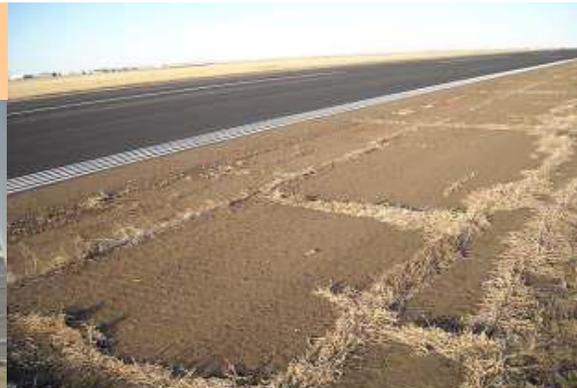
**Medium** Filled or nonfilled cracks that are moderately spalled. Nonfilled cracks with mean width greater than approximately ¼ inch. Filled medium cracks with failed sealant.  
**Repair:** Seal cracks / Apply rejuvenator / Pulverized & repave

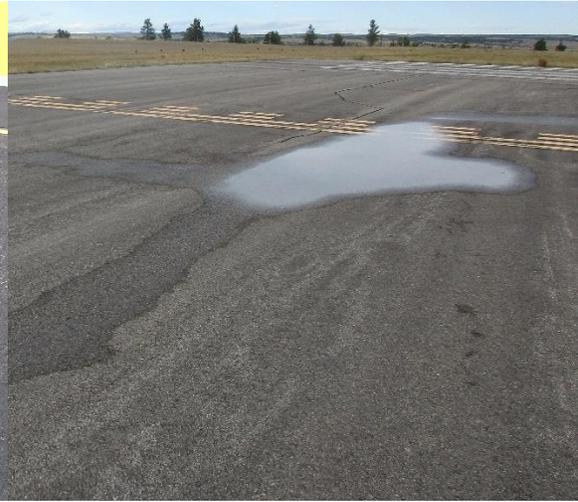
## Light

Mean depth: Runways and High-speed Taxiways: 1/8 to 1/2 inch,  
Taxiways and Aprons: 1/2 – 1 inch.  
**Repair:** Do nothing

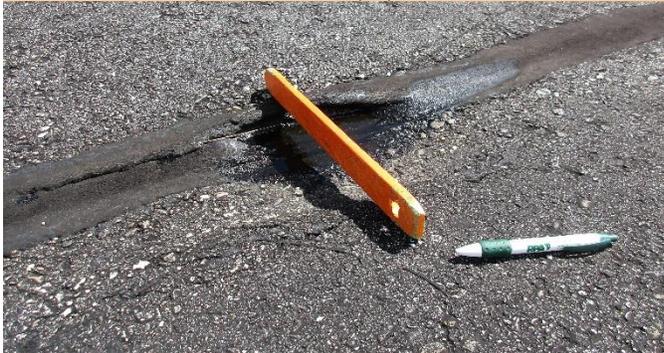
## Medium

Mean depth: Runways and High-speed Taxiways: 1/2 - 1 inch,  
Taxiways and Aprons: 1 - 2 inches.  
**Repair:** Partial or full depth patch

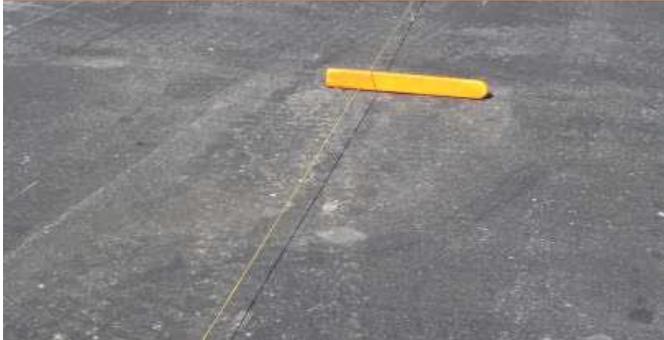
## High

Mean depth: Runways and High-speed Taxiways: > 1 inch,  
Taxiways and Aprons: > 2 inches.  
**Repair:** Partial or full depth patch

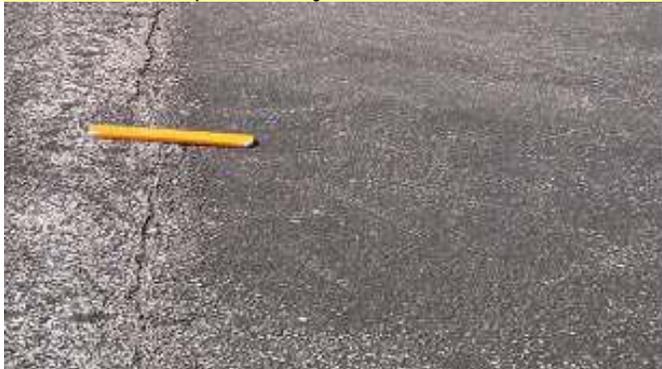
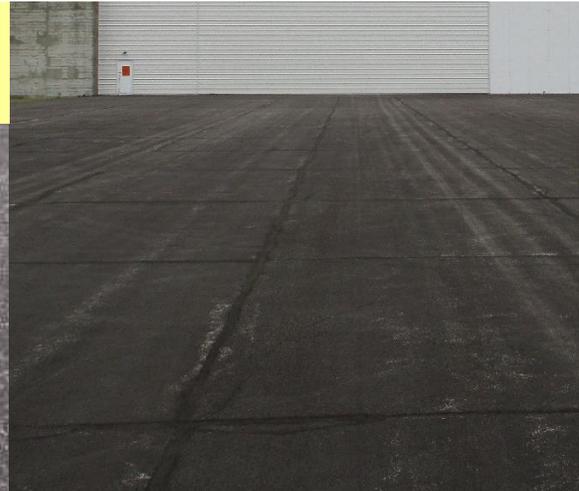
Filled or nonfilled cracks have light or no spalling, nonfilled cracks have a mean width of 1/4 inch or less. Filled cracks are of any width but with filler material in satisfactory condition.

**Repair:** Do nothing / Seal cracks over 1/8 inch

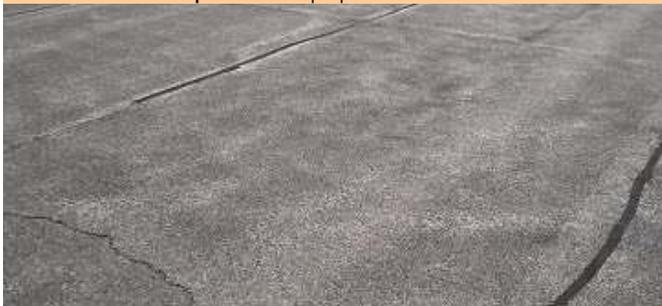
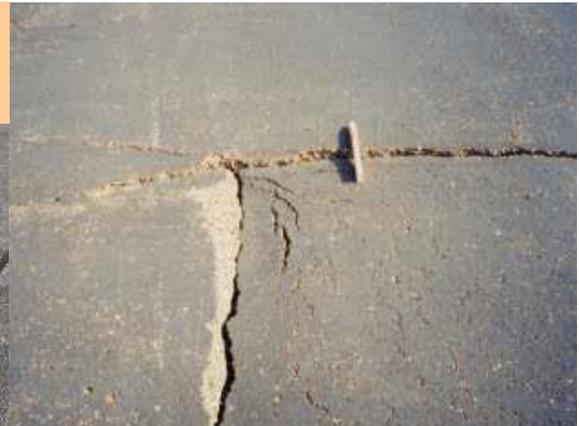
## Medium

Filled or nonfilled cracks are moderately spalled. Filled cracks are not spalled or are only lightly spalled but with failed filler. Nonfilled cracks have mean crack width greater than 1/4 inch with light or no spalling.

**Repair:** Partial depth patch / Seal cracks

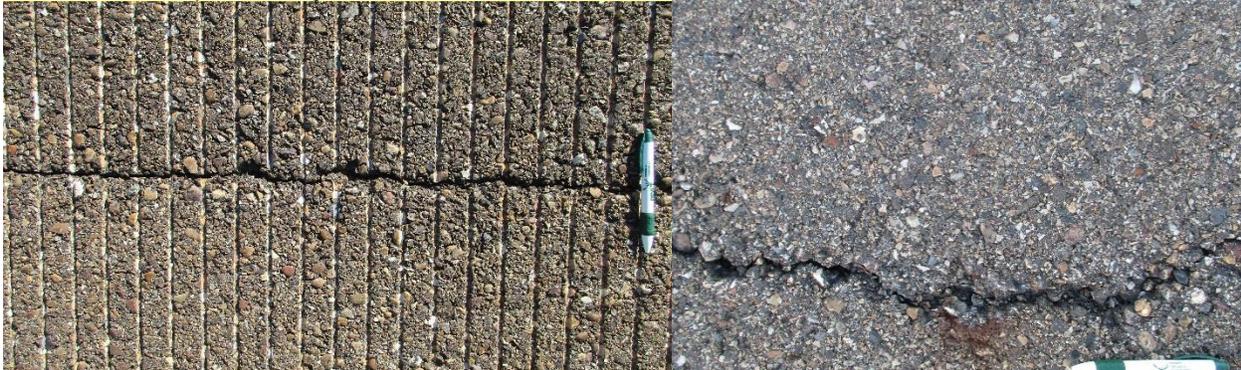
## Light

Nonfilled cracks have a mean width of 1/4 inch or less, cracks have no or minor spalling (little or no FOD potential).  
**Repair:** Do nothing / Seal cracks over 1/8 inch / Surface seal

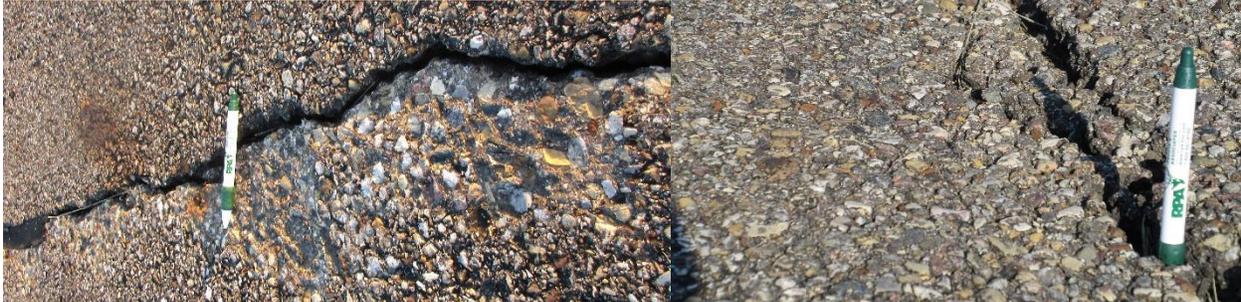
## Medium

Nonfilled cracks have mean crack width greater than 1/4 inch possibly with light spalling. Cracks are moderately spalled (some FOD potential).  
**Repair:** Seal cracks

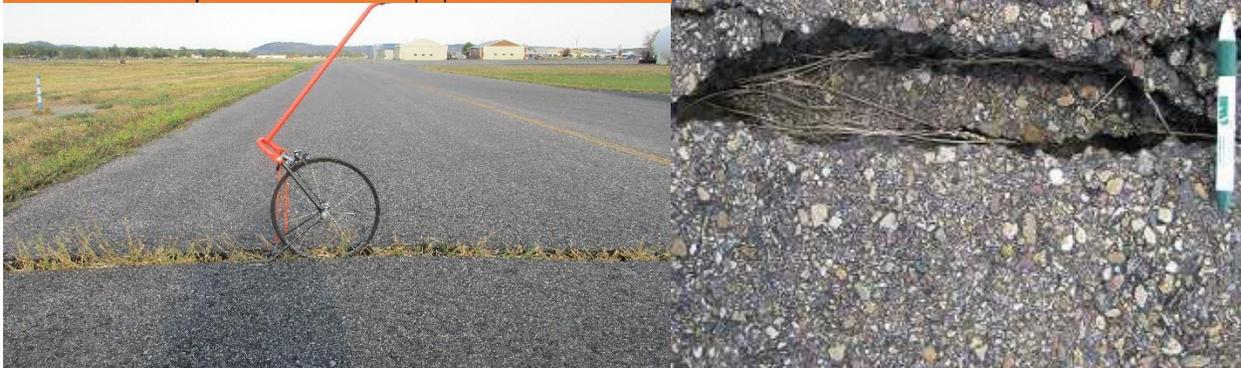
## High

Cracks are severely spalled, causing definite FOD potential. They're usually greater than 1 inch wide.  
**Repair:** Seal cracks / Partial depth patch

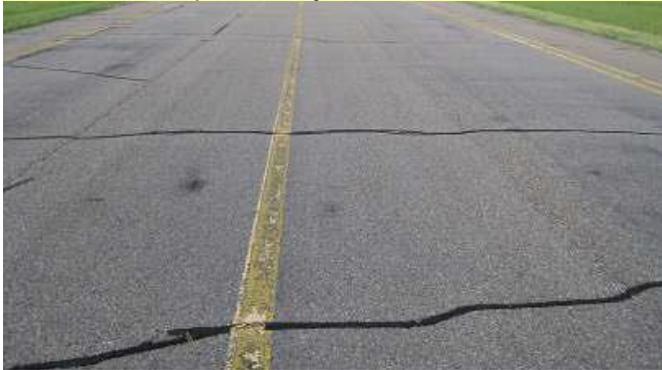
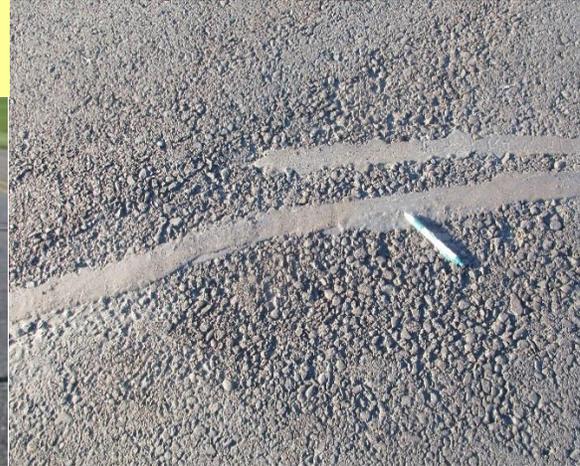
Filled cracks are of any width but their filler material is in satisfactory condition. Cracks have no or minor spalling (little or no FOD potential).

**Repair:** Do nothing / Seal cracks over 1/8 inch / Surface seal

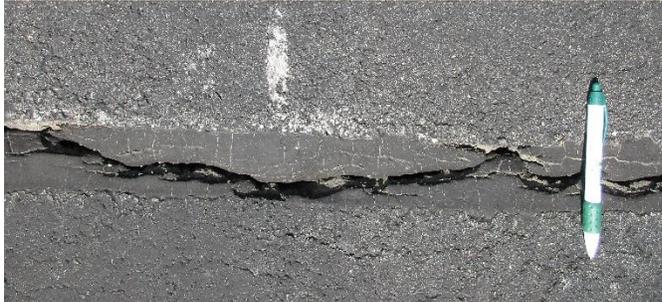
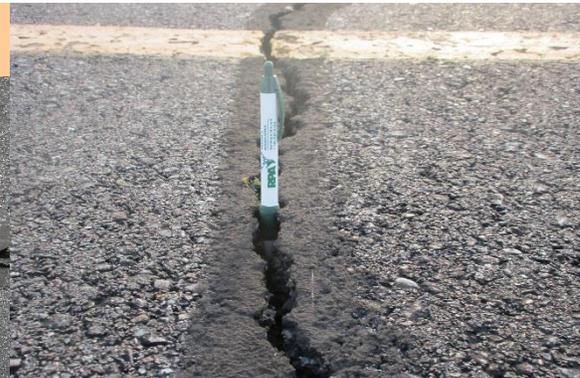
## Medium

Filled cracks are moderately spalled (some FOD potential). Filled cracks have failed sealant with possible light spalling.

**Repair:** Seal cracks

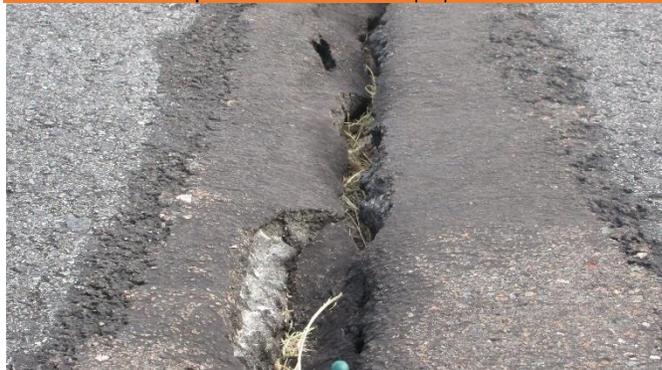
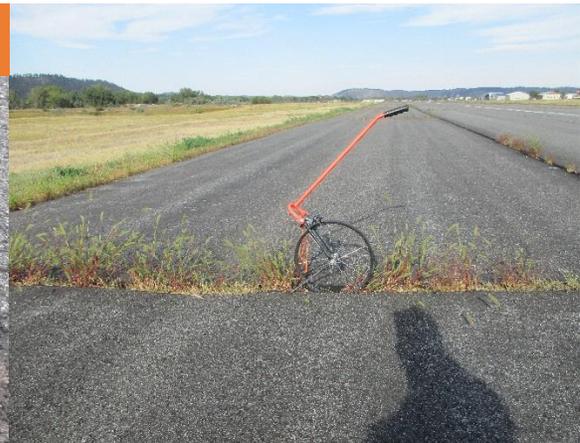
## High

Cracks are severely spalled, causing definite FOD potential. They're usually greater than 1 inch wide.

**Repair:** Seal cracks / Partial depth patch

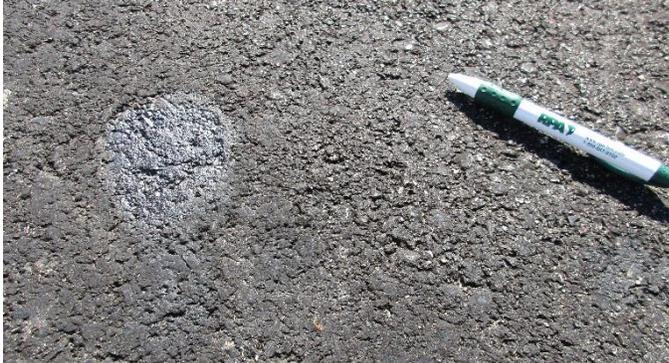
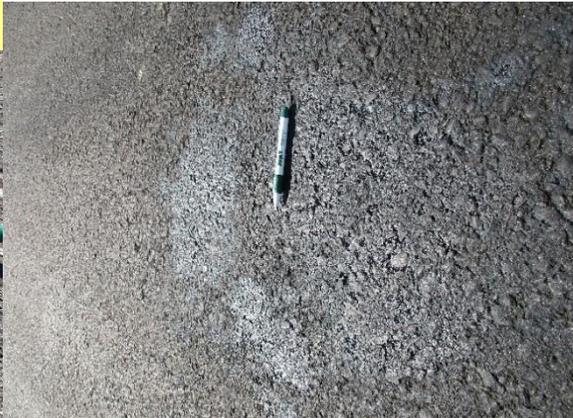
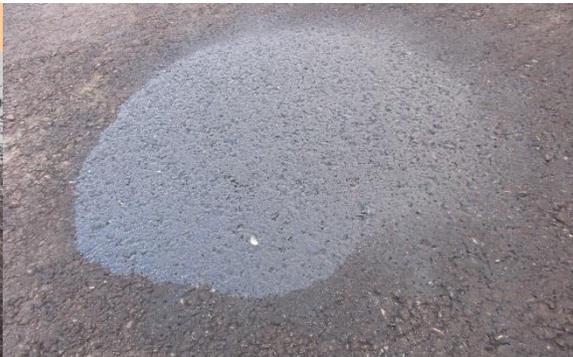
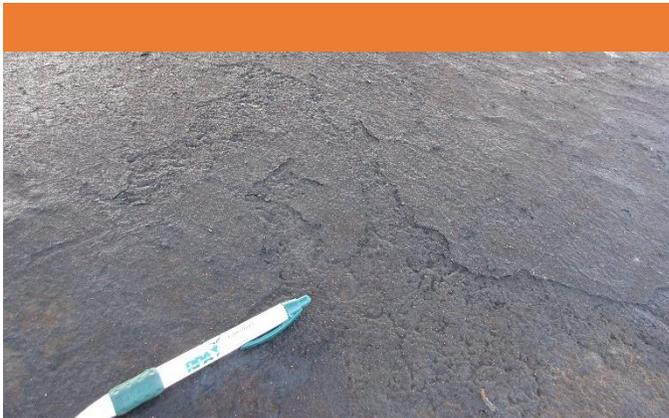
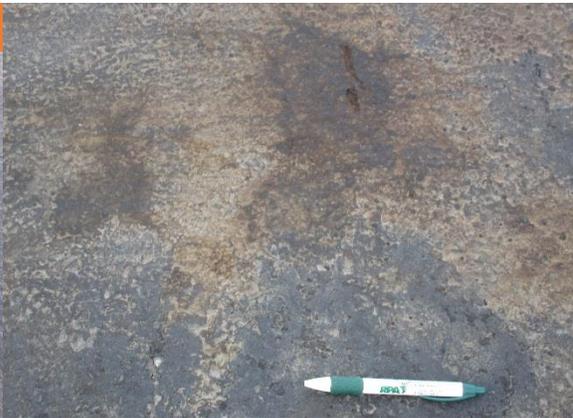
# “Oil” Spillage

**Causes:** Spills, leaks, accidents, etc.

**Yes/No** Spillage exists.  
Repair: Do nothing / Partial or full depth patch

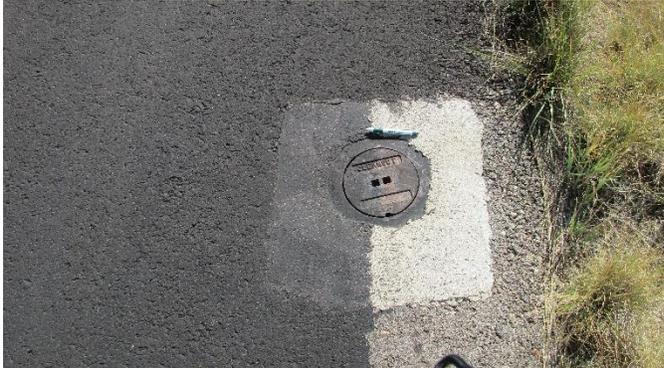
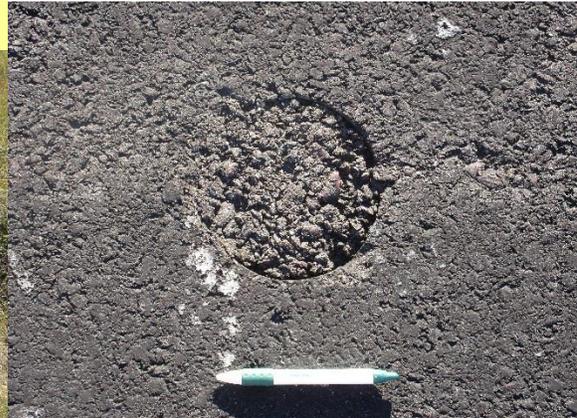
## Light

Patch is in good condition and performing satisfactorily.  
**Repair:** Do nothing

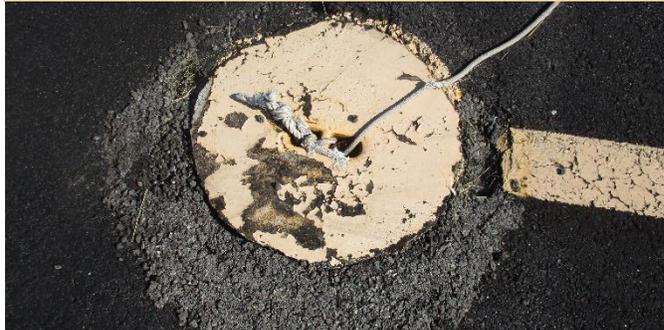
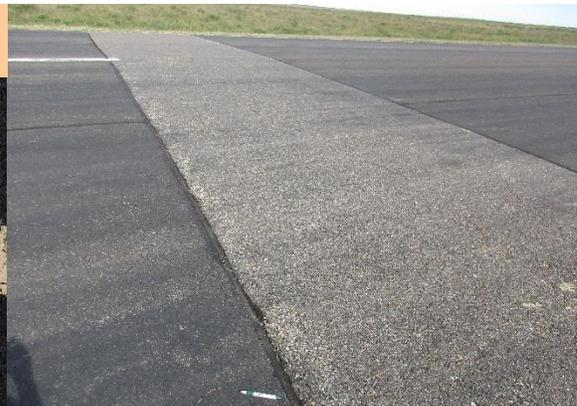
## Medium

Patch and/or patch joint has deteriorated and/or affects riding quality.  
**Repair:** Seal cracks / Repair distress in patch / Replace patch

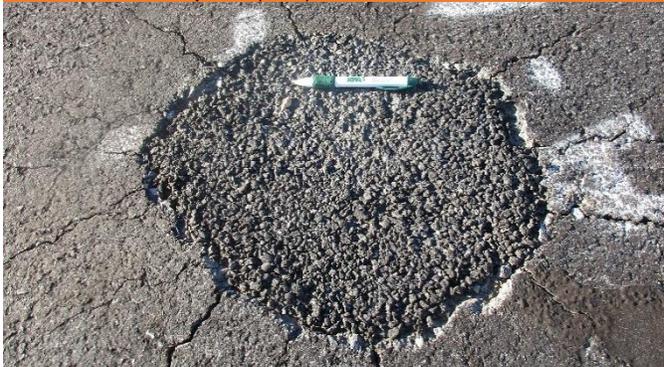
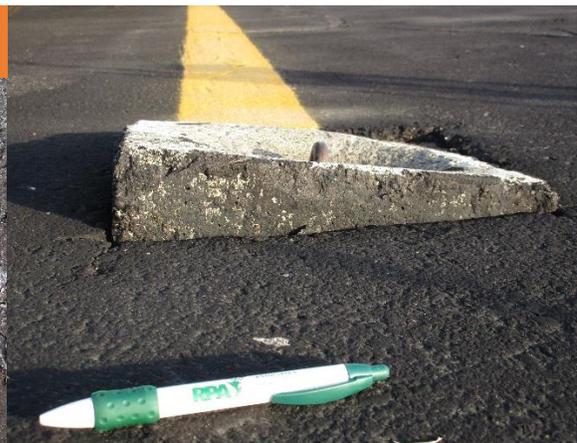
## High

Patch and/or patch joint has badly deteriorated resulting in high FOD potential and poor ride quality.  
**Repair:** Replace patch

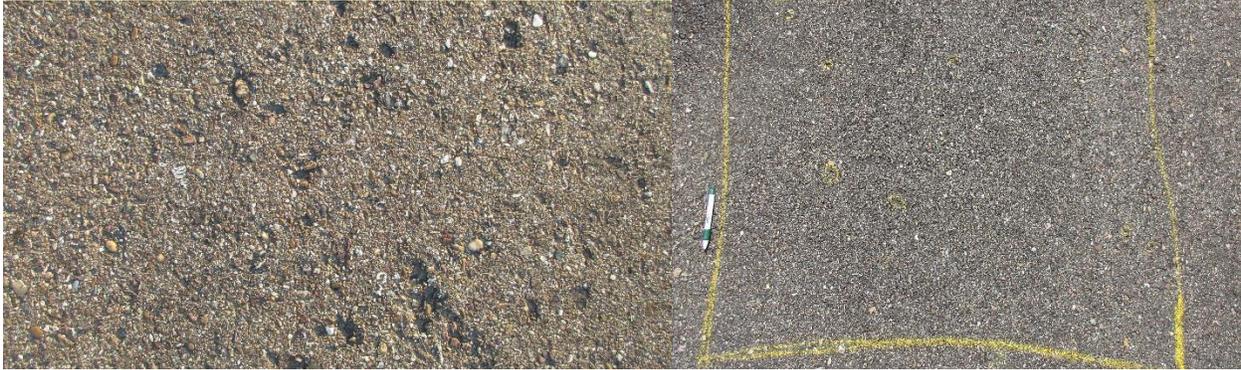
In a square yard, the number of aggregate particles missing is between 5 and 20. There is little to no FOD potential.  
**Repair:** Do nothing

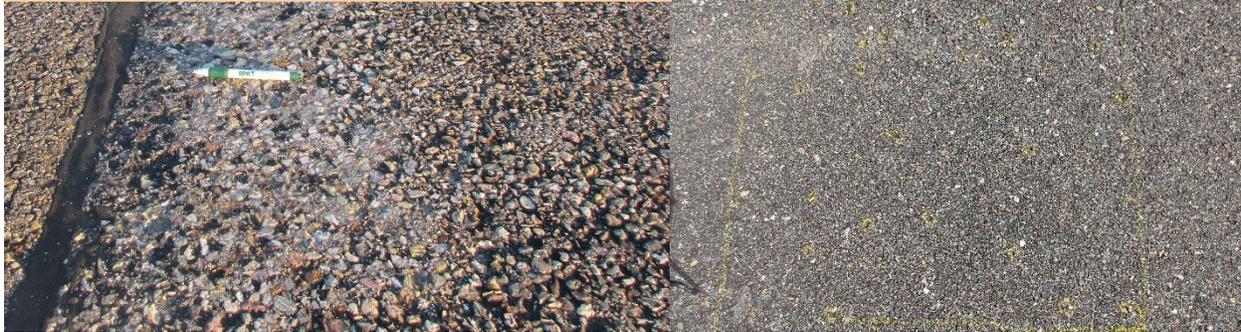
## Medium

In a square yard, the number of aggregate particles missing is between 21 and 40. There is some FOD potential.  
**Repair:** Surface seal

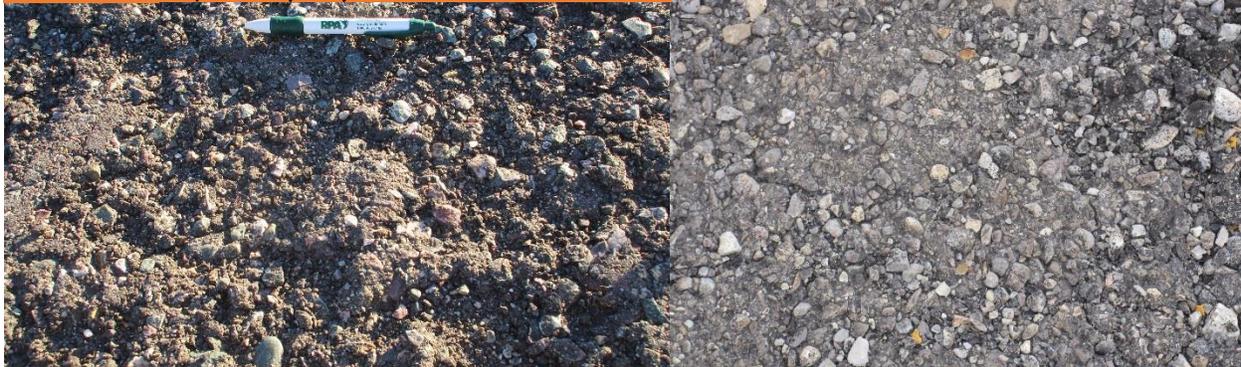
## High

In a square yard, the number of aggregate particles missing is over 40. There is significant FOD potential.  
**Repair:** Overlay / Recycle / Reconstruct

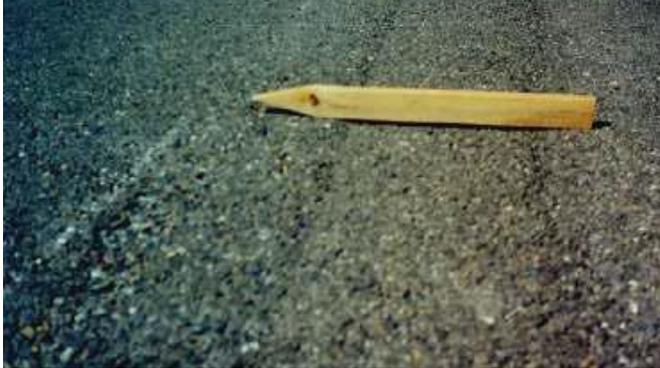
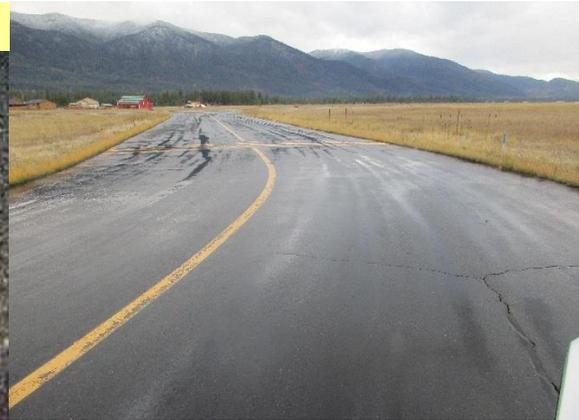
## Light

¼ - ½ inch mean depth.  
**Repair:** Do nothing

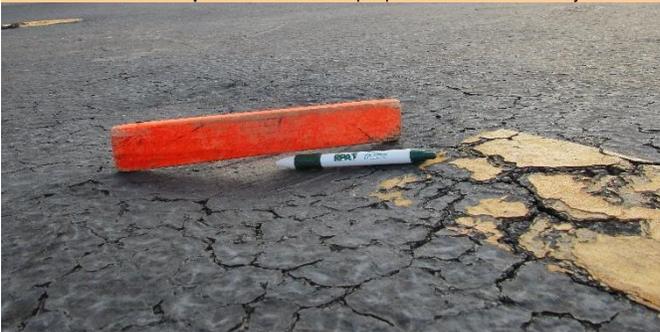
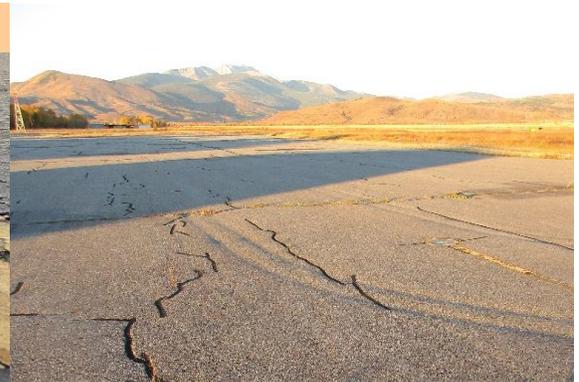
## Medium

> ½ inch ≤ 1 inch mean depth.  
**Repair:** Partial or full depth patch / Patch and overlay

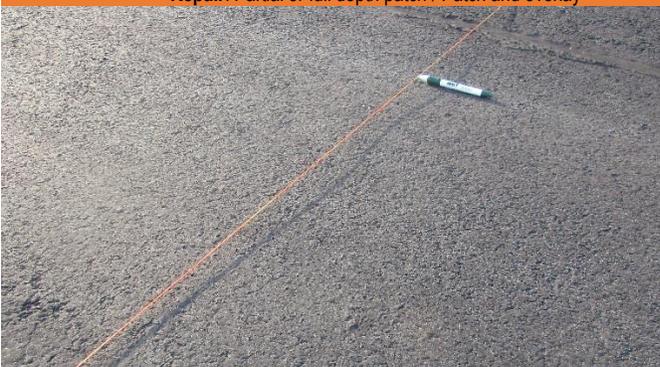
## High

> 1 inch mean depth.  
**Repair:** Partial or full depth patch / Patch and overlay

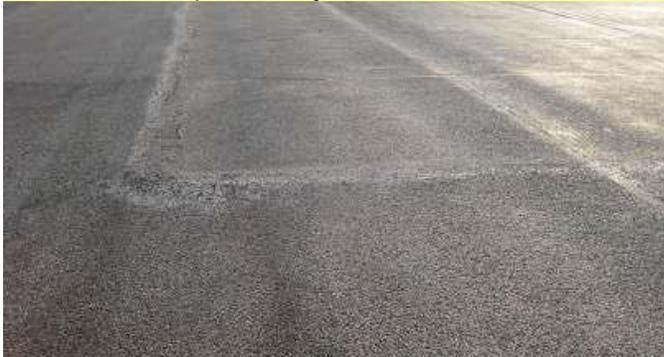
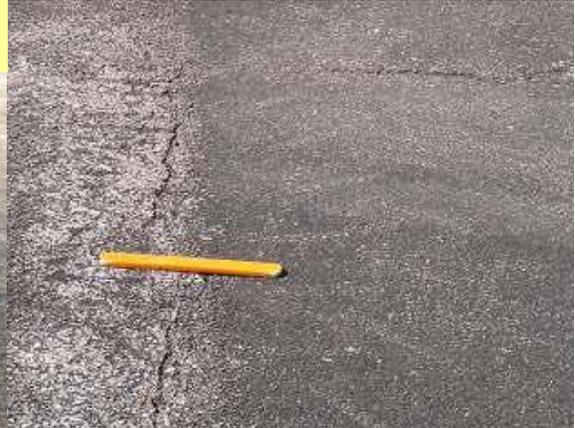
## Light

A slight amount of shoving has occurred with little effect on ride quality and no asphalt break-up.  
**Repair:** Do nothing

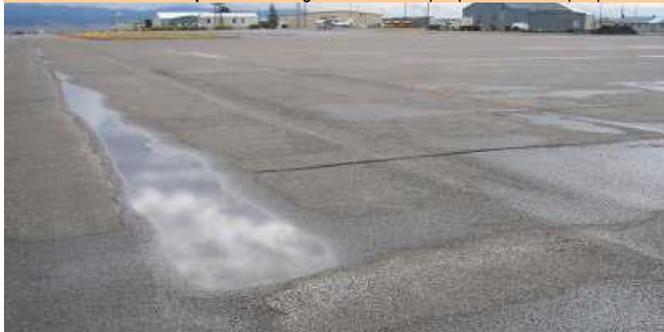
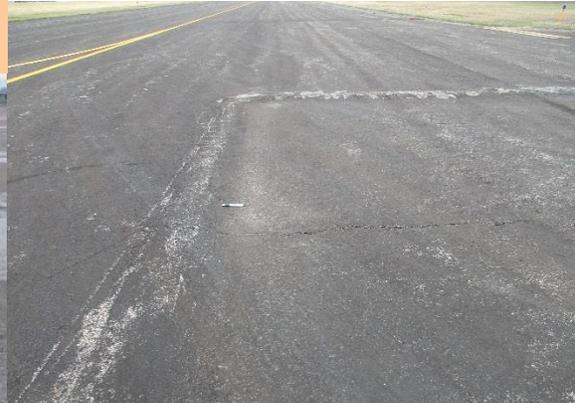
## Medium

A significant amount of shoving has occurred causing moderate roughness and little or no asphalt break up.  
**Repair:** Surface grind / Partial depth patch / Full depth patch

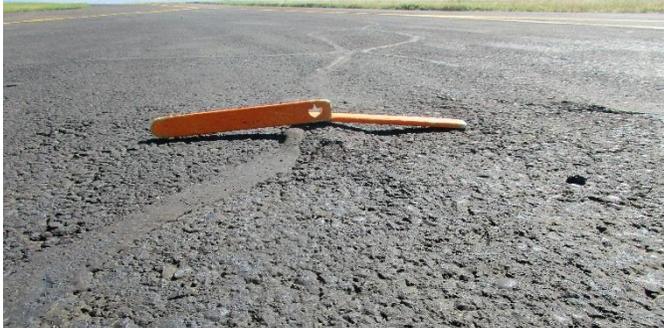
## Medium

3/4 - 1 1/2 inches height differential.  
**Repair:** Reconstruct / Patch / Surface grind

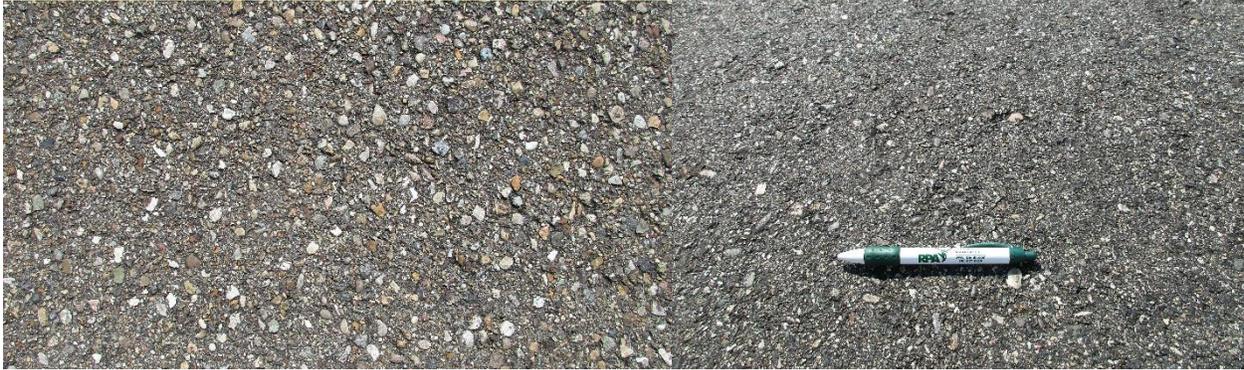
**Repair:** Do nothing

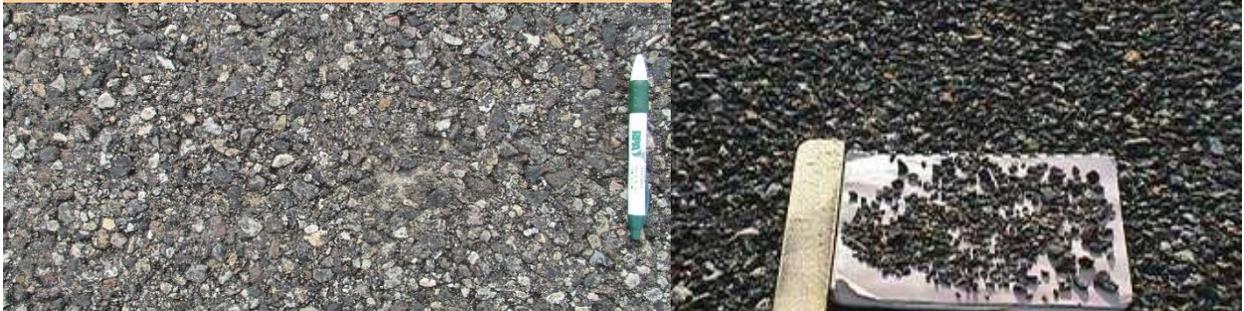
## Medium

Loss of fine aggregate matrix is noticeable and edges of coarse aggregate are exposed up to 1/4 width (of the longest side) of the coarse aggregate.

**Repair:** Surface seal

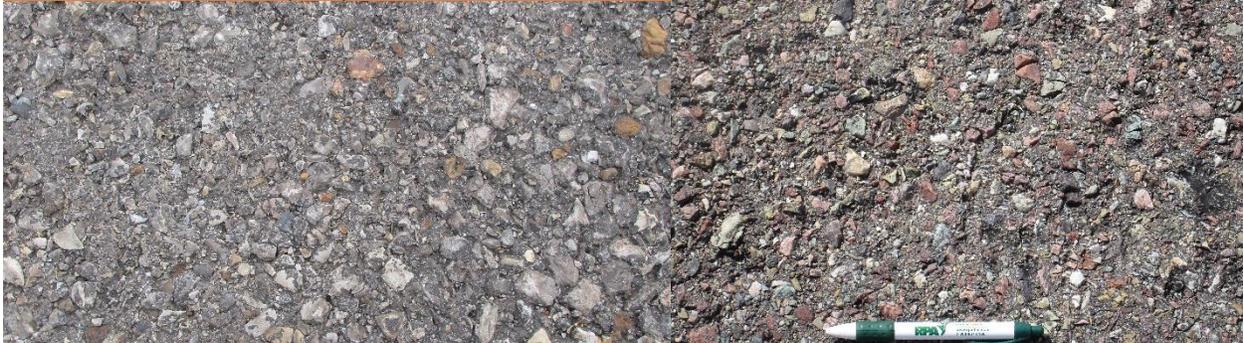
## High

Edges of coarse aggregate have been exposed greater than 1/4 width (of the longest side) of the coarse aggregate and considerable loss of the fine aggregate matrix.

**Repair:** Overlay / Recycle / Reconstruct

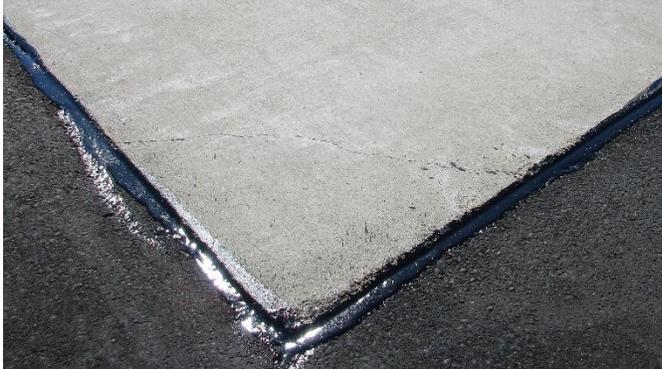
## Light

Crack has either no spalling or minor spalling (no FOD potential) with a mean width less than approximately 1/8 inch.  
**Repair:** Do nothing / Seal cracks / Undersealing project

**Description:** A crack that intersects the joints at a distance less than or equal to one-half the slab length on both sides, measured from the corner of the slab. The crack extends vertically through the entire slab thickness.

**Causes:** Load repetition combined with loss of support and curling stresses.

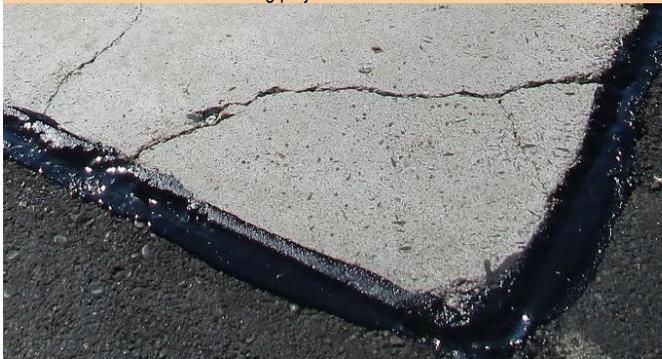
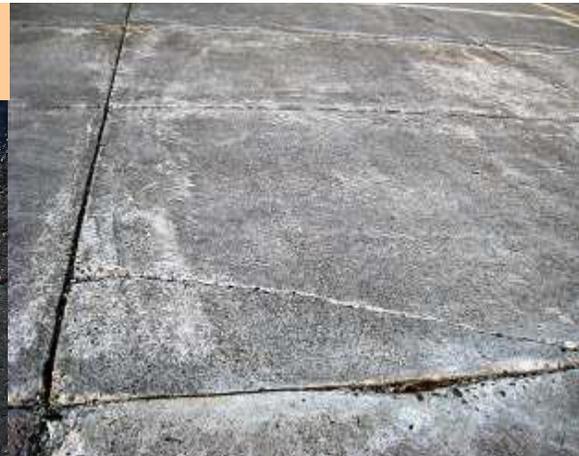
## Medium

A nonfilled crack has a mean width between 1/8 and 1 inch, moderately spalled, failed filler.  
**Repair:** Seal cracks / Full depth patch / Slab replacement / Undersealing project

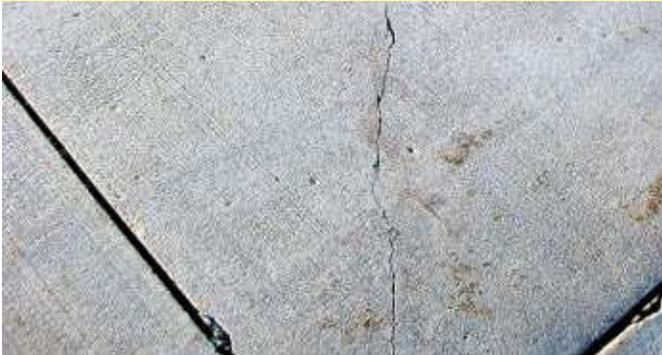
## Light

Crack has either no spalling or minor spalling (no FOD potential) with a mean width less than approximately  $\frac{1}{8}$  inch. Filler in unsatisfactory condition or slab is divided into three pieces by low severity cracks.  
**Repair:** Do nothing / Seal cracks

**Description:** Cracks that divide the slab into two or three pieces.

**Causes:** Load repetition, curling stresses and shrinkage stress.

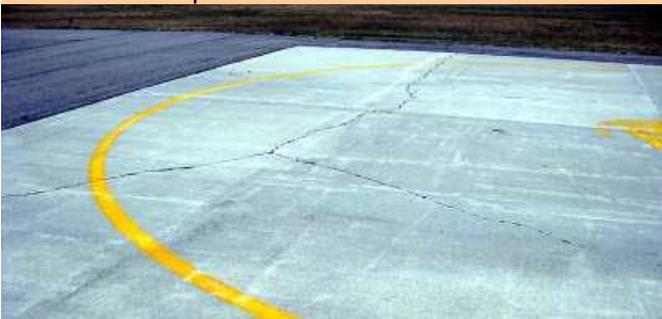
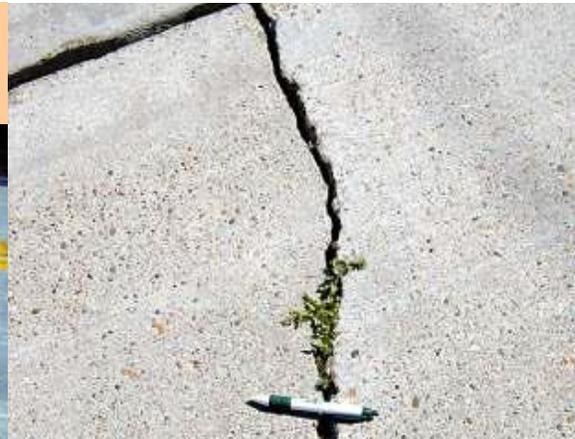
## Medium

Moderately spalled, a nonfilled crack has a mean width between  $\frac{1}{8}$  inch and 1 inch. Filler in unsatisfactory condition or slab is divided into three pieces by two or more cracks, one of which is at least medium severity.  
**Repair:** Seal cracks

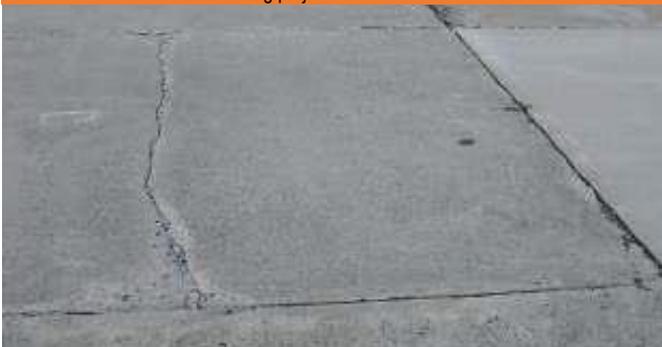
## High

Severely spalled and a nonfilled crack has a mean width approximately greater than 1 inch.  
**Repair:** Seal cracks / Full depth patch / Slab replacement / Undersealing project

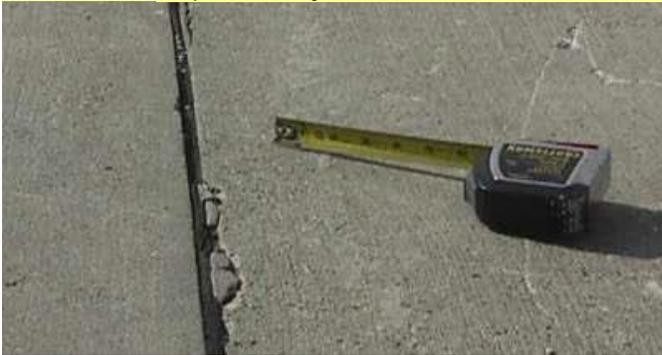
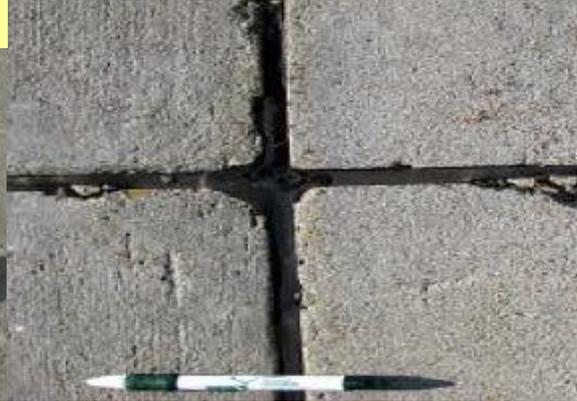
## Light

Sealant is performing well with minor, if any, damage.  
**Repair:** Do nothing

**Description:** Any condition that allows significant infiltration of water or enables soil or rocks to accumulate in the joints preventing the slabs from expanding (may result in slab buckling, shattering, or spalling). Sealant hardens and cracks, loses edge bond, doesn't fill the joint, or has weed penetration.

**Causes:** Reduced pliability from weathering, or poor construction practices. .

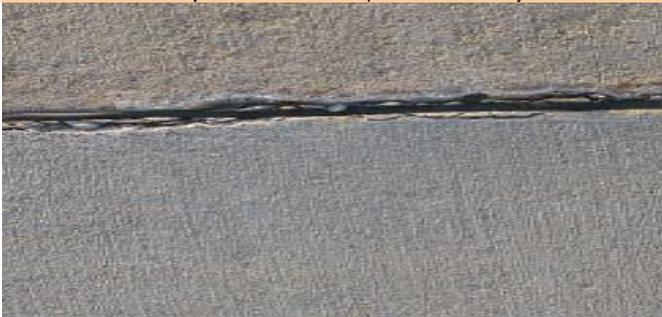
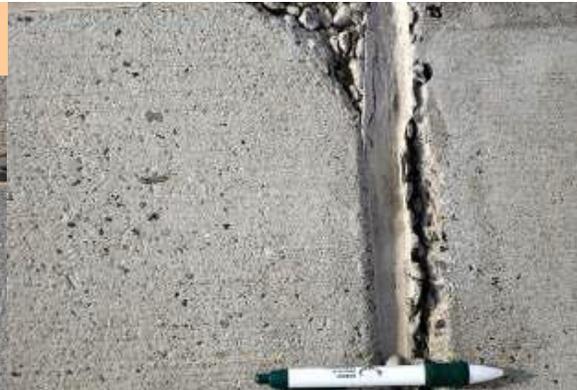
## Medium

Joints sealer is in generally fair condition with some moderate damage.  
**Repair:** Sealant needs replacement within 2 years

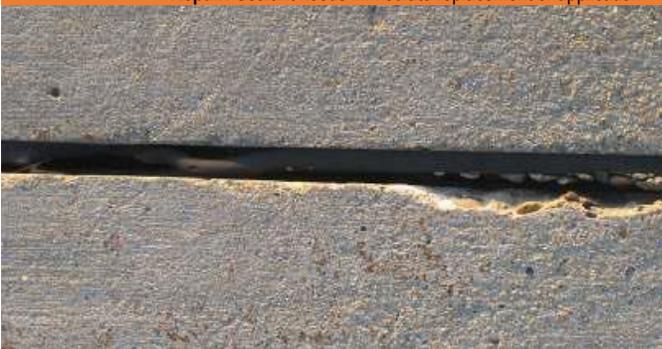
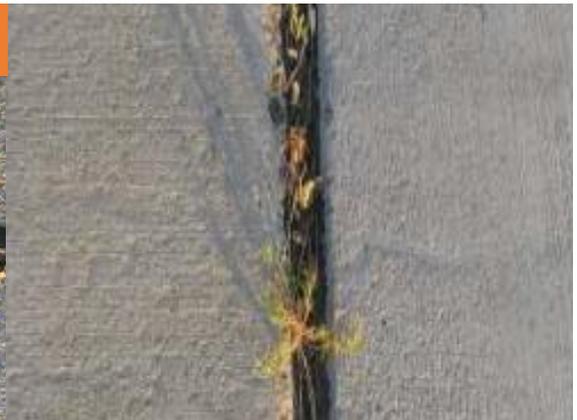
## High

Joint sealer is in generally poor condition or lacking over the entire surveyed section.  
**Repair:** Sealant needs immediate replacement or application

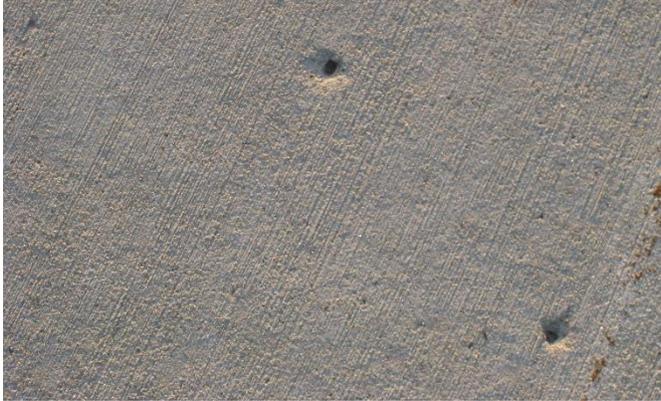
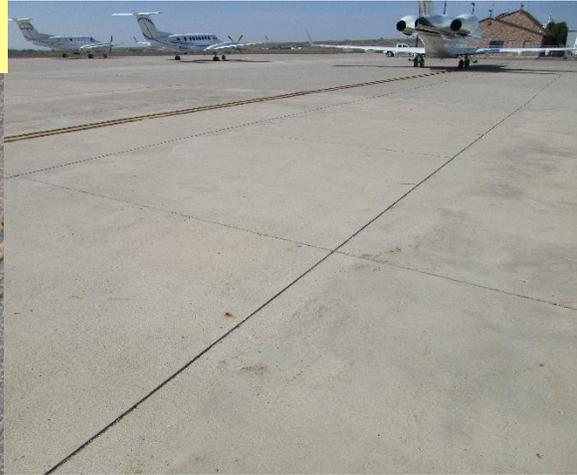
# Popouts

**Description:** A small inverted cone of concrete that breaks loose from the surface ranging from 1 to 4 inches in diameter and 1/2 to 2 inches deep.

**Causes:** Freeze thaw action and/or expansive aggregate.

**Yes/ No** Average density should exceed over 3 per square yard over the entire slab.  
**Repair:** Do nothing / Replace slab

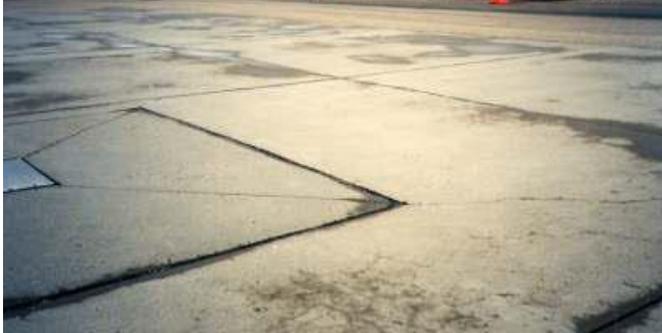
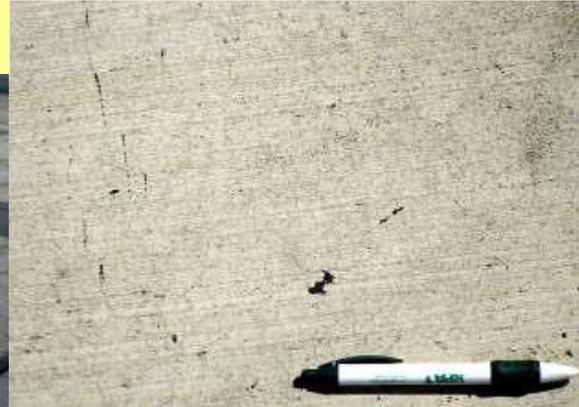
## Light

Crazing or map cracking exists over most of the slab area; the surface is in good condition with no scaling.  
**Repair:** Do nothing

**Description:** A network of shallow, fine, or hairline cracks tending to intersect at angles of 120 degrees, which extend only through the upper surface of the concrete. May lead to “scaling” of the surface (the breakdown of the slab’s top approximate 1/4” – 1/2”).

**Causes:** Reduced pliability from weathering, or poor construction practices.

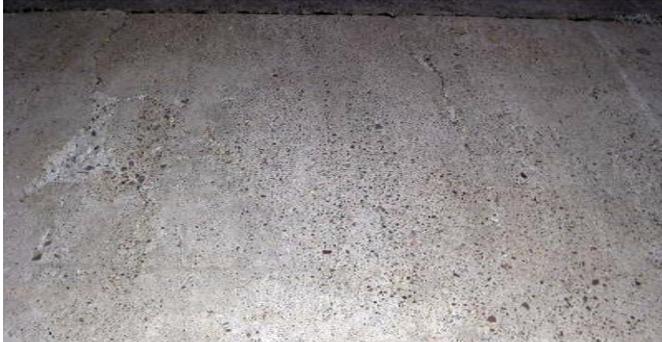
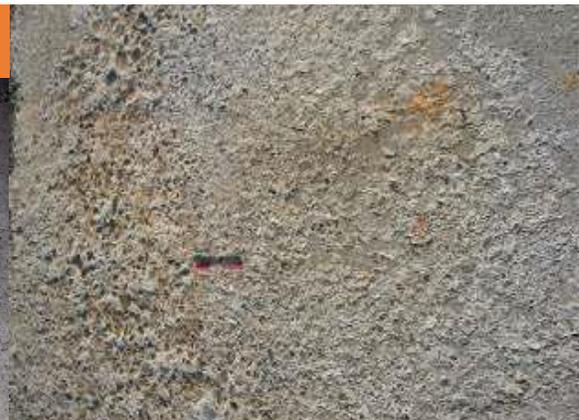
## High

Slab is severely scaled causing a high FOD potential. Usually more than 5 percent of the surface is affected.  
**Repair:** Slab replacement
