## AVIATION SYSTEM PLAN - 2015 UPDATE

### PAVEMENT CONDITION INDEXES

**A.I.P. 3-30-0000-013-2015**

### Montana Department of Transportation - Aeronautics Division

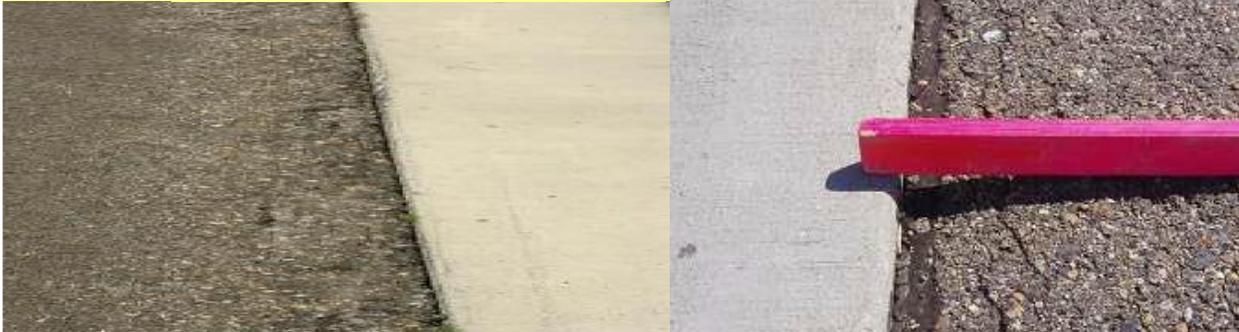
Edge elevation difference: Runways and Taxiways: ¼ inch,  
Aprons ⅙ - ½ inch.  
**Repair:** Do nothing / Joint seal / Injection-fill under slab /  
Underseal

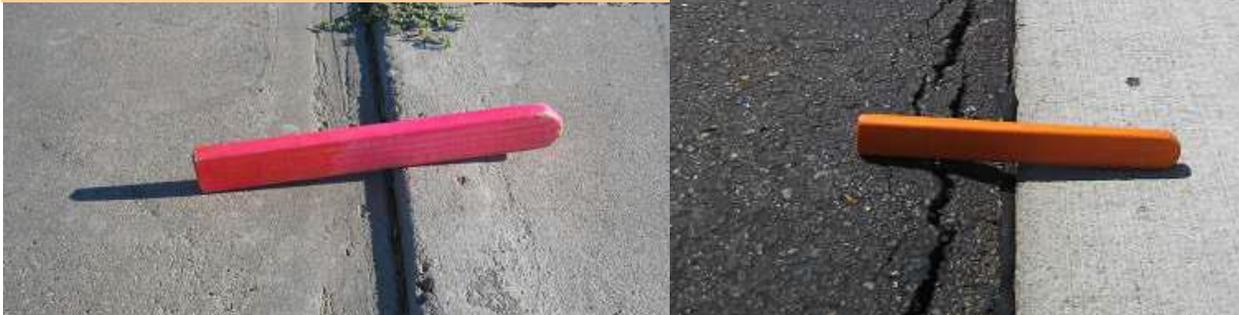
## Medium

Edge Elevation Difference: Runways and Taxiways: ¼ - ½ inch,  
Aprons: ½ - 1 inch.  
**Repair:** Slab grinding / Joint seal / Injection-fill under slab /  
Underseal

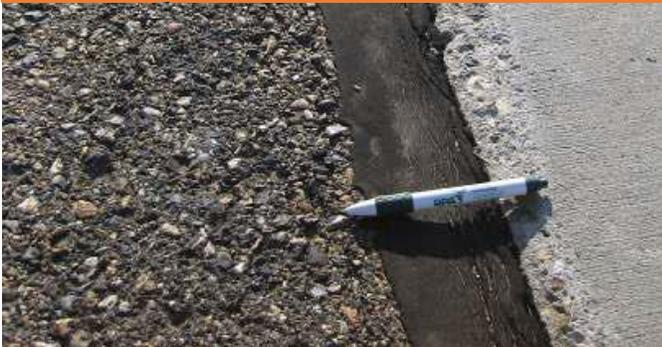
## High

Edge Elevation Difference: Runways and Taxiways: > ½ inch  
Aprons: > 1 inch.  
**Repair:** Slab grinding / Joint seal / Injection-fill under slab /  
Underseal

**Description:** A difference of elevation at a joint or crack.

**Causes:** Water intrusion into expansive subgrades, base course leach-out and consolidation or contamination, and/or poor construction practices.

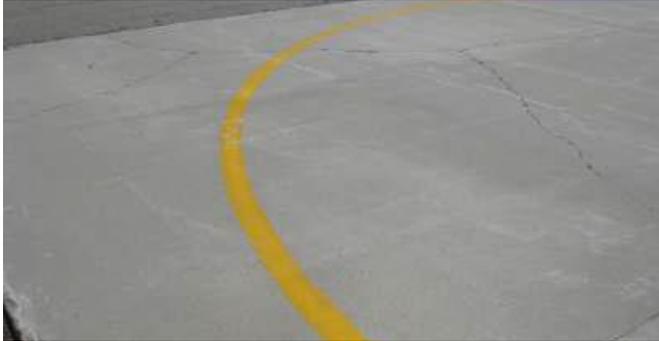
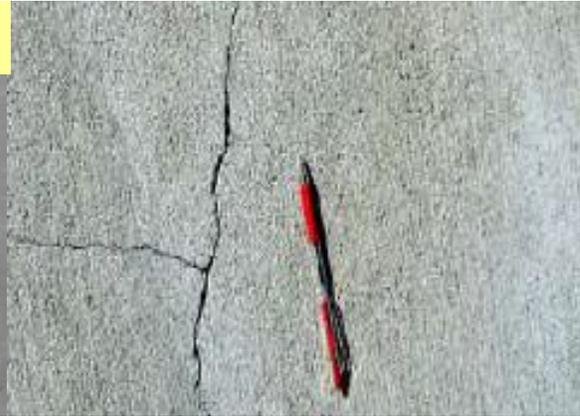
## Light

The slab is broken into 4 or 5 pieces with over 85% of the cracks of low severity.  
**Repair:** Seal cracks

**Description:** The slab is broken into four or more pieces, not all contained in a corner break

**Causes:** Overloading or inadequate support of the slab.

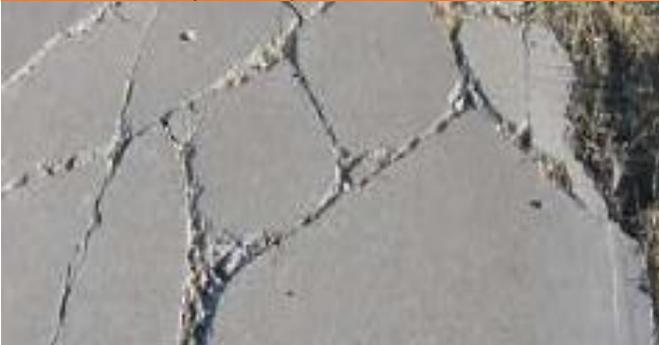
## High

The slab is broken into 4 or 5 pieces with some or all of the cracks of high severity or the slab is broken into 6 or more pieces with over 15% of the cracks of medium or high severity.  
**Repair:** Slab replacement

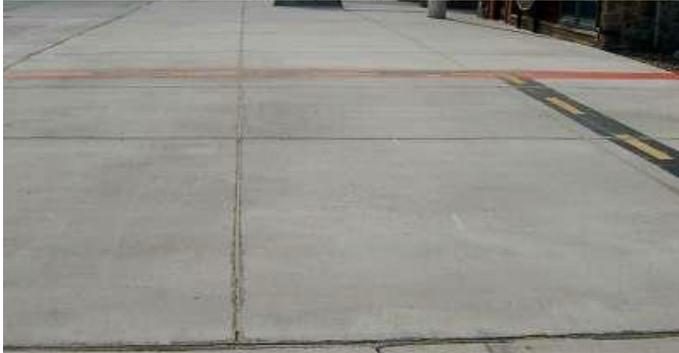
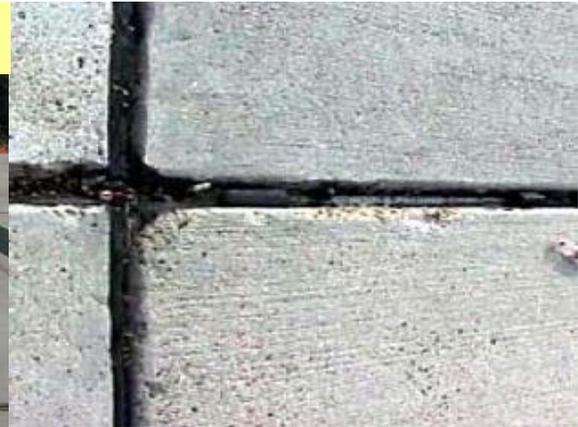
## Light

Corner edges are lightly frayed with few pieces (little or no FOD potential).  
**Repair:** Do nothing

**Description:** The raveling or breakdown of the slab within approximately 2 feet of the corner. Spalls angle downward to intersect the joint, not vertically through the slab.

**Causes:** Infiltration on incompressible materials, excessive traffic loads, or weak (overworked) concrete at the joint.

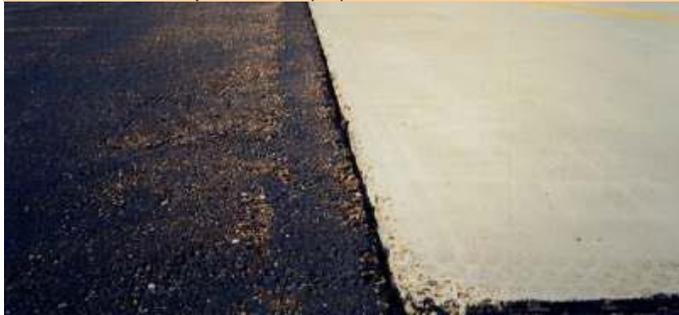
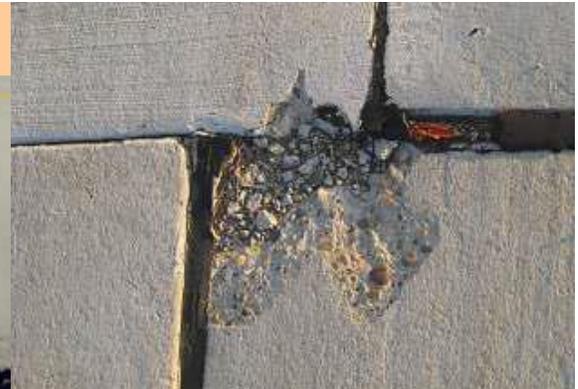
## Medium

Moderately frayed edge, fractured pieces may be loose or absent (some FOD or tire damage potential).  
**Repair:** Partial depth patch

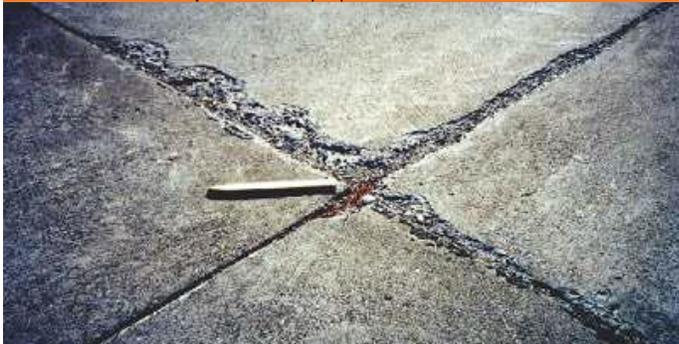
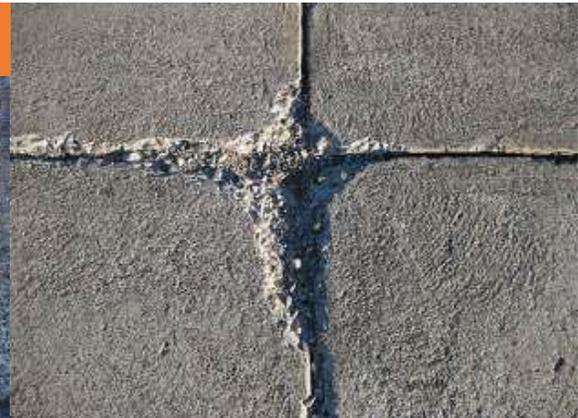
## High

Severely frayed, high severity cracks, fractured pieces absent (high FOD or tire damage potential).  
**Repair:** Partial depth patch

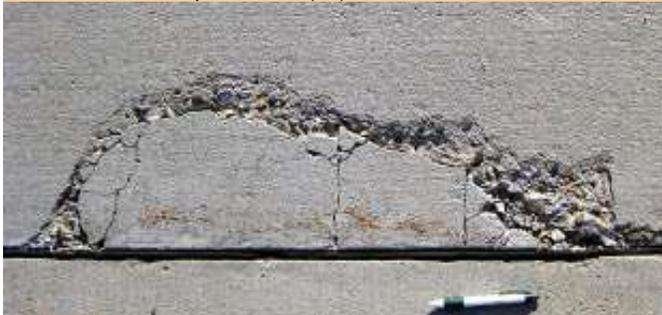
## Medium

Moderately frayed edge, fractured pieces may be loose or absent (some FOD or tire damage potential).  
**Repair:** Partial depth patch

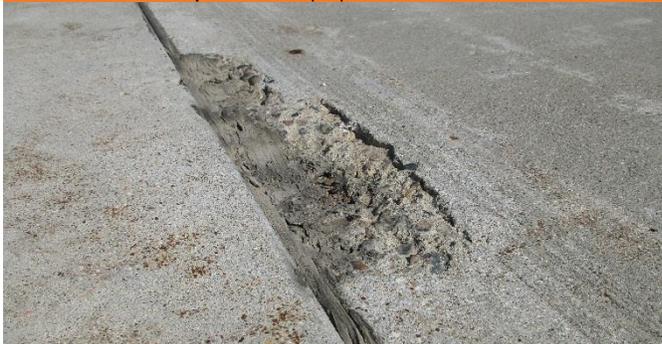
## High

Severely frayed, high severity cracks, fractured pieces absent (high FOD or tire damage potential).  
**Repair:** Partial depth patch
