MONTANA DEPARTMENT OF TRANSPORTATION WETLAND MITIGATION MONITORING REPORT: YEAR 2009

Ringling - Galt Ringling, Montana

MDT Project Number F 59-2(4)49 Control Number N1513

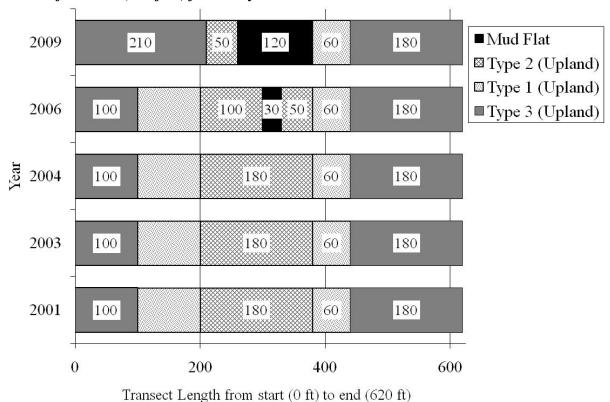
Chart 1: Transect maps showing vegetation types from the start of transect (0 feet) to the end of transect (620 feet) for each year monitored.

Vegetation transect results are detailed in the **Monitoring Form** (**Appendix B**), and are summarized in the transect map (**Chart 1**). Sagebrush communities dominate the landscape with the exception of a narrow band along the Agate Creek channel, where sagebrush does not persist. This area showed little change in 2009 with trace amounts of hydrophytic vegetation appearing along the channel as a result of inundation. The primary change though was the conversion of upland grass to mud flat. Inundation was sufficiently long to kill the existing upland grasses, but was not replaced in 2009 by emergent wetland species except in trace amounts as previously mentioned. Continued inundation in 2010 and beyond would further advance the conversion to wetland habitat in the analysis area

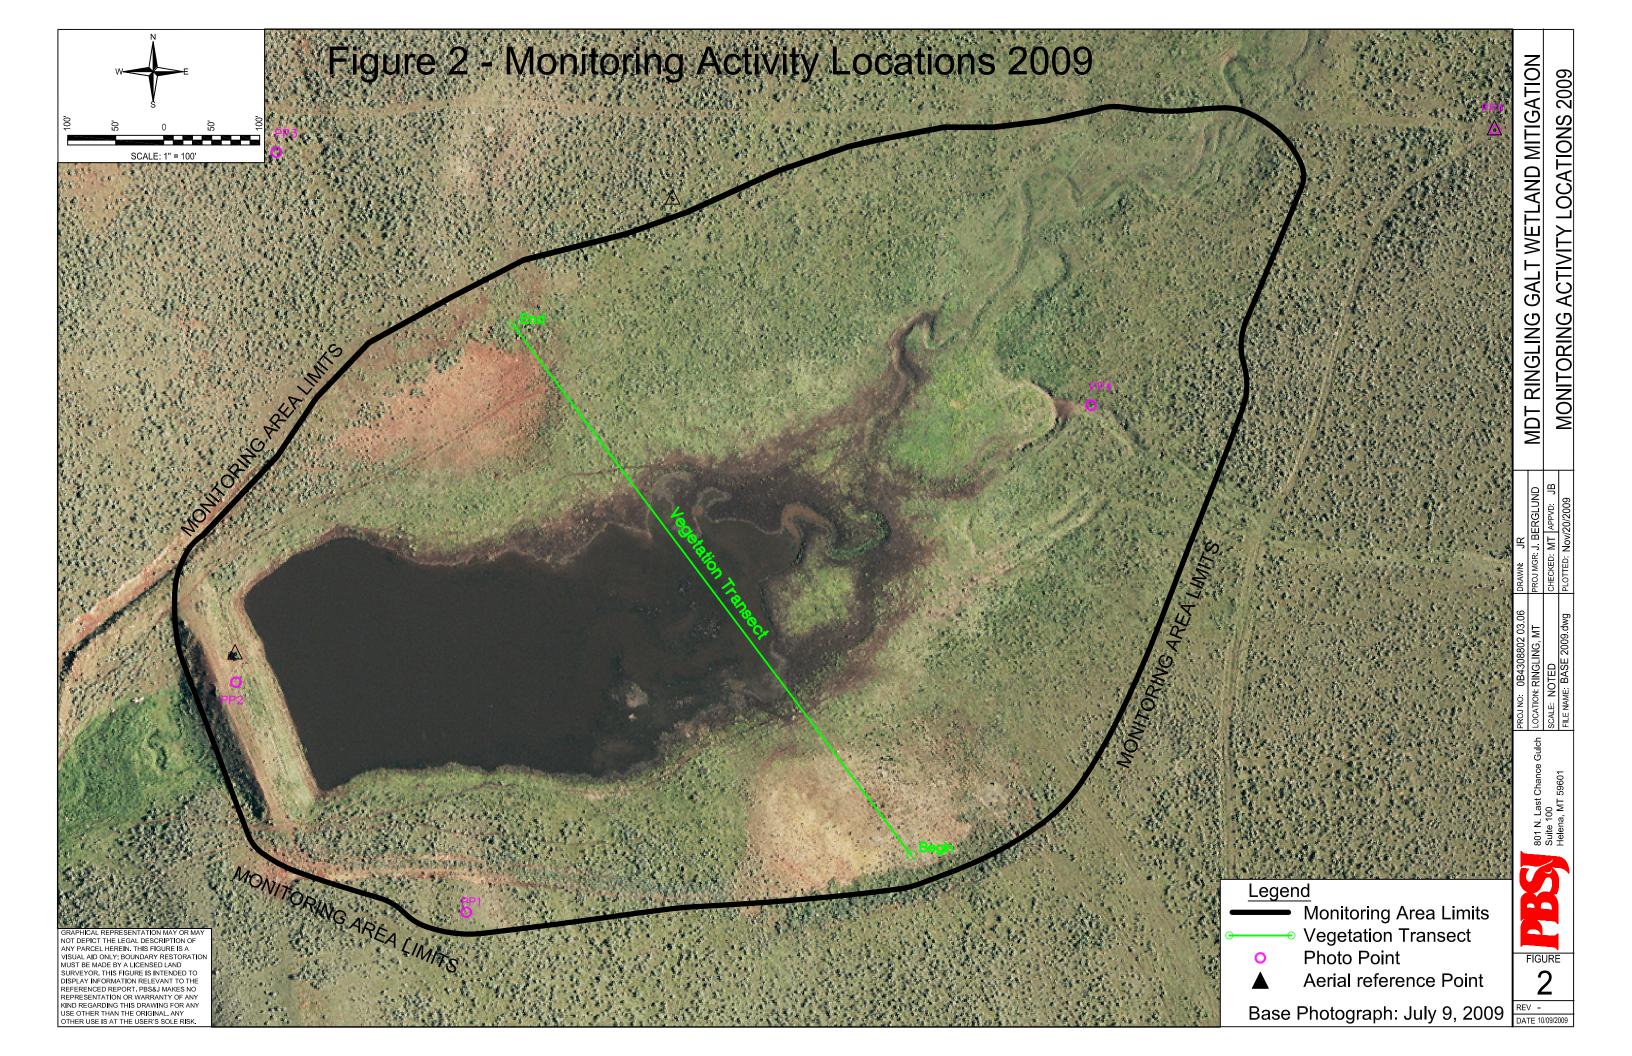
Figure 2 Monitoring Activity Locations 2009

In May 2000, the U.S. Army Corps of Engineers (COE) determined that this site could not be used as permanent mitigation for the Ringling – North project due to the lack of a perpetual conservation easement (COE 2000). Periodic monitoring of the site proceeded in order to document the establishment of wetland habitat to be used as mitigation should the landowner agree to a perpetual conservation easement in the future. The monitoring area is illustrated in **Figure 2** (**Appendix A**).

The 10-foot wide belt transect that was established in 2001 was evaluated for the fifth time **Figure 2** (**Appendix A**). Percent cover was estimated for each successive vegetative species encountered within the "belt" using the following values: + (<1%); 1 (1-5%); 2 (6-10%); 3 (11-20%); 4 (21-50%); and 5 (>50%). The purpose of the transect was to evaluate changes over time, especially the establishment and increase of hydrophytic vegetation. The transect location was marked on the air photo and all data recorded on the mitigation site monitoring form. Transect endpoint locations were initially recorded in 2001 with a global positioning system (GPS) unit. Photographs were taken along the transect from both end points.

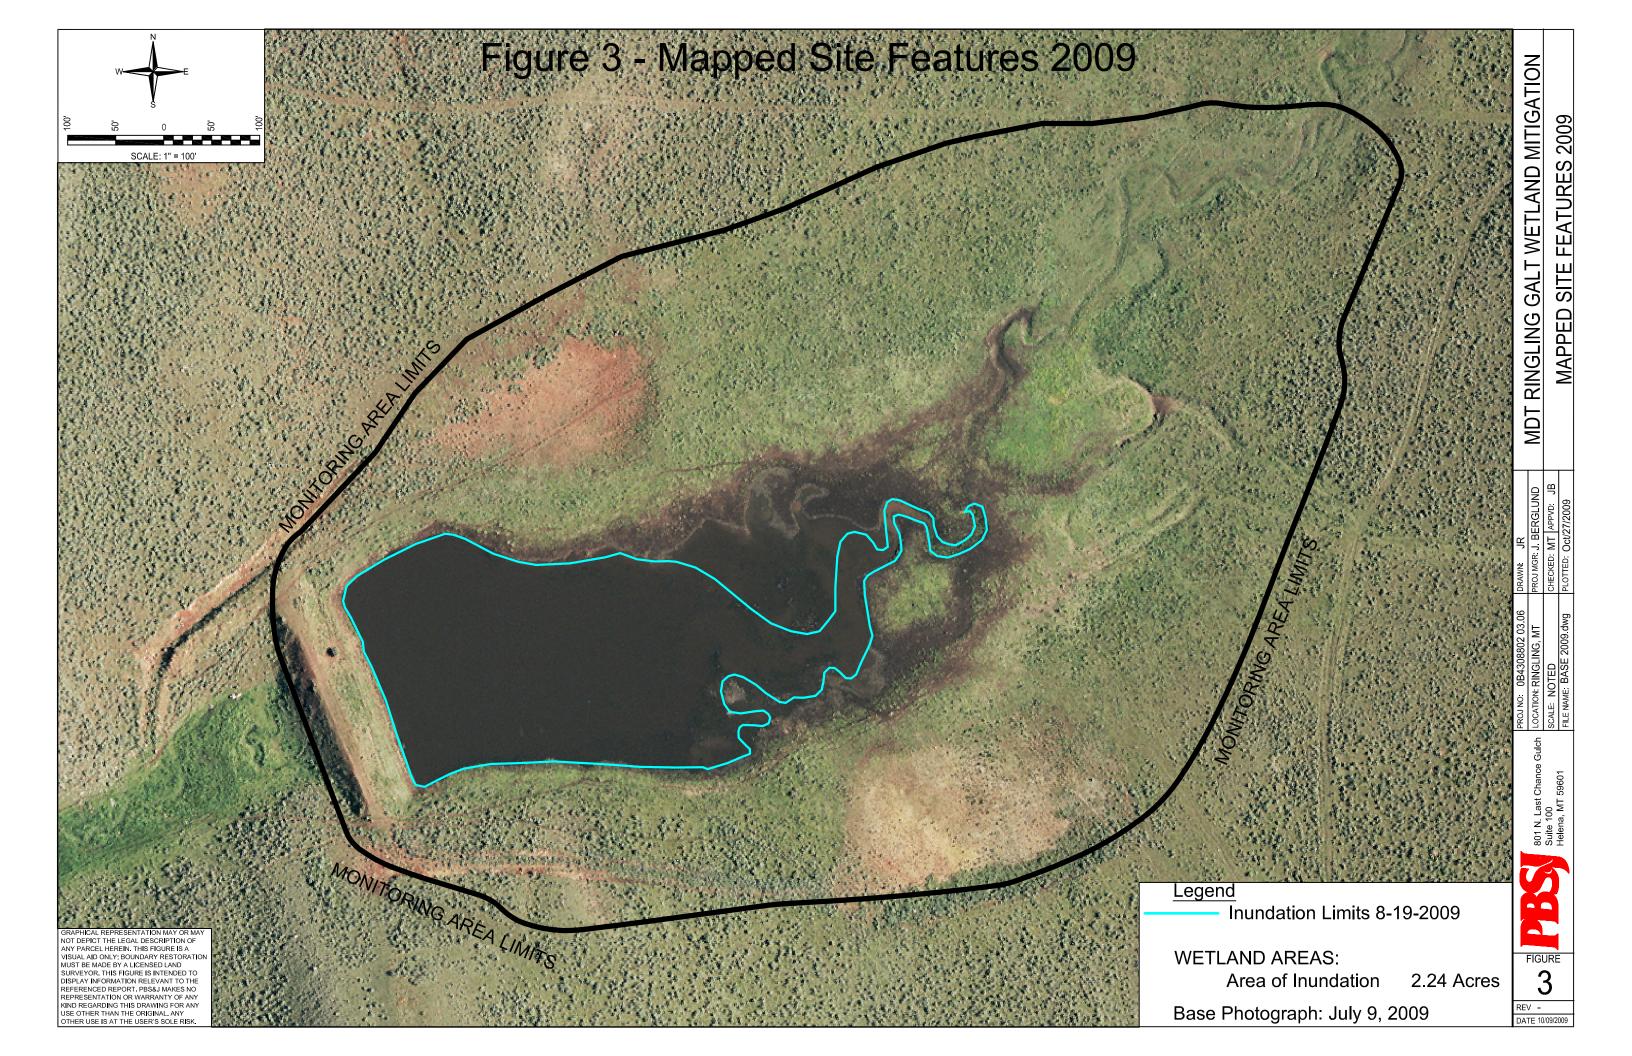
Figure 3 Mapped Site Features 2009

The July 9, 2009 aerial photograph was used as the base for **Figures 2** and **3** (**Appendix A**). Photographs were taken in 2009 showing the current land use surrounding the site, upland buffer, monitored area, and vegetation transect (**Appendix C**). Four photograph points were established and recorded with a resource grade GPS unit in 2001. All photographs were taken using a digital camera. A description and compass direction for each photograph was recorded on the Wetland Mitigation Site Monitoring Form (**Appendix B**).
