**MONTANA DEPARTMENT OF TRANSPORTATION  
WETLAND MITIGATION MONITORING REPORT: YEAR 2012**

*Camp Creek  
Ravalli County, Montana*

December 2012

MDT Project Number NH 41(24)  
Control Number 1285

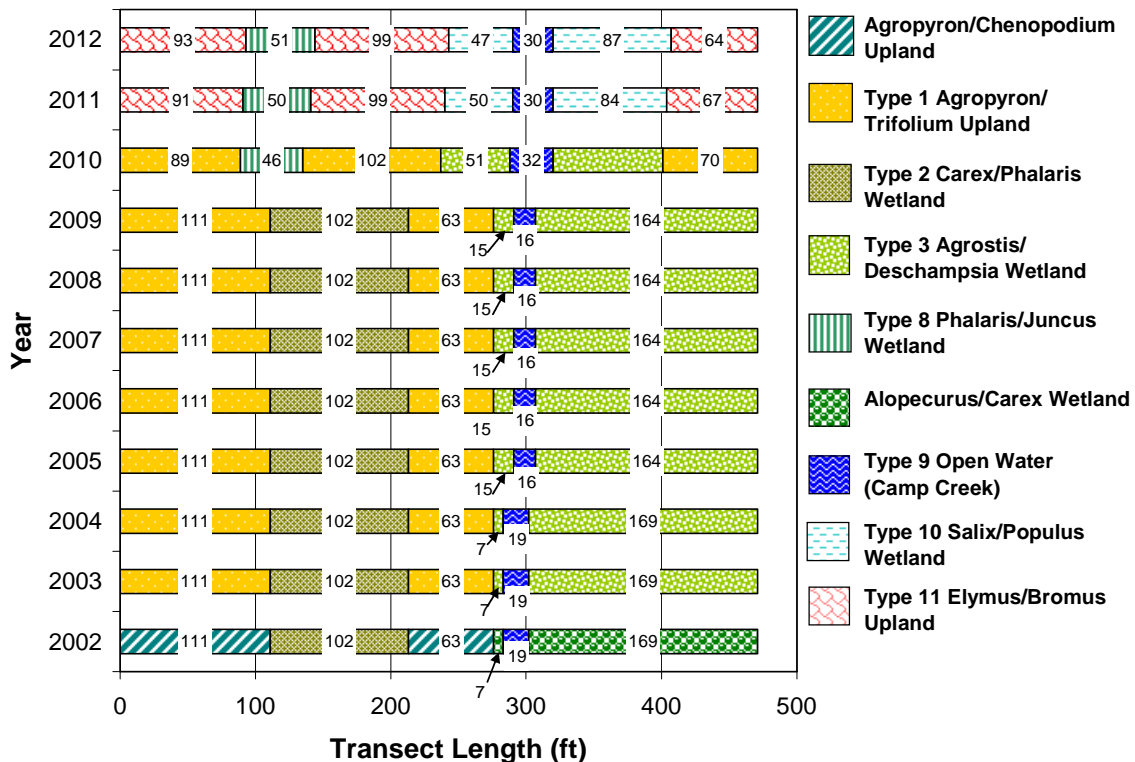
**Chart 6. Transect 1 maps showing vegetation types from transect start (0 feet) to finish (471 feet) from 2002 to 2012.**

Monitoring Year	2002	2003	2004	2005	2006	2007	2008	2009	2010	2011	2012
Transect Length (feet)	471	471	471	471	471	471	471	471	471	471	471
Vegetation Community Transitions along Transect	4	4	4	4	4	4	4	4	6	6	6
Vegetation Communities along Transect	3	3	3	3	3	3	3	3	3	3	3
Hydrophytic Vegetation Communities along Transect	2	2	2	2	2	2	2	2	2	2	2
Total Vegetative Species	28	27	30	31	31	37	34	36	46	44	48
Total Hydrophytic Species	15	16	17	17	17	17	20	21	30	27	35
Total Upland Species	13	11	13	14	14	20	14	15	16	17	13
Estimated % Total Vegetative Cover	85	95	86	84	84	88	87	87	85	95	95
% Transect Length Comprised of Hydrophytic Vegetation Communities	59	59	59	60	60	60	60	60	40	39	39.3
% Transect Length Comprised of Upland Vegetation Communities	37	37	37	36	36	36	36	36	53	55	54.4
% Transect Length Comprised of Unvegetated Open Water	4	4	4	4	4	4	4	4	7	6	6.4
% Transect Length Comprised of Bare Substrate	0	0	0	0	0	0	0	0	0	0	0

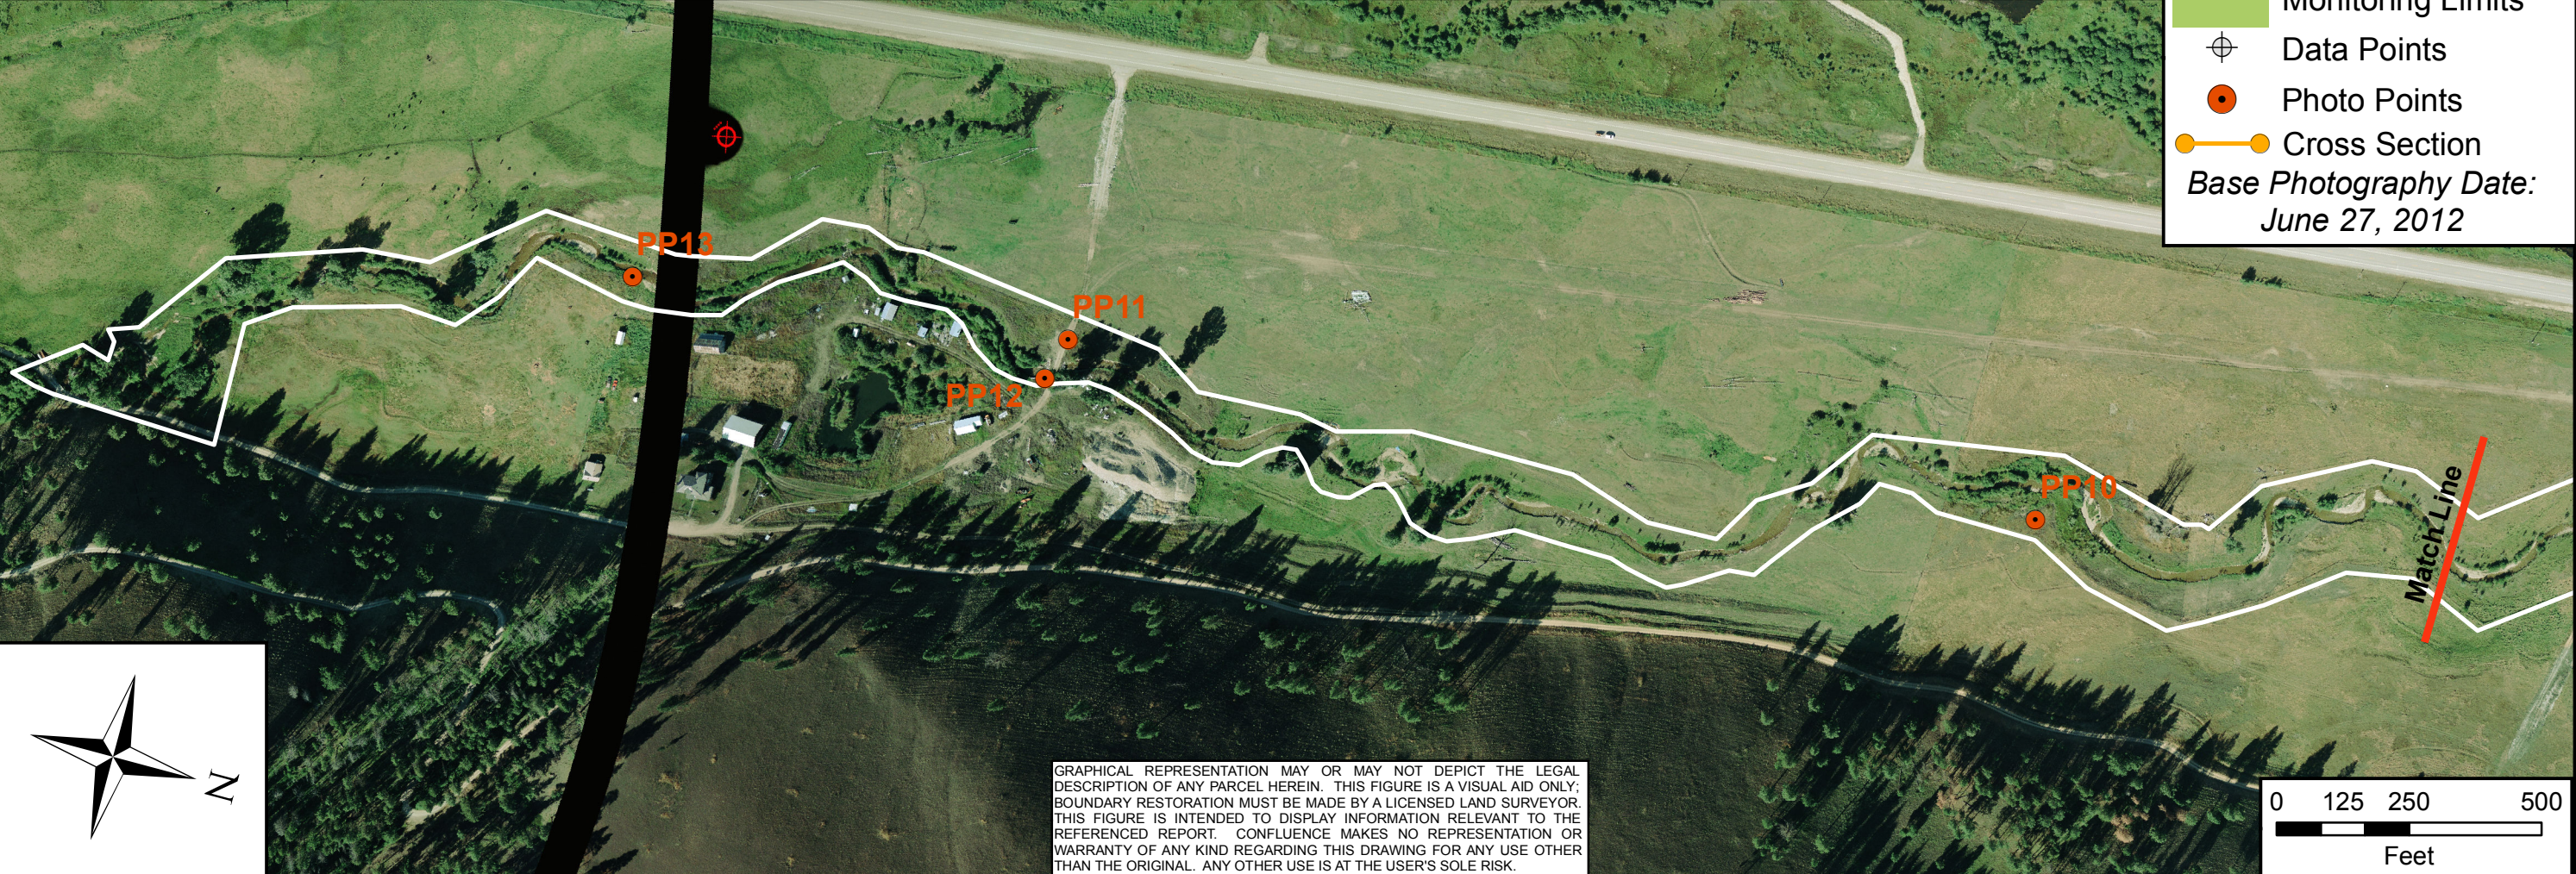
Figure 2: 2012 Monitoring Activity Locations

The presence of hydrologic indicators as outlined on the Wetland Determination Data Form was assessed at three data points established within the project area (Figure 2, Appendix A). Hydrologic indicators were evaluated according to features observed during the site visit. The data were recorded on the electronic Wetland Determination Data Form (Appendix B). Hydrologic assessments allow evaluation of wetland criteria addressing inundation/saturation requirements.

Monitoring at photo points provided supplemental information documenting wetland and upland conditions, trends, current land uses surrounding the site, and vegetation transect changes. Photographs were taken at thirteen established photo points throughout the mitigation site during the site visit. Photographs at the photo points, vegetation transect end points, surveyed cross-sections, and wetland data points are included in Appendix C. Photo point locations were recorded with a sub-meter grade GPS unit (Figure 2, Appendix A).
