# MONTANA DEPARTMENT OF TRANSPORTATION WETLAND MITIGATION MONITORING REPORT: YEAR 2013

*I-90 East Bozeman  
Gallatin County, Montana*

MDT Project Number STPX-0016(057)  
Control Number 5710

SPA # MDT-R3-62-2007  
Corps #: NWO-2007-3408-MTH

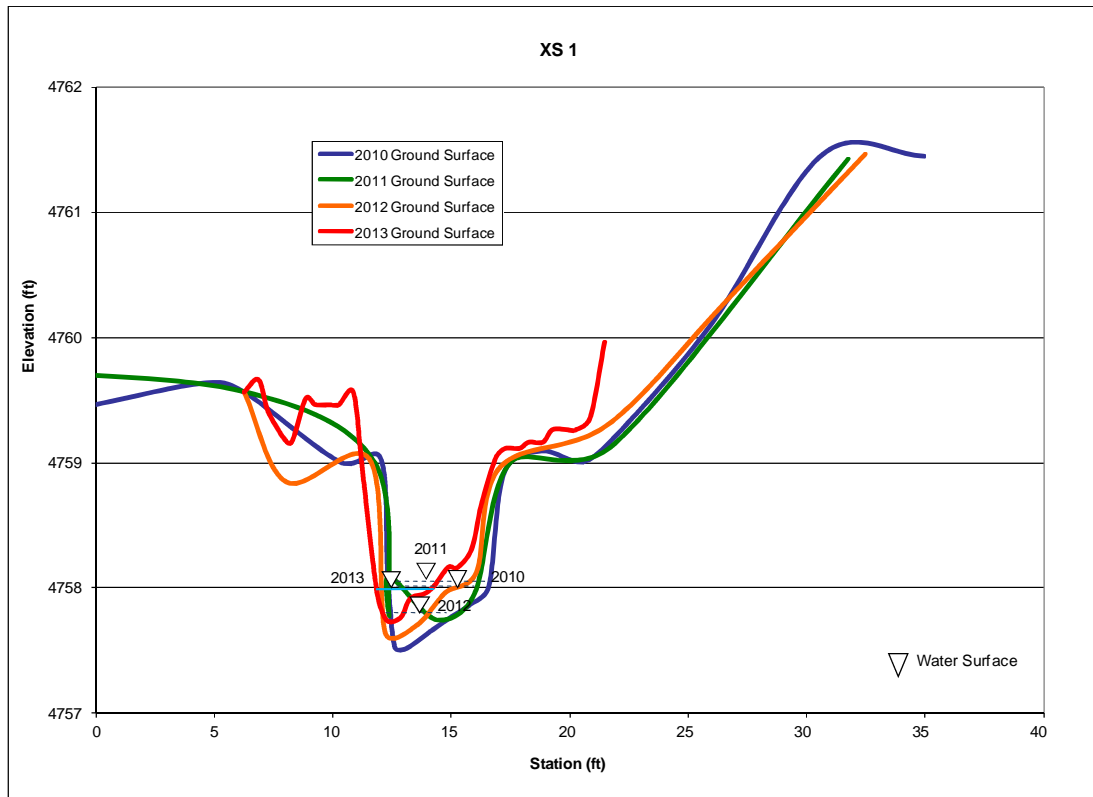
**Chart 1. Survey data collected at cross-section 1 from 2010 to 2013.**

Cross-section 1 has remained stable and has not displayed any notable lateral adjustment from 2010 to 2013 (Chart 1). The banks of this cross-section are entirely vegetated with reed canarygrass (*Phalaris arundinacea*) and exhibit highly-stable conditions. Approximately two inches of accumulation of fine-sediment streambed material was noted on the right side of the channel bottom in 2013.

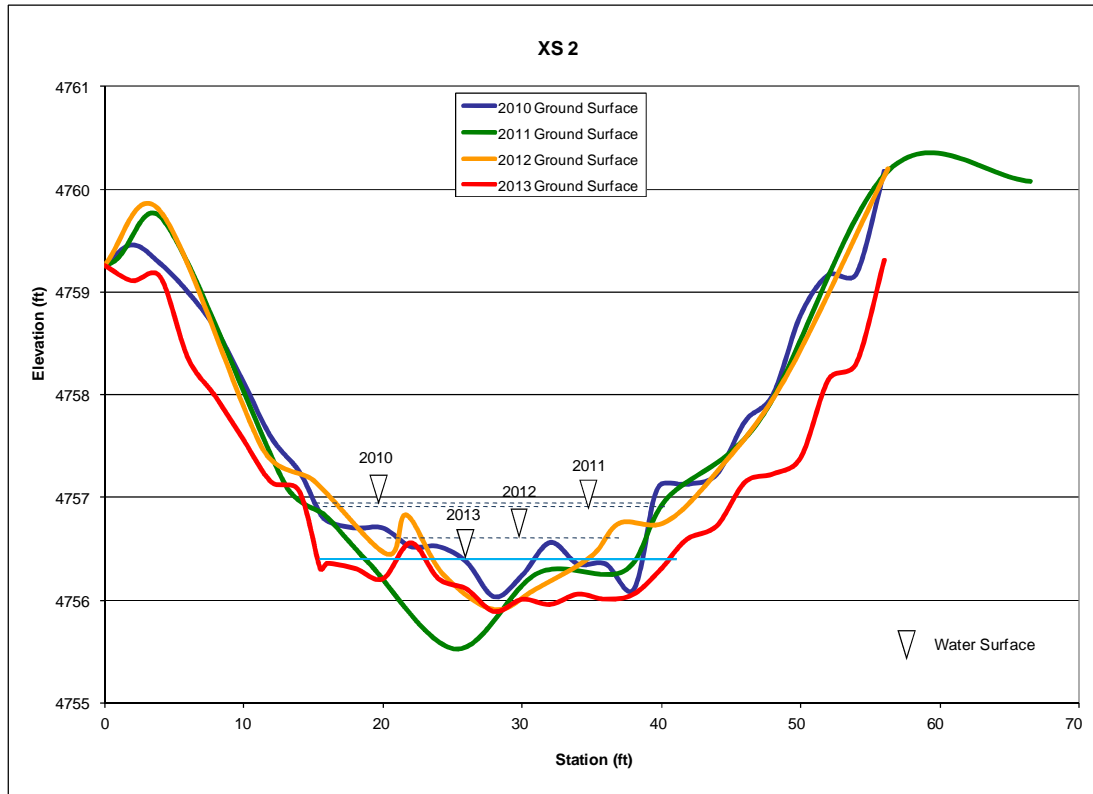
**Chart 2. Survey data collected at cross-section 2 from 2010 to 2013.**

The channel at cross-section 2 has displayed over-wide conditions since construction (Chart 2). Natural fluvial geomorphological adjustments at this cross-section have included a slight narrowing of the channel width with aggradation (accumulation of material) on the left and right edges of the channel bottom. Vegetation establishment along both banks of the channel have effectively narrowed the surface water flow and thalweg. The average width of the constructed creek channel down-gradient of the culvert outlet is generally greater than the 2 to 3 feet stipulated in the design. The width of the creek at

cross-section 2 is approximately 25 feet. Continued aggradation of the channel appears to be improving the width/depth ratio and general aquatic habitat quality of this stream.
