## MONTANA DEPARTMENT OF TRANSPORTATION WETLAND MITIGATION MONITORING REPORT: YEAR 2013

*Redstone – East & West  
Sheridan County, Montana*

MDT Project Number STPP 22-1(5)14  
Redstone – East & West  
Control Number 2024

USACE: NWO-2001-90723-MTH

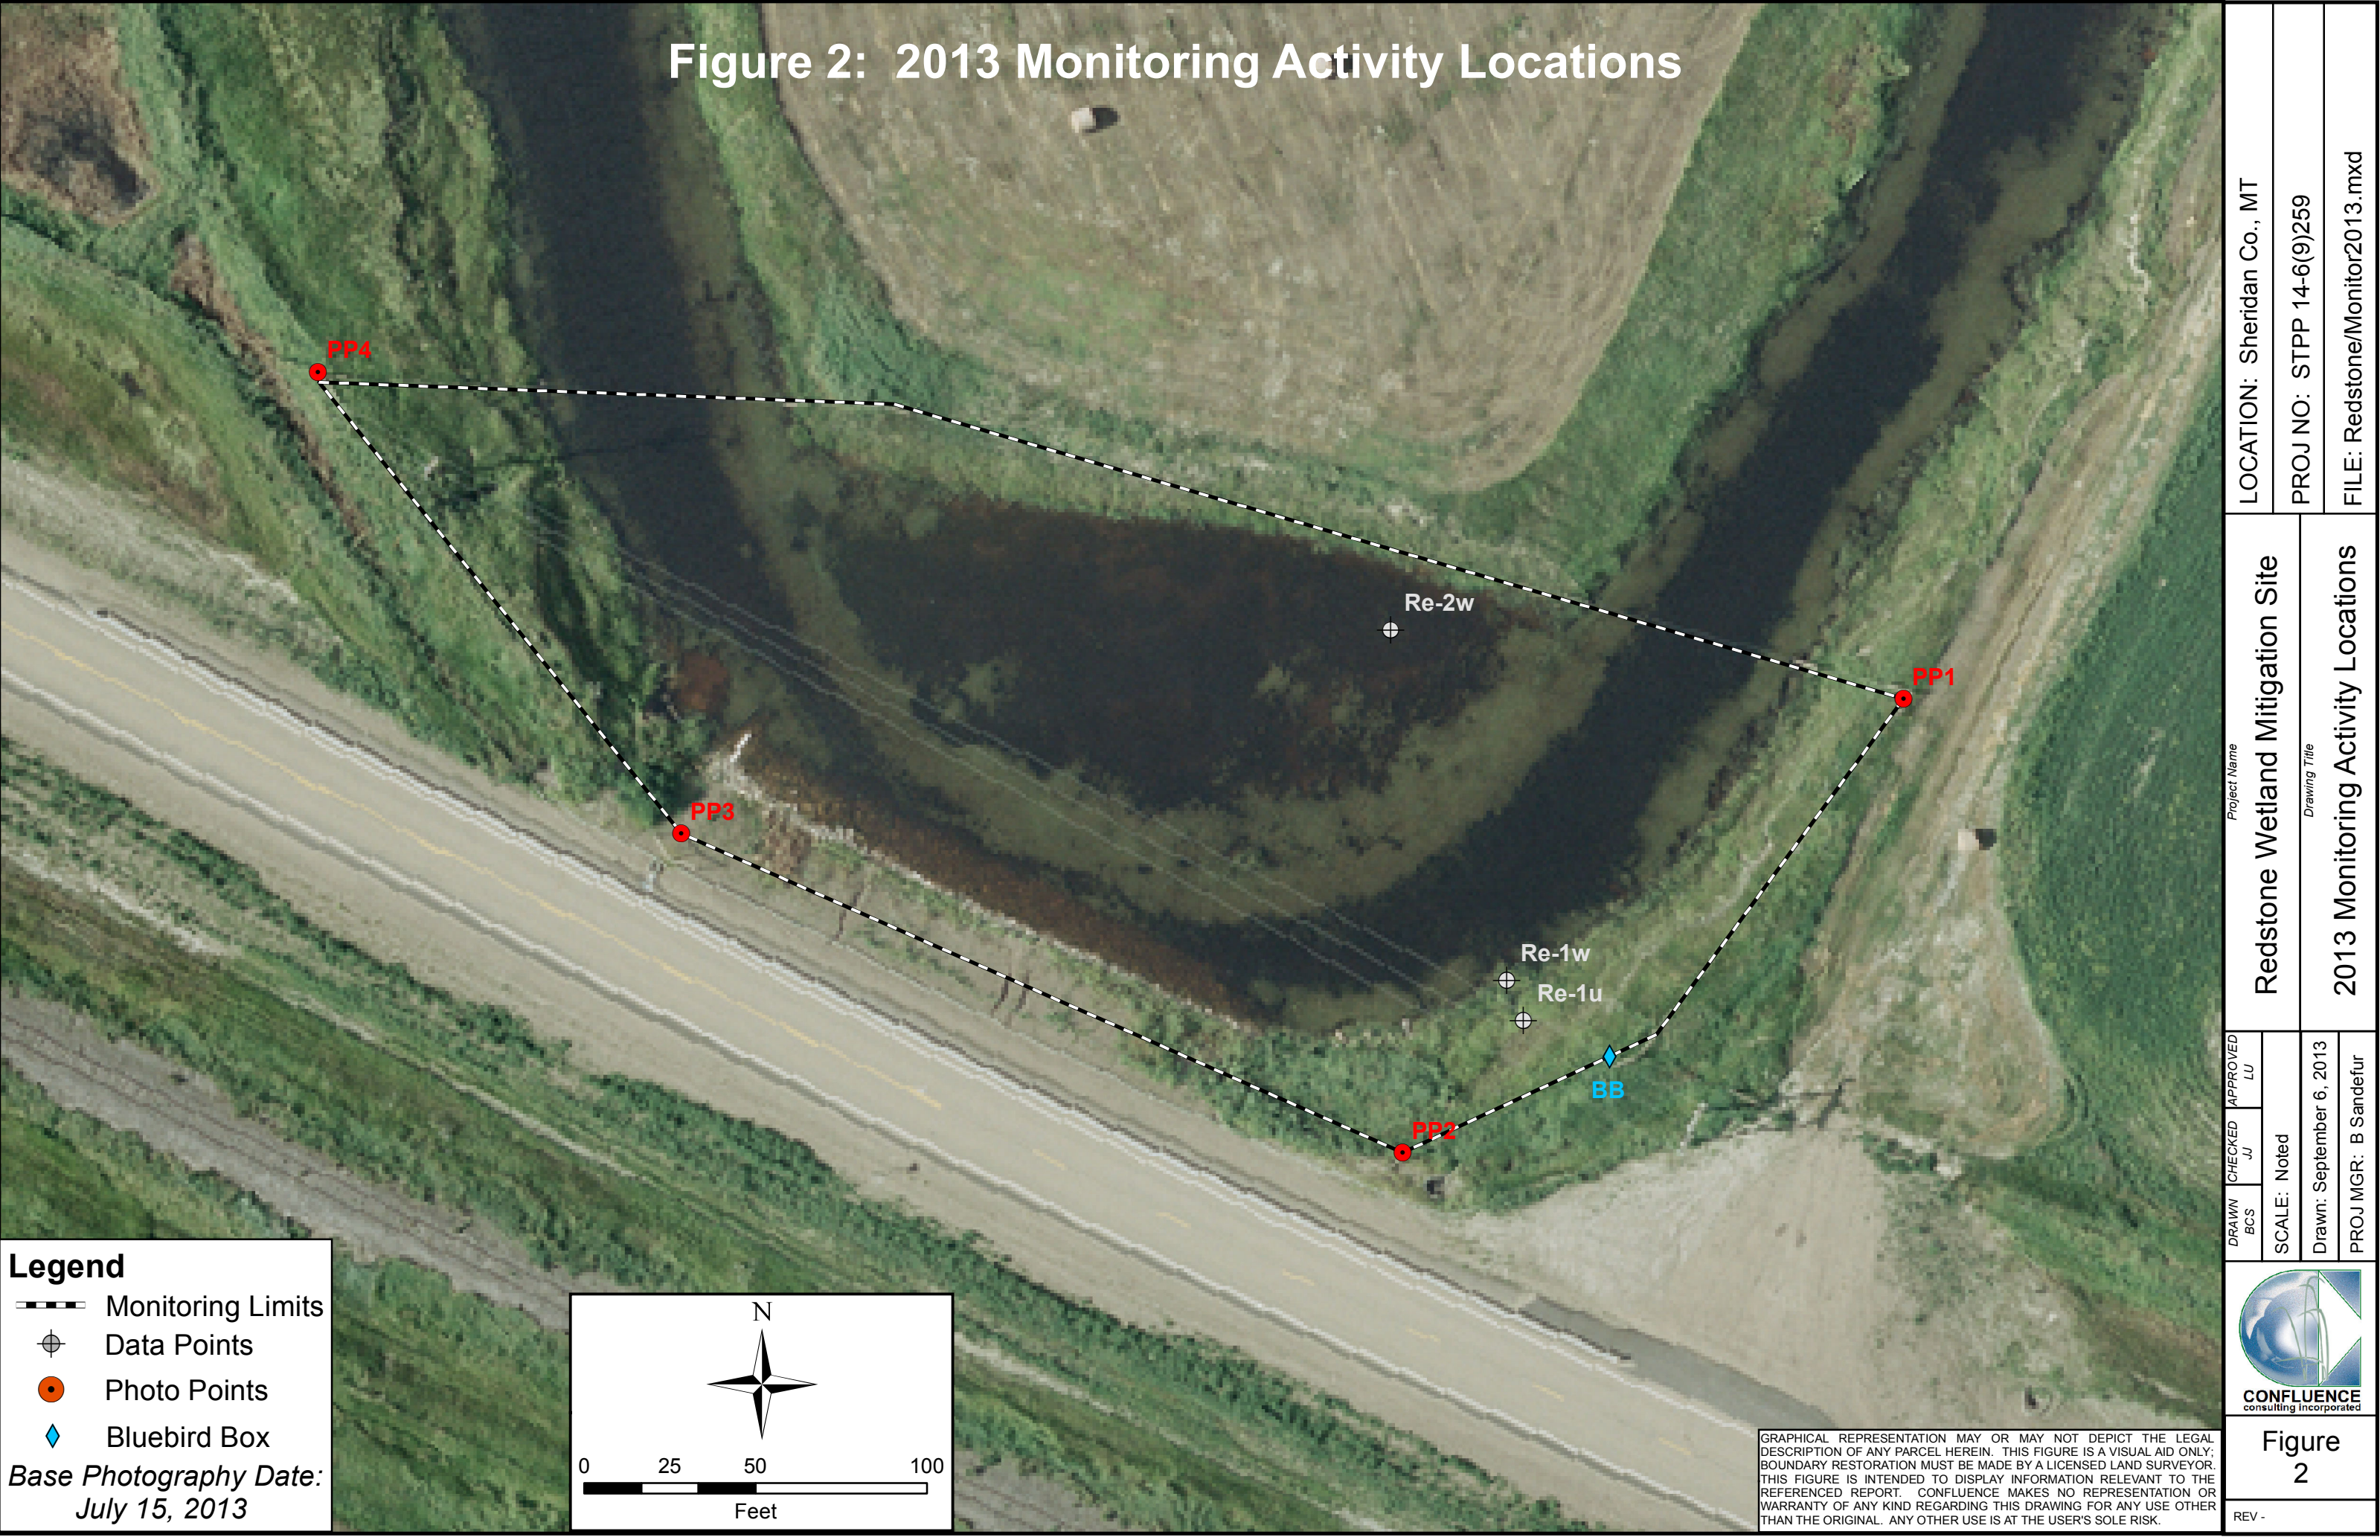
Figure 2: 2013 Monitoring Activity Locations

LOCATION: Sheridan Co., MT		Redstone Wetland Mitigation Site		Project Name	
PROJ NO: STPP 14-6(9)259		2013 Monitoring Activity Locations		Drawing Title	
FILE: Redstone/Monitor2013.mxd		DRAWN BCS		CHECKED JJ	APPROVED LU
		SCALE: Noted		Drawn: September 6, 2013	
				PROJ MGR: B Sandefur	
		CONFLUENCE consulting incorporated		Figure 2	
				REV -

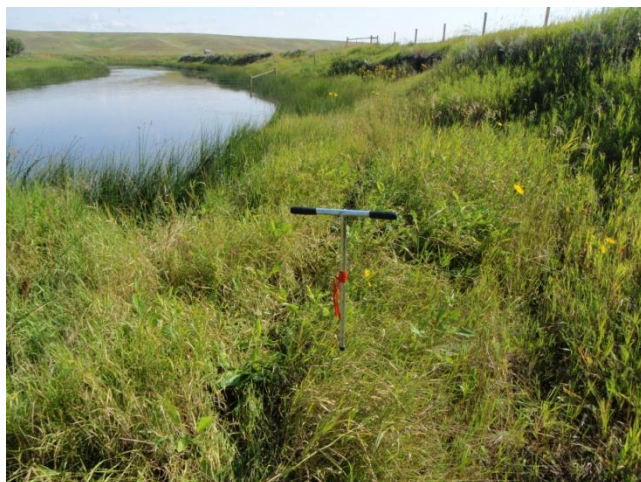
**Data Point – Re-1u**      **Location:** Veg community 1  
**Bearing:** 0 Degrees      **Taken in 2013**

Three soil pits were excavated to characterize the site soil. Data points Re-1w (Community 2) and Re-2w (Community 3) were located in areas that met the wetland criteria. Data point Re-1w was located at the edge of the open water. The soil profile at this point revealed very dark gray (7.5YR 3/1) sandy clay with 5 percent dark yellowish brown (10YR 4/6) redoximorphic concentrations. The depleted matrix was a positive indicator for hydric soil. The presence of hydric soil at Re-2w was confirmed with a depleted matrix (F3). This clay soil exhibited a dark reddish gray (5YR 4/2) matrix with five percent reddish brown (7.5YR 4/4) redox concentrations. This data point was situated within the recently excavated soil. The presence of redox features to surface was likely the result of excavation to existing hydric soil. Soil pit Re-1u was located in upland community type 1 and consisted of dark reddish brown (5YR 3/2) and dark gray (5YR 4/1)

matrix with no redoximorphic characteristics within the upper 13 inches of the profile.

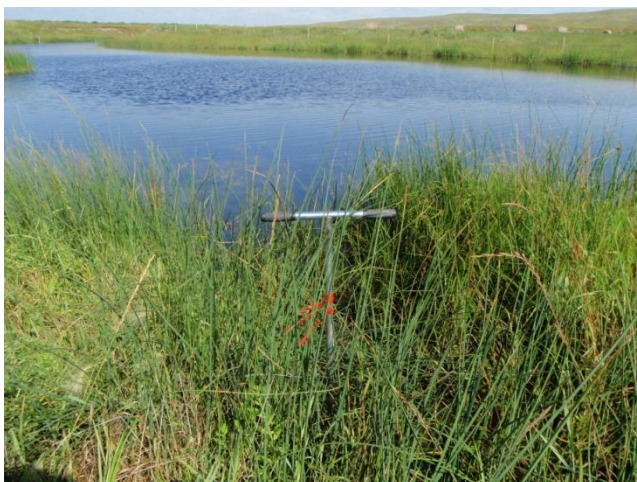
**Data Point – Re-1w**      **Location:** Veg community 2  
**Bearing:** 330 Degrees      **Taken in 2013**

Wetland community Type 2 – *Schoenoplectus* spp. characterized 0.14 acres within the shallower water depths surrounding community Type 3. This community was dominated by saltmarsh club-rush (*Schoenoplectus maritimus*) with hard-stem club-rush (*Schoenoplectus acutus*), three-square club-rush (*Schoenoplectus pungens*), and freshwater cord grass (*Spartina pectinata*) were identified in standing water with fox-tail barley, American wild mint (*Mentha arvensis*), white horehound (*Marrubium*) and western water-hemlock (*Cicuta douglasii*) along the margins of inundation. This community will likely expand into the recently constructed wetland area.

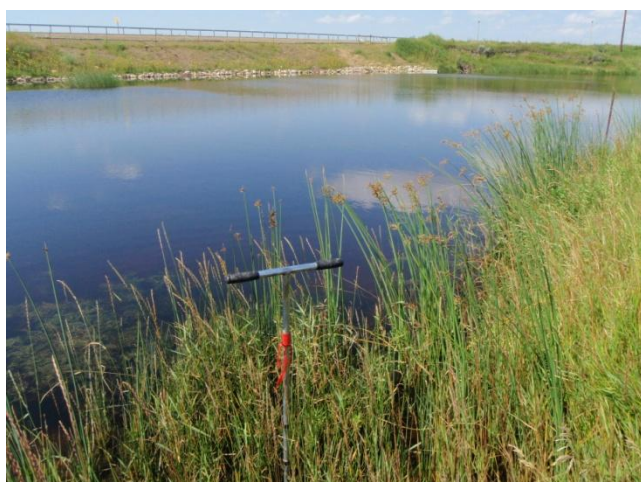
**Data Point – Re-2w**      **Location:** Veg community 3  
**Bearing:** 215 Degrees      **Taken in 2013**

Wetland community Type 3 – Aquatic macrophytes/Open Water was identified across 0.82 acres within the 1.26-acre monitoring area. This community was characterized by 100 percent inundation and included green algae, beaked ditch-grass (*Ruppia maritima*), additional unidentified aquatic macrophytes, and saltmarsh club-rush along the transition of this community with Type 2. It appeared during the 2013 field survey that this area is perennially inundated.

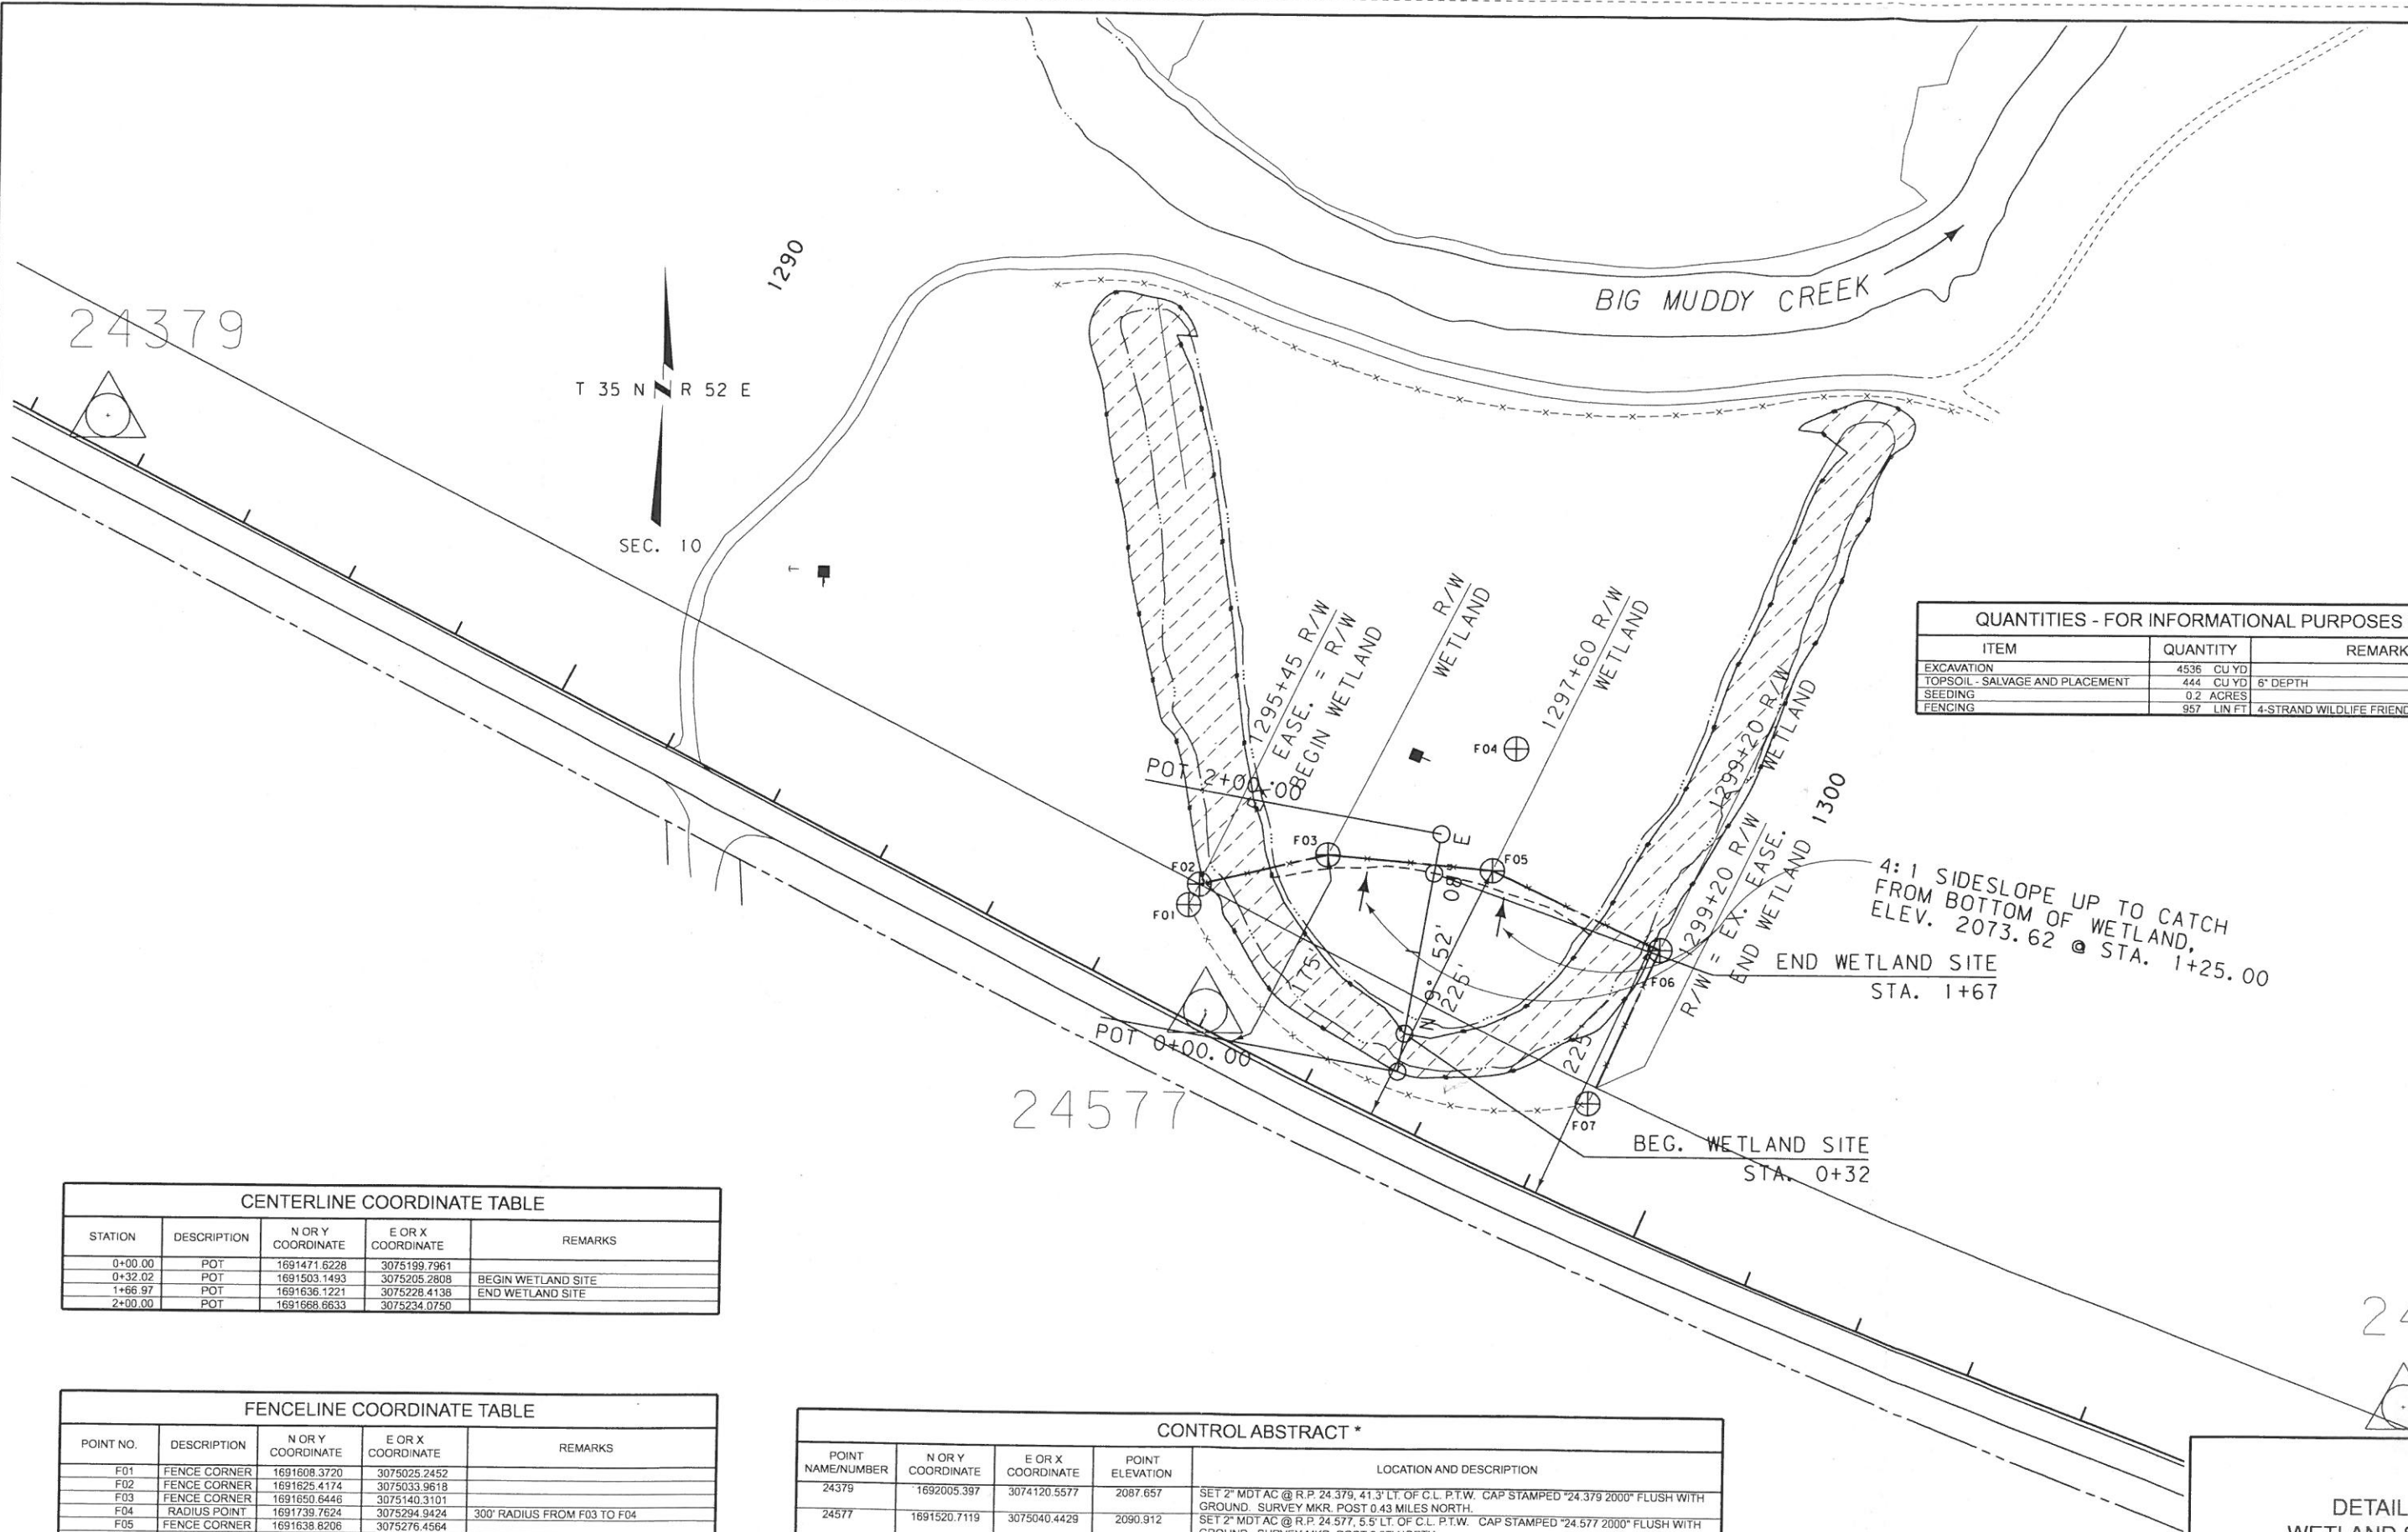
QUANTITIES - FOR INFORMATIONAL PURPOSES ONLY		
ITEM	QUANTITY	REMARKS
EXCAVATION	4536 CU YD	
TOPSOIL - SALVAGE AND PLACEMENT	444 CU YD	6" DEPTH
SEEDING	0.2 ACRES	
FENCING	957 LIN FT	4-STRAND WILDLIFE FRIENDLY FENCE

4:1 SIDESLOPE UP TO CATCH  
FROM BOTTOM OF WETLAND,  
ELEV. 2073.62 @ STA. 1+25.00  
END WETLAND SITE  
STA. 1+67
