# MONTANA DEPARTMENT OF TRANSPORTATION WETLAND MITIGATION MONITORING REPORT: YEAR 2013

*Rostad Ranch  
Meagher County, Montana*

MDT Project Number STPX-0002(749)  
Control Number 5565

USACE: NWO-2006-90851-MTB

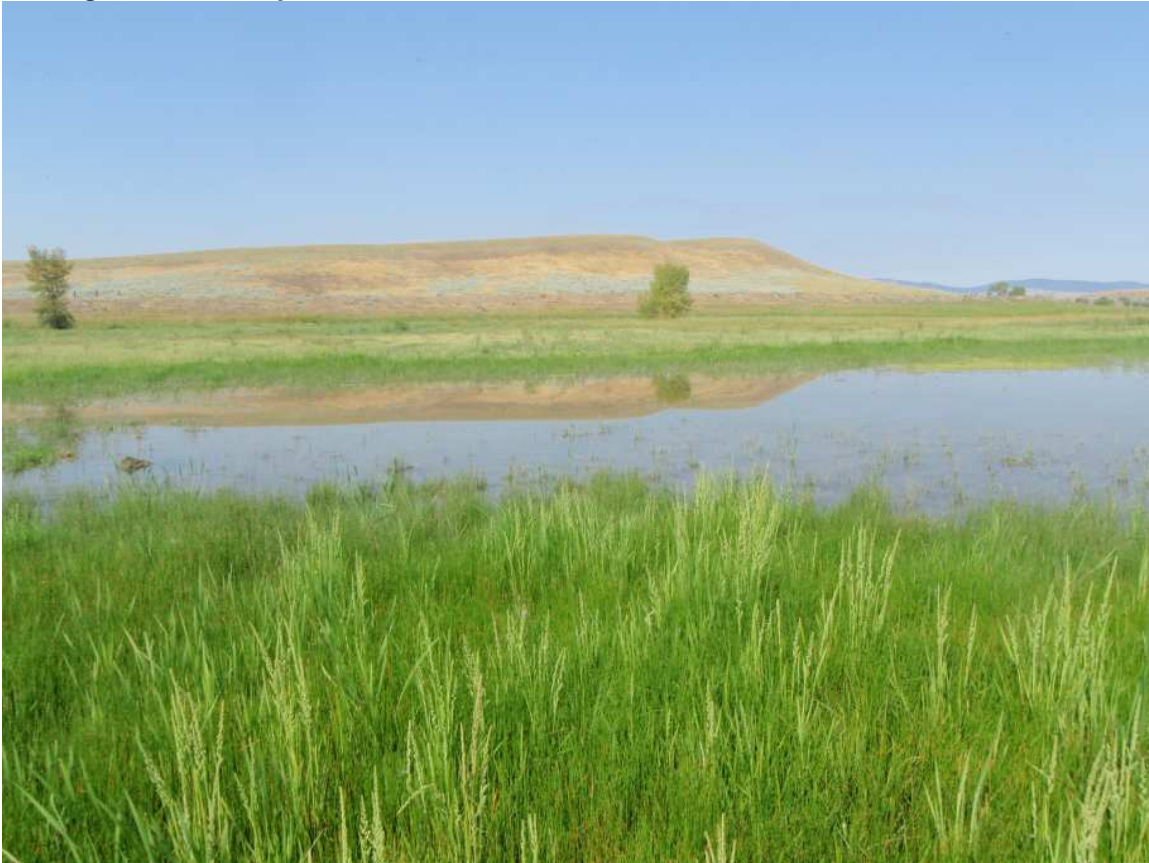
Cover: View of the inundated man-made impoundment at the Rostad Ranch wetland mitigation site.

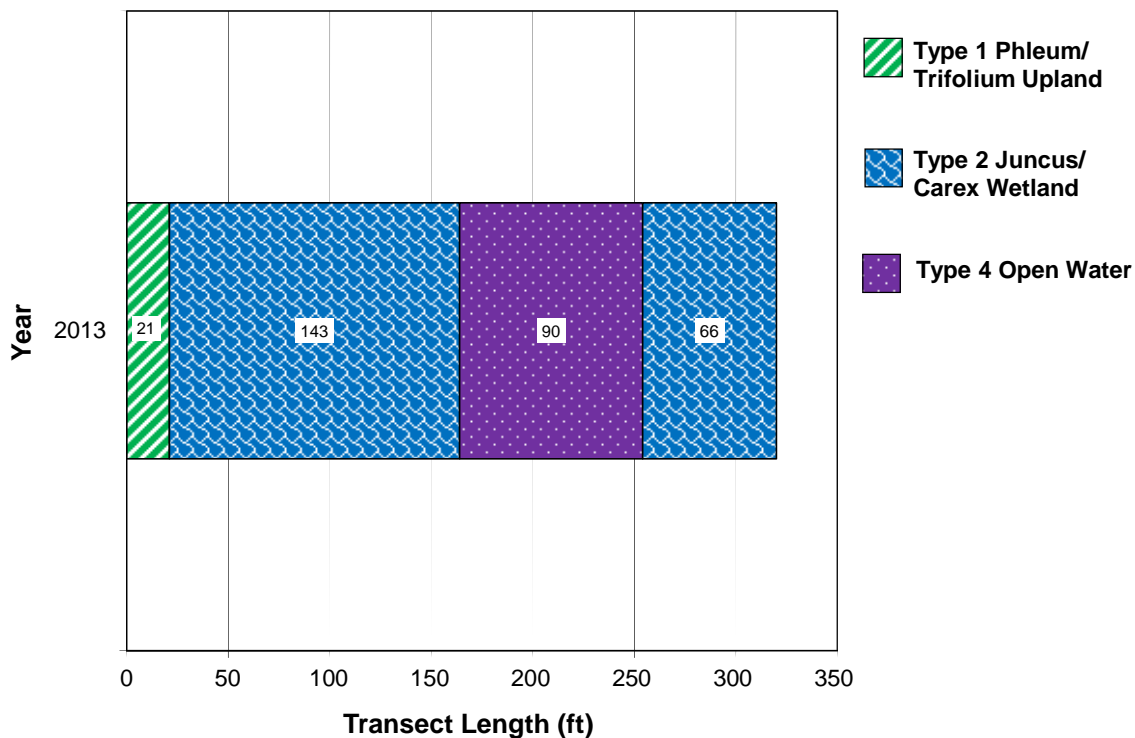
Chart 5. Transect maps showing community types on Transect T-3 in 2013 at the Rostad Ranch Wetland Mitigation Site.

Transect T-3 was established in the southern end of the mitigation site and traversed the excavated re-establishment and rehabilitation credit areas. Transect T-3 also began at a mature cottonwood and extended east for 320 feet (Figure 2, Appendix A). This transect originated in the upland *Phleum* community, transitioned into community Type 2, continued through the excavated open water depression, and ended in community Type 2. Approximately fifteen percent of this transect consisted of bare ground reflecting the recently disturbed conditions of constructed wetland mitigation area.
